THE GOODSYARD

Structural Engineering Condition Survey Report

September 2019

This is a structural visual condition survey report of the existing structures on the Bishopsgate Goodsyrd site undertaken on 15th & 18th February 2019 prepared by WSP.

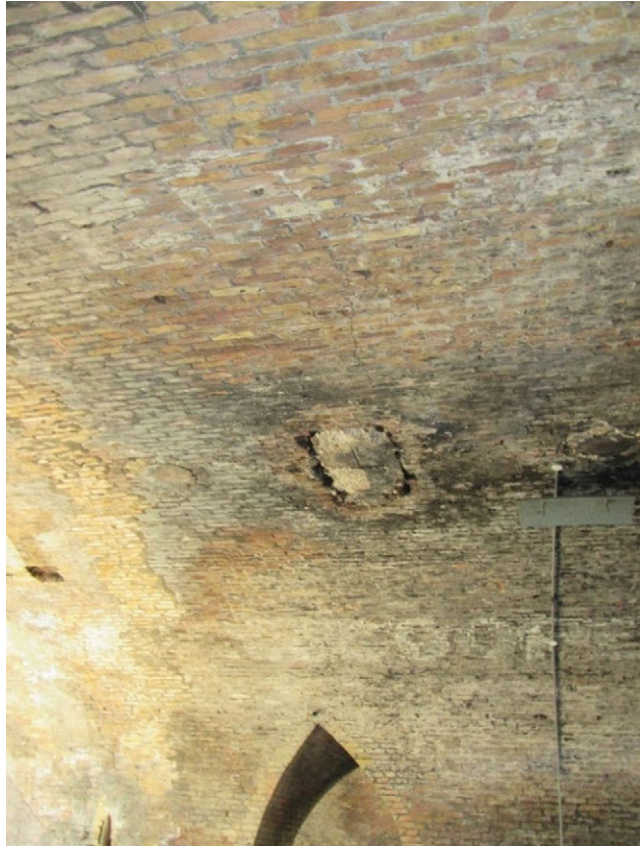
BA1: Historic modification to Braithwaite Arch

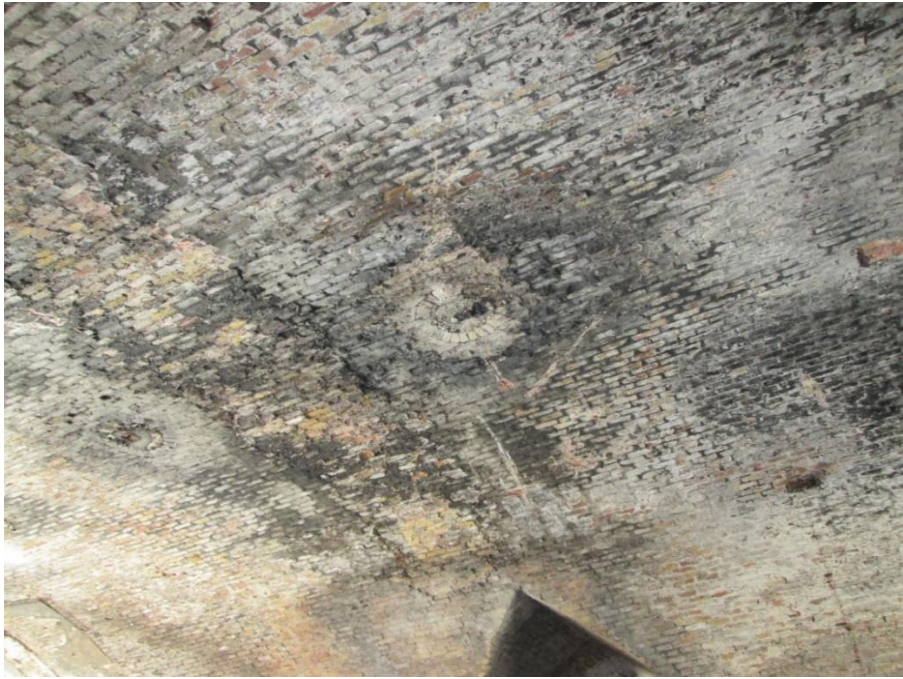
BA2: Minor Cracking to soffit of arch

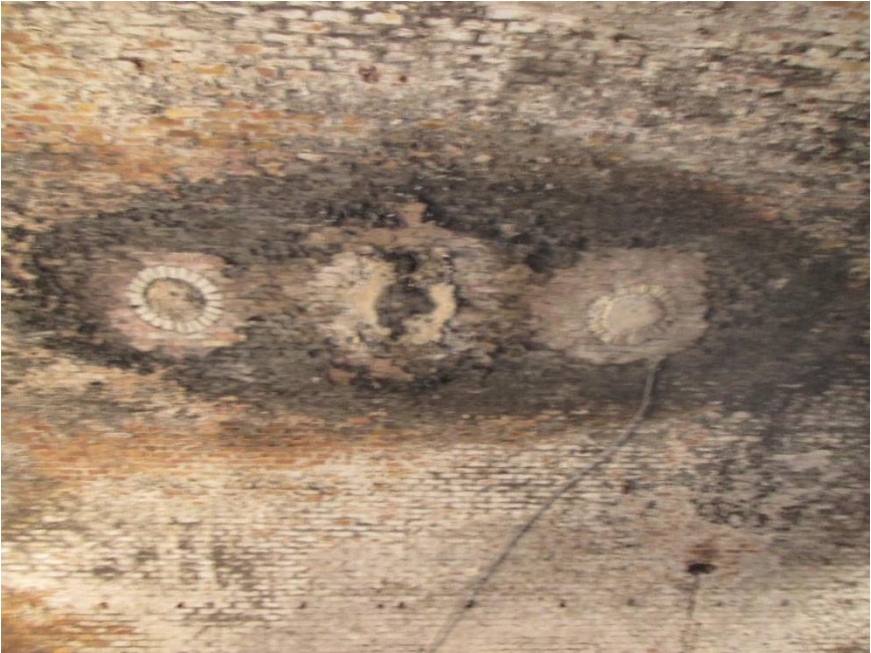
BA3: Weathered Brickwork Braithwaite Arch

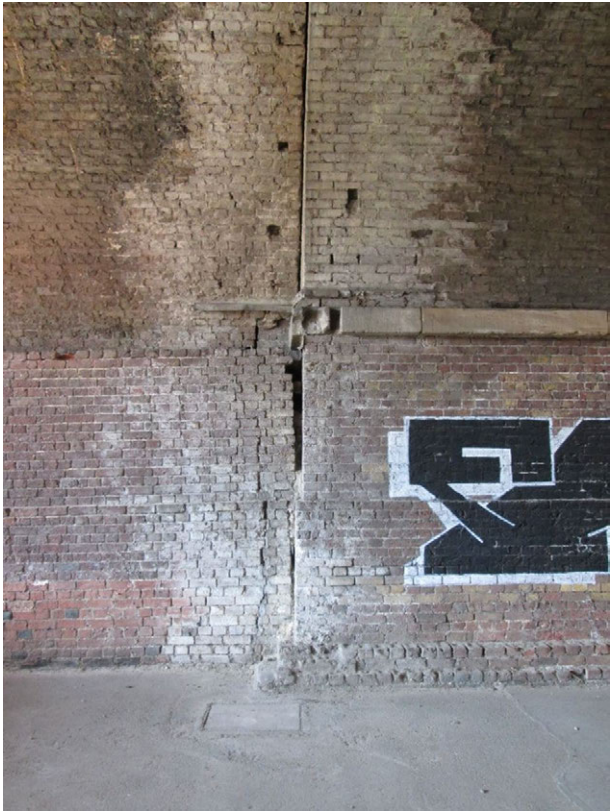
BA4: Historic Settlement

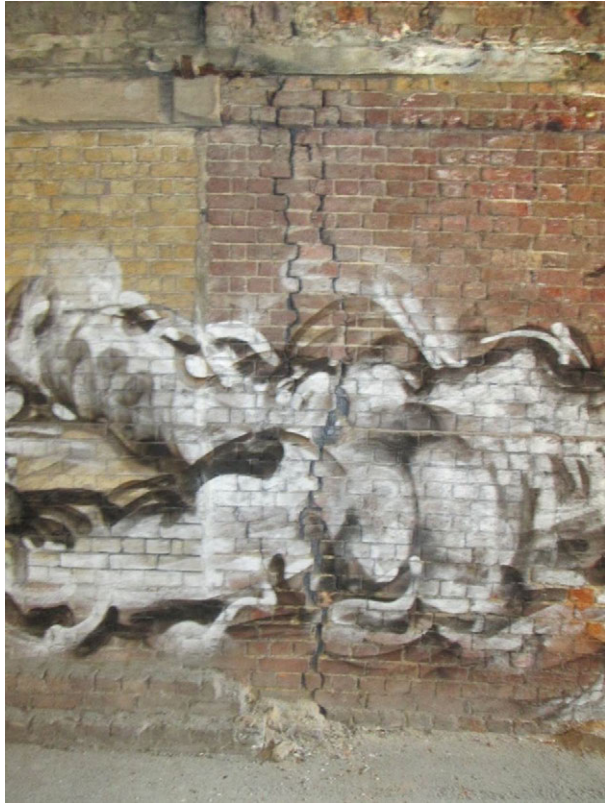
BA5: Historic Settlement to 1860's Arch

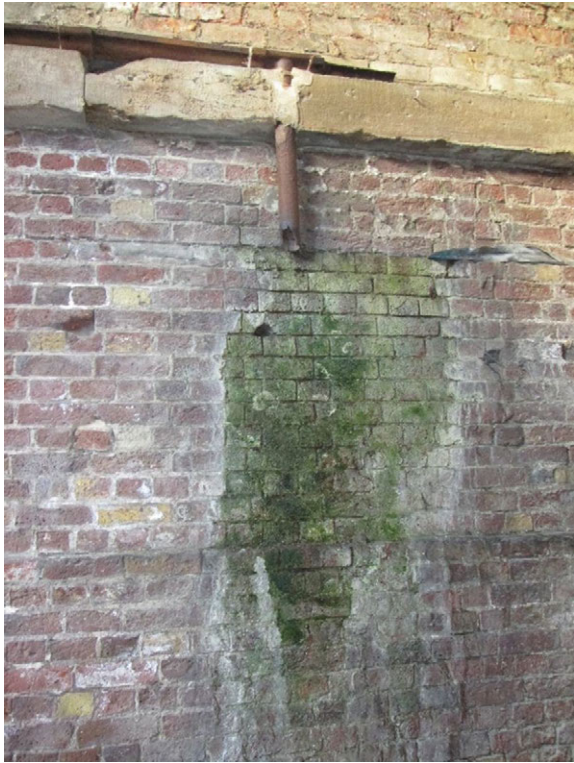
BA6: Staining / Efflorescence of Brickwork

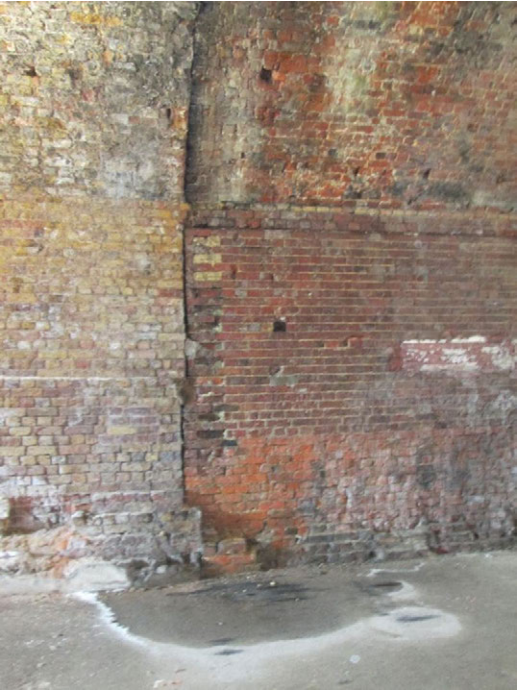
BA7: Weathering of brickwork due to water ingress

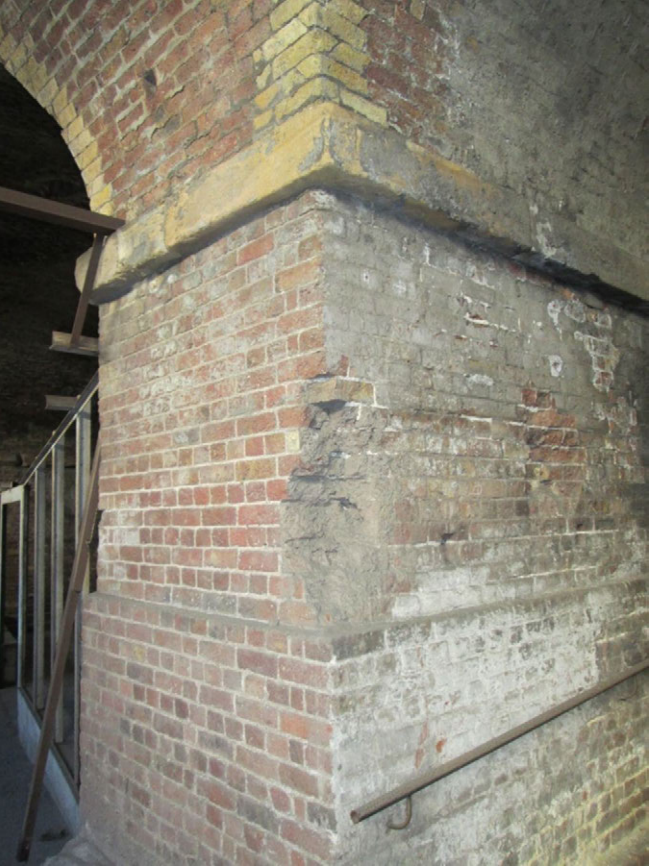
BA8: Localised damage to Braithwaite Arch

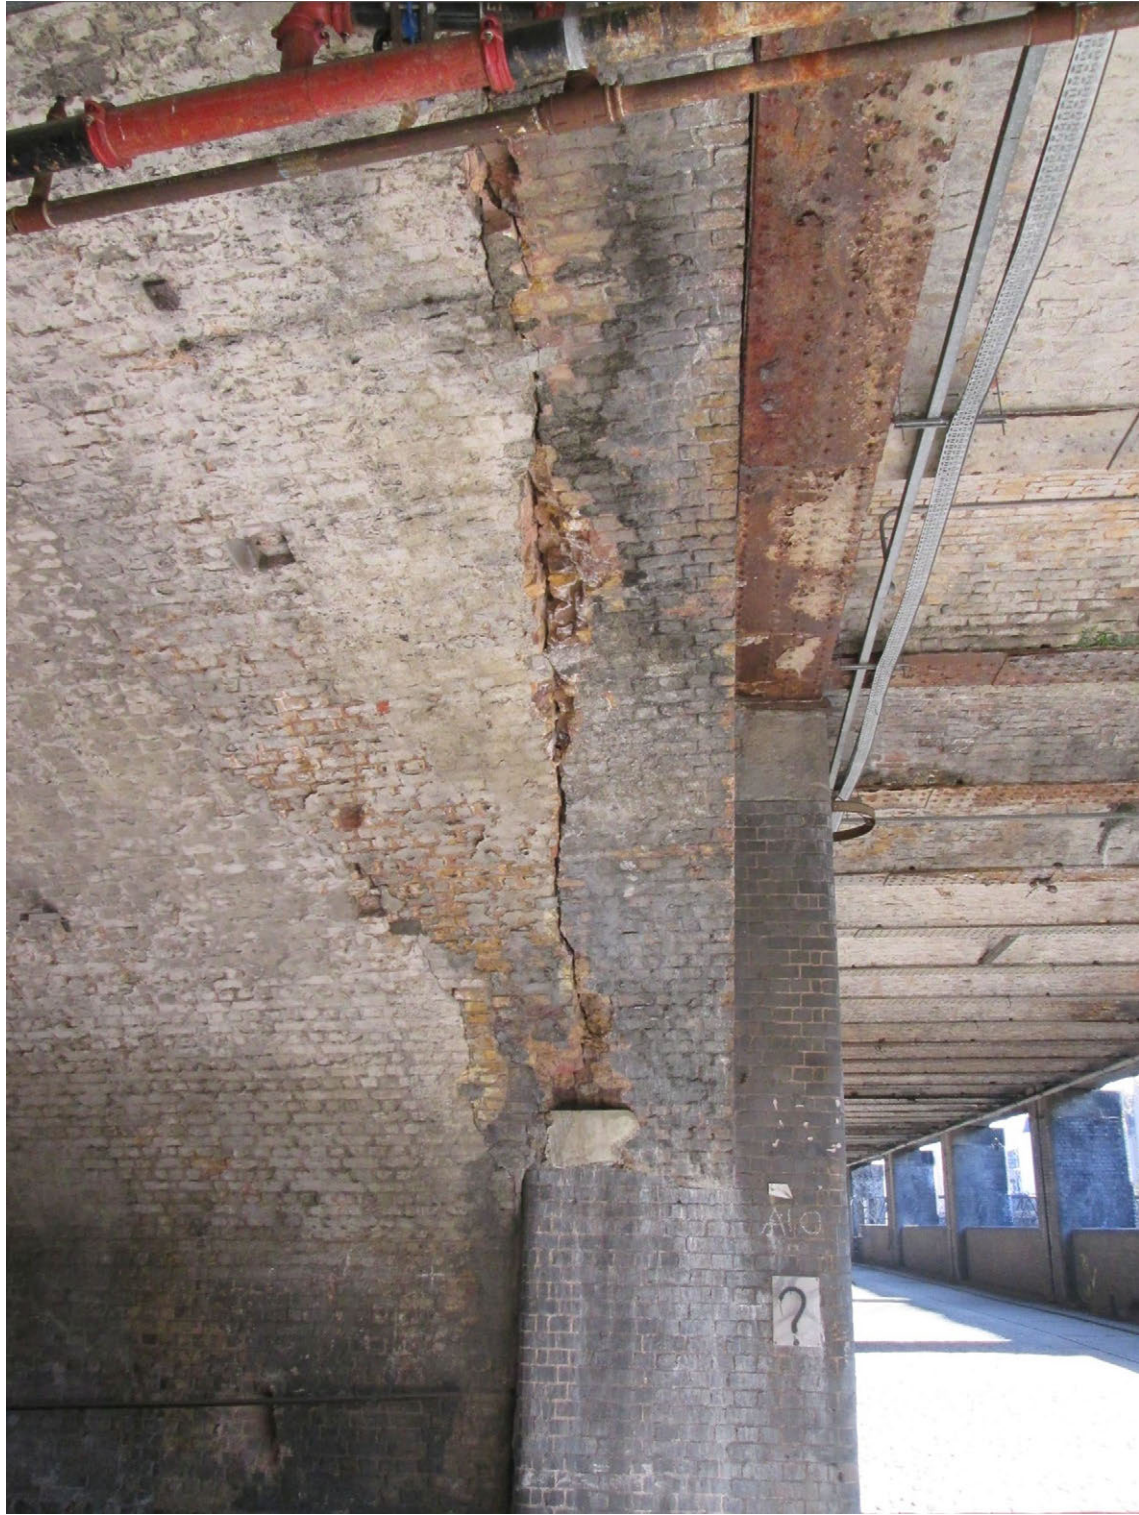
BA9: Cracking due to historic settlement of 1880's arch at junction with jack arch structure.

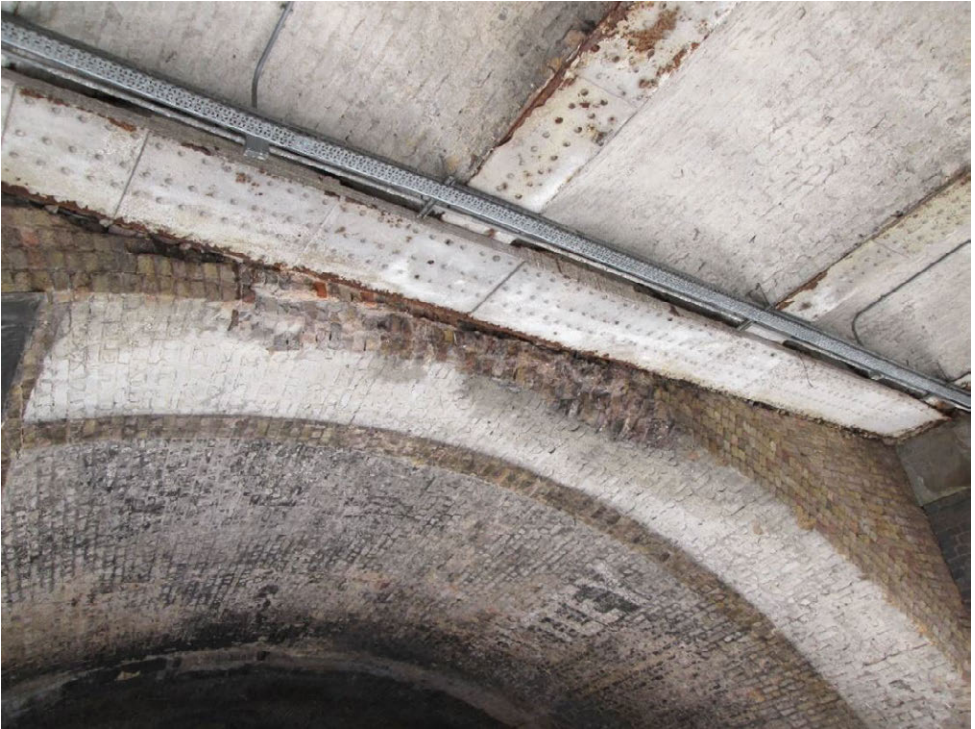
BA10: Weathered brickwork of 1880 arch at junction with Jack Arch due to water ingress

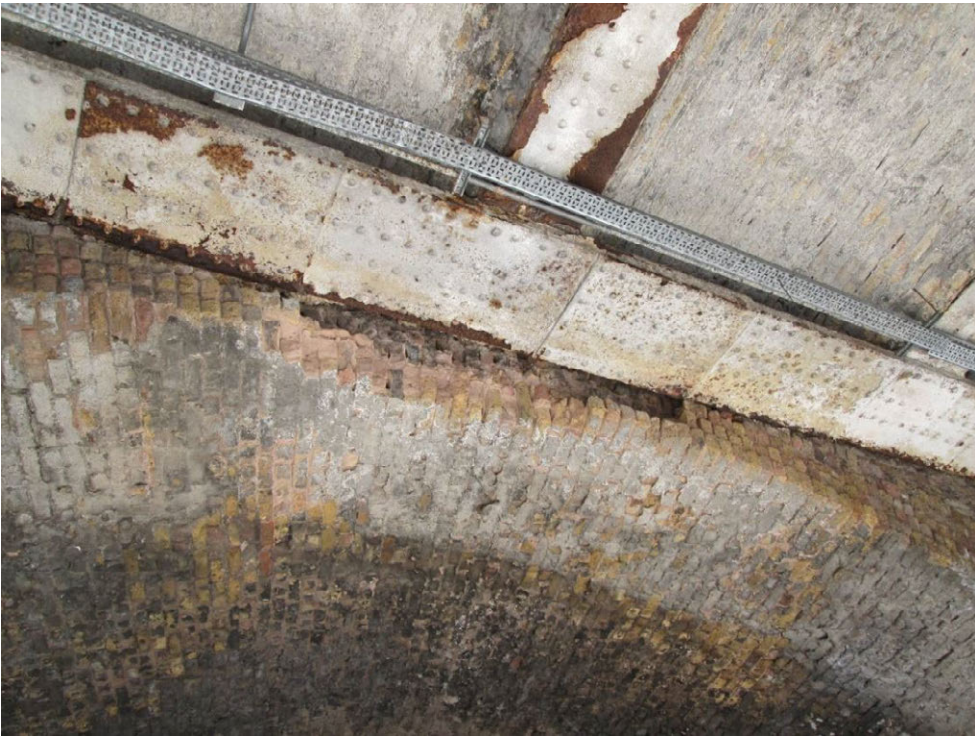
BA11: Weathered brickwork of 1880 arch at junction with Jack Arch due to water ingress

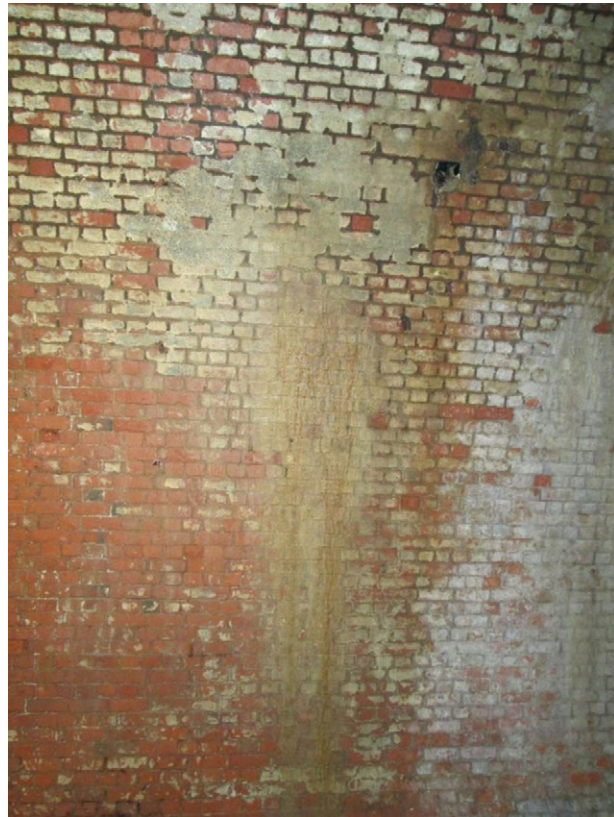
WA1: Water ingress through Arch

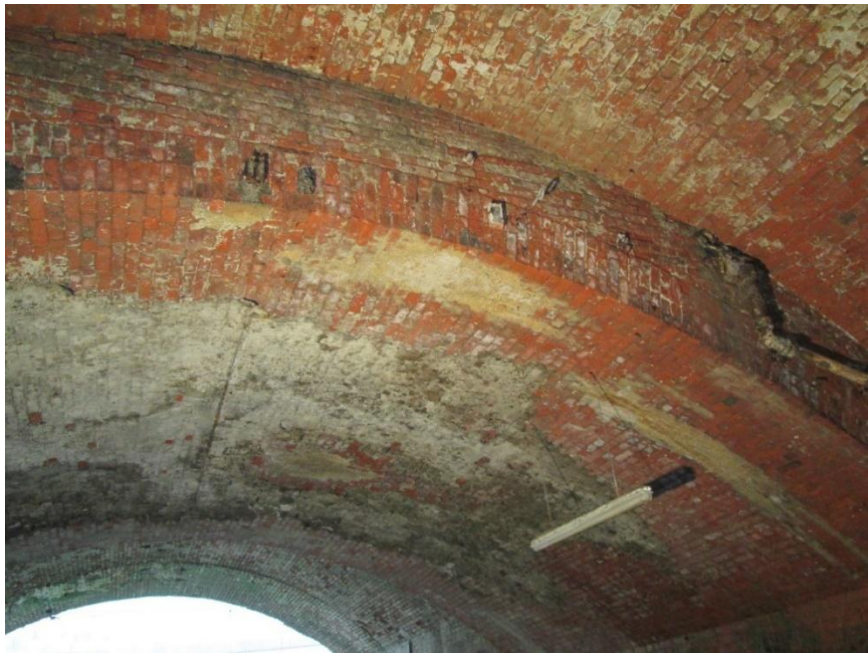
WA3: Minor Cracking & Water ingress

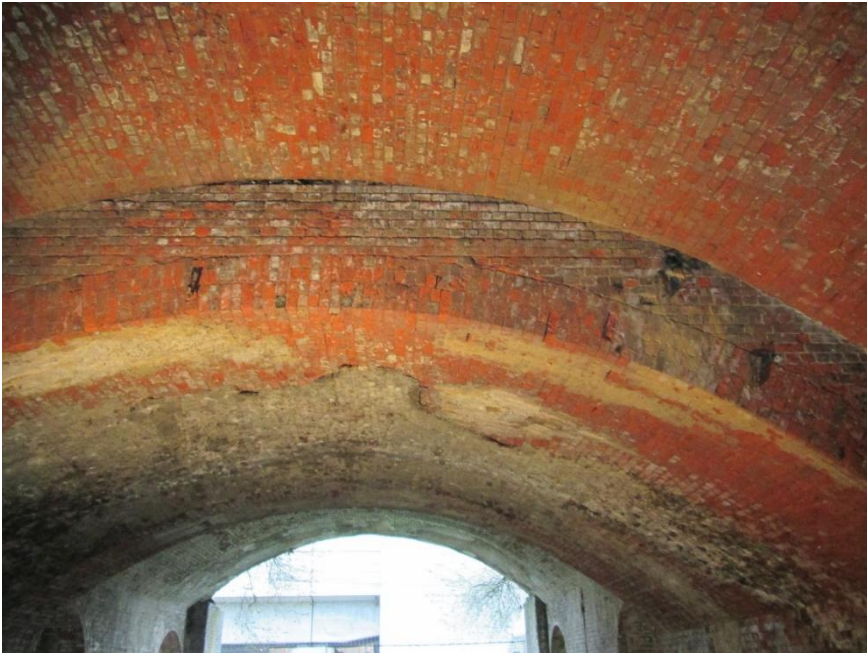
WA5: Weathered brickwork due to water ingress

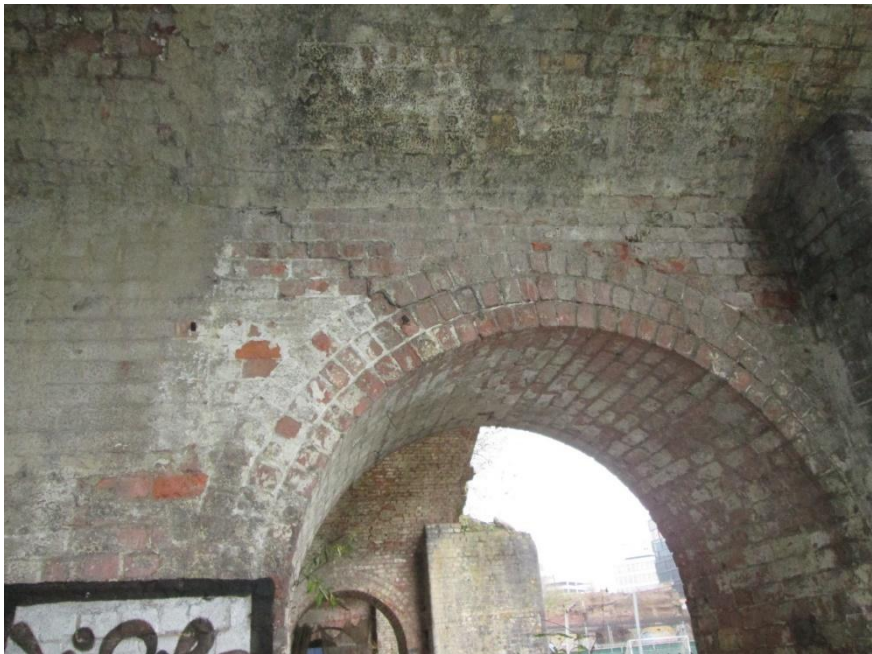
WA4: Minor cracking at crown of arch

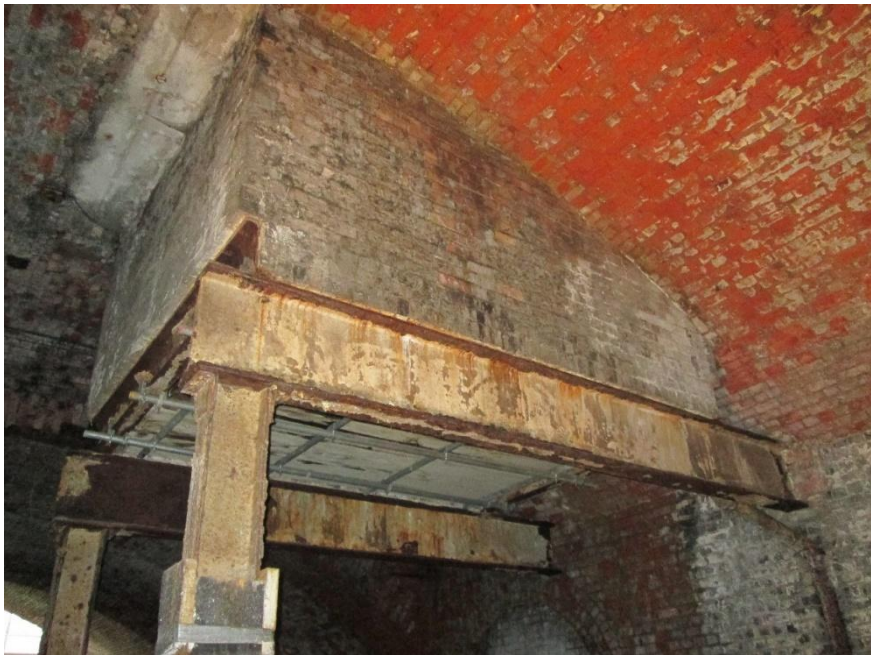
WA6: modifications to arch from previous use

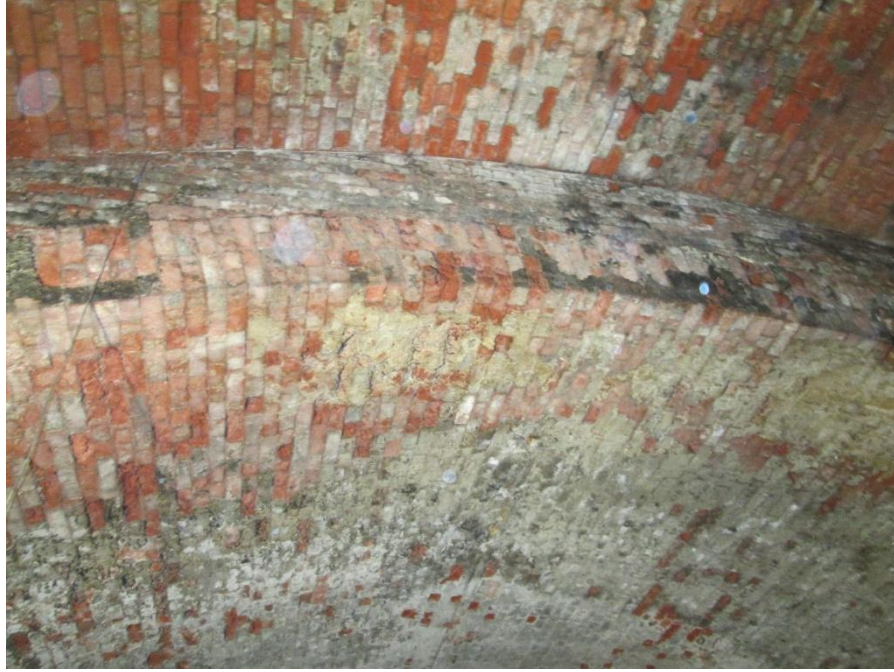
WA7: Arch dry no water ingress

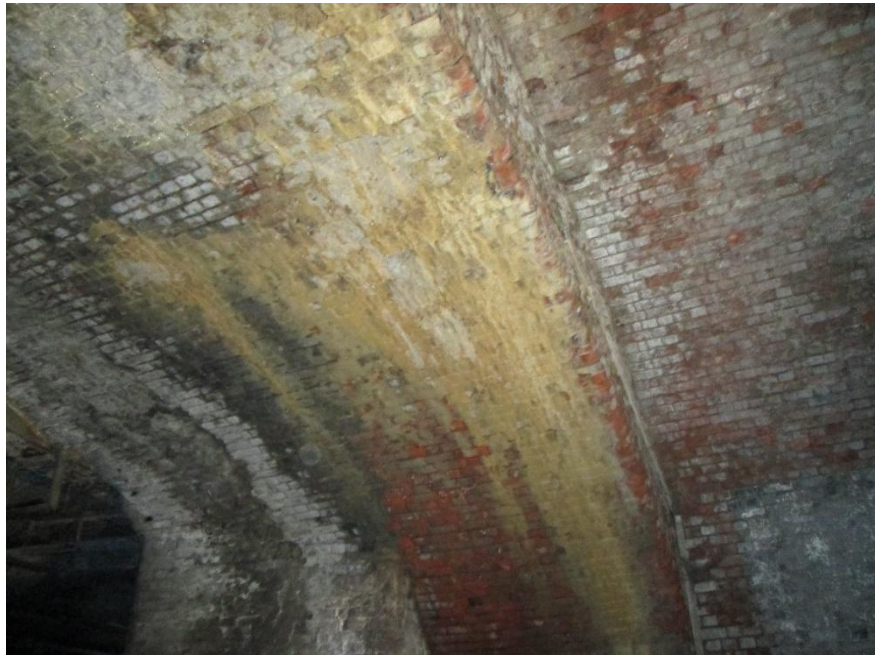
WA8: Water ingress through arch

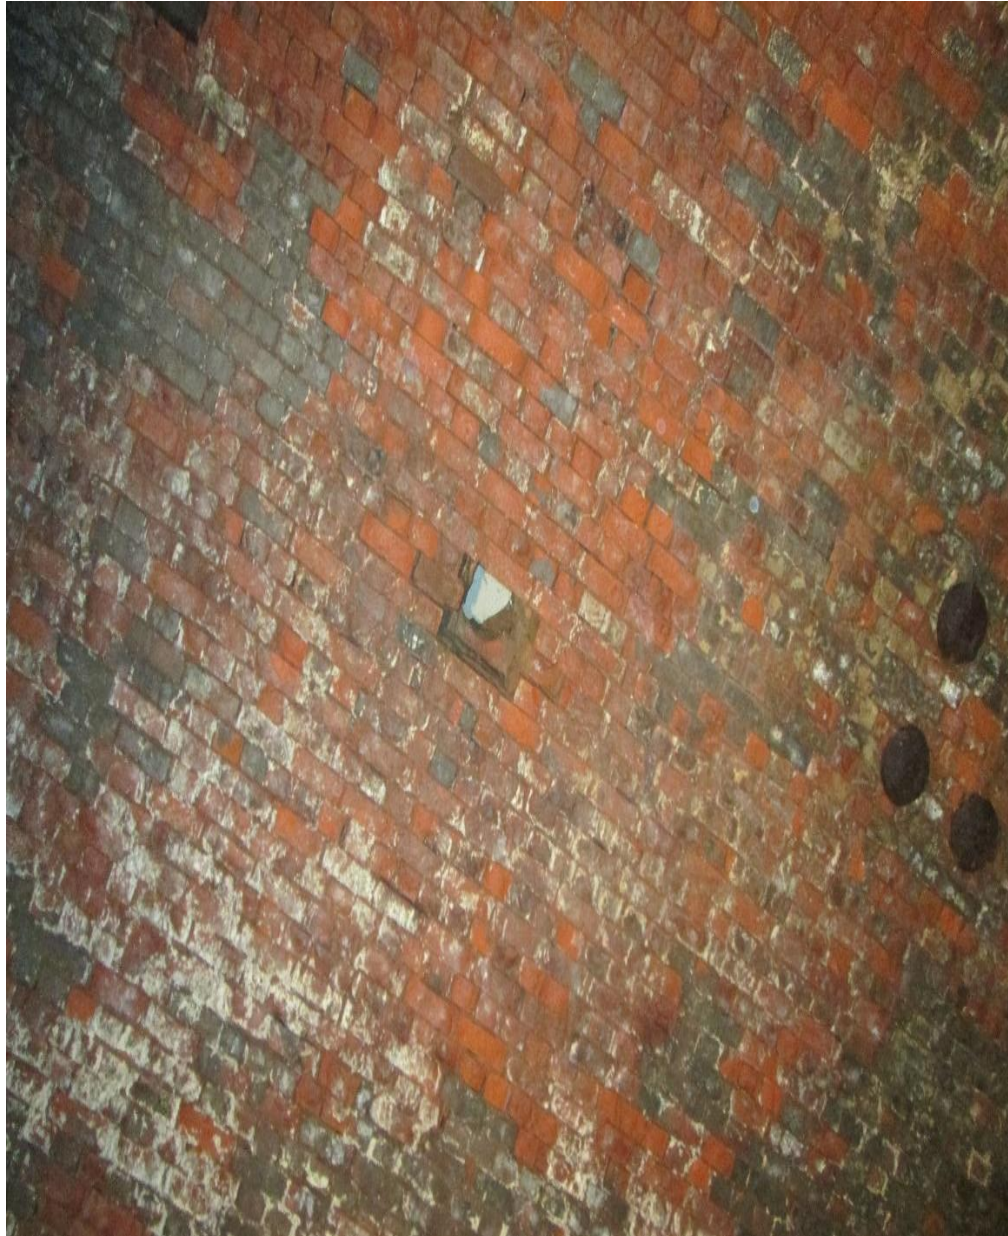
WA9: Efflorescence (crystalline salts deposits)

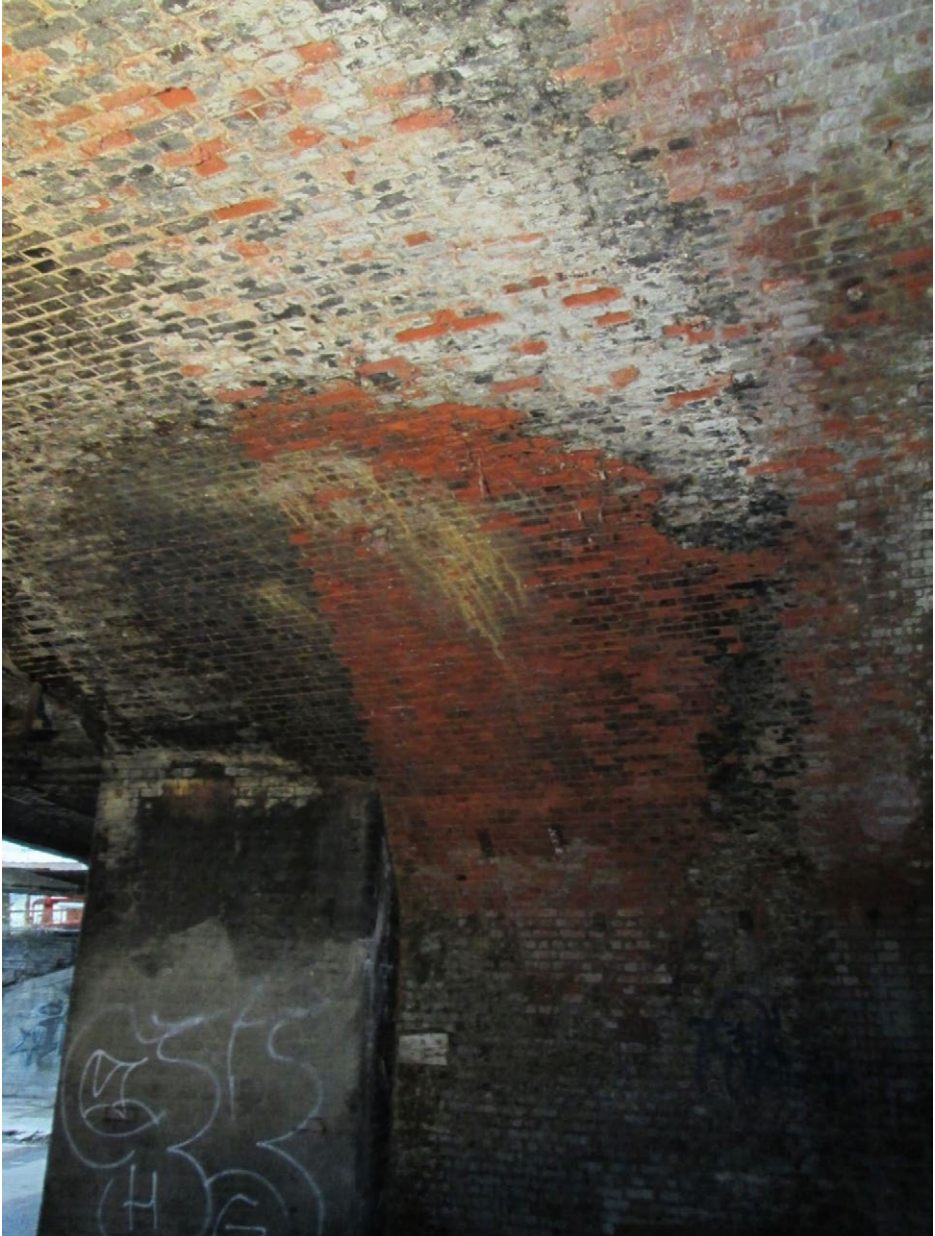
WA10: Water ingress through arch

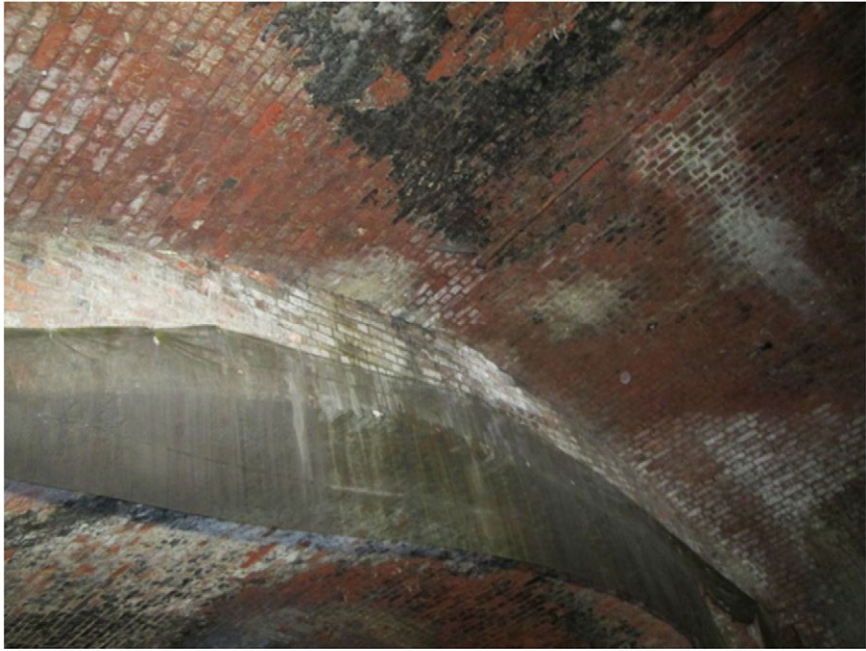
WA11: Modification to arch & water ingress

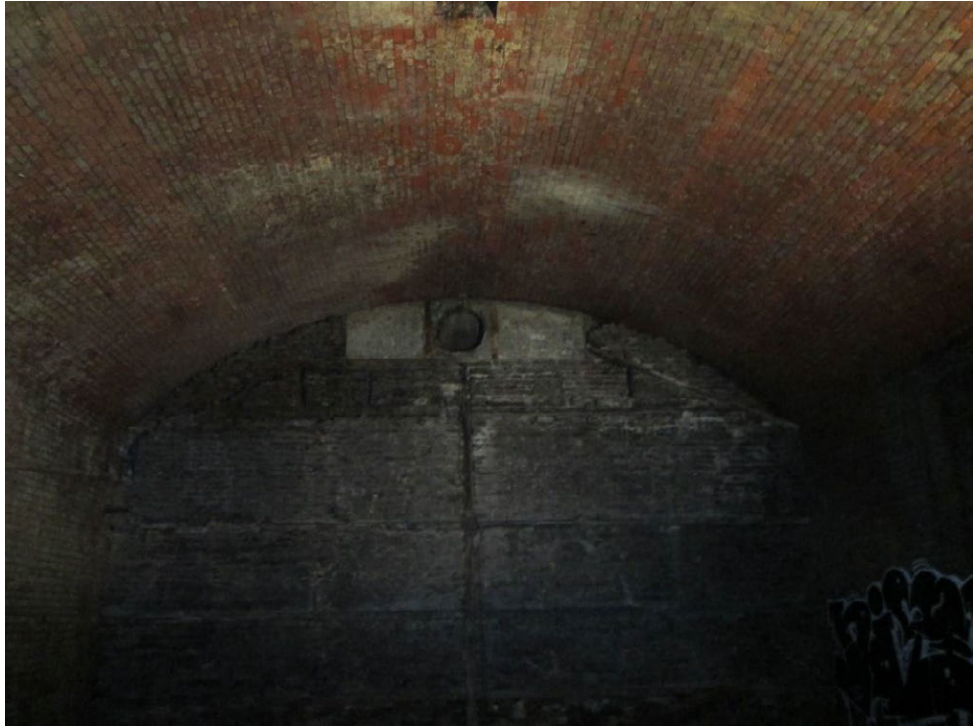
WA13: Brick end wall cracking and intermediate timbers rotting

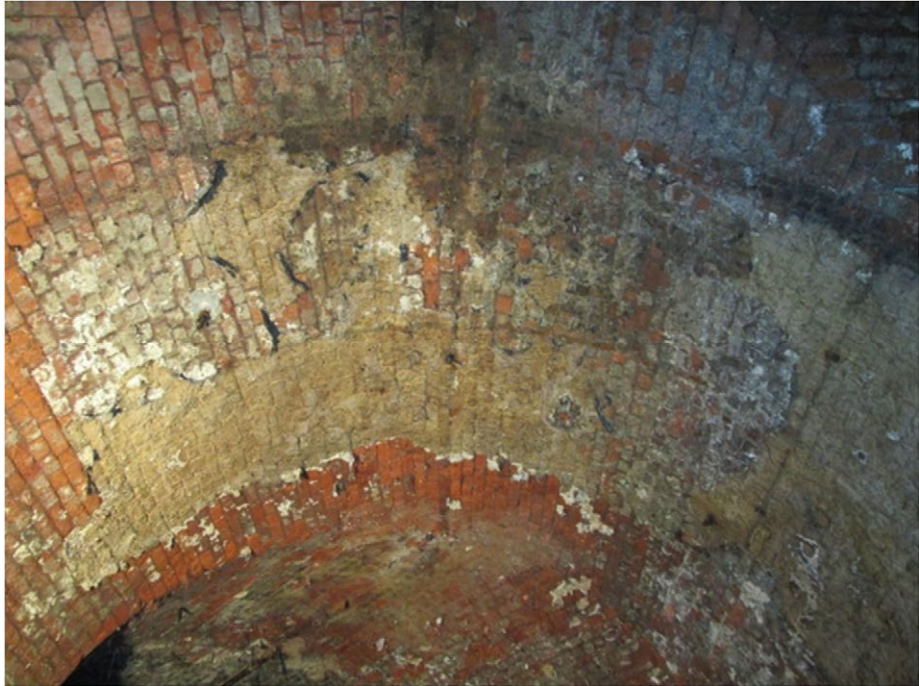
WA15 Weathered brickwork due to water ingress

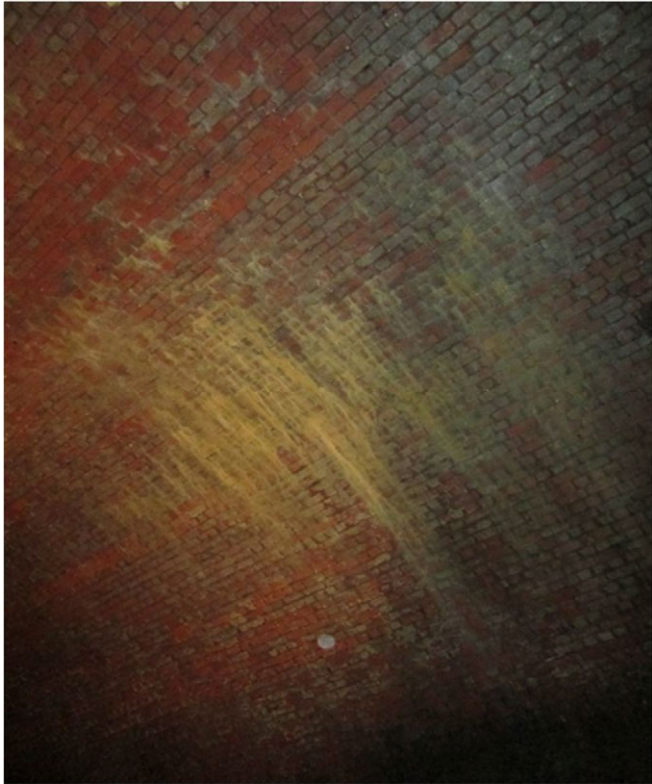
WA12: Severe Water ingress through arch

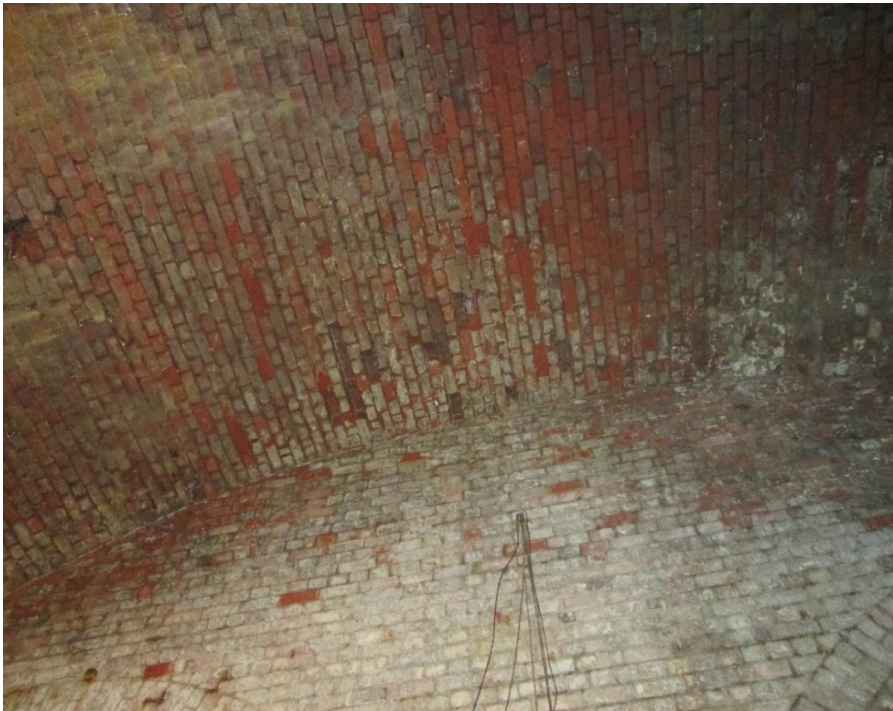
WA14: Minor water seepage through crown of arch

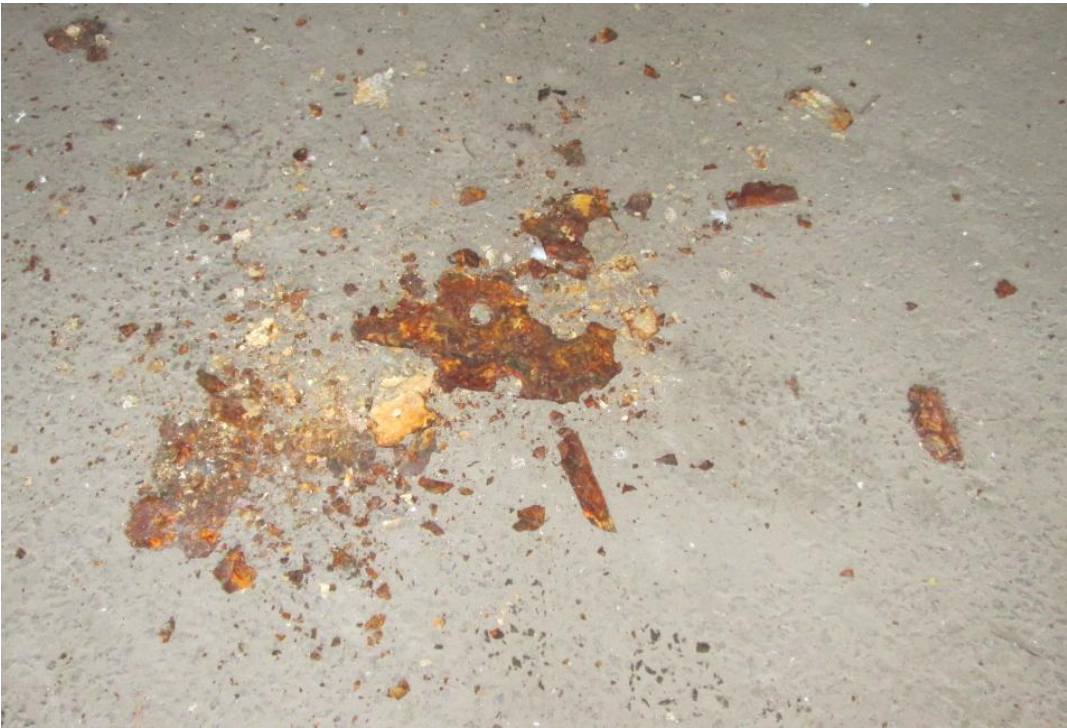
Image indicating falling corroded steel from beam above

Due to the substantial loss of steel to some of the members combined with the ongoing continued deterioration due to water ingress, we are of the opinion in order to avoid the potential risk of structural failure to the worst corroded areas temporary propping to these beams should be undertaken as soon possible combined with the removal of the fill material above currently surcharging the jack Arch structure.

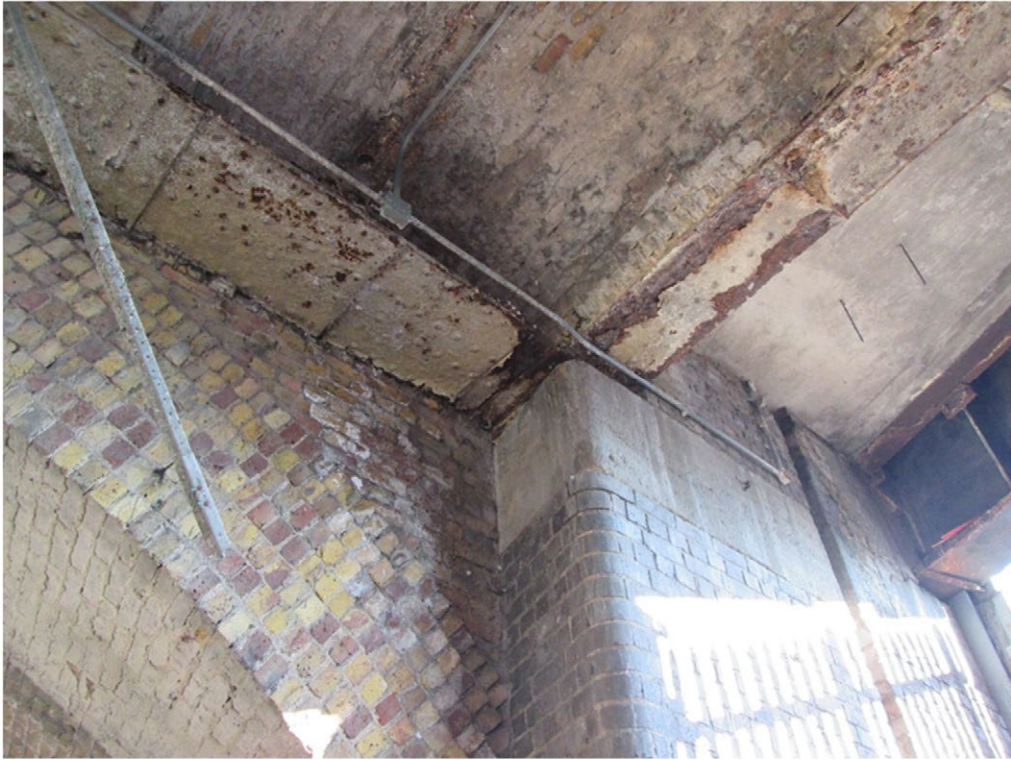
JA1 Severe corrosion to beams at supports

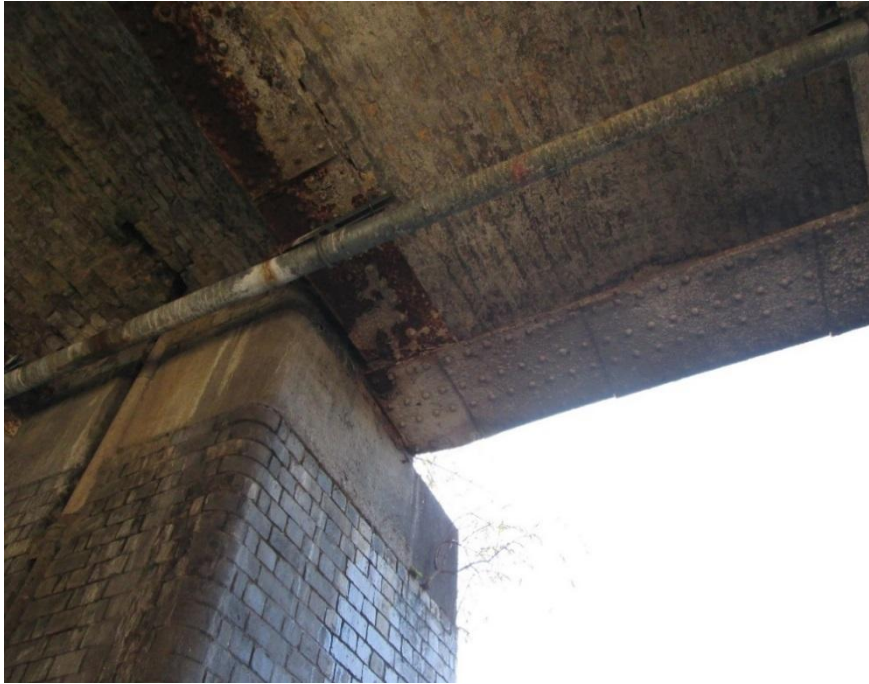
JA3 Severe corrosion and delamination

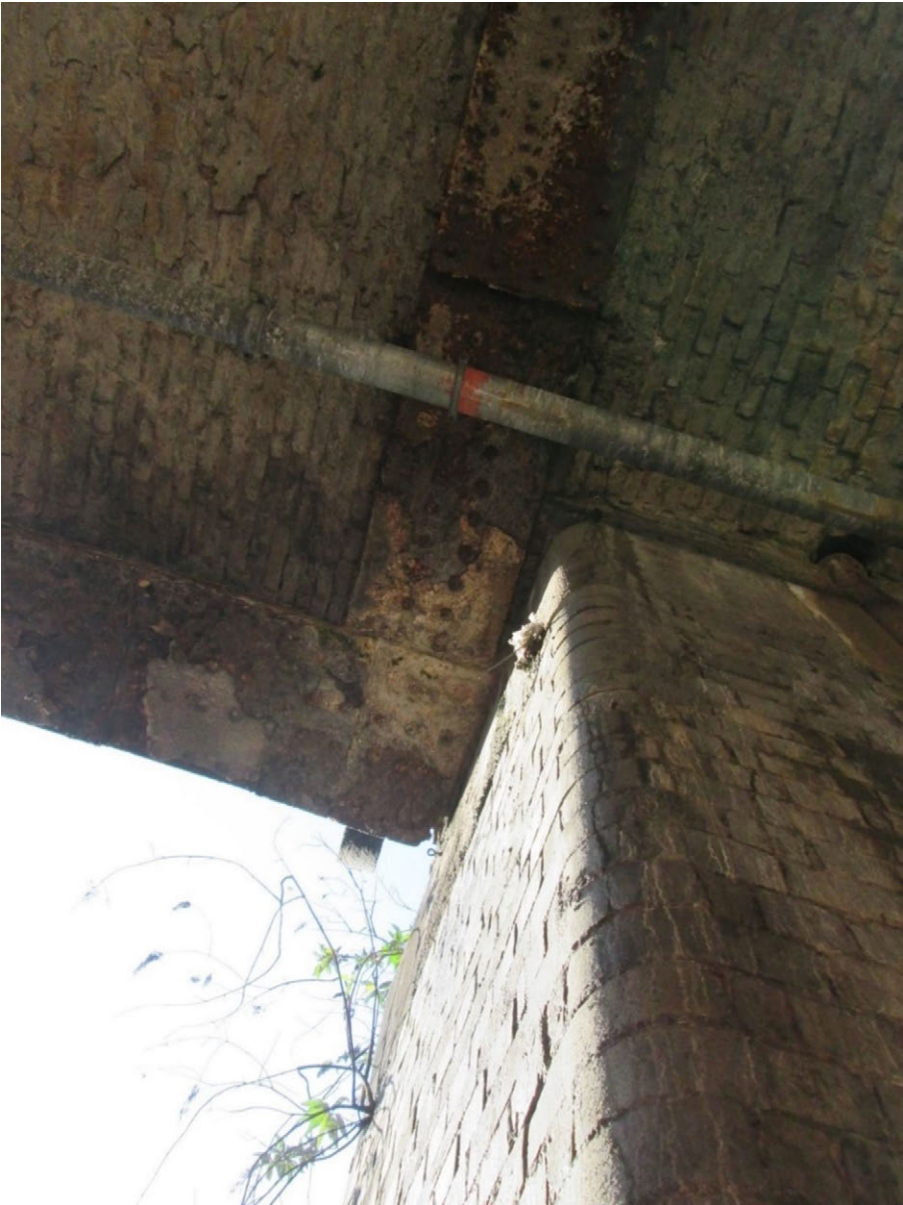
JA4 Severe corrosion and delamination

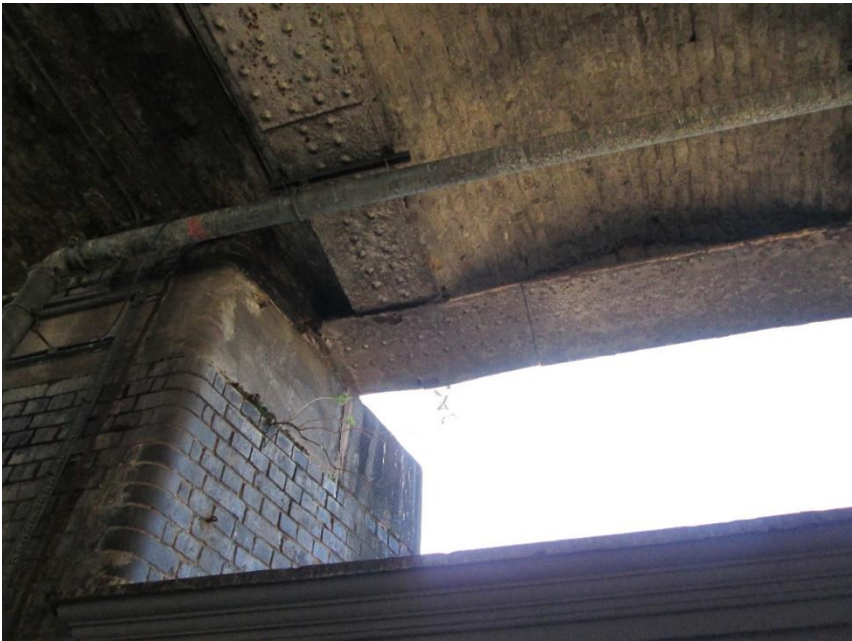
JA2 Severe corrosion and distortion at end of beam

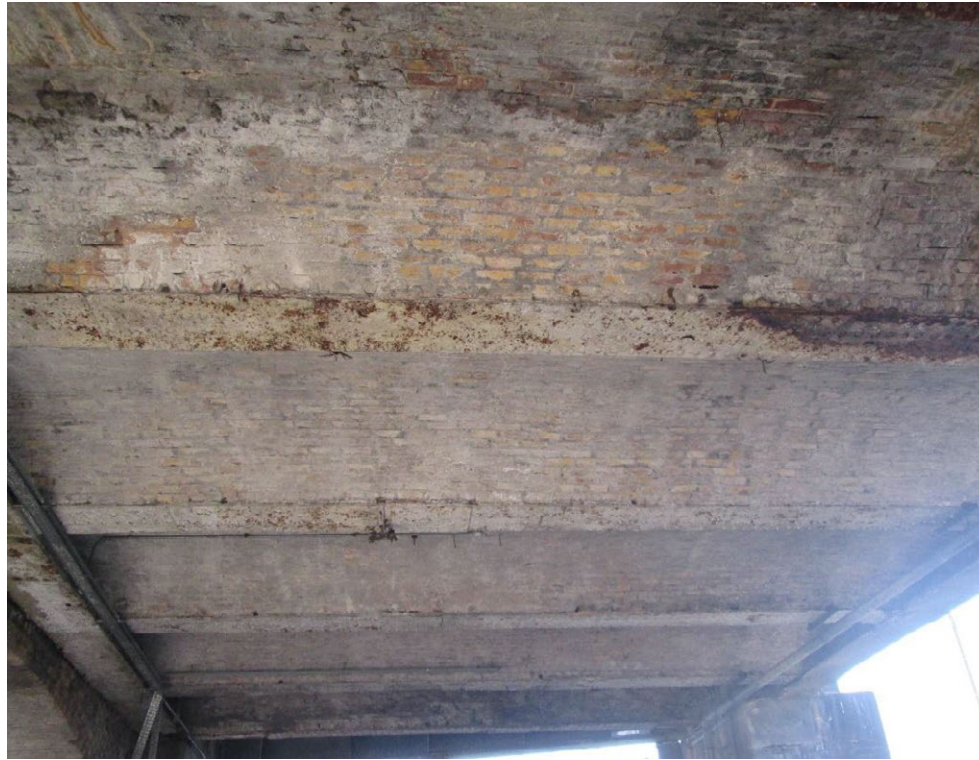
JA5 Brick Arches general in reasonable condition

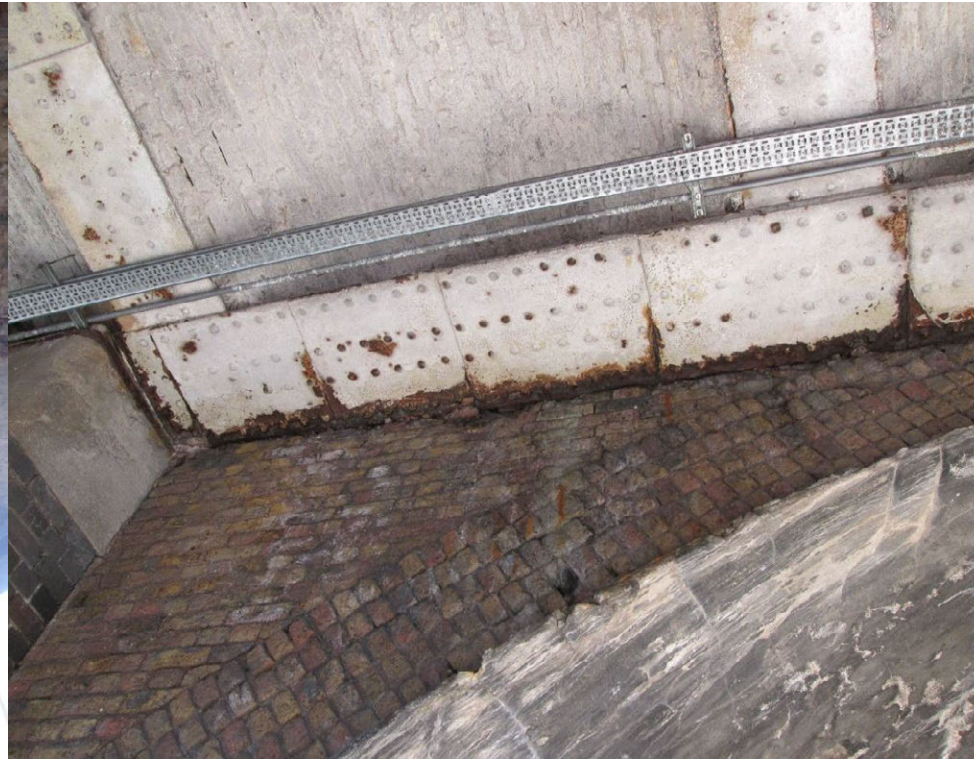
JA7 Severe corrosion to bottom flange of beam

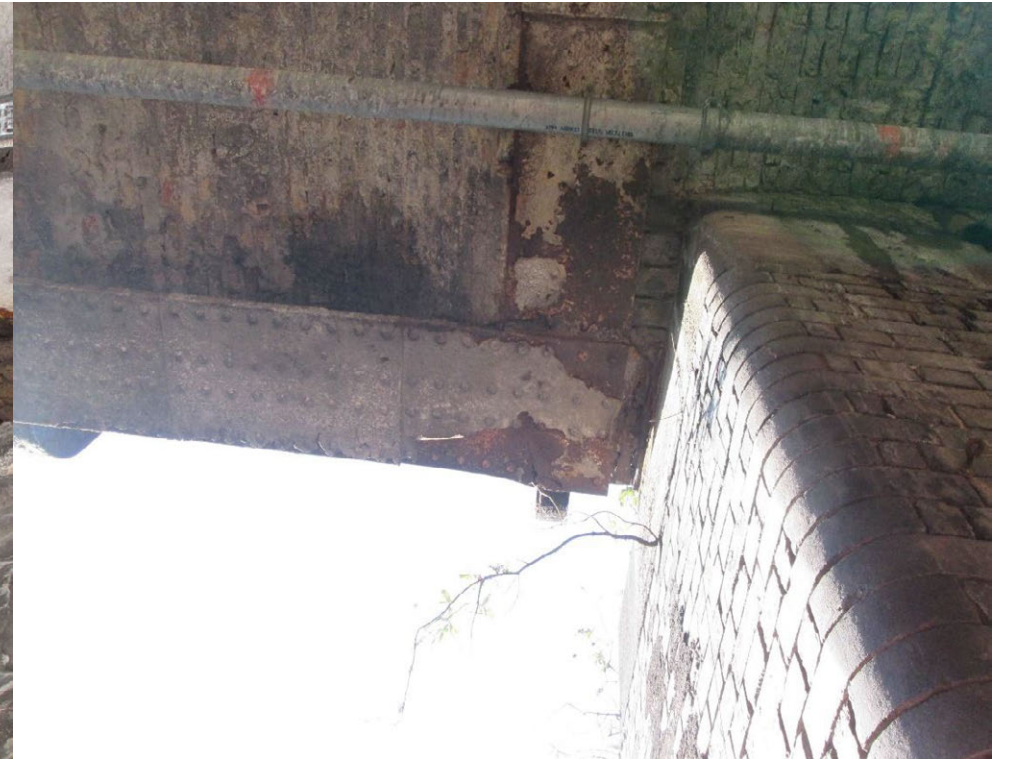
JA9 Severe Corrosion and delamination to end of beam
