THE GOODSYARD

Structural Engineering Condition Survey Report

September 2019

This is a structural visual condition survey report of the existing structures on the Bishopsgate Goodsyrd site undertaken on 15th & 18th February 2019 prepared by WSP.

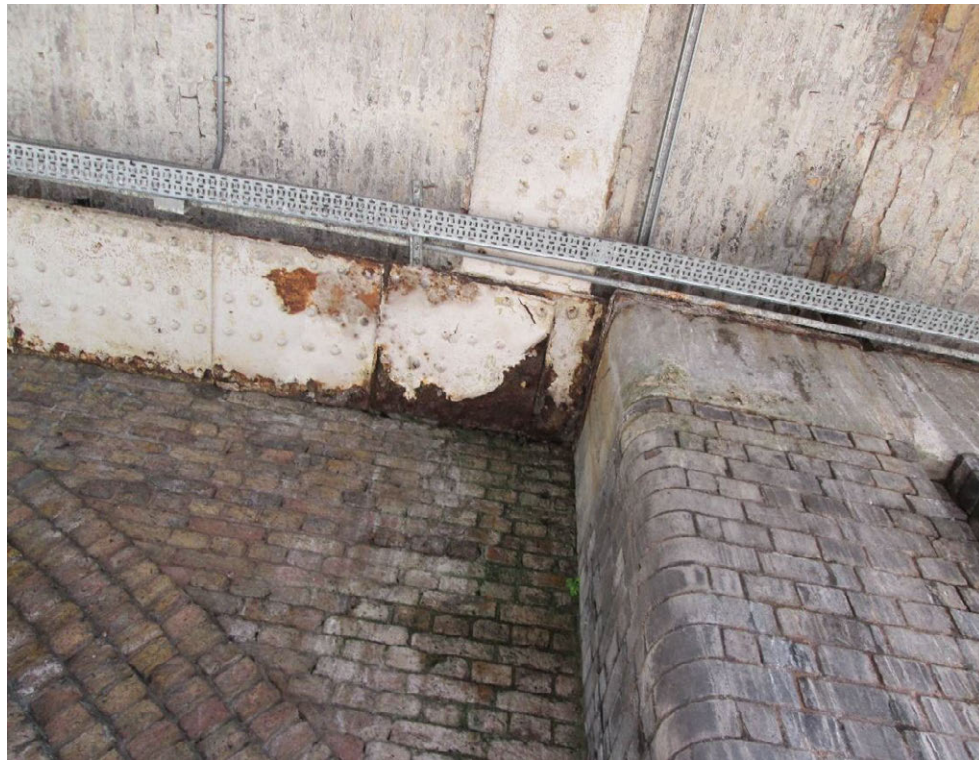
JA6 Severe corrosion and distortion at end of beam

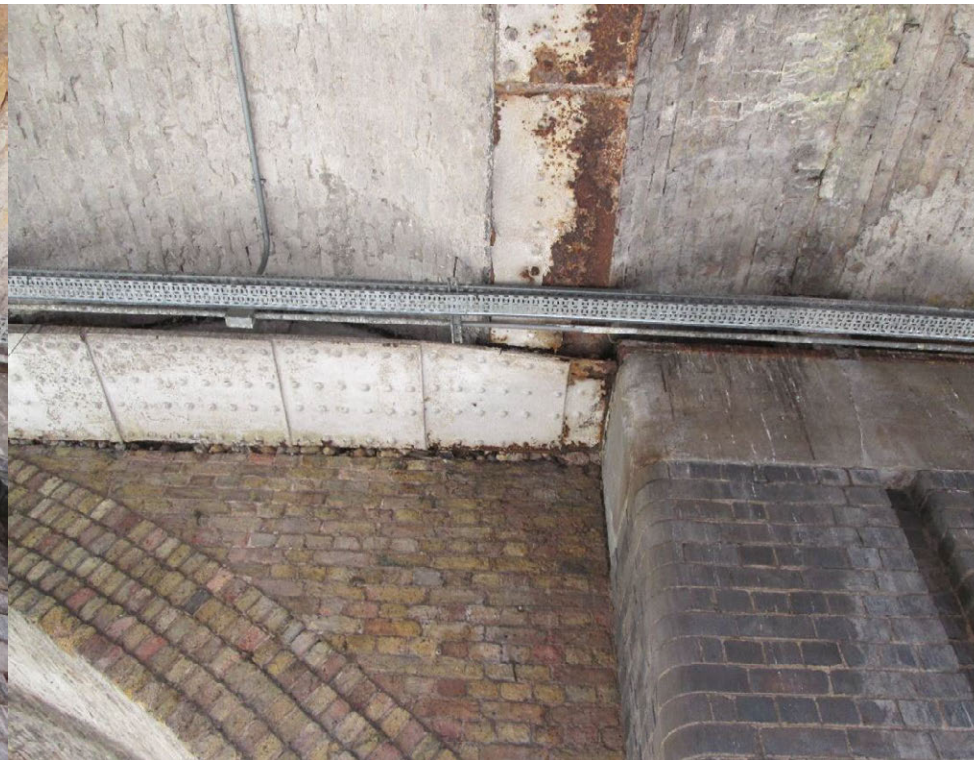
JA8 Corrosion visible with distortion of beam at support

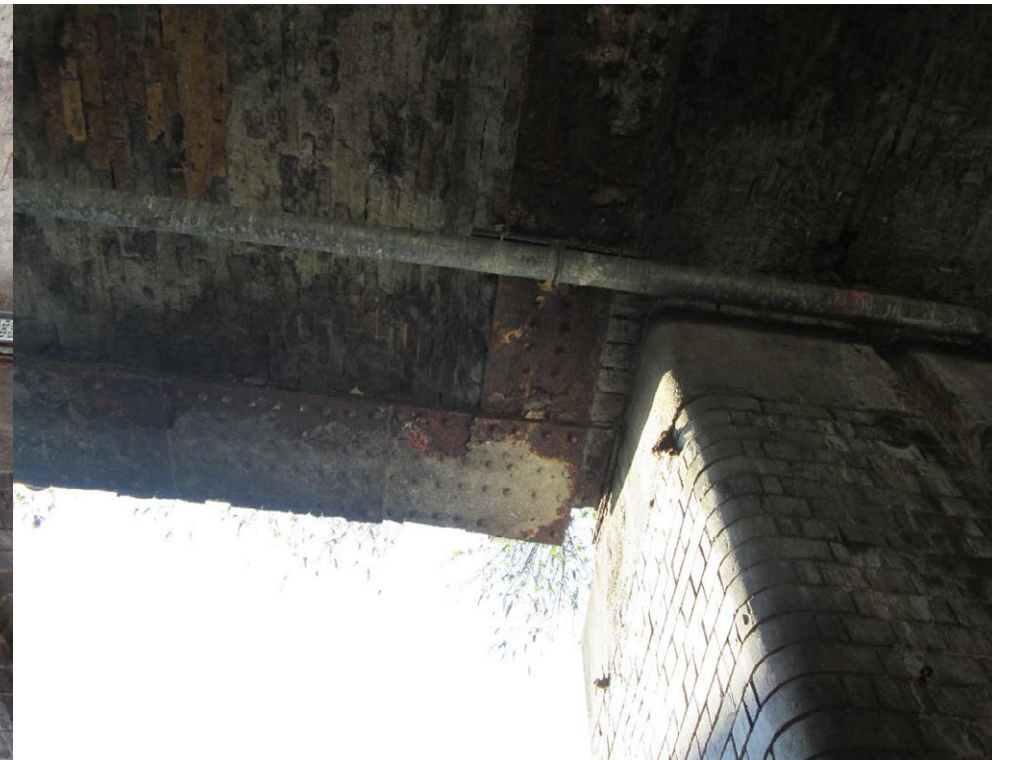
JA10 Large section of bottom flange eroded away at support

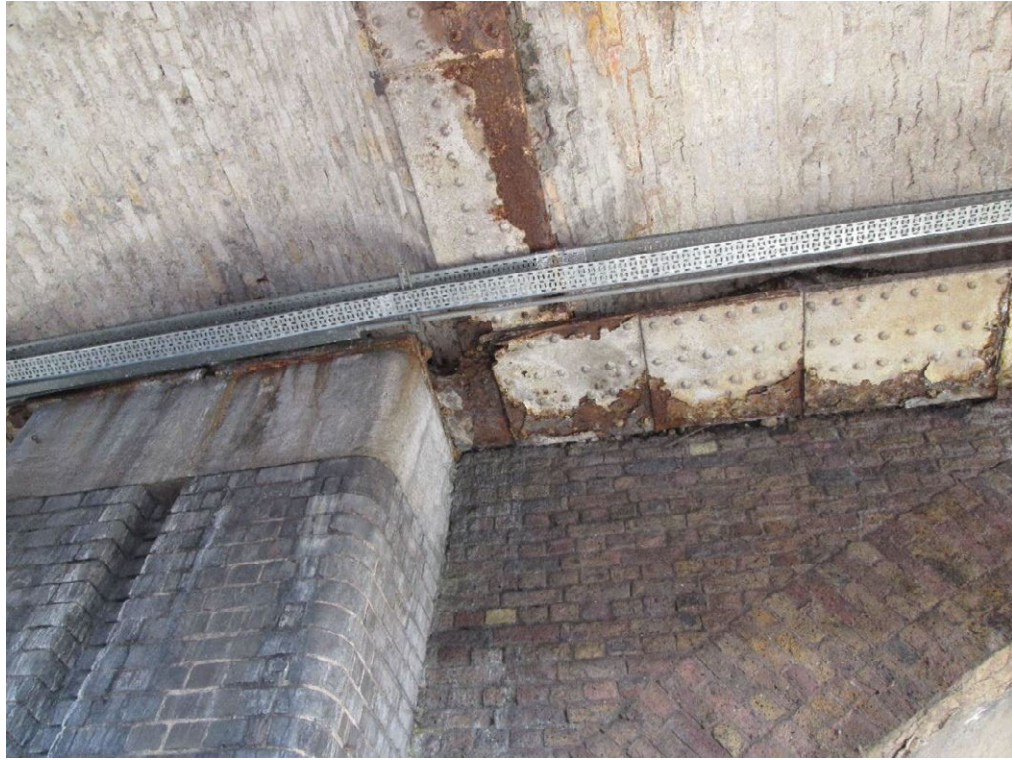
JA11 Severe corrosion and delamination to bottom flange

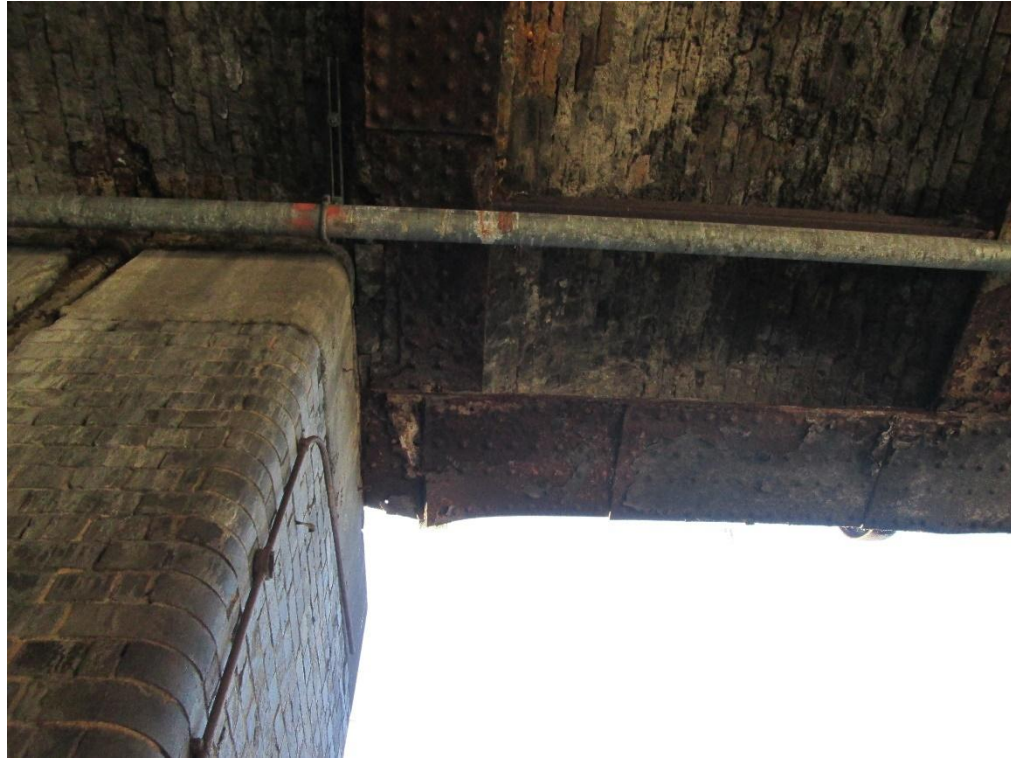
JA13 Severe distortion and corrosion of bottom flange

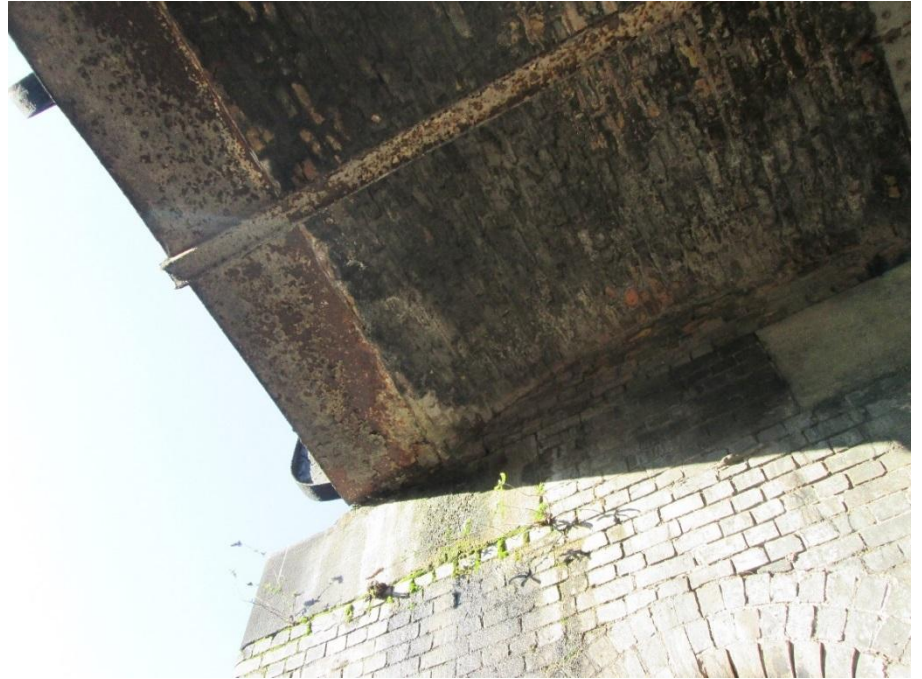
JA15

Corrosion visible

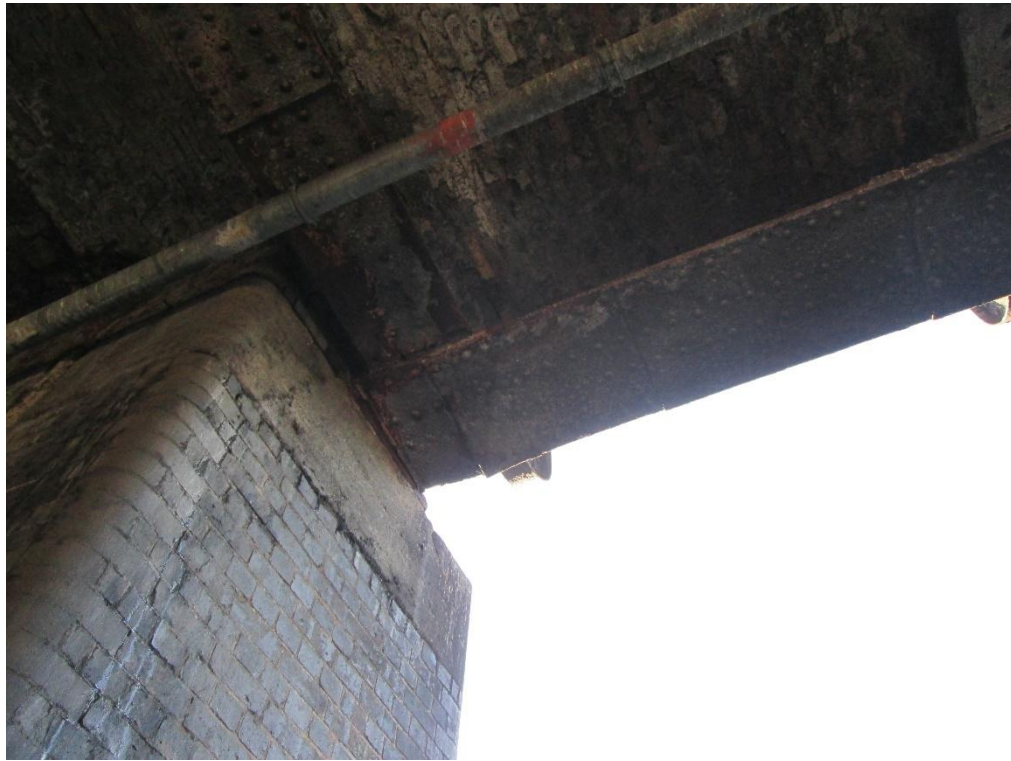
JA12 Delamination and distortion of bottom flange

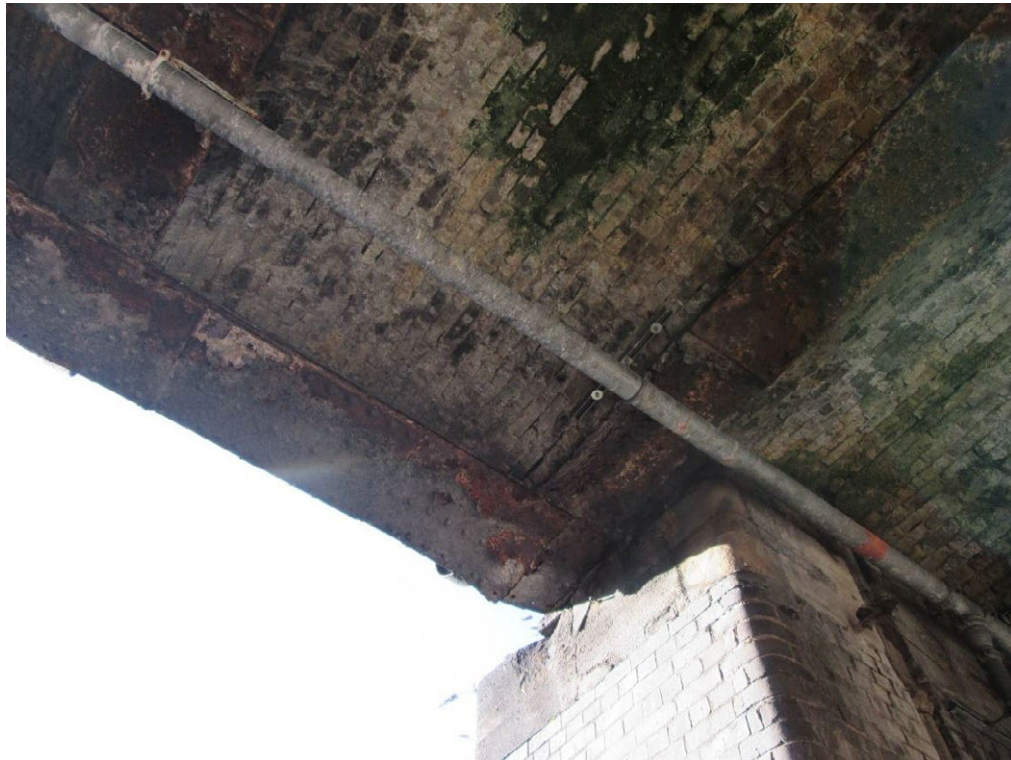
JA14 Severe corrosion and delamination of beams at support

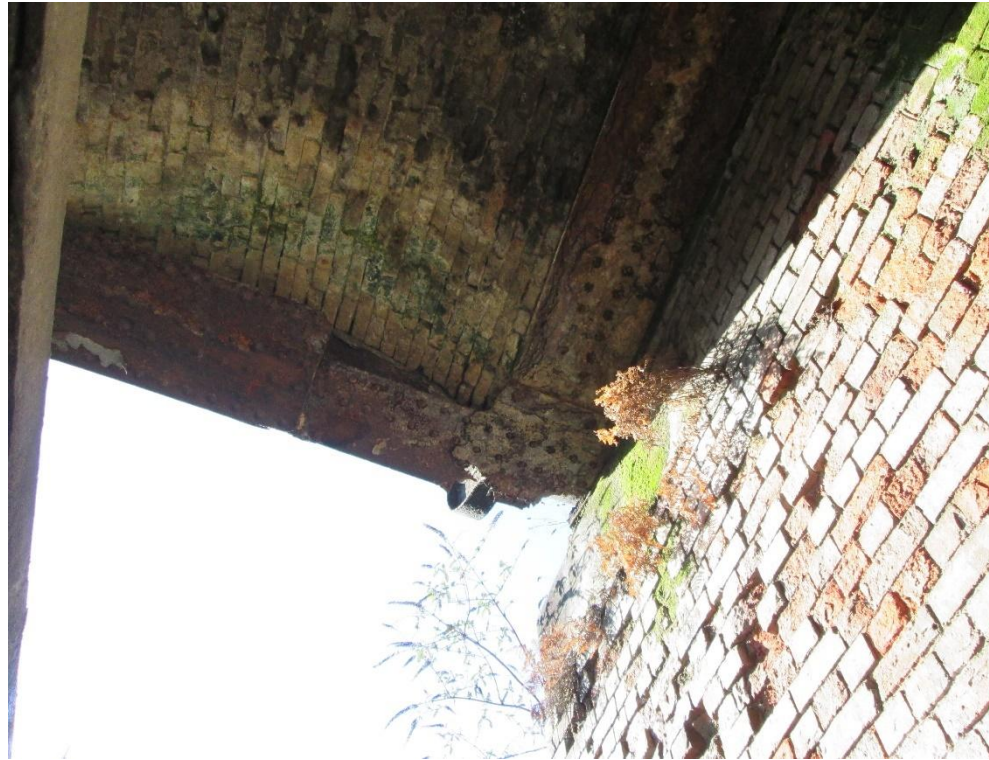
JA16 Severe corrosion and delamination to bottom flange

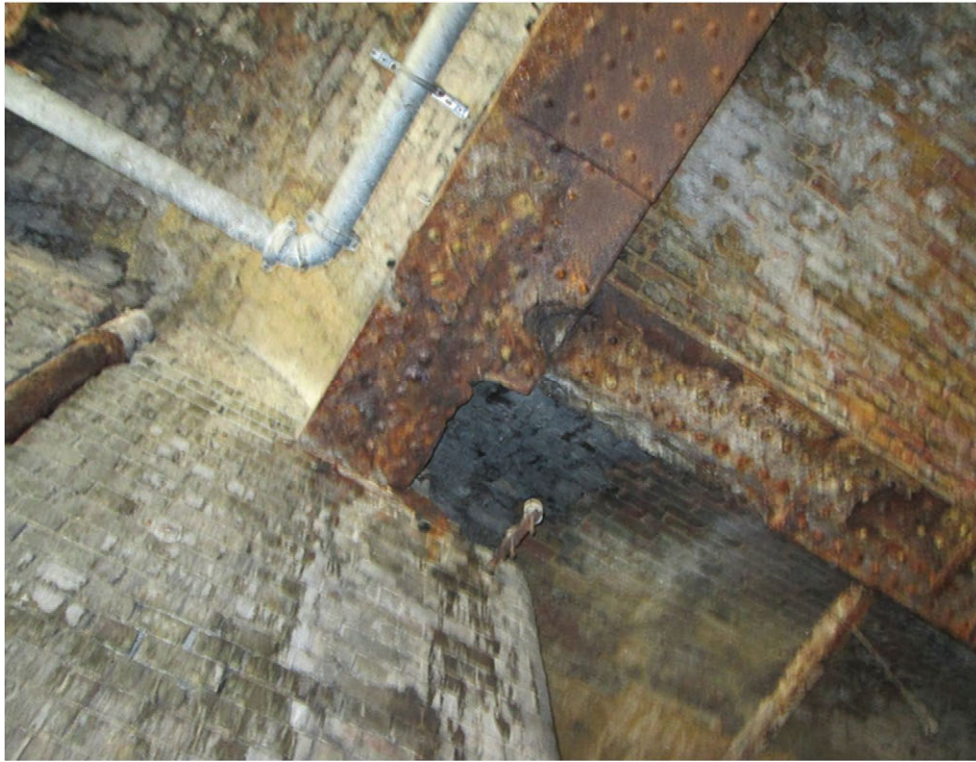
JA17 Bottom flange of beam corroded away

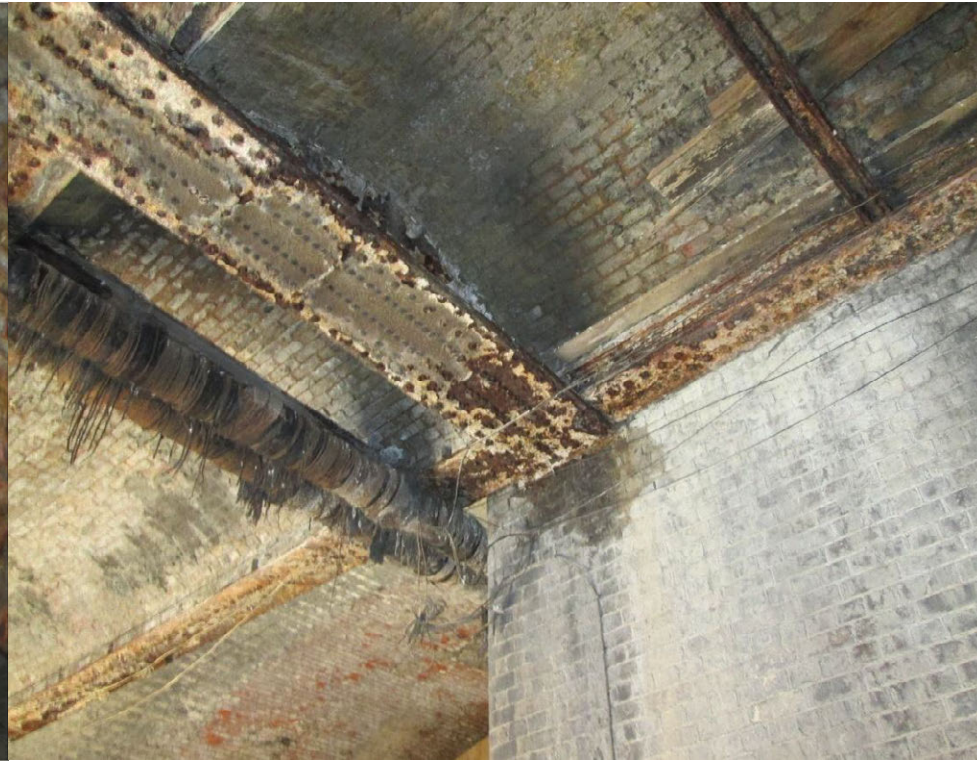
JA19 beam corroded / delaminated

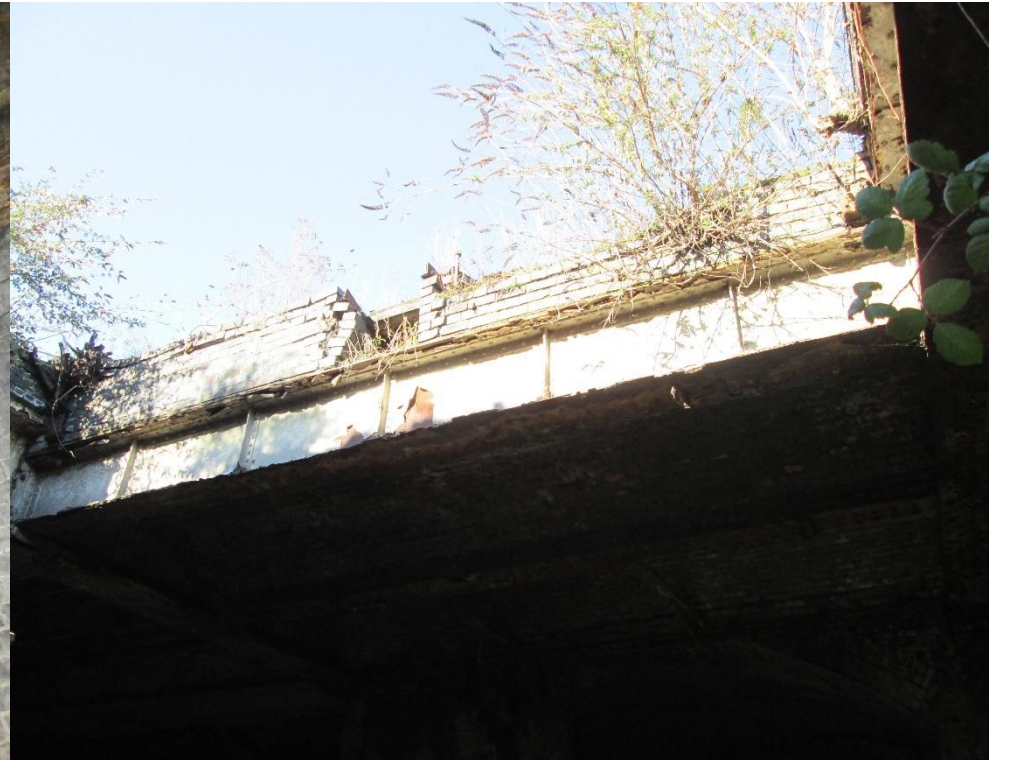
JA21 Beam severely corroded and delaminated

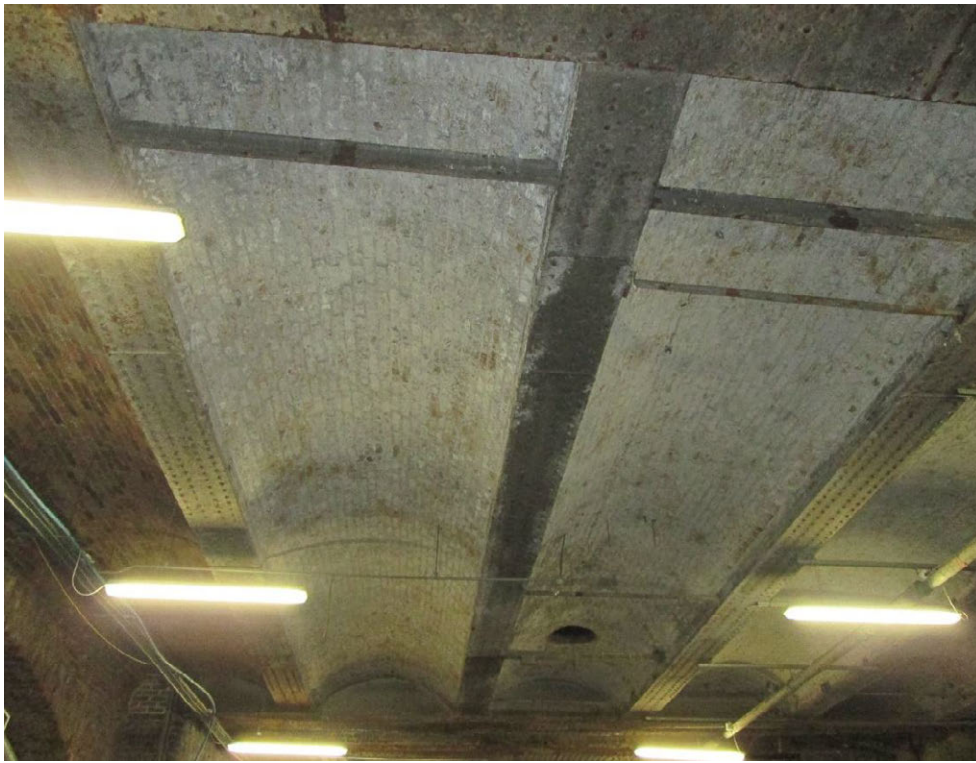
JA18 Arch structure dry and in good condition

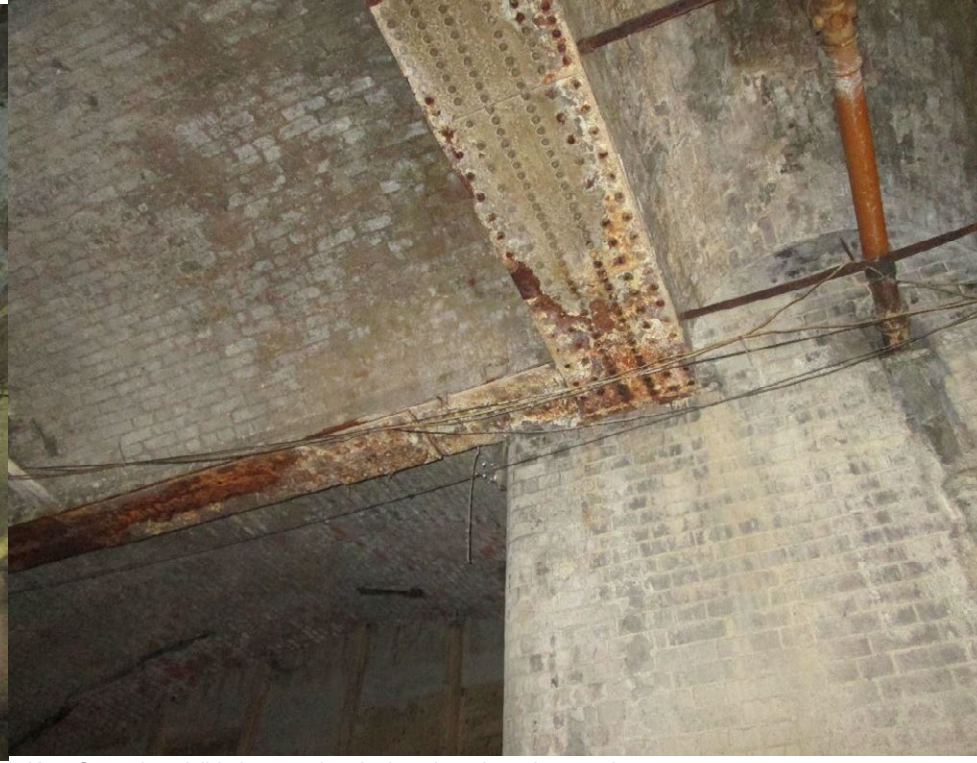
JA20 Corrosion visible intersection Jack arch and southern arches

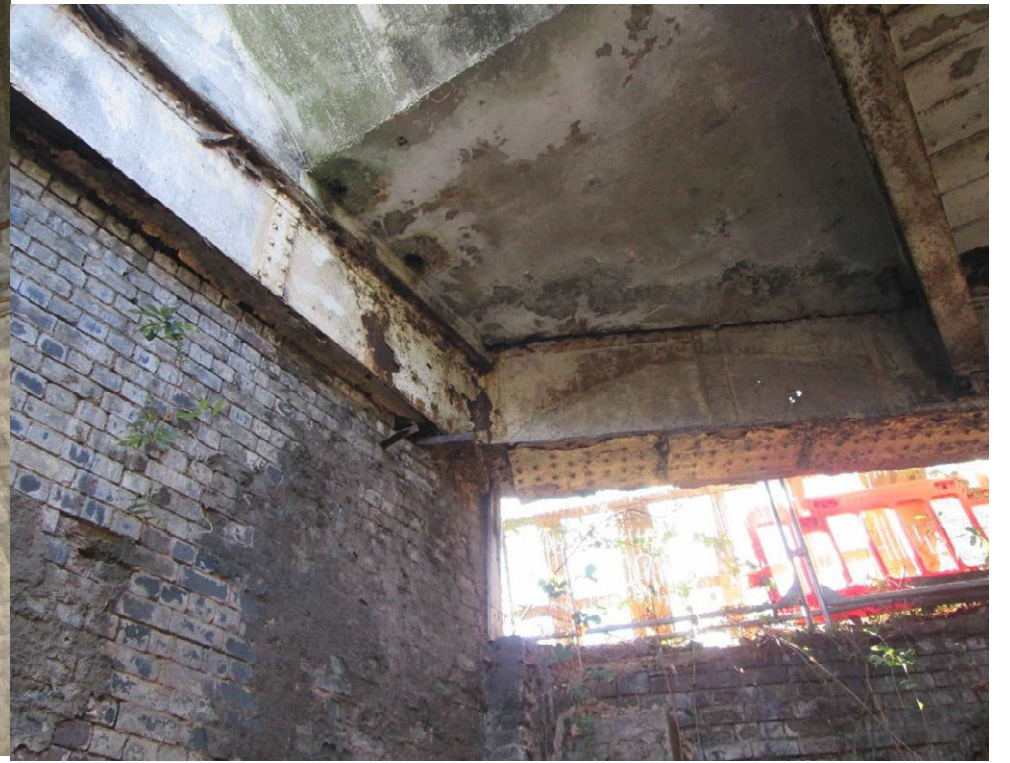
JA22 Beam severely corroded and distorted

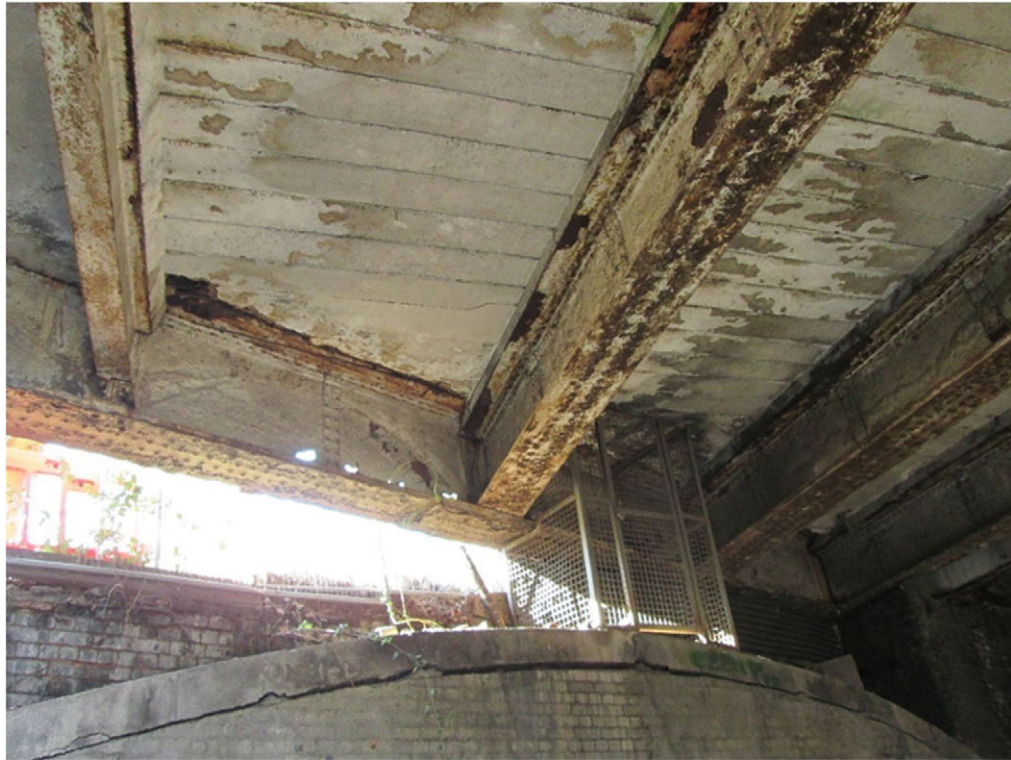
JA23 Web at intersection of bottom flange severely corroded

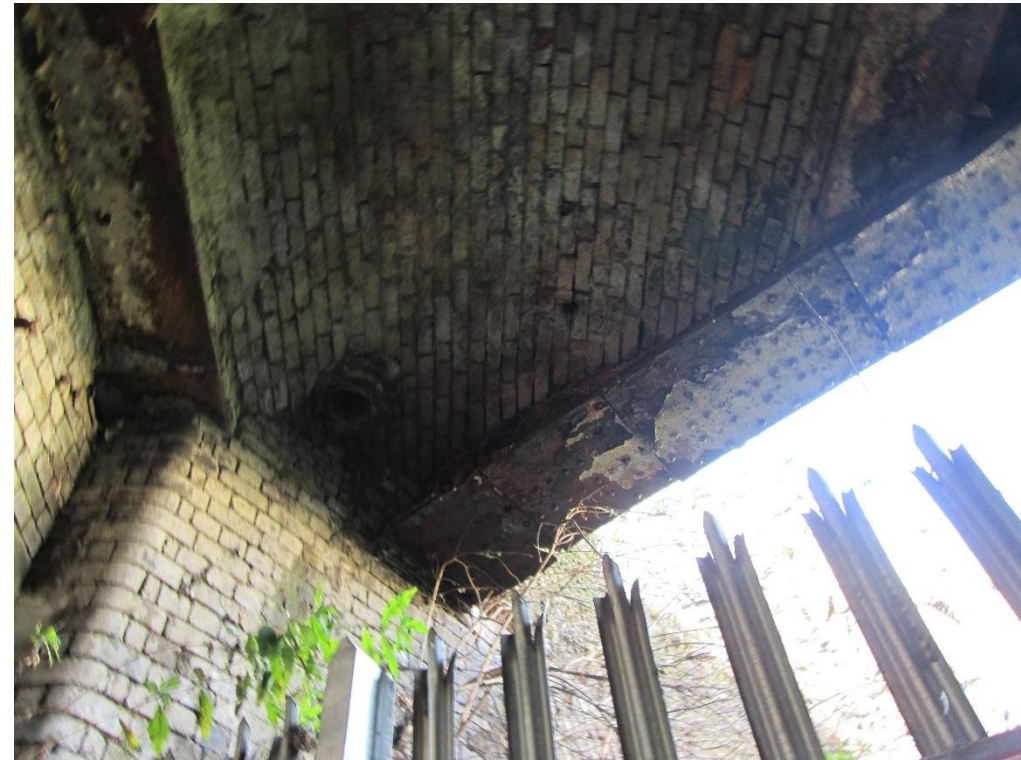
JA25 Severe corrosion of beam at support.

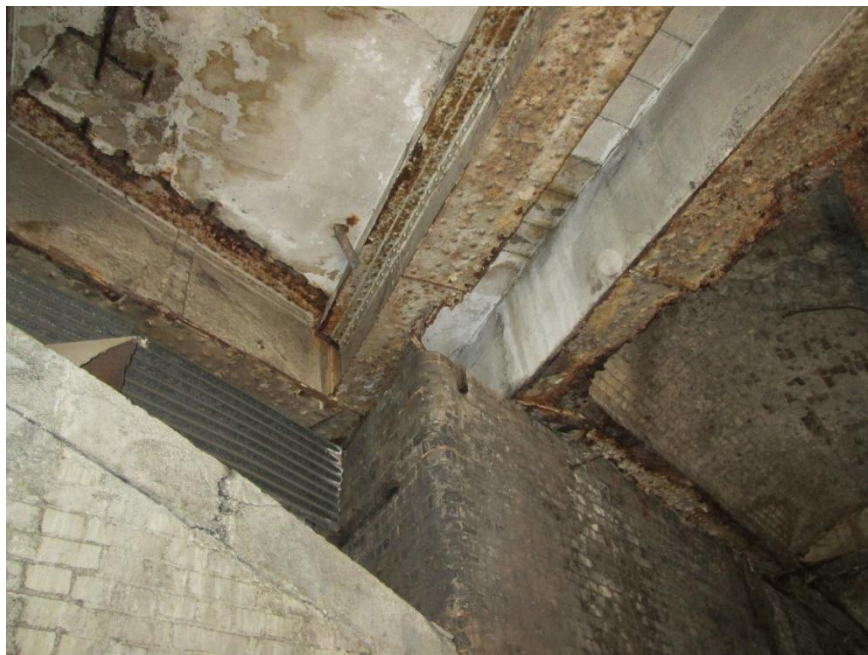
JA24 Beams severely corroded and bottom flanges eroded away

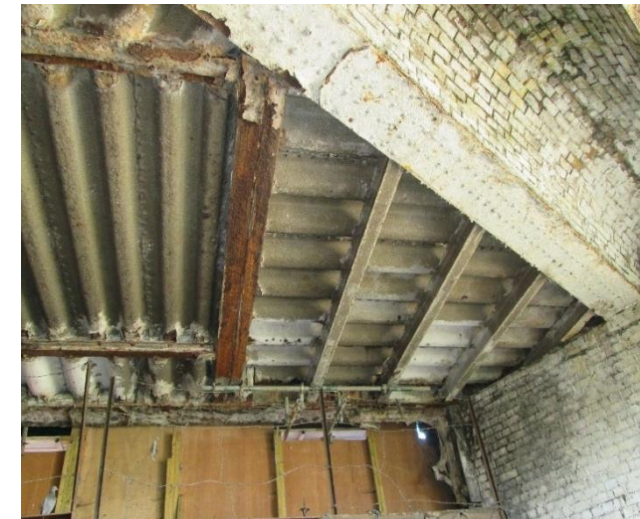
Severely corroded steel under Oriel

We concur with the previous Alan Baxter findings, due to the extensive corrosion of the steel members they will need to be strengthened / replaced. All efforts in the first instance will be taken to undertake this work leaving the Oriel insitu.

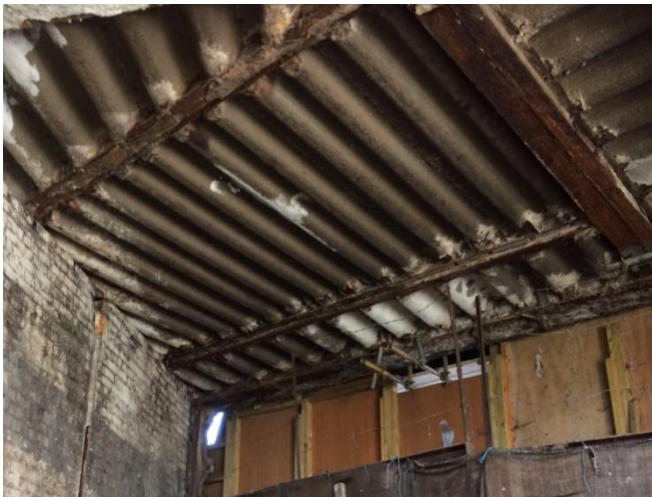
Severely corroded primary and secondary steel under Oriel

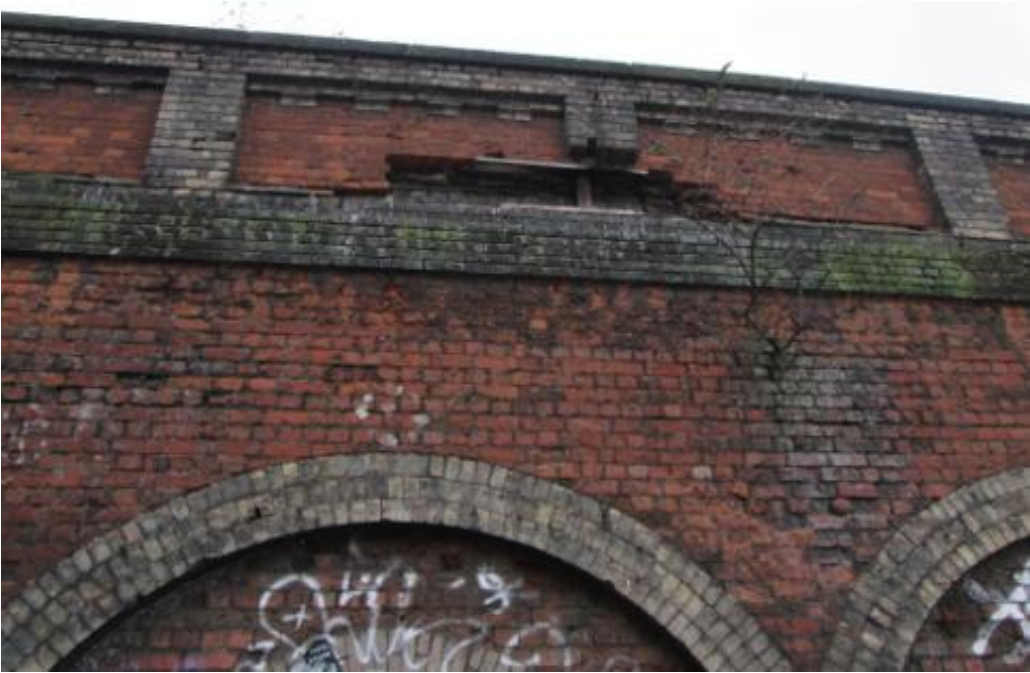
Timber propping to damaged pier requiring repair

It was previously recorded in 2013, temporary timber propping to the damaged pier and surrounding brickwork above the seventh arch west of Braithwaite street (formally known as Wheeler Street) had been installed and remedial repairs were need. The timber propping is still in place with no remedial works having been undertaken. We would recommend as per Alan Baxter report that these remedial works are undertaken as soon as possible along with the treatment / removal of the vegetation through the wall.

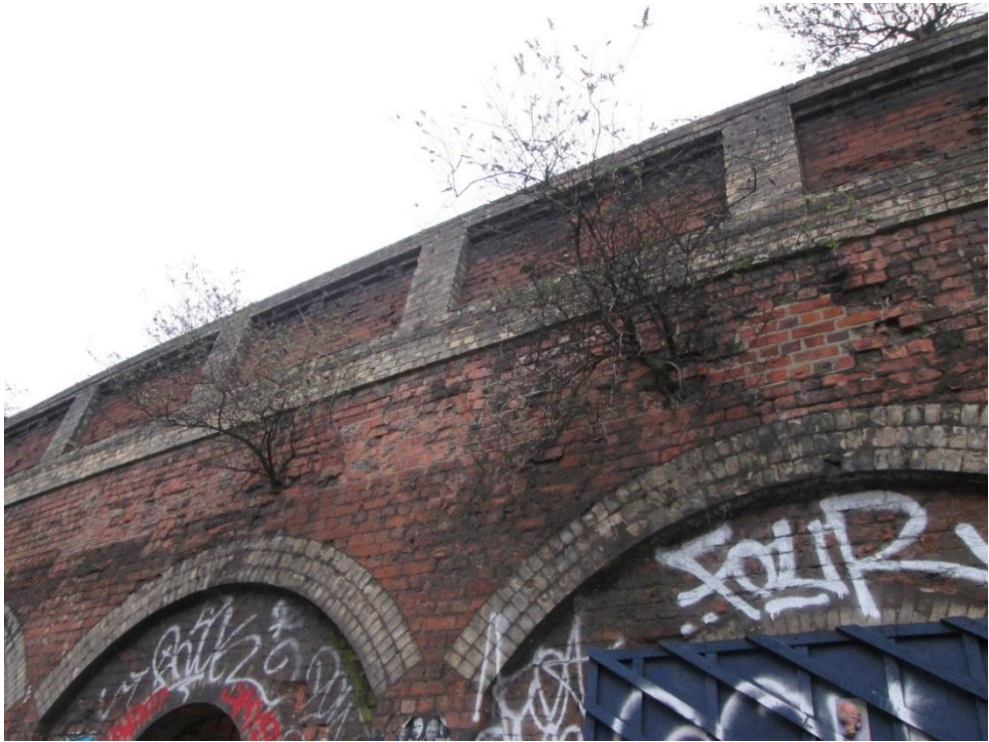
Vegetation growing through wall causing damage to brickwork
