THE GOODSYARD

Heritage Statement: Appendix C – Heritage Fabric Assessment

September 2019

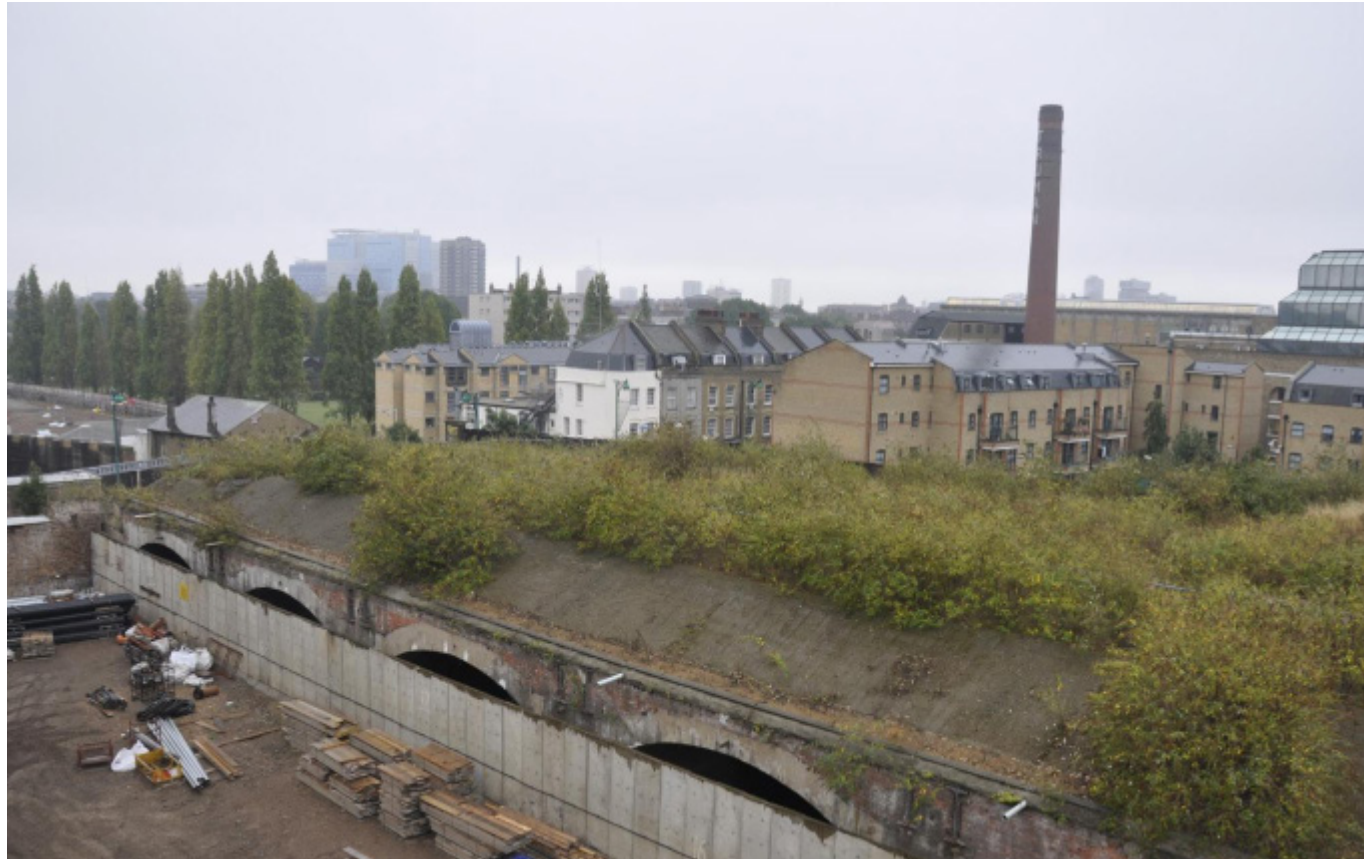
2.1.1.2.1 The Braithwaite Arches constructed in the 1840's was recorded as being in good condition for its age and type. There was no apparent sign of settlement and no sign of cracking or frost damage to the brickwork. It was noted that the northern face of the Braithwaite Viaduct appeared to be cut back to accommodate an extension which has since been demolished leaving the rendered cut face exposed.

Fig 2.1.1: Braithwaite Arches Platform Level

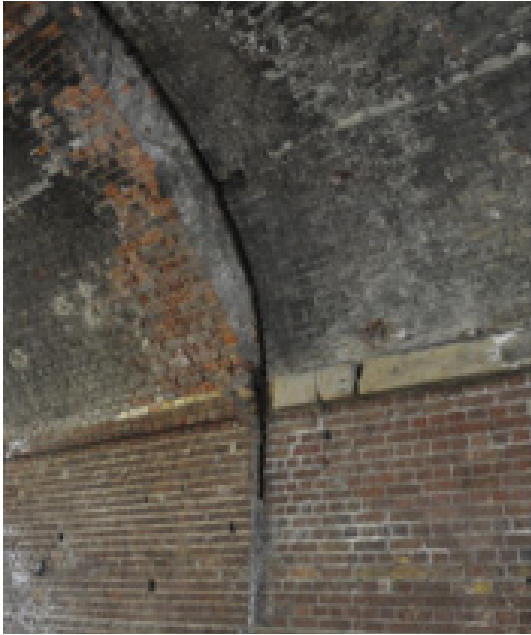
Fig 2.1.4: Joint between 1860s & 1840s Braithwaite arches

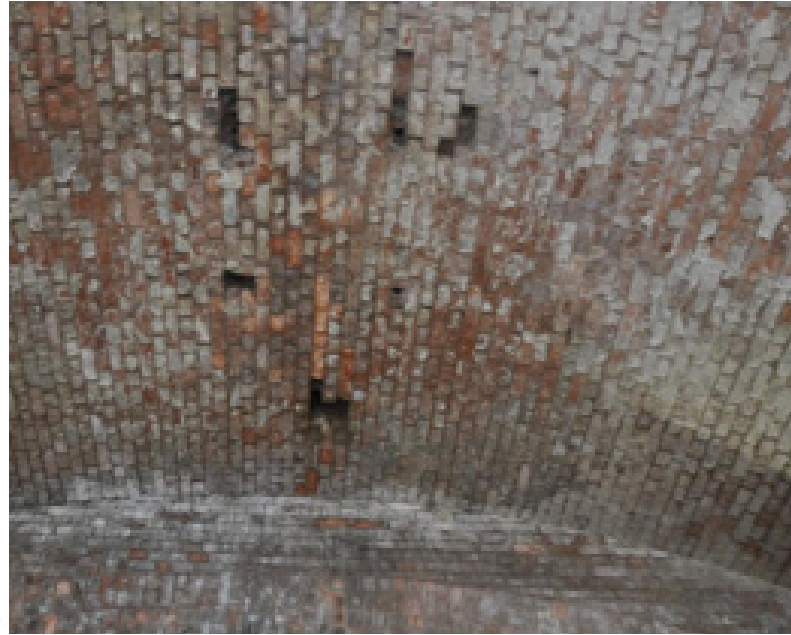
Fig 2.1.5: 1880s arches indicating localised missing brickwork

2.1.1.3.2 The 1880's arches to the west of Wheler Street again appeared to be in reasonable condition for their age and type, although it was stated there were localised areas of lost or damaged brickwork.

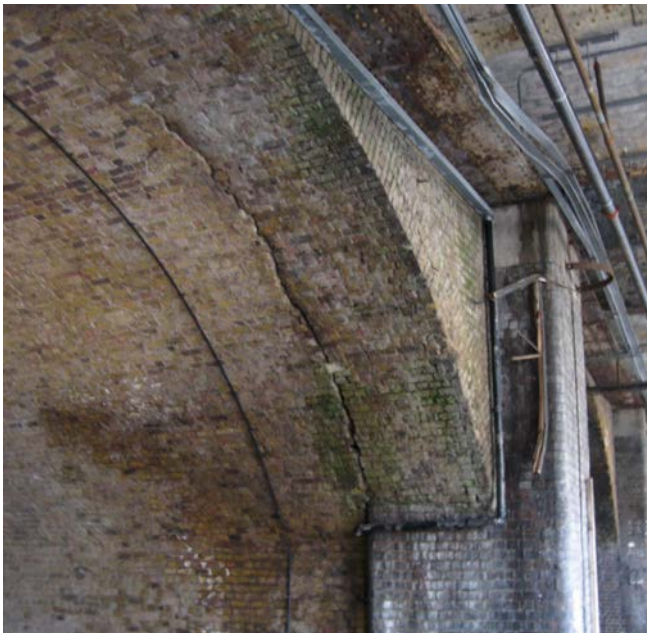
Fig 2.1.6: 1880s arches : Evidence of settlement

2.1.1.3.1 It was noted that the 1860's and 1880's arches to the east of Wheler Street had been subject to settlement in the past which had caused cracking of the arch brickwork in some locations. The cracks appeared to have been monitored in the past with rendered tell-tale patches cast over them some of which date back to the 1960's which were still in place at the time. Therefore, these sections of the viaduct appear not to have moved much over the past 40 years and generally can be considered in reasonable condition for their age and type. The cracks were not considered structurally significant.

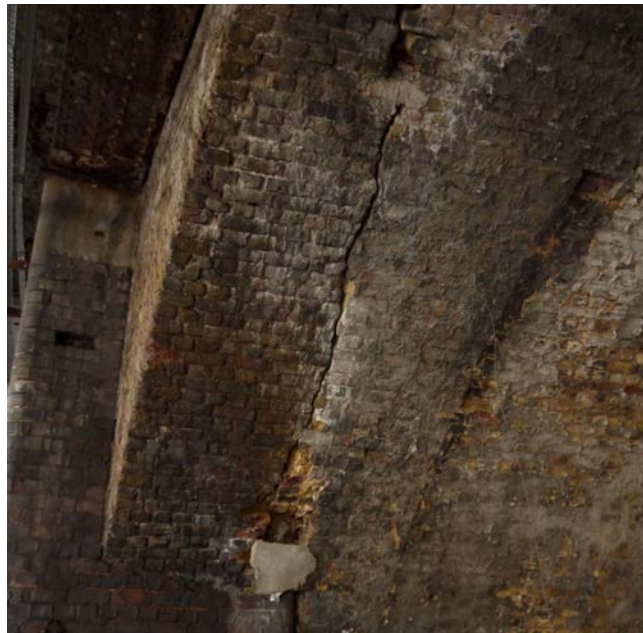
Fig 2.1.7: 1880s arches: Evidence of defected repair to brickwork crack

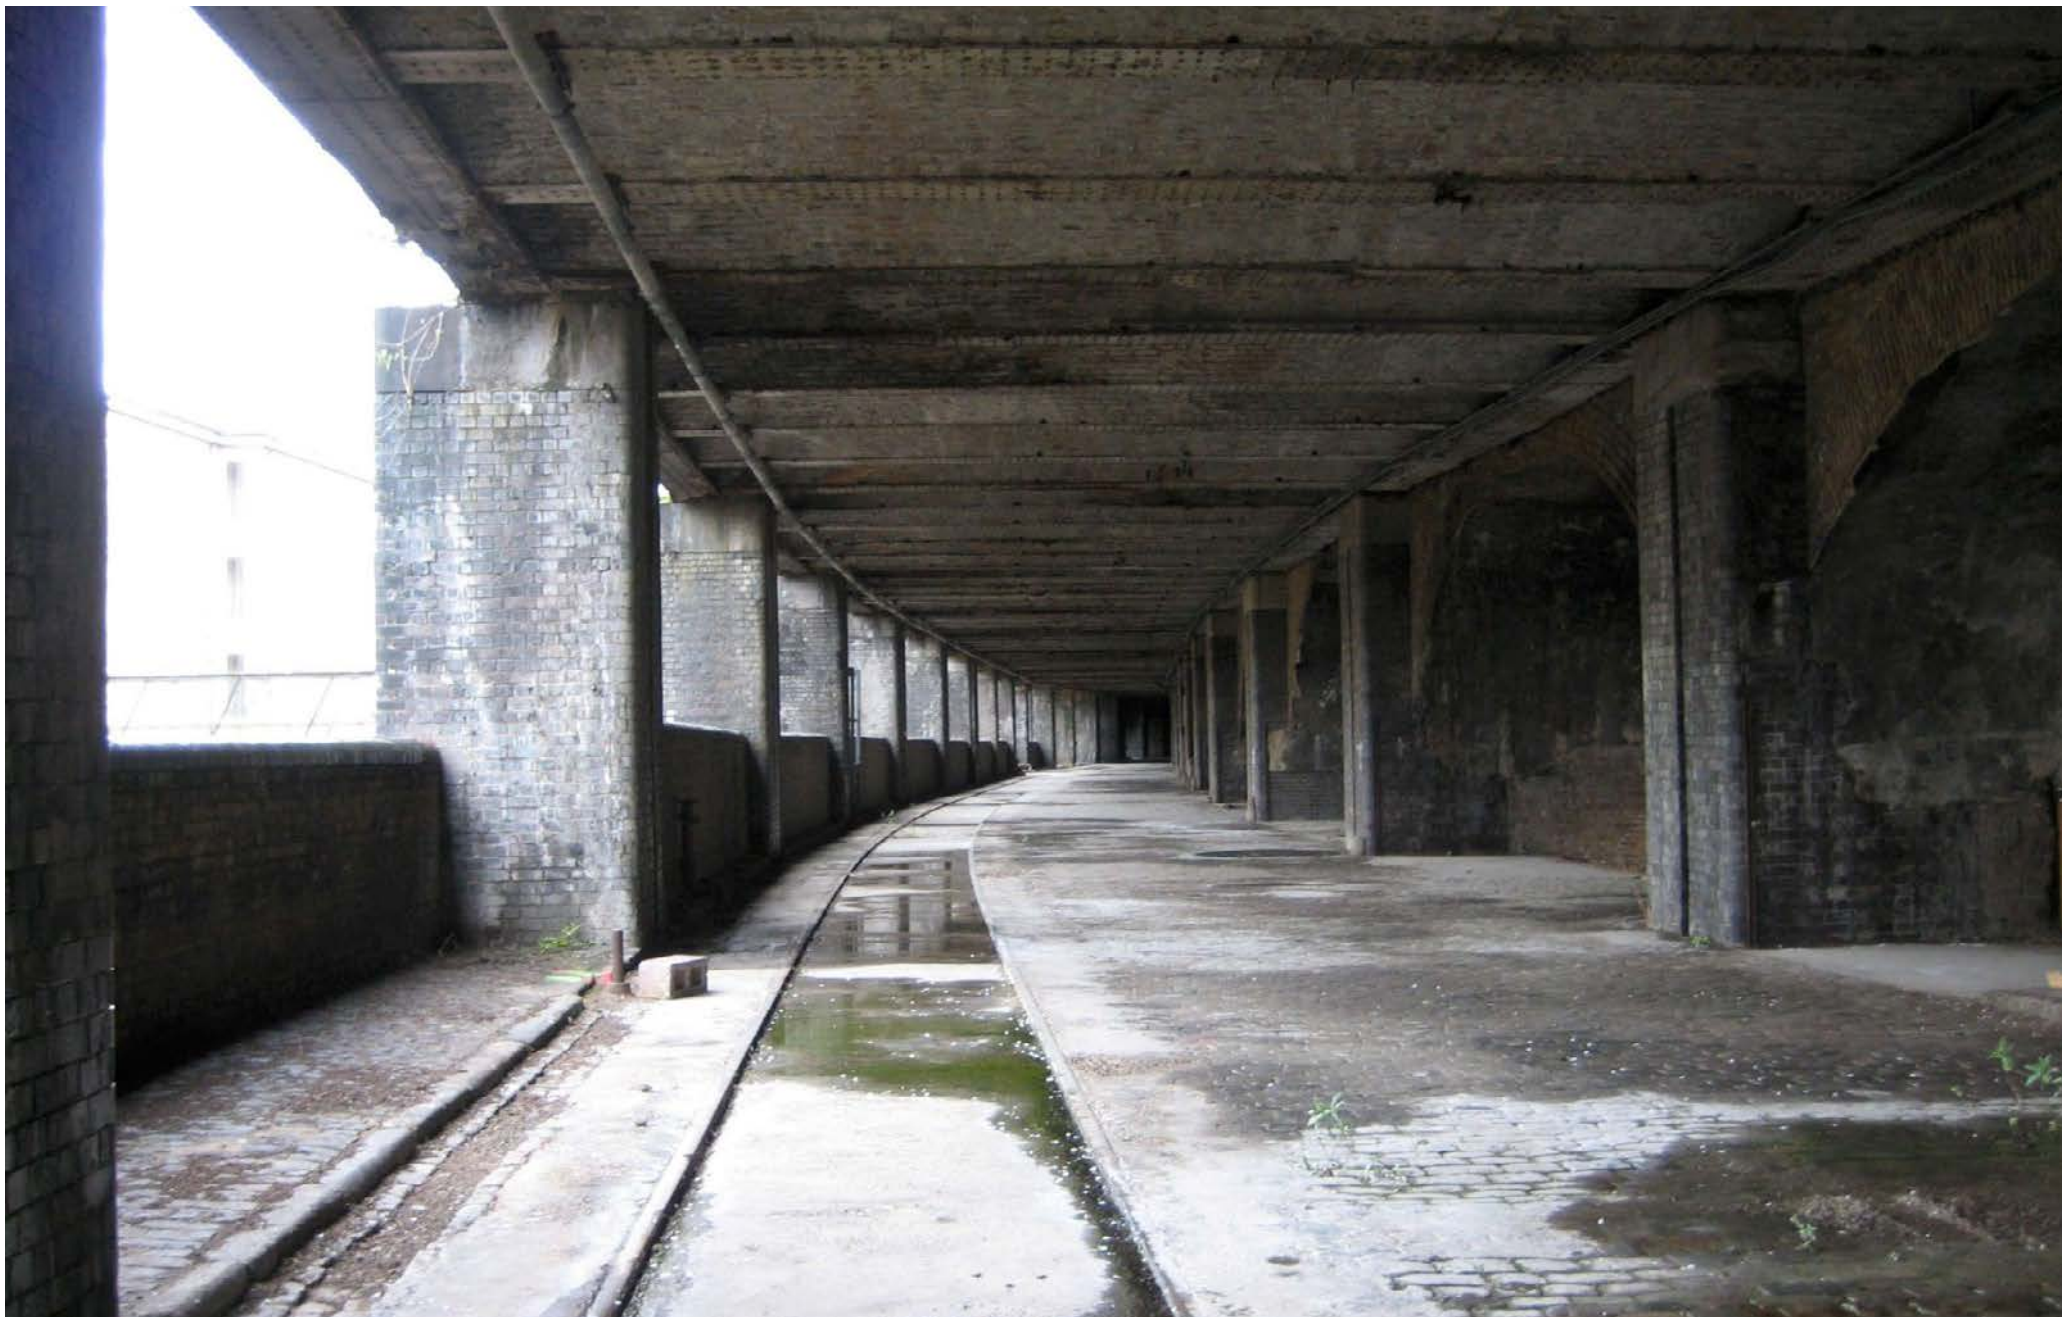
Fig 2.1.8: London Road jack arch structure looking west

- 2.1.1.4.1 The jack arch section over London Road was constructed in the 1880's and consists of a series of brick arches spanning between built up rivetted iron/steel beams. It was noted that whilst the masonry elements of the structure were in good condition for its age and type overall the jack arches were in poor condition with significant deterioration /corrosion to the steel / iron beams evident.
- 2.1.1.4.2 The worst of the corrosion was noted as being along the southern most exposed side of the structure, at the edge of the viaduct. Further closer observations and opening made reference to water penetration to the jack arch structures and that this needed to be dealt with to prevent further corrosion of the steel / iron beams.

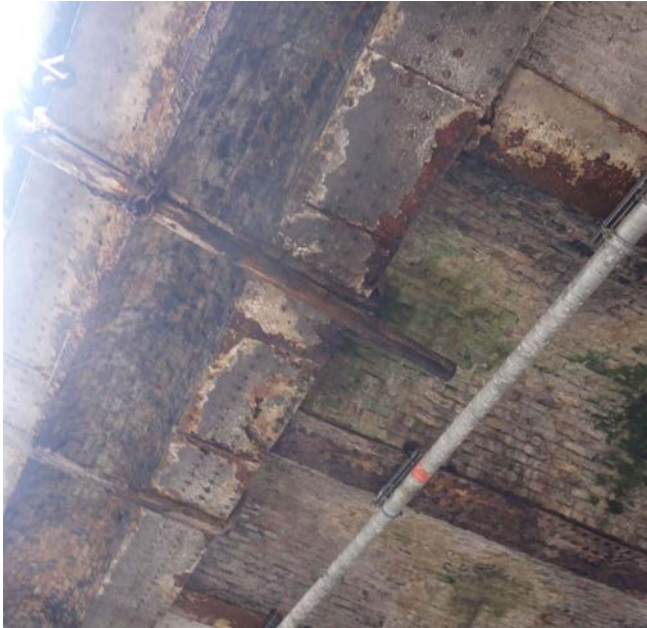
Fig 2.1.9: Evidence of corrosion to steel beams

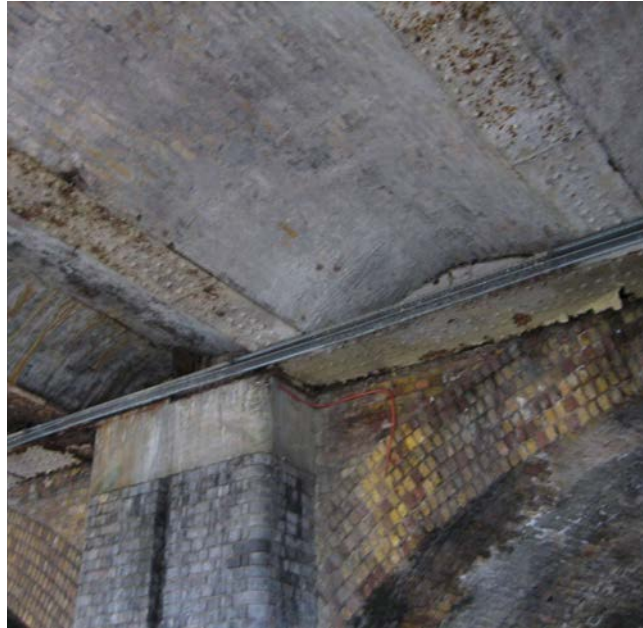
Fig 2.1.10: Corrosion and water ingress

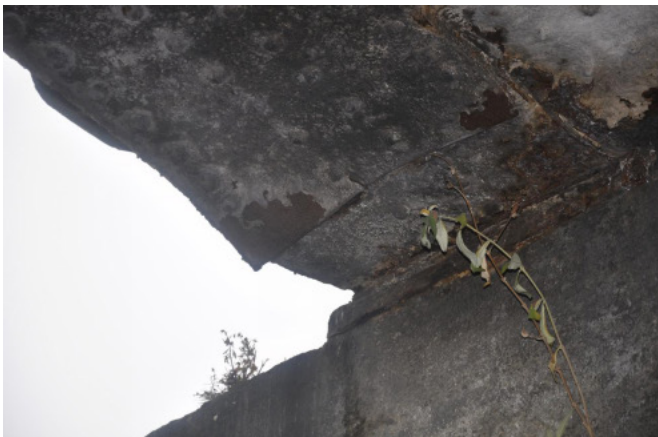
Fig 2.1.11: Significant deterioration of steel work

2.1.2.3.2 The Alan Baxter 2013 report states the Jack Arch structure is in extremely poor condition with further deterioration of the jack arch beams and supporting beams having taken place. Where water continues to penetrate the structure very significant loss to sections of the beams is apparent.

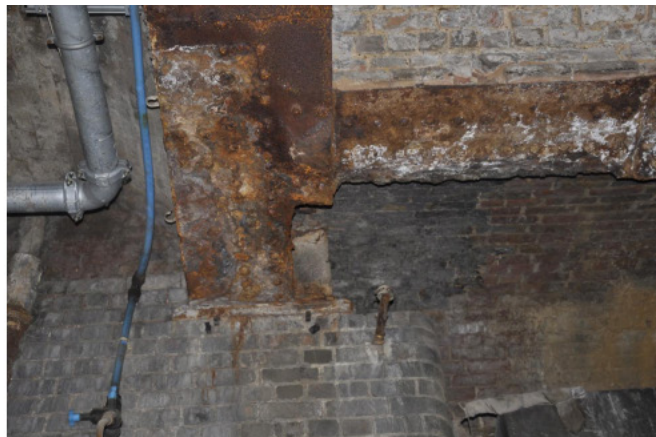
Fig 2.1.12: Severe deterioration to supporting edge beam

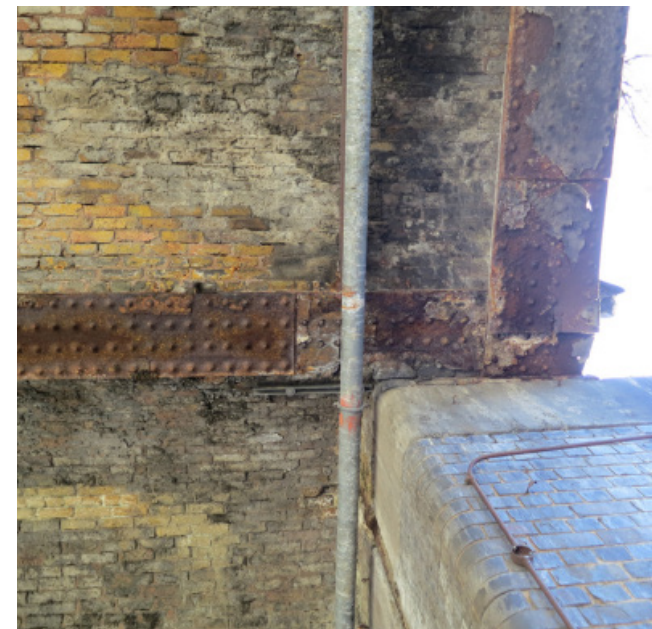
Fig 2.1.13: Severe delamination and twisting to the flange plates

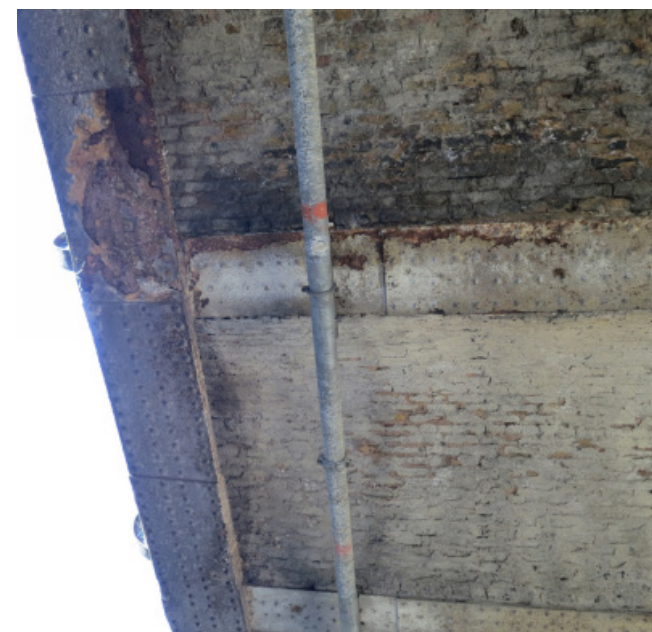
Fig 2.1.14: Severe deterioration to supporting edge beam

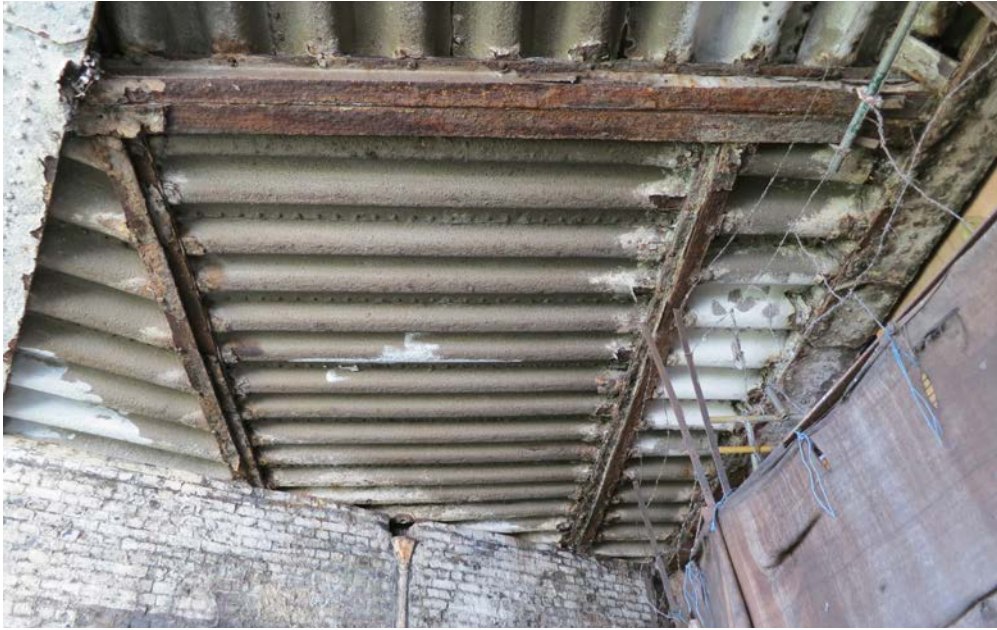
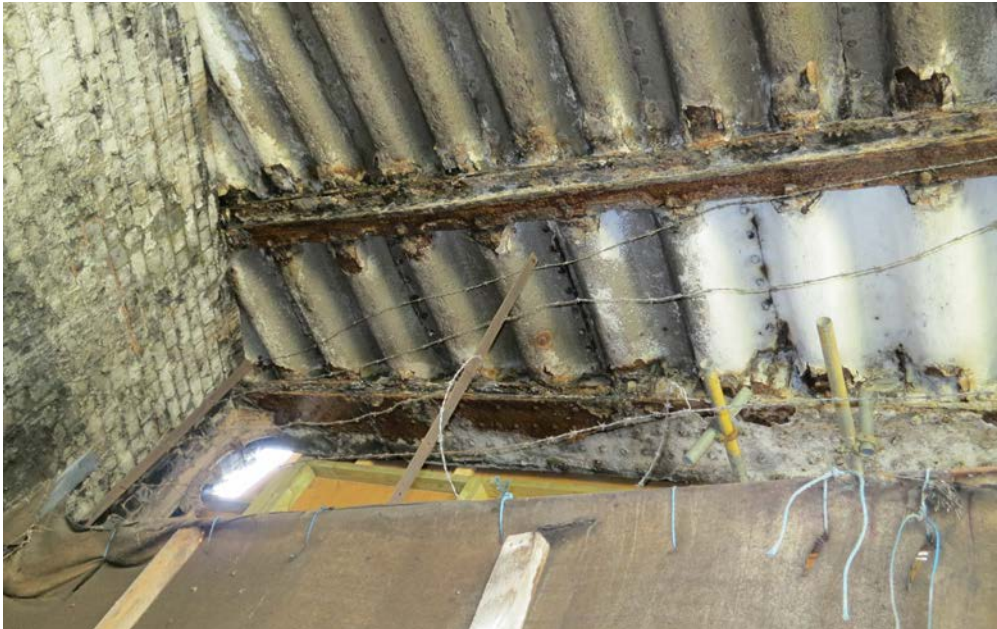
2.1.2.4.2 The supporting structure iron / steel beams to the underside of the structure appeared to be severely corroded and delaminated, it was recommended that temporary support be provided to those beams.

Fig 2.1.15: Severe delamination and corrosion to the underside of the supporting Oriel structure

2.1.2.4.3 It was further stated that the appropriate approach may be for the Oriel structure to be carefully dismantled and refurbished by a specialist which would enable uncomplicated access to the iron / steel beams supporting the floor structure and Oriel to be repaired or replaced.

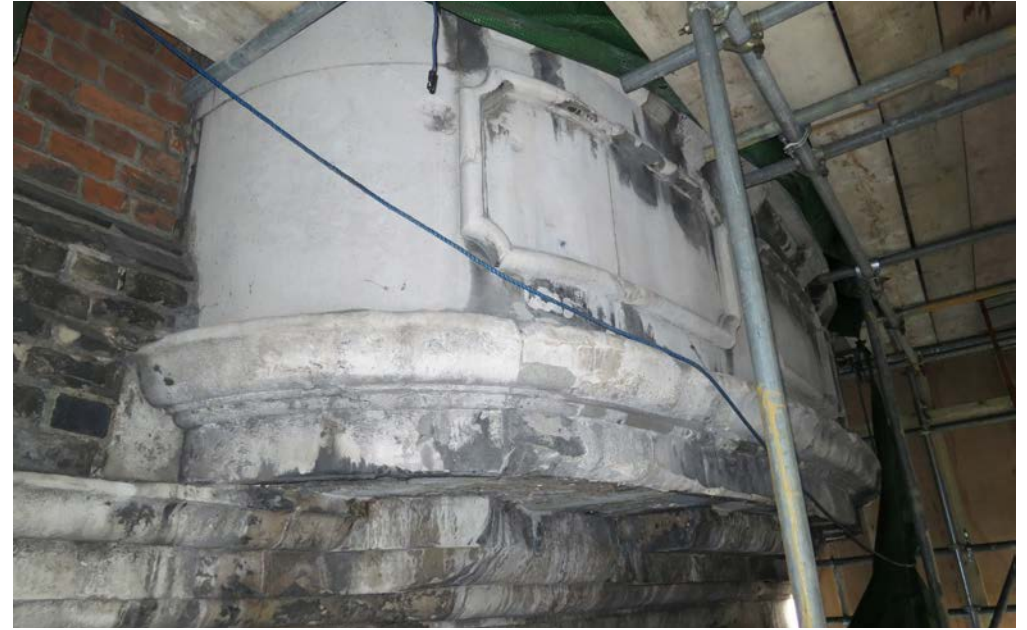
2.1.2.4.1 The Alan Baxter 2013 report states the Listed Oriel is in very poor condition with large parts of the stonework having eroded with numerous cementitious repairs evident.

Fig 2.1.17: Cornice stone missing under the Oriel with patch repair visible

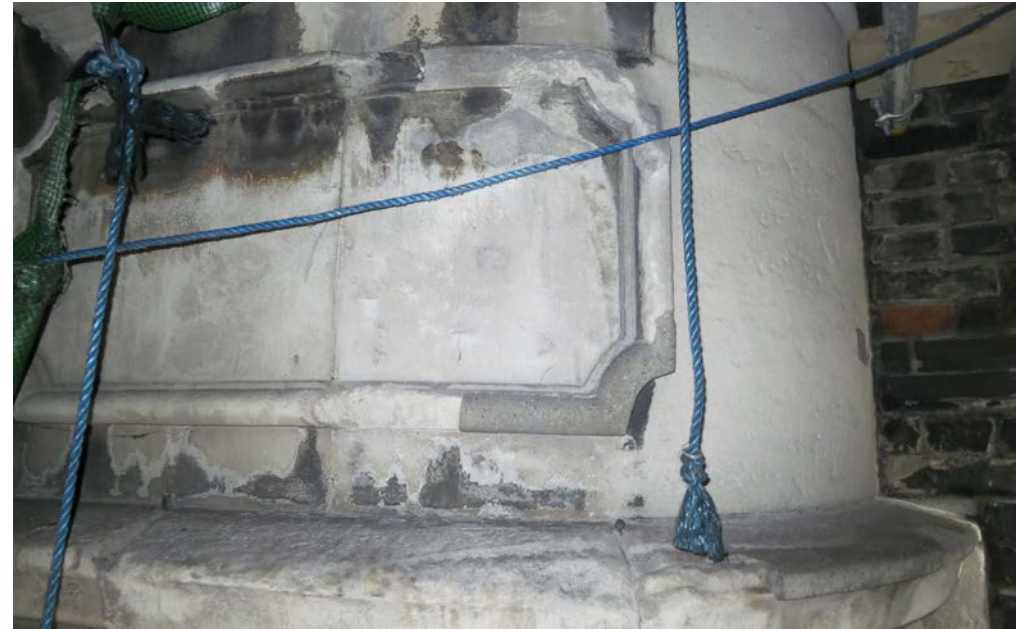
Fig 2.1.18: Evidence of cementitious repairs to the Oriel have eroded

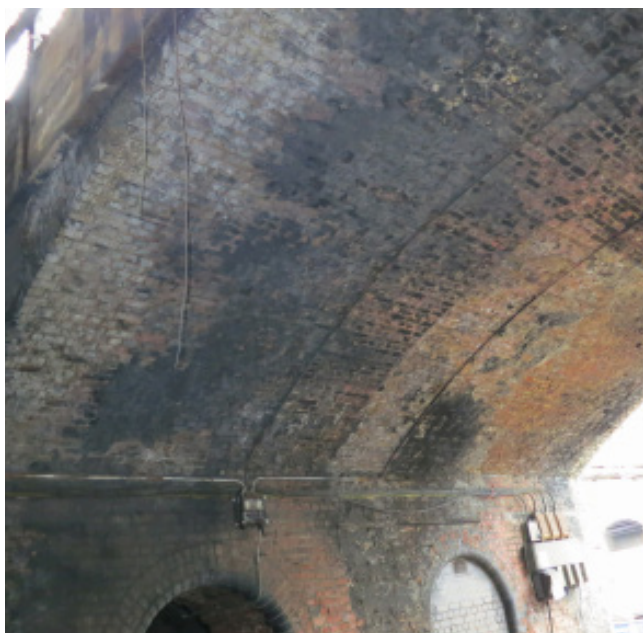
- 2.1.2.5.7 Water markings were noted to the underside of the brickwork arch soffits, which most probably has been caused from water seeping in from above, but there was no evidence of spalling to the brick arches due to weathering. Missing bricks to the fascia fronting the main line railway to a few arches were noted.

Fig 2.1.20: Evidence of water marking to brickwork

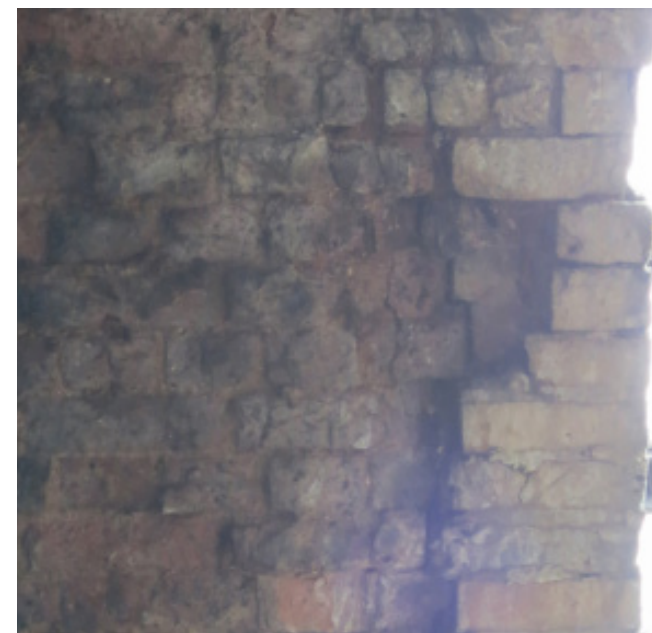
Fig 2.1.21: Missing brickwork to face of arch

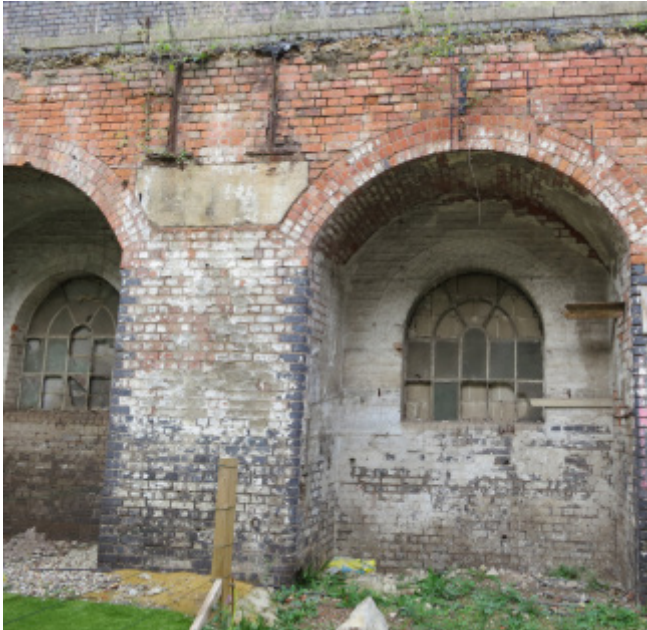
Fig 2.1.22: Boundary Wall: Remnants of iron/steel beams visible

- 2.1.2.6.3 The original structure adjacent the wall would have taken the form of jack arched brickwork with iron/steel beams, and evidence of this was found to the inside of the boundary wall, where iron/ steel stubs bearing on large stone pad stones protrude out of the brickwork wall.

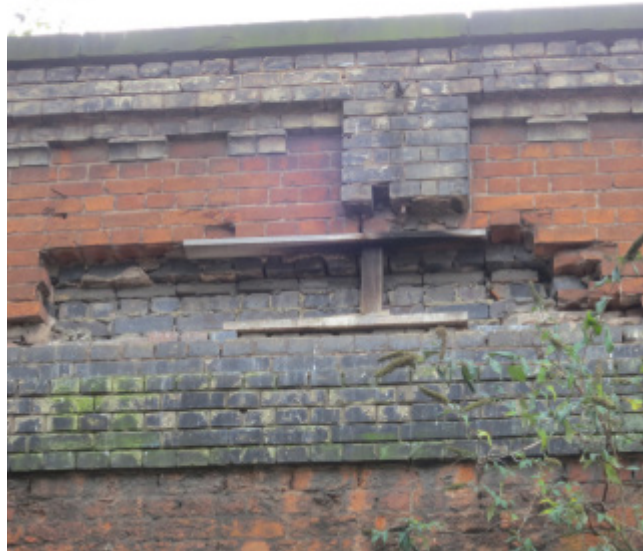
Fig 2.1.23: Evidence of temporary timber prop to brickwork

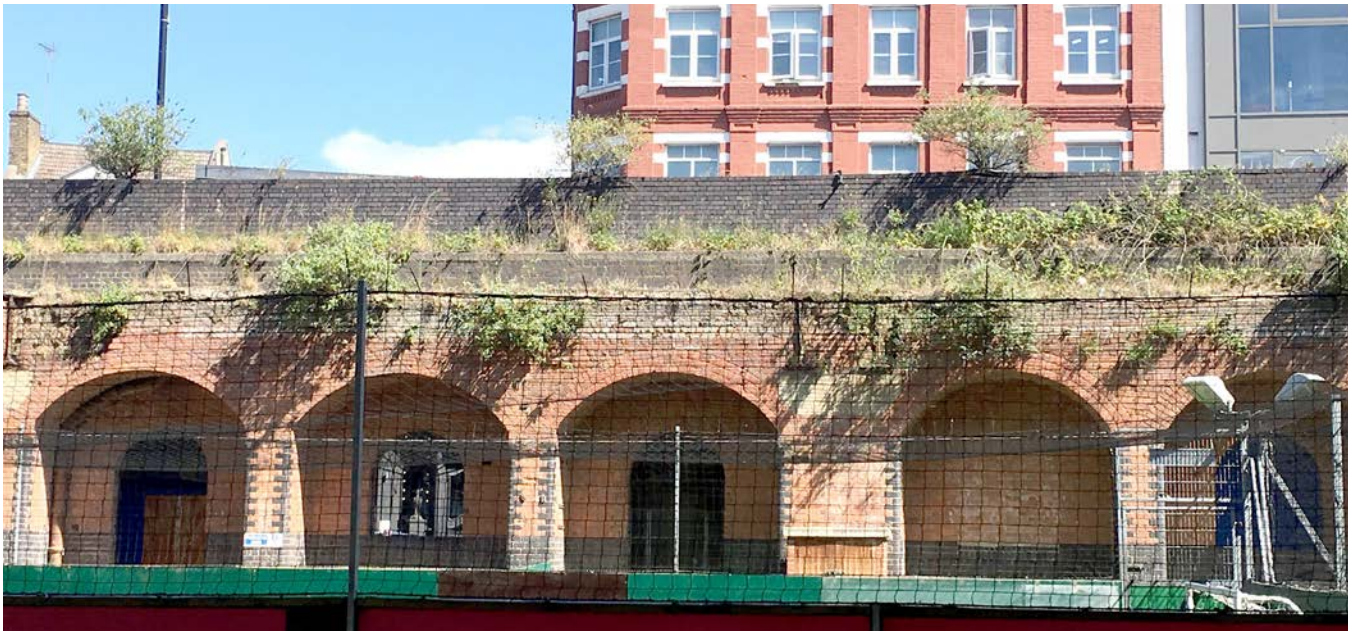
Fig 2.1.24: Spalled brickwork and Buddleia type vegetation growing along the length of the Boundary Wall

- 2.1.2.6.6 Vegetation going outwards through the brickwork was evident in many locations causing spalling to the facing brickwork fronting Sclater Street. Spalling of brickwork was also observed along the length of the wall probably caused by freeze / thaw action. There was an area of brickwork at parapet level which had fallen away and this had been temporarily propped using wooden propping which Alan Baxter suggested should be made good by re-stitching in brickwork to match the existing.

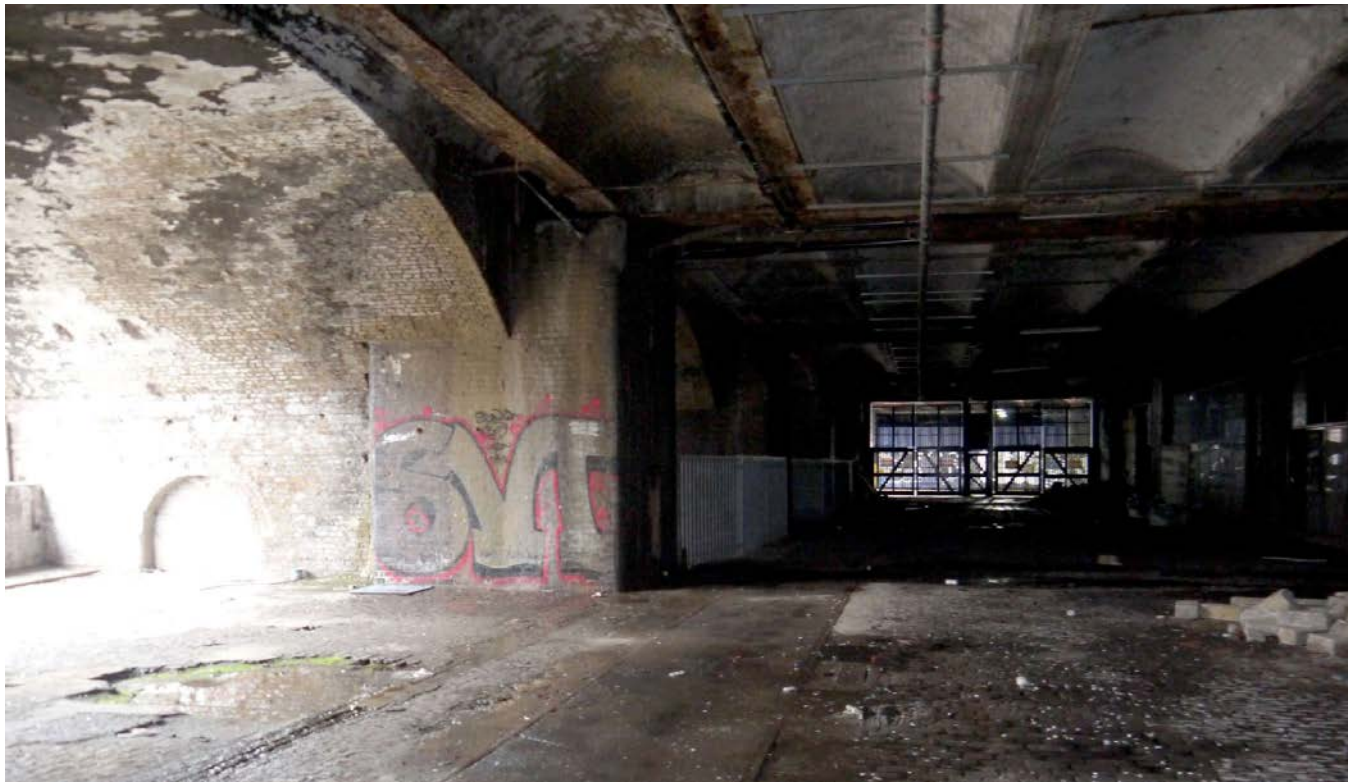
3.6.12.1 Above London road and the SLT a series of steel and brick jack arches span across the line at London Road level and at Park level. The condition of the Jack Arch structure is poor as previously reported by Alan Baxter's in their reports of 2009 & 2013.

3.6.12.2 The steelwork to the jack arches at the upper and lower levels are heavily corroded and a number are likely to have to be replaced. Alan Baxter in their report of 2009 proposed a possible solution where the existing steel beams remain in place and are hung from a new reinforced concrete structure installed above the beams.

Fig 3.6.19: Existing view of jack arches forming the lid to London Road (2013)

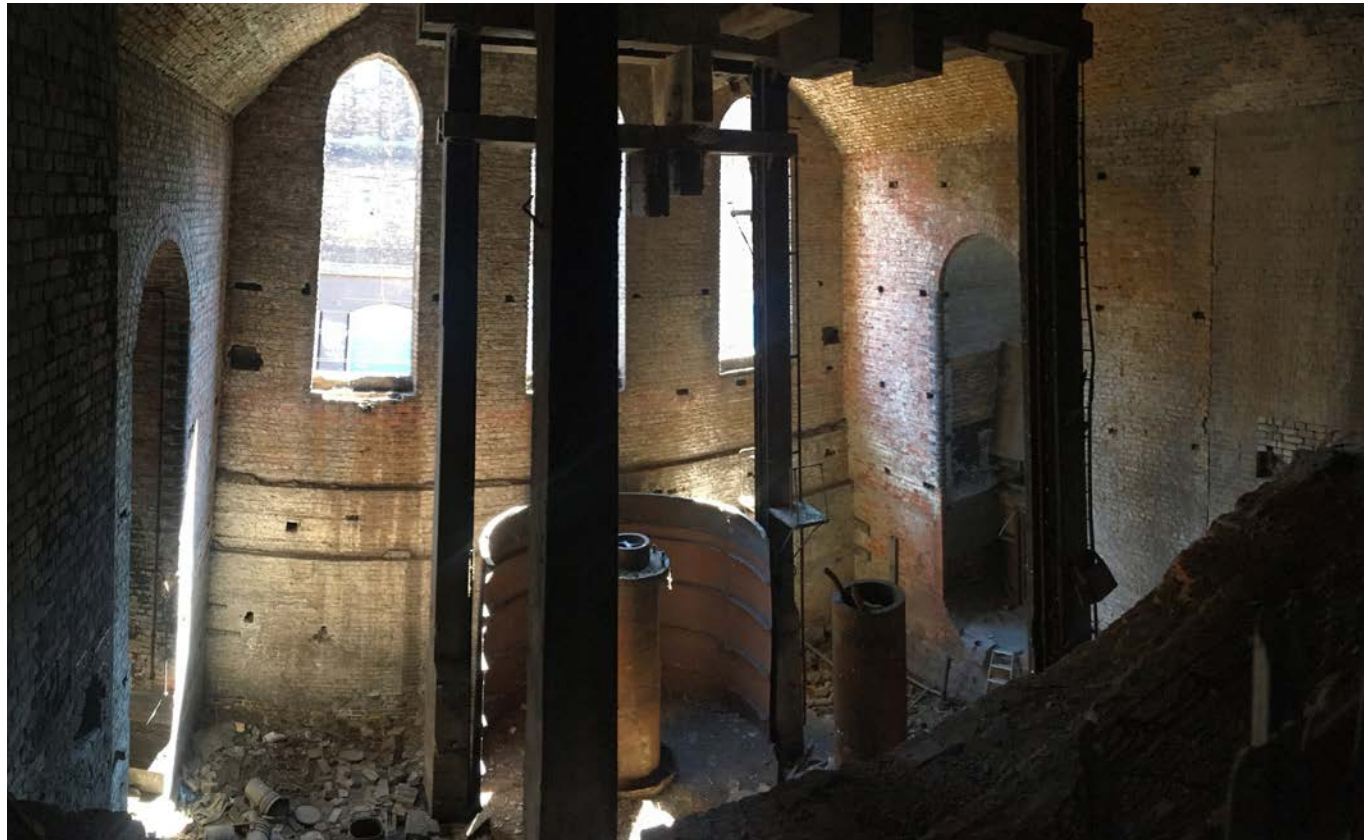
Fig 4.3.5: Photograph of the existing Accumulator double height area showing current condition c.2018
