REPORT N° STR 001

70-74 SCLATER STREET

STRUCTURAL EXTERNAL INSPECTION

OCTOBER 2017

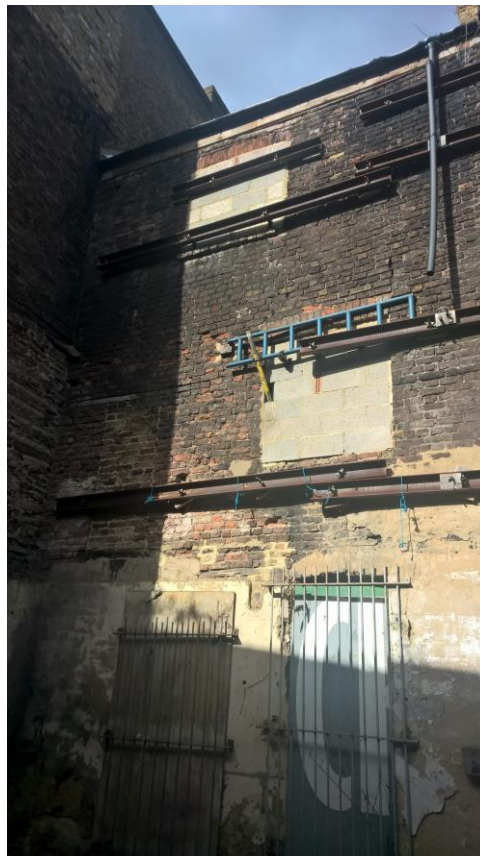
The rear elevation to number 70 contained a series of blocked up windows and some boarded over windows and doors at ground floor level.

Rear elevation of Number 70 Sclater Street

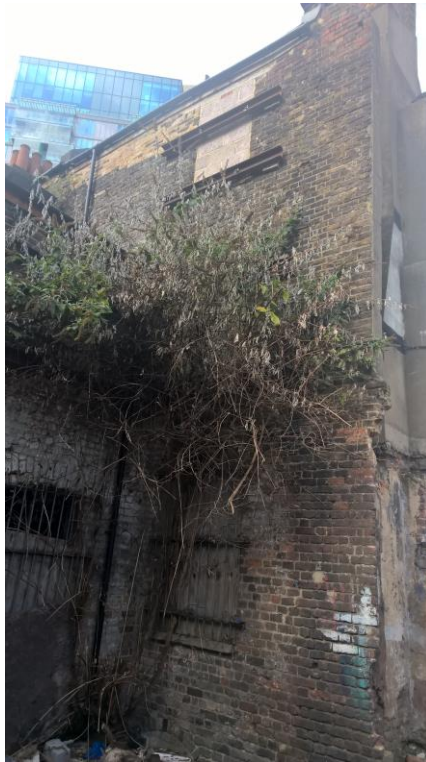
Rear Elevation of Number 74 Sclater Street

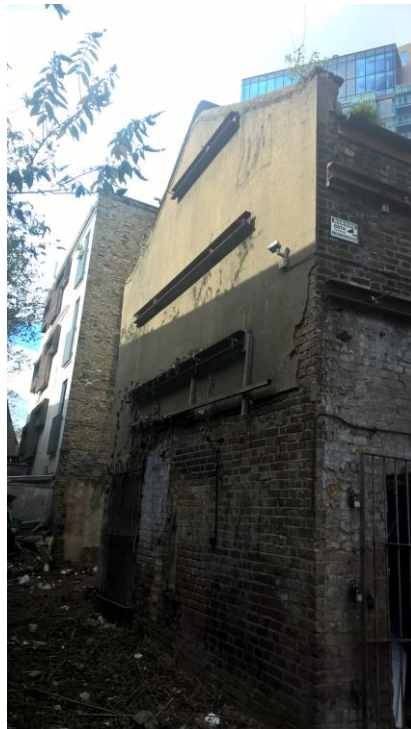
The rear addition showed signs of severe dilapidation, with the first floor completely missing on the west side, along with the existing roof being completely replaced with a temporary corrugated sheeting. With the missing first floor, the integrity and restraint of the west wall has been compromised with noticeable bowing around first floor level. The top of the wall at eaves level did not appear to be restrained in any robust way. The east elevation of the addition appeared more robust, but contained cracking around first floor level, in and around door and window lintels from ground floor. The soldier courses in these areas over the openings were split or were in the process of failing. A small bush, similar to a buddleia was noticed to be well established and there was considerable plant growth around the junction of the addition and the main building, making inspection restricted. Minor cracking to the rendered south face of the addition was noticed, but without removal of the render, verification of blown render or structural cracking could not be readily distinguished.

Rear elevation of numbers 72/74 Rear Addition

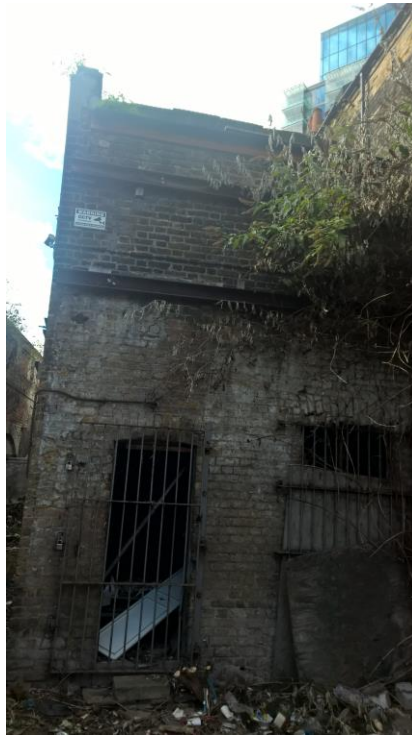
The rear addition to numbers 72 and 74 also had open doorways at ground floor allowing an limited inspection inside. The east elevation had internal scaffold standards and bracing back propping the first floor. There was evidence of the scaffolding continuing into the main building within. The west elevation revealed similar extent of back propping but with no first floor the propping extended to support the corrugated temporary roof only. There was no signs of any restraints or ties to the west wall here, which spanned two stores

East wall of rear addition to number 74

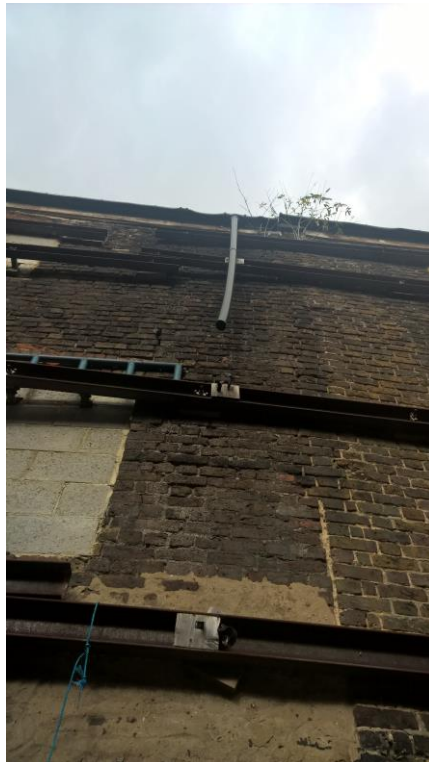
The condition of the rear wall to the main building is poor, with cracking immediately in front of party wall junctions and very obvious bulging and bowing of masonry at 1st floor and eaves level particularly between numbers 70 and 72. Where the main building rear wall met the west wall of the rear addition, there was also evidence of the wall and window bowing inwards. The rear addition obstructed the view of the junction between numbers 72 and 74, but cracking was noticed at the party wall above the rear additions ridge line. The most easterly section of wall immediately below the eaves also appeared to be bowing inwards slightly. In general the

Rear wall junction between numbers 70 and 72 Sclater Street

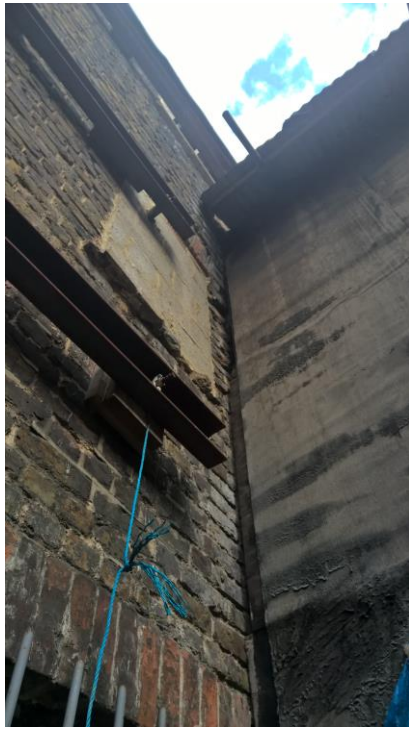
Junction of rear wall to west wall of rear addition to Number 72 Sclater Street

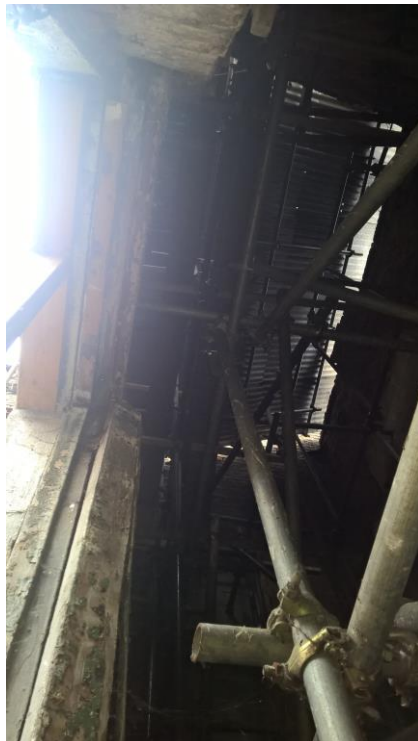
Inside the west elevation of the rear addition to Number 72 Sclater Street

The immediate priority is to ensure the structure is safe and that the temporary works are validated. A TWC (temporary works contractor) should be appointed to inspect the site, with anticipated provision of a safe external access being provided to all floors from the rear, in the form of either a mobile temporary scaffold tower or more permanent scaffold framing with the provision for both access and additional restraint for the building (from the site inspection, this would be our recommendations, but the detail of this would need to be confirmed by the TWC). The west wall to the rear addition needs immediately tying back, both at first floor and eaves level.

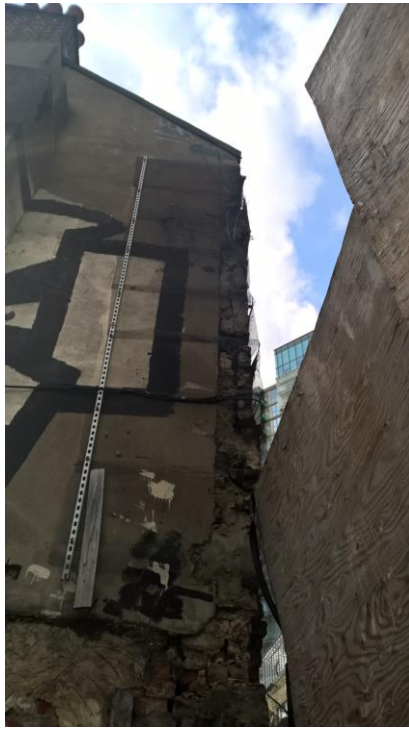
East elevation of Number 74 Sclater Street
