Appendix C BuroHappold January 2020 Thameside West Visual Inspection Report

Technical Note

Project Thames Side West

Subject River Wall Inspection – January 2020

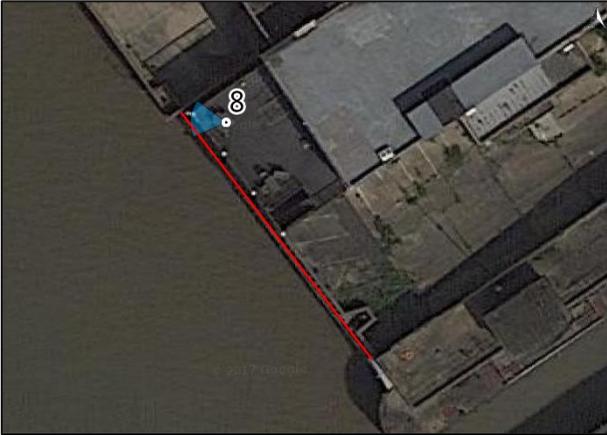
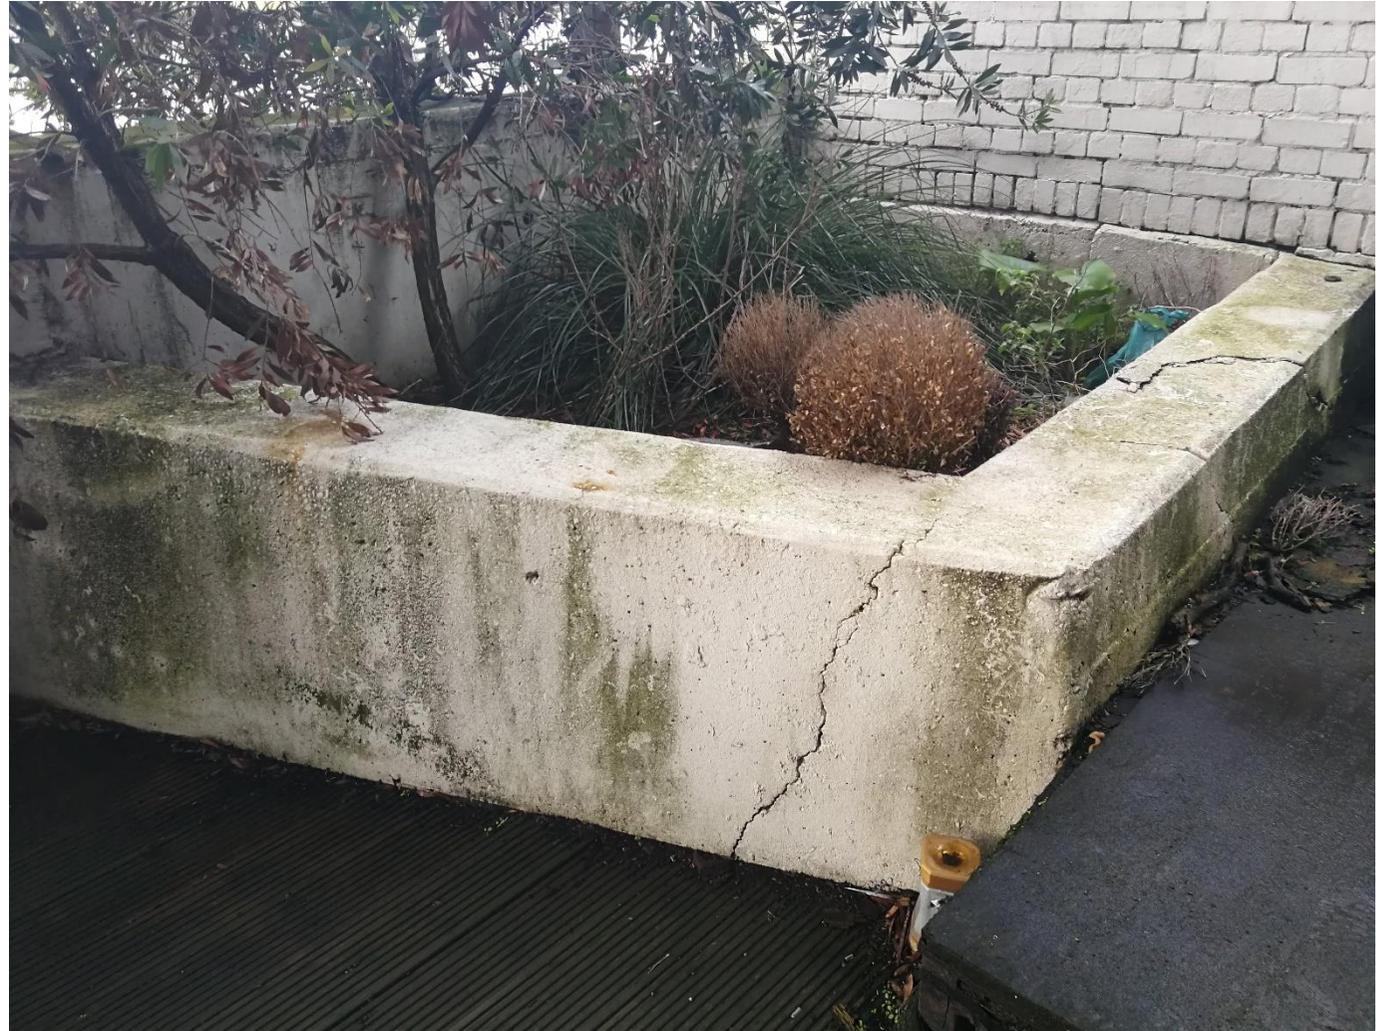
Location 8

TOBS terrace area – north corner planter crack detail

- Existing crack in wall of concrete planter first observed during first inspection on 19th December 2017.
- Extent of crack remains unchanged since last inspection.
- No evidence to indicate that crack has widened since last inspection.
- No new cracks observed in wall of concrete planter.

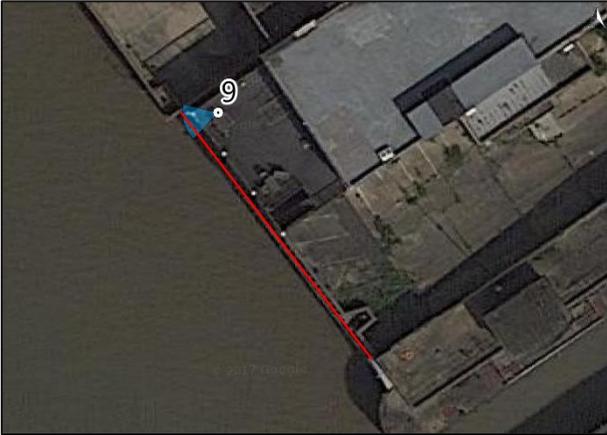
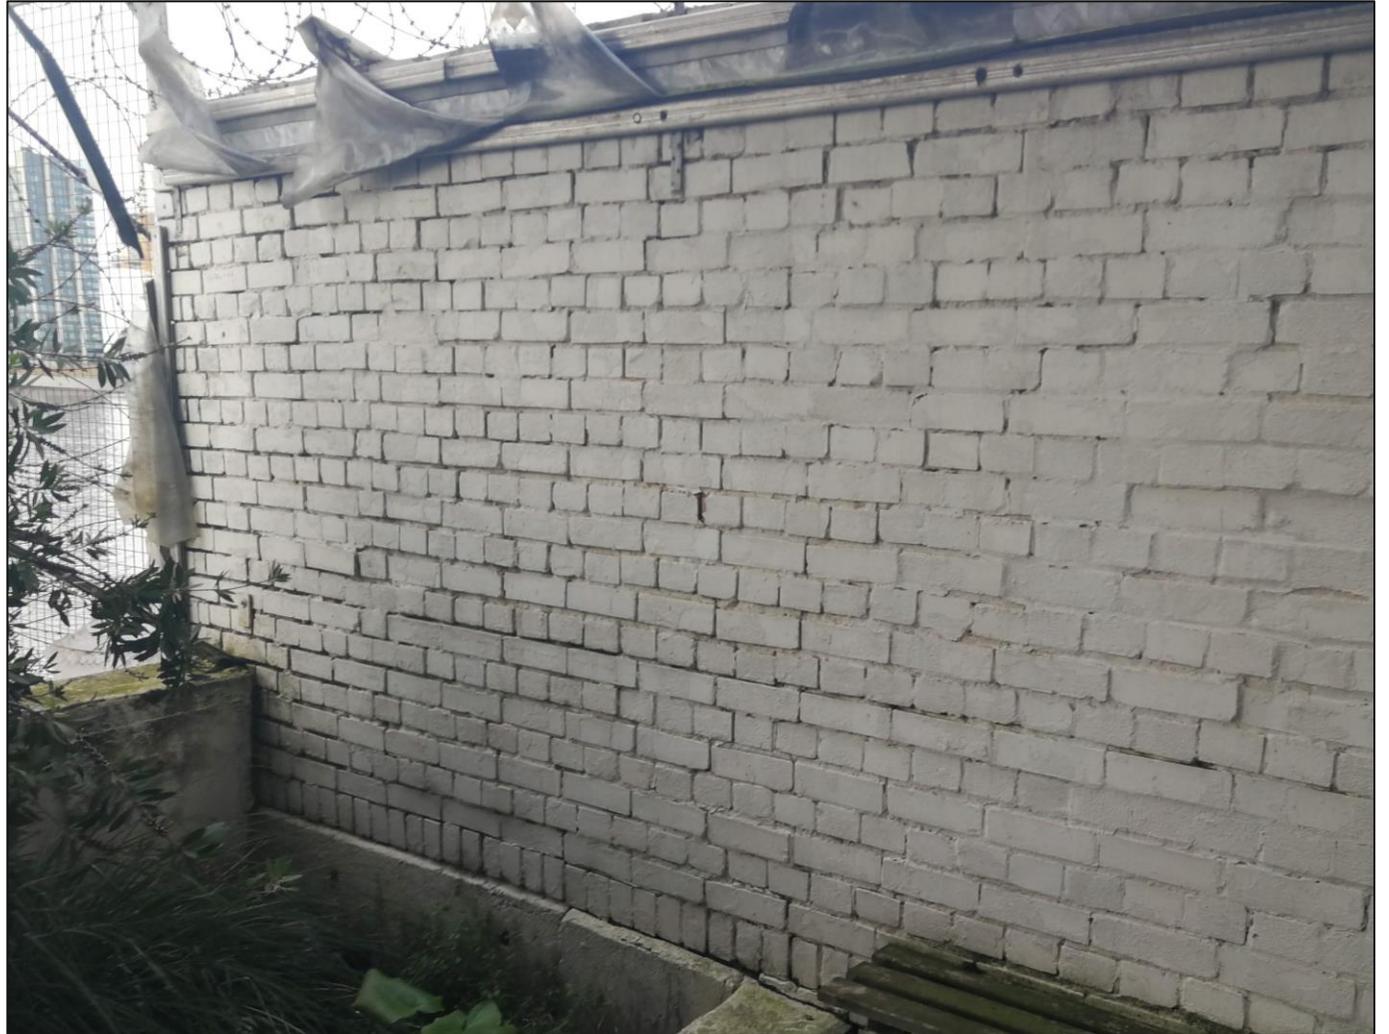
Location 9

TOBS terrace area – north cornered brick wall detail

- Adjoining brick wall at north boundary of Dohm Wharf river wall.
- Existing minor crack along horizontal mortar joints in brick wall first observed during first inspection on 19th December 2017.
- No evidence to indicate that crack has widened or extended since last inspection.
- No new cracks observed in brick wall.
- Note that condition of mortar is poor in places.

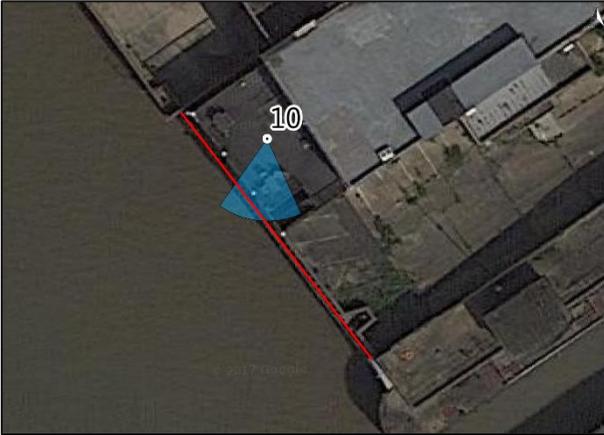
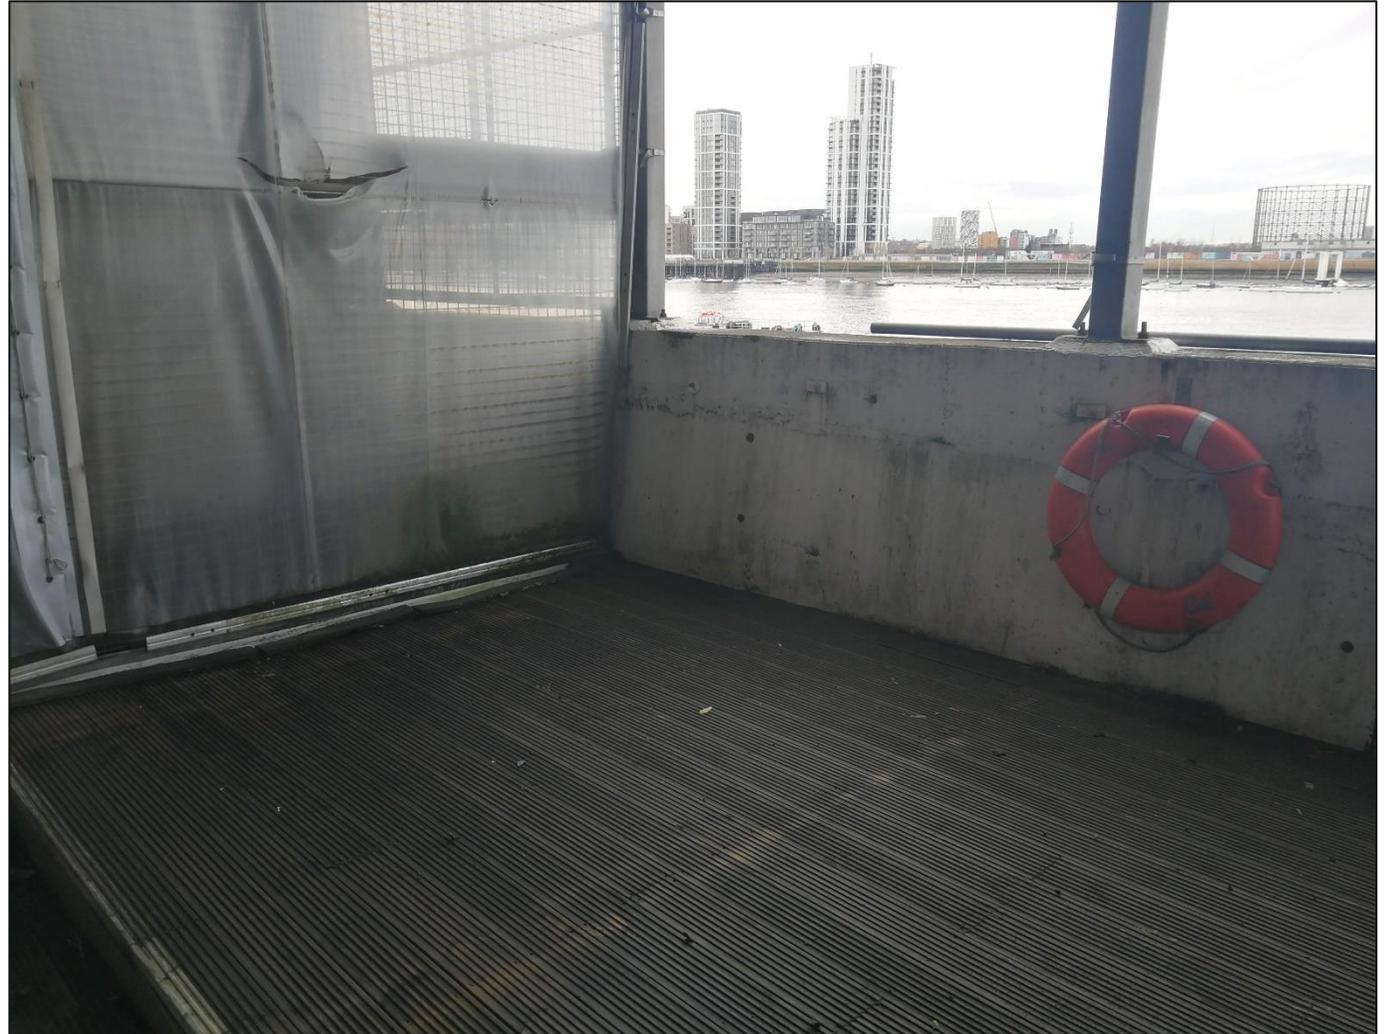
Location 10

TOBS terrace area – south corner

- No new cracks observed in concrete parapet wall.
- No obvious indications of movement or settlement.

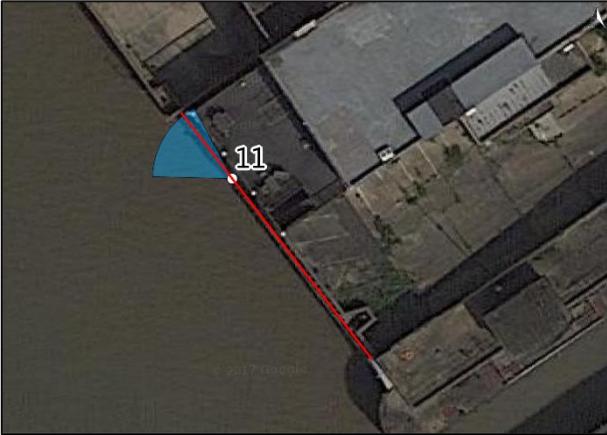
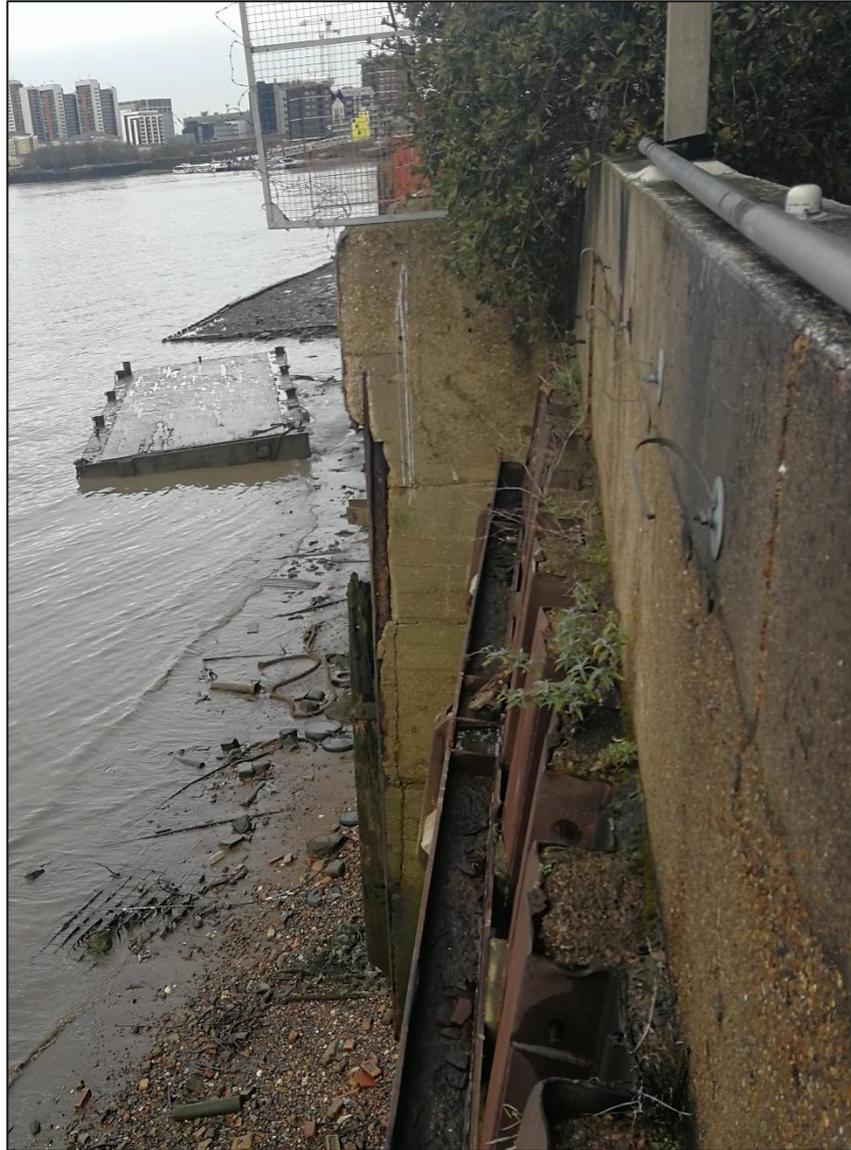
Location 11

TOBS terrace area – end face of adjacent wall to north

- Adjoining river wall to north steps out from alignment of Dohm Wharf river wall.
- Reinforcement within concrete face of adjoining river wall exposed, first observed during first inspection on 19th December 2017. No obvious significant deterioration since last visit on 24th May 2019.
- No evidence of movement at interface between two river walls.

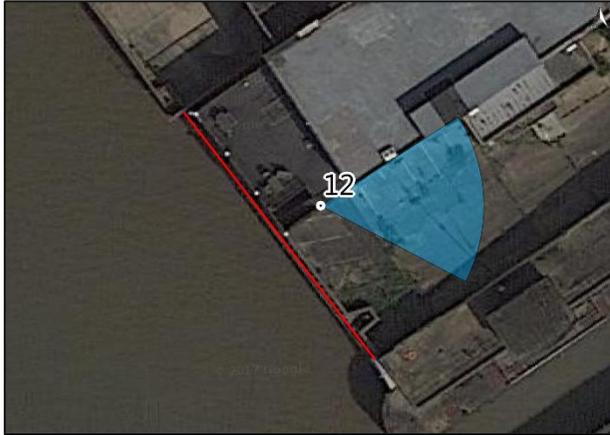
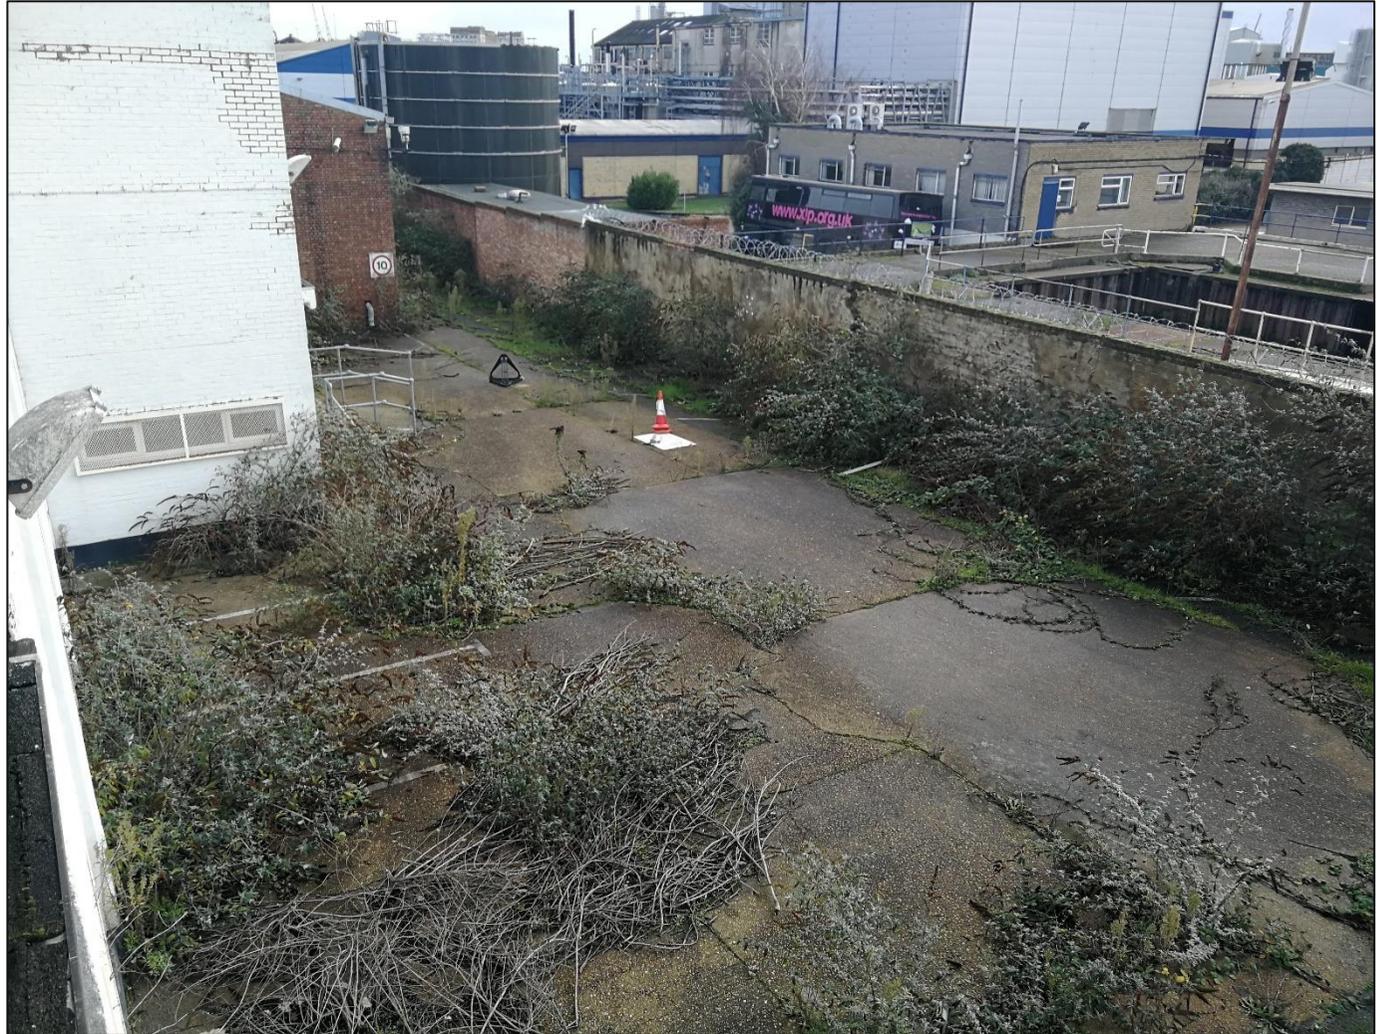
Location 12

Hard standing area – overview of hard standing

- Taken from the upper deck of the TOBS roof terrace.
- Existing cracks in concrete hard standing first observed during first inspection on 19th December 2017.
- No new cracks or other evidence of movement or settlement within concrete hard standing observed.
- Further vegetation growth within concrete hard standing since the previous inspection on 24th May 2019.
- Borehole within concrete hardstanding, containing monitoring equipment. Presumed to be part of site investigation works by TfL for the Silvertown Tunnel.

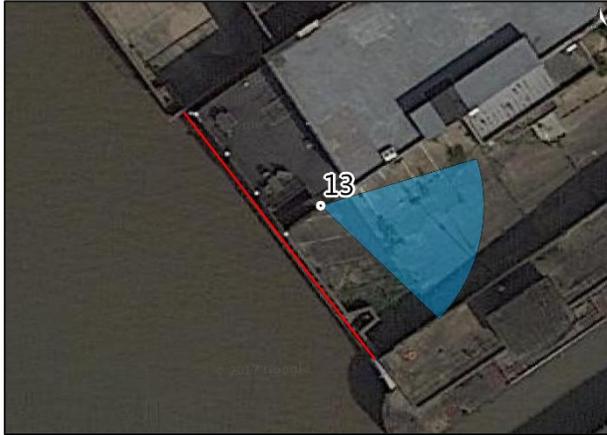
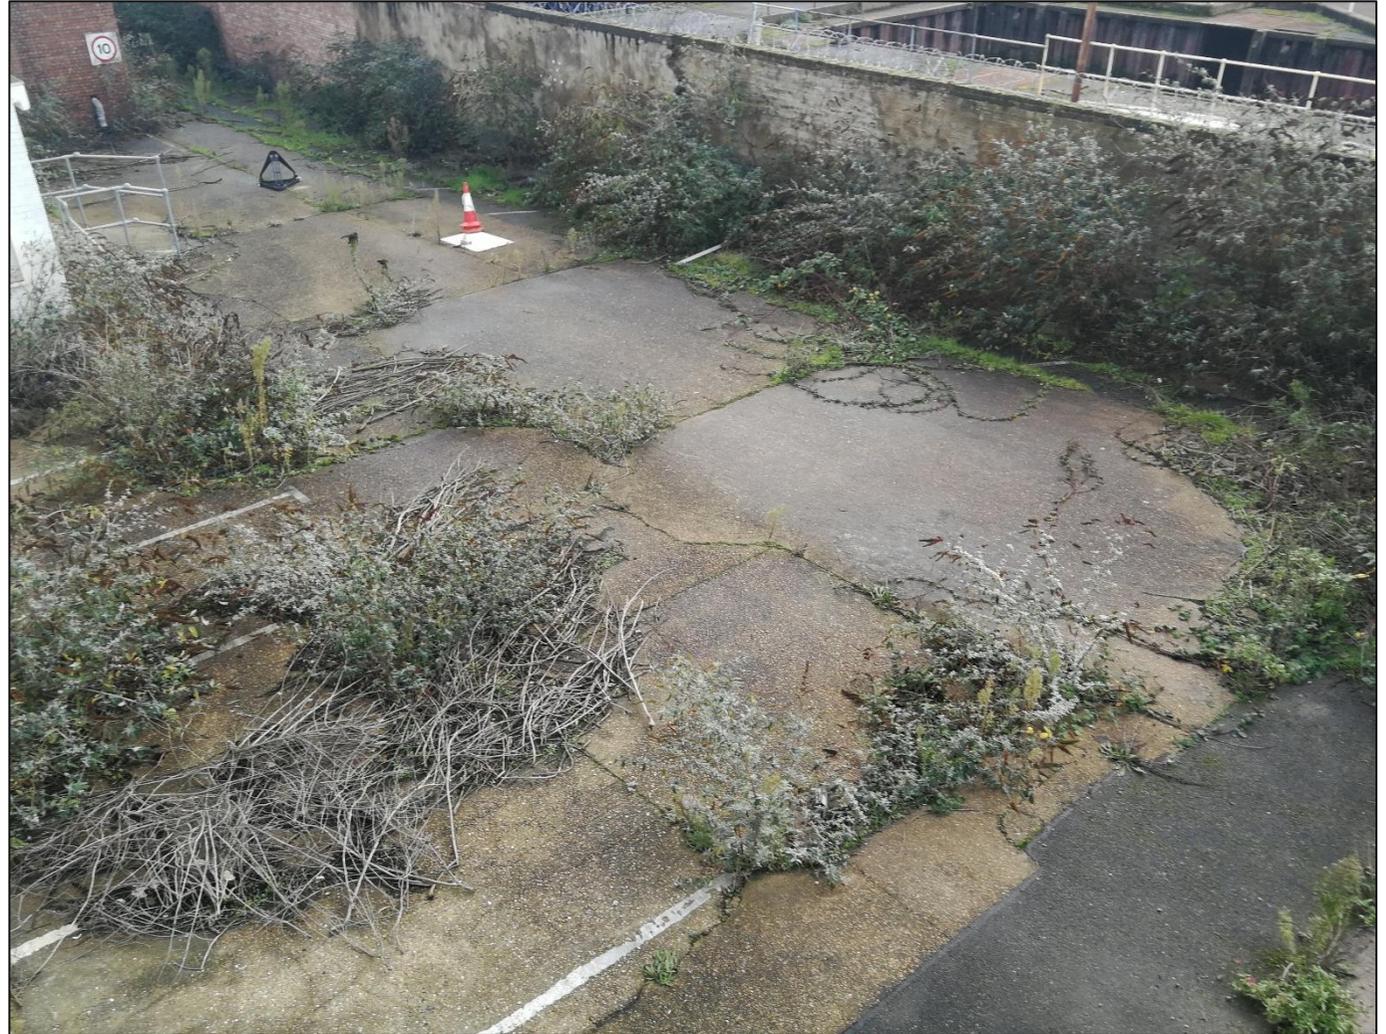
Location 13

Hard standing area – overview of hard standing

- Taken from the upper deck of the TOBS roof terrace.
- Existing cracks in concrete hard standing first observed during first inspection on 19th December 2017.
- No new cracks or other evidence of movement or settlement within concrete hard standing observed.
- Further vegetation growth within concrete hard standing since the previous inspection on 24th May 2019.
- Borehole within concrete hardstanding, containing monitoring equipment. Presumed to be part of site investigation works by TfL for the Silvertown Tunnel.

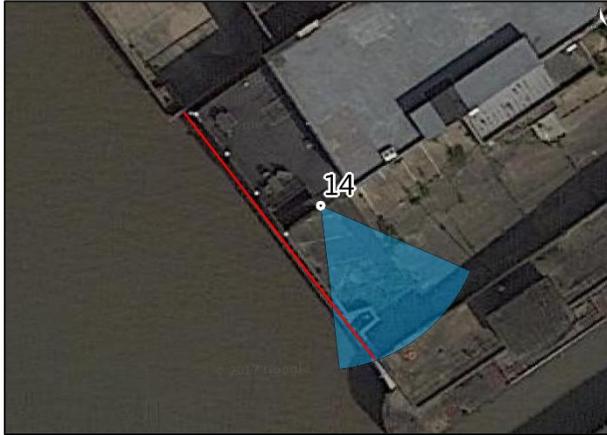
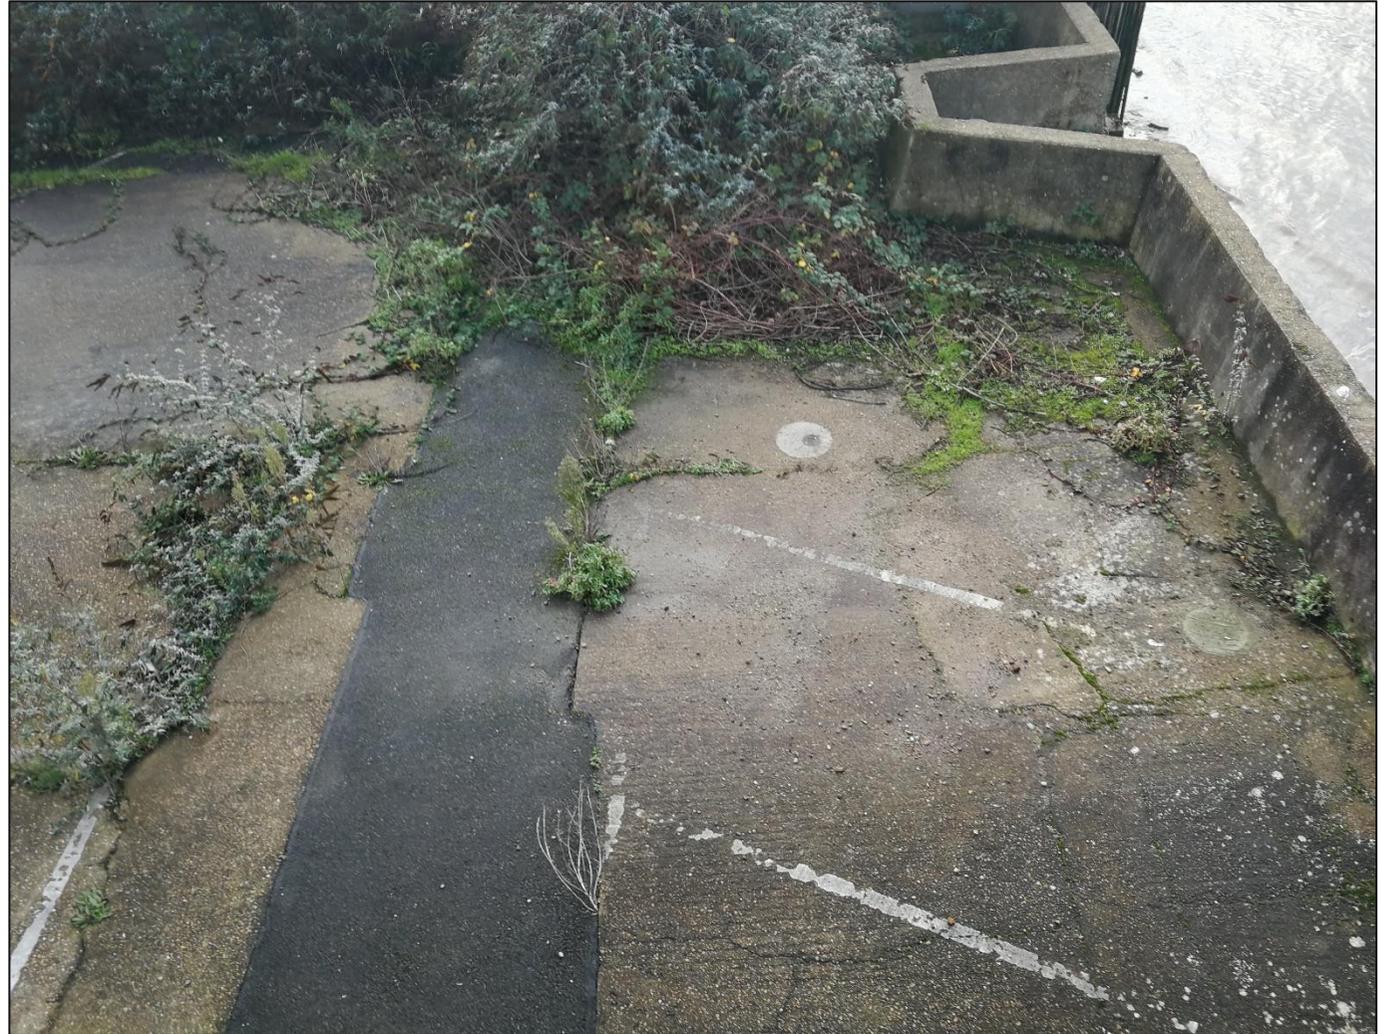
Location 14

Hard standing area – overview of hard standing

- Taken from the upper deck of the TOBS roof terrace.
- Existing cracks in concrete hard standing first observed during first inspection on 19th December 2017.
- No new cracks or other evidence of movement or settlement within concrete hard standing observed.
- Further vegetation growth within concrete hard standing since the previous inspection on 24th May 2019.

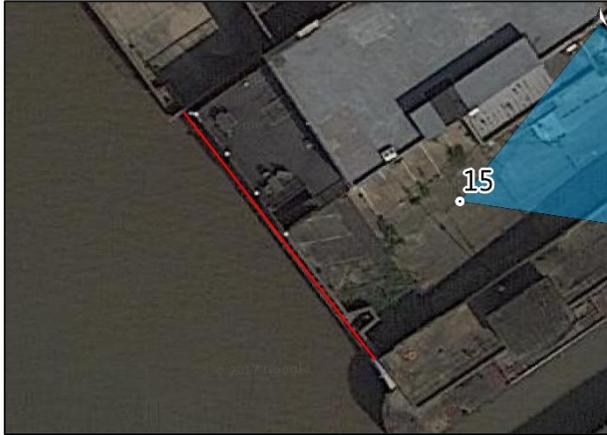
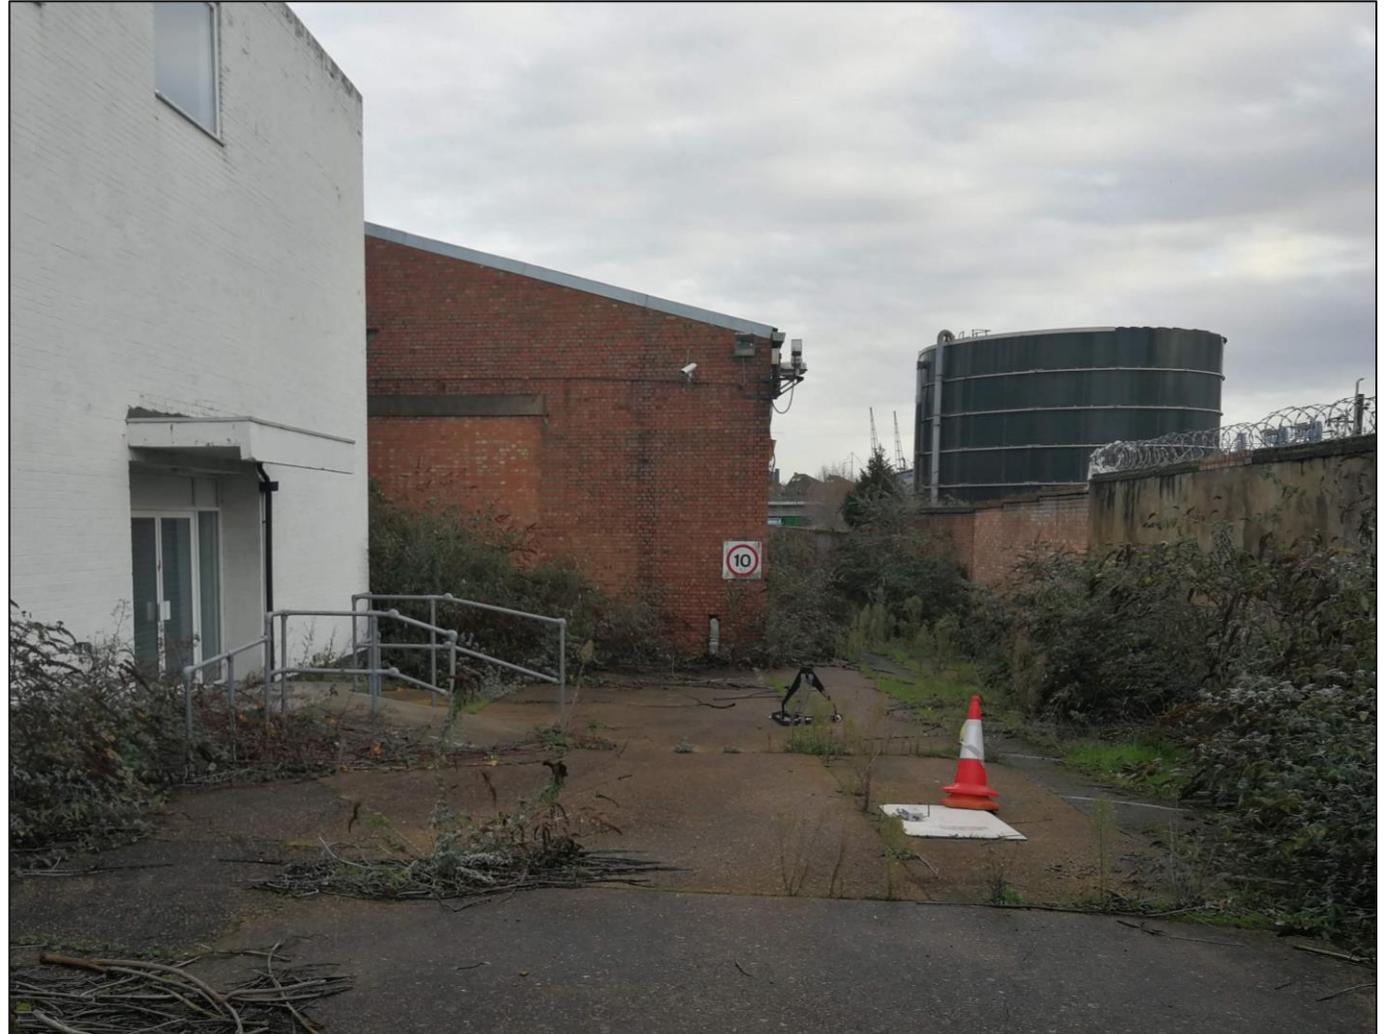
Location 15

Hard standing area – view away from river wall

- Existing cracks in concrete hard standing first observed during first inspection on 19th December 2017.
- No new cracks or other evidence of movement or settlement within concrete hard standing observed.
- Further vegetation growth within concrete hard standing since the previous inspection on 24th May 2019.
- Borehole within concrete hardstanding, containing monitoring equipment. Presumed to be part of site investigation works by TfL for the Silvertown Tunnel.

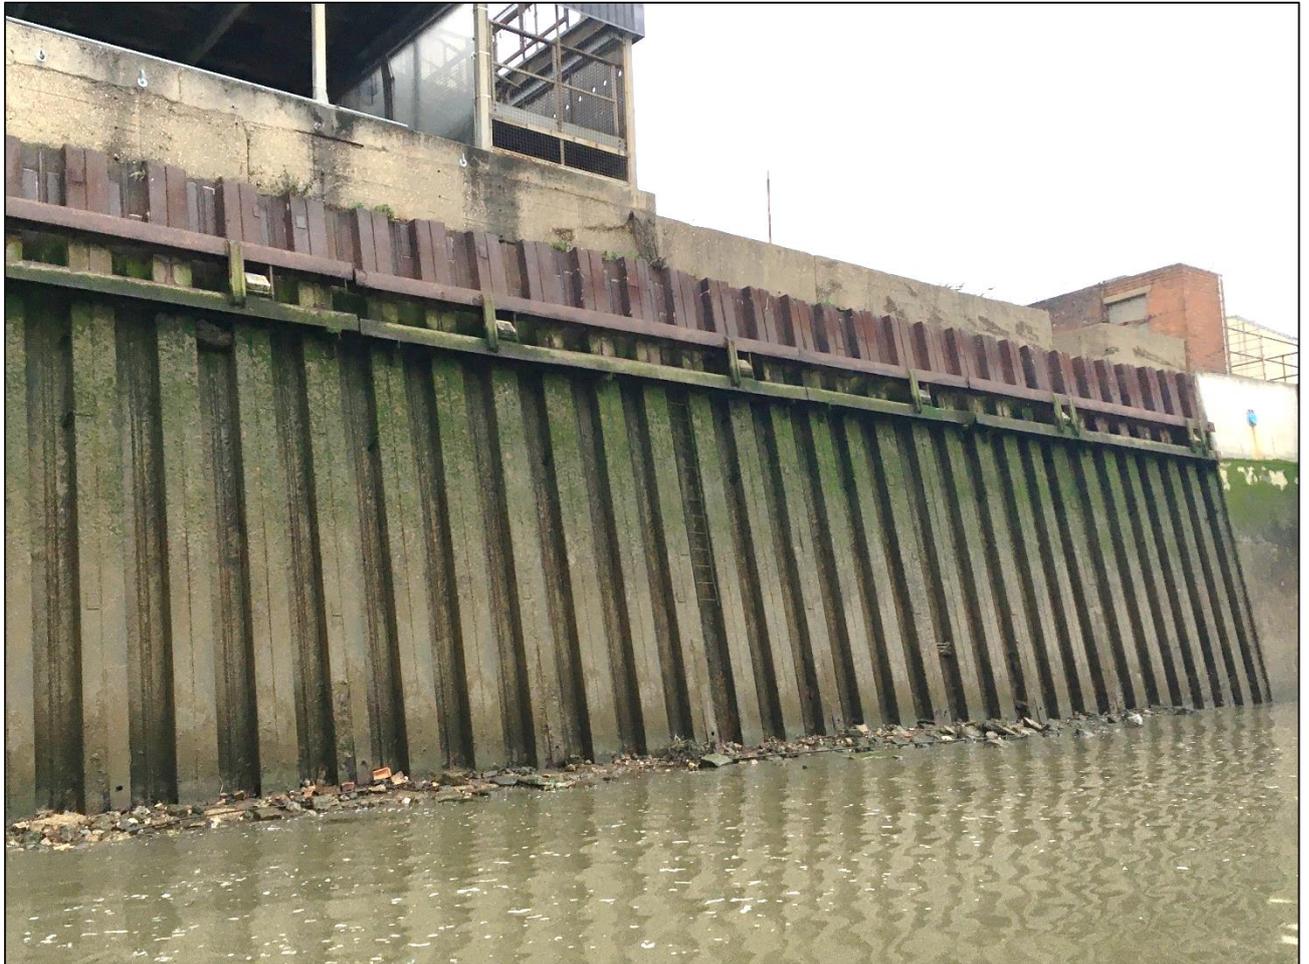
Figure 2-1 shows the overall condition of the river wall at Dohm Wharf, taken from a boat approximately one hour after low tide. The patch repairs are no longer clearly visible from a distance due to the growth of vegetation and algae.

Figure 2-1: Overall view of the river wall at Dohm Wharf, taken from a boat at low tide

While there is minor corrosion to the steel sheet pile, no significant deterioration since the previous inspection was observed.

No evidence of movement or settlement of the existing river wall was observed, either at the interface with the adjacent river wall structures or overall.

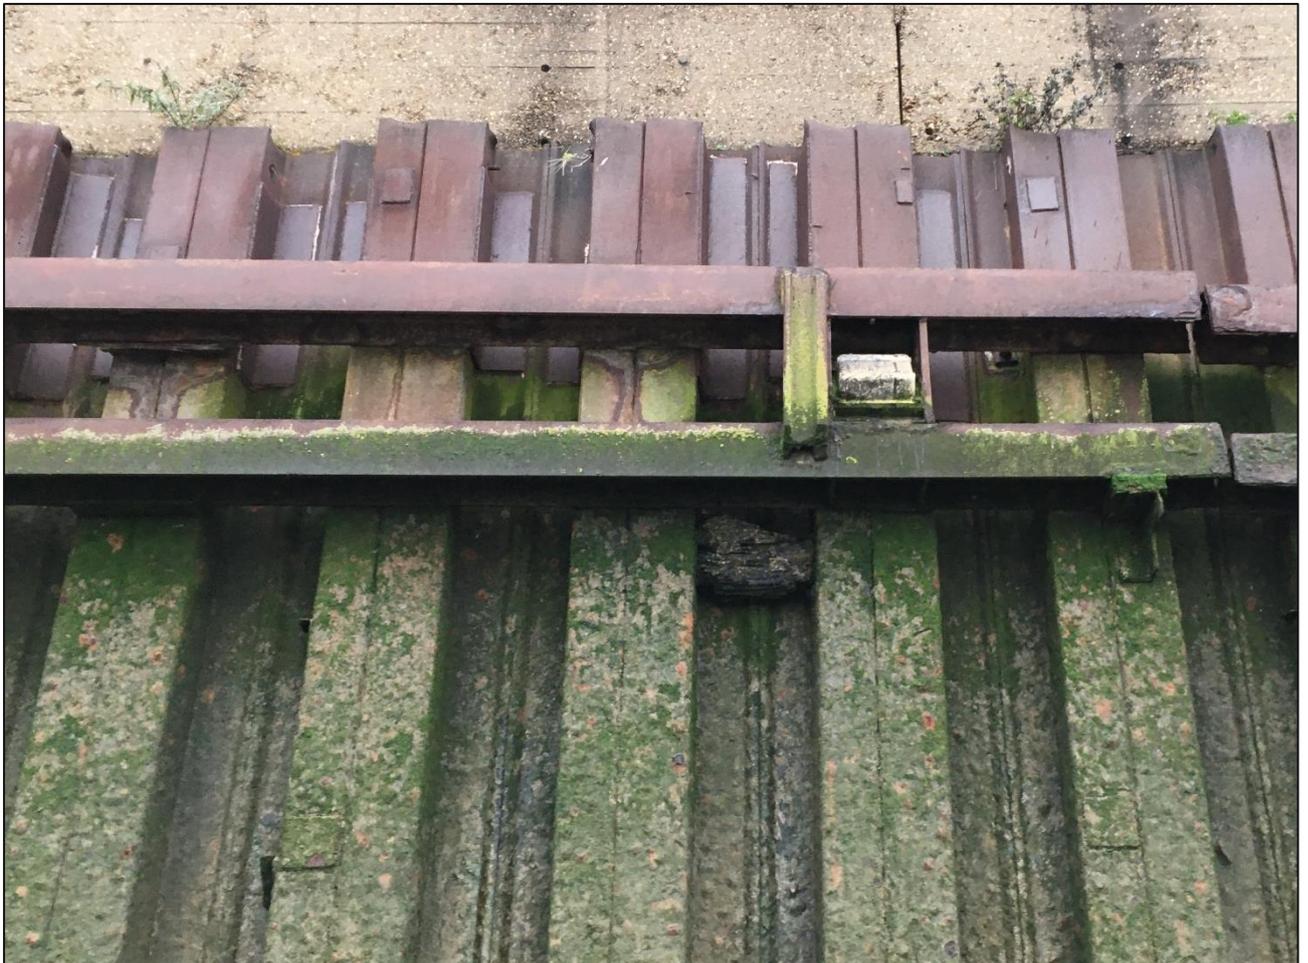
All plate repairs appear to remain securely welded to the existing sheet pile sections and there is no evidence of further degradation of the condition of the remaining steel. Figure 3-1 shows a typical photograph of the upper level of the river wall, showing the steel plate repairs securely welded to the sheet piling, with mastic sealant still in place.

Figure 3-1: Typical photograph of upper level of river wall, showing steel plate repairs to sheet piling, taken from the river side of the river wall

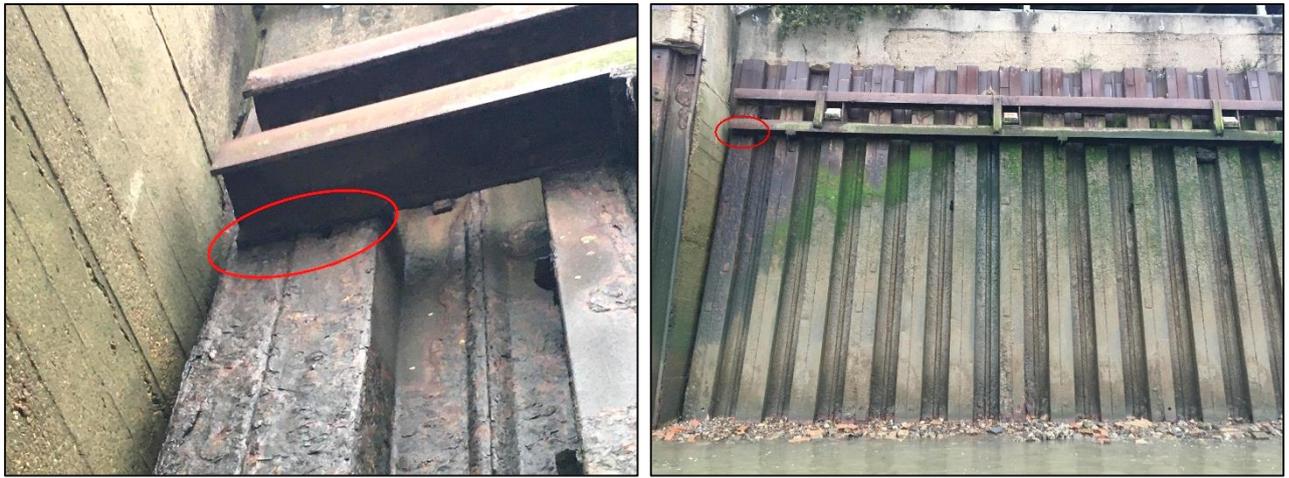
During the most recent river side inspection, carried out in March 2018, two locations where a perforation had not had a patch repair installed were observed. At the time, it was considered that the two perforations would not pose a risk of structural failure of the river wall and that additional repair would therefore not be required. The extent of these two perforations does not appear to have deteriorated significantly since the previous inspection. One of the perforations, immediately below the lower waling beam at the upstream end of the river wall is shown in Figure 3-2.

Figure 3-2: Location at north extent of river wall where patch repair to perforation steel sheet piling has been missed

During the March 2018 inspection, two locations were identified where a perforation had not had a patch repair installed, which was not observed at the time of remedial works. Subsequent additional repairs were considered not to be required. The extent of these two perforations does not appear to have deteriorated significantly since the previous inspection, however it is recommended that this continues to be closely monitored during subsequent inspections.

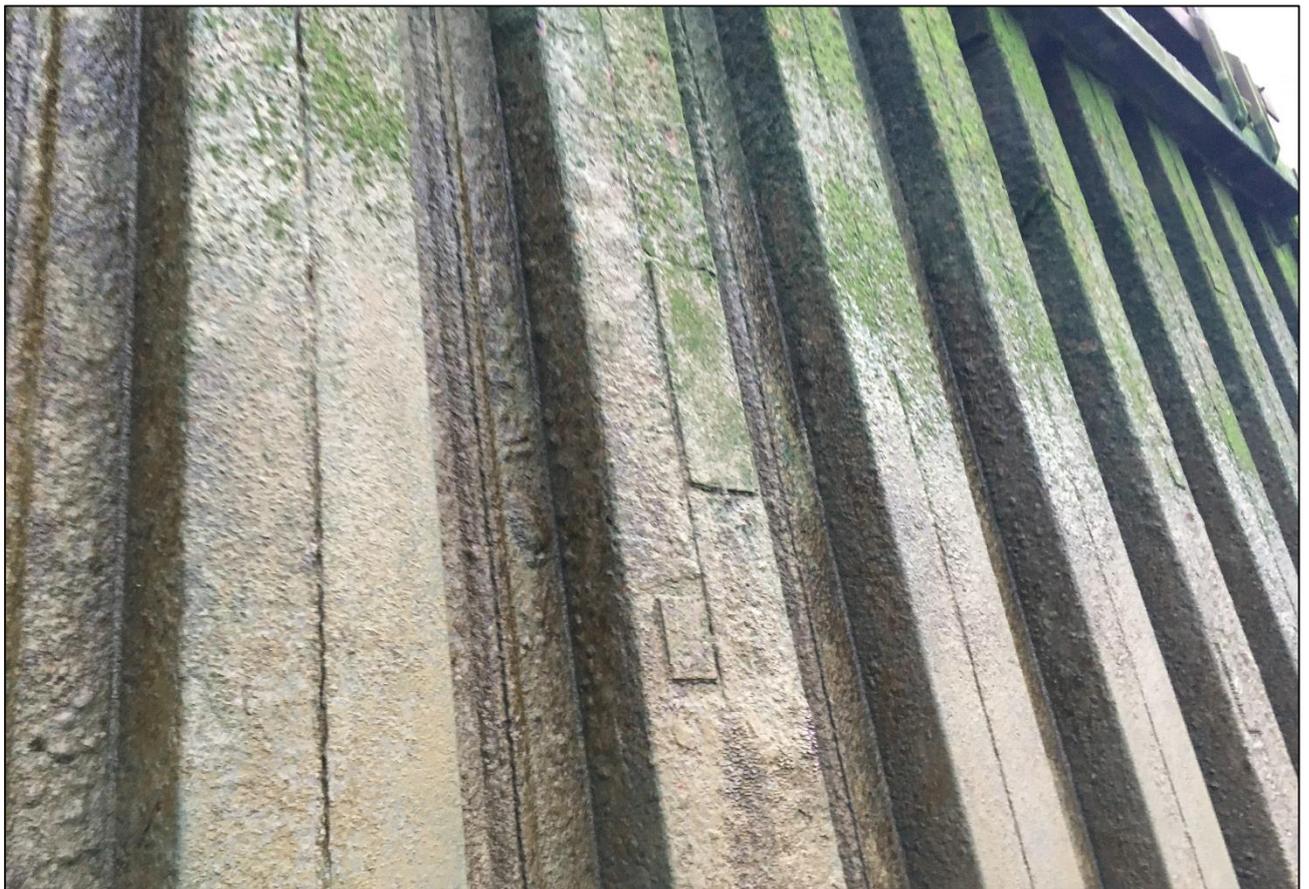
All repairs at the mid level appear to be in good condition, with no new perforations. A typical example of one of the mid level repairs is shown in Figure 3-3

Figure 3-3: Typical patch repair to the mid level of the steel sheet pile wall, in good condition

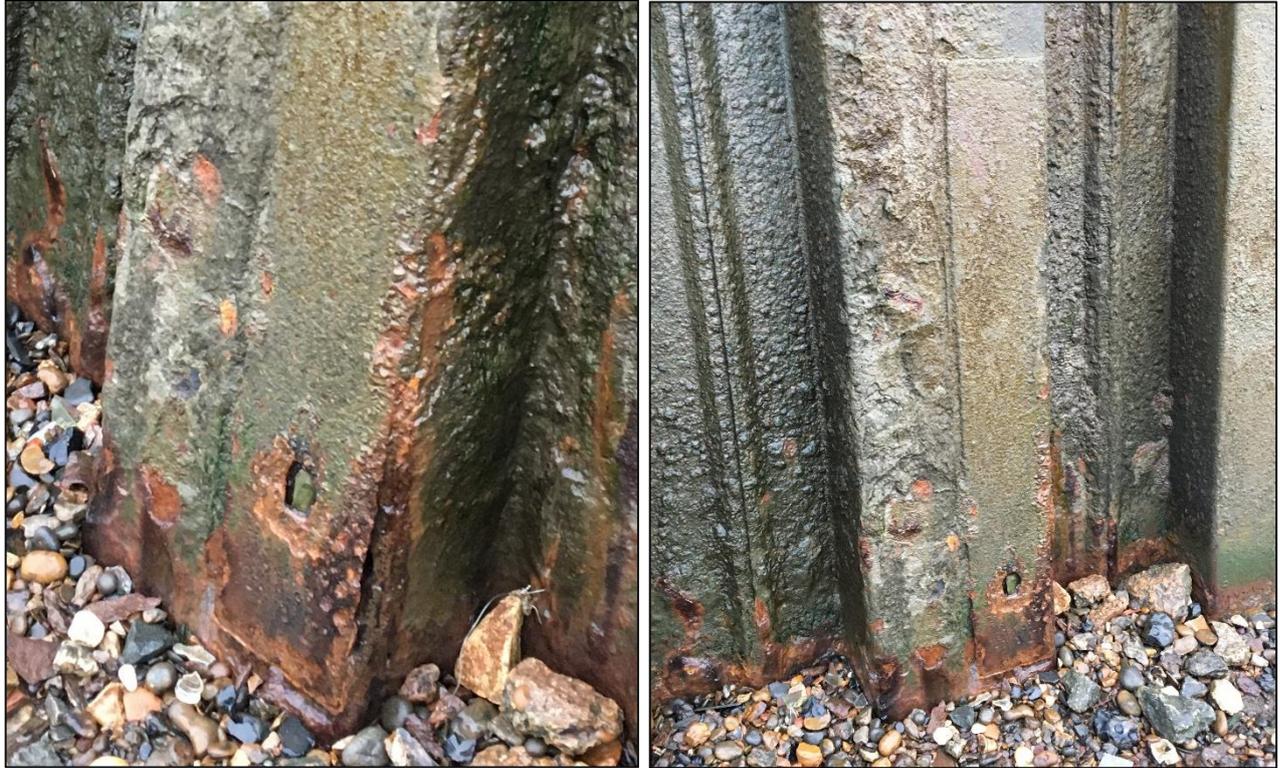
Figure 3-4: Typical patch repair to the low level of the steel sheet pile wall, in acceptable condition

The low level patch repairs are generally in acceptable condition. Each patch repair has a weep hole at the bottom to allow water to drain from behind the river wall, as was the case with the existing wall.

It is considered that this missing length of weld would not pose a risk of structural failure of the river wall. However it is recommended that these areas are monitored during subsequent quarterly inspections to check that degradation of the repair does not occur.

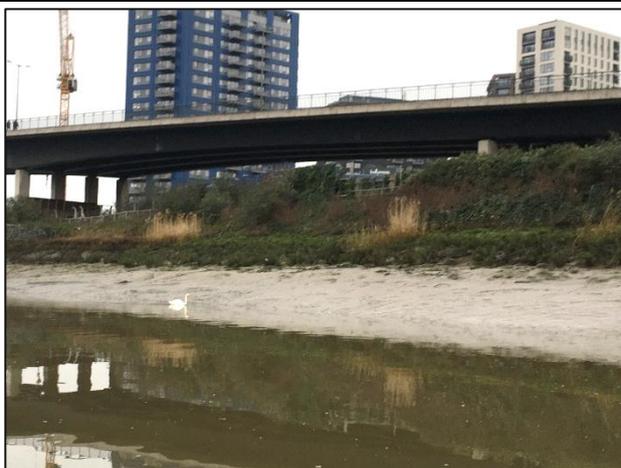
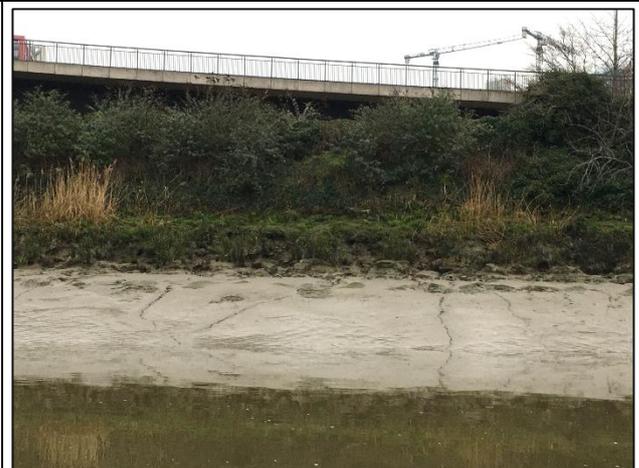
Construction Type	Earth embankment, with significant vegetation growth. Embankment acts as flood defence.
Condition	Embankment considered to be generally in fair condition. No evidence of movement, settlement, or any other failure of the embankment. Paved walkway on land side of embankment not visible during river side inspection.
Condition Grade	3

Figure 4-2: Upstream extent

Figure 4-3: Downstream extent

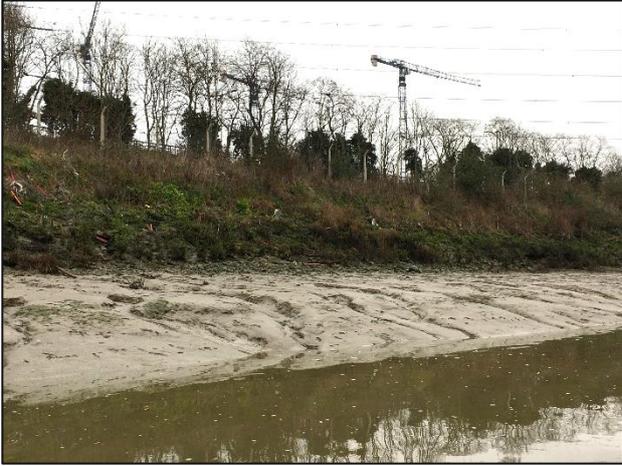
Construction Type	Earth embankment, with significant vegetation growth. Embankment acts as flood defence.
Condition	Embankment considered to be generally in fair condition. No evidence of movement, settlement, or any other failure of the embankment. Paved walkway on land side of embankment not visible during river side inspection.
Condition Grade	3

<p>Figure 4-4: Typical condition of earth embankment</p>

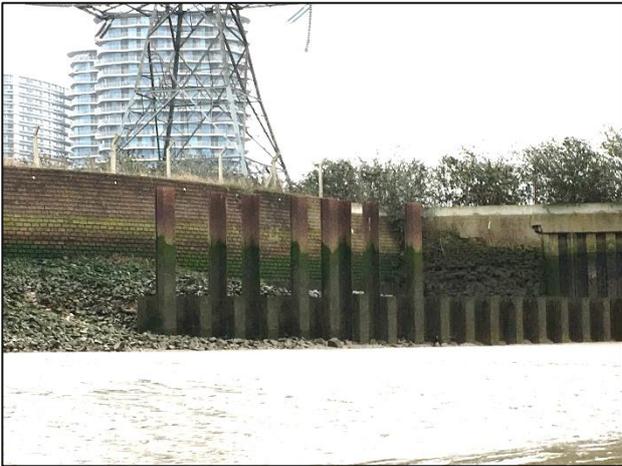
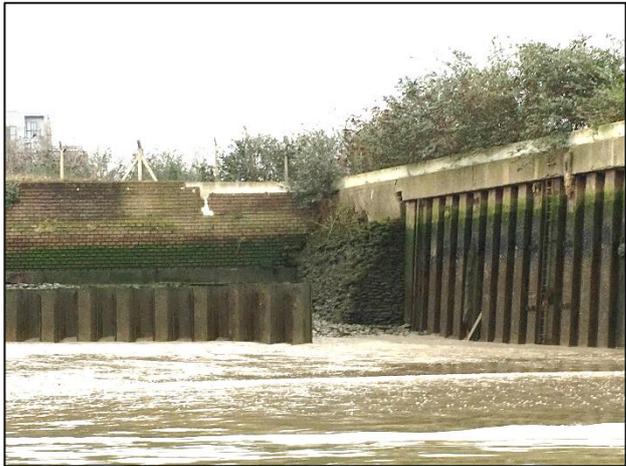
Construction Type	Upstream: blockwork wall with rock armour revetment. Downstream: steel sheet piling with concrete capping. Steel sheet pile cut off installed approximately 10m in front of river wall.
Condition	Blockwork generally in good condition and appears to be stable. Steel sheet piling and concrete capping in good condition, with only surface corrosion to steel. No evidence of vessel impact to sheet pile cut off. No evidence of degradation in condition since 2015 inspection.
Condition Grade	3

<p>Figure 4-5: Blockwork wall, rock armour revetment, sheet pile cut off</p>

<p>Figure 4-6: Steel sheet pile river wall with concrete capping</p>

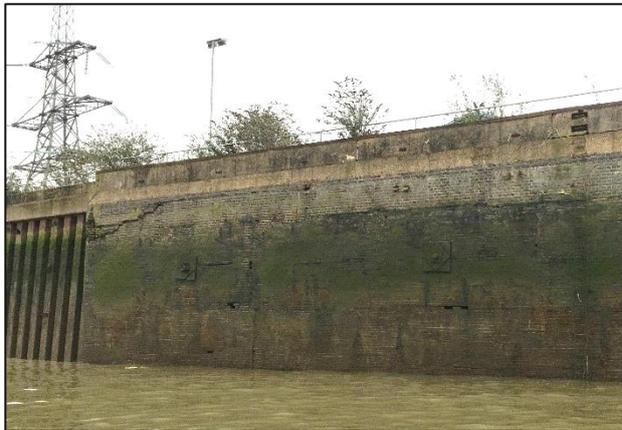
Construction Type	Masonry mass gravity wall with raised concrete parapet and 3 no. ground anchors at approx. 5m centres. Vertical timber fenders attached to older masonry at downstream extent of asset.
Condition	Masonry wall generally in poor condition. Horizontal cracks and occasional missing bricks throughout. Vertical crack in masonry at upstream extent continues into concrete parapet above. Large area of missing pointing at downstream extent, where timber fenders fixed to masonry. Large area of missing bricks and significant cracking at upper level, which appears to be unstable. No evidence of significant deterioration in condition since 2015 inspection.
Condition Grade	4 (masonry wall and concrete parapet)

Figure 4-7: Upstream extent
