Appendix C BuroHappold January 2020 Thameside West Visual Inspection Report

Technical Note

Project Thames Side West

Subject River Wall Inspection – January 2020

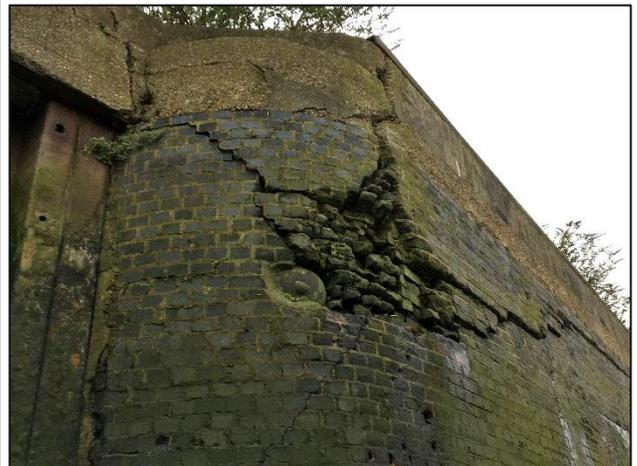
Construction Type	Masonry mass gravity wall with raised concrete parapet and 3 no. ground anchors at approx. 5m centres. Vertical timber fenders attached to older masonry at downstream extent of asset.
Condition	Masonry wall generally in poor condition. Horizontal cracks and occasional missing bricks throughout. Vertical crack in masonry at upstream extent continues into concrete parapet above. Large area of missing pointing at downstream extent, where timber fenders fixed to masonry. Large area of missing bricks and significant cracking at upper level, which appears to be unstable. No evidence of significant deterioration in condition since 2015 inspection.
Condition Grade	4 (masonry wall and concrete parapet)

Figure 4-10: Close-up of unstable masonry at upper level

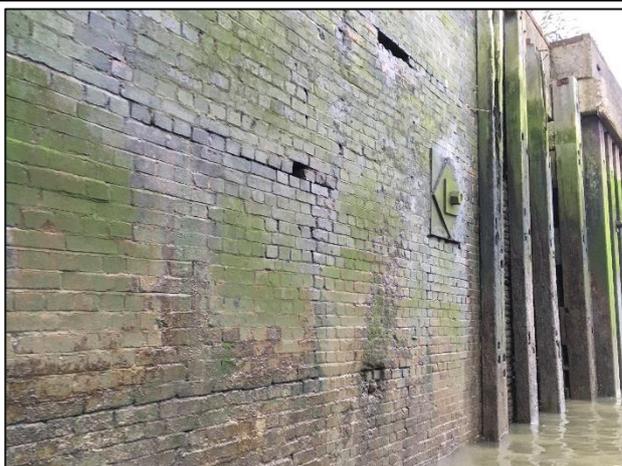
Figure 4-11: Horizontal crack, missing bricks and ground anchor

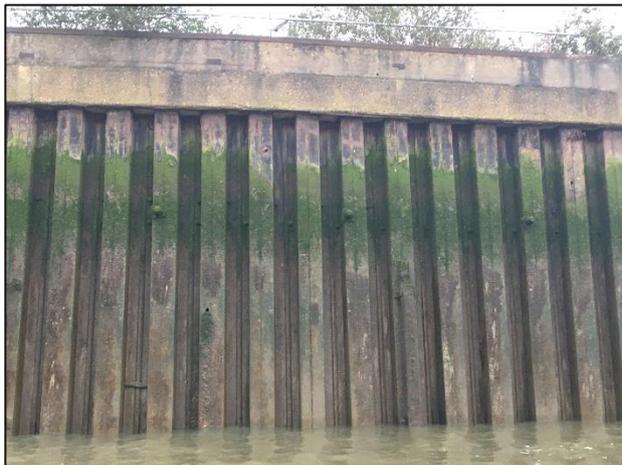
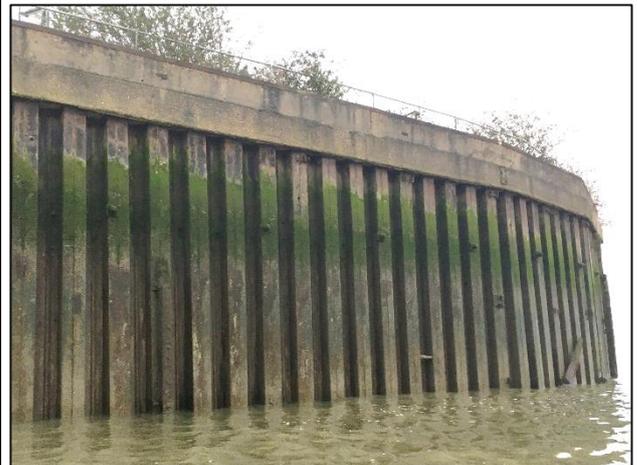
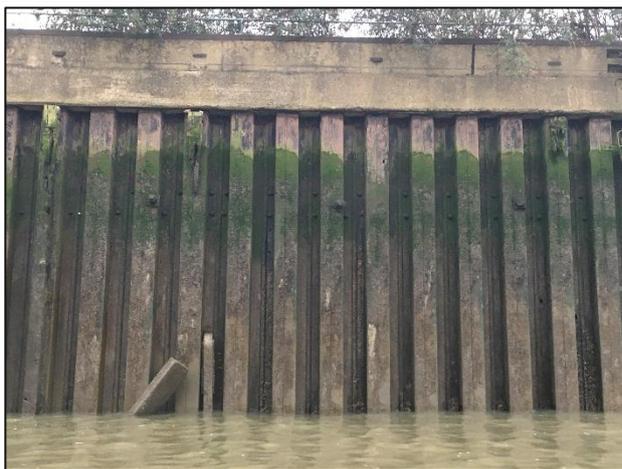
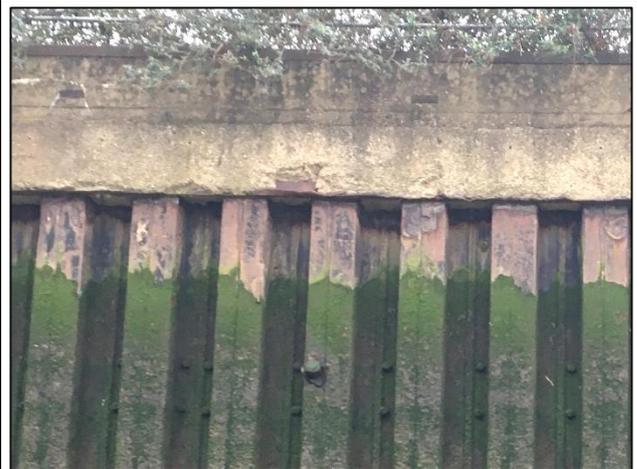
Construction Type	Anchored steel sheet pile wall with concrete capping beam. The steel frame, used for spoil transfer, present during the 2015 inspection has since been removed.
Condition	Steel sheet pile and concrete capping generally in good condition. Minor cracking to concrete capping present. Accelerated corrosion to the sheet piles around the welded connections to the bracing structure for the spoil transfer frame, noted during the 2015 inspection. No significant further corrosion evident since removal of frame. No full-depth corrosion present. No evidence of degradation in condition since 2015 inspection.
Condition Grade	2 (steel sheet pile) 3 (concrete capping)

Figure 4-12: General condition of steel sheet pile and concrete capping

Figure 4-13: Downstream extent

Figure 4-14: No evidence of full-depth corrosion around former connections to spoil transfer frame

Figure 4-15: Minor cracking to concrete parapet

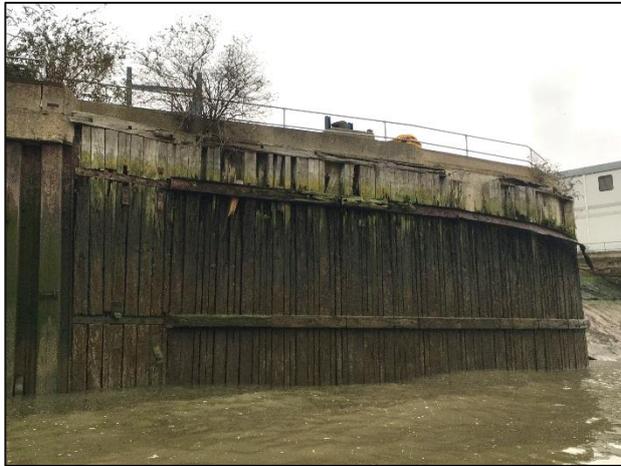
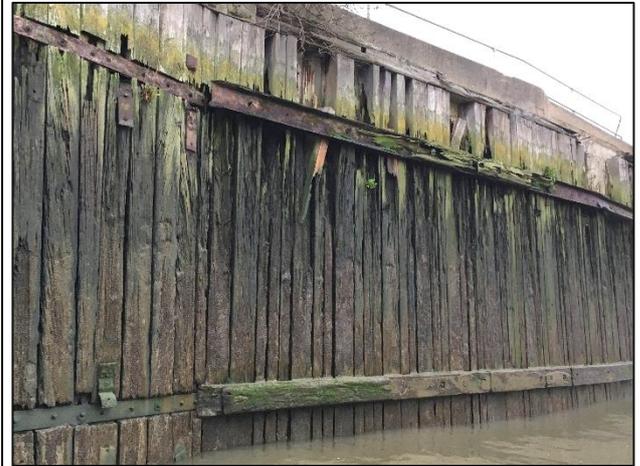
Construction Type	Masonry mass gravity wall with timber cladding, concrete capping and sections of concrete repair.
Condition	Where exposed, masonry is in poor condition with missing pointing and vertical cracking. Separation lines between masonry and concrete repairs evident. Significant parts of masonry not visible behind timber cladding, which is severely degraded. Connections between horizontal steel beam appear to be loose. There is no visible cracking to the concrete capping. No evidence of significant degradation in condition since 2015 inspection.
Condition Grade	3 / 4

Figure 4-16: Upstream extent

Figure 4-17: Timber cladding severely degraded, condition of masonry wall not visible behind

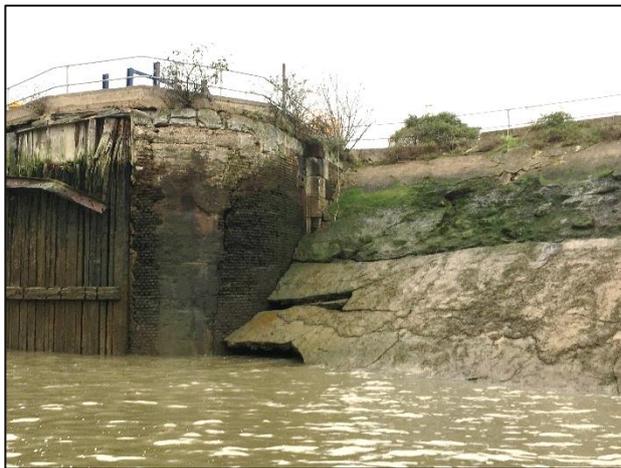
Construction Type	Concrete apron with masonry wing walls and a concrete upstand as a flood defence parapet.
Condition	<p>Frontage generally in poor condition.</p> <p>Significant voids present behind cracked concrete apron, including new voids at interface with upstream wing wall (Figure 4-18), not reported in 2015 Atkins inspection.</p> <p>Significant loss of pointing and cracking present in masonry wing walls on both upstream and downstream side of concrete apron. Previous repairs to masonry no longer well integrated with existing masonry.</p> <p>Although the condition of the concrete apron has deteriorated since the 2015 inspection, the condition grading remains the same.</p> <p>No evidence of significant degradation in condition of the wing walls since 2015 inspection.</p>
Condition Grade	<p>4 (masonry wing walls)</p> <p>5 (concrete apron)</p>

Figure 4-18: Upstream masonry wing wall, with loss of mortar
New void present in upstream extent of concrete apron

Additional voids in the concrete apron of Asset ID 14896 were observed, however the deterioration has not resulted in a change to the overall condition, rated as *very poor*.

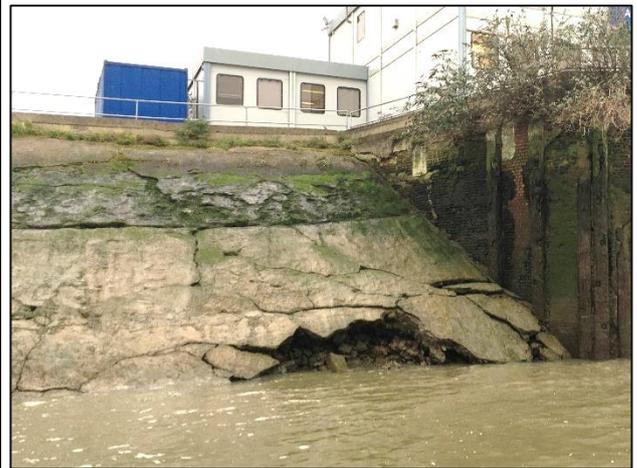
Figure 4-19: Downstream masonry wing wall and large void in concrete apron

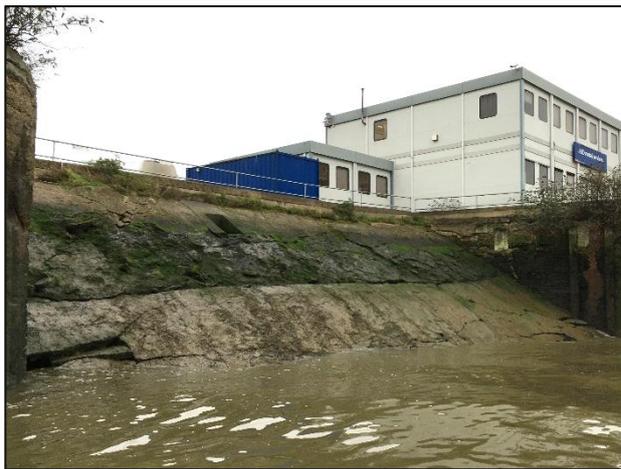
Figure 4-20: Concrete apron, showing voids and cracking

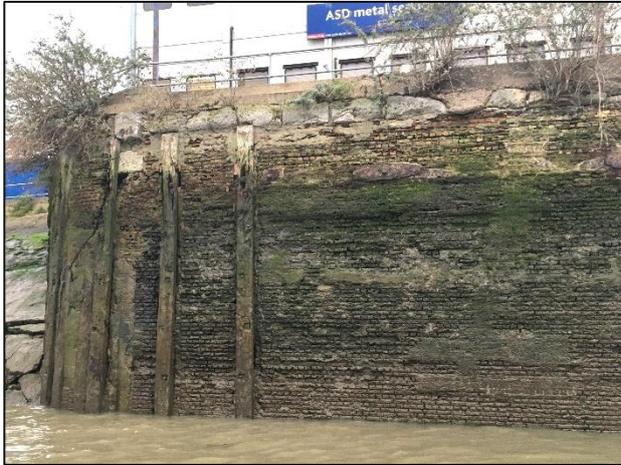
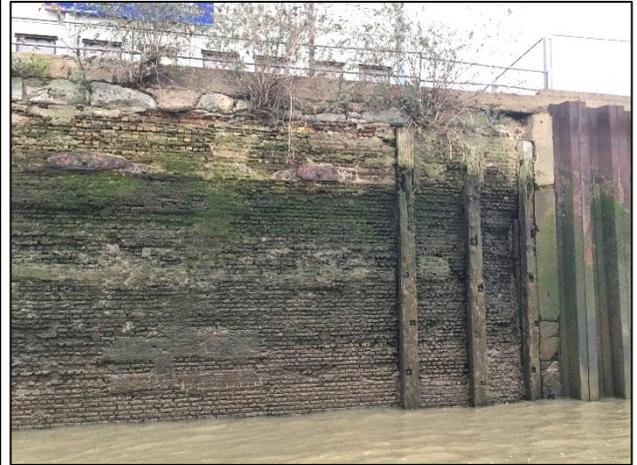
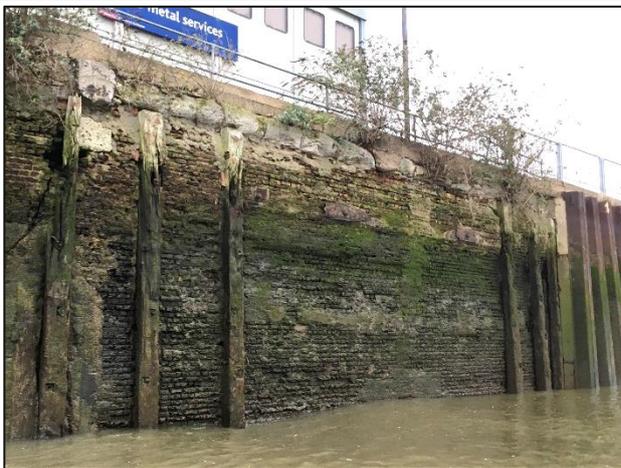
Construction Type	Masonry mass gravity wall, with concrete capping.
Condition	Masonry wall generally in poor condition. Significant loss of pointing and loss of brick facing throughout. Vertical timber fenders are degraded. Concrete capping appears to be in fair condition, although growth of vegetation present within joint between masonry and concrete, so overall grading given as poor. No evidence of significant degradation in condition since 2015 inspection.
Condition Grade	4 (masonry wall and concrete capping)

Figure 4-21: Upstream extent

Figure 4-22: Downstream extent

Figure 4-23: Masonry generally in poor condition, with loss of pointing and brick facing throughout
Vegetation growth at interface between masonry and concrete capping

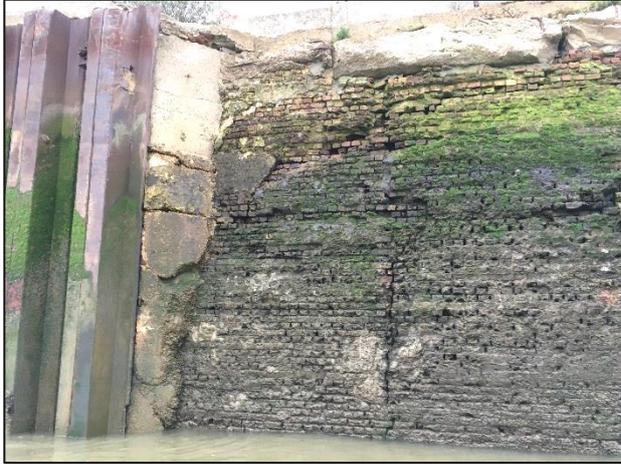
Construction Type	Steel sheet pile with concrete capping beam.
Condition	Steel sheet pile generally in fair condition, although superficial corrosion present throughout. Horizontal cracks in mass concrete 'plug' at downstream interface with adjoining masonry. Full thickness corrosion also present at upper level on pan at downstream extent of steel sheet pile wall. Note: photos of steel sheet pile not recorded. No evidence of significant degradation in condition since 2015 inspection.
Condition Grade	3 (steel sheet pile wall, generally) 4 (steel sheet pile wall, where full thickness corrosion present) 4 (mass concrete at downstream extent)

Figure 4-24: Downstream extent, showing full thickness corrosion to upper part of steel sheet pile and cracks in concrete 'plug'

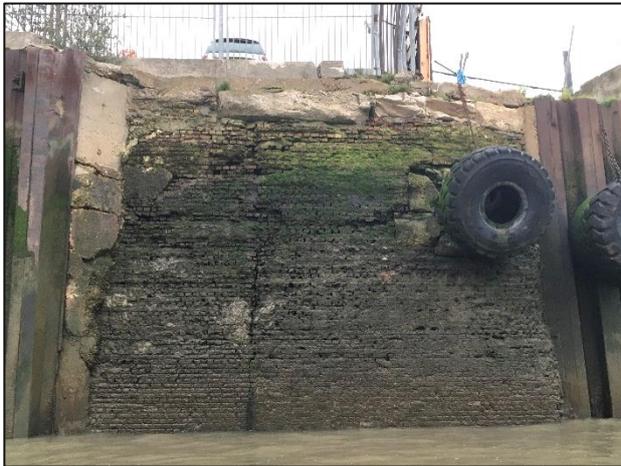
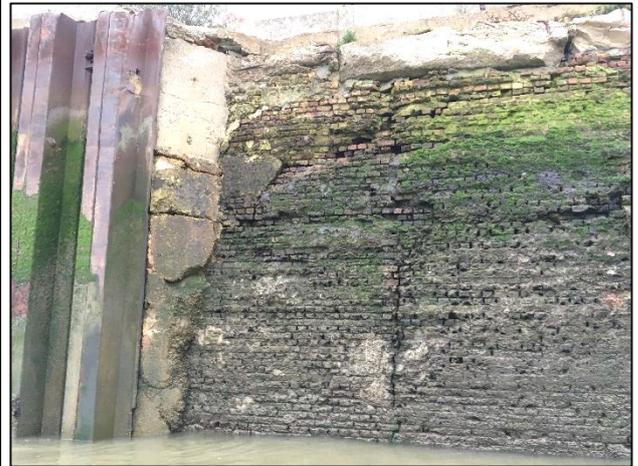
Construction Type	Masonry mass gravity wall, with concrete capping.
Condition	Masonry wall generally in poor condition. Significant loss of pointing and loss of brick facing throughout. Large vertical crack present in masonry, extending full height of wall. No evidence of significant degradation in condition since 2015 inspection.
Condition Grade	4

Figure 4-25: Masonry generally in poor condition, with loss of pointing and brick facing throughout

Figure 4-26: Upstream extent, with vertical crack in masonry

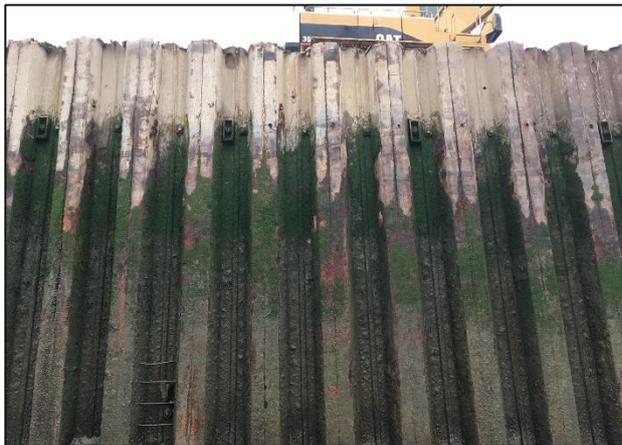
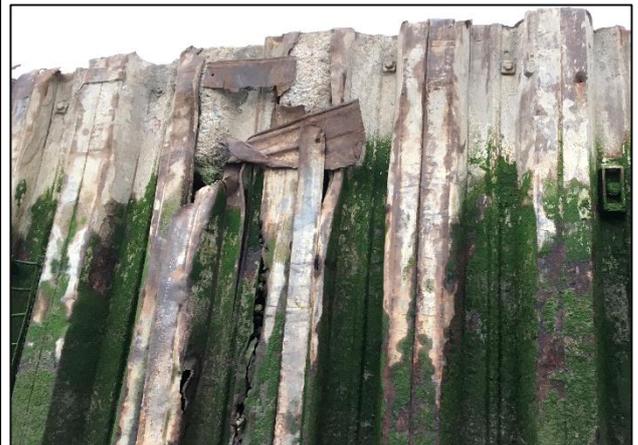
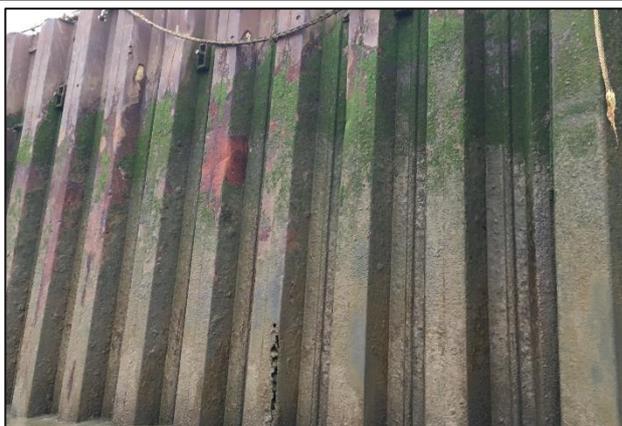
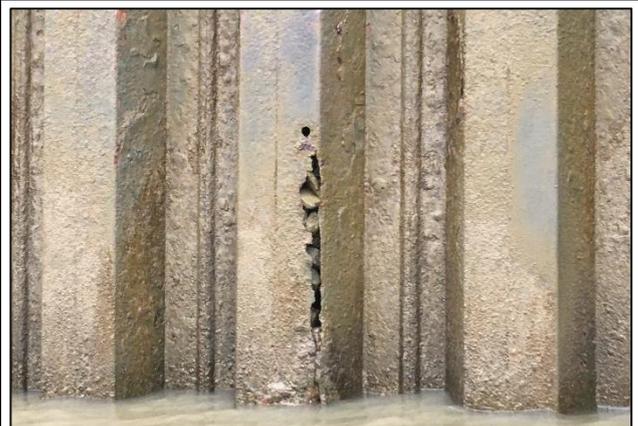
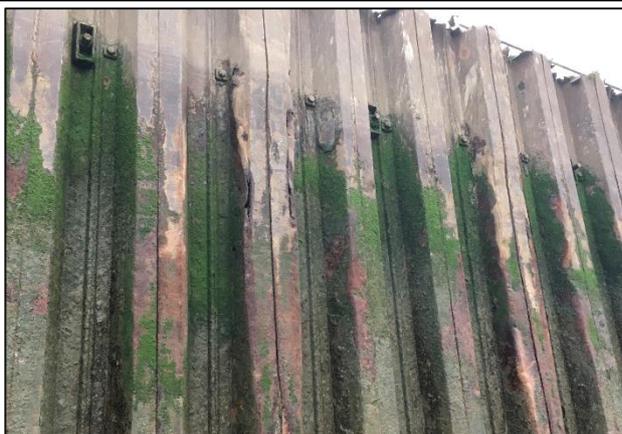
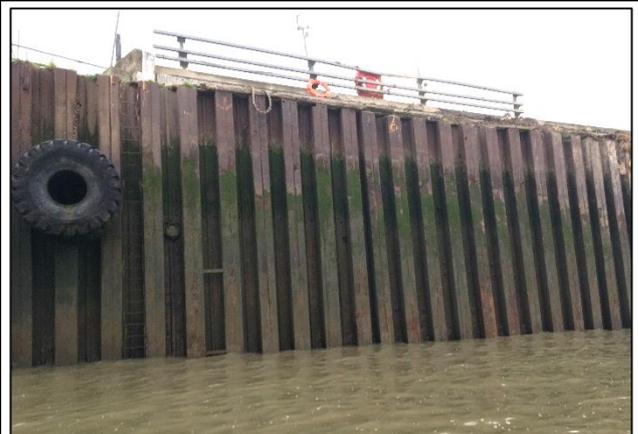
Construction Type	Steel sheet pile wall with ground anchors. No concrete capping present.
Condition	<p>Steel sheet piles are generally in fair to poor condition.</p> <p>Superficial corrosion of steel sheet pile is present throughout, with full thickness corrosion at low and high levels. Full thickness corrosion at low level not reported in 2015 Atkins inspection.</p> <p>Crumpling to tops of steel sheet piles throughout, previously observed.</p> <p>Impact damage to upper part of steel sheet pile in one location has revealed void below concrete slab, not reported in 2015 Atkins inspection. Access to view void no possible, so extent of void unknown.</p> <p>Condition of steel sheet pile has deteriorated since the 2015 inspection.</p>
Condition Grade	<p>3 (steel sheet pile, generally); 4 (steel sheet pile, where full thickness corrosion present)</p> <p>5 (damage to upper part of steel sheet pile, shown in Figure 4-28)</p>

Figure 4-27: Crumpling to tops of sheet pile throughout

Figure 4-28: Isolated damage to steel sheet pile, revealing void below concrete slab

Figure 4-29: Full thickness corrosion within steel at low level

Figure 4-30: Close-up of full thickness corrosion at low level

Figure 4-31: Evidence of previous patch repairs to steel sheet pile

Figure 4-32: Steel sheet pile generally in fair condition

Full thickness corrosion and impact damage was observed in the steel sheet pile of Asset ID 14894, that was not reported in the 2015 Atkins inspection report. The overall condition of this asset is therefore considered to have deteriorated since 2015.

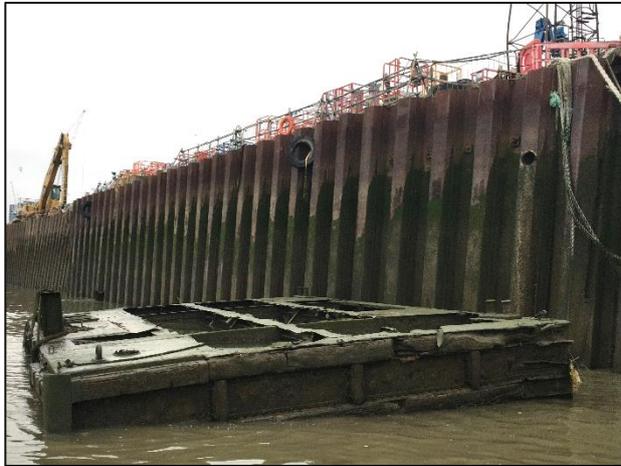
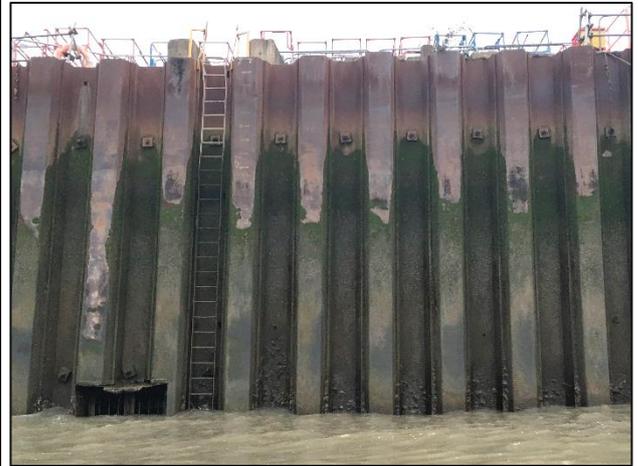
Construction Type	Sheet pile wall with ground anchors. No concrete capping present.
Condition	Steel sheet piles are generally in fair to poor condition. Superficial corrosion and crumpling to top of steel sheet pile is present throughout. Top of steel sheet piles lean back towards land side, which could indicate poor installation or movement of toe. General misalignment attributed to poor installation. No evidence of significant degradation in condition since 2015 inspection.
Condition Grade	3 (steel sheet pile, generally) 4 (misalignment of steel sheet pile at downstream extent)

Figure 4-33: Steel sheet piling

Figure 4-34: Crumpling to top of steel sheet piling

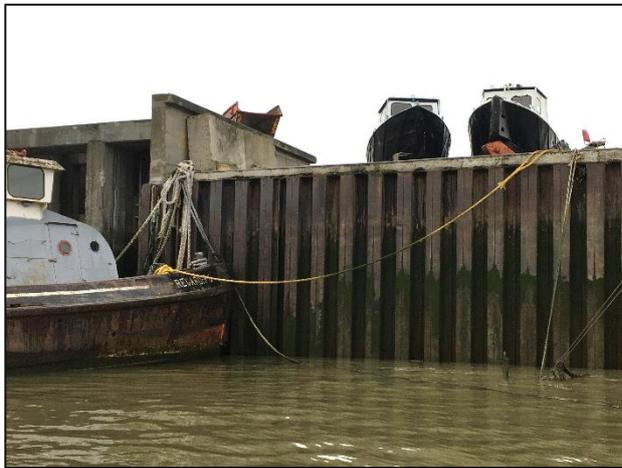
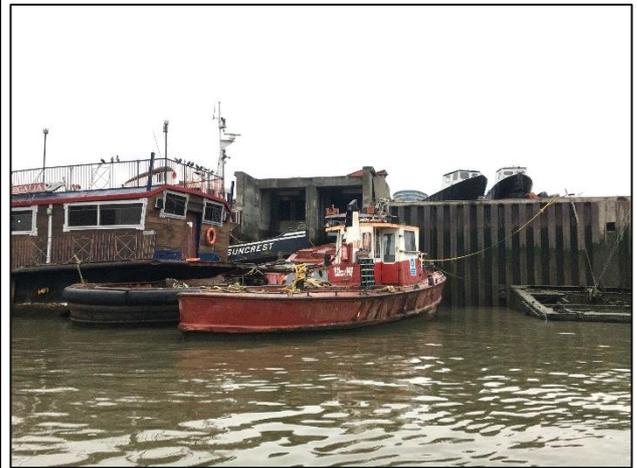
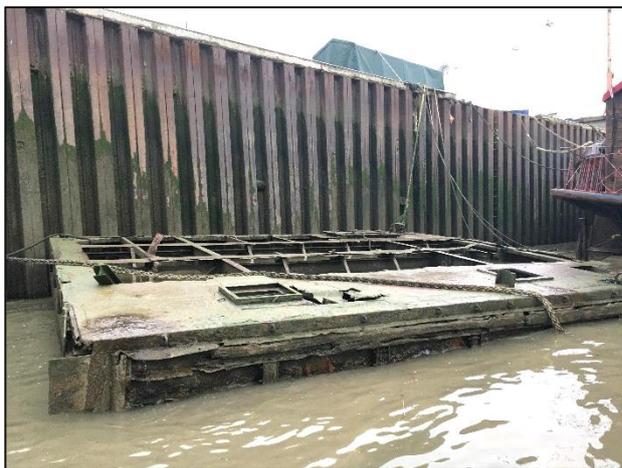
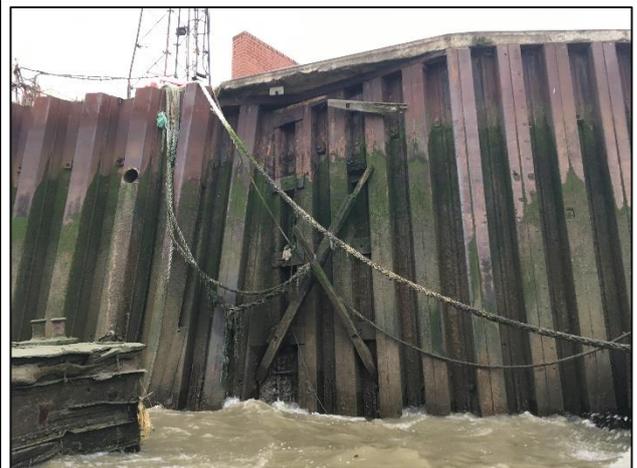
Construction Type	Steel sheet pile wall with concrete capping. Large concrete Thames Water outfall present within steel sheet pile wall.
Condition	Steel sheet piles and concrete generally in good to fair condition, with no evidence of damage. Moored and disused barges present along frontage. River wall vulnerable to impact damage due to lack of fenders, however no significant damage to steel sheet pile evident. Misalignment of steel sheet piling at upstream extent, attributed to poor installation. Detailed inspection of Thames Water outfall not possible due to presence of boats and barges. No evidence of significant degradation in condition since 2015 inspection.
Condition Grade	2 / 3 (steel sheet pile, generally) 4 (misalignment of steel sheet pile at upstream extent)

Figure 4-36: Downstream extent

Figure 4-37: Barges and boats obscure large concrete Thames Water outfall

Figure 4-38: Disused barge present in front of upstream extent

Figure 4-39: Upstream extent with misaligned steel sheet piling

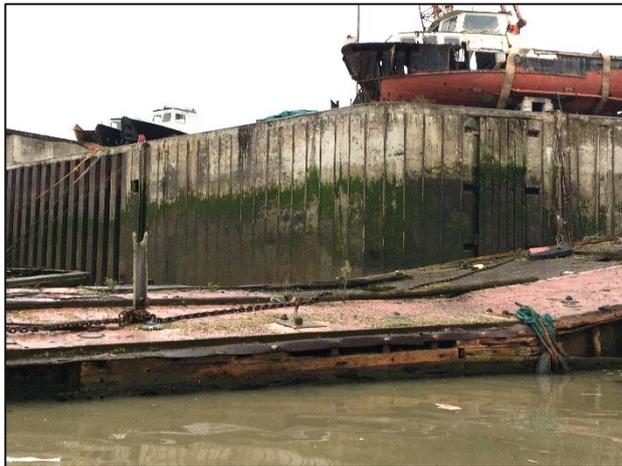
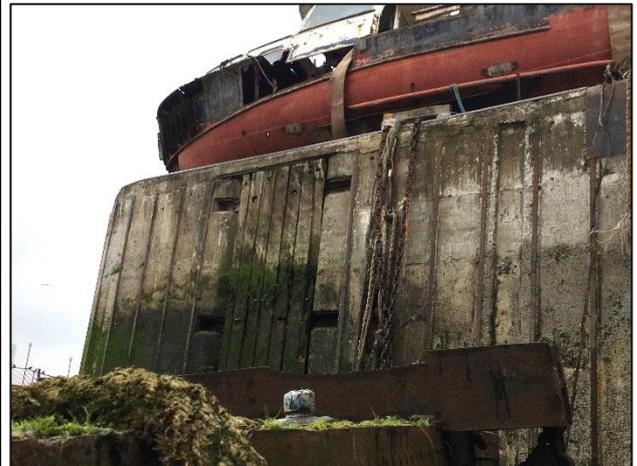
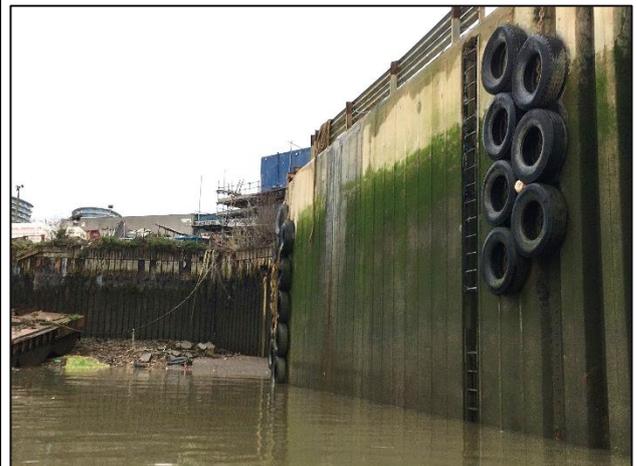
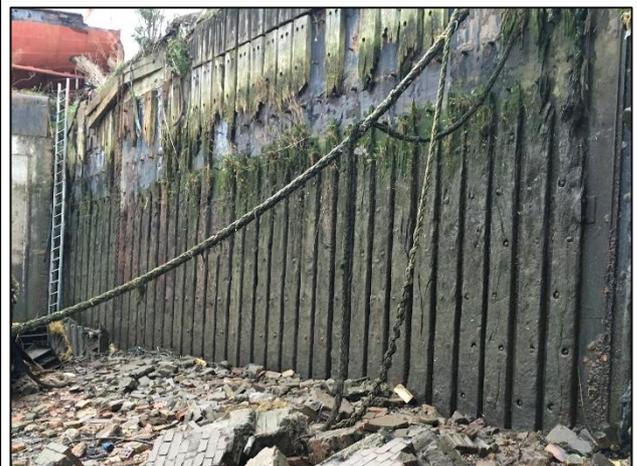
Construction Type	Steel lock gates to Royal Victoria Dock, including concrete abutment walls.
Condition	Steel lock gates appear to be in fair condition, although significant deterioration of timber cladding present, particularly at high tide level. Timber cladding obscured detailed inspection of lock gates. Concrete abutments are in good condition, with only surface corrosion to steel guide rails. Significant accumulation of debris since 2015 inspection, on foreshore in front of lock gates, as well as disused and damaged barges. No evidence of significant degradation in structural condition since 2015 inspection.
Condition Grade	2 (concrete abutments), 3 (steel lock gates), 4 (debris and other obstructions present)

Figure 4-40: Upstream concrete abutment with steel guide rails

Figure 4-41: Detail of upstream abutment

Figure 4-43: Downstream concrete abutment

Figure 4-45: Debris present in front of lock gates

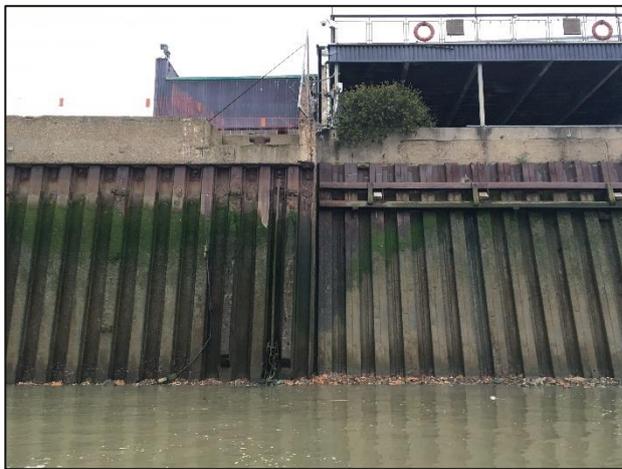
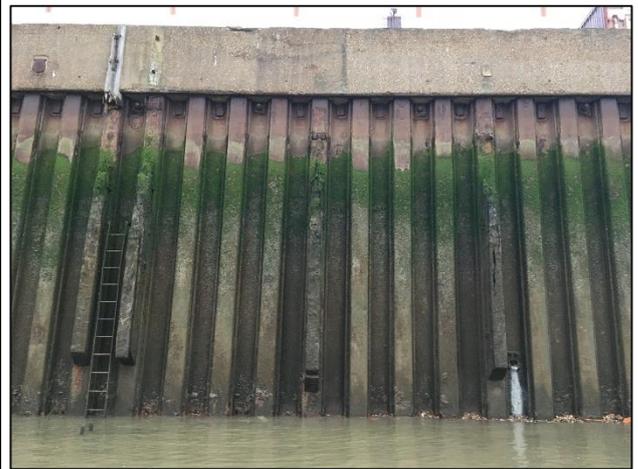
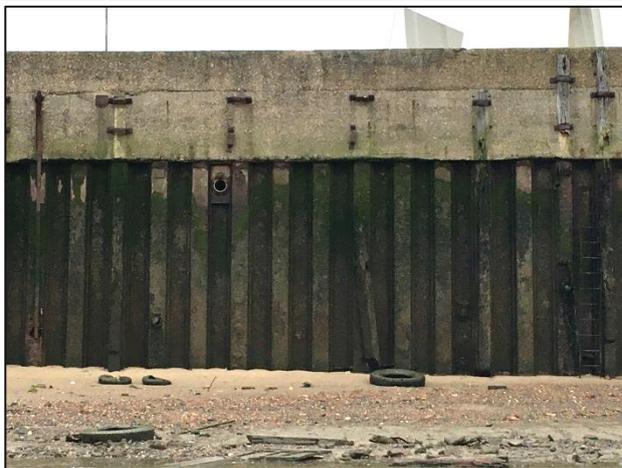
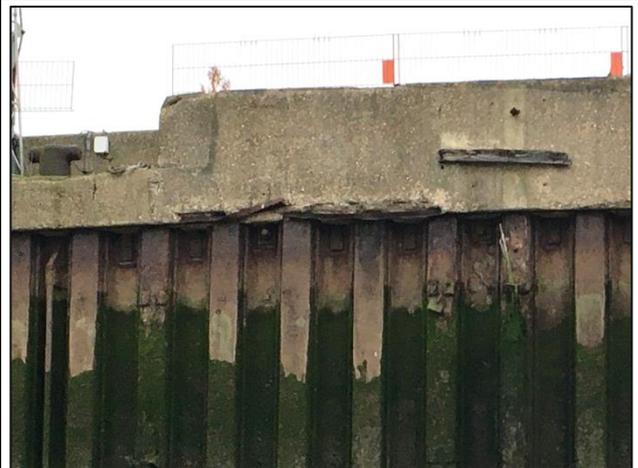
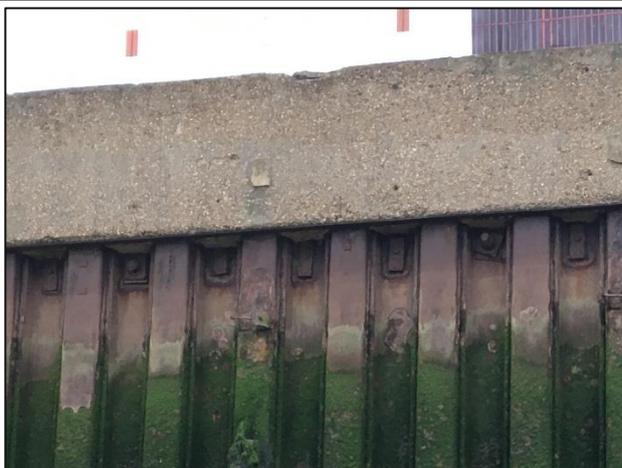
Construction Type	Steel sheet pile wall with ground anchors and concrete capping.
Condition	Steel sheet pile generally in fair condition, with superficial corrosion only. Concrete capping generally in fair condition, however localised spalling and exposure of reinforcement present at underside of capping (Figure 4-49). No evidence of significant degradation in condition since 2015 inspection.
Condition Grade	2 (steel sheet pile, generally) 3 (concrete capping)

Figure 4-46: Downstream extent, at interface with Dohm Wharf

Figure 4-47: Steel sheet pile generally in fair condition

Figure 4-48: Localised corrosion of former fender fixings

Figure 4-49: Localised corrosion of underside of concrete capping

Figure 4-50: Concrete capping generally in fair condition

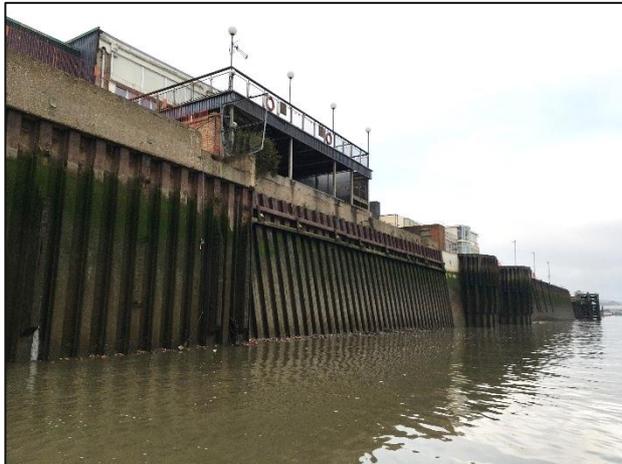
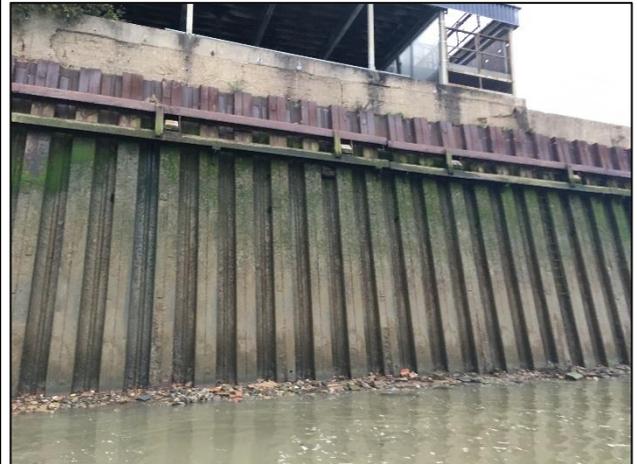
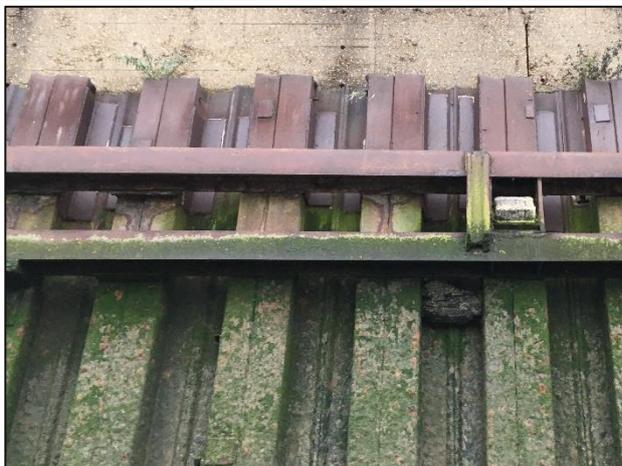
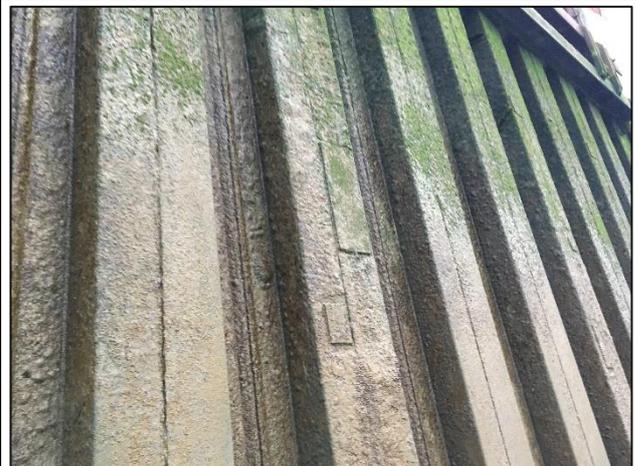
Construction Type	Steel sheet pile wall with external waling beam, ground anchors and concrete parapet. Sheet pile is raked back. As built drawings confirm this is as constructed and not due to failure.
Condition	Steel sheet pile in fair condition following patch repairs to full thickness corrosion, carried out in August to September 2017.
Condition Grade	3

Figure 4-51: Raked steel sheet pile wall

Figure 4-52: External waling beam

Figure 4-53: Patch repairs to steel sheet pile wall remain securely fixed at upper level, above external waling beam

Figure 4-54: Patch repairs to steel sheet pile at mid and lower level remain securely fixed
