## Technical Note

Project Thames Side West  
Subject Dohm Wharf River Wall Quarterly Inspection – March 2018  
Project no 035668  
Date 9 April 2018

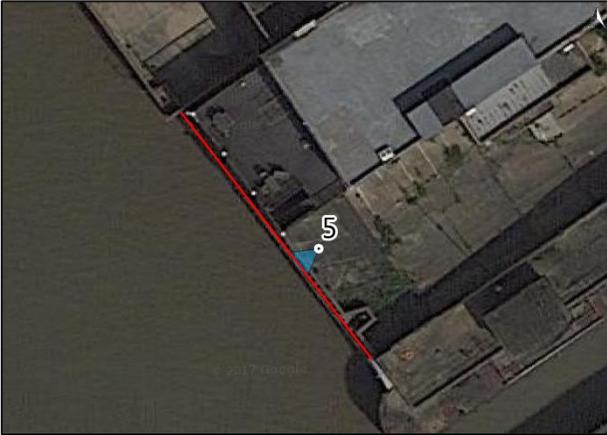
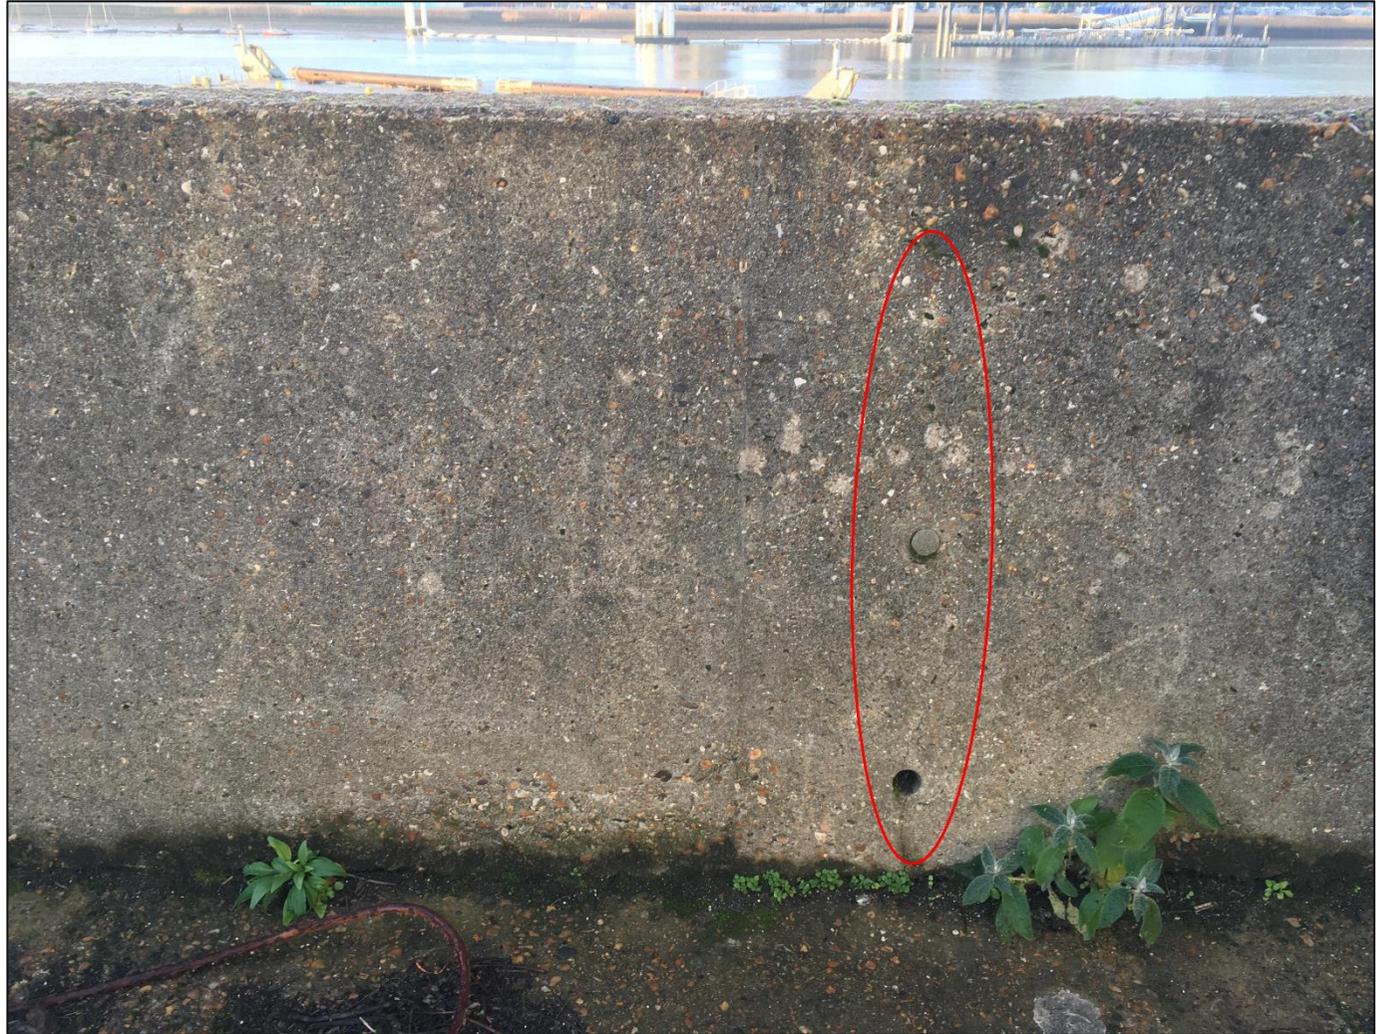
### Location 5

Hard standing area – crack in parapet wall

- Hairline crack in concrete parapet wall.
- Crack originates through penetration in wall, assumed to be a construction defect rather than caused by movement of the river wall.

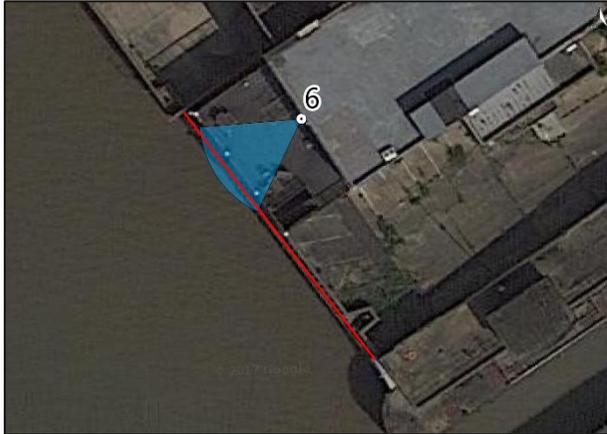
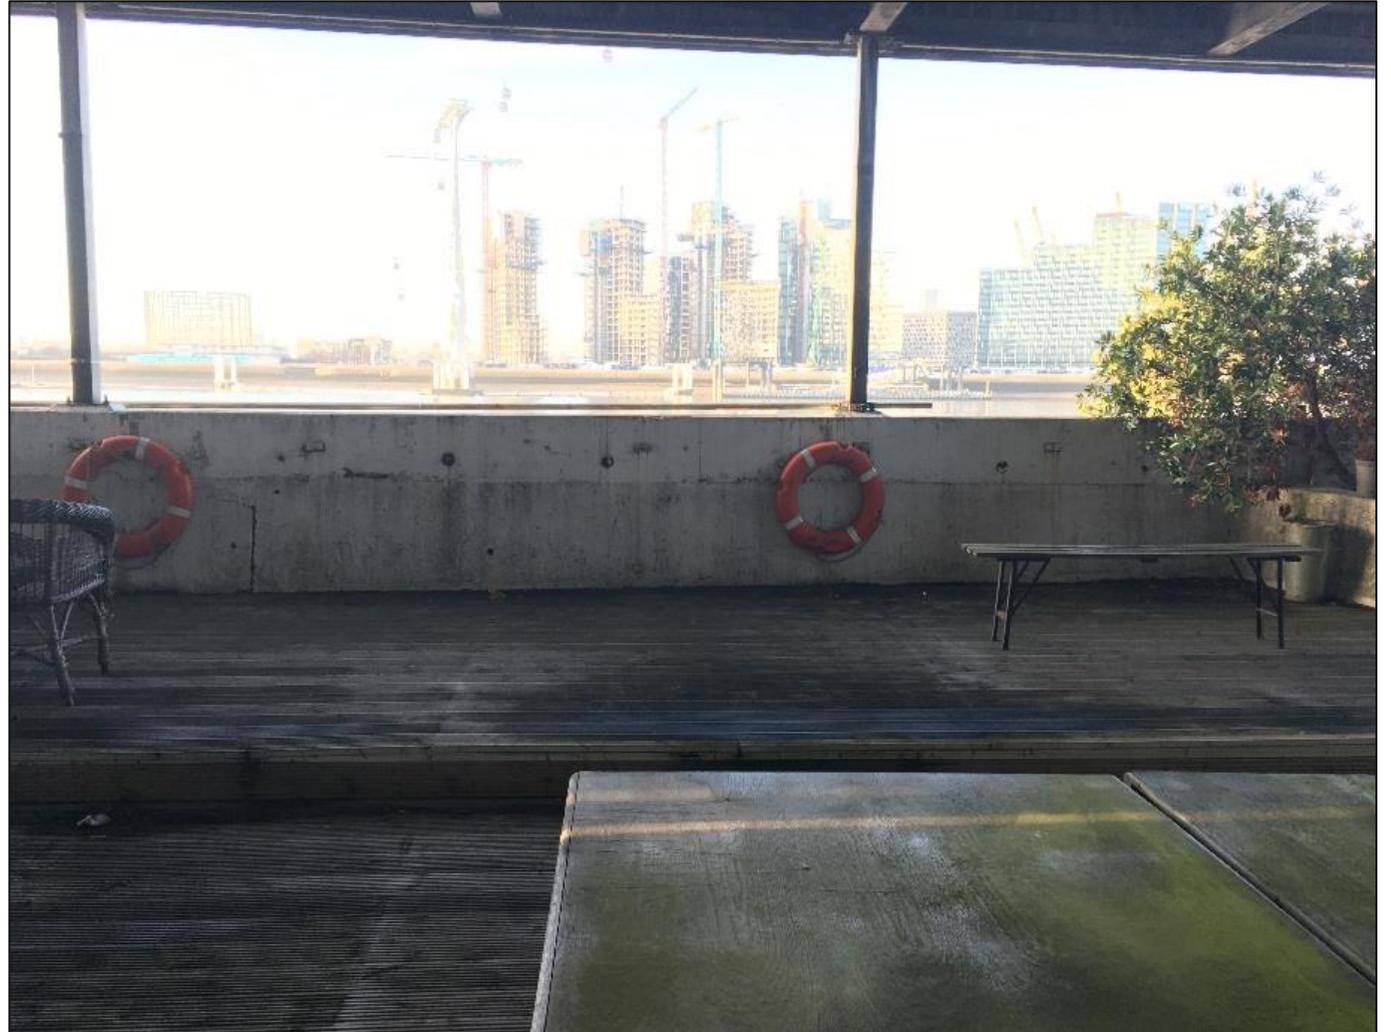
## Location 6

TOBS terrace area – overview of parapet wall

- No new cracks observed in concrete parapet wall.
- Inspection of ground behind parapet wall prevented by presence of timber deck.
- No obvious indications of movement or settlement.

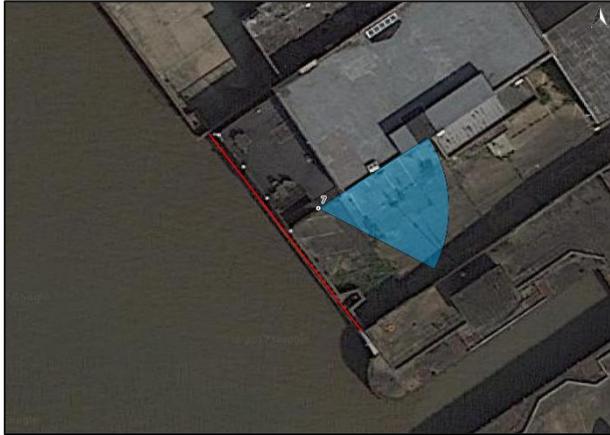
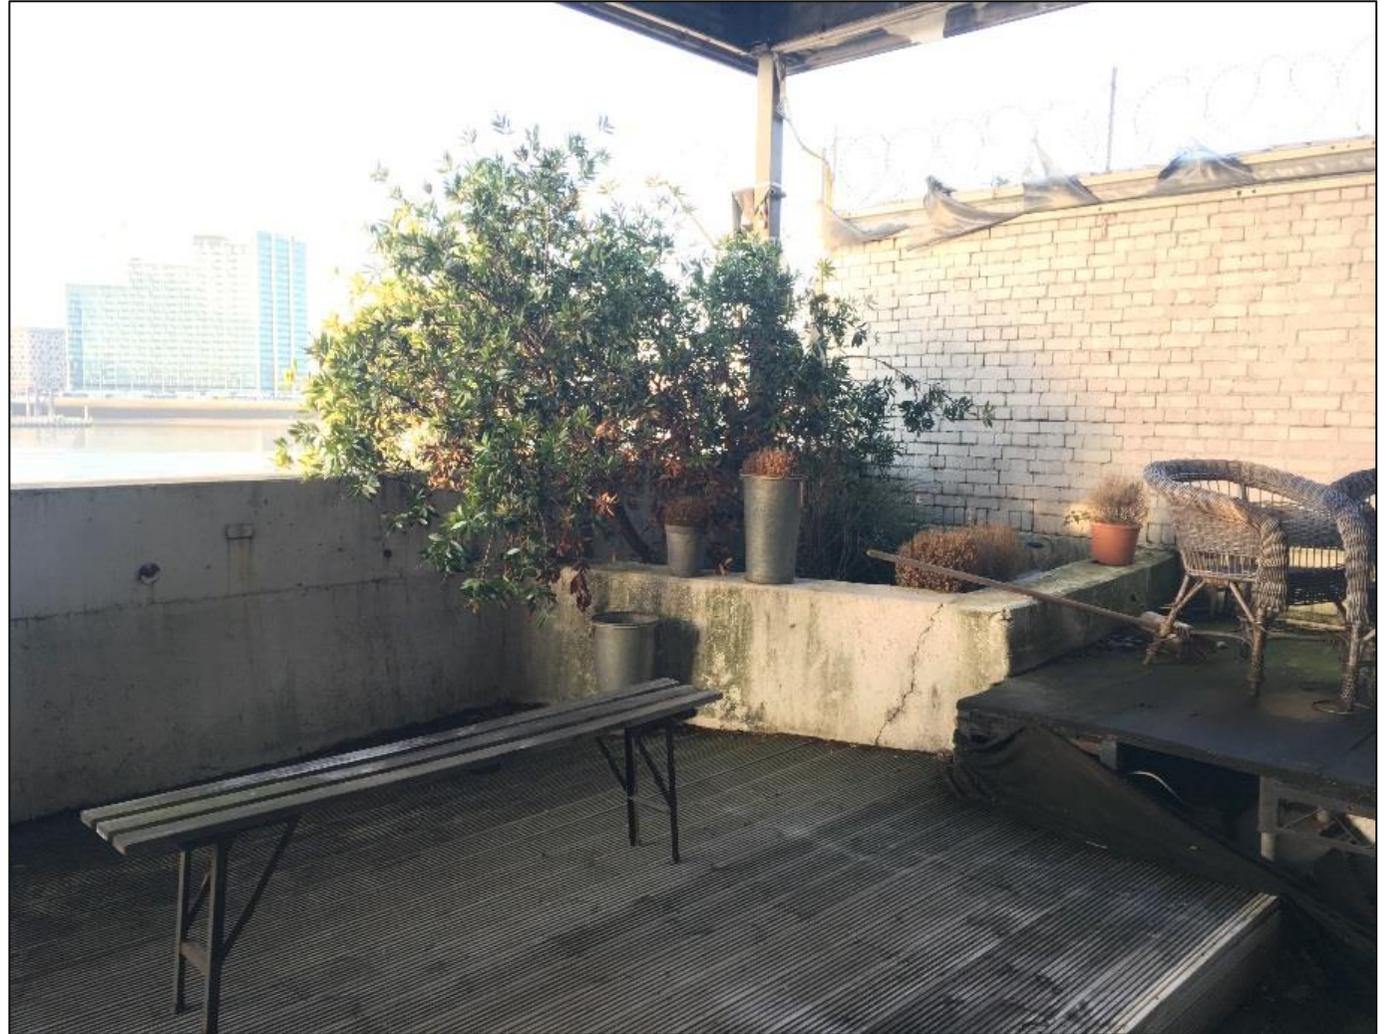
### Location 7

TOBS terrace area – north corner

- Existing crack in wall of concrete planter. See location 8 for detail.
- No new cracks observed in concrete parapet wall.
- No obvious indications of movement or settlement.

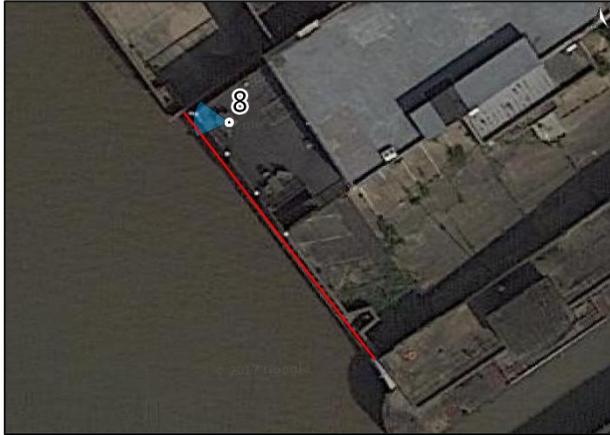
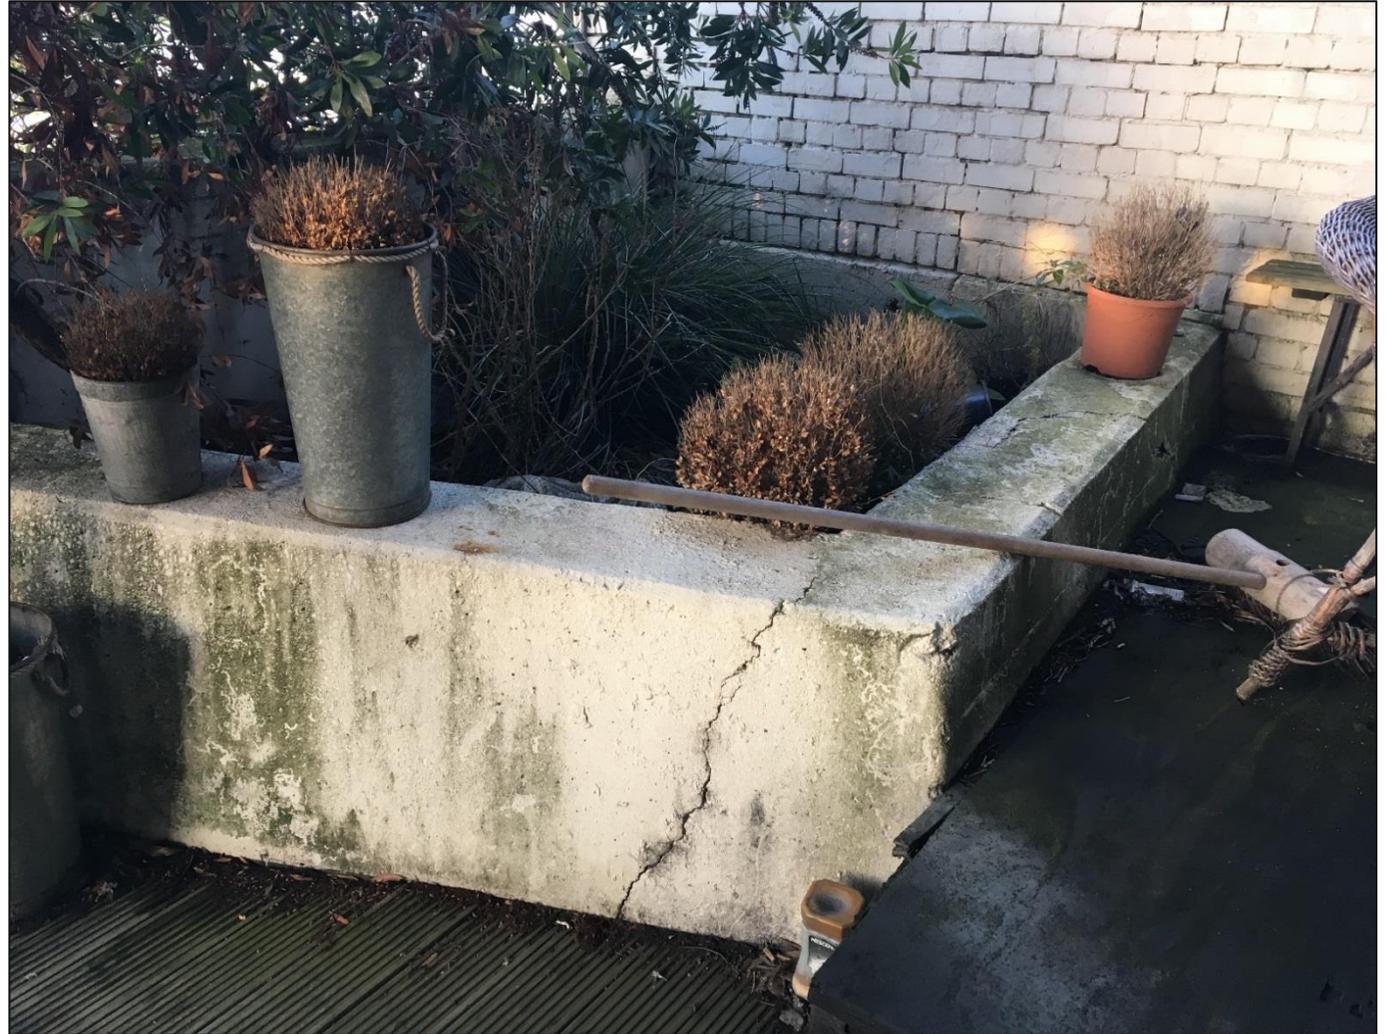
## Location 8

TOBS terrace area – north corner planter crack detail

- Existing crack in wall of concrete planter.
- Extent of crack remains unchanged since last inspection.
- No evidence to indicate that crack has widened since last inspection.

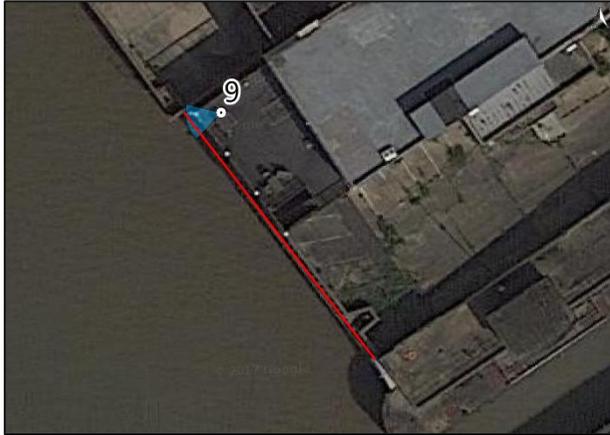
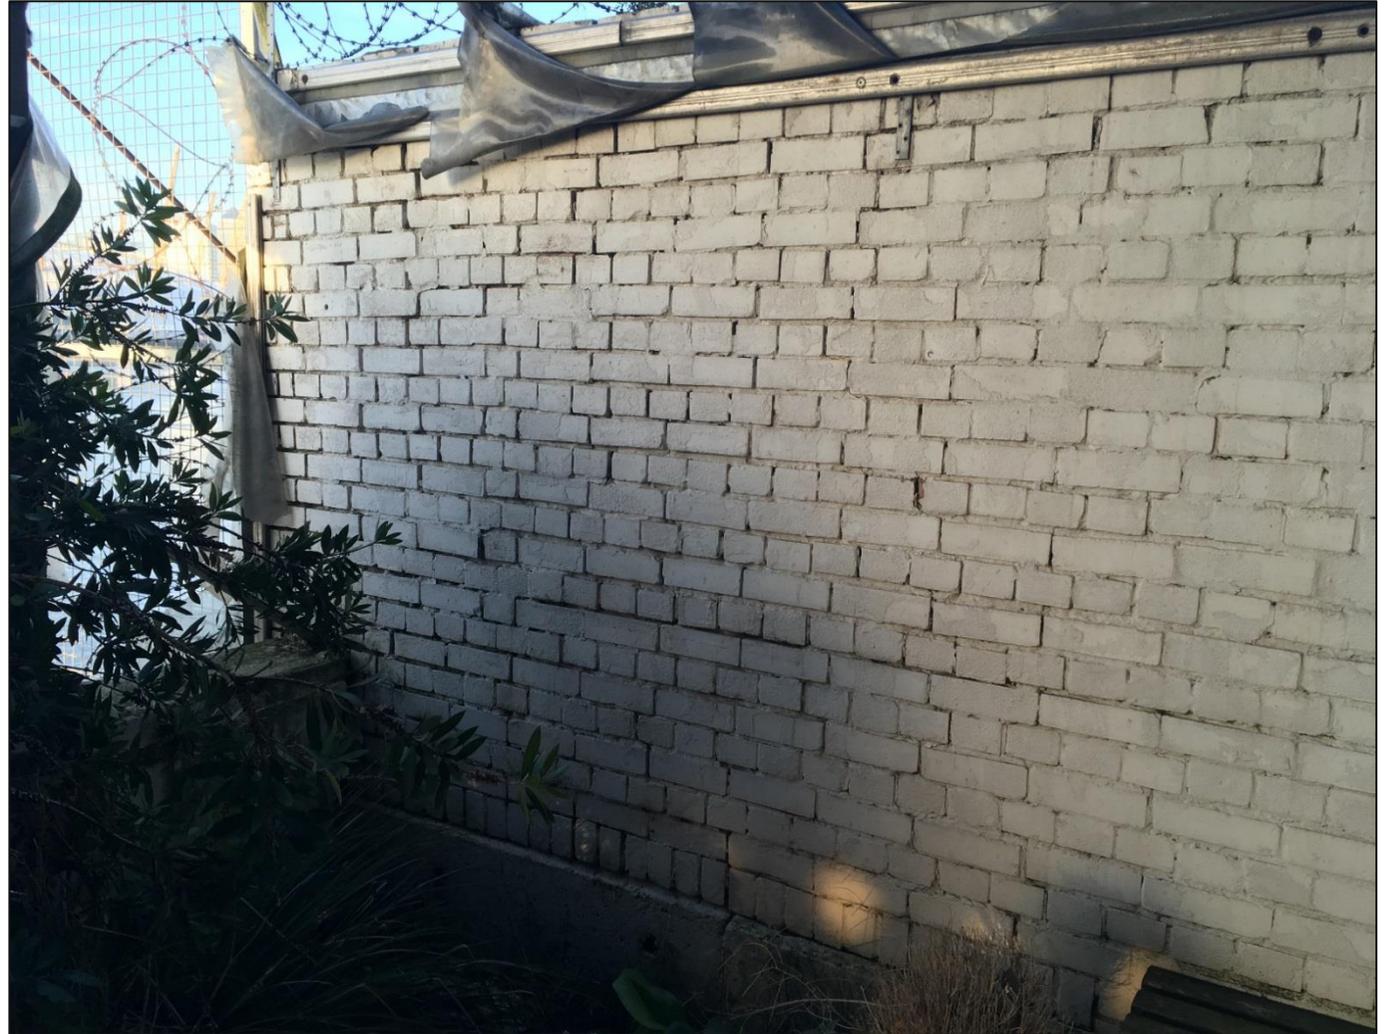
## Location 9

TOBS terrace area – north cornered brick wall detail

- Adjoining brick wall at north boundary of Dohm Wharf river wall.
- No cracks or other evidence of movement in bricks or mortar joints.
- Note that condition of mortar is poor in places.

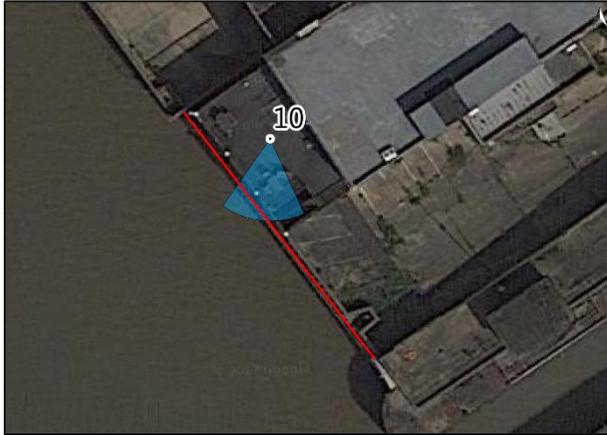
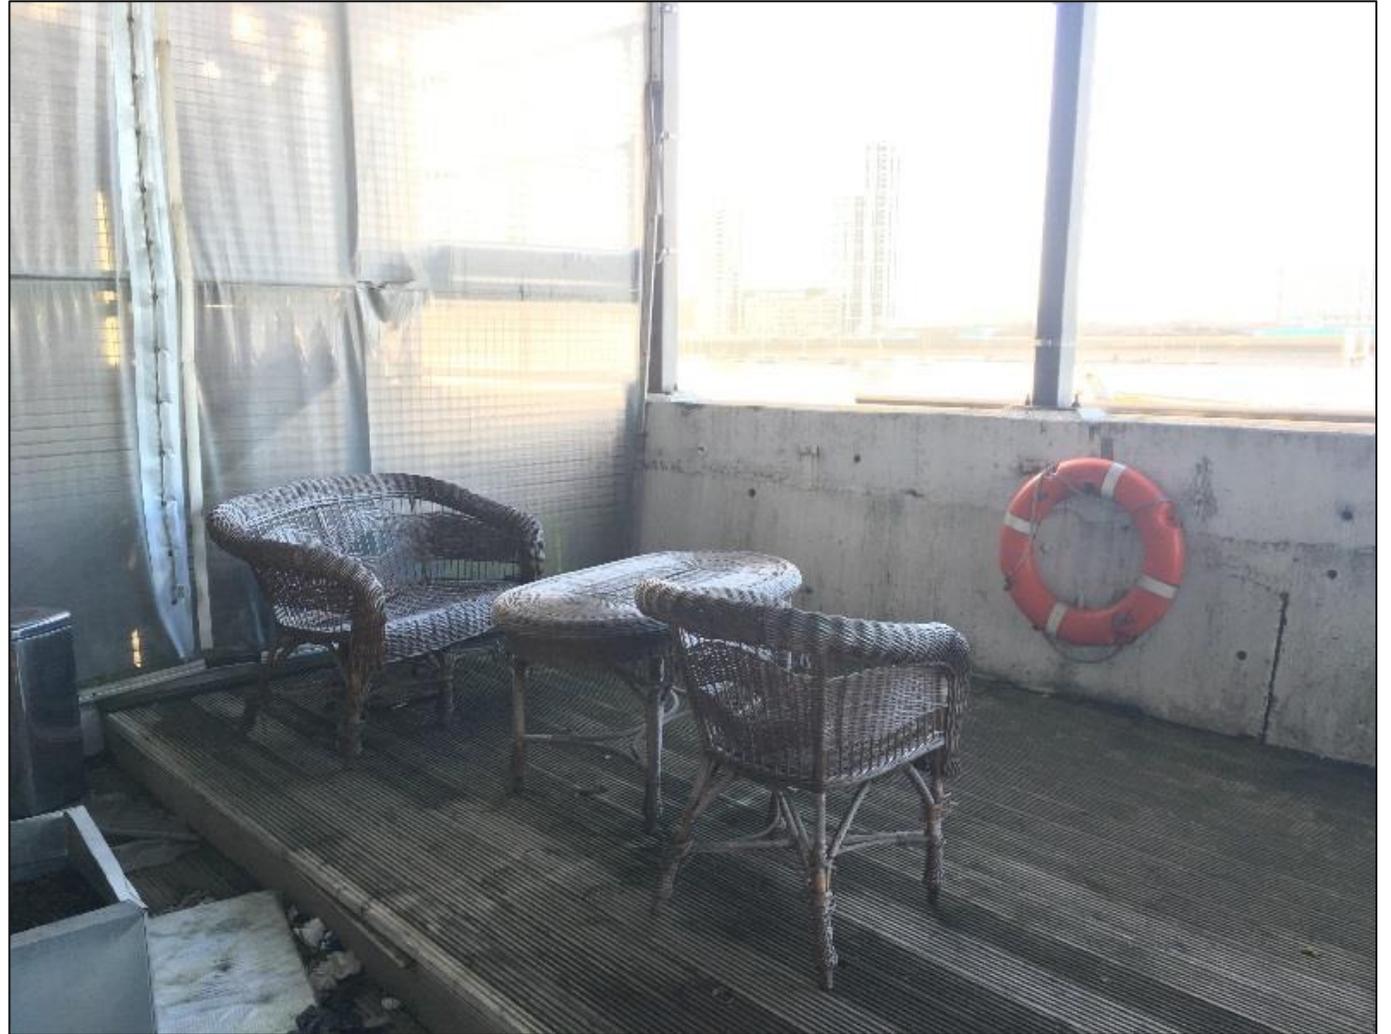
### Location 10

TOBS terrace area – south corner

- No new cracks observed in concrete parapet wall.
- No obvious indications of movement or settlement.

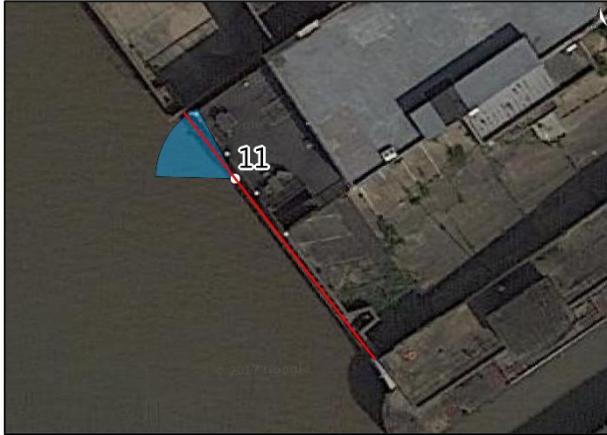
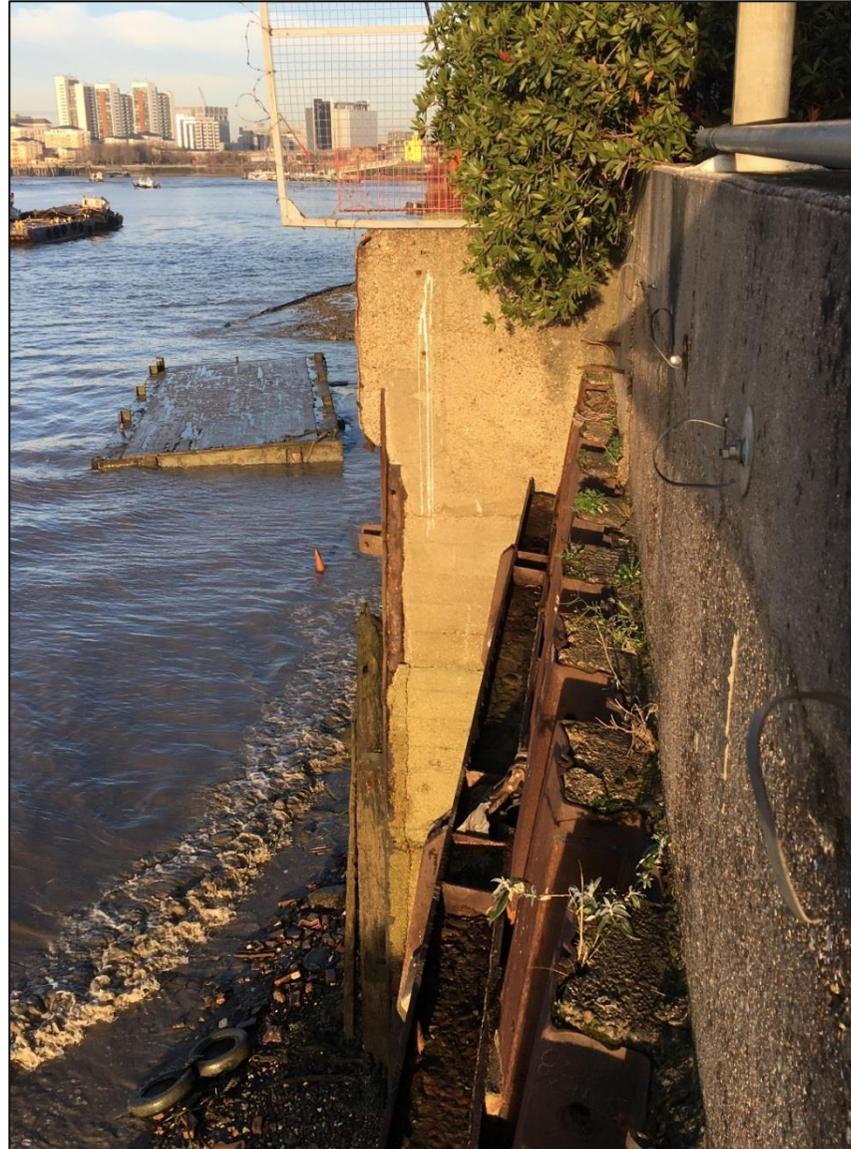
## Location 11

TOBS terrace area – end face of adjacent wall to north

- Adjoining river wall to north steps out from alignment of Dohm Wharf river wall.
- Reinforcement within concrete face of adjoining river wall exposed.
- No evidence of movement at interface between two river walls.

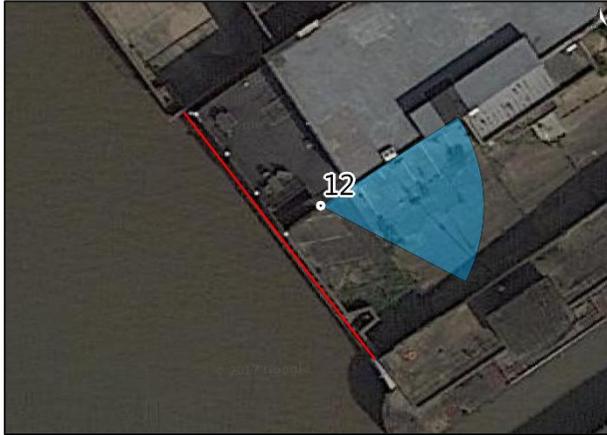
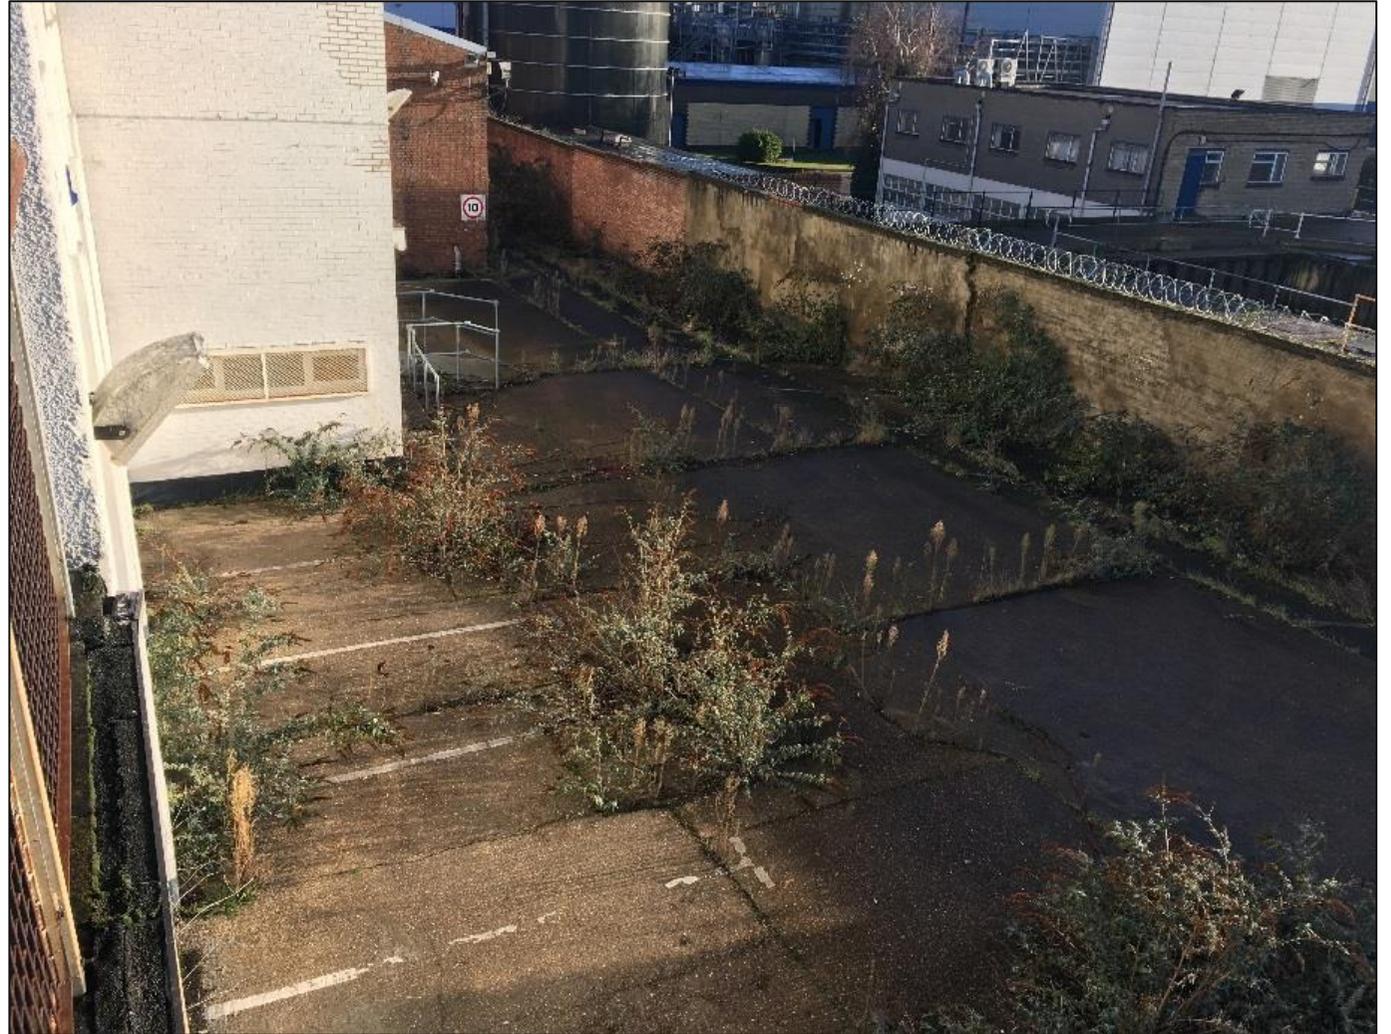
## Location 12

Hard standing area – overview of hard standing

- Taken from the upper deck of the TOBS roof terrace.
- No new cracks or other evidence of movement or settlement within concrete hard standing observed.

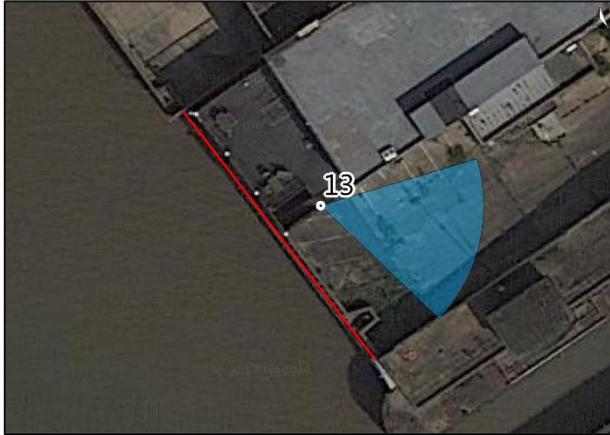
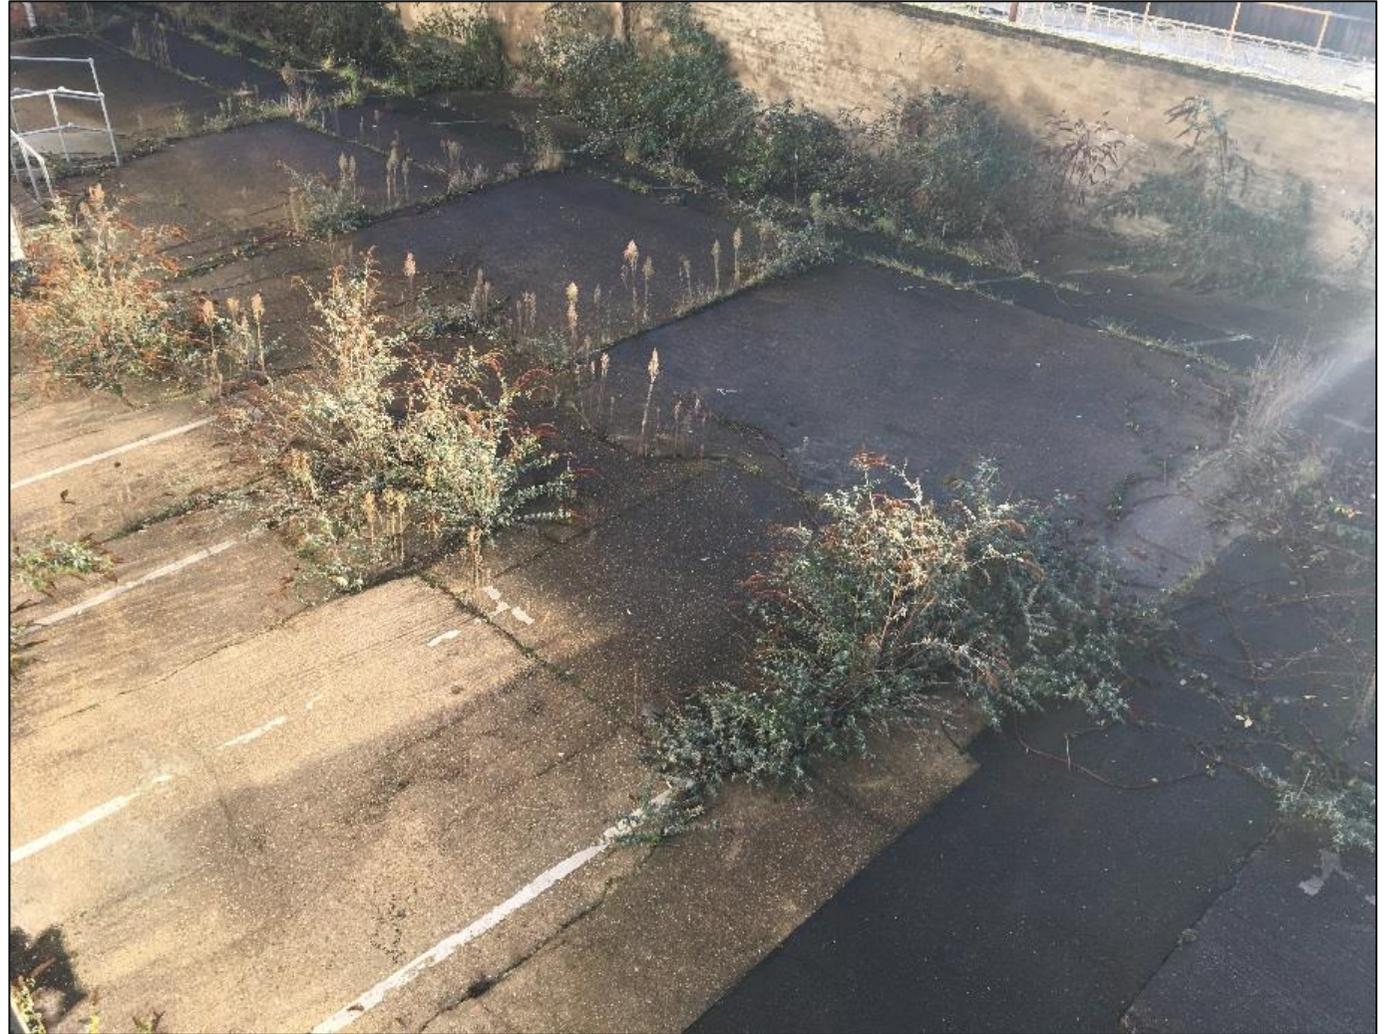
### Location 13

Hard standing area – overview of hard standing

- Taken from the upper deck of the TOBS roof terrace.
- No new cracks or other evidence of movement or settlement within concrete hard standing observed.

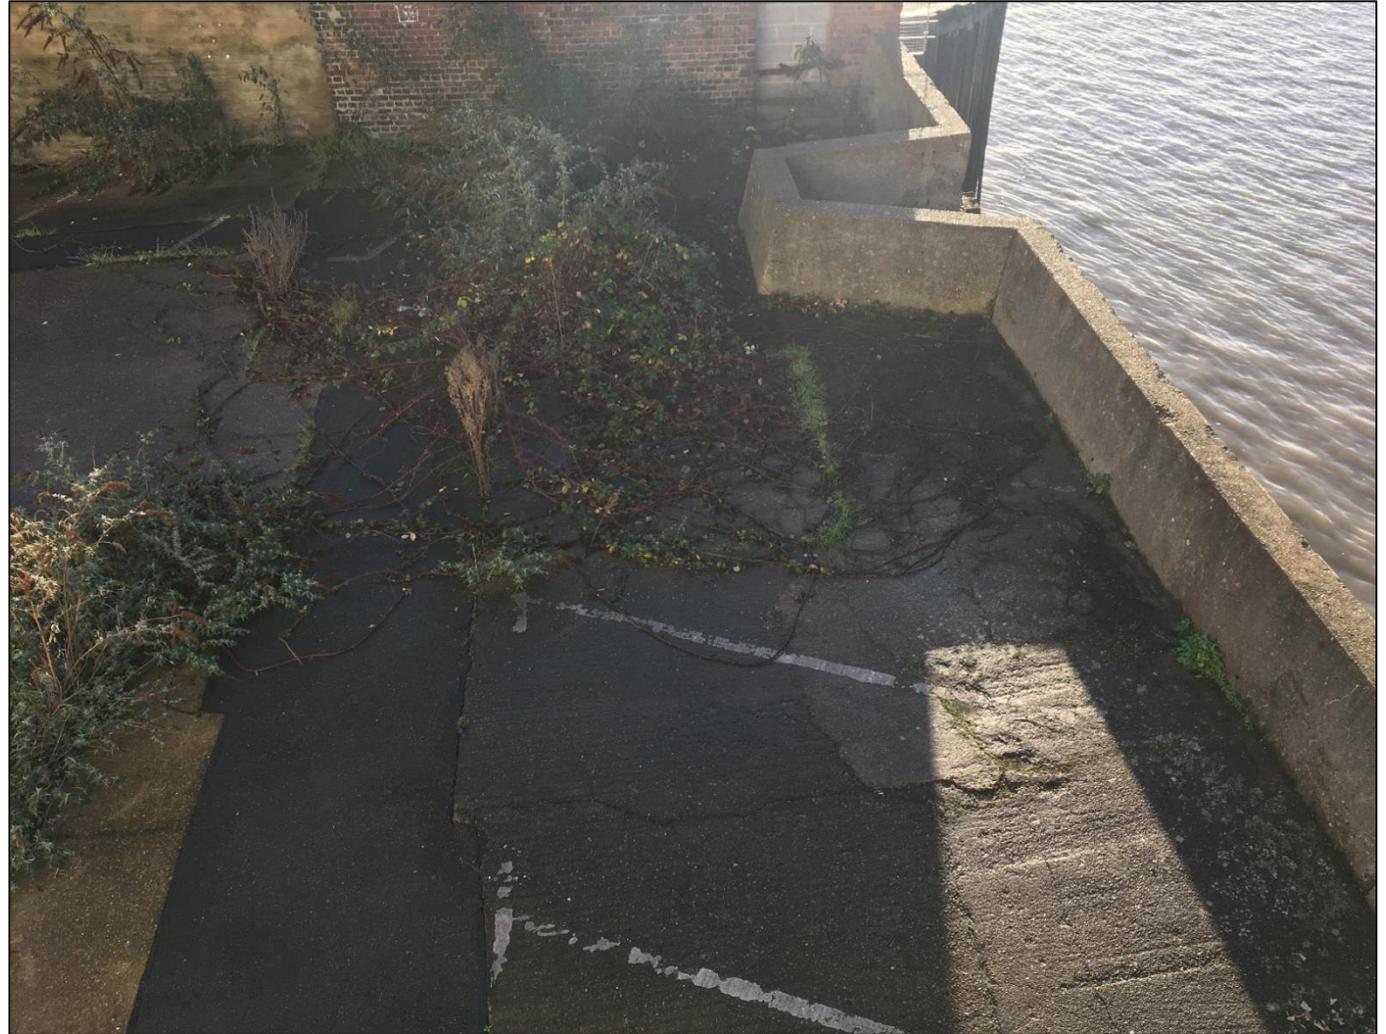
### Location 14

Hard standing area – overview of hard standing

- Taken from the upper deck of the TOBS roof terrace.
- No new cracks or other evidence of movement or settlement within concrete hard standing observed.

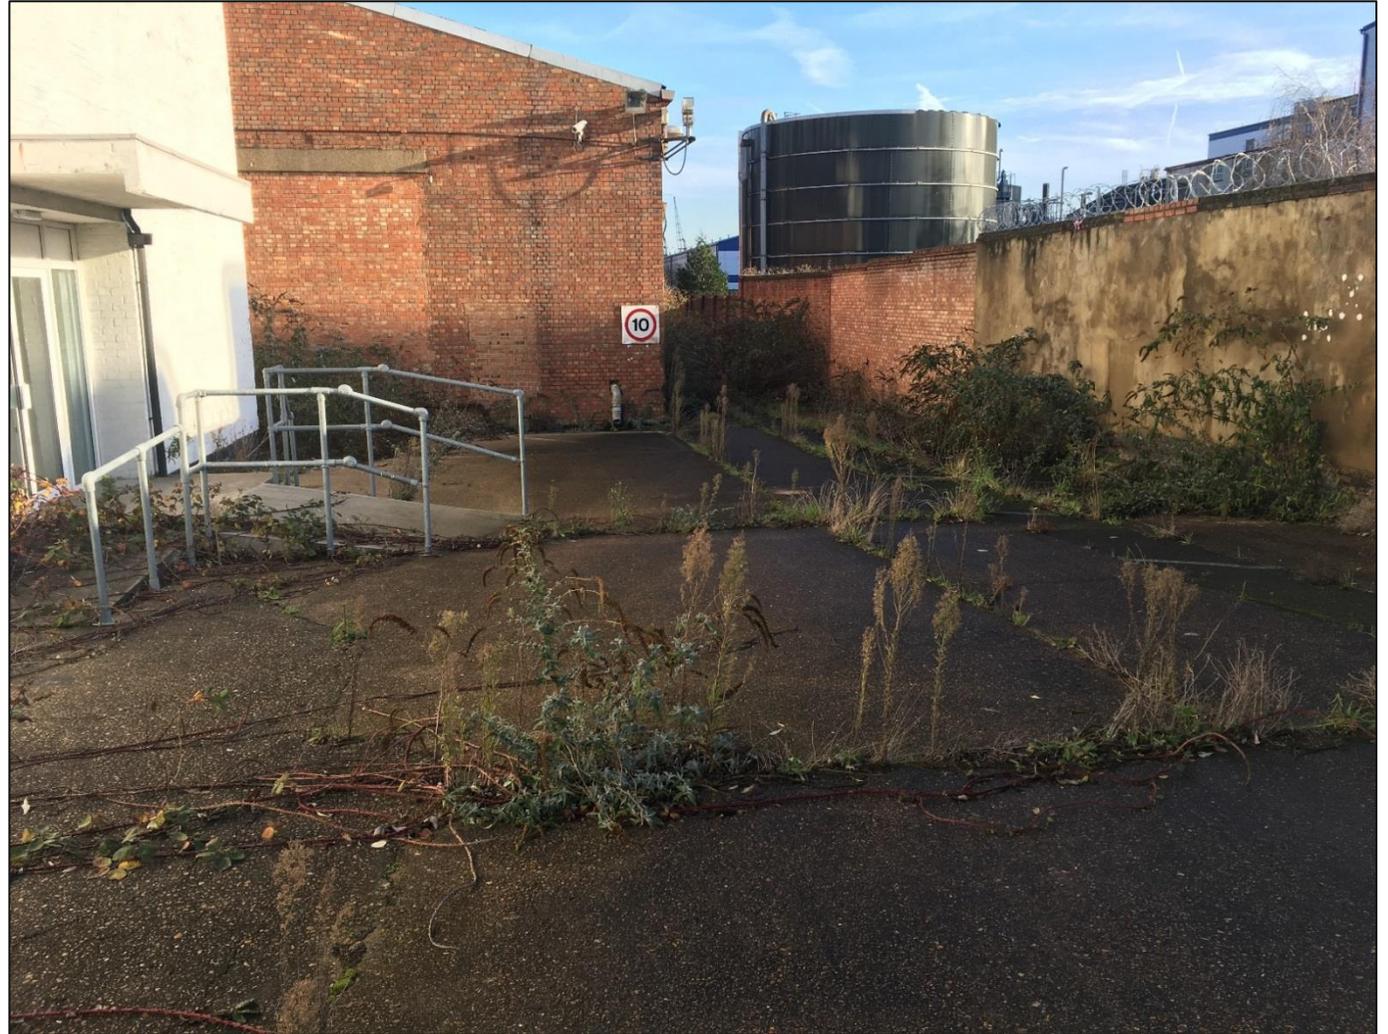
### Location 15

Hard standing area – view away from river wall

- No new cracks or other evidence of movement or settlement within concrete hard standing observed.

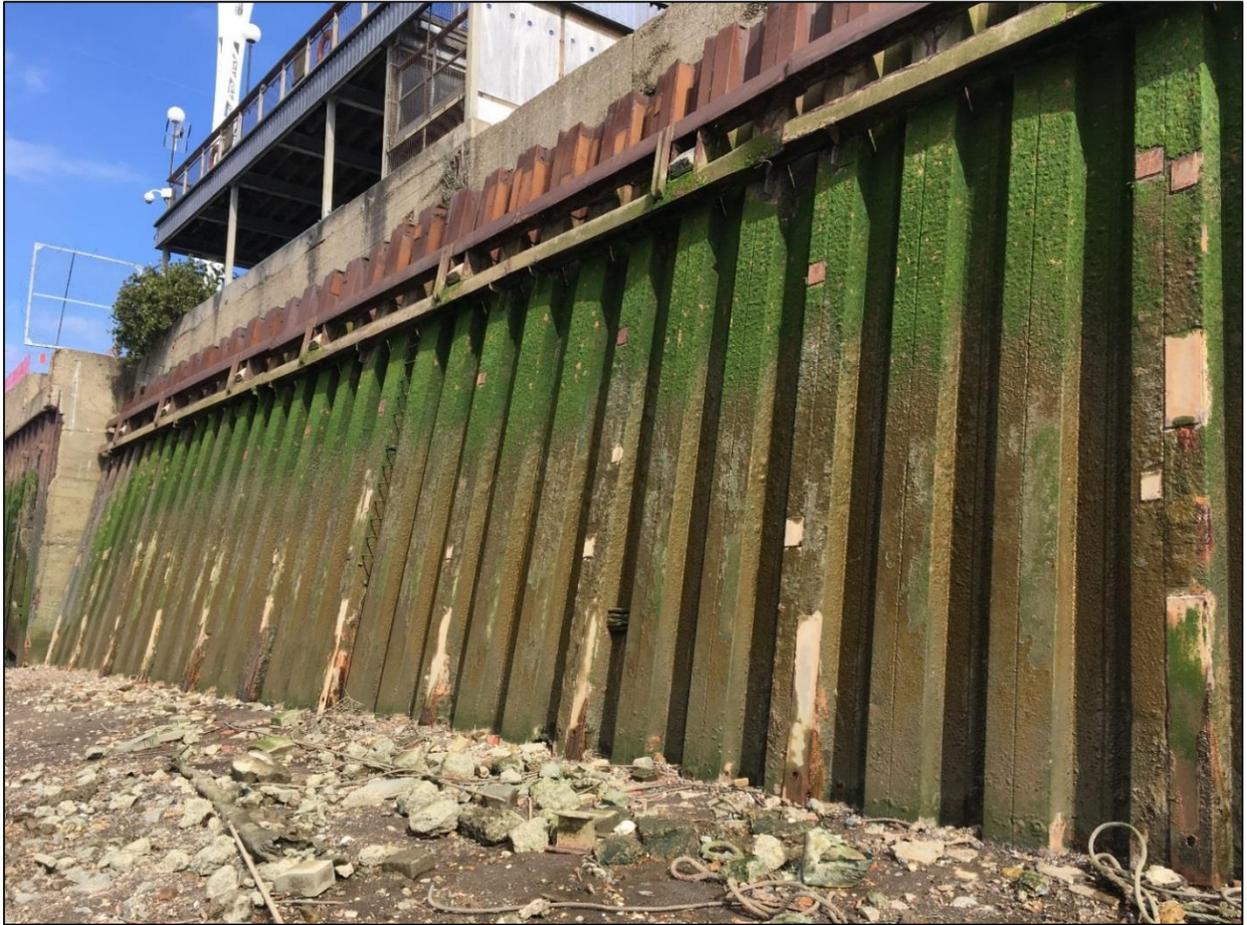
Record photos of the repairs previously carried out to the steel sheet pile wall were taken and are discussed in further detail in Section 3. Figure 2.2 shows the overall condition of the river wall, taken from the river bed at low tide. The patch repairs can clearly be seen in Figure 2.2 as areas with less vegetation growth.

While there is minor corrosion to the steel sheet pile, no significant deterioration since the previous inspection was observed.

No evidence of movement or settlement of the existing river wall was observed, either at the interface with the adjacent river wall structures or overall.

Figure 2.2: Overall view of the river wall, taken from the river bed at low tide

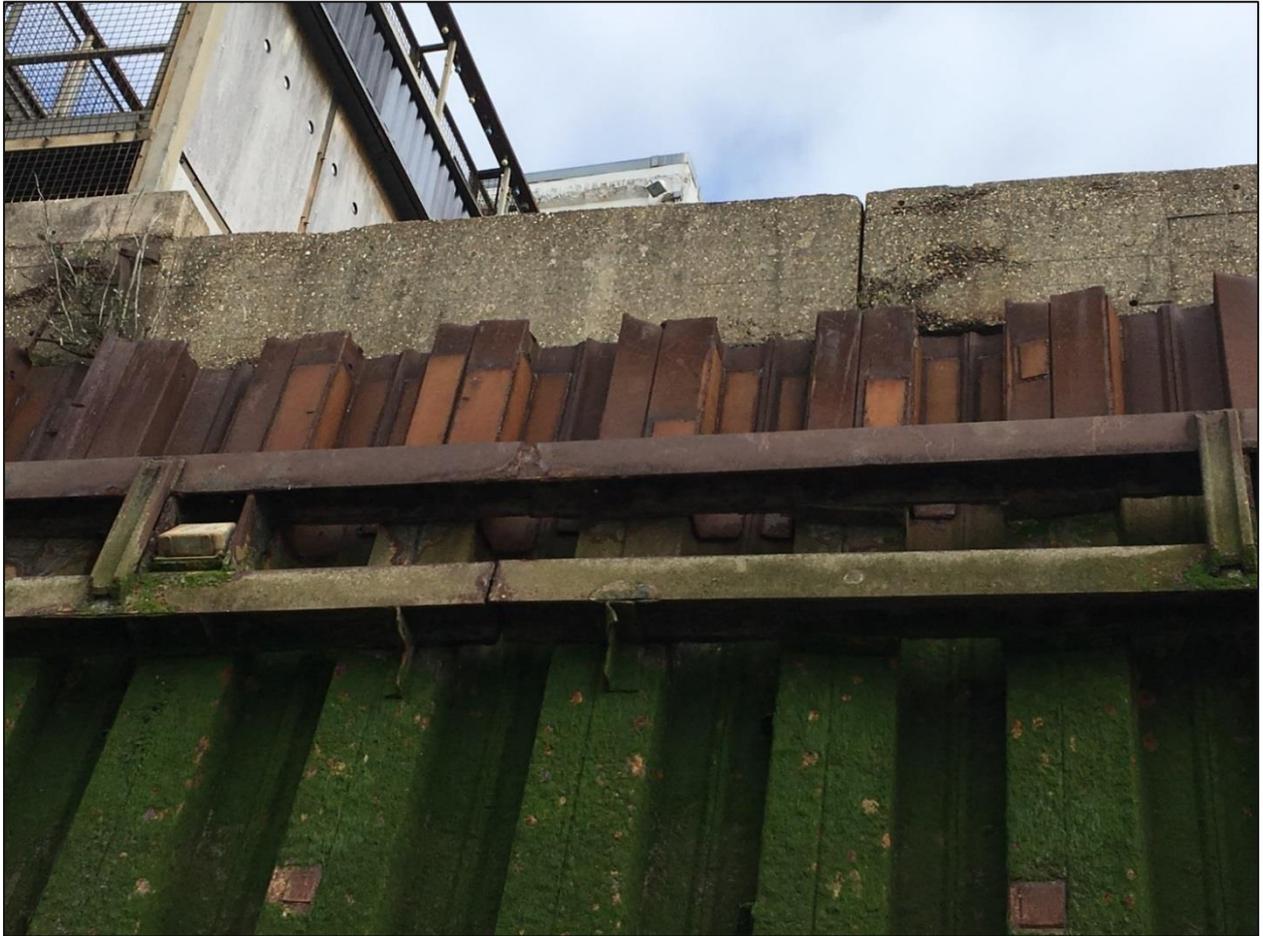
All plate repairs appear to remain securely welded to the existing sheet pile sections and there is no evidence of further degradation of the condition of the remaining steel. Figure 3.1 shows a typical photograph of the upper level of the river wall, showing the steel plate repairs securely welded to the sheet piling.

**Figure 3.1: Typical photograph of upper level of river wall, showing steel plate repairs to sheet piling, taken from the river bed**

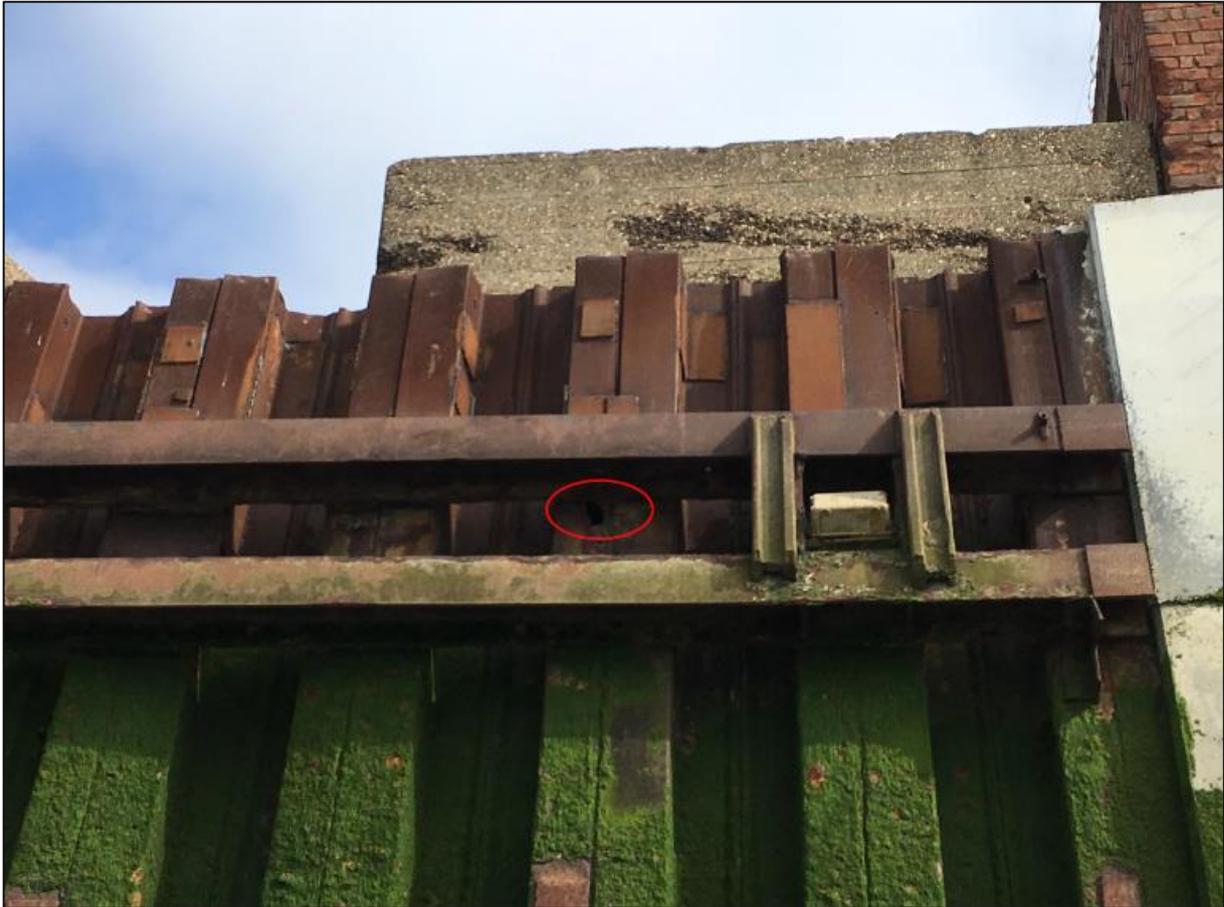
There are two locations where a perforation has not had a patch repair installed. One is between the two waling beams immediately north of the southernmost ground anchor, shown in Figure 3.2. This was not observed at completion of the repair works, but it is likely to have been missed due to access issues to this section of the river wall during the remedial works, and proximity to the waling beam. The extent of this perforation does not appear to have deteriorated since the previous inspection.

It is considered that the two perforations observed would not pose a risk of structural failure of the river wall. Additional repair works are therefore not proposed, however these two areas will be closely monitored as part of the ongoing quarterly inspection programme to identify whether any further significant corrosion occurs.

Figure 3.2 Location at south end of river wall where patch repair to perforation in steel sheet piling has been missed

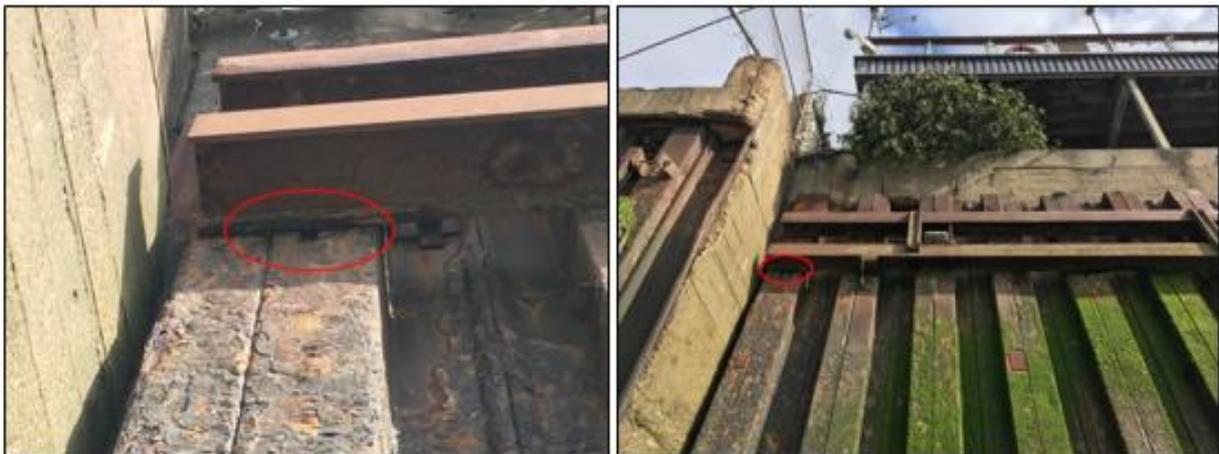
The other perforation that has not been patched is immediately under the lower waling beam on the northernmost out-pan of the sheet pile wall, as shown in Figure 3.3. This perforation was not observed during the 19<sup>th</sup> December inspection as it is not visible from the land side.

Figure 3.3 Location at north end of river wall where patch repair to perforation in steel sheet piling has been missed
