## Technical Note

Project Thames Side West  
Subject Dohm Wharf River Wall Quarterly Inspection – March 2018  
Project no 035668  
Date 9 April 2018

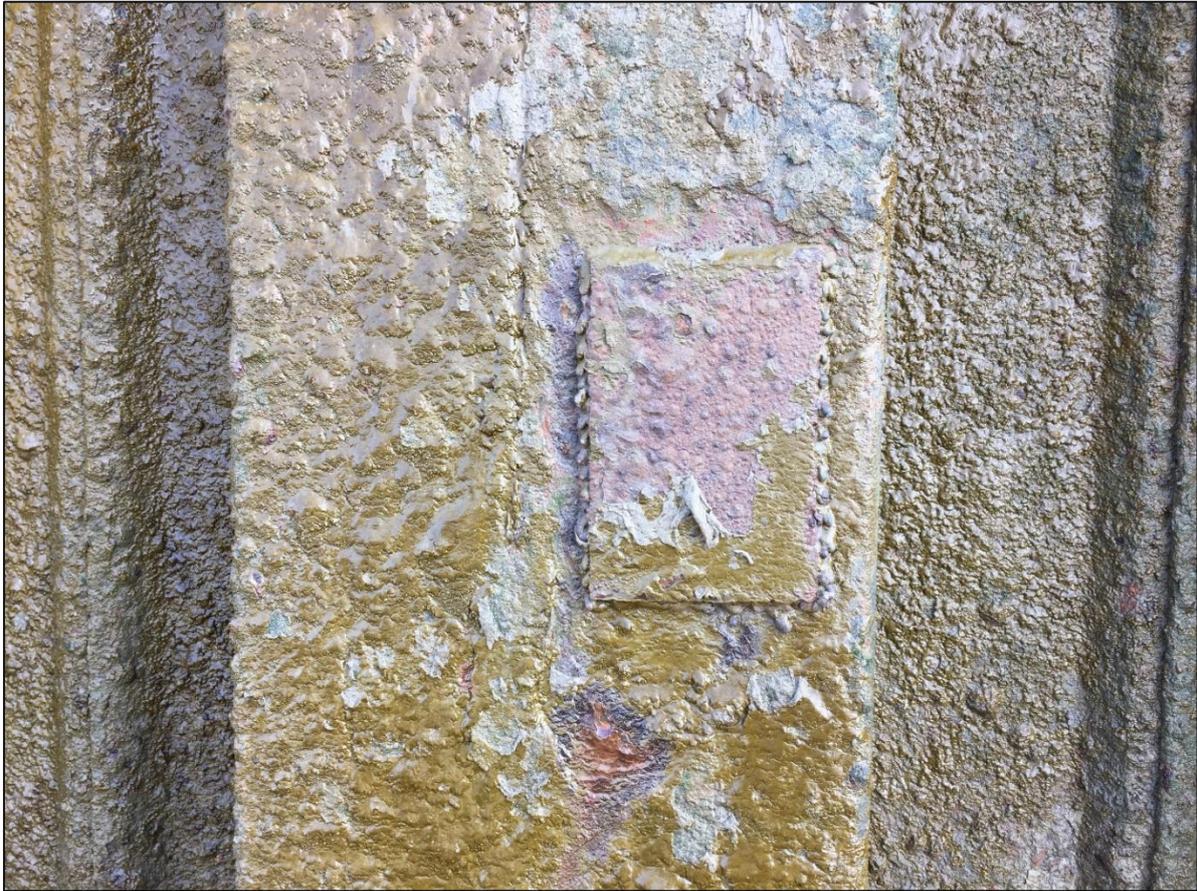
The repairs to the mid level of the sheet pile wall were visible from the river side only. All repairs at the mid level appear to be in good condition, with no new perforations.

Figure 3.4 Typical patch repair to the mid level of the steel sheet pile wall, in good condition

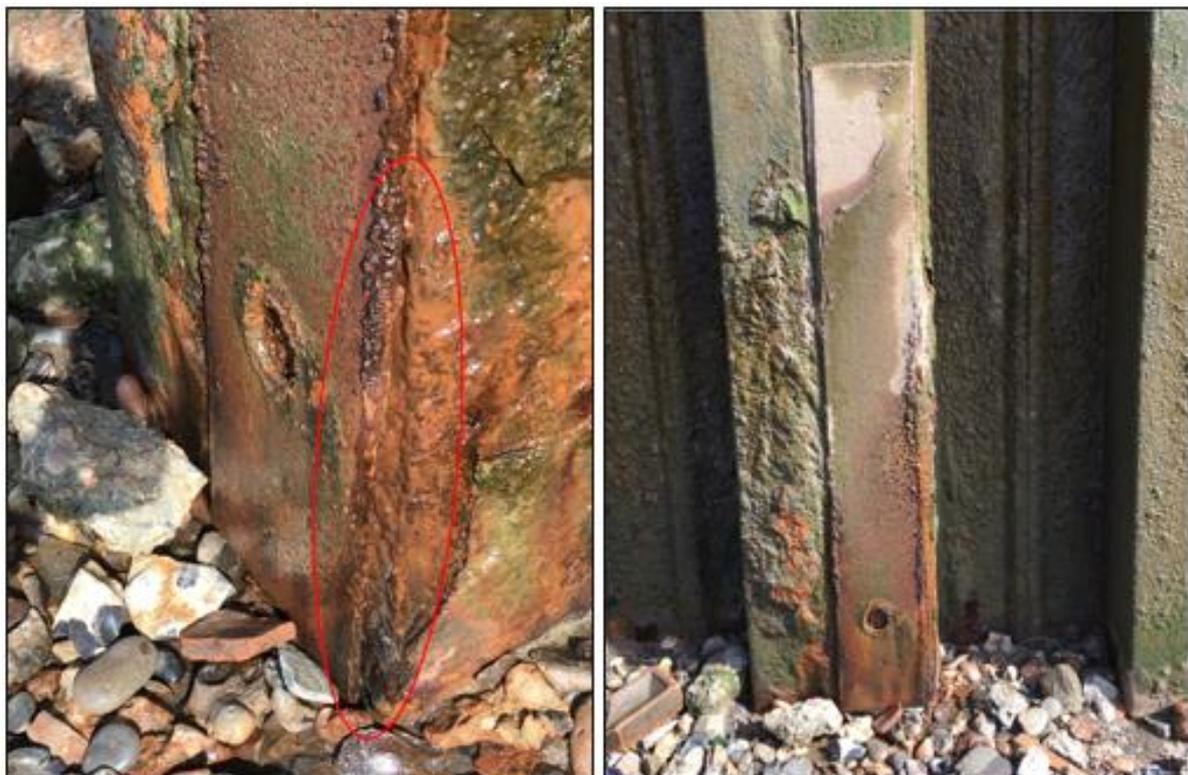
Figure 3.5 Typical patch repair to the low level of the steel sheet pile wall, in acceptable condition

The low level patch repairs are generally in acceptable condition. Each patch repair has a weep hole at the bottom to allow water to drain from behind the river wall, as was the case with the existing wall.

In all locations, the lower southern side of the plate has not been fully welded to the existing sheet pile, as circled in red in Figure 3.5. This is due to the continuous flow of water draining from behind the river wall, which prevented a weld from being completed.

It is considered that this missing length of weld would not pose a risk of structural failure of the river wall. However it is recommended that these areas are monitored during subsequent quarterly inspections to check that degradation of the repair does not occur.

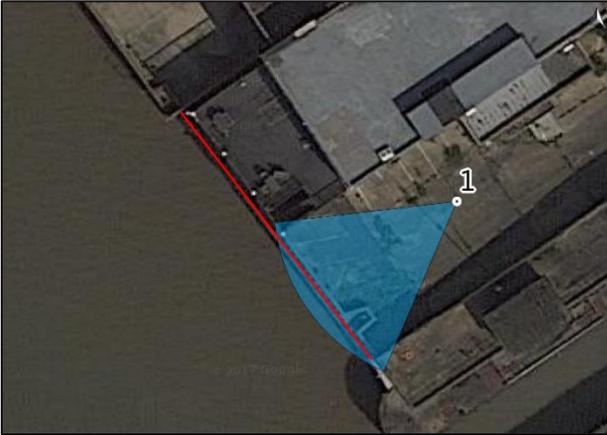
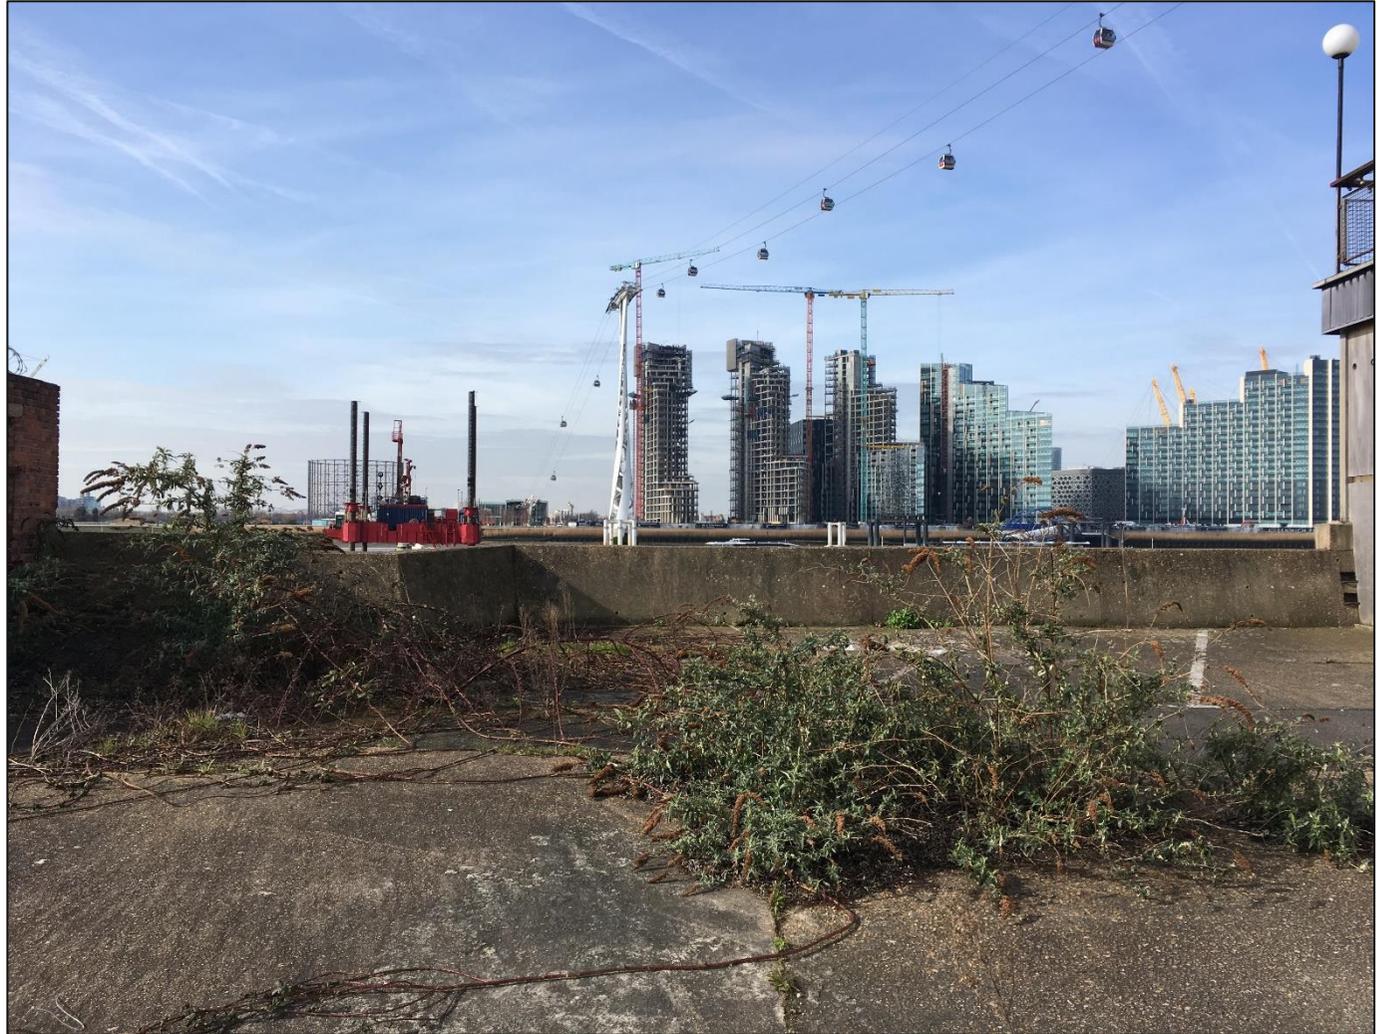
## Location 1

Hard standing area – overview of parapet wall

- Hard standing generally in good condition.
- Existing cracks in hard standing previously observed during 23<sup>rd</sup> February and 19<sup>th</sup> December inspections.
- No new cracks observed in concrete parapet wall or concrete hard standing.
- No obvious indications of movement or settlement of parapet wall or hard standing.
- Vegetation present within cracks in hard standing, similar extent to previous inspection on 19<sup>th</sup> December.

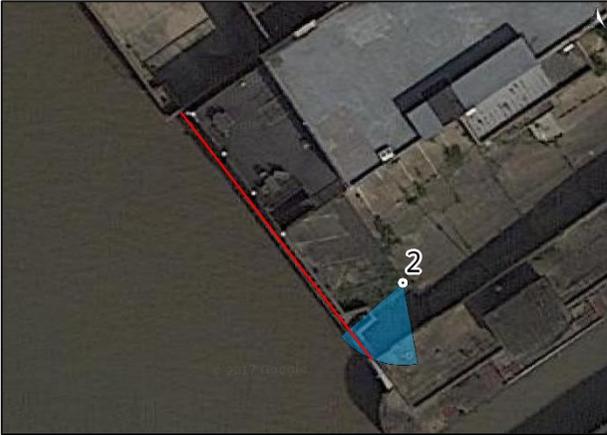
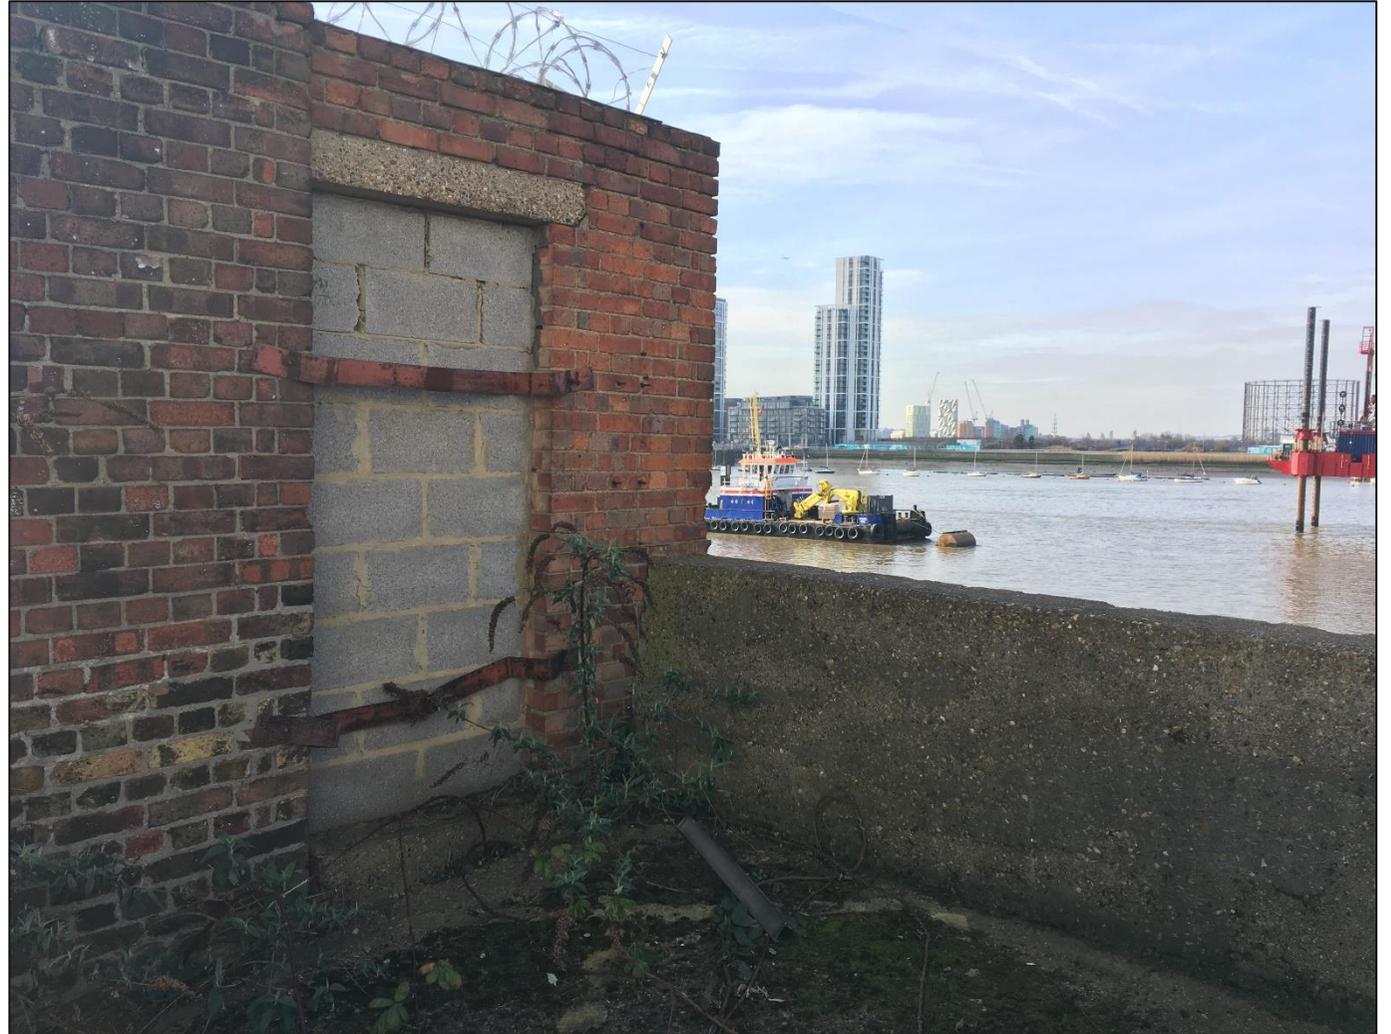
## Location 2

Hard standing area – south corner

- Brick wall perpendicular to river wall, at south boundary of Dohm Wharf river wall.
- Existing crack in brick wall unchanged since last inspection. See location 3 for detail.
- No new cracks observed in concrete parapet wall, adjoining red brick wall or concrete hardstanding.

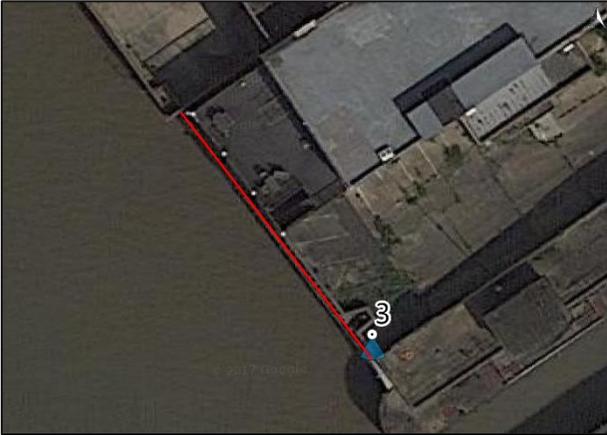
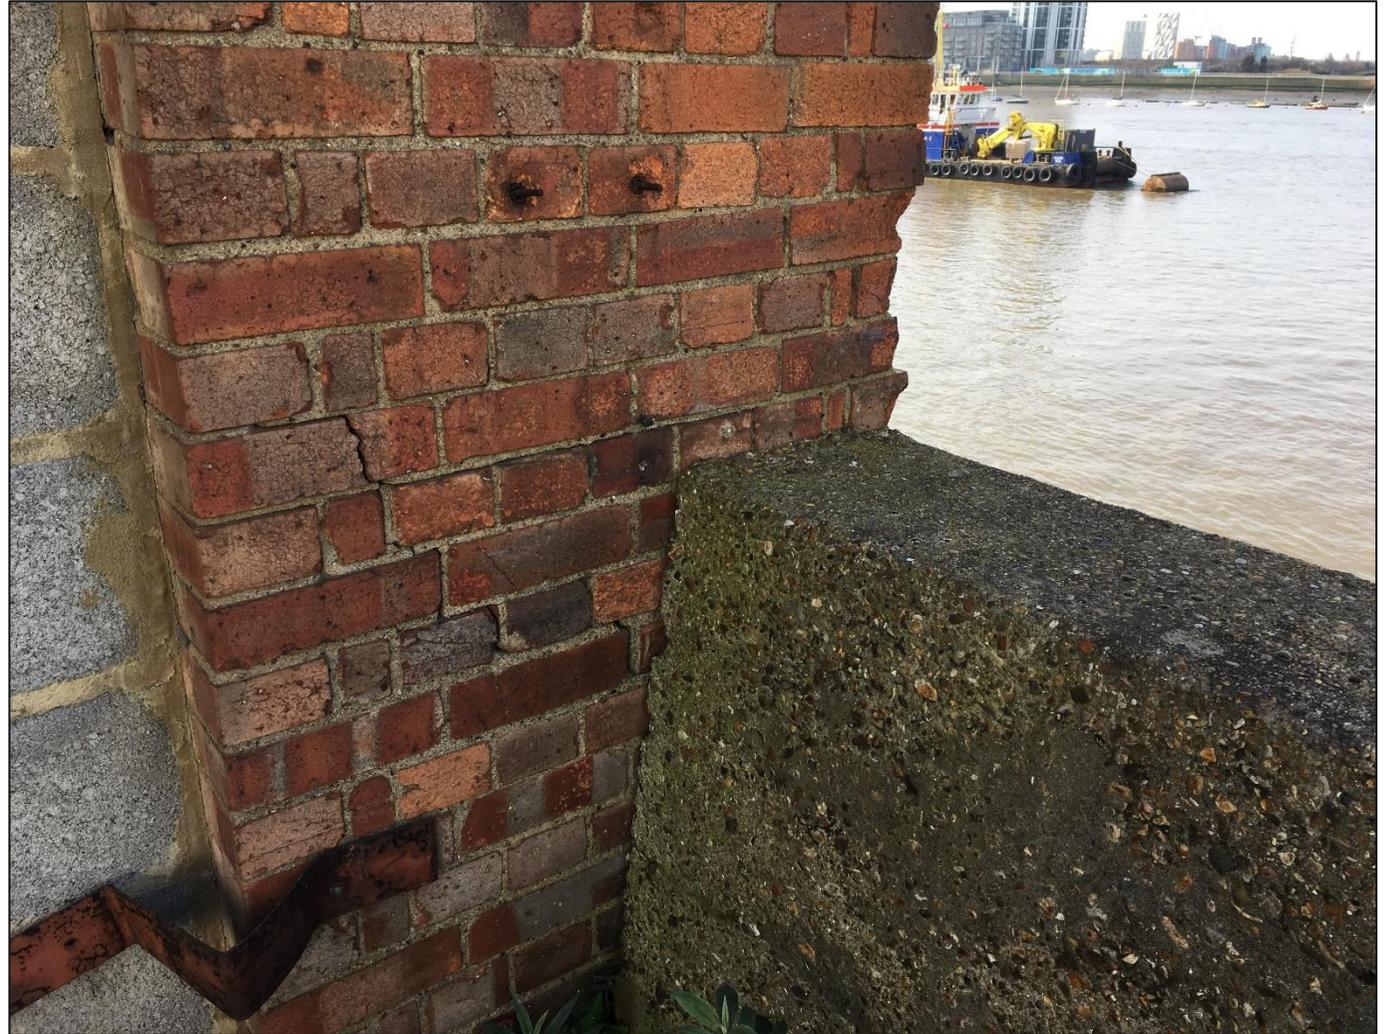
### Location 3

Hard standing area – south corner brick wall crack detail

- Brick wall perpendicular to river wall, at south boundary of Dohm Wharf river wall.
- Existing crack in brick wall at approximate level of crest of concrete parapet wall.
- Extent of crack remains unchanged since 19<sup>th</sup> December 2017 inspection.
- Crack does not appear to have widened since 19<sup>th</sup> December 2017 inspection.
- No obvious indications of movement or settlement.

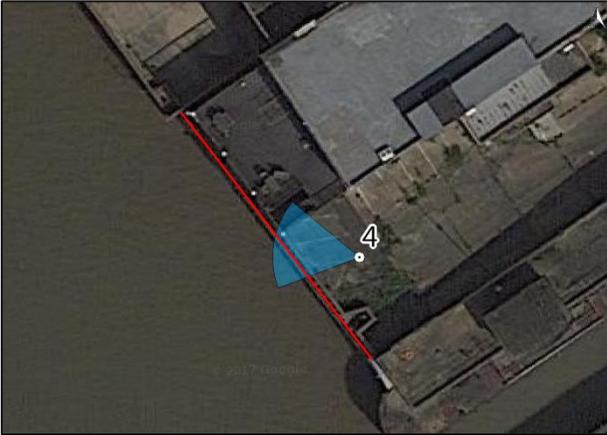
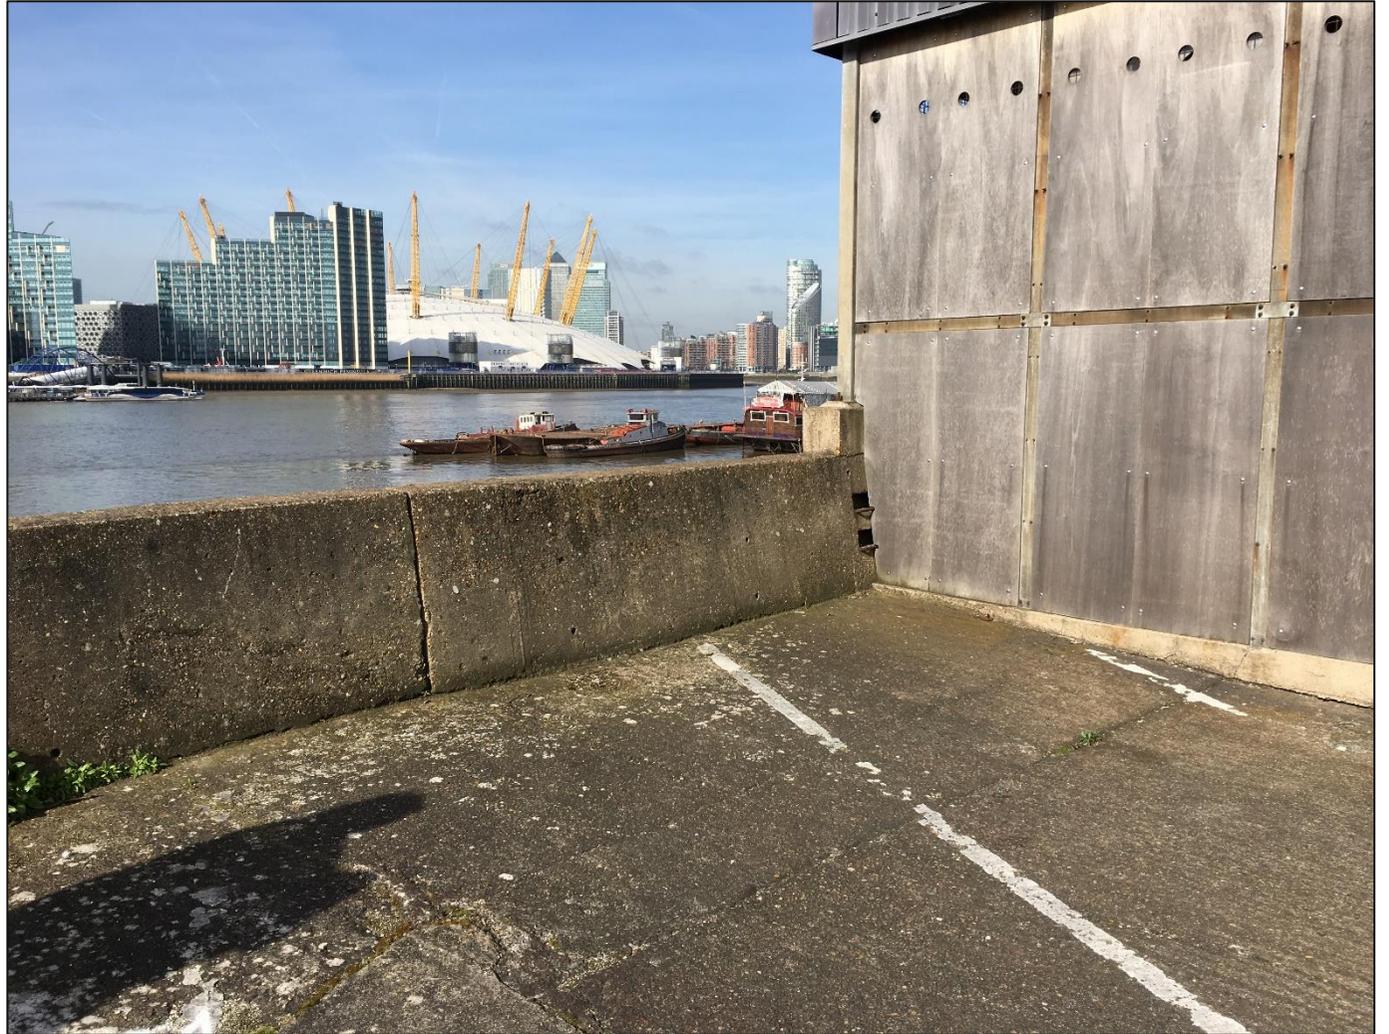
#### Location 4

Hard standing area – north corner

- No new cracks observed in concrete parapet wall or concrete hard standing.
- No evidence of movement at interface between timber hoarding, concrete parapet wall and concrete hard standing.
- No obvious indications of movement or settlement of parapet wall or hard standing.

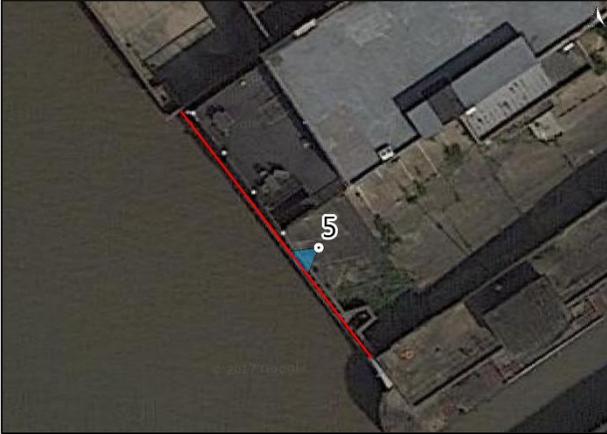
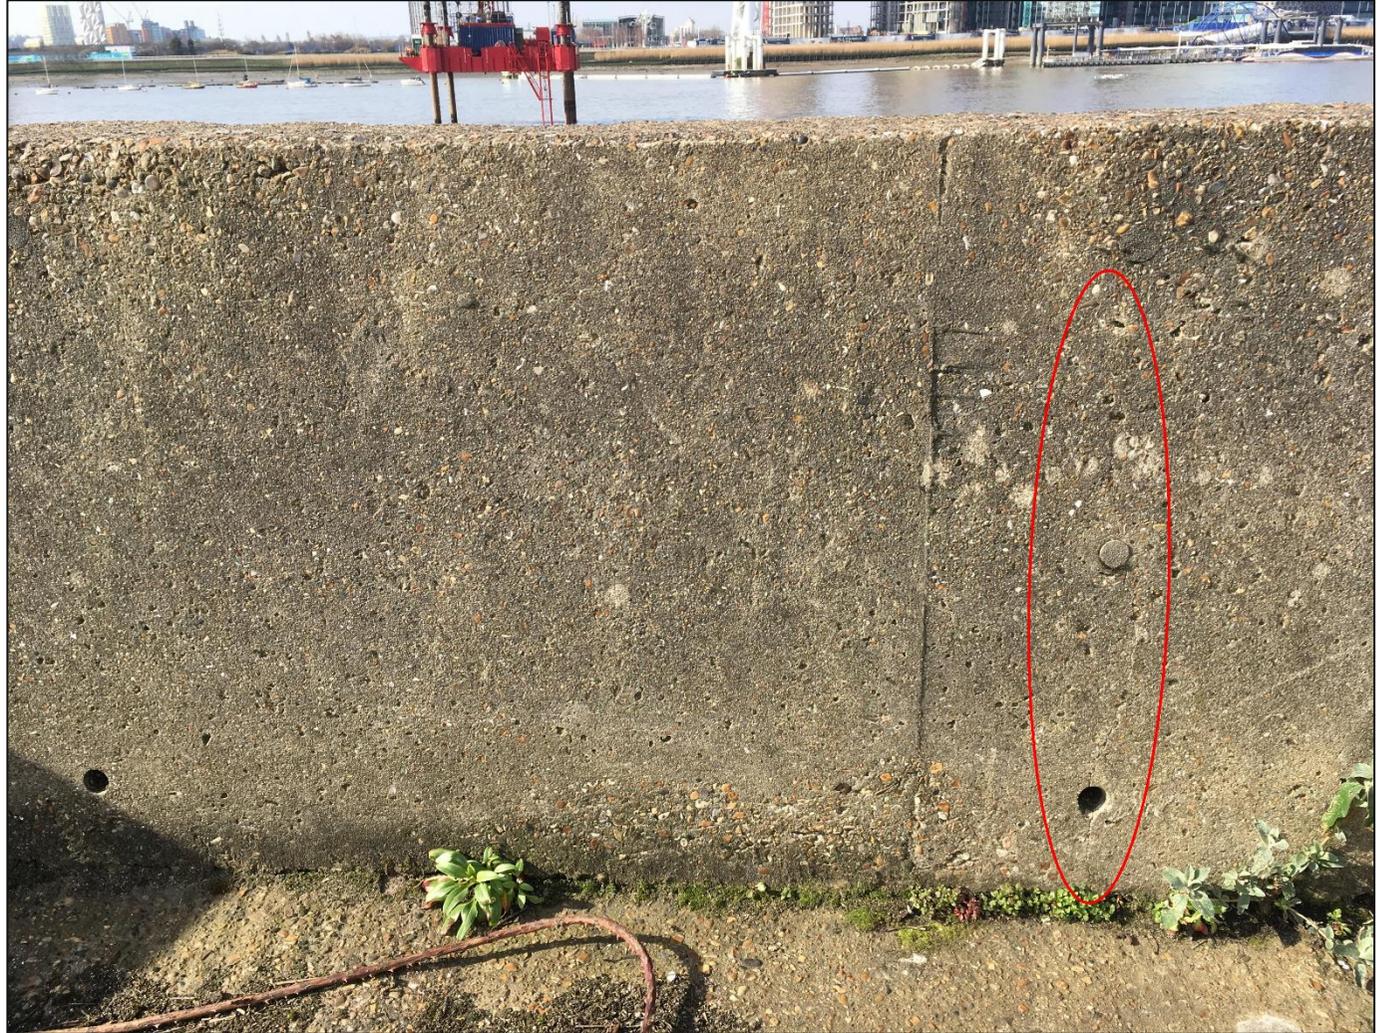
### Location 5

Hard standing area – crack in parapet wall

- Hairline crack in concrete parapet wall.
- Crack originates through penetration in wall, assumed to be a construction defect rather than caused by movement of the river wall.

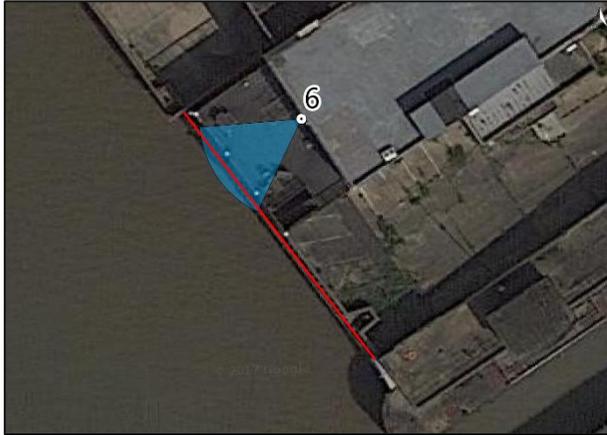
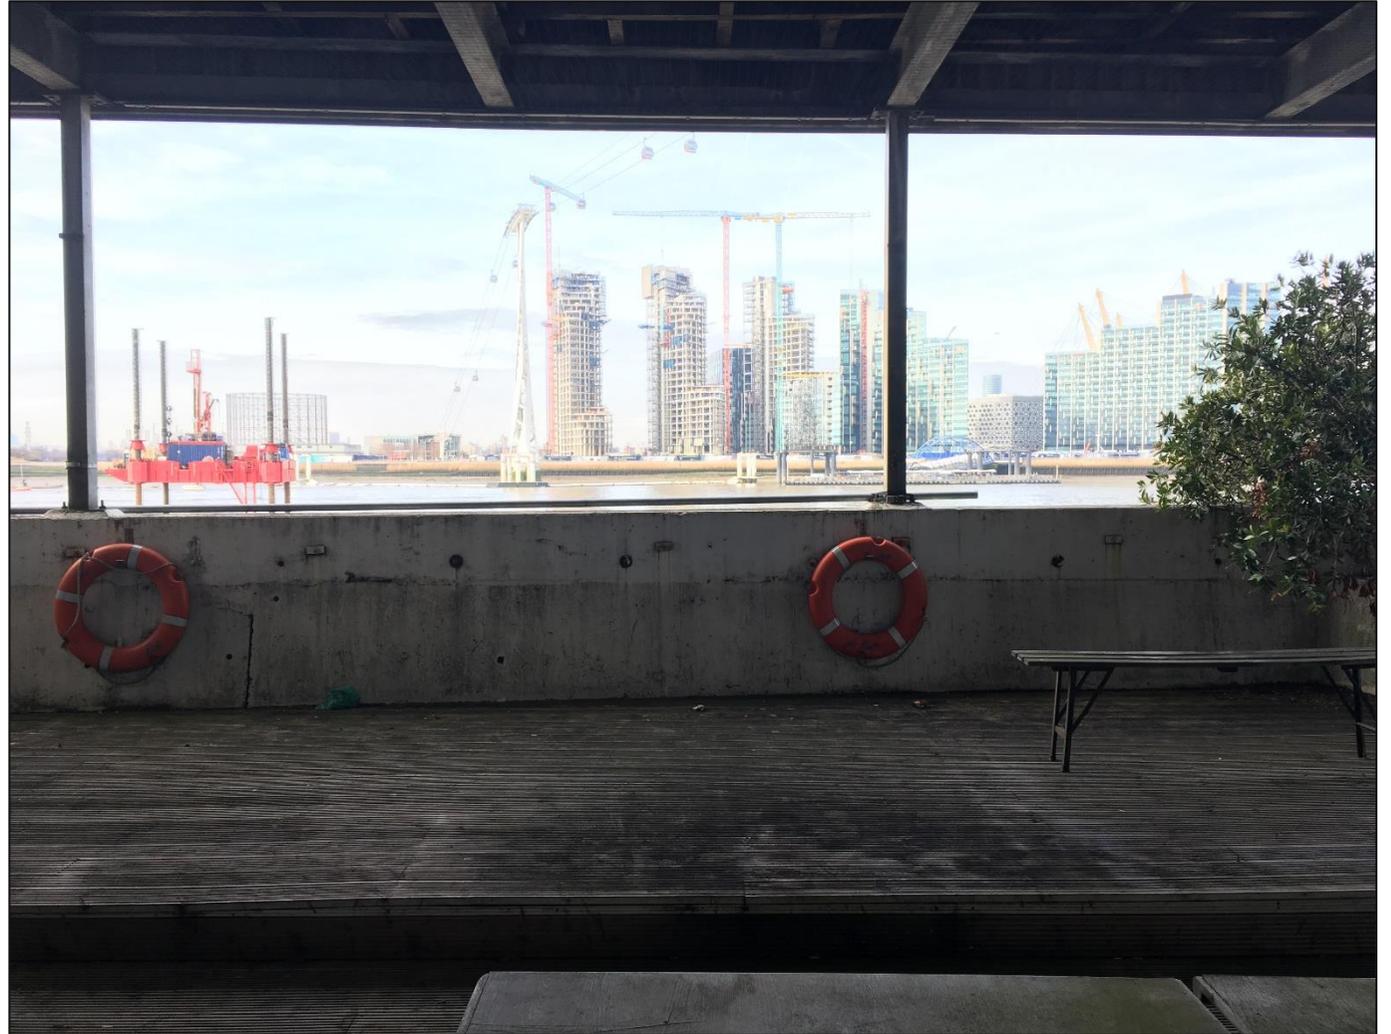
## Location 6

TOBS terrace area – overview of parapet wall

- No new cracks observed in concrete parapet wall.
- Inspection of ground behind parapet wall prevented by presence of timber deck.
- No obvious indications of movement or settlement.

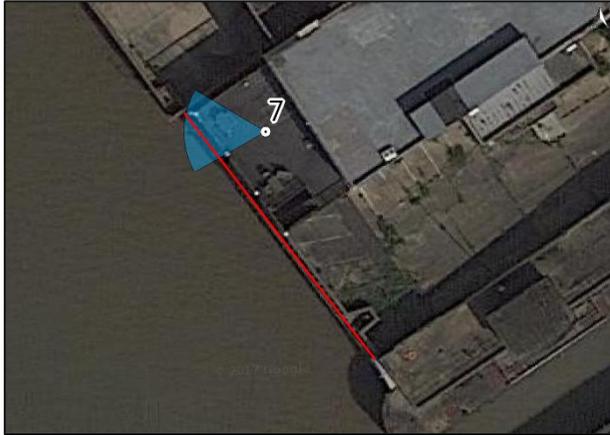
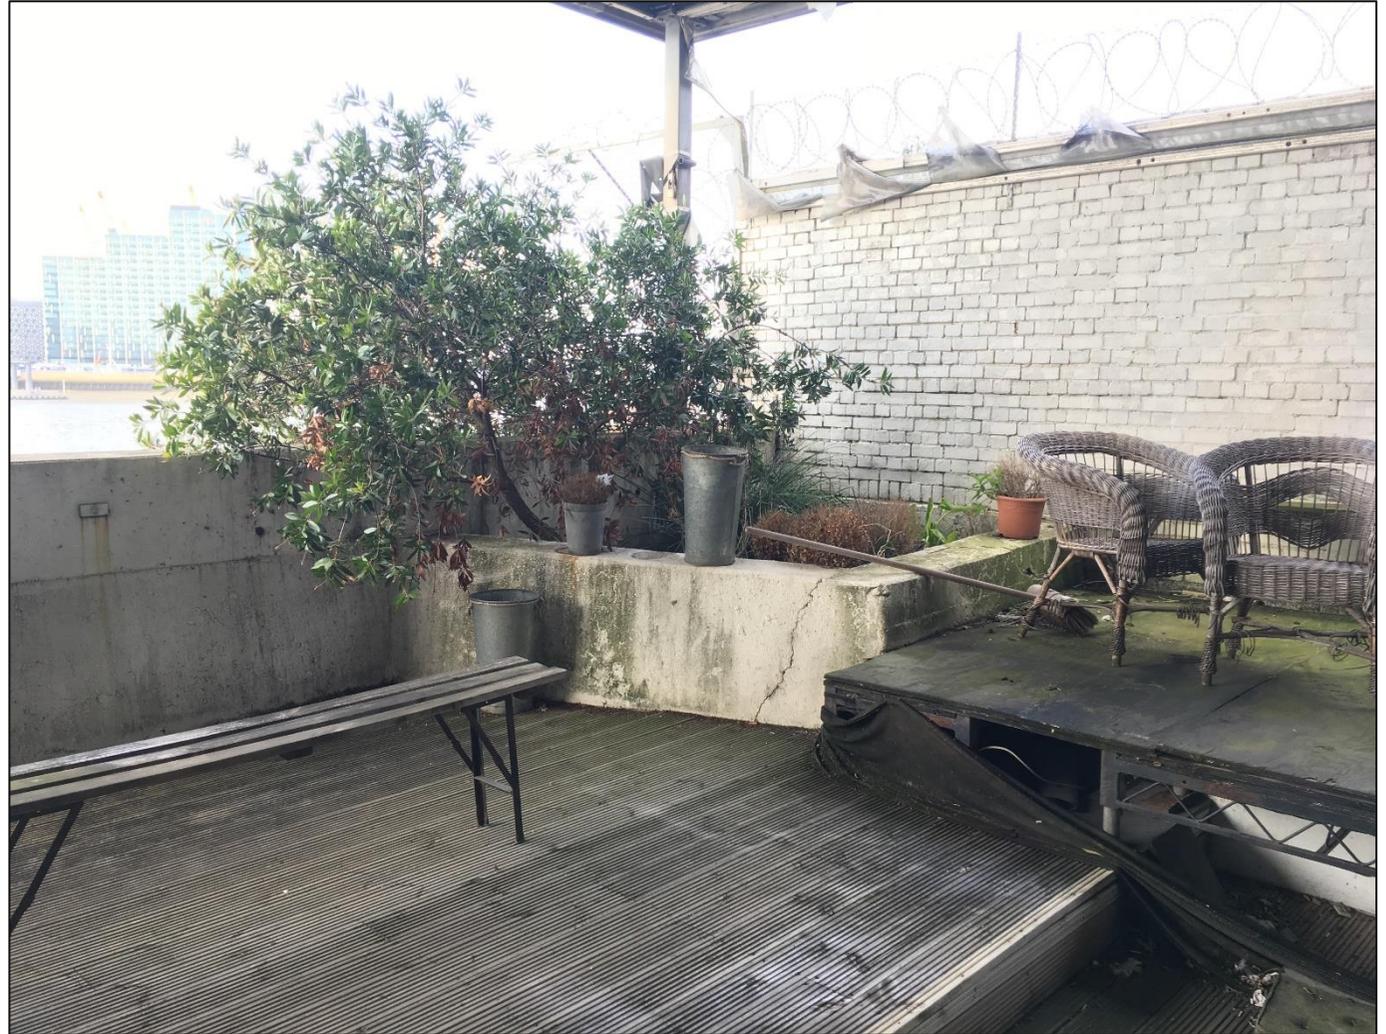
### Location 7

TOBS terrace area – north corner

- Existing crack in wall of concrete planter. See location 8 for detail.
- No new cracks observed in concrete parapet wall.
- No obvious indications of movement or settlement.

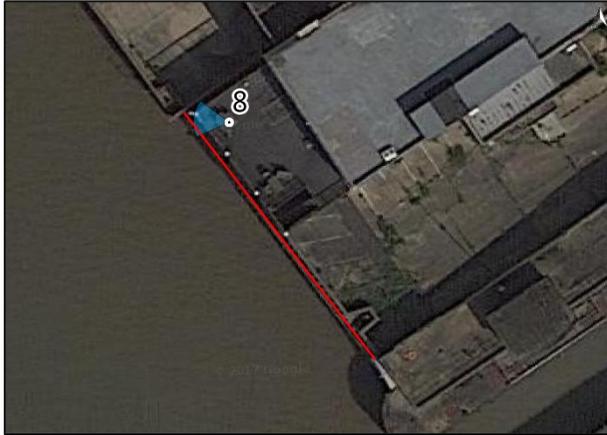
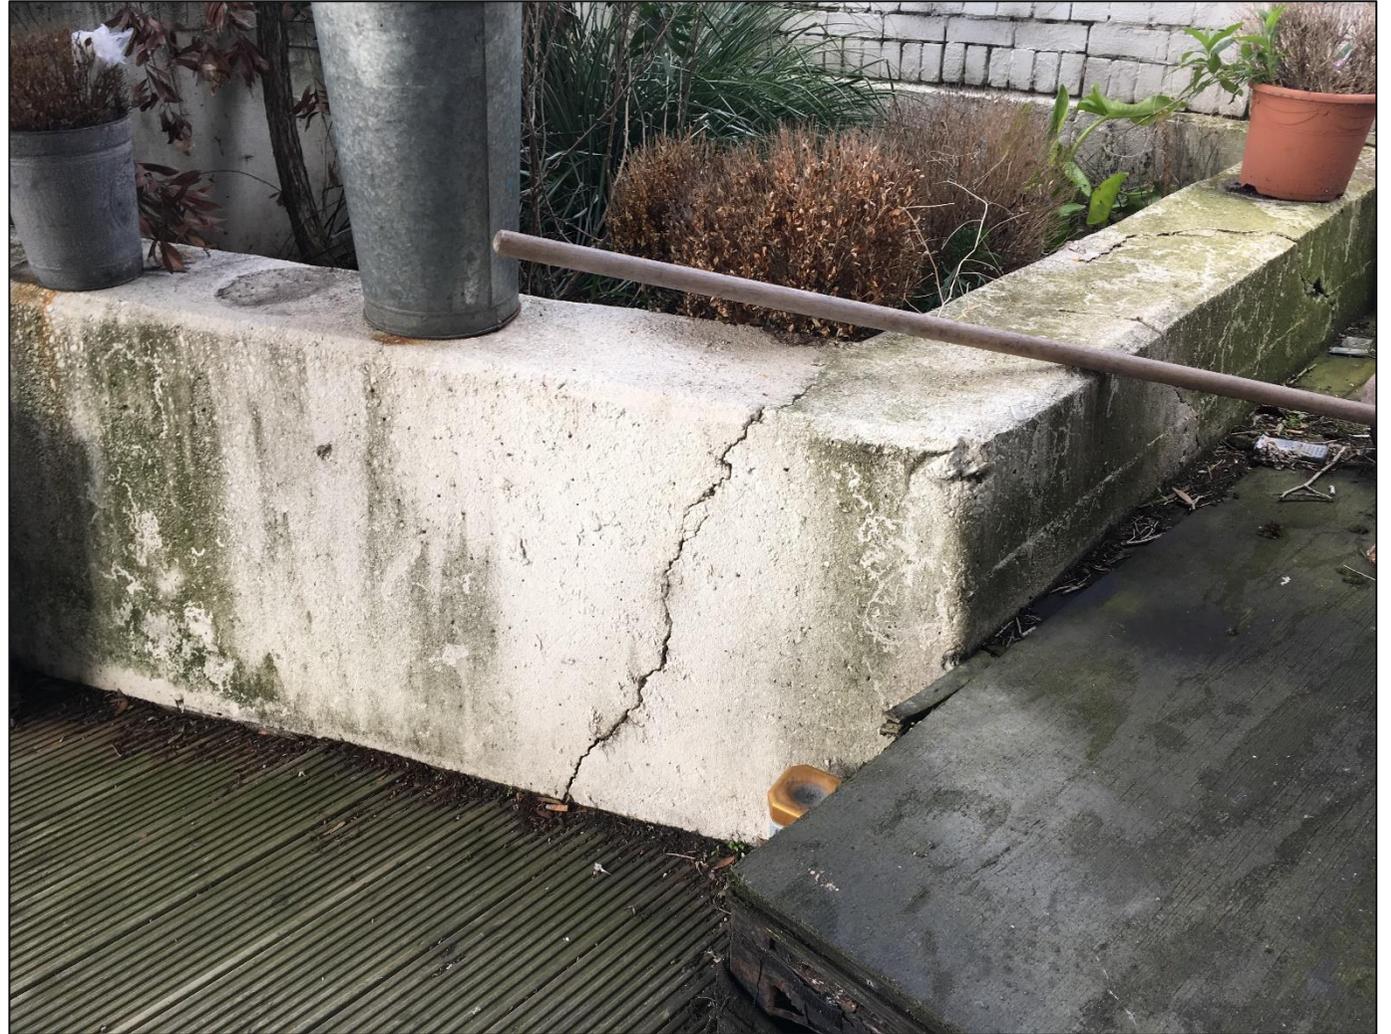
## Location 8

TOBS terrace area – north corner planter crack detail

- Existing crack in wall of concrete planter.
- Extent of crack remains unchanged since last inspection.
- No evidence to indicate that crack has widened since last inspection.

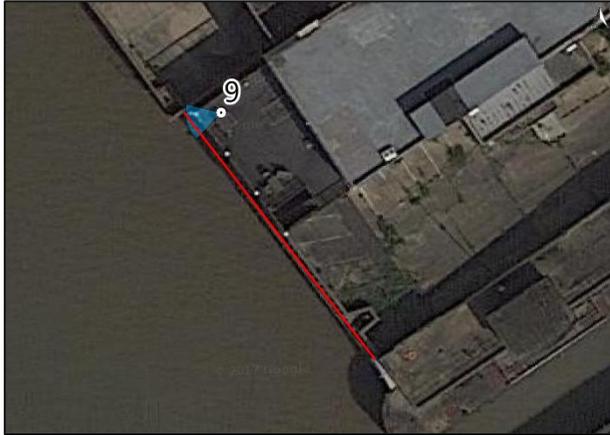
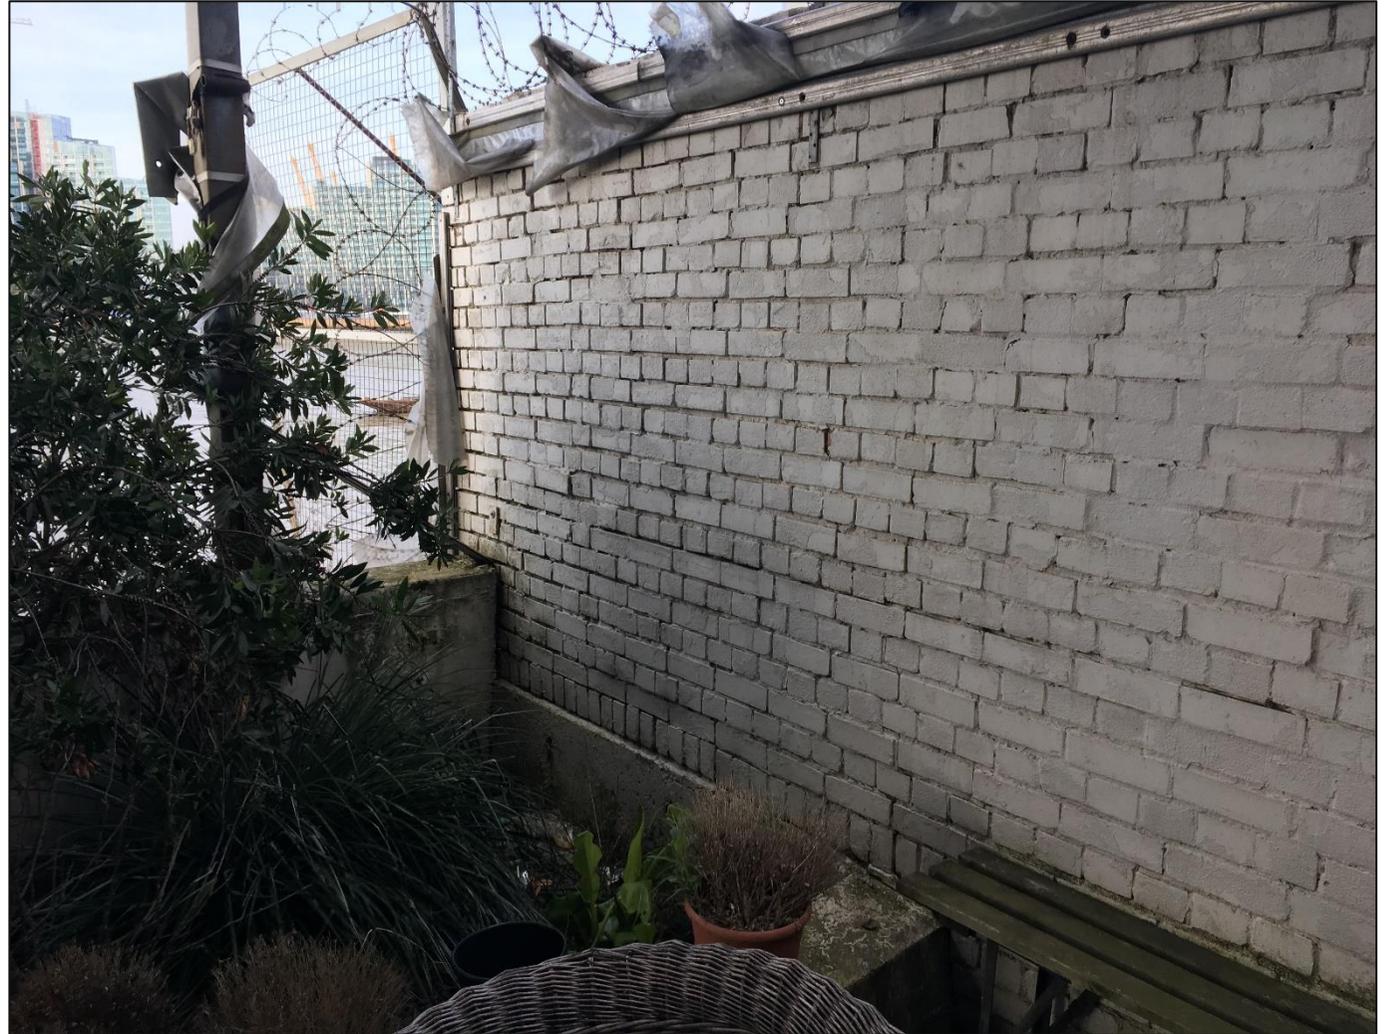
### Location 9

TOBS terrace area – north cornered brick wall detail

- Adjoining brick wall at north boundary of Dohm Wharf river wall.
- No evidence to indicate that crack has widened or extended since last inspection.
- Note that condition of mortar is poor in places.

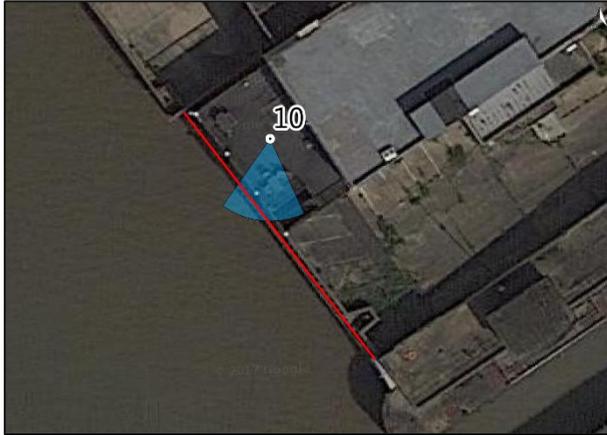
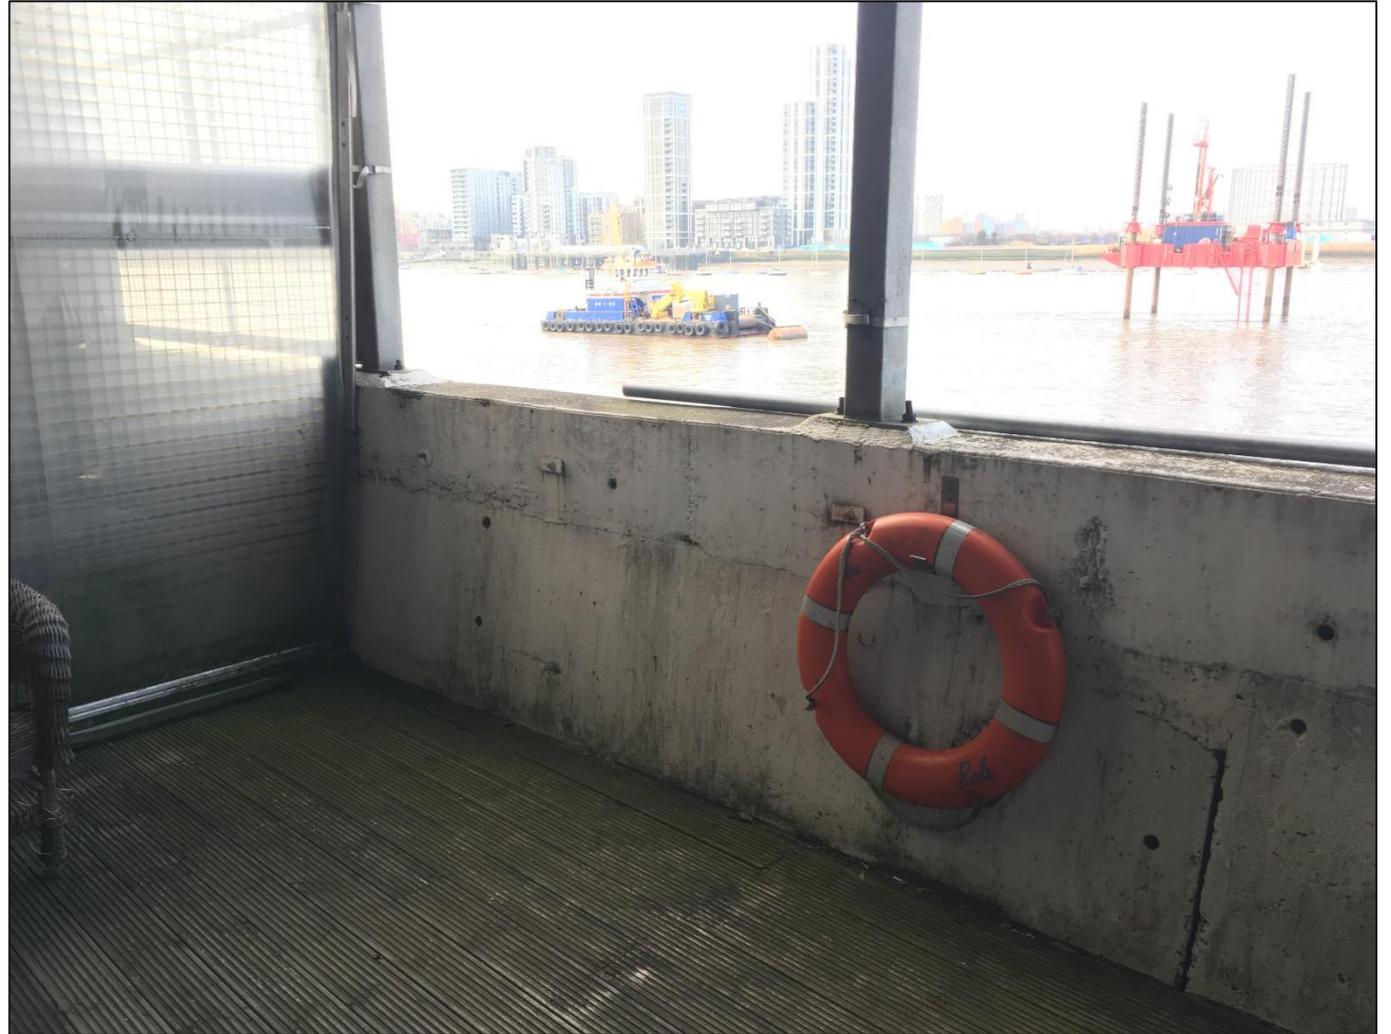
### Location 10

TOBS terrace area – south corner

- No new cracks observed in concrete parapet wall.
- No obvious indications of movement or settlement.
