Technical Note

Project Thames Side West

Subject Dohm Wharf River Wall Quarterly Inspection – September 2018

Date 28 September 2018

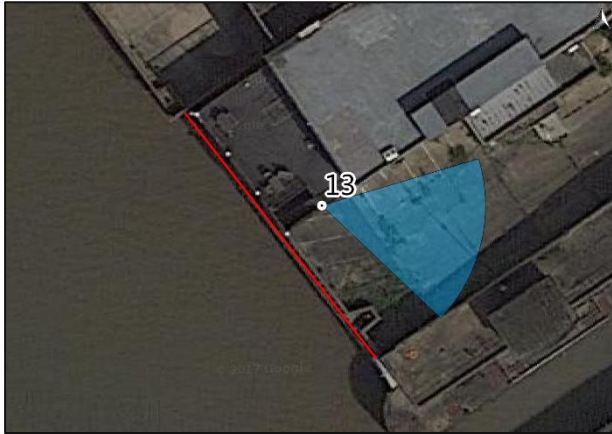
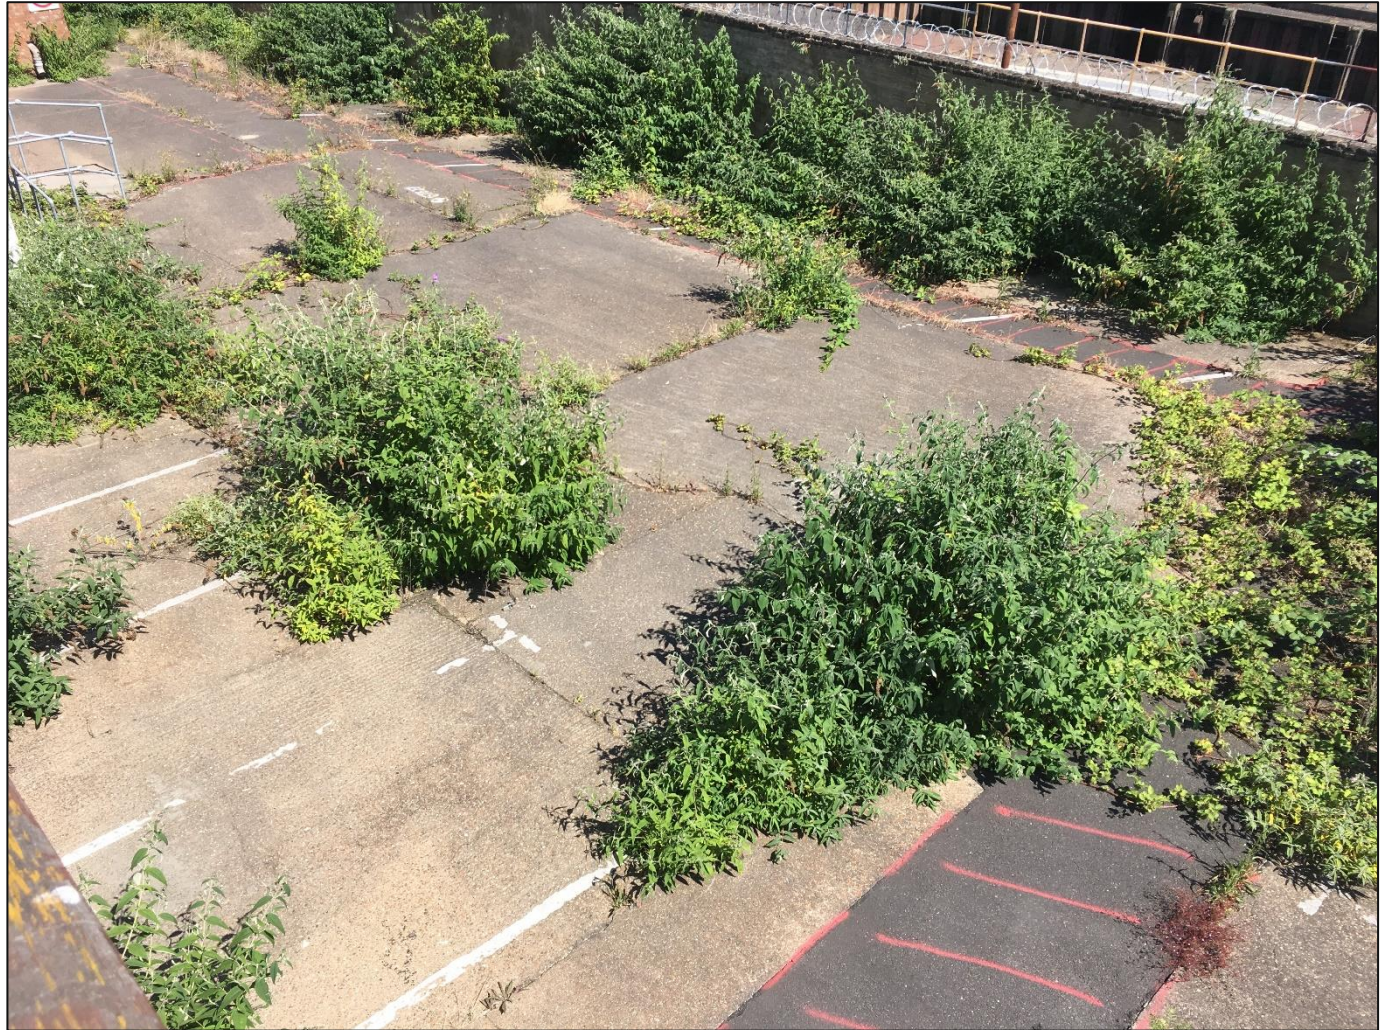
Location 13

Hard standing area – overview of hard standing

- Taken from the upper deck of the TOBS roof terrace.
- No new cracks or other evidence of movement or settlement within concrete hard standing observed.

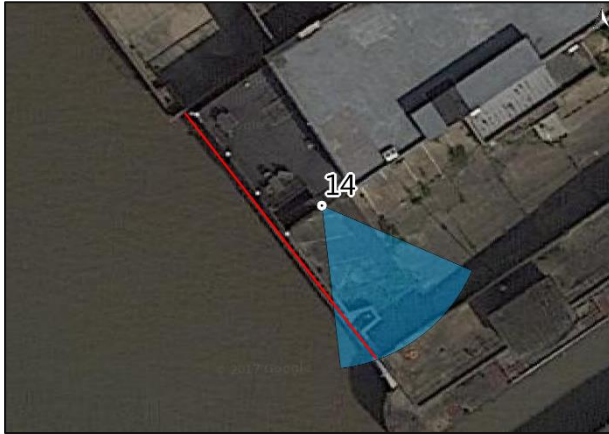
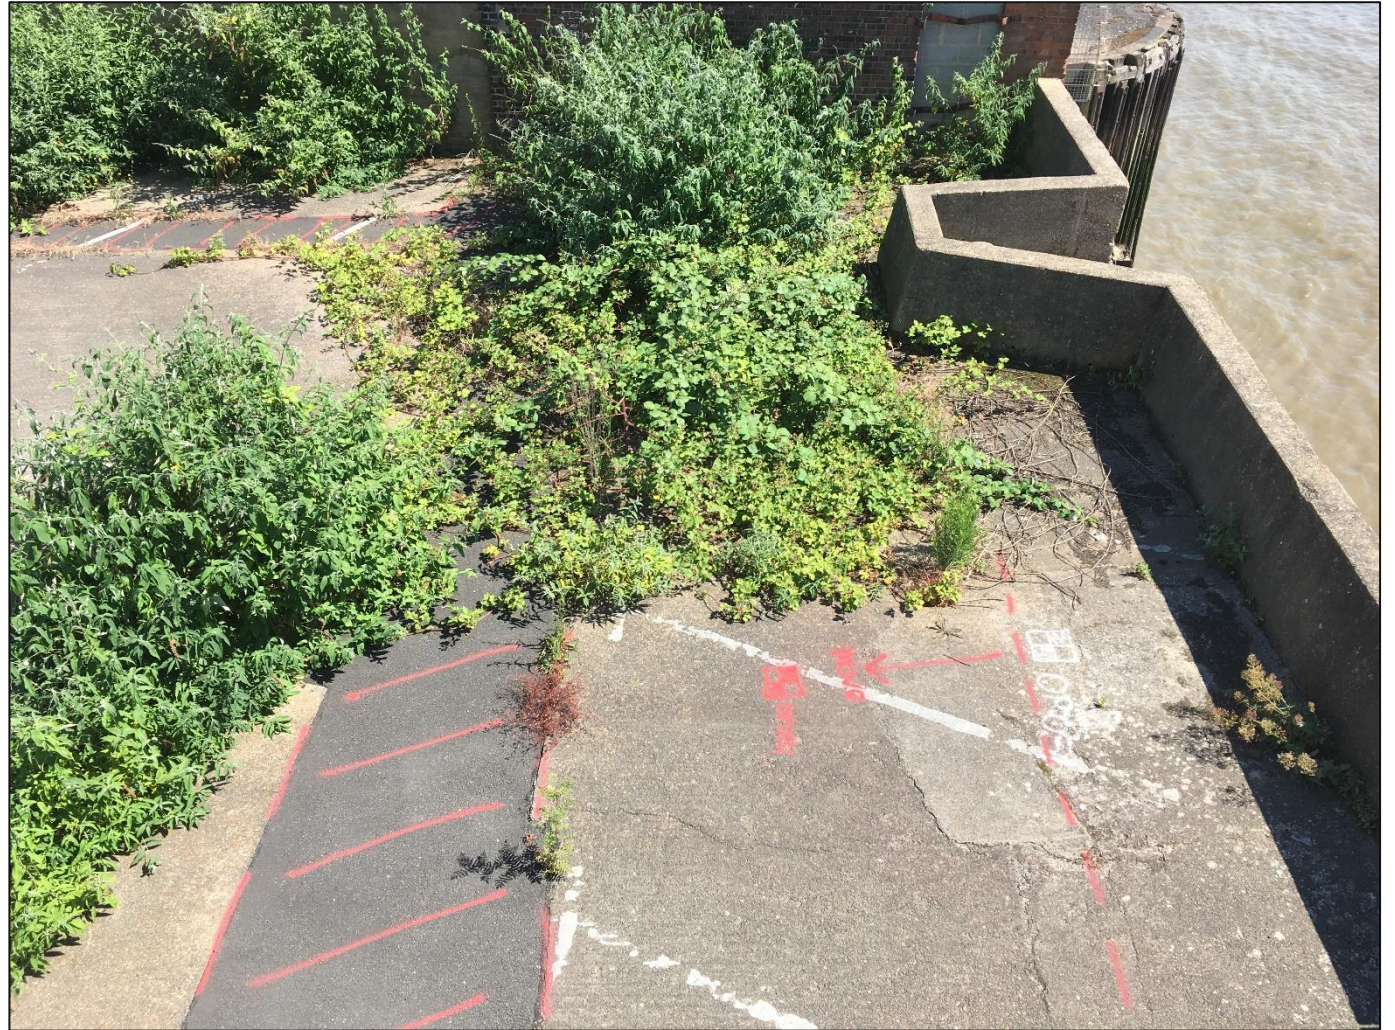
Location 14

Hard standing area – overview of hard standing

- Taken from the upper deck of the TOBS roof terrace.
- No new cracks or other evidence of movement or settlement within concrete hard standing observed.

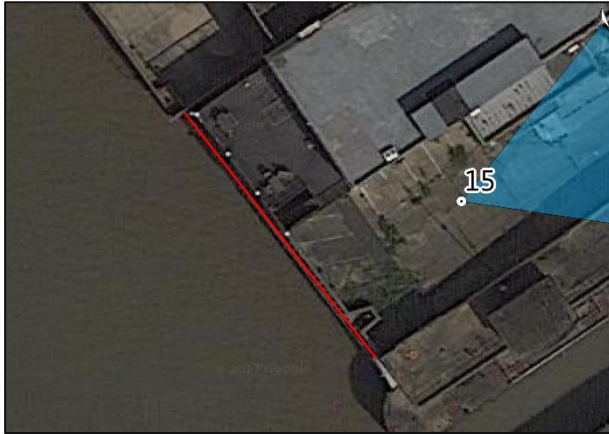
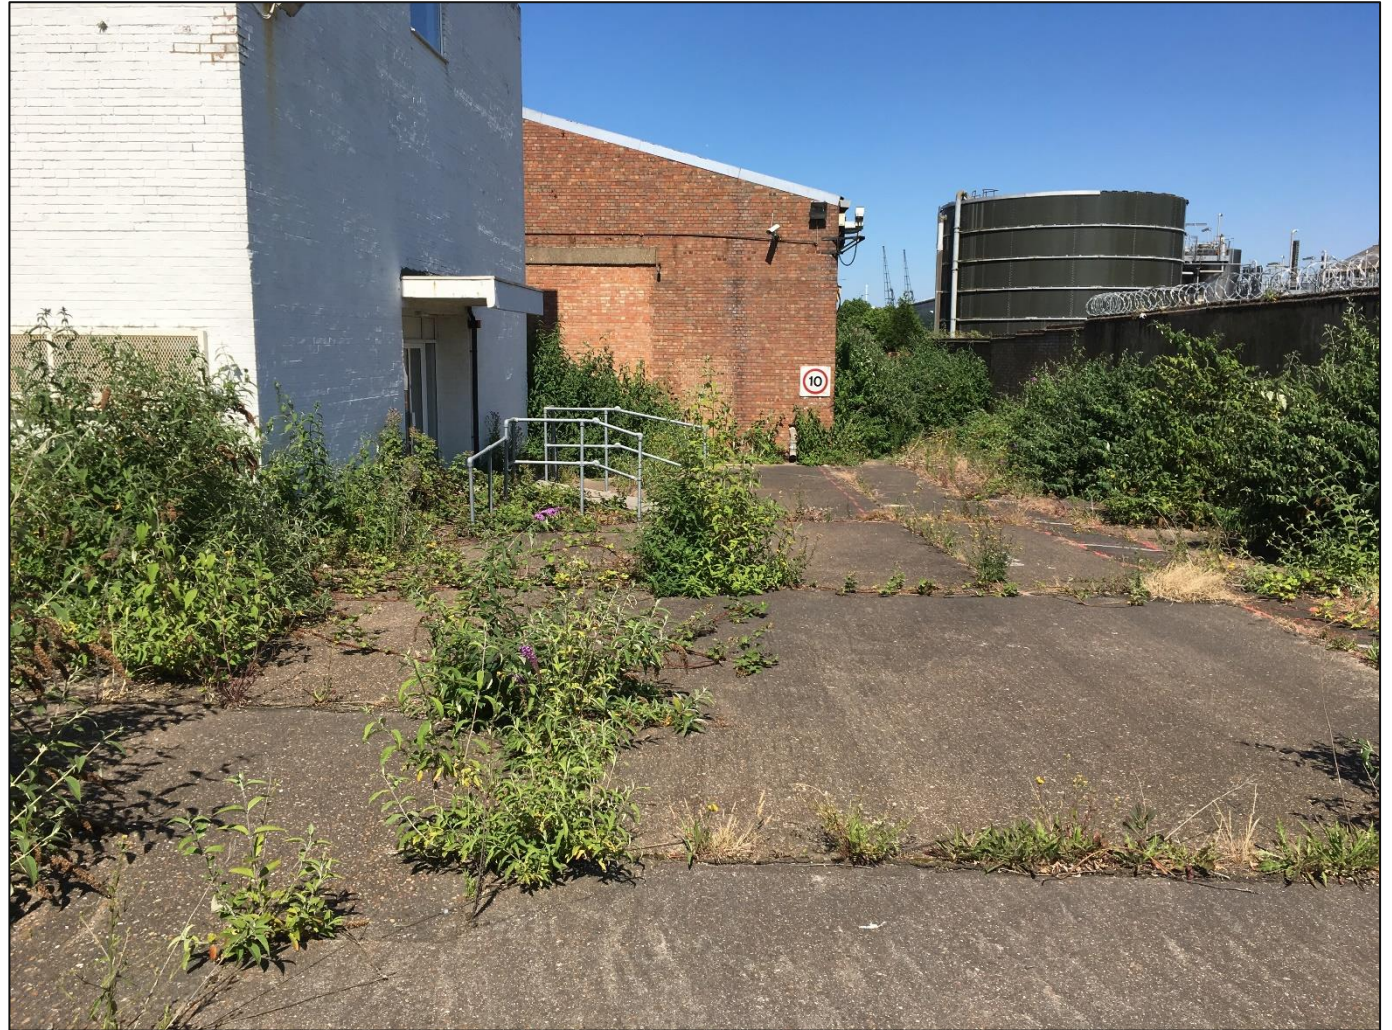
Location 15

Hard standing area – view away from river wall

- No new cracks or other evidence of movement or settlement within concrete hard standing observed.
- Significant vegetation growth since previous inspection on 22nd March 2018.

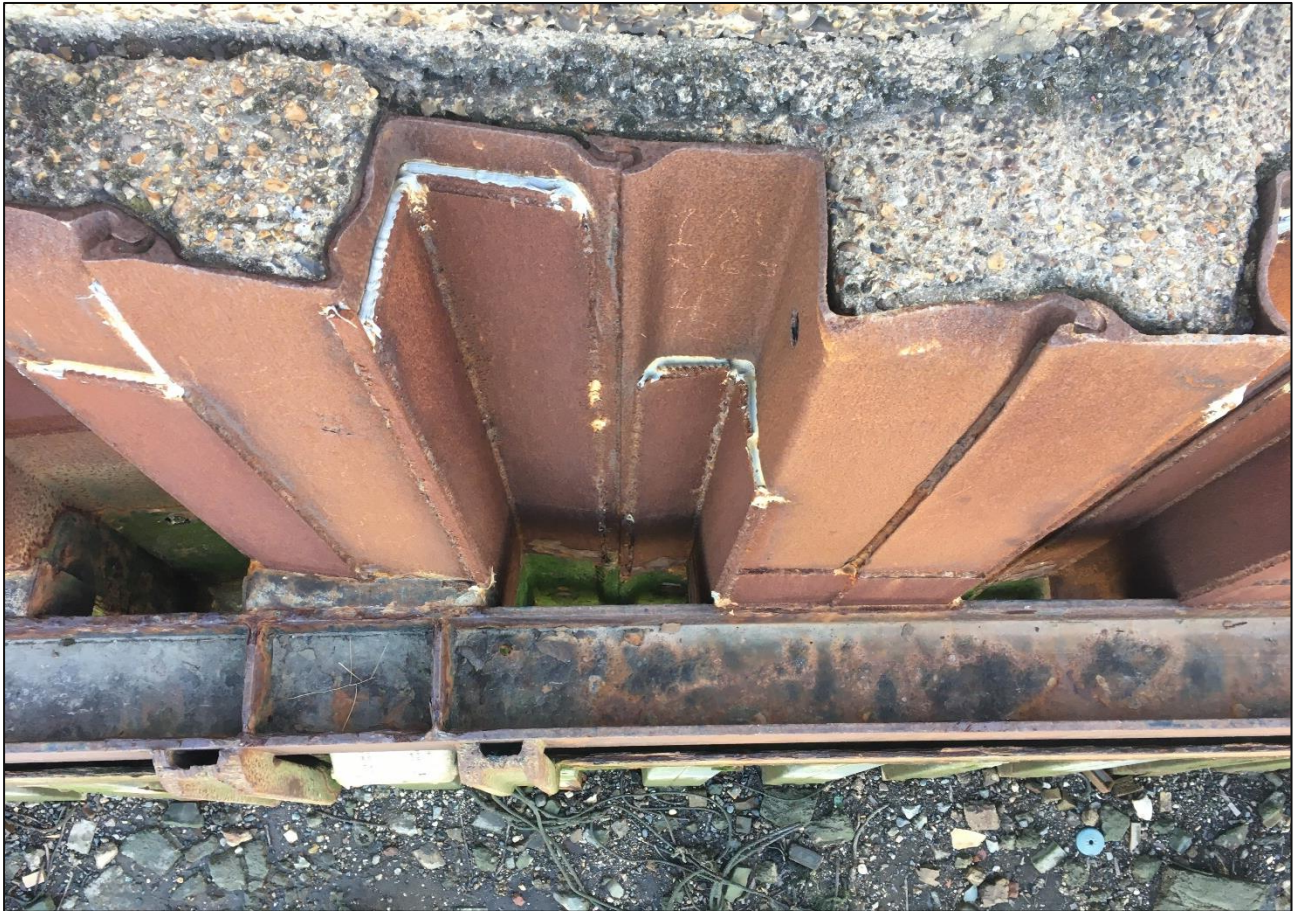
Figure 3.1: Typical photograph of upper level of river wall, showing steel plate repairs to sheet piling, taken from the land side of the river wall

All plate repairs appear to remain securely welded to the existing sheet pile sections and there is no evidence of further degradation of the condition of the remaining steel. Figure 3.1 shows a typical photograph of the upper level of the river wall, showing the steel plate repairs securely welded to the sheet piling.

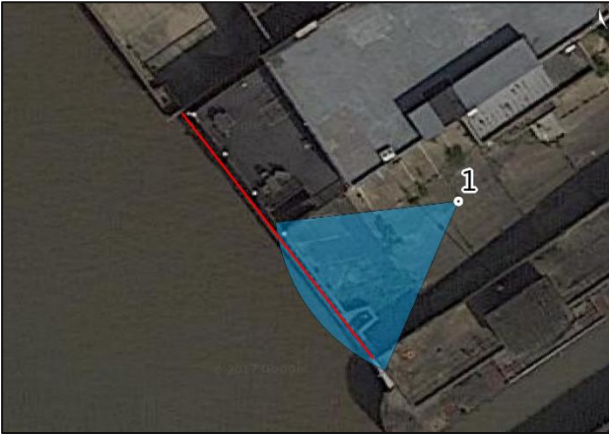
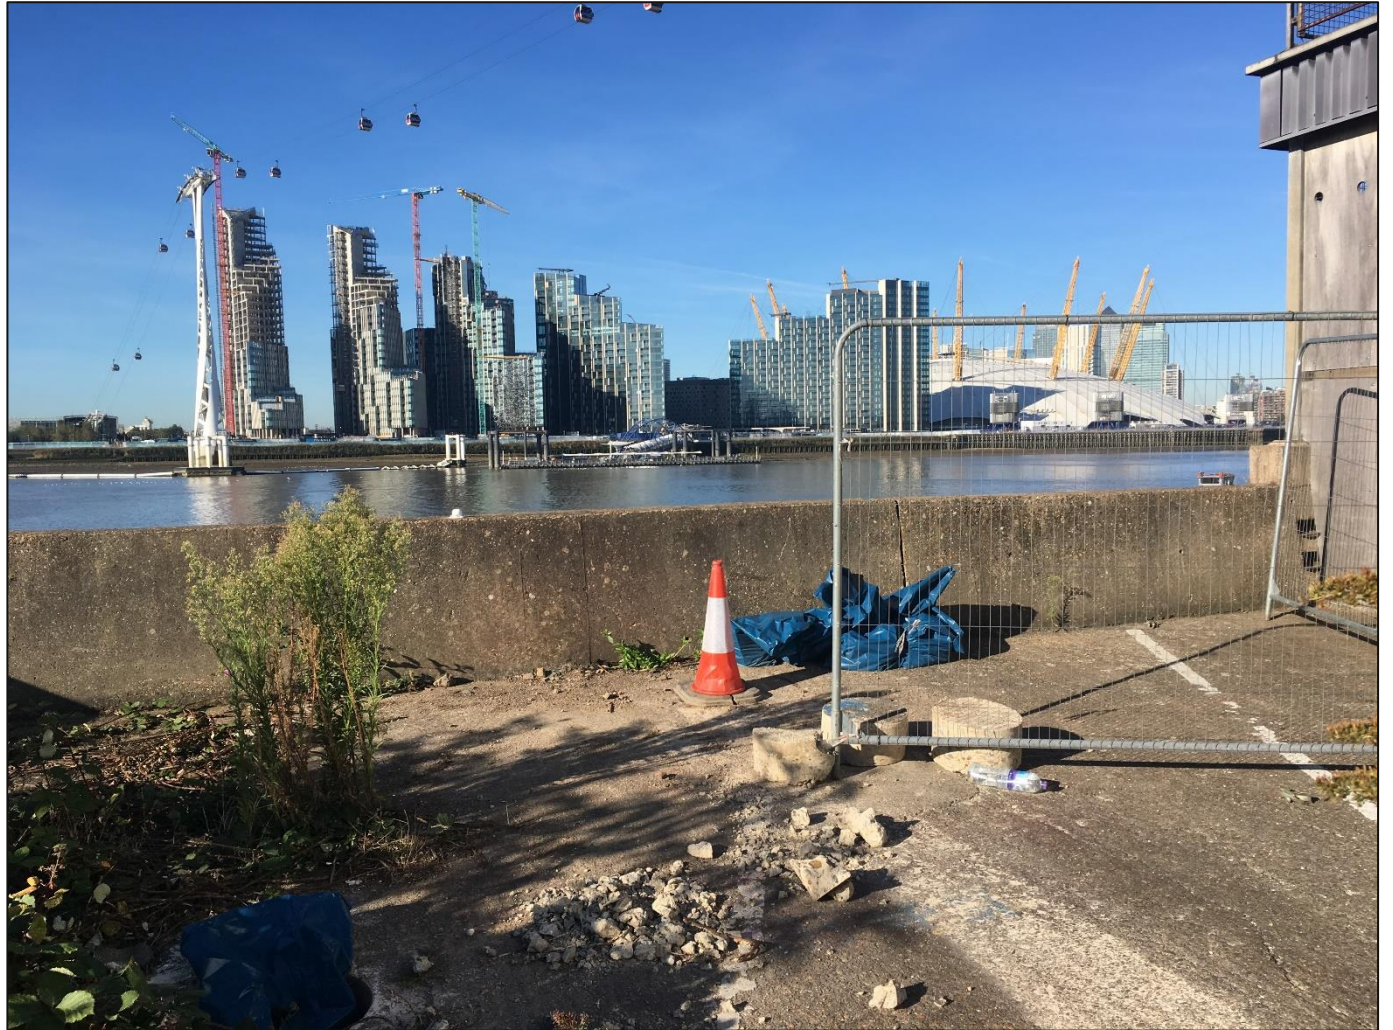
Location 1

Hard standing area – overview of parapet wall

- Hard standing generally in good condition.
- Existing cracks in hard standing previously observed during 23rd February 2017, 19th December 2017, 22nd March 2018 and 25th June 2018 inspections.
- No new cracks observed in concrete parapet wall or concrete hard standing.
- No obvious indications of movement or settlement of parapet wall or hard standing.
- Significant growth of vegetation within concrete hard standing since previous inspection on 25th June 2018.

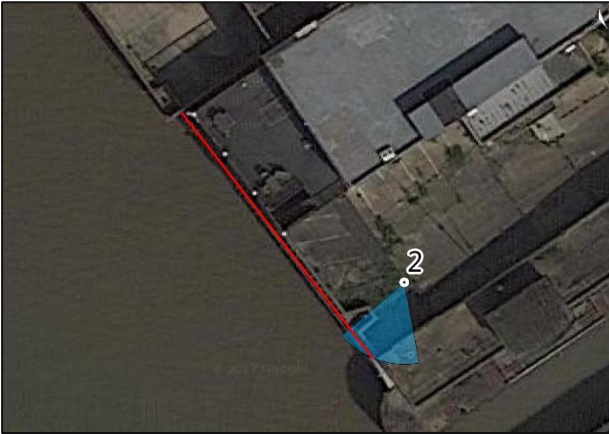
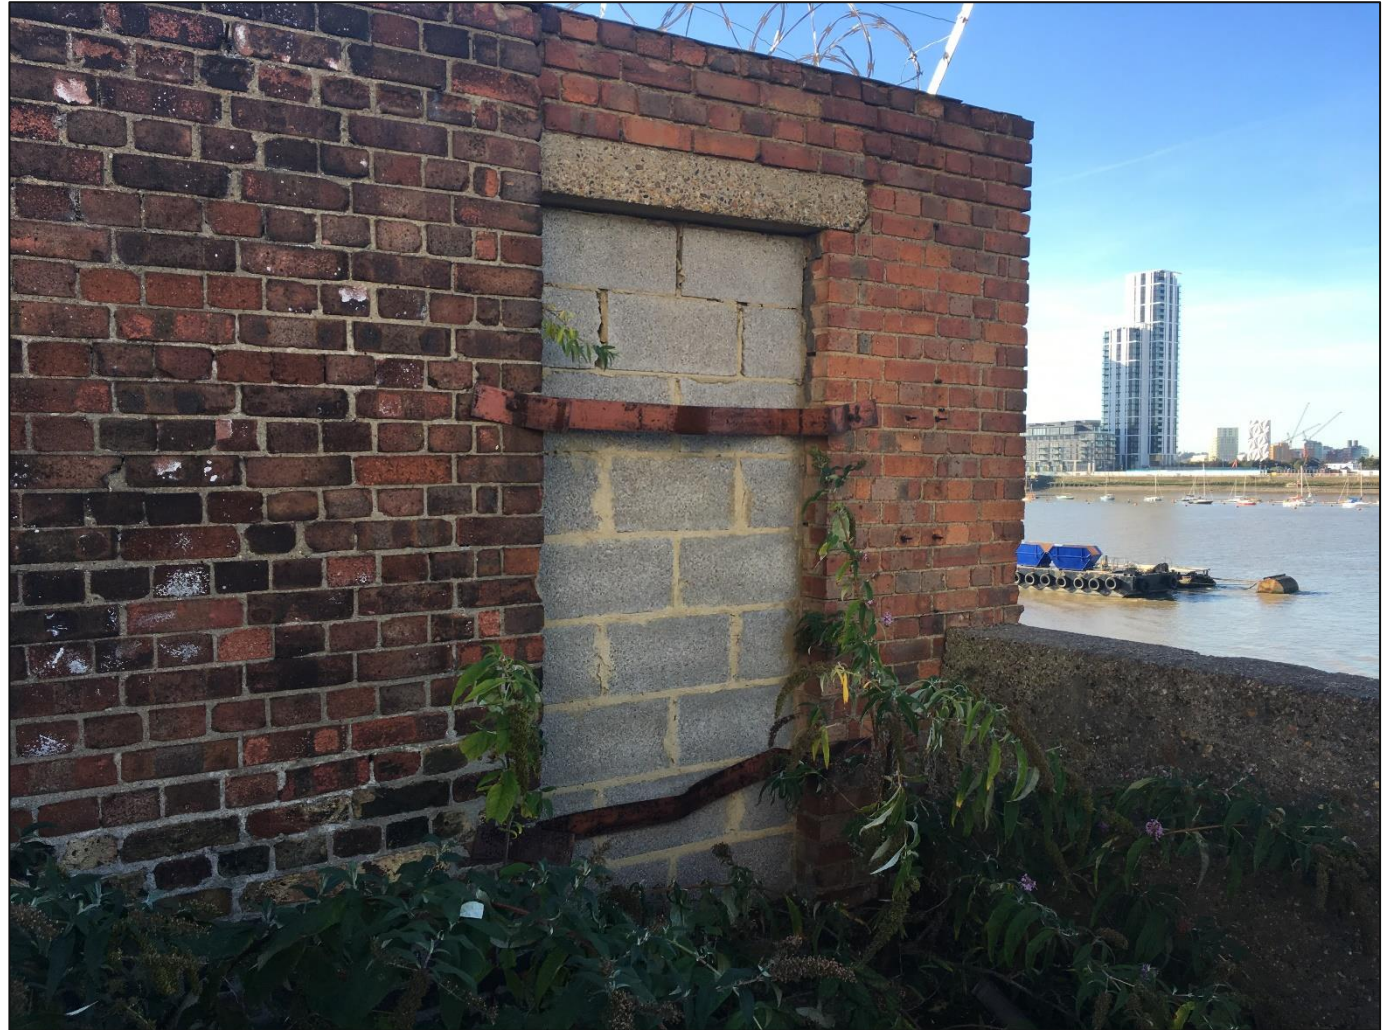
Location 2

Hard standing area – south corner

- Brick wall perpendicular to river wall, at south boundary of Dohm Wharf river wall.
- Existing crack in brick wall unchanged since last inspection. See location 3 for detail.
- No new cracks observed in concrete parapet wall, adjoining red brick wall or concrete hardstanding.
- Significant growth of vegetation within concrete hard standing since previous inspection on 25th June 2018.

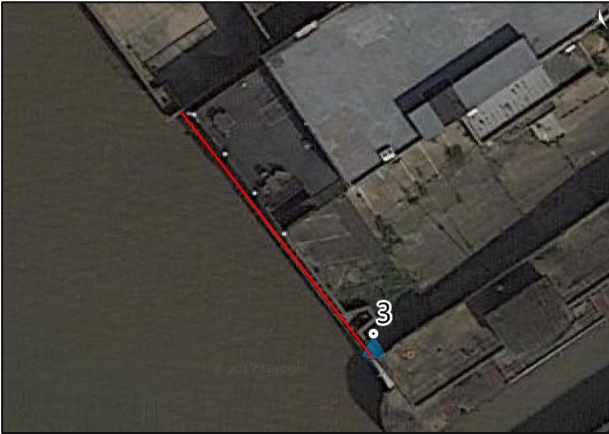
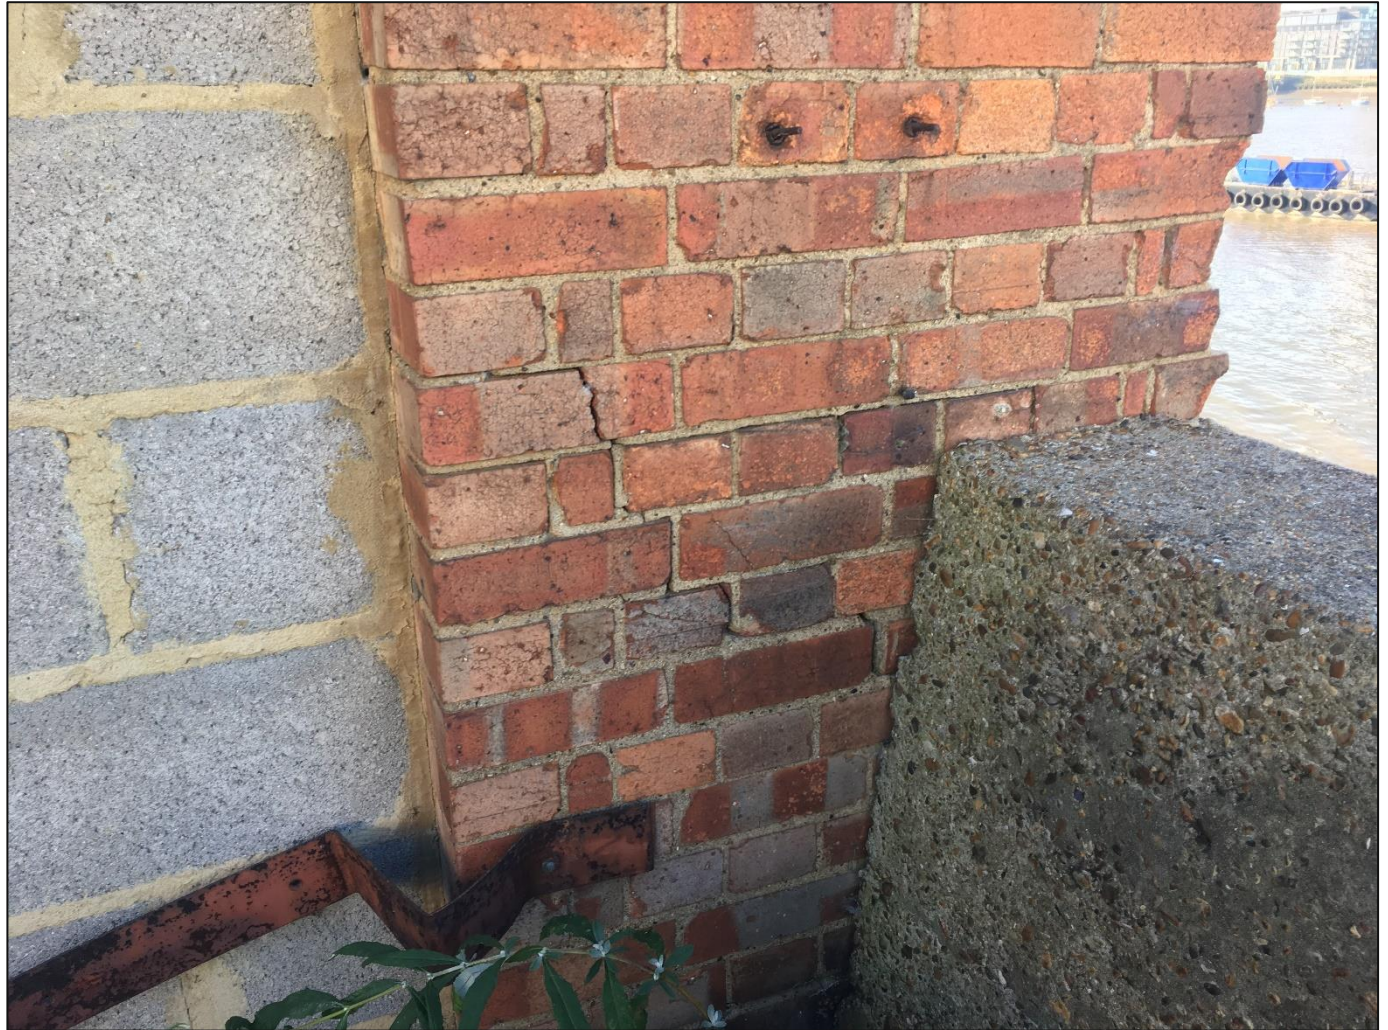
Location 3

Hard standing area – south corner brick wall crack detail

- Brick wall perpendicular to river wall, at south boundary of Dohm Wharf river wall.
- Existing crack in brick wall at approximate level of crest of concrete parapet wall first observed during first inspection on 19th December 2017.
- Extent of crack remains unchanged since 19th December 2017, 22nd March 2018 and 25th June 2018 inspection.
- Crack does not appear to have widened since 19th December 2017, 22nd March 2018 and 25th June 2018 inspection.
- No new cracks observed within brick wall or concrete parapet wall.
- No obvious indications of movement or settlement.

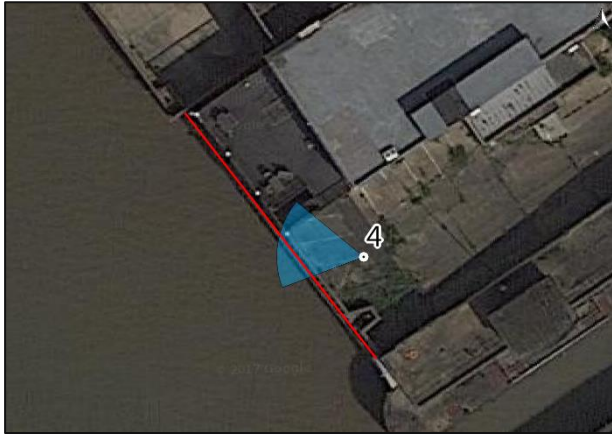
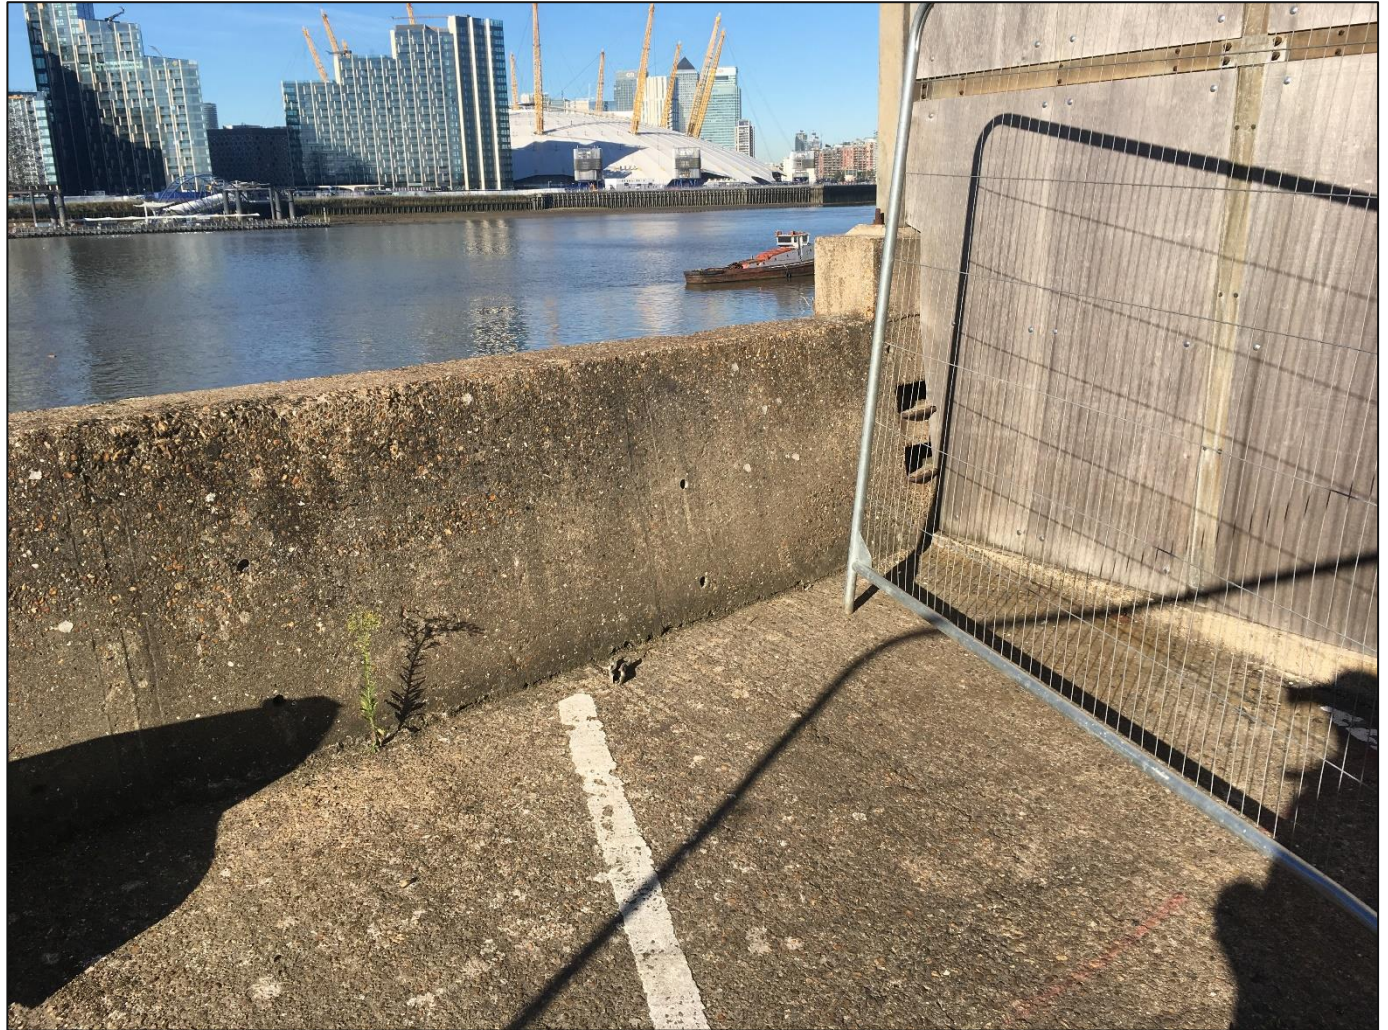
Location 4

Hard standing area – north corner

- No cracks observed in concrete parapet wall or concrete hard standing during first inspection on 19th December 2017.
- No new cracks observed in concrete parapet wall or concrete hard standing.
- No evidence of movement at interface between timber hoarding, concrete parapet wall and concrete hard standing.
- No obvious indications of movement or settlement of parapet wall or hard standing.

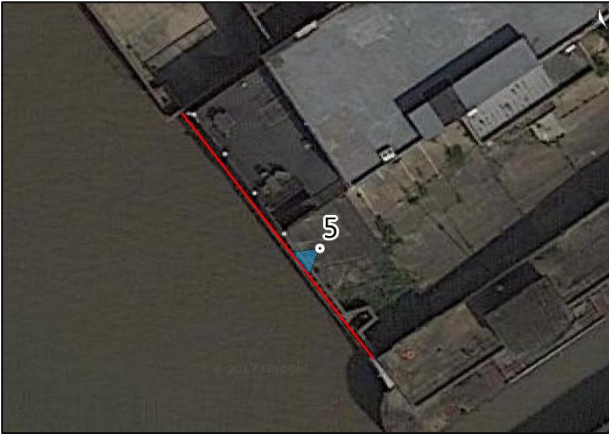
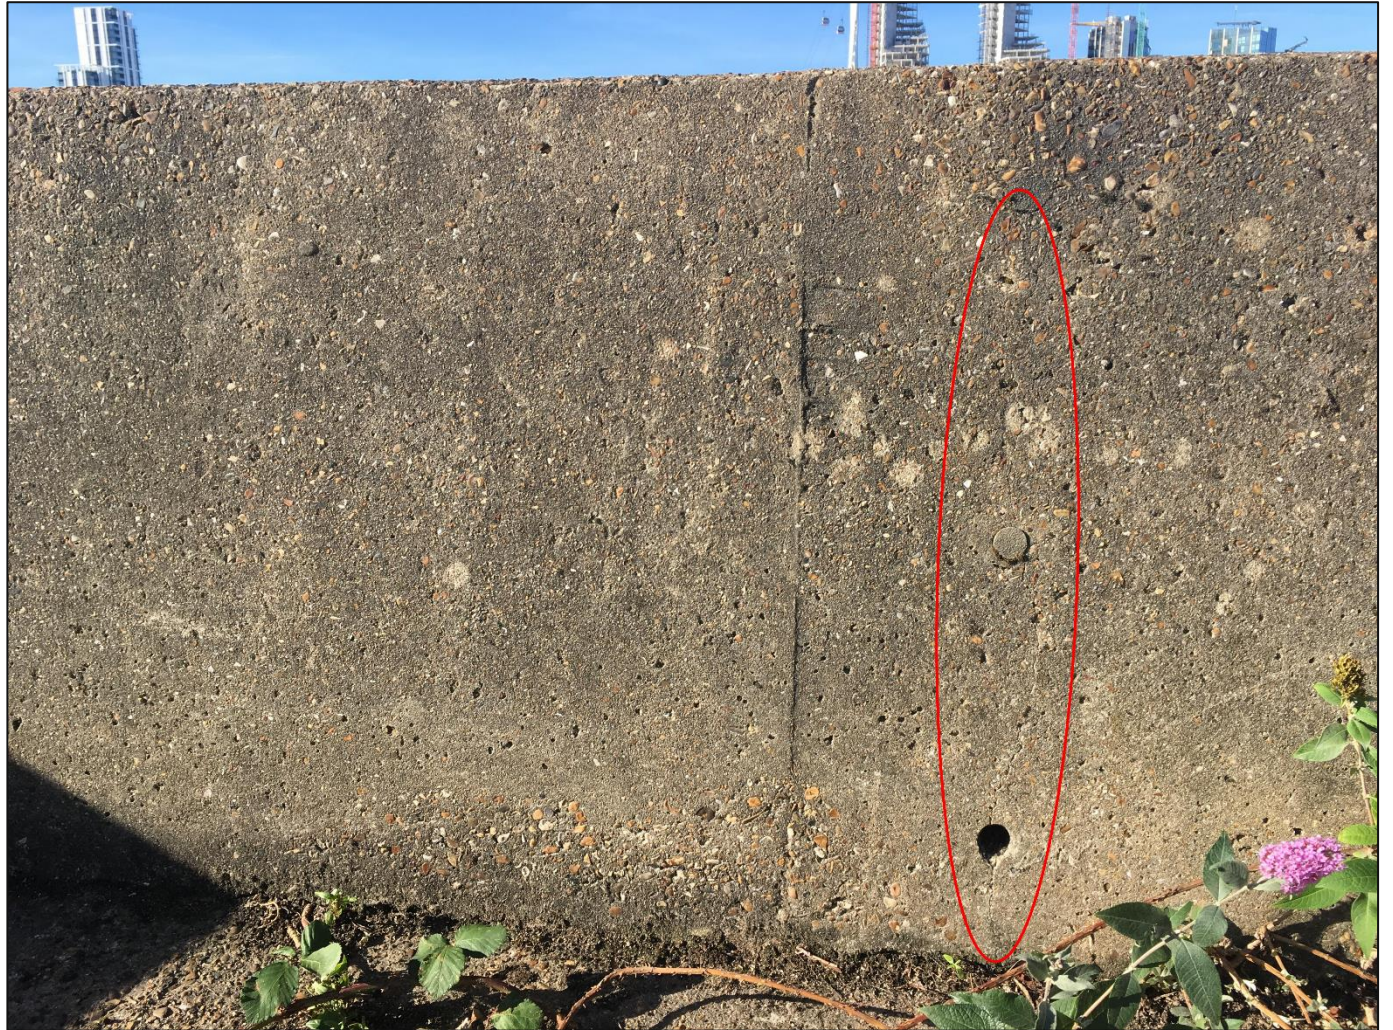
Location 5

Hard standing area – crack in parapet wall

- Existing hairline crack in concrete parapet wall first observed during first inspection on 19th December 2017.
- Crack originates through penetration in wall, assumed to be a construction defect rather than caused by movement of the river wall.
- No new cracks observed in concrete parapet wall or concrete hard standing.
- No evidence of movement since previous inspection on 25th June 2018.

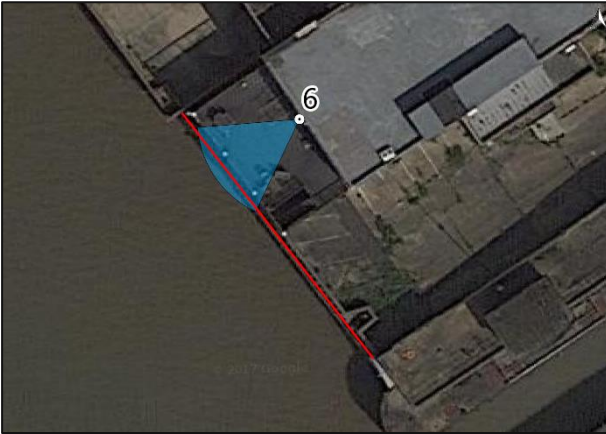
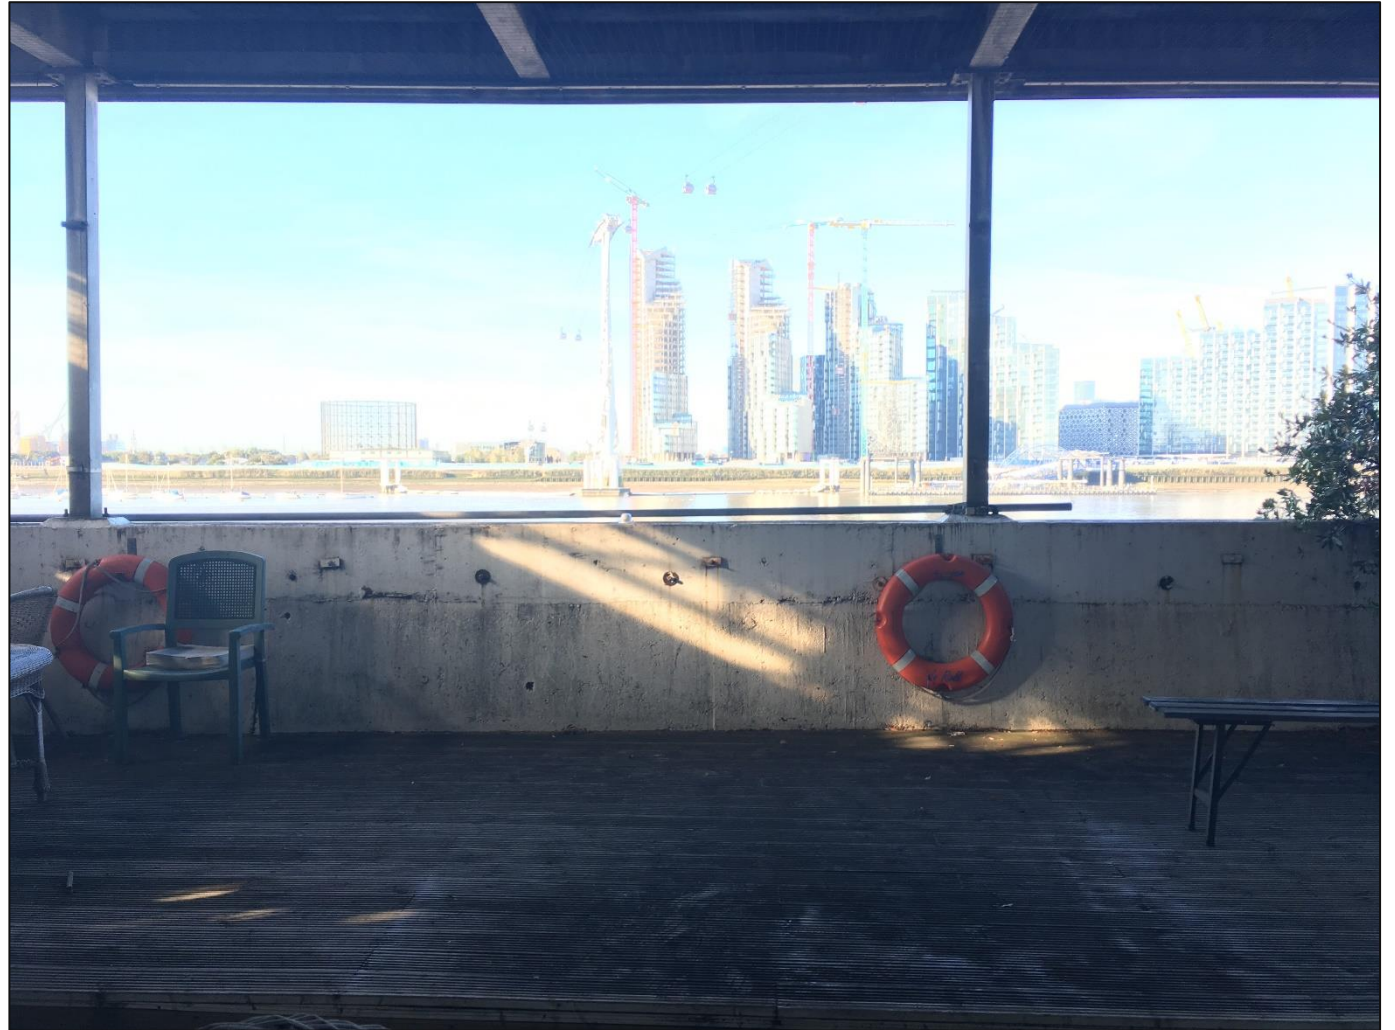
Location 6

TOBS terrace area – overview of parapet wall

- No new cracks observed in concrete parapet wall.
- Inspection of ground behind parapet wall prevented by presence of timber deck.
- No obvious indications of movement or settlement.
- Sensor fixed to concrete parapet wall, also presumed to have been installed by TfL as part of Silvertown Tunnel works.

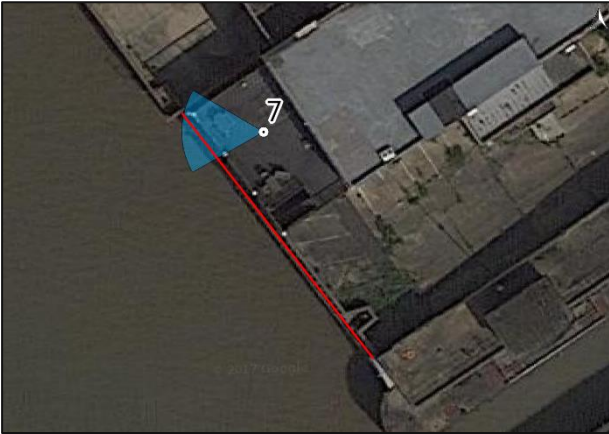
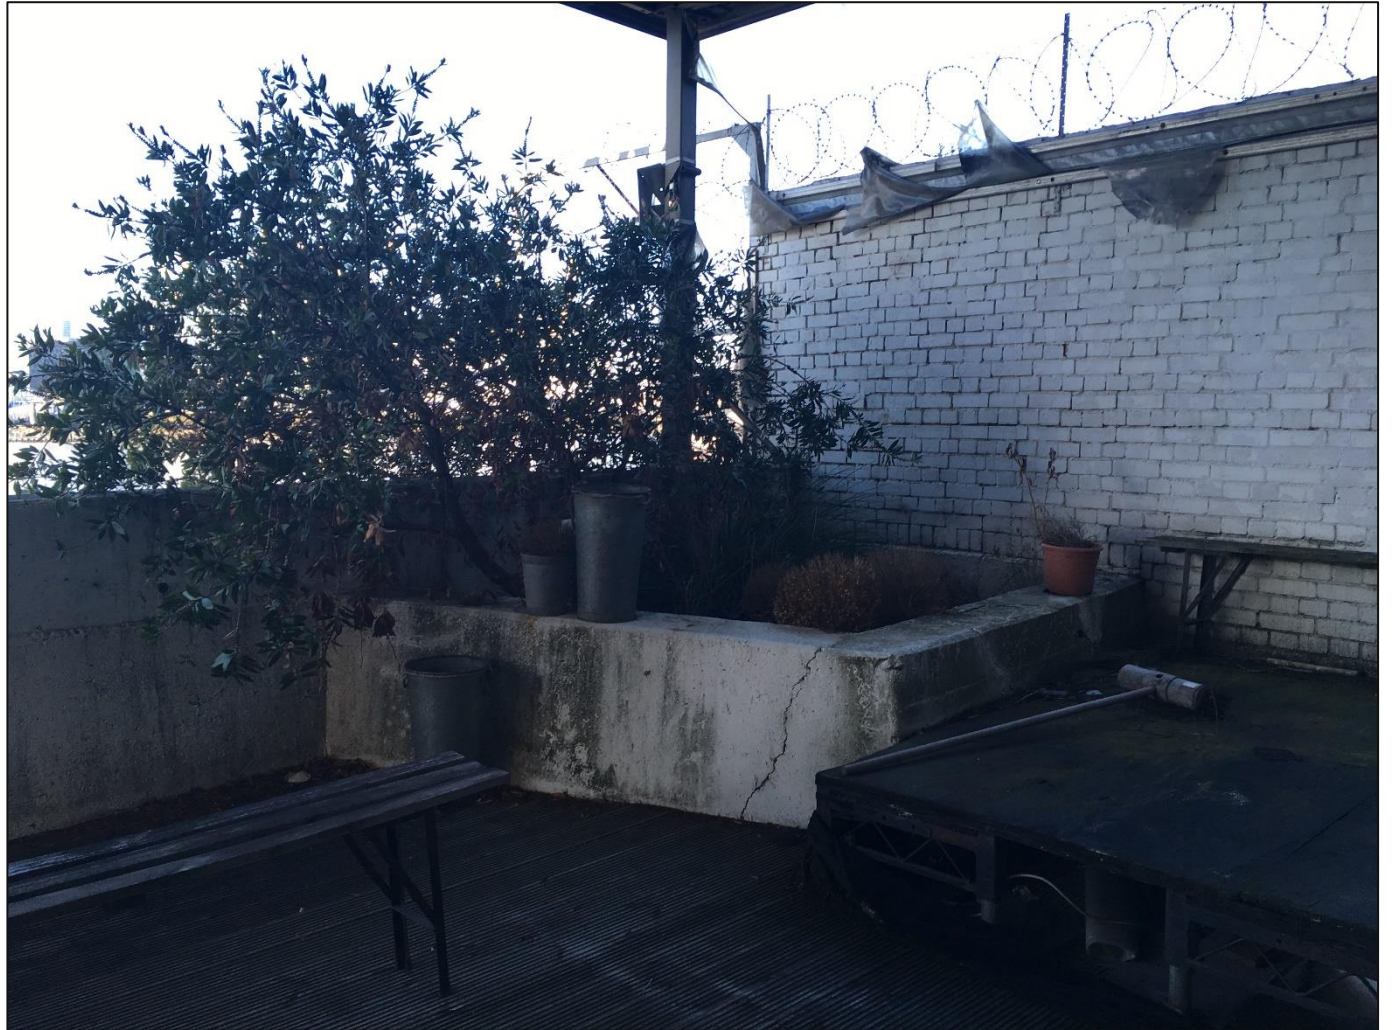
Location 7

TOBS terrace area – north corner

- Existing crack in wall of concrete planter first observed during first inspection on 19th December 2017. See location 8 for detail.
- No new cracks observed in concrete parapet wall or adjoining brick wall.
- No obvious indications of movement or settlement.

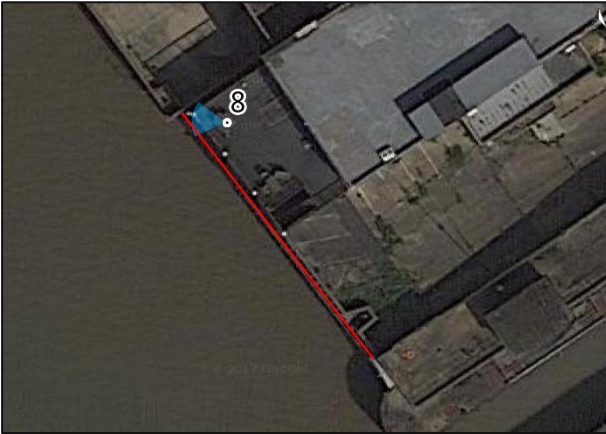
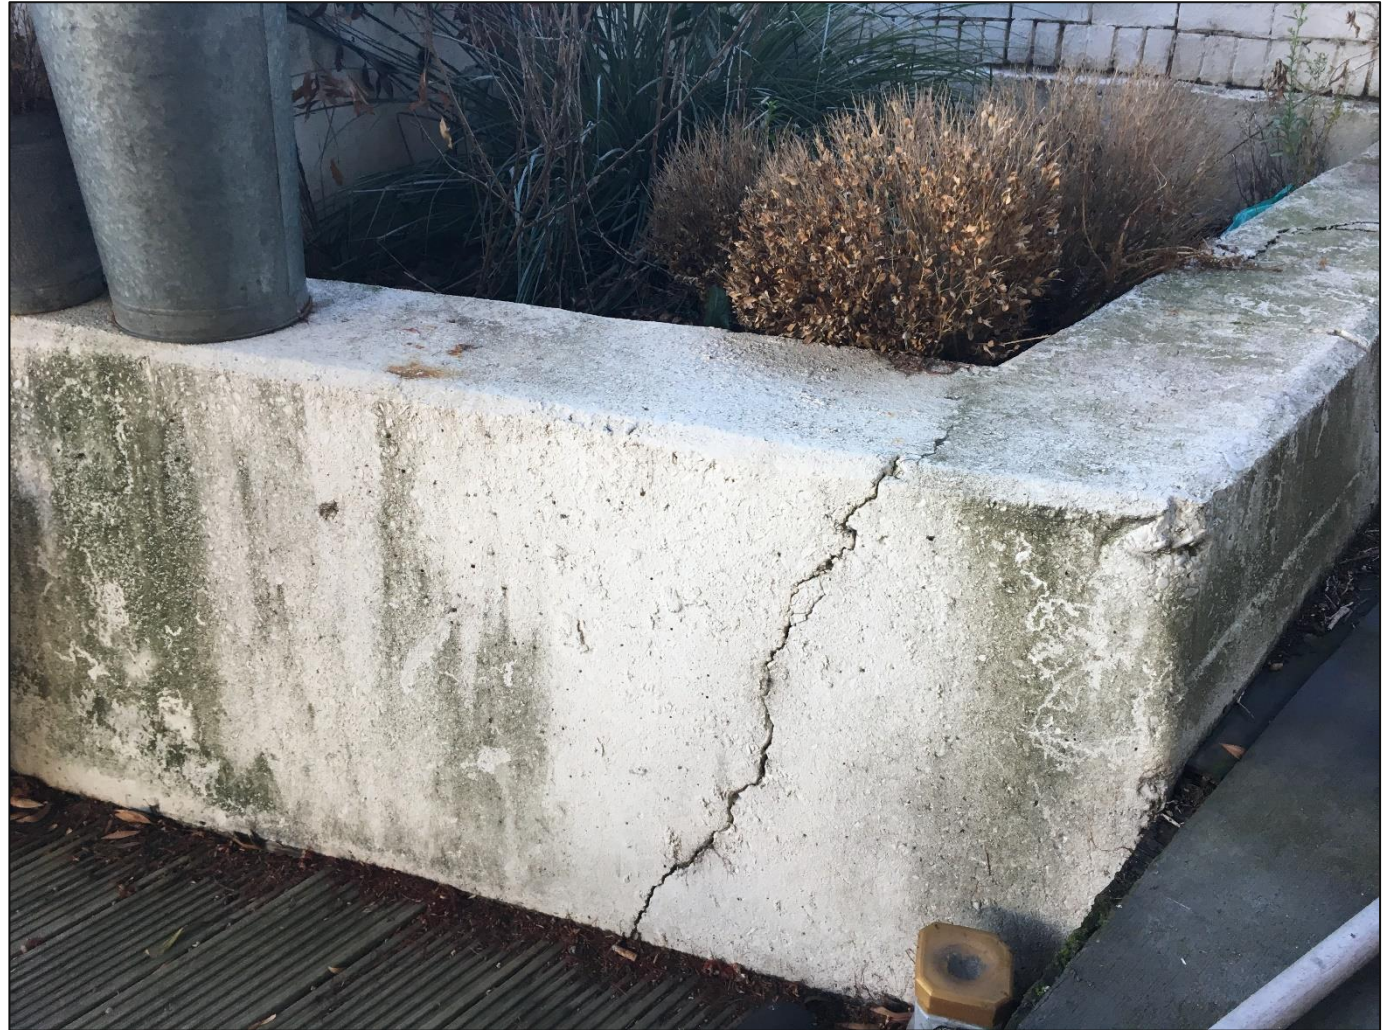
Location 8

TOBS terrace area – north corner planter crack detail

- Existing crack in wall of concrete planter first observed during first inspection on 19th December 2017.
- Extent of crack remains unchanged since last inspection.
- No evidence to indicate that crack has widened since last inspection.
- No new cracks observed in wall of concrete planter.

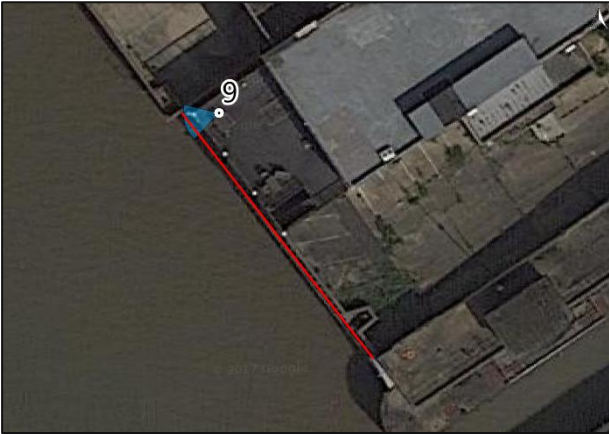
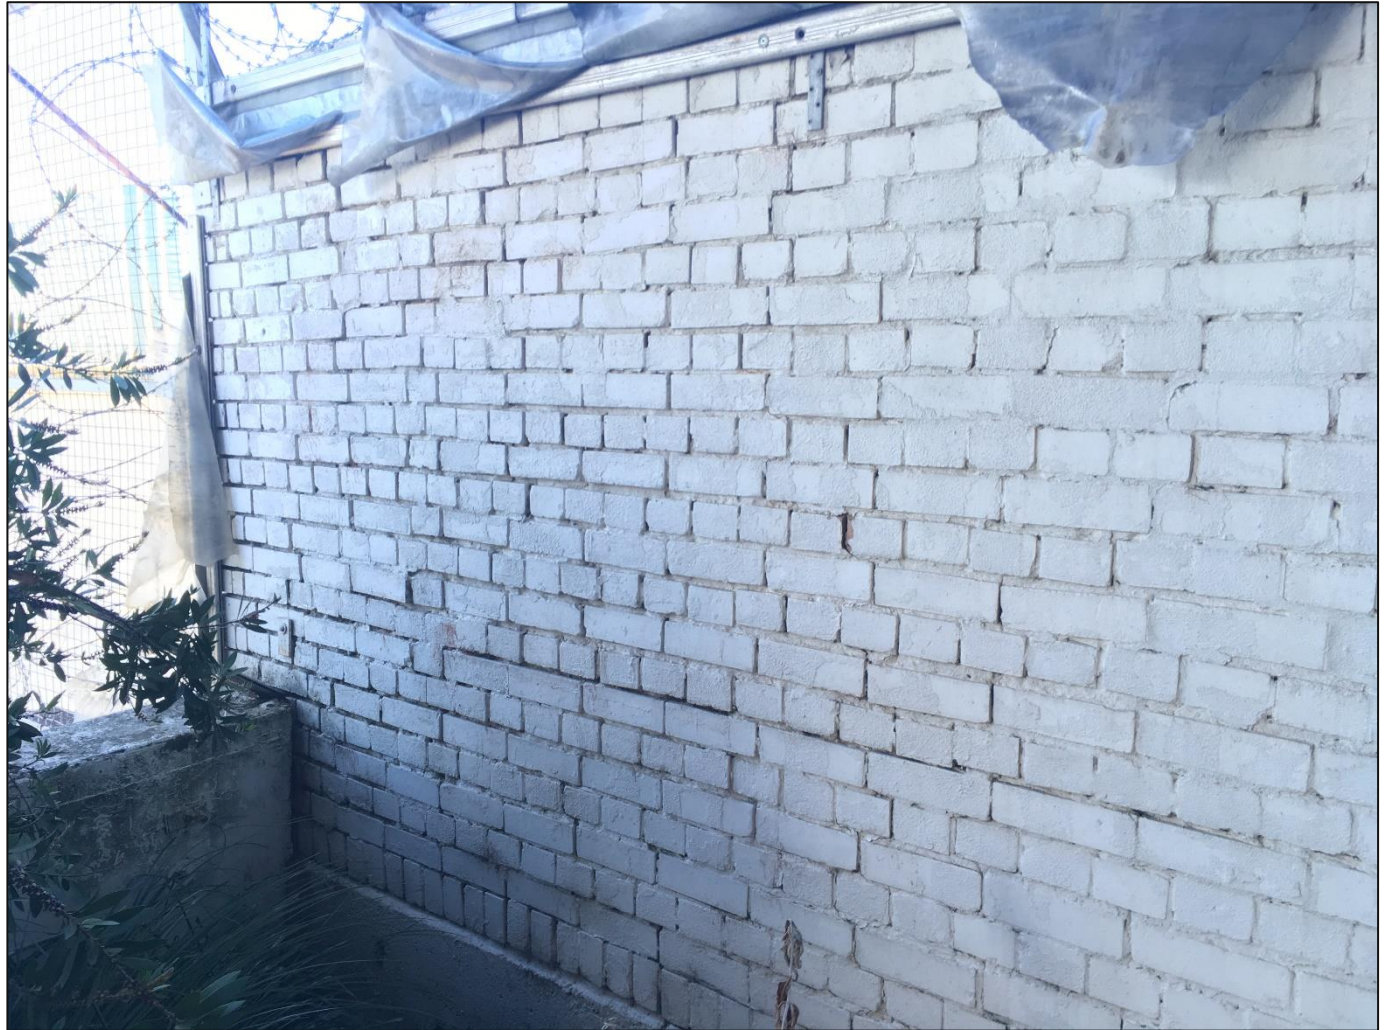
Location 9

TOBS terrace area – north cornered brick wall detail

- Adjoining brick wall at north boundary of Dohm Wharf river wall.
- Existing minor crack along horizontal mortar joints in brick wall first observed during first inspection on 19th December 2017.
- No evidence to indicate that crack has widened or extended since last inspection.
- No new cracks observed in brick wall.
- Note that condition of mortar is poor in places.
