Technical Note

Project Thames Side West

Subject Dohm Wharf River Wall Quarterly Inspection – September 2018

Date 28 September 2018

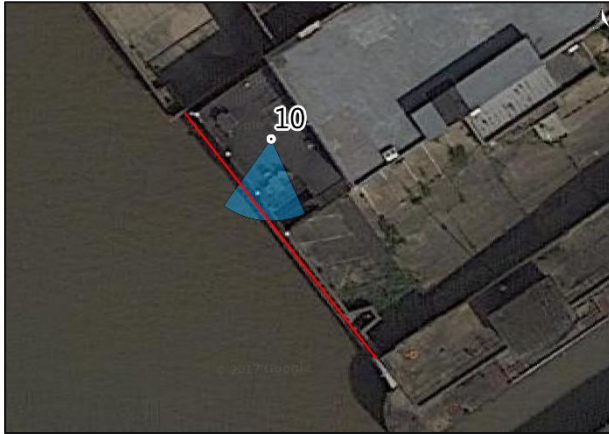
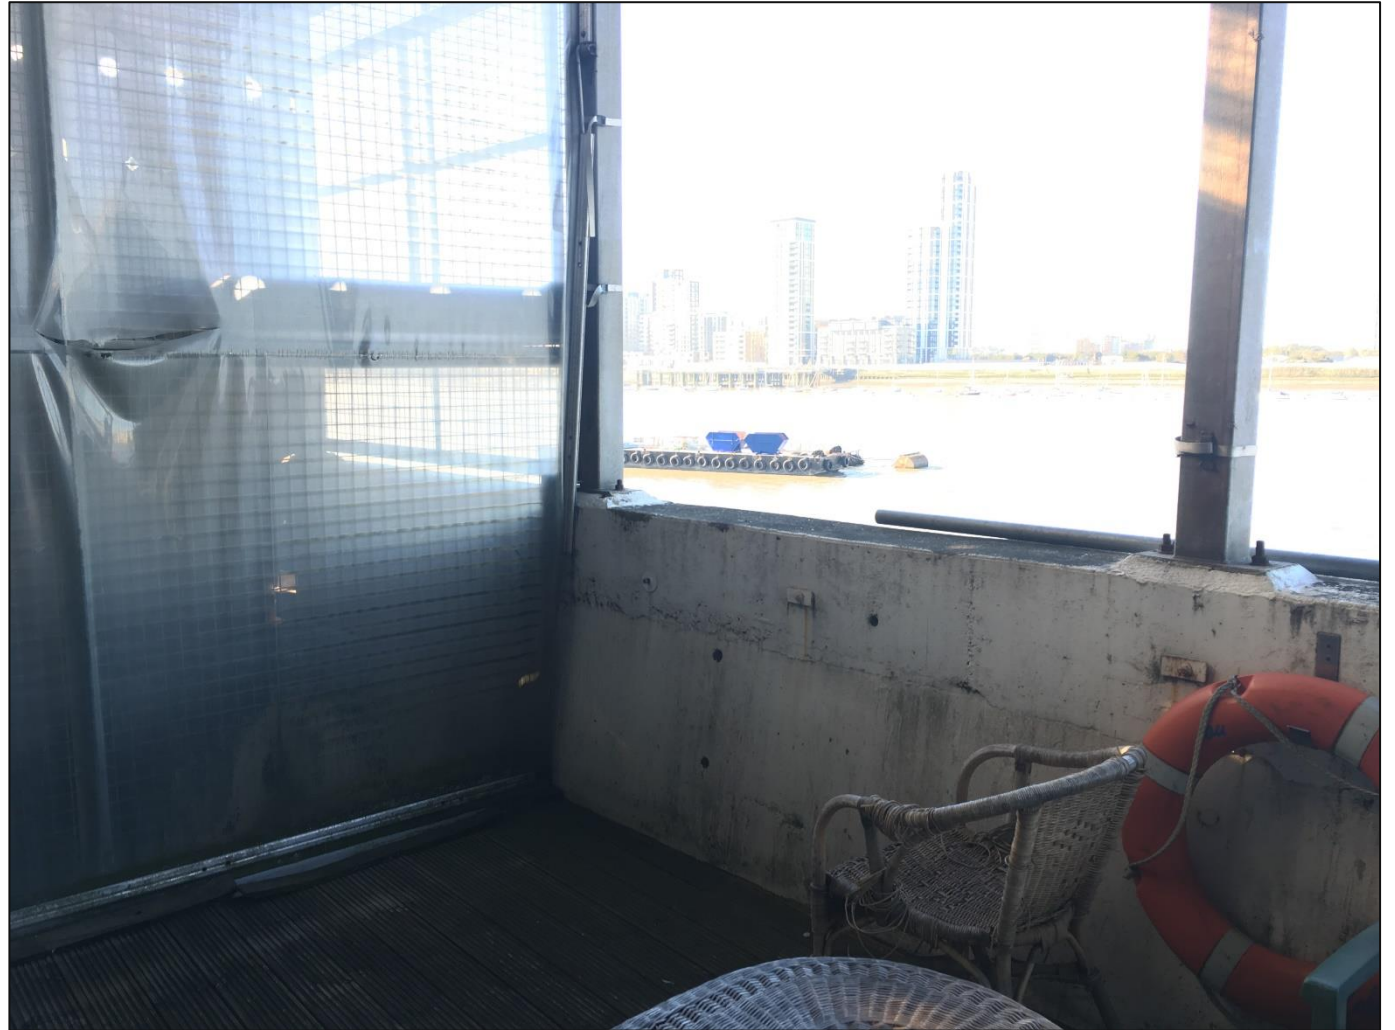
Location 10

TOBS terrace area – south corner

- No new cracks observed in concrete parapet wall.
- No obvious indications of movement or settlement.

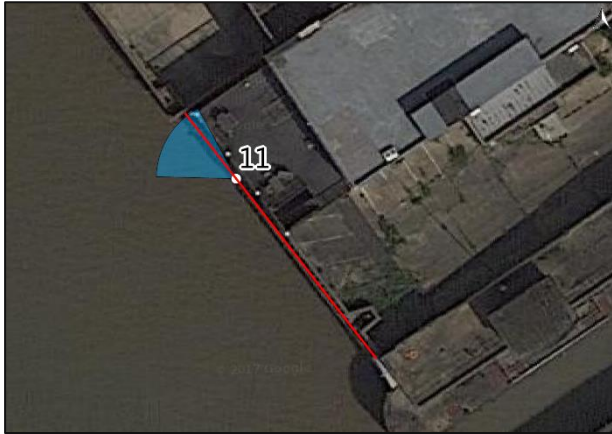
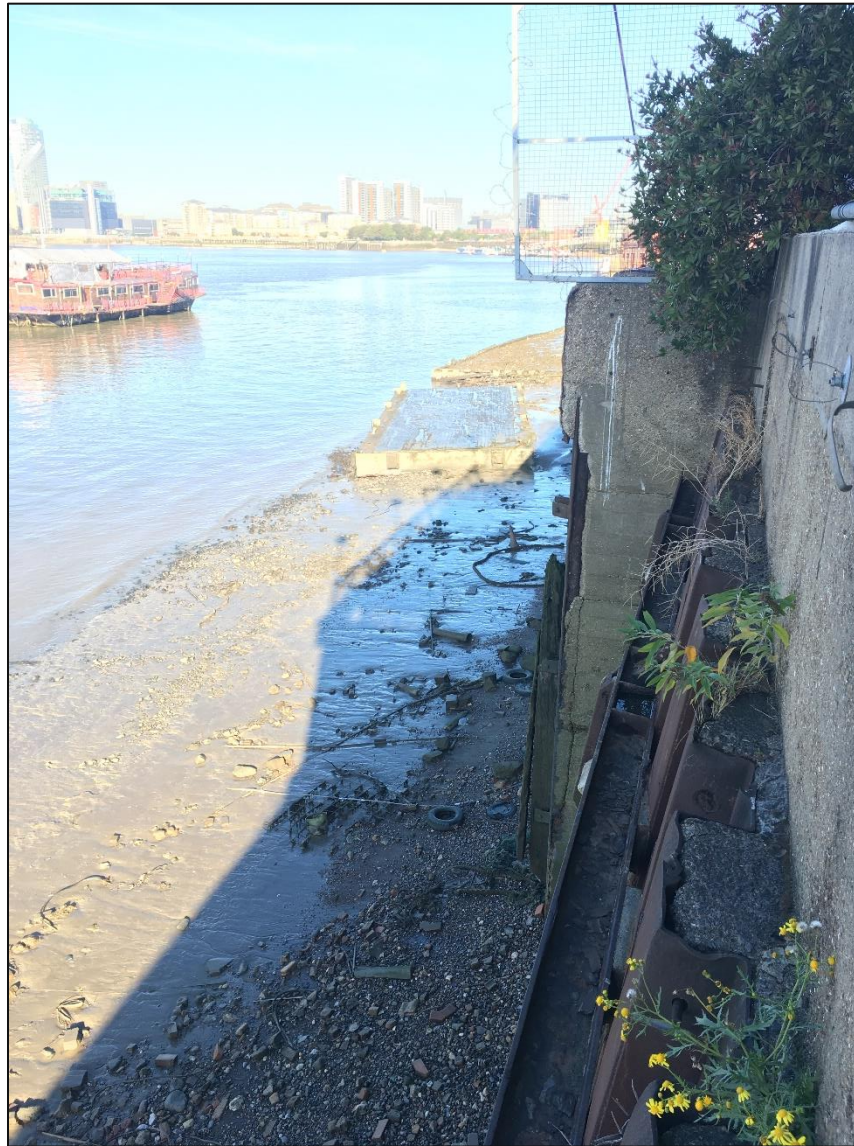
Location 11

TOBS terrace area – end face of adjacent wall to north

- Adjoining river wall to north steps out from alignment of Dohm Wharf river wall.
- Reinforcement within concrete face of adjoining river wall exposed, first observed during first inspection on 19th December 2017. No obvious deterioration since last visit on 25th June 2018.
- No evidence of movement at interface between two river walls.

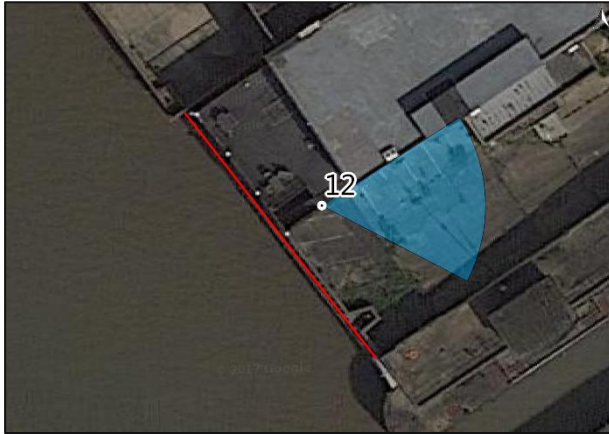
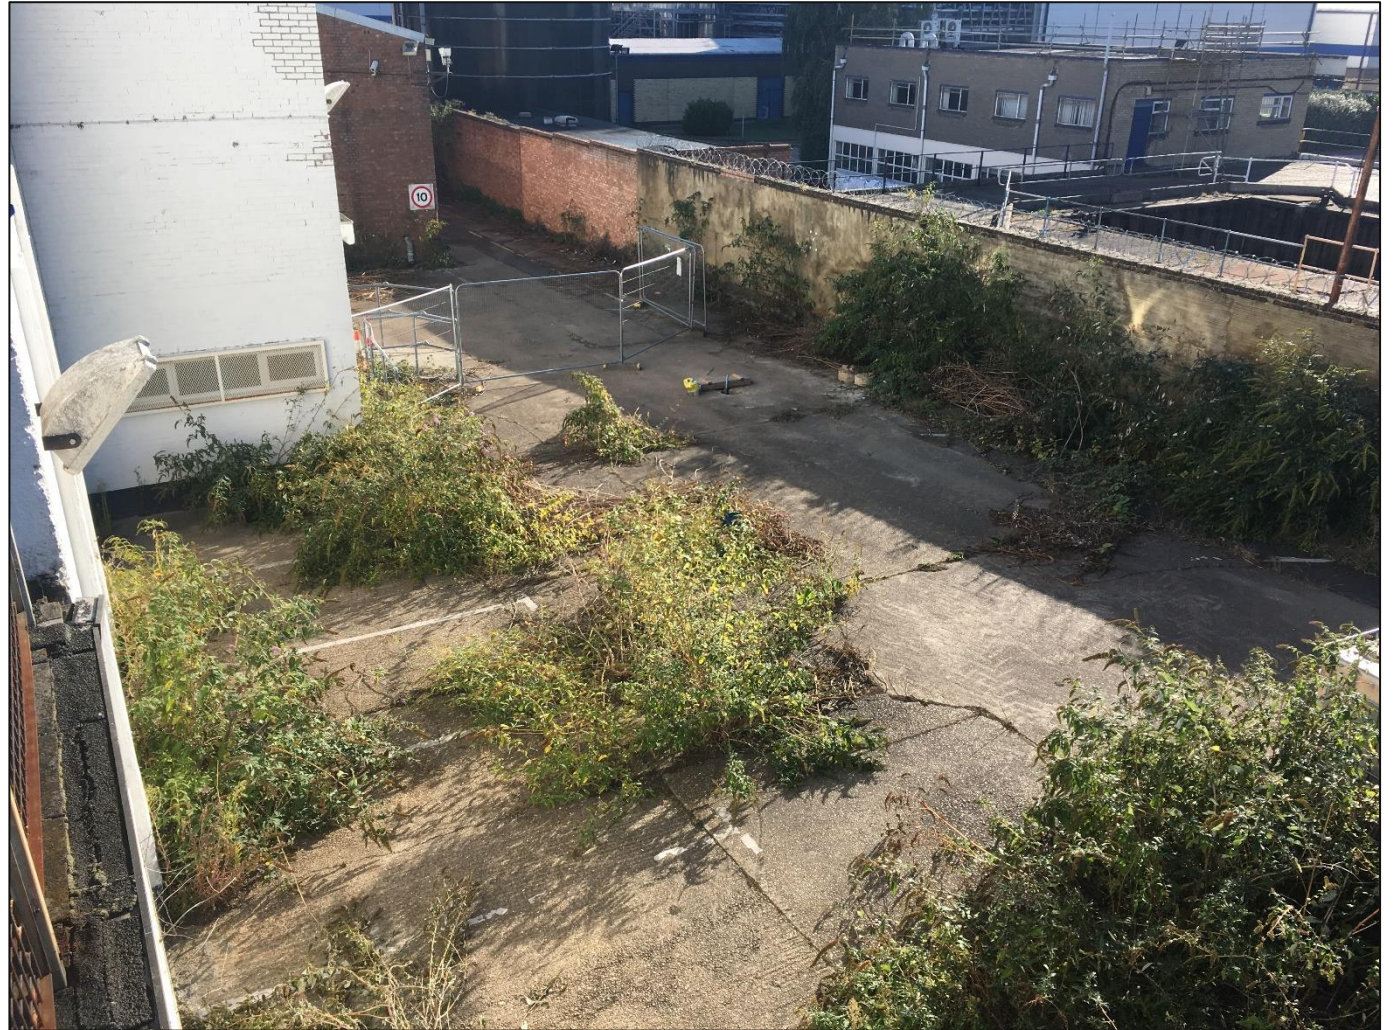
Location 12

Hard standing area – overview of hard standing

- Taken from the upper deck of the TOBS roof terrace.
- Existing cracks in concrete hard standing first observed during first inspection on 19th December 2017.
- No new cracks or other evidence of movement or settlement within concrete hard standing observed.
- Borehole within concrete hardstanding, containing monitoring equipment. Presumed to be part of site investigation works by TfL for the Silvertown Tunnel.

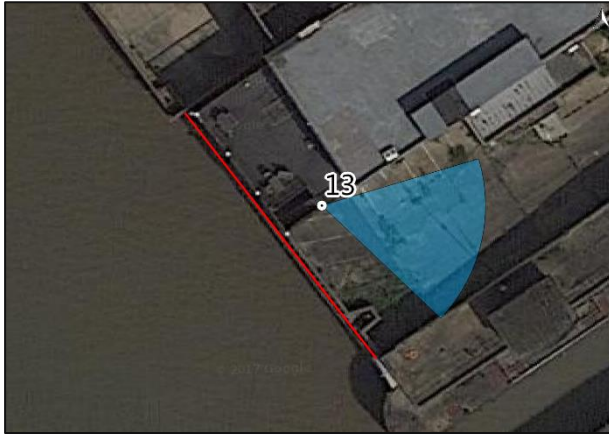
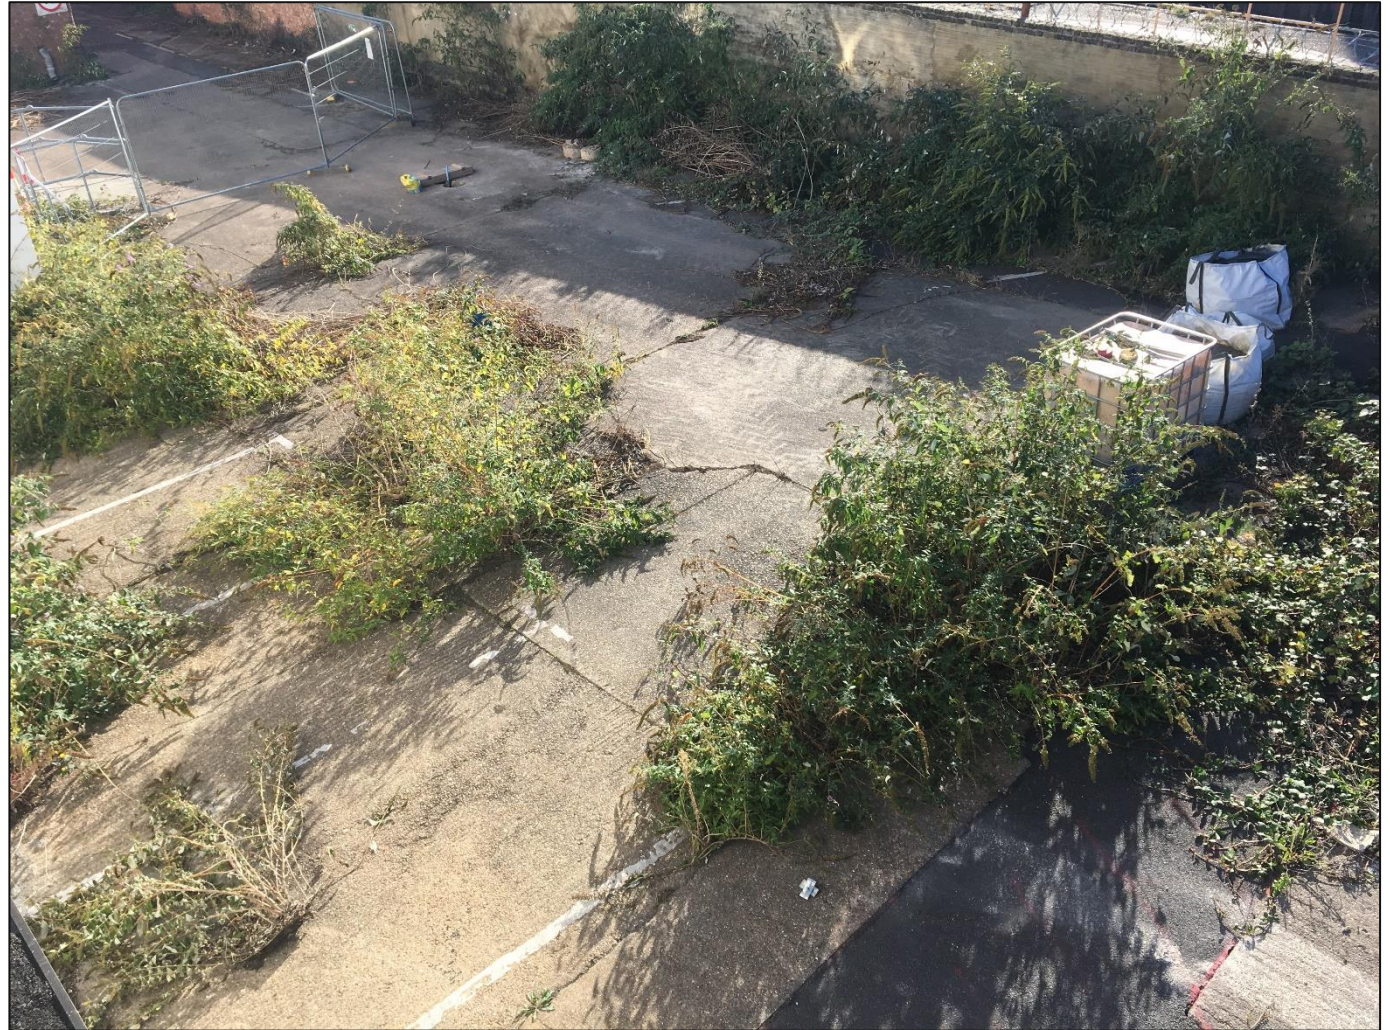
Location 13

Hard standing area – overview of hard standing

- Taken from the upper deck of the TOBS roof terrace.
- Existing cracks in concrete hard standing first observed during first inspection on 19th December 2017.
- No new cracks or other evidence of movement or settlement within concrete hard standing observed.
- Significant vegetation growth since previous inspection.
- Borehole within concrete hardstanding, containing monitoring equipment. Presumed to be part of site investigation works by TfL for the Silvertown Tunnel.

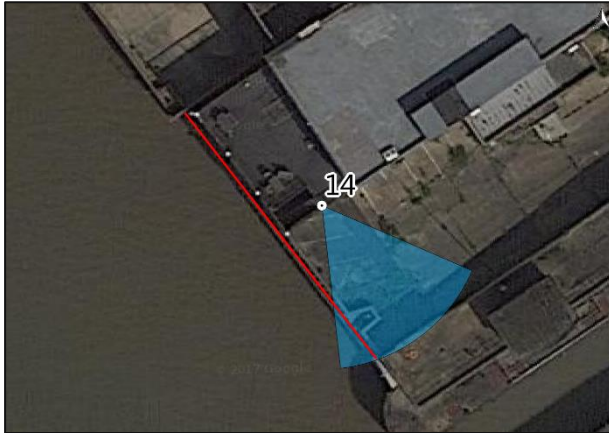
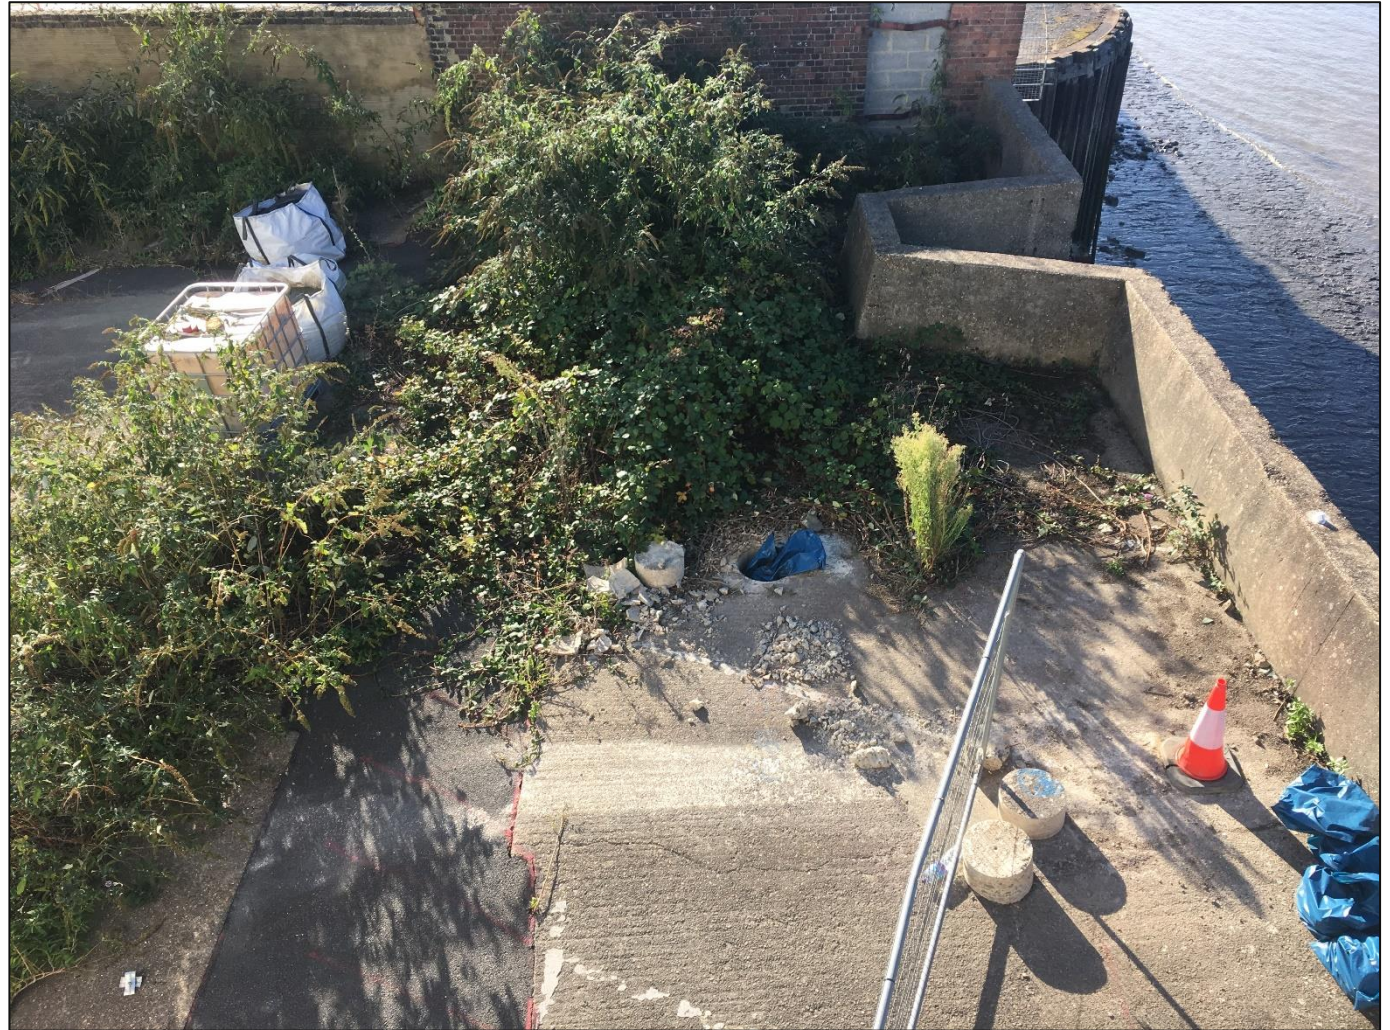
Location 14

Hard standing area – overview of hard standing

- Taken from the upper deck of the TOBS roof terrace.
- Existing cracks in concrete hard standing first observed during first inspection on 19th December 2017.
- No new cracks or other evidence of movement or settlement within concrete hard standing observed.
- Significant vegetation growth since previous inspection.
- Borehole within concrete hardstanding approx. 2m from face of river wall. No monitoring equipment present within borehole. Presumed to be part of site investigation works by TfL for the Silvertown Tunnel.
- Sensor fixed to concrete parapet wall, also presumed to have been installed by TfL as part of Silvertown Tunnel works.
