Thameside West

River Wall Structural Survey

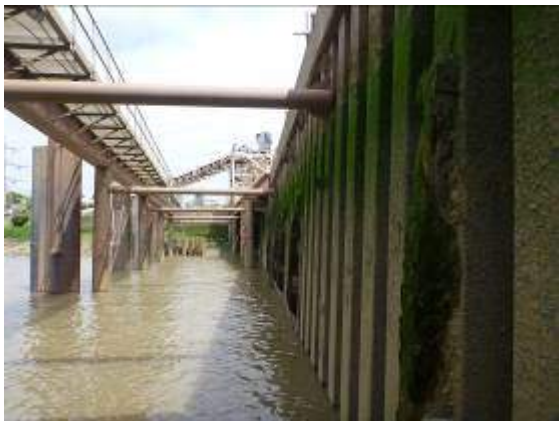
Figure 1 - Steel sheet pile wall with large diameter fender piles and rails for spoil transfer system

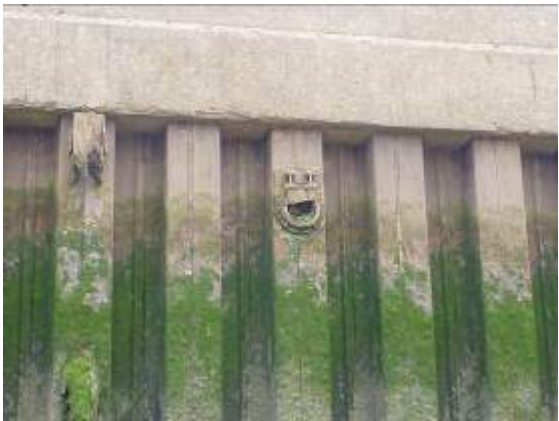
Figure 4 - Broken flap valve on sheet pile wall

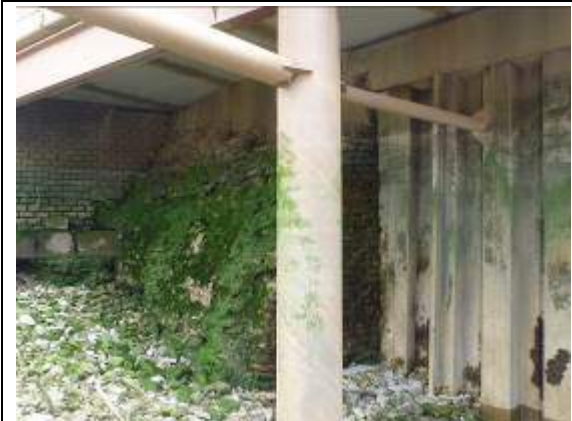
Figure 5 - Concrete bagwork section with steel frame for spoil transfer hopper in foreground

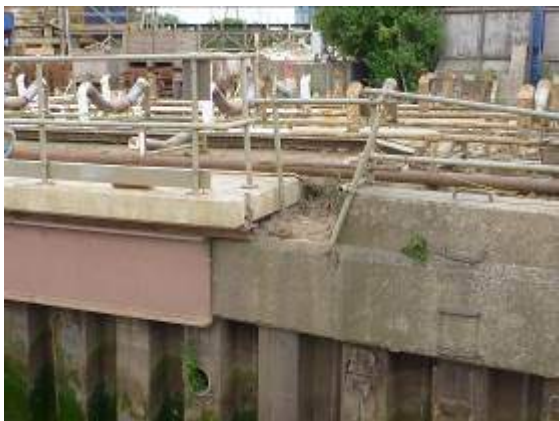
Figure 9 - Intersection between temporary structure and existing river wall

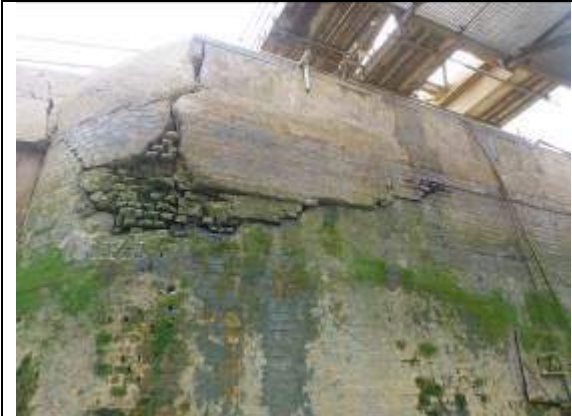
Figure 10 - Section of heavily cracked and unstable masonry at upstream end

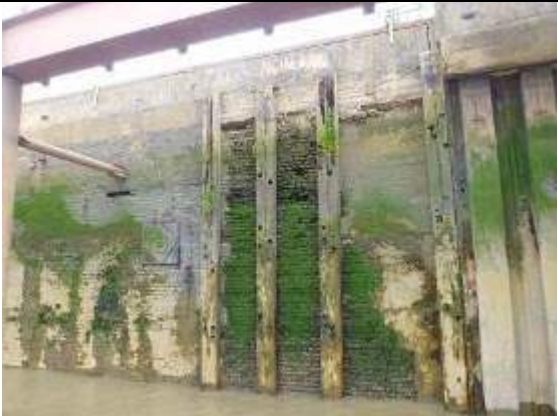
Figure 11 - View of older masonry and timber fenders at downstream end

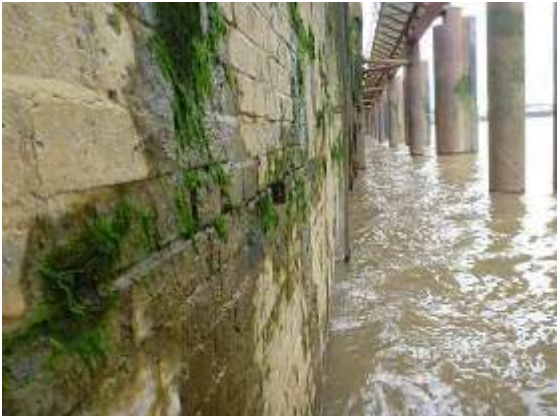
Figure 13 - View of horizontal crack in bed joints mid-height between bed level and anchor height

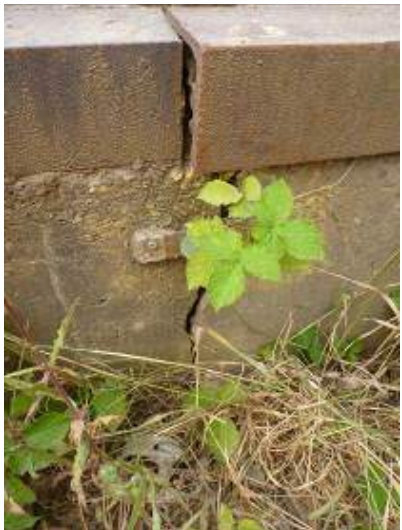
Figure 14 - Crack in concrete parapet with crack monitoring plates

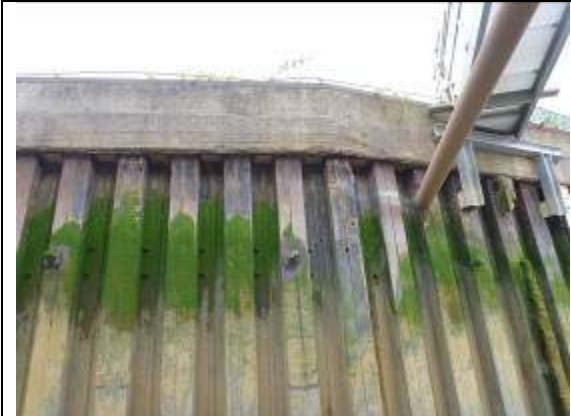
Figure 15 - Steel sheet pile with steel brace and concrete parapet

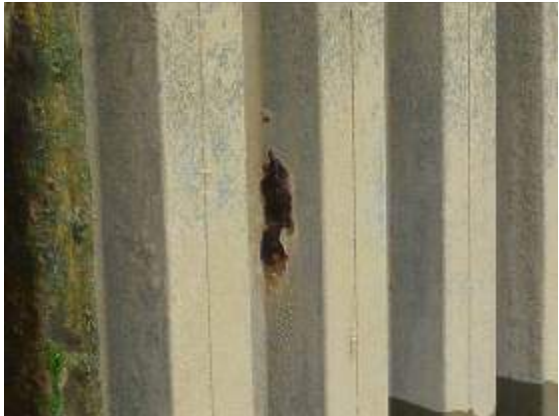
Figure 17 - Localised corrosion, possible Accelerated Low Water Corrosion

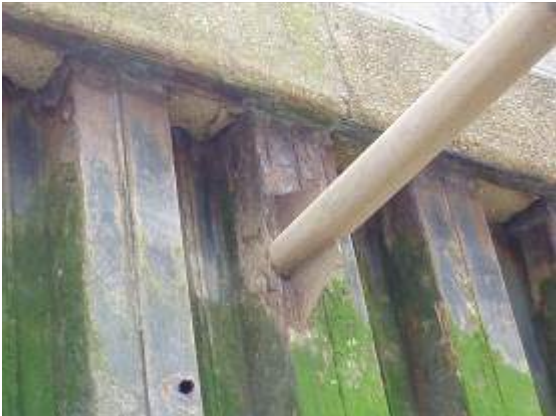
Figure 18 - Welded connection to brace hopper support frame. Elevated corrosion of piles around connection evident

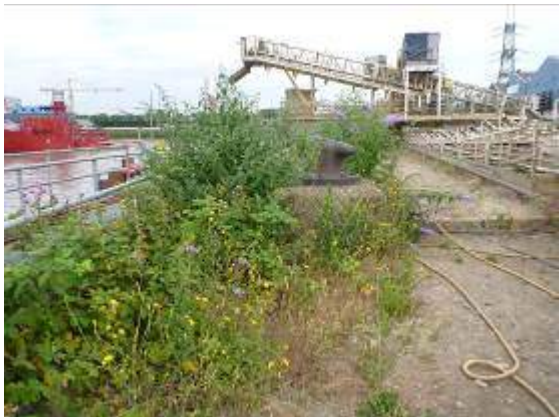
Figure 19 - Vegetation growth behind the raised flood wall

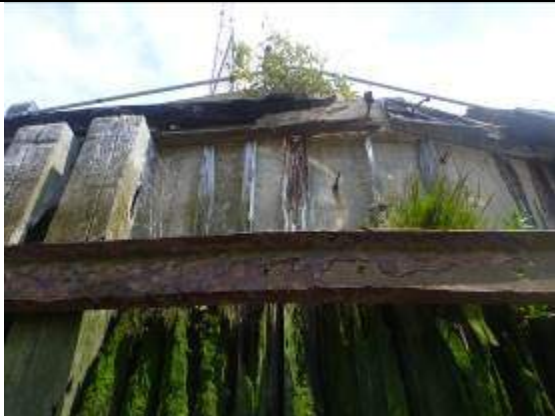
Figure 20 - Corroded steel restraint channel which is separating from the wall

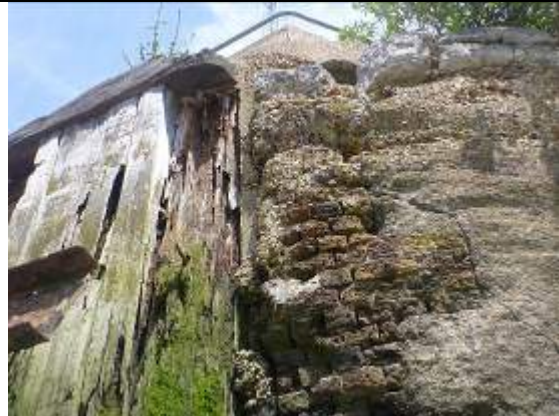
Figure 21 - Interface between exposed masonry sections and timber clad section. Masonry is badly eroded or missing. Large repairs using (sprayed) concrete

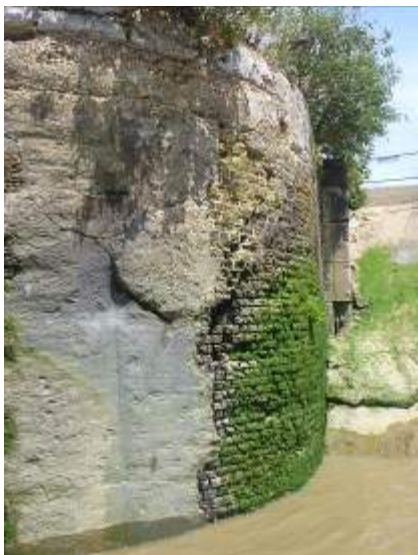
Figure 22 - Large vertical crack in masonry section

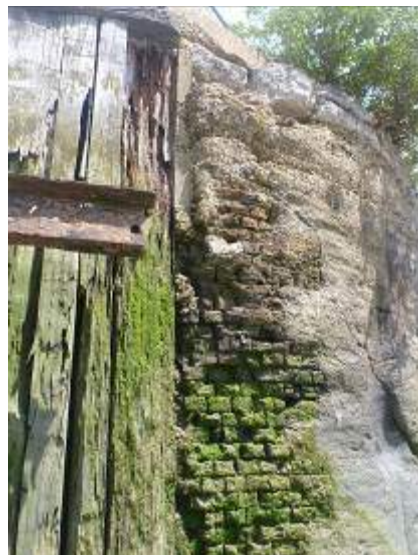
Figure 23 - Loss of pointing in masonry section, together with rotten timber cladding

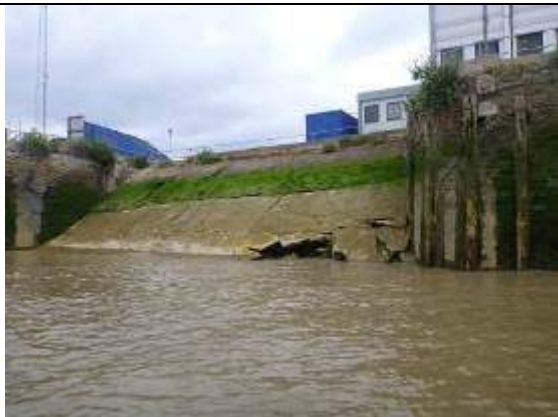
Figure 24 - Concrete apron and masonry abutments

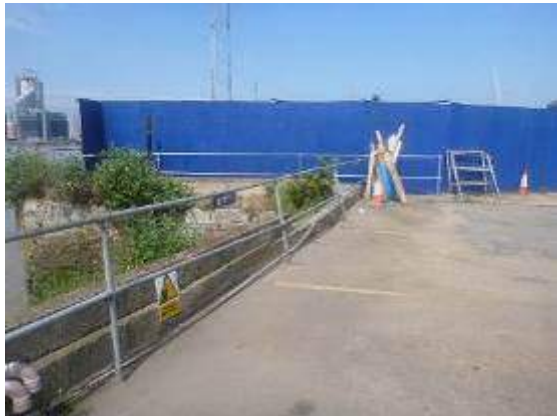
Figure 26 - Impact damage to concrete parapet and possible settlement behind the frontage

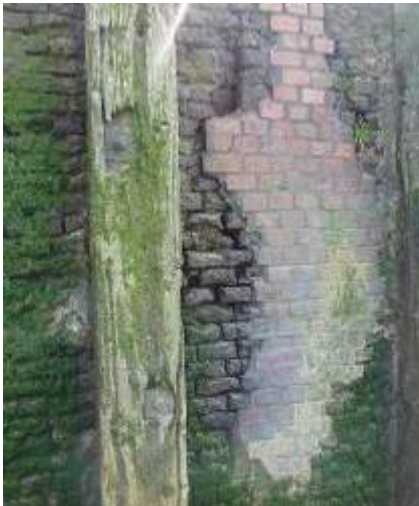
Figure 27 - Repaired section of masonry wall

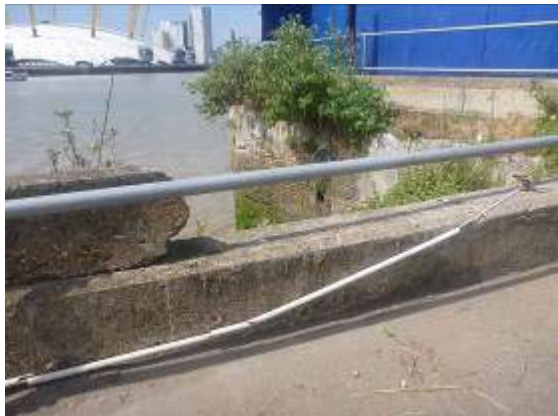
Figure 28 - Missing section of raised concrete parapet

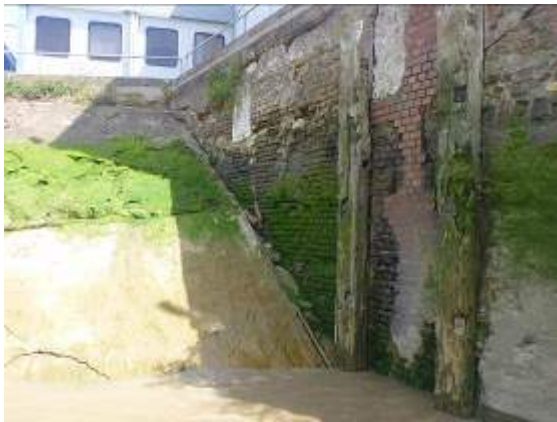
Figure 29 - Interface between masonry wall and masonry abutment. View of large sections of replacement masonry

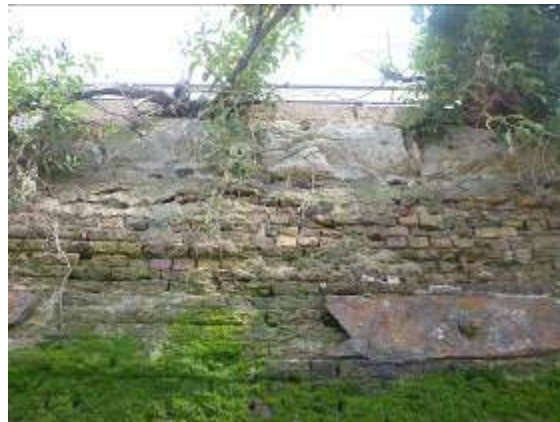
Figure 30 – View of eroded masonry wall with concrete parapet and remnants of steel waling beam.

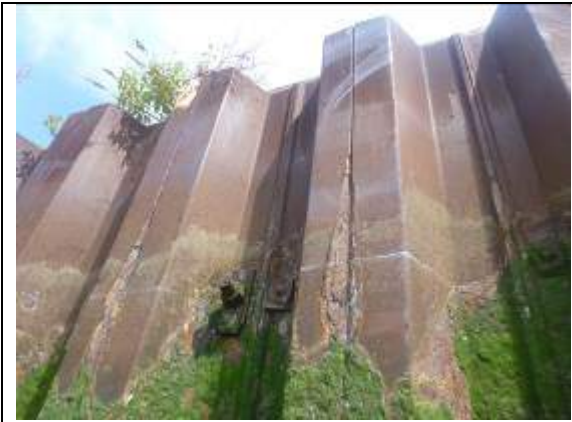
Figure 33 - Waling bolt on sheet pile wall

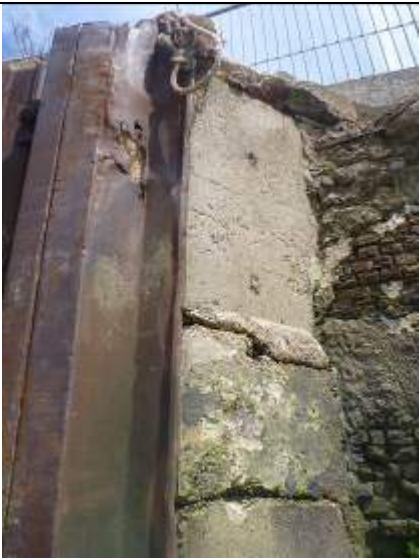
Figure 34 – Damage to concrete interface between sheet pile wall and downstream adjacent masonry wall

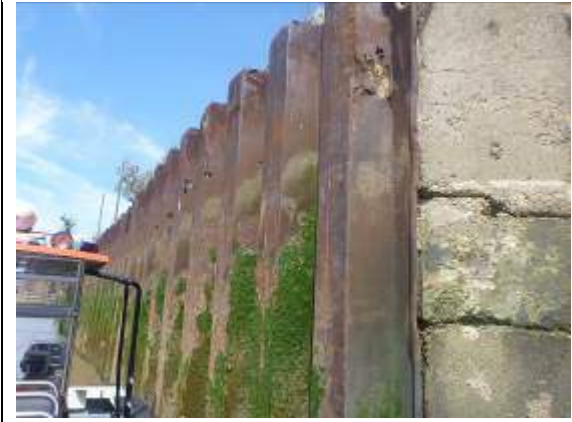
Figure 35 – View of steel sheet pile wall and concrete interface

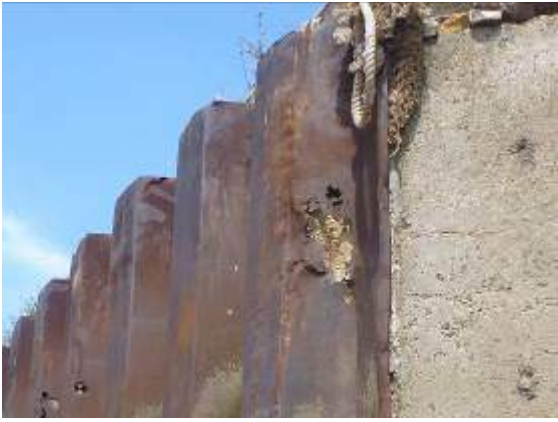
Figure 36 – Full-thickness corrosion at the downstream extent of the frontage

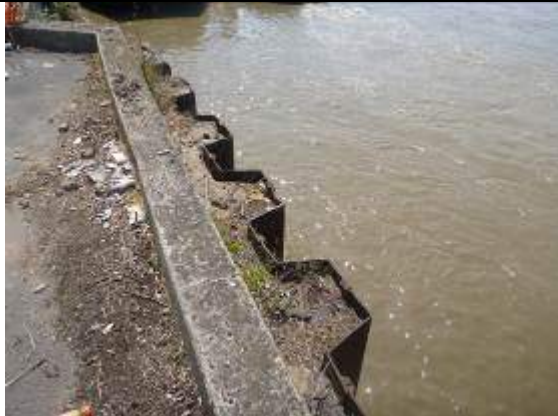
Figure 37 - Concrete backfill behind sheet piles and concrete parapet

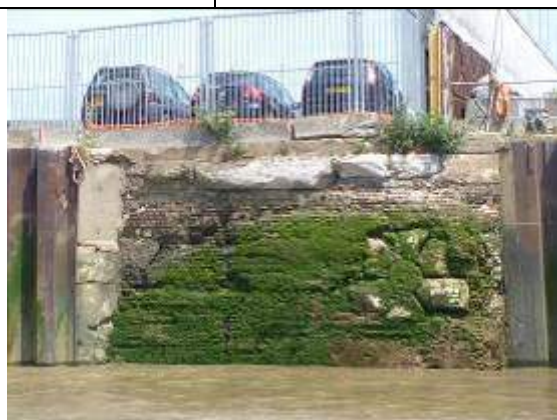
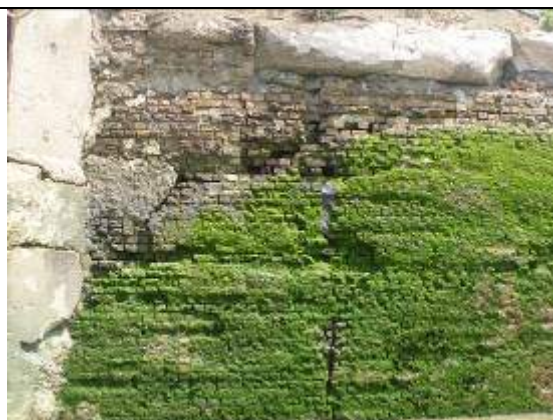
Figure 38 - Masonry wall with car park behind the frontage Figure 39 – Cracking in masonry wall

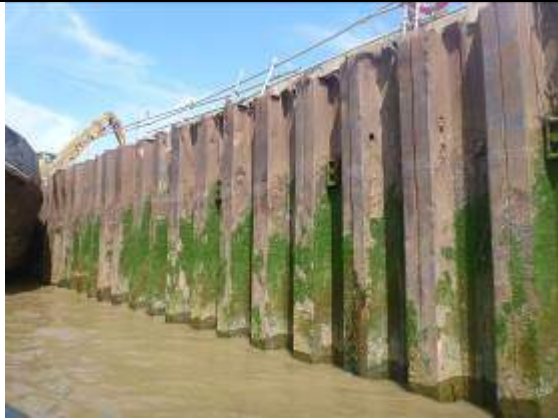
Figure 40 - Steel sheet pile wall with crumple damage to the top of the piles

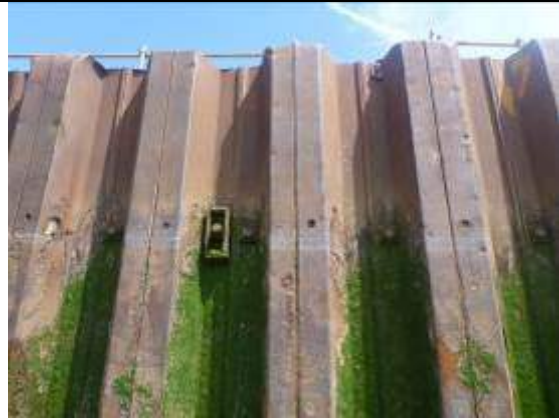
Figure 41 - Waling and anchor bolts

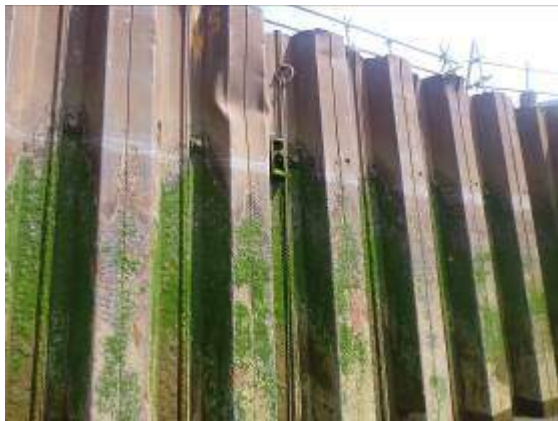
Figure 42 - Impact damage to steel sheet piles

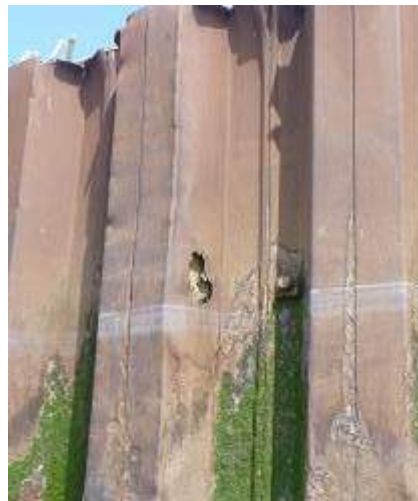
Figure 43 - Localised full-thickness corrosion to sheet piles

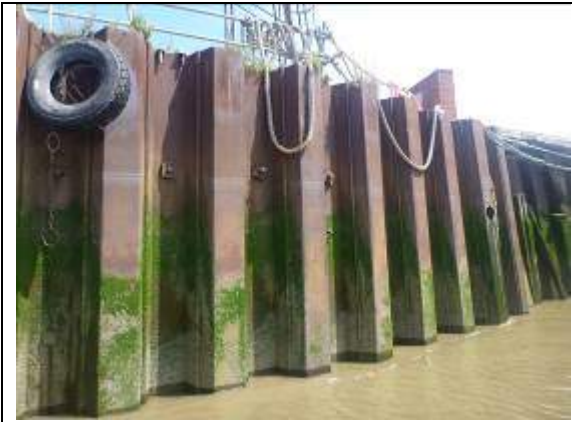
Figure 44 – Pile non-verticality

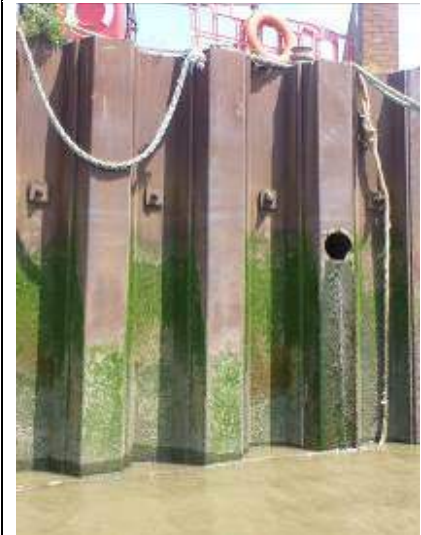
Figure 46 - Hole in sheet piling indicating missing flap valve

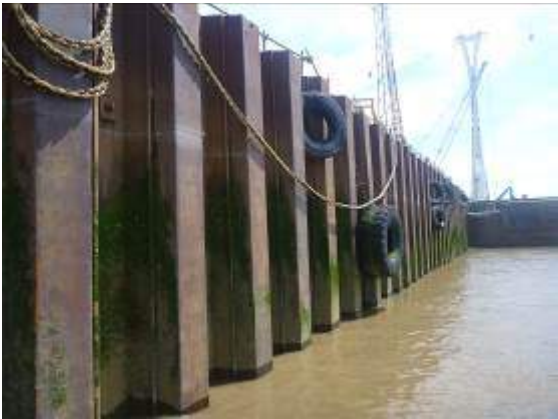
Figure 47 - Steel sheet pile wall

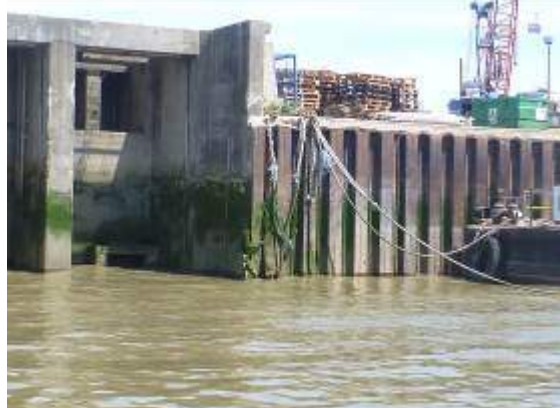
Figure 49 - Steel sheet pile wall and concrete Thames Water outfall

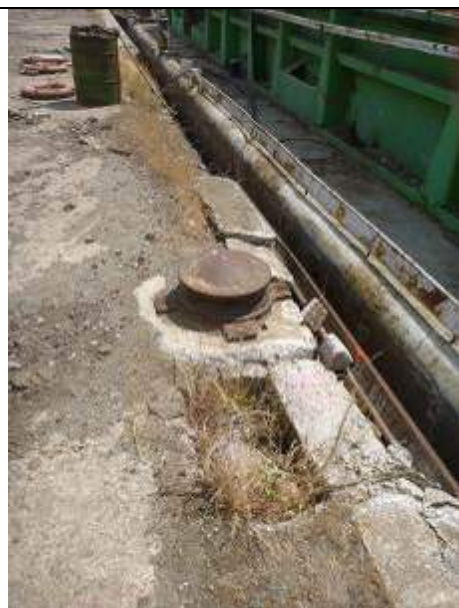
Figure 51 – Damage to coping adjacent to mooring bollard

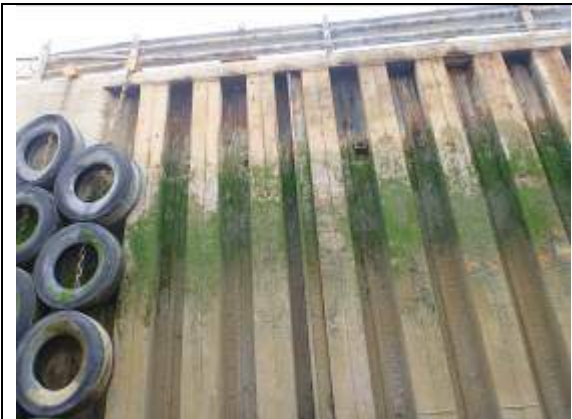
Figure 52 - Steel sheet pile wall with waling, anchor bolts and concrete coping

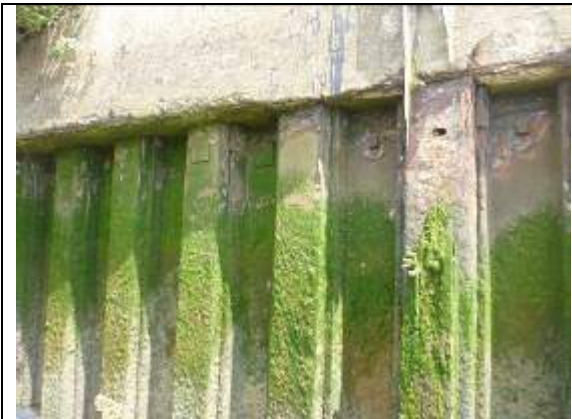
Figure 57 – Splash zone corrosion and erosion of soffit of the concrete capping beam

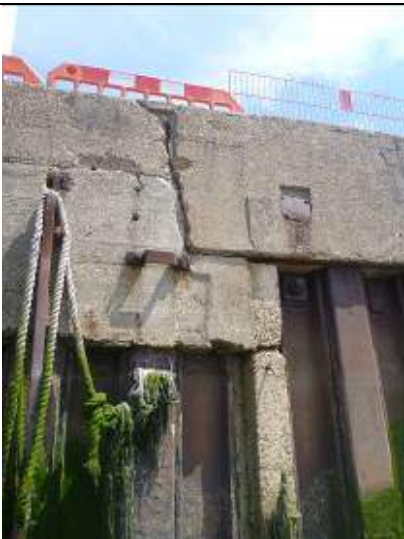
Figure 58 – View of break in construction – joint in capping beam and concrete “plug” in place of pile below joint

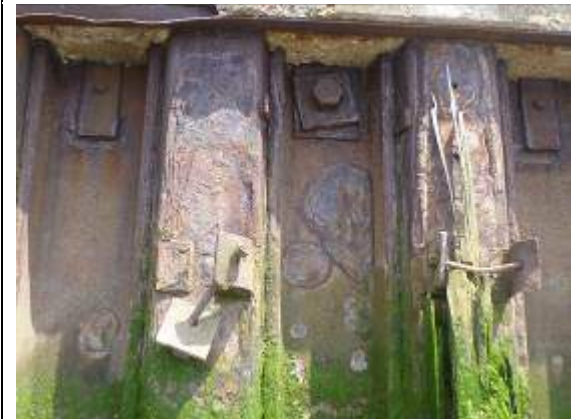
Figure 59 - Accelerated corrosion of steel sheet piles at welded connections

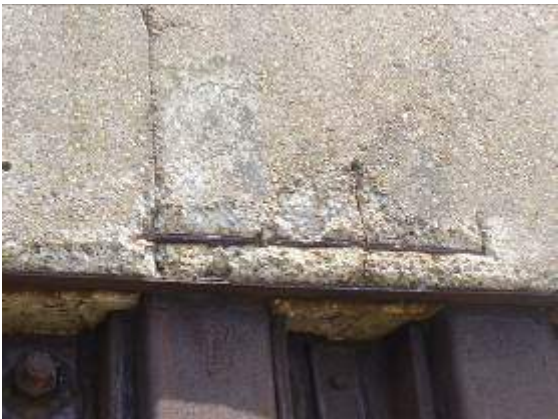
Figure 60 - Spalling to soffit of concrete capping beam with exposed corroded steel reinforcement

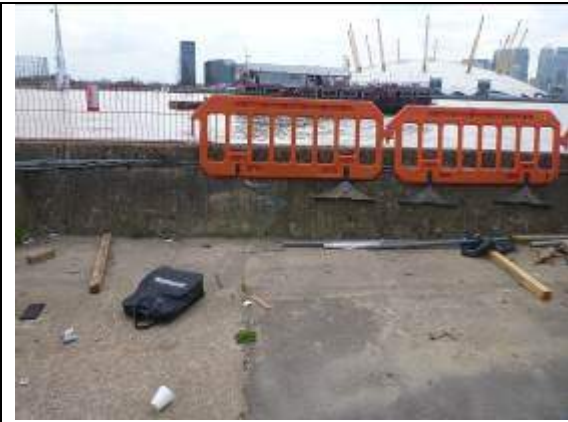
Figure 61 - Crack in river wall with resurfacing on the land directly behind the frontage

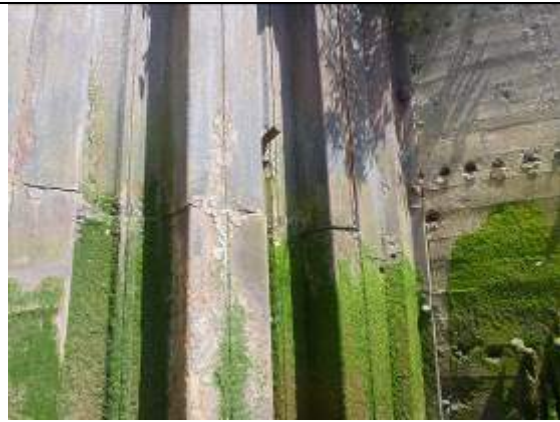
Figure 62 - Section of sheet piles which have been horizontally spliced

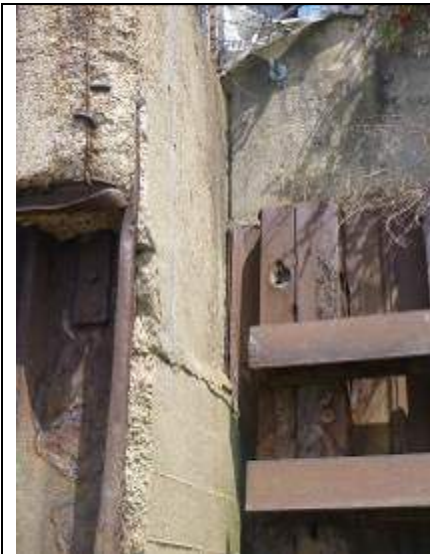
Figure 63 - Interface between steel sheet pile wall and adjacent upstream asset

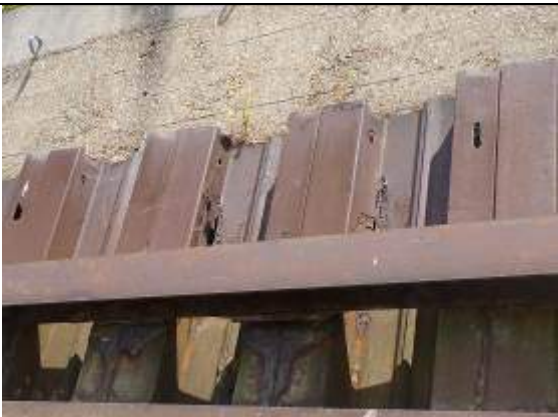
Figure 64 - Full depth corrosion of steel sheet piles with voids in the concrete back fill

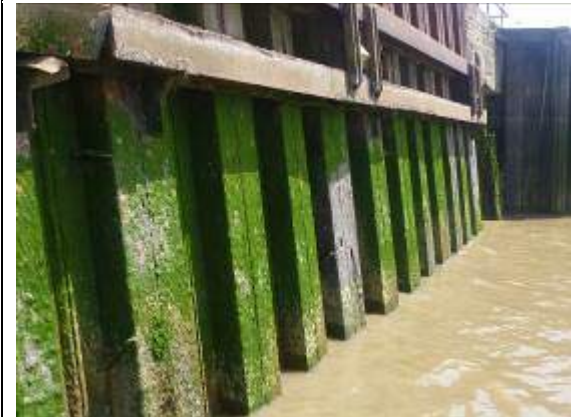
Figure 65 - Steel sheet pile wall with external waling beam. Piles leaning backwards

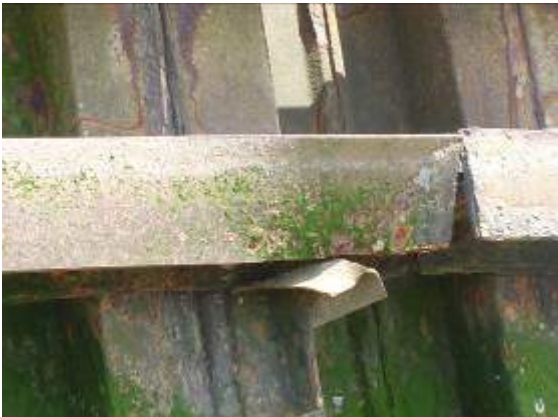
Figure 66 - Impact damage to waling beam

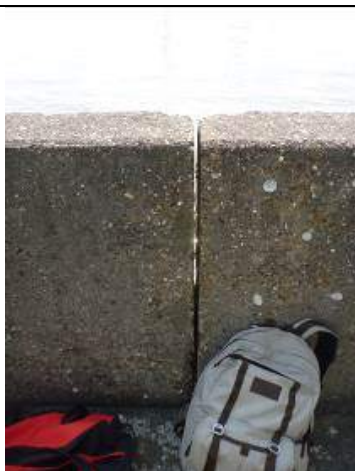
Figure 67 - Movement joint with no sealant present

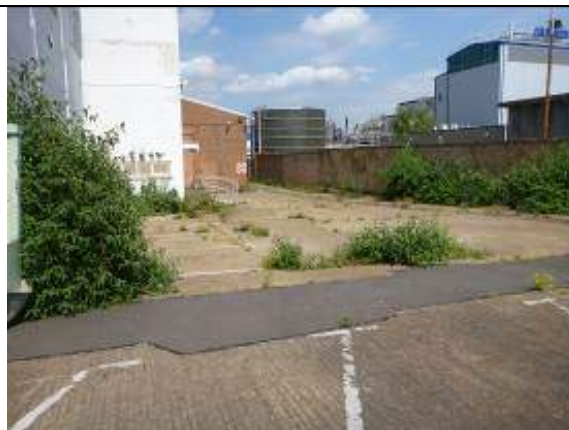
Figure 68 - Cracked and uneven surfacing behind the frontage

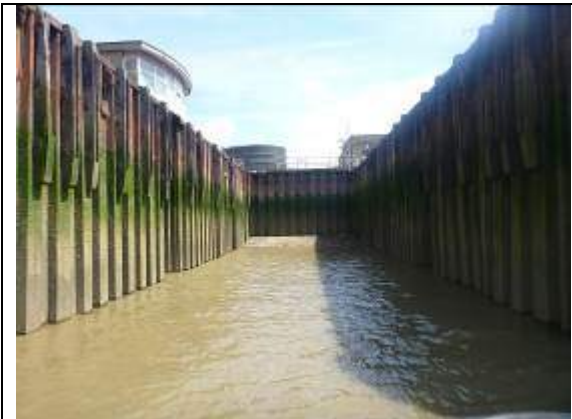
Figure 69 - Steel sheet pile dock

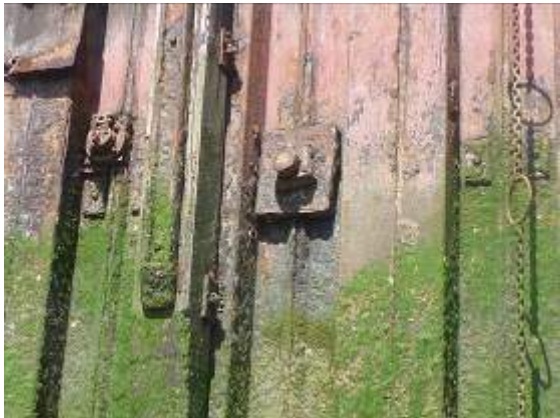
Figure 72 - Corroded waling and anchor bolts

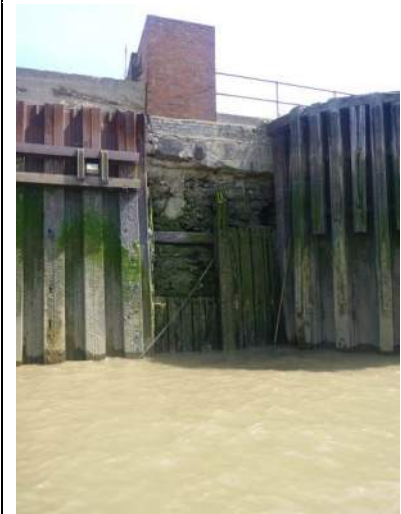
Figure 73 - Timber wall section at upstream extent of asset

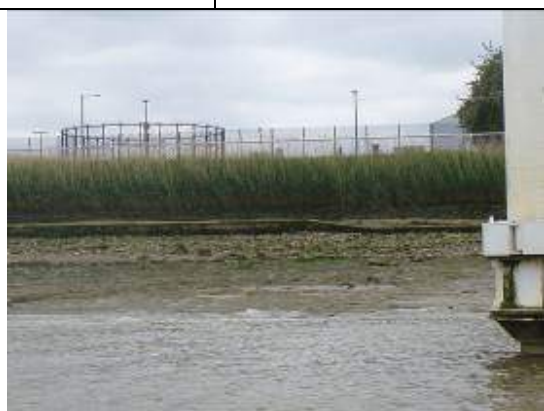
Figure 76 - Concrete wall is obstructed by reeds but gabion baskets at the toe are visible

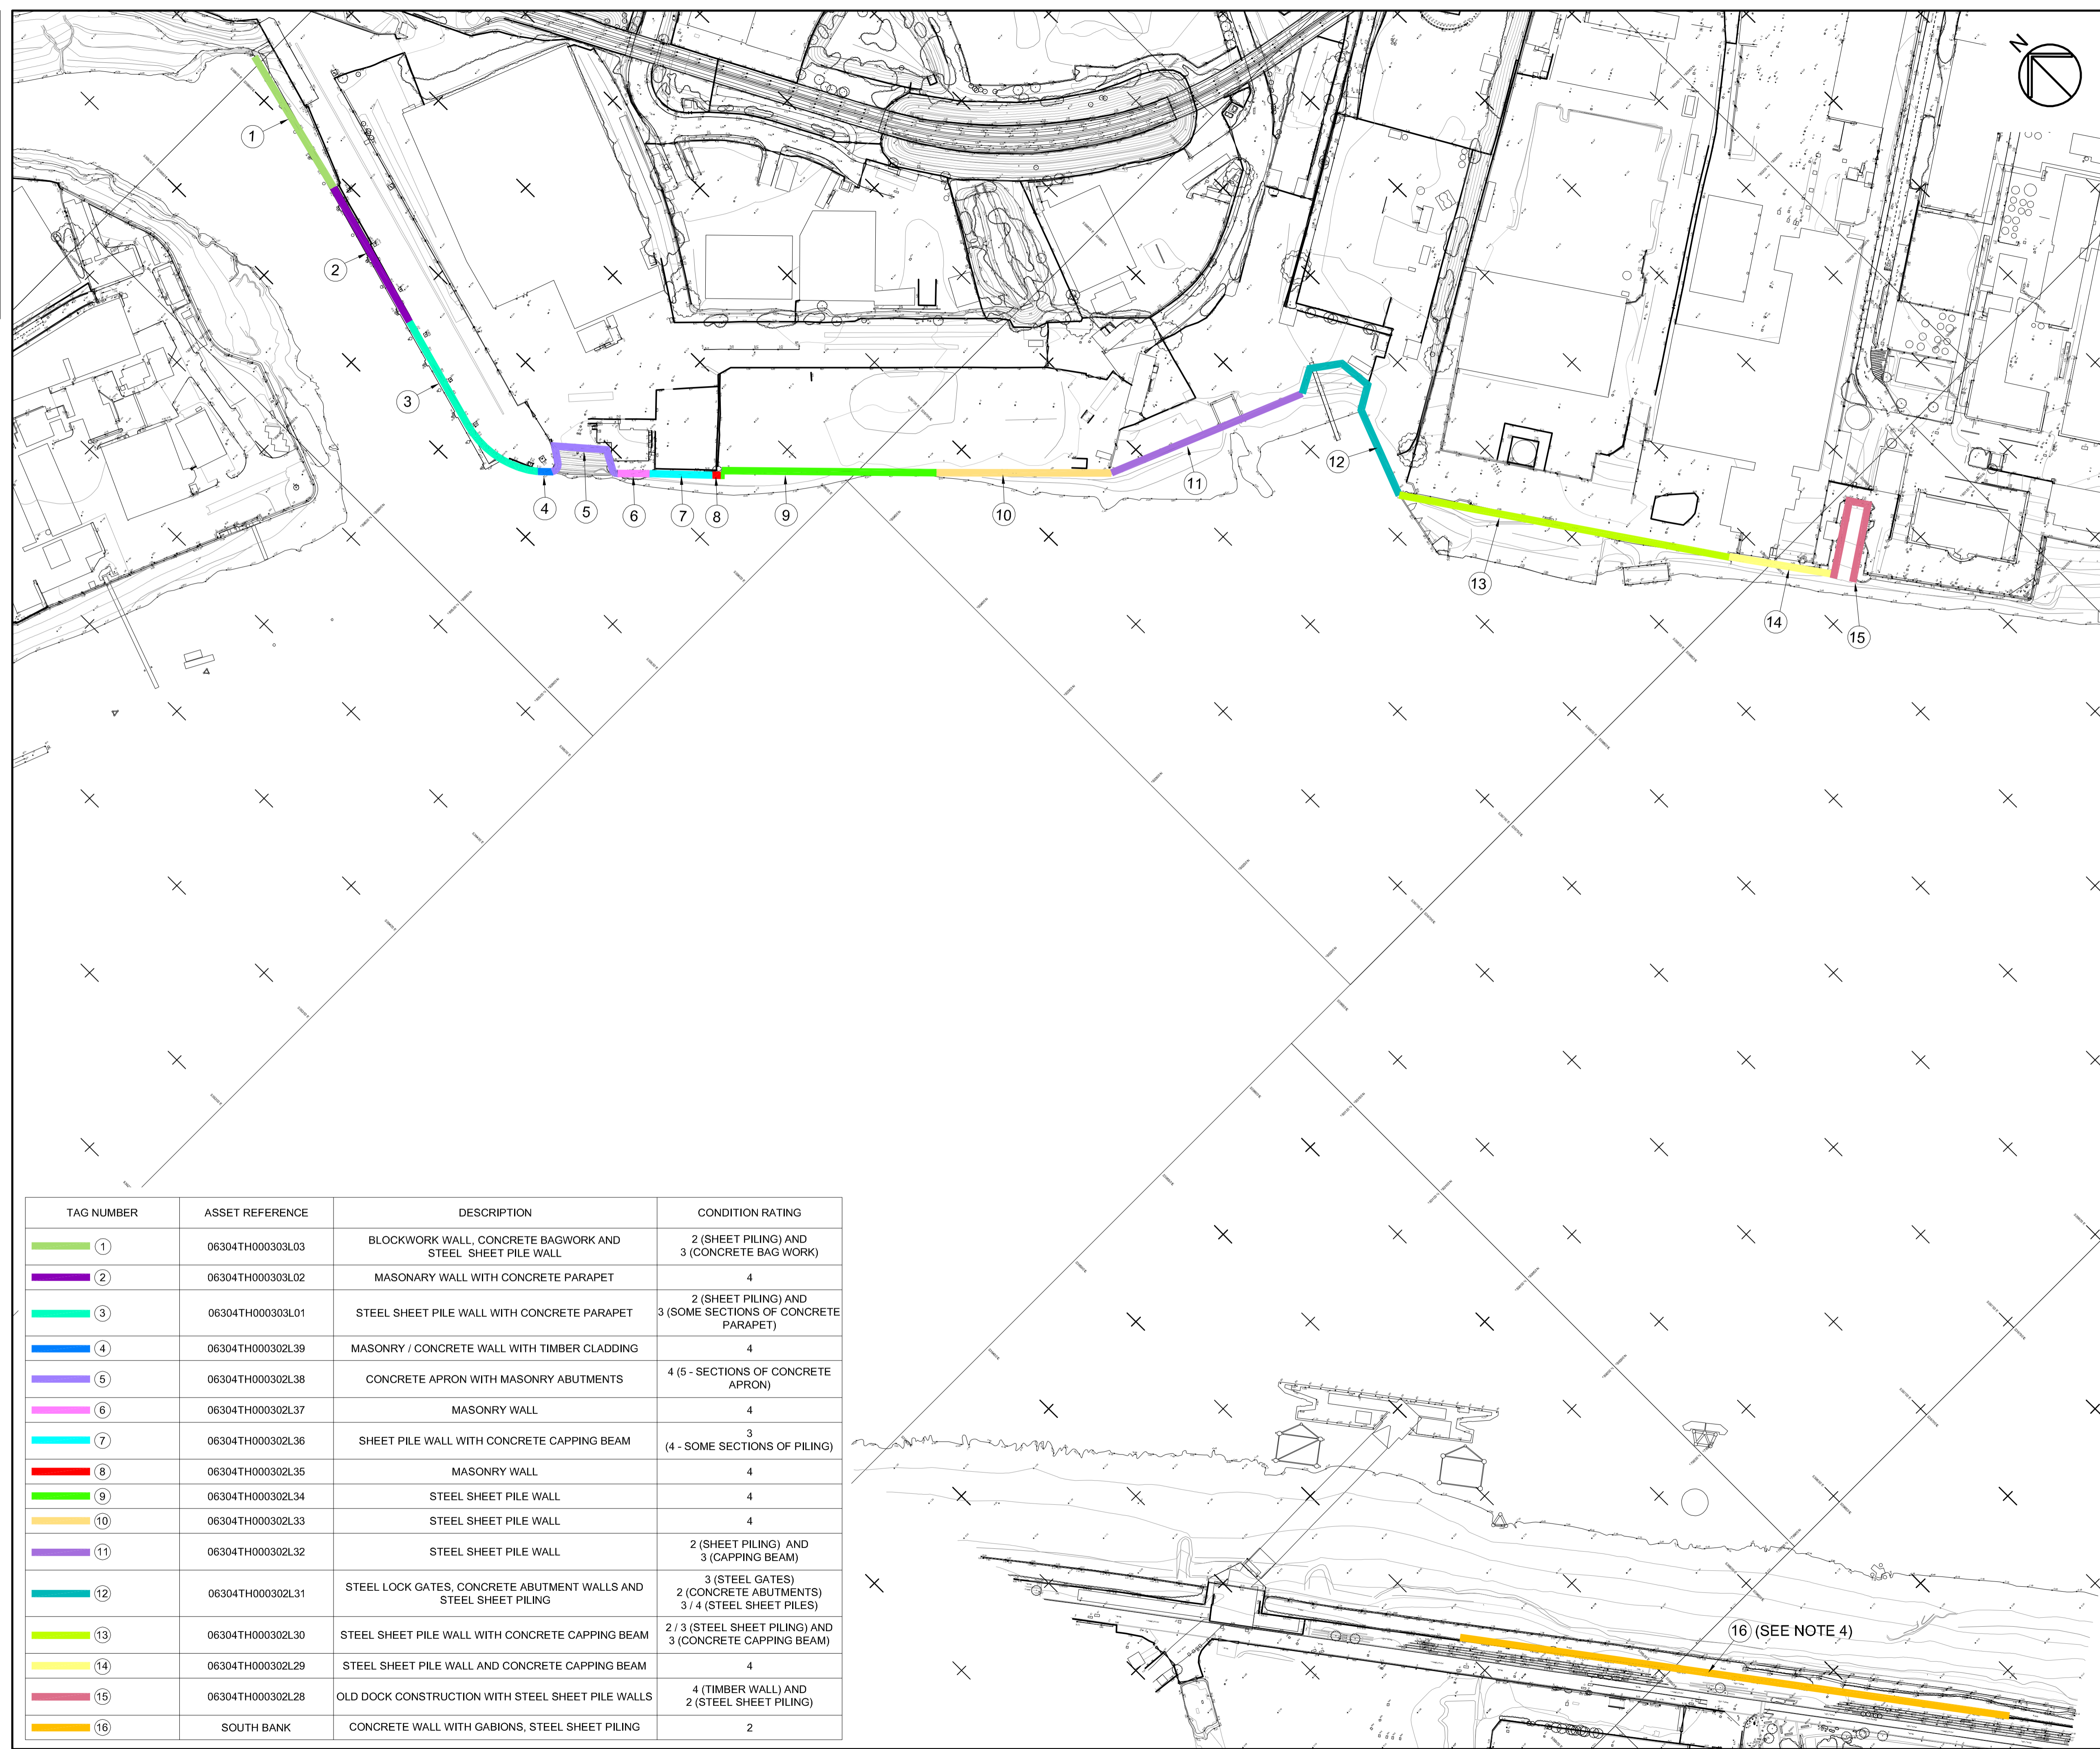
SAFETY, HEALTH AND ENVIRONMENTAL INFORMATION

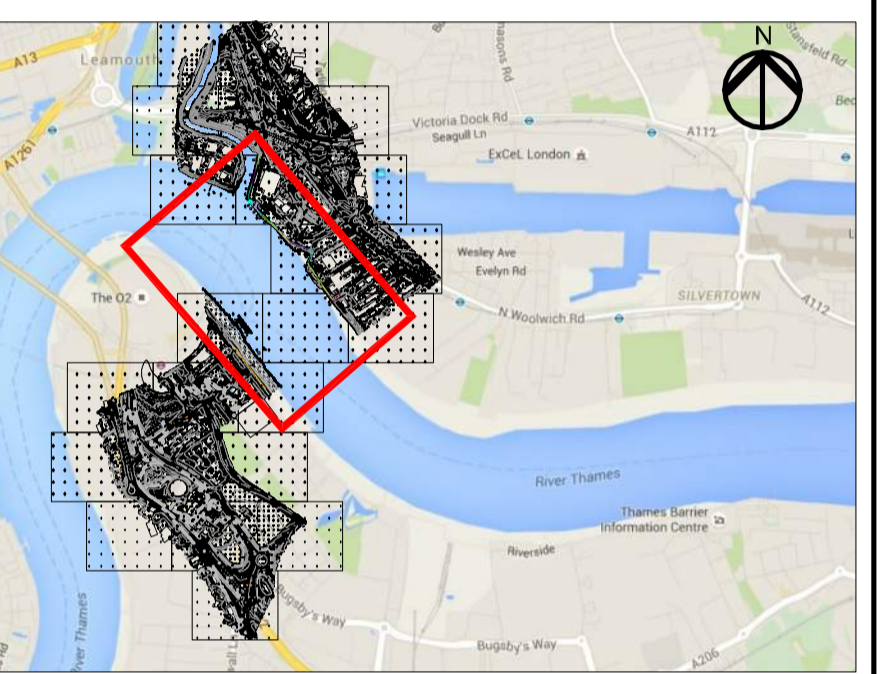
- NOTES:**
1. ALL DIMENSIONS ARE IN MILLIMETRES UNLESS NOTED OTHERWISE.
 2. ALL LEVELS ARE IN METRES TO ORDNANCE SURVEY DATUM (NEWLYN).
 3. HIGHLIGHTED WALLS WERE SURVEYED BETWEEN 16/06/2015 AND 02/07/2015.
 4. SOUTH BANK WAS SURVEYED FROM EASTERN EXTENT OF QUANTUM SCULPTURE FOR APPROXIMATELY 225m.

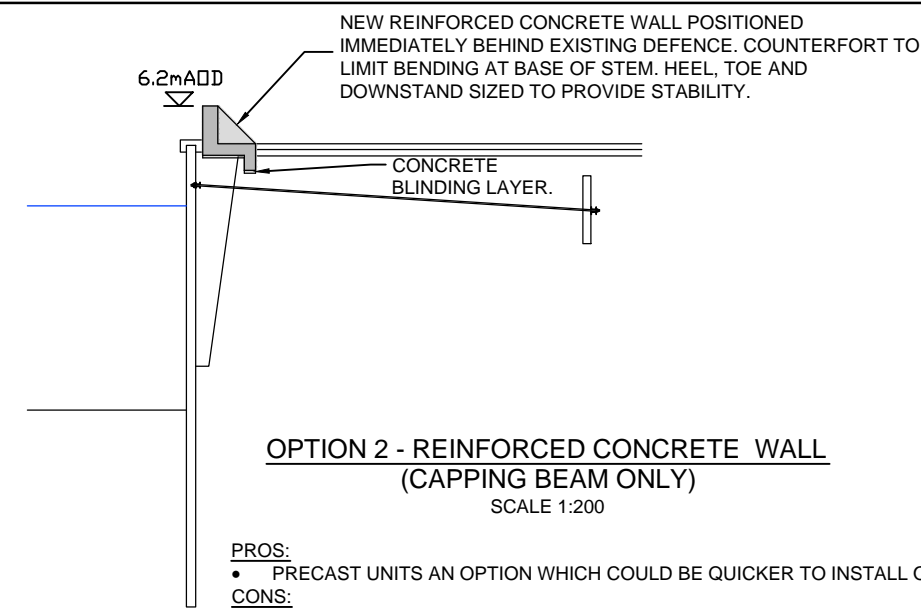
OPTION 2 - REINFORCED CONCRETE WALL (CAPPING BEAM ONLY)
SCALE 1:200

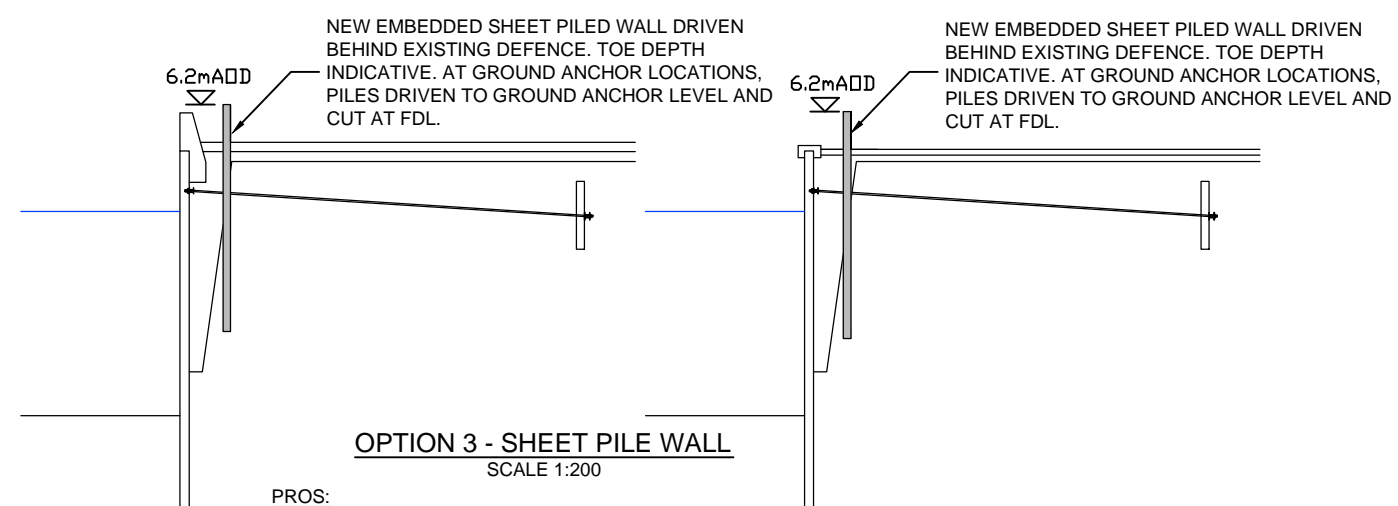
OPTION 3 - SHEET PILE WALL
SCALE 1:200

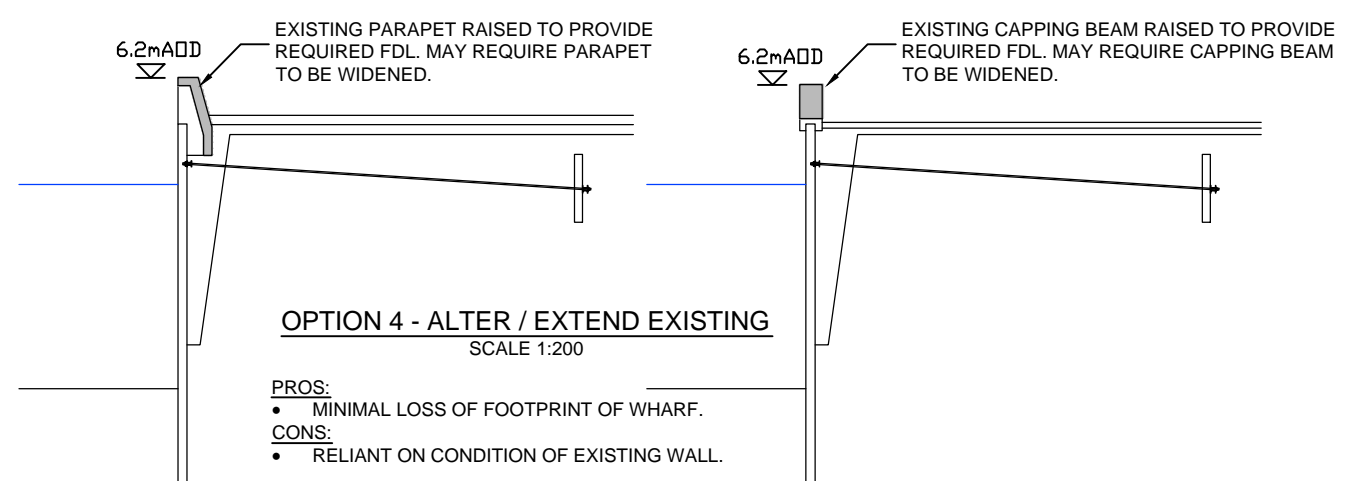
OPTION 4 - ALTER / EXTEND EXISTING
SCALE 1:200

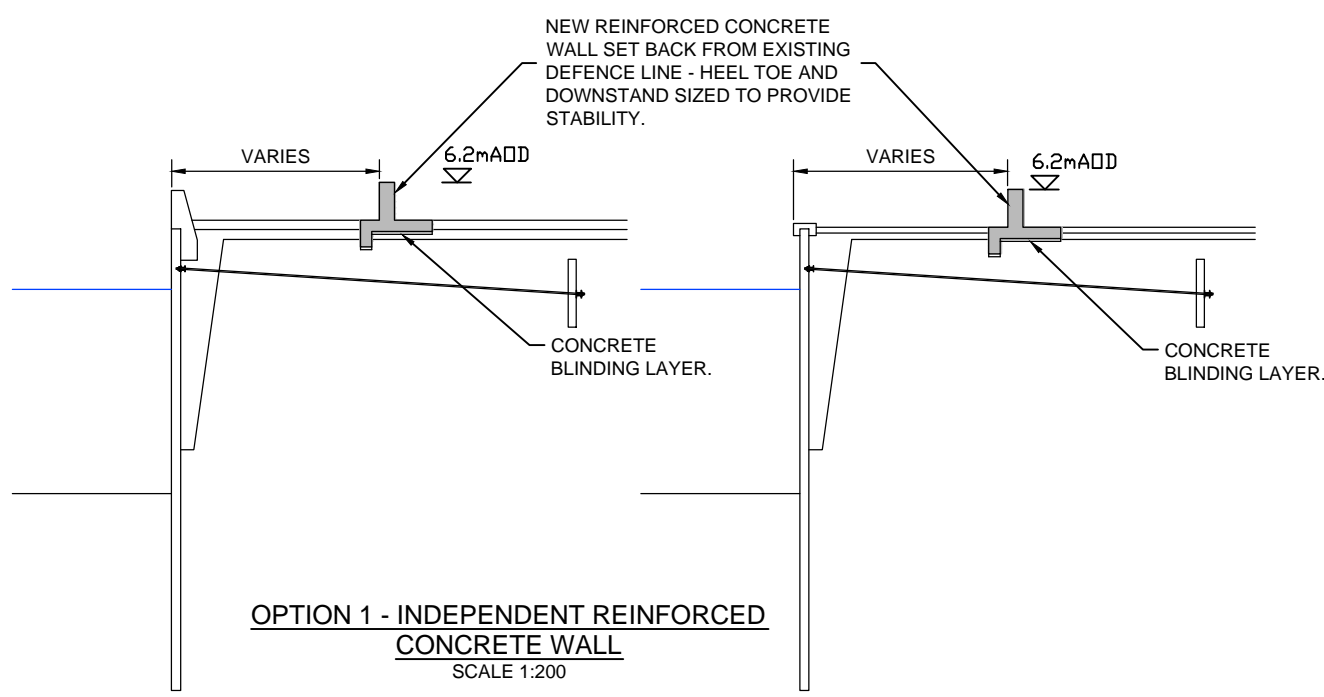
OPTION 1 - INDEPENDENT REINFORCED CONCRETE WALL
SCALE 1:200

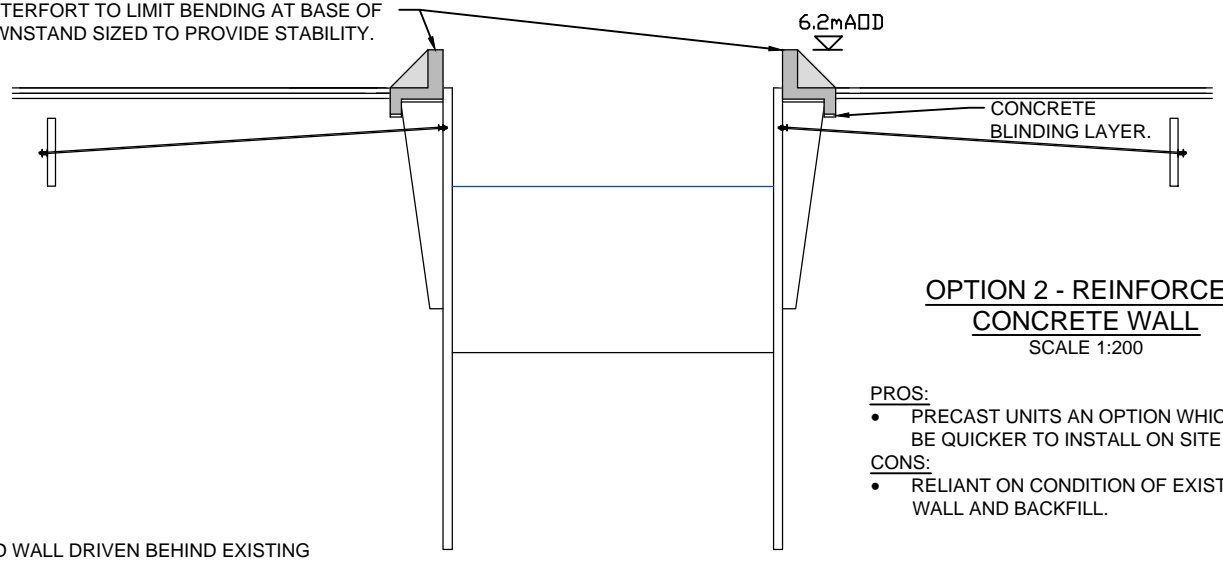
OPTION 2 - REINFORCED CONCRETE WALL
SCALE 1:200

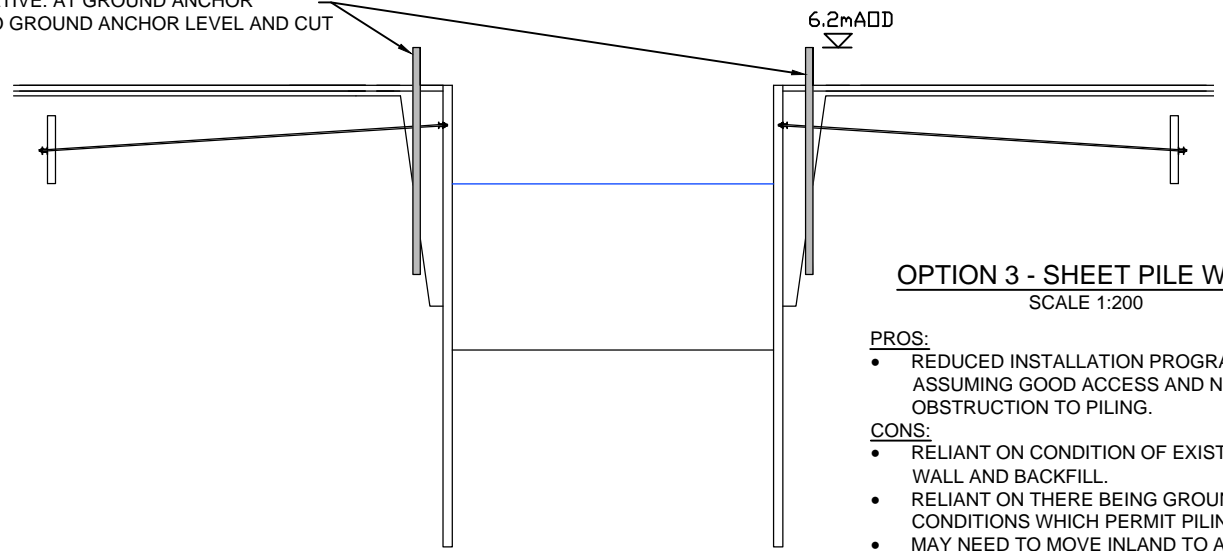
OPTION 3 - SHEET PILE WALL
SCALE 1:200
