Thameside West

River Wall Structural Survey

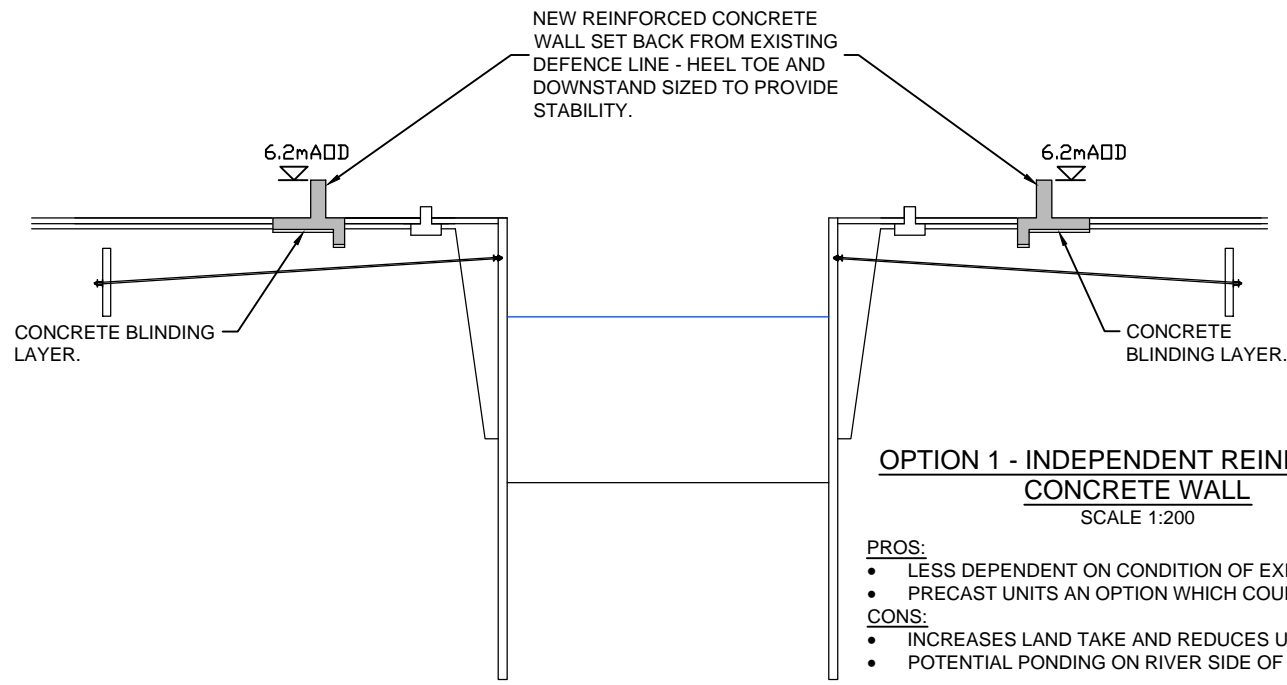
OPTION 1 - INDEPENDENT REINFORCED CONCRETE WALL
SCALE 1:200

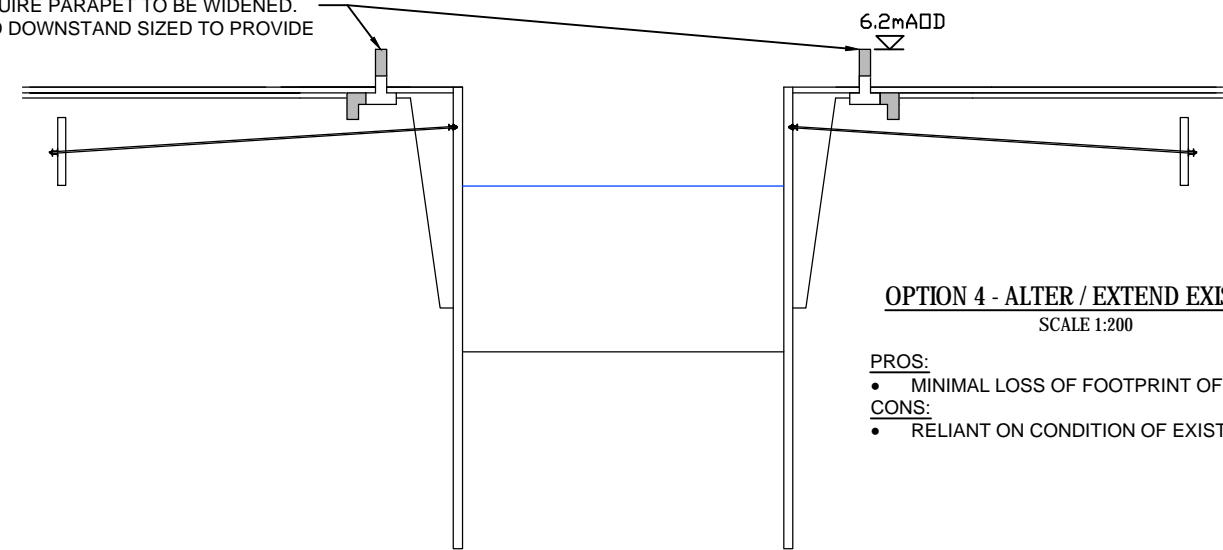
OPTION 4 - ALTER / EXTEND EXISTING
SCALE 1:200

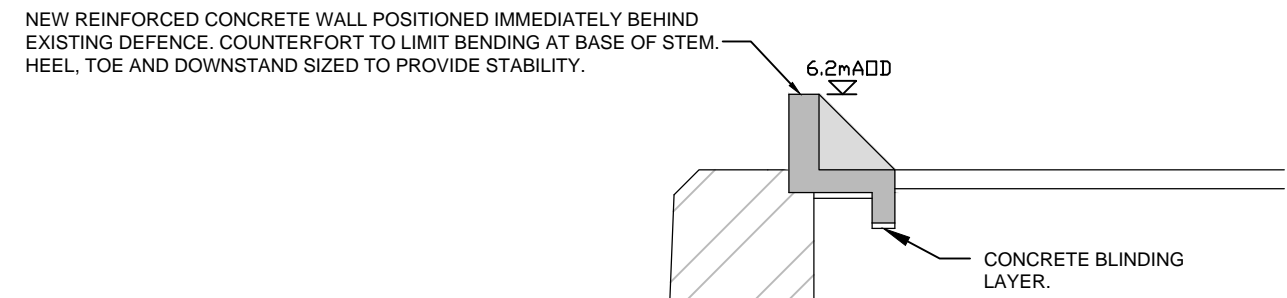
OPTION 2 - REINFORCED CONCRETE WALL
SCALE 1:100

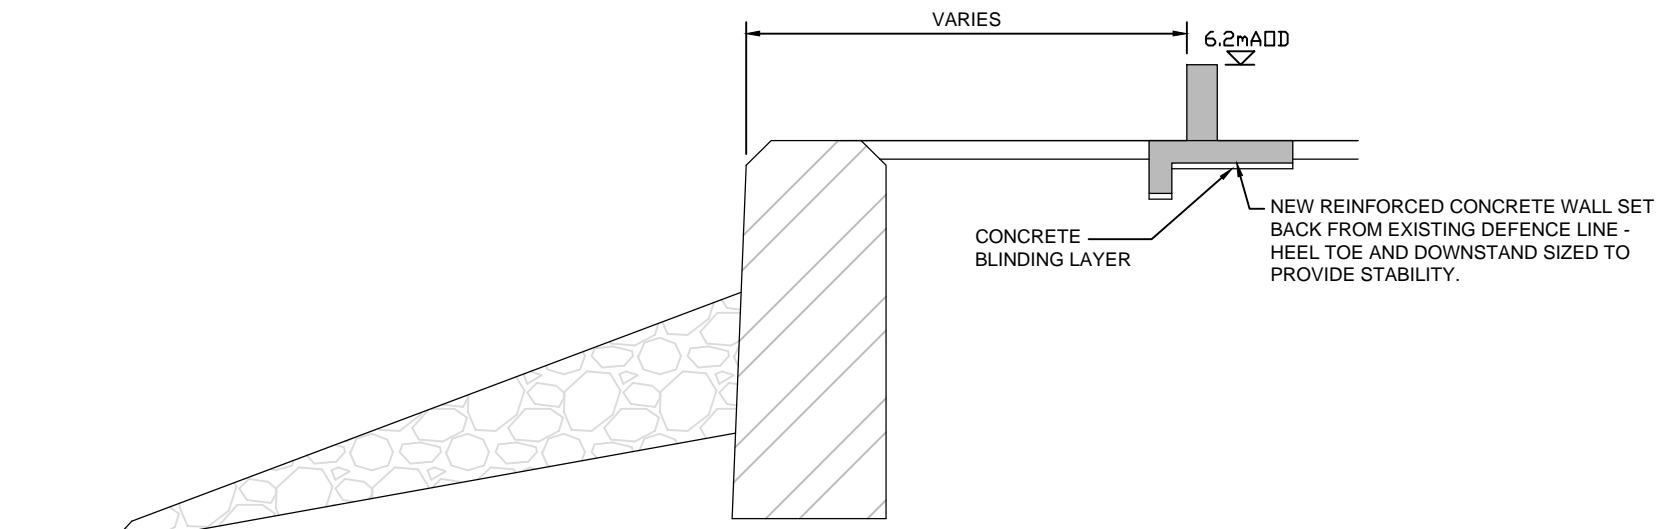
OPTION 1 - INDEPENDENT REINFORCED CONCRETE WALL
SCALE 1:100

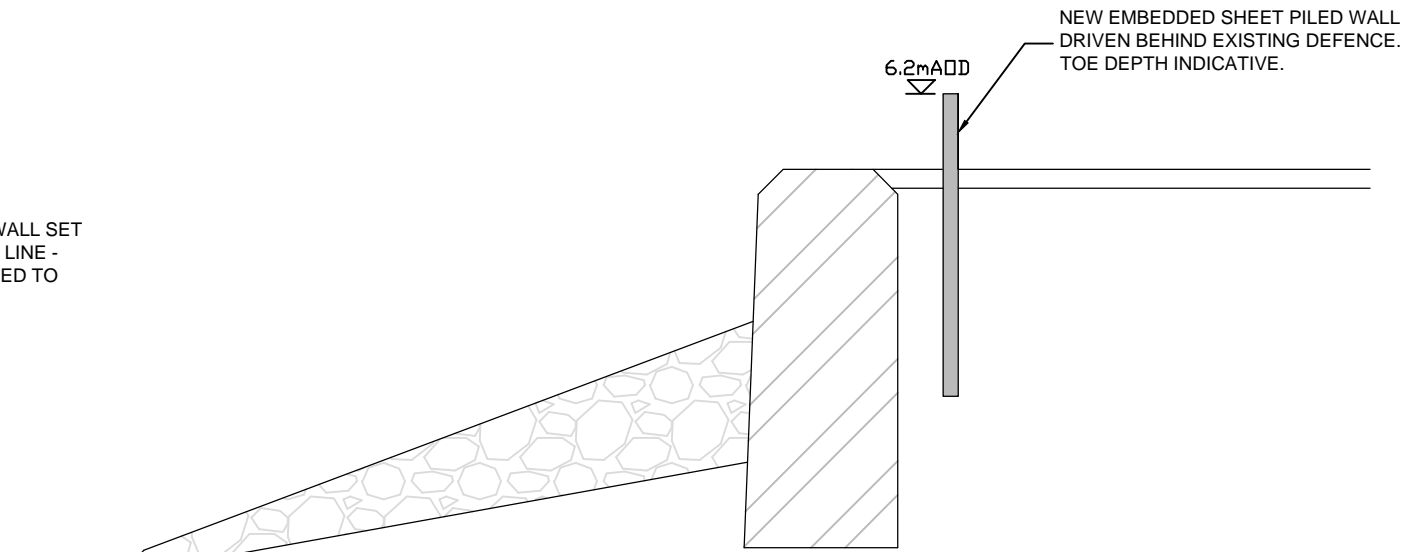
OPTION 3 - SHEET PILE WALL
SCALE 1:100

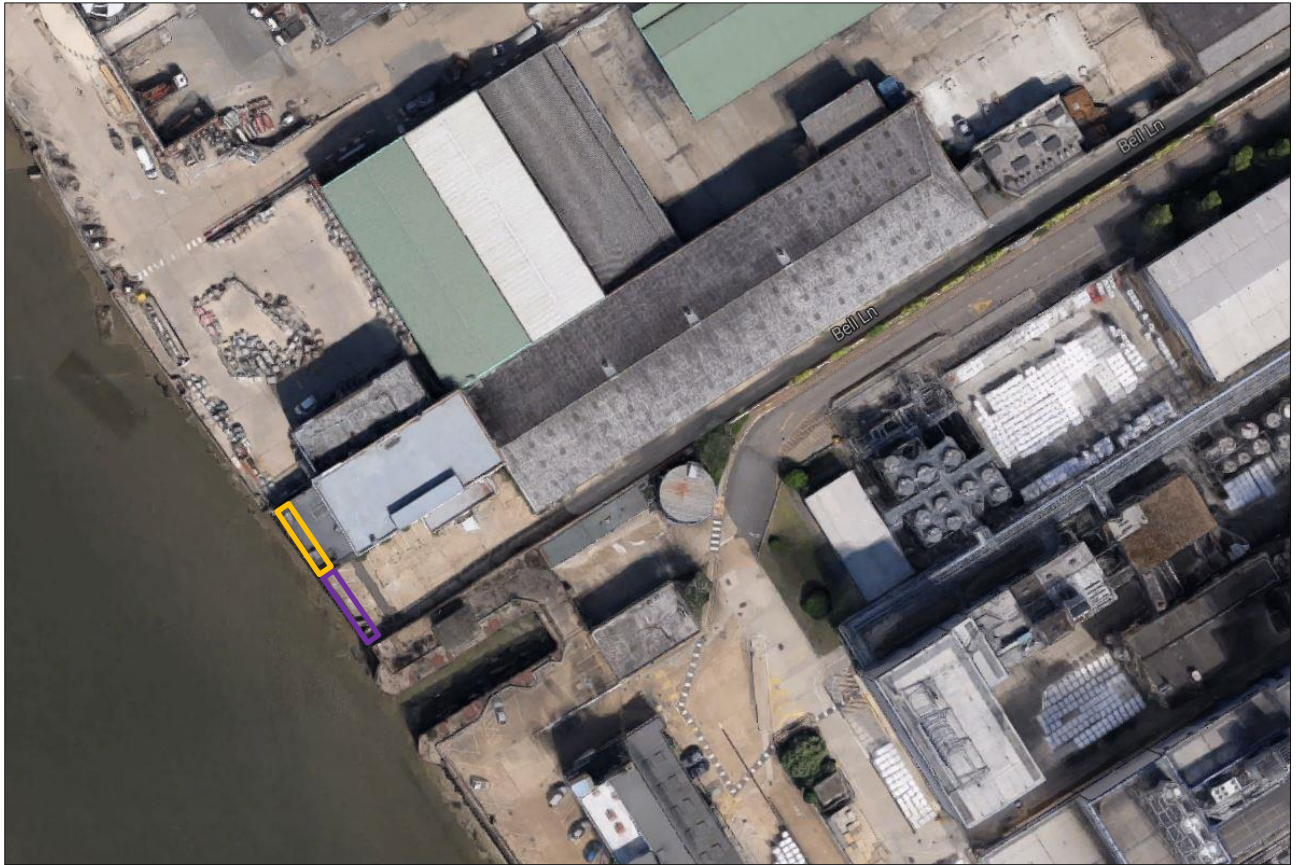
Figure 2-1: Aerial view of Dohm Wharf showing inspection areas

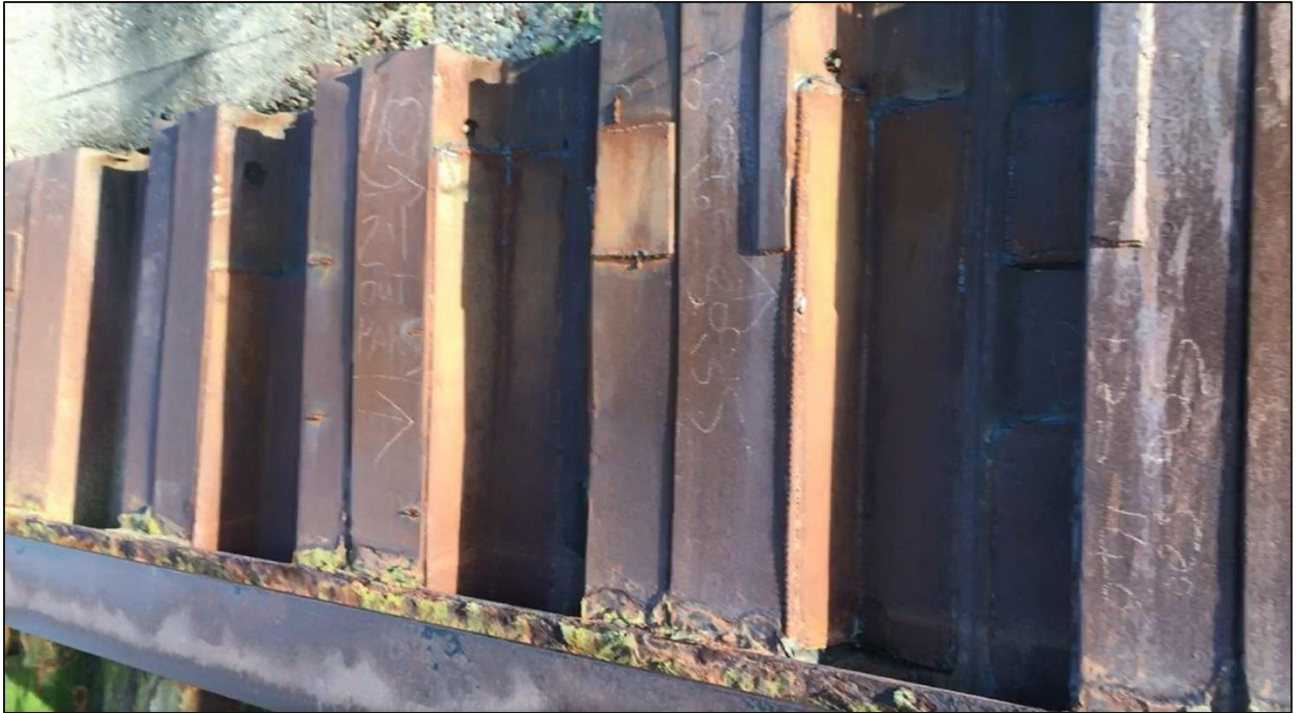
Figure 3-1: Typical photograph of upper level of river wall, showing steel plate repairs to sheet piling

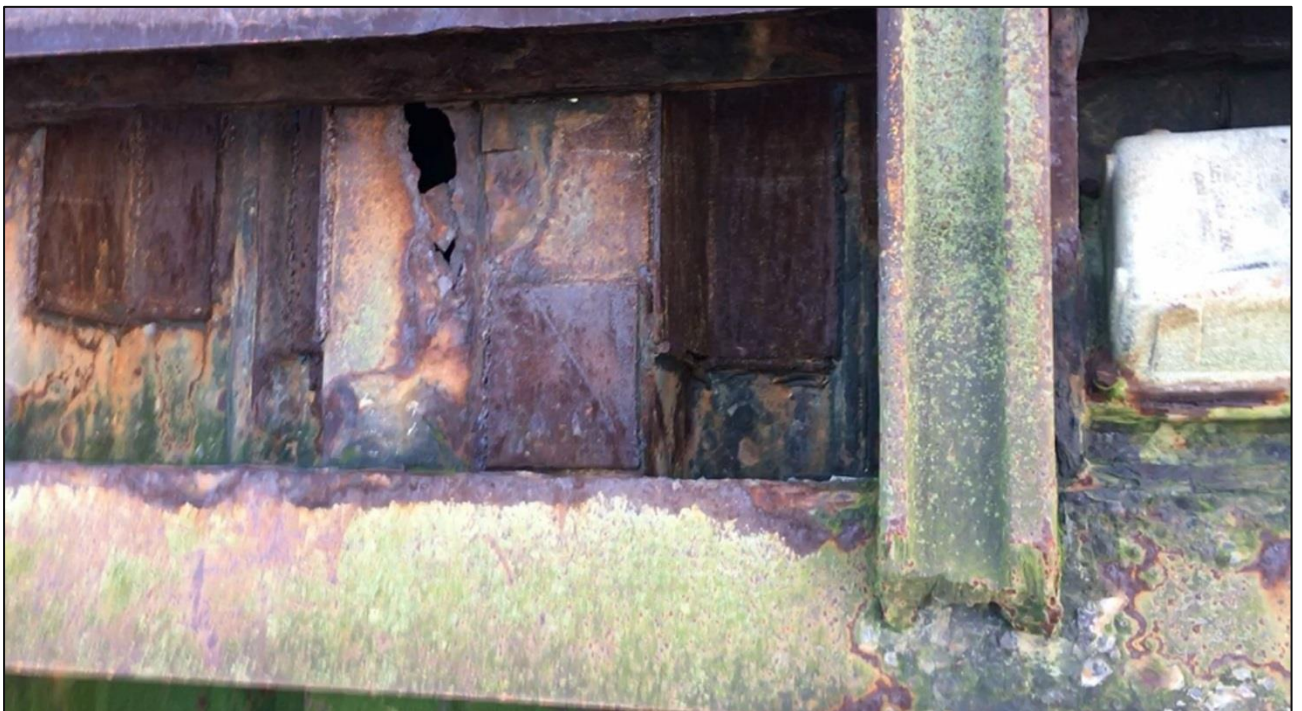
Figure 3-2: Location where patch repair to perforation in steel sheet piling has been missed

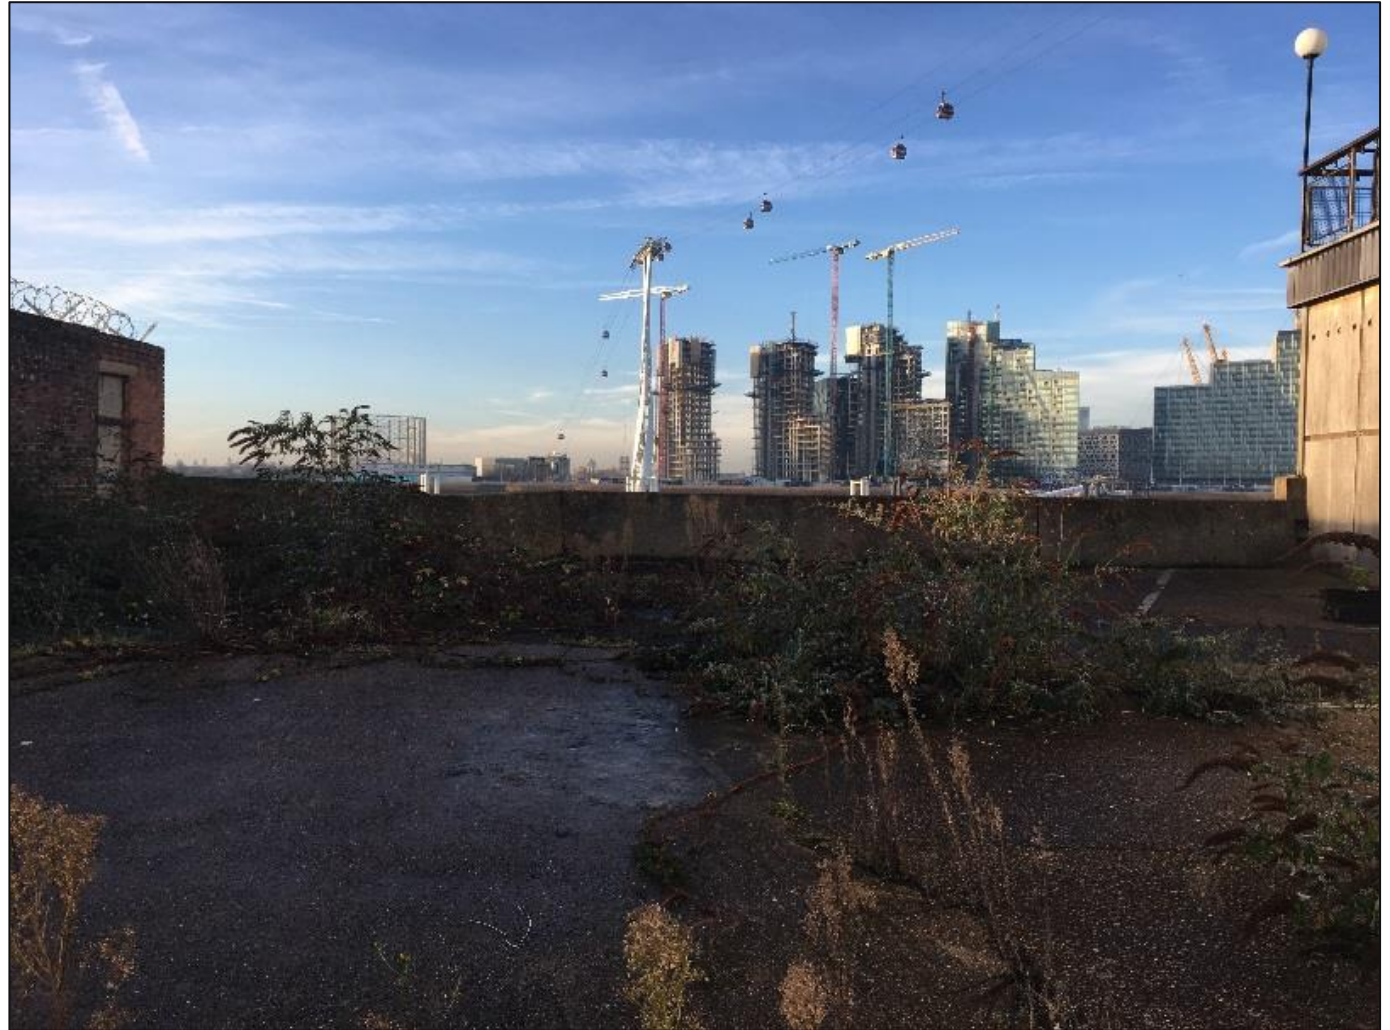
- Hard standing generally in good condition.
- Existing cracks in hard standing previously observed during 23rd February inspection.
- No new cracks observed in concrete parapet wall or concrete hard standing.
- No obvious indications of movement or settlement of parapet wall or hard standing.
- Vegetation present within cracks in hard standing, with increased growth since 23rd February 2017 inspection.

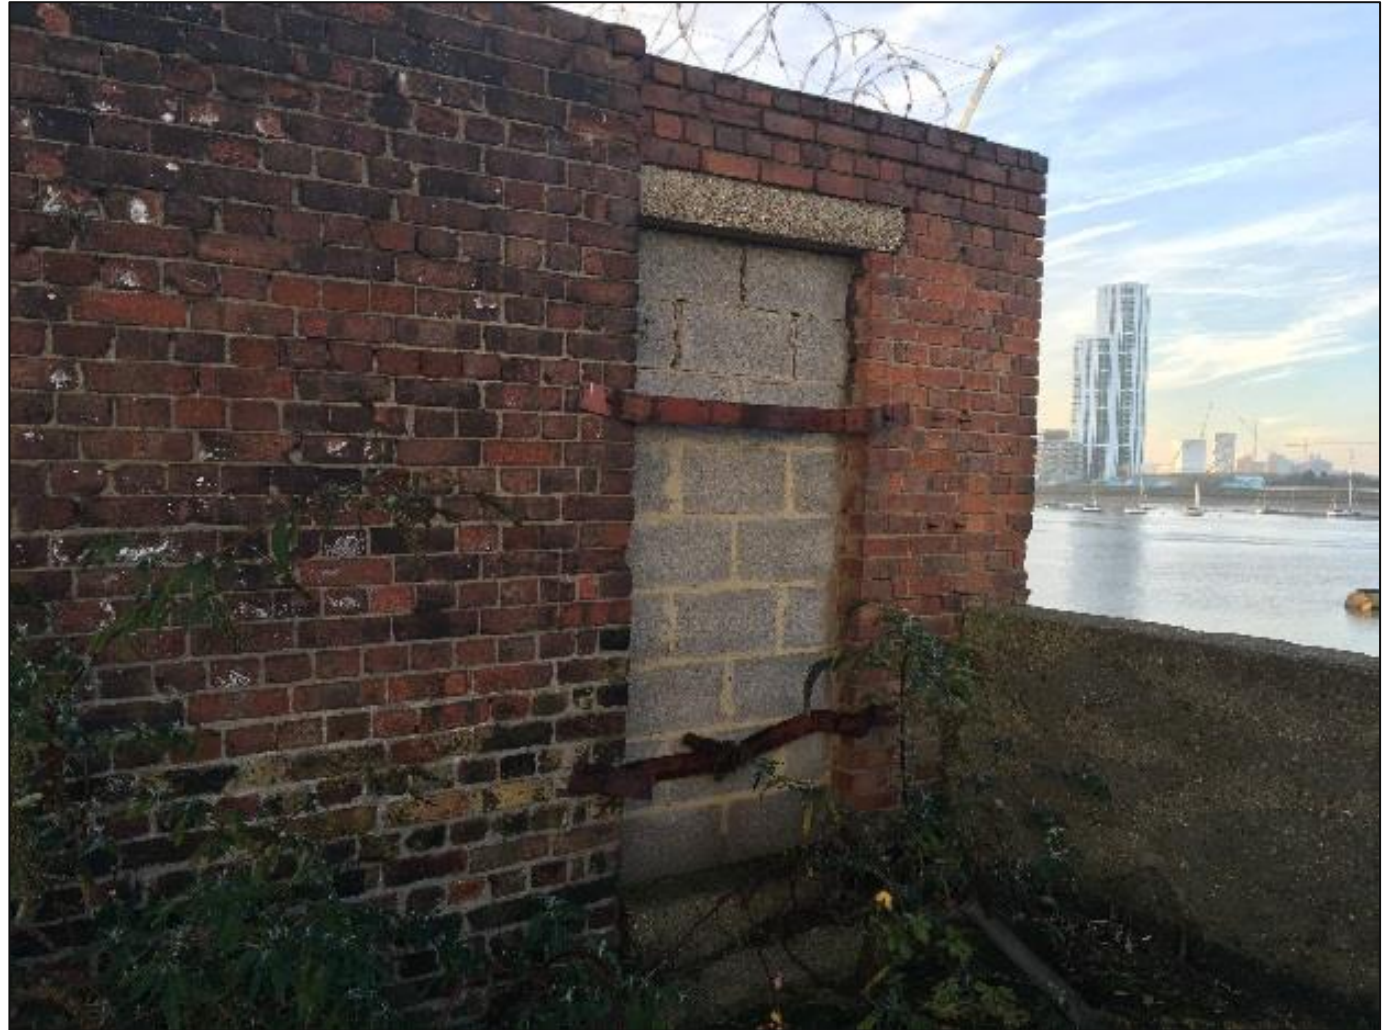
- Brick wall perpendicular to river wall, at south boundary of Dohm Wharf river wall.
- Existing crack in brick wall unchanged since last inspection. See location 3 for detail.
- No new cracks observed in concrete parapet wall, adjoining red brick wall or concrete hardstanding.

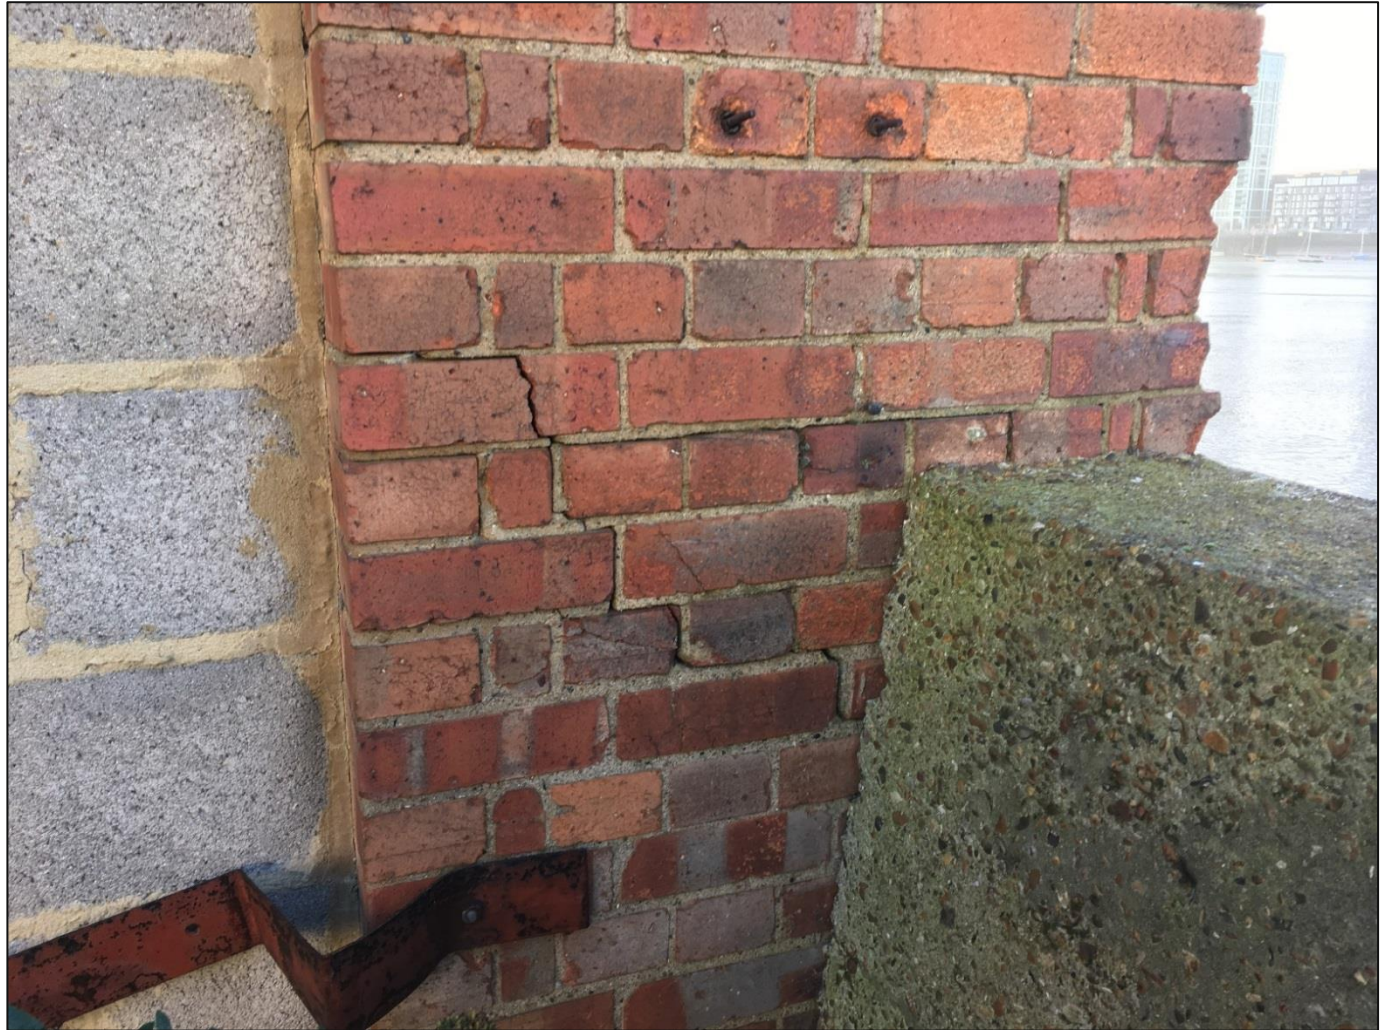
- Brick wall perpendicular to river wall, at south boundary of Dohm Wharf river wall.
- Existing crack in brick wall at approximate level of crest of concrete parapet wall.
- Extent of crack remains unchanged since 23rd February 2017 inspection.
- Crack does not appear to have widened since 23rd February 2017 inspection.
- No obvious indications of movement or settlement.

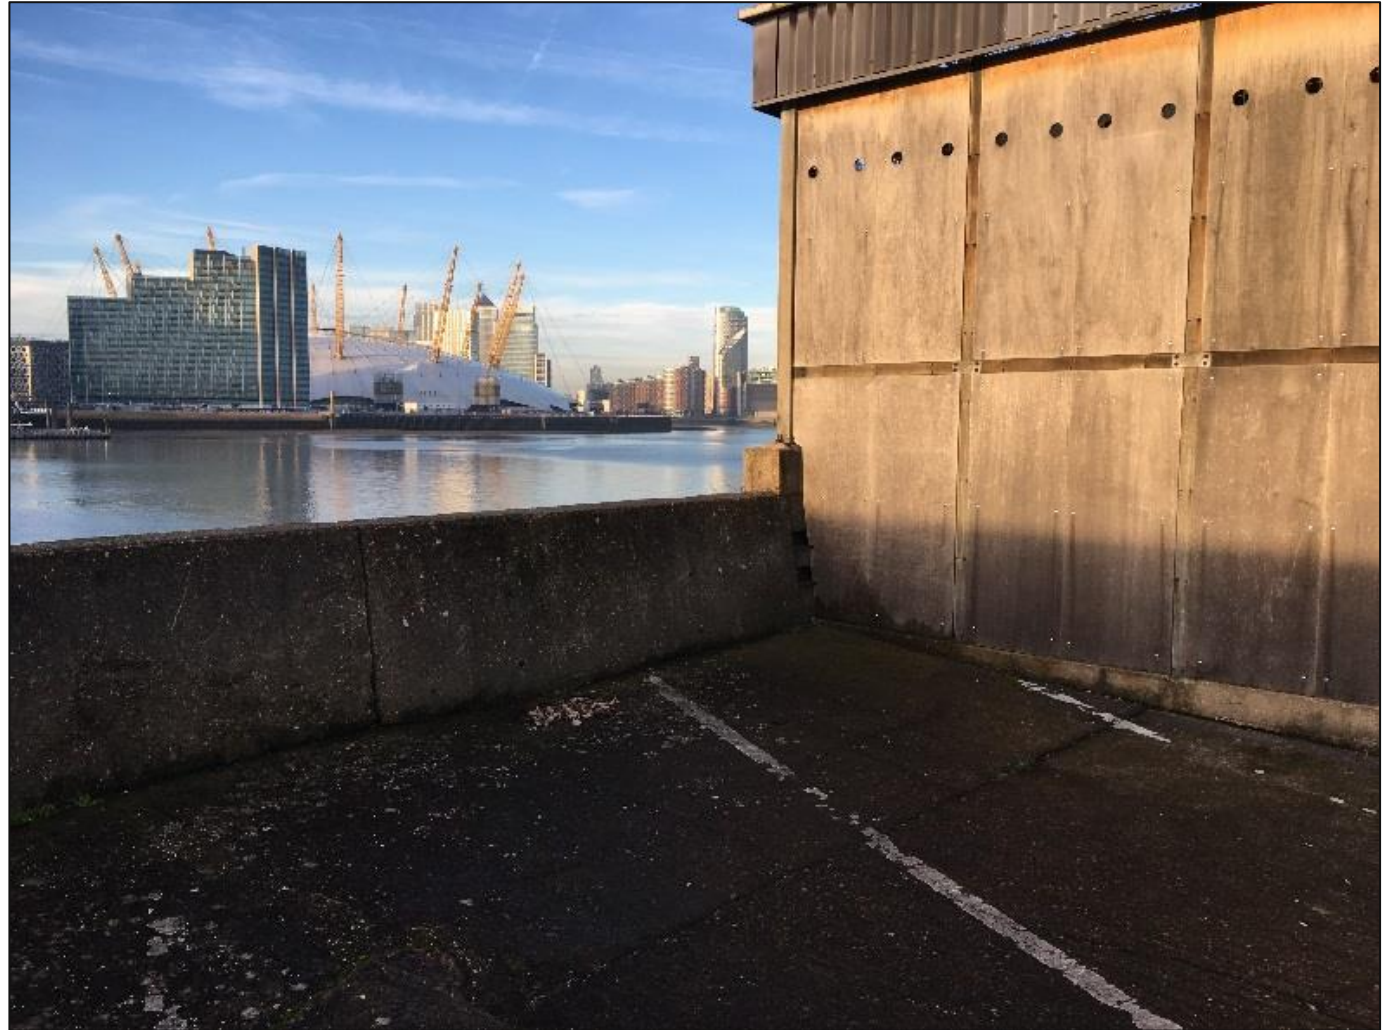
- No new cracks observed in concrete parapet wall or concrete hard standing.
- No evidence of movement at interface between timber hoarding, concrete parapet wall and concrete hard standing.
- No obvious indications of movement or settlement of parapet wall or hard standing.
