Project Thames Side West

Subject Dohm Wharf River Wall Quarterly Inspection – February 2019

Project no 035668

Date 14 February 2019

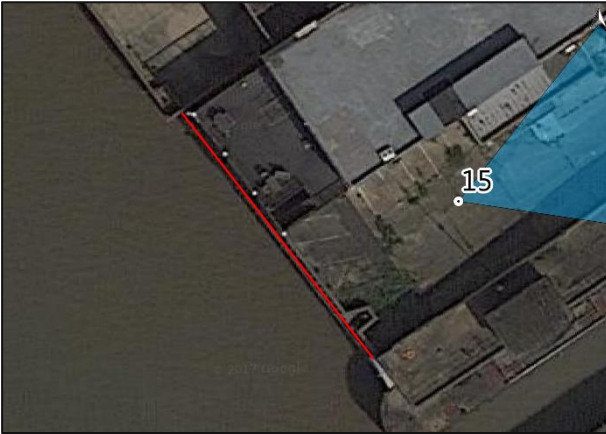
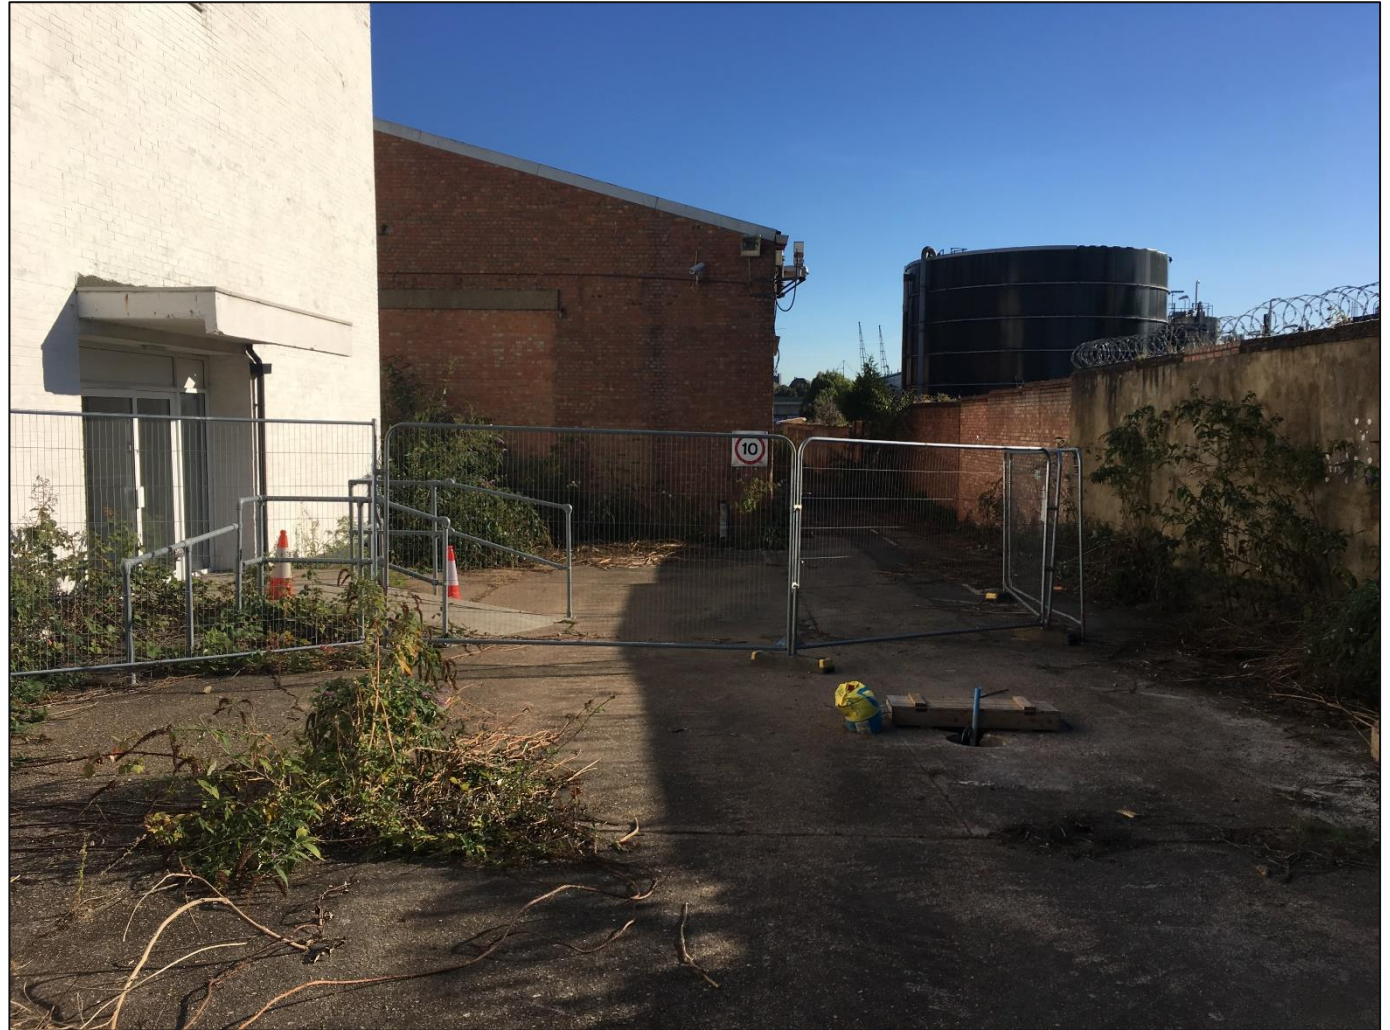
Location 15

Hard standing area – view away from river wall

- Existing cracks in concrete hard standing first observed during first inspection on 19th December 2017.
- No new cracks or other evidence of movement or settlement within concrete hard standing observed.
- Borehole within concrete hardstanding, containing monitoring equipment. Presumed to be part of site investigation works by TfL for the Silvertown Tunnel.

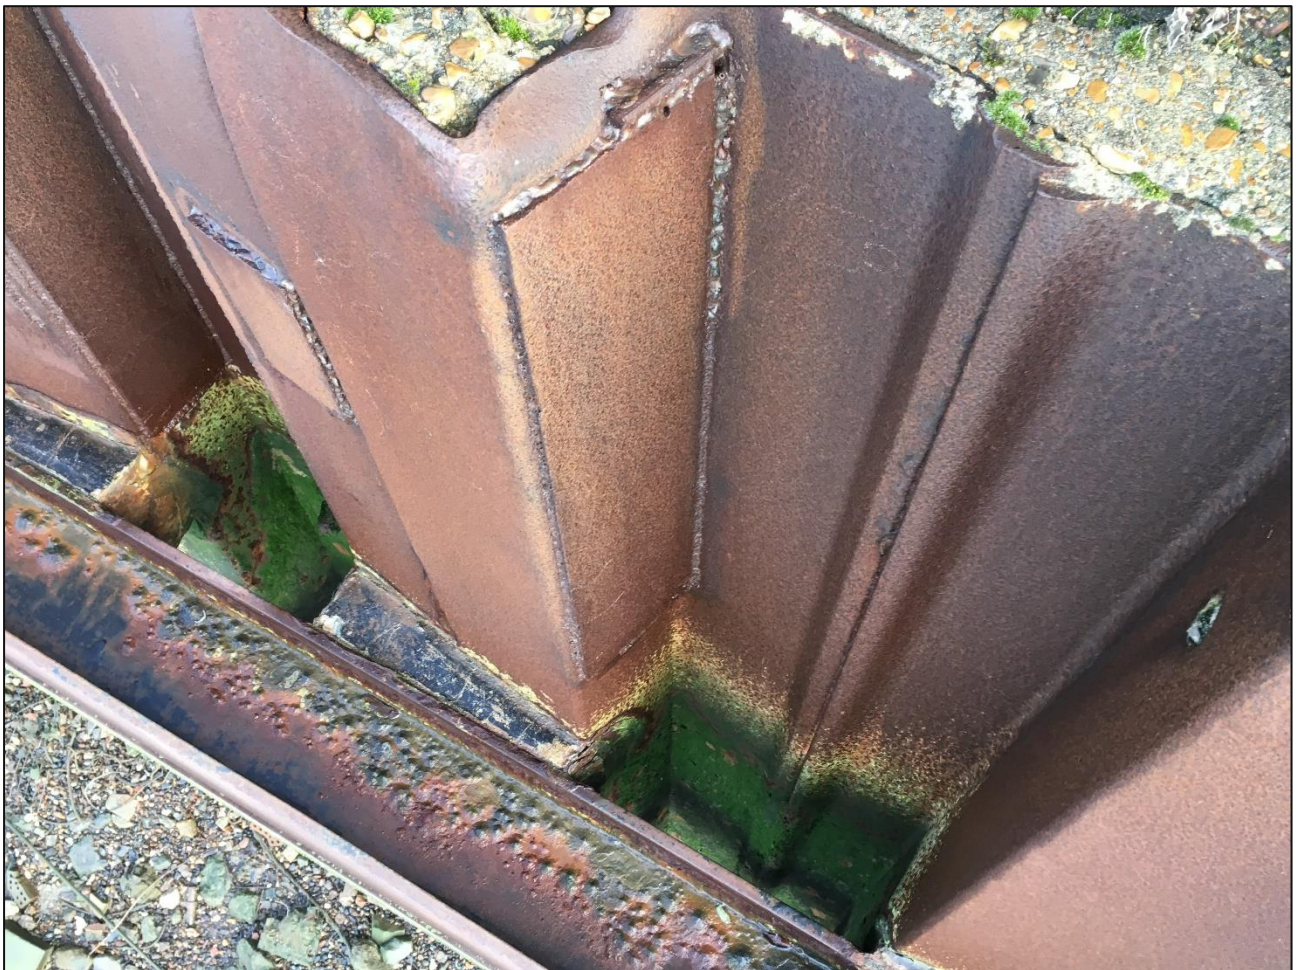
Figure 3.1: Typical photograph of upper level of river wall, showing steel plate repairs to sheet piling, taken from the land side of the river wall

All plate repairs appear to remain securely welded to the existing sheet pile sections and there is no evidence of further degradation of the condition of the remaining steel. Figure 3.1 shows a typical photograph of the upper level of the river wall, showing the steel plate repairs securely welded to the sheet piling.

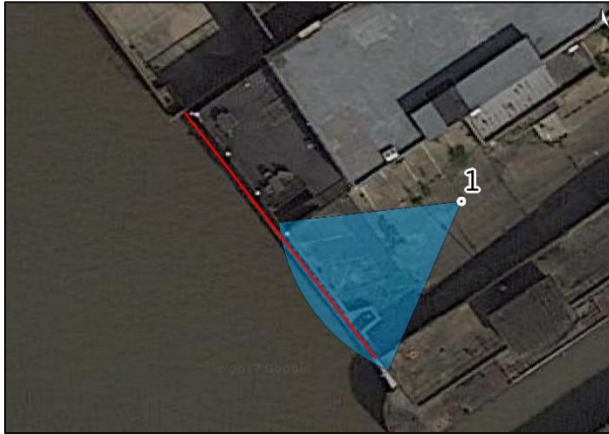
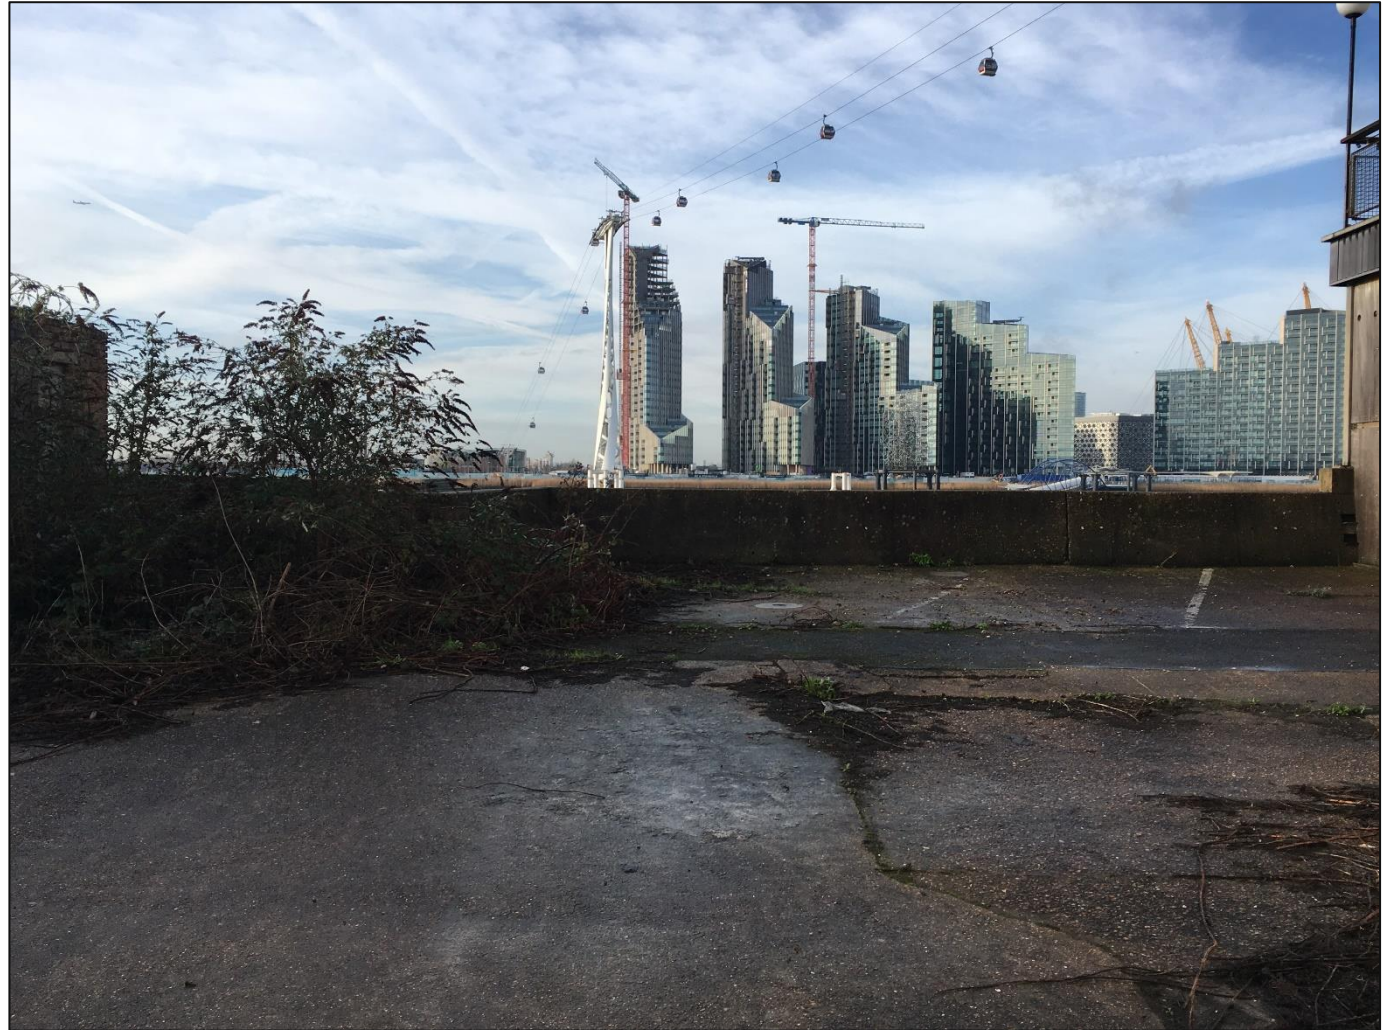
Location 1

Hard standing area – overview of parapet wall

- Hard standing generally in good condition.
- Existing cracks in hard standing previously observed during 23rd February 2017, 19th December 2017, 22nd March 2018, 25th June 2018 and 26th September 2018 inspections.
- No new cracks observed in concrete parapet wall or concrete hard standing.
- No obvious indications of movement or settlement of parapet wall or hard standing.
- Vegetation within concrete hard standing has been partially cut back since previous inspection on 26th September 2018.

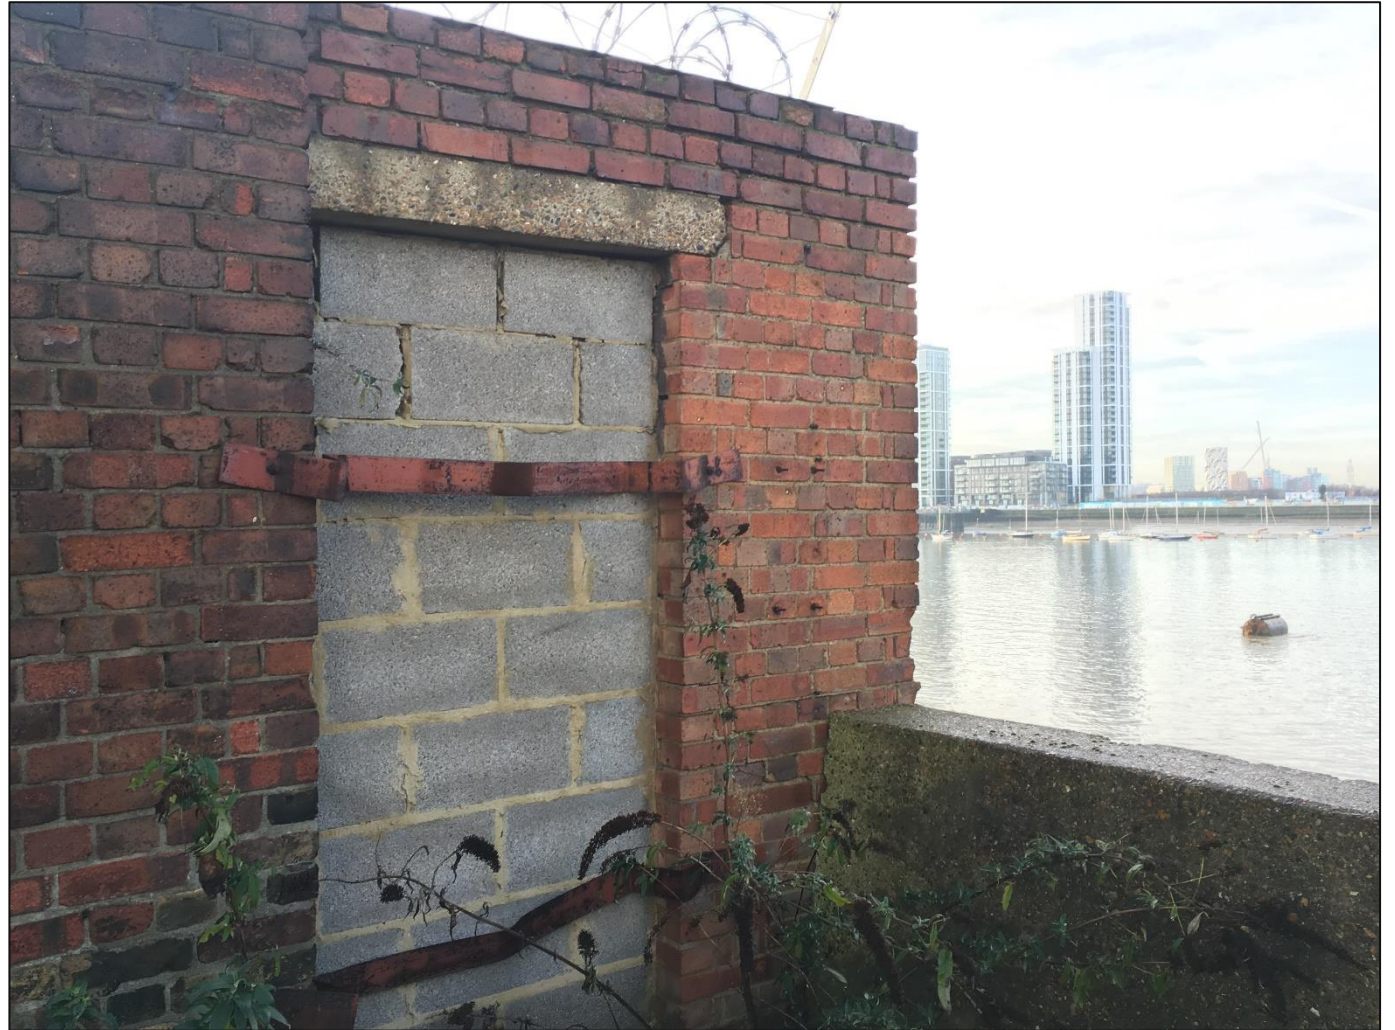
Location 2

Hard standing area – south corner

- Brick wall perpendicular to river wall, at south boundary of Dohm Wharf river wall.
- Existing crack in brick wall unchanged since last inspection. See location 3 for detail.
- No new cracks observed in concrete parapet wall, adjoining red brick wall or concrete hardstanding.
-

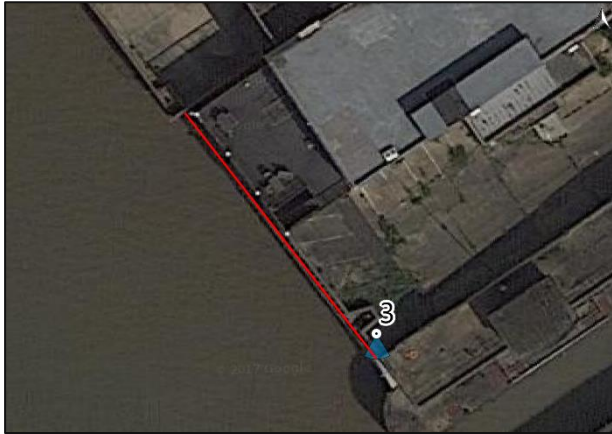
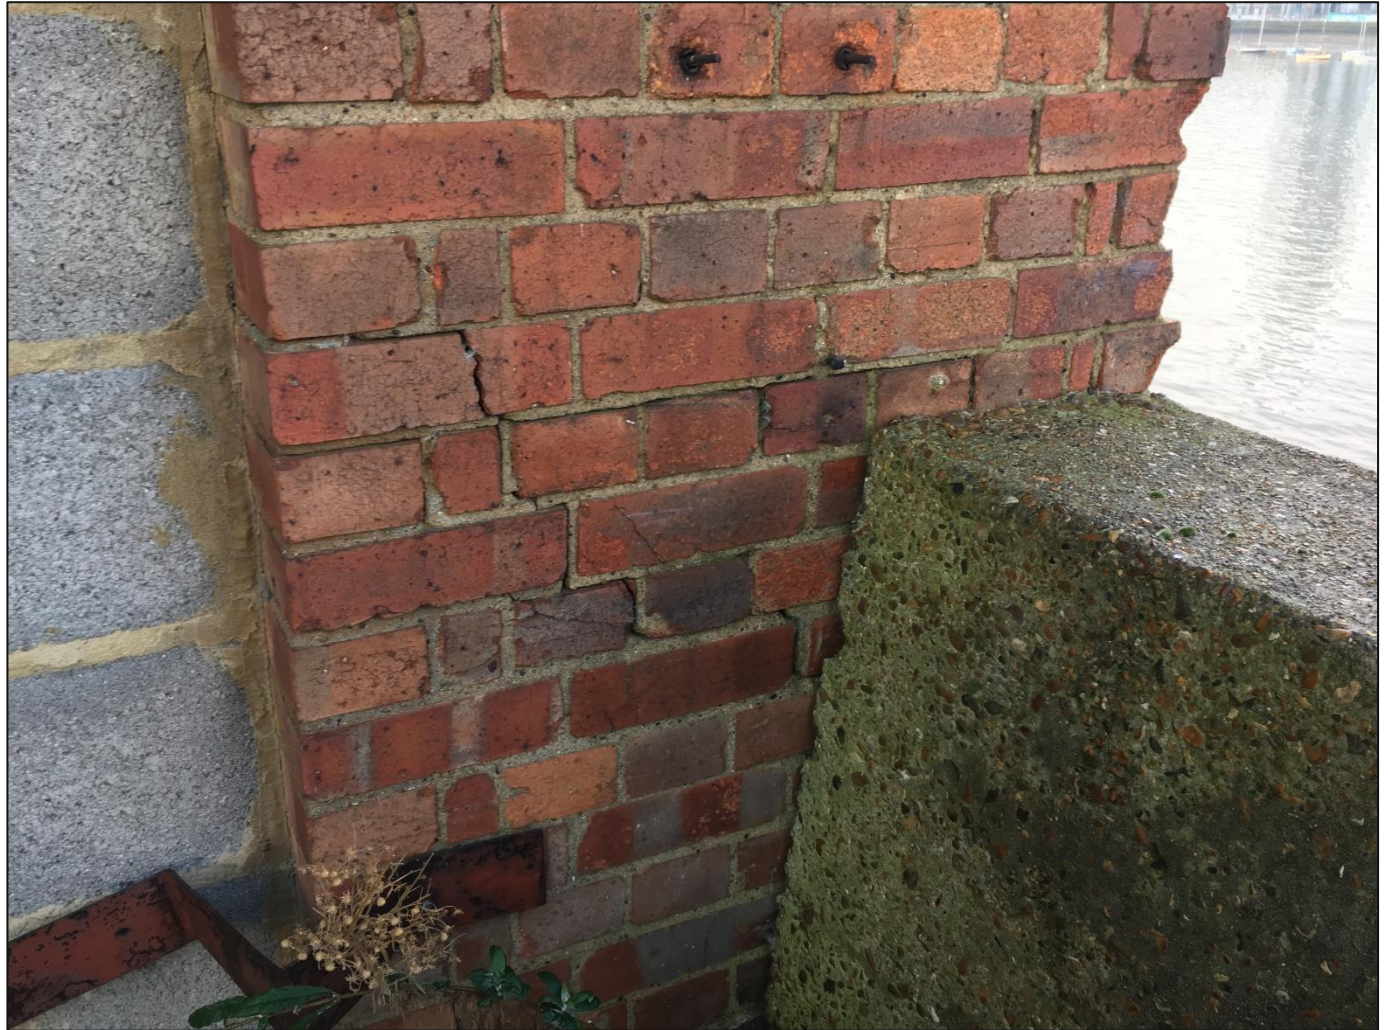
Location 3

Hard standing area – south corner brick wall crack detail

- Brick wall perpendicular to river wall, at south boundary of Dohm Wharf river wall.
- Existing crack in brick wall at approximate level of crest of concrete parapet wall first observed during first inspection on 19th December 2017.
- Extent of crack remains unchanged since 19th December 2017, 22nd March 2018, 25th June 2018 and 26th September 2018 inspections.
- Crack does not appear to have widened since 19th December 2017, 22nd March 2018, 25th June 2018 and 26th September 2018 inspections.
- No new cracks observed within brick wall or concrete parapet wall.
- No obvious indications of movement or settlement.

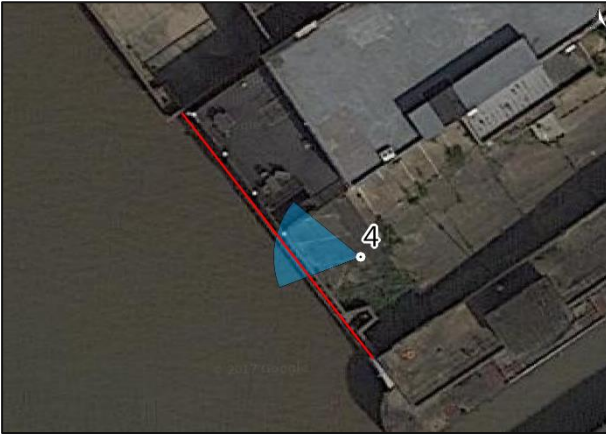
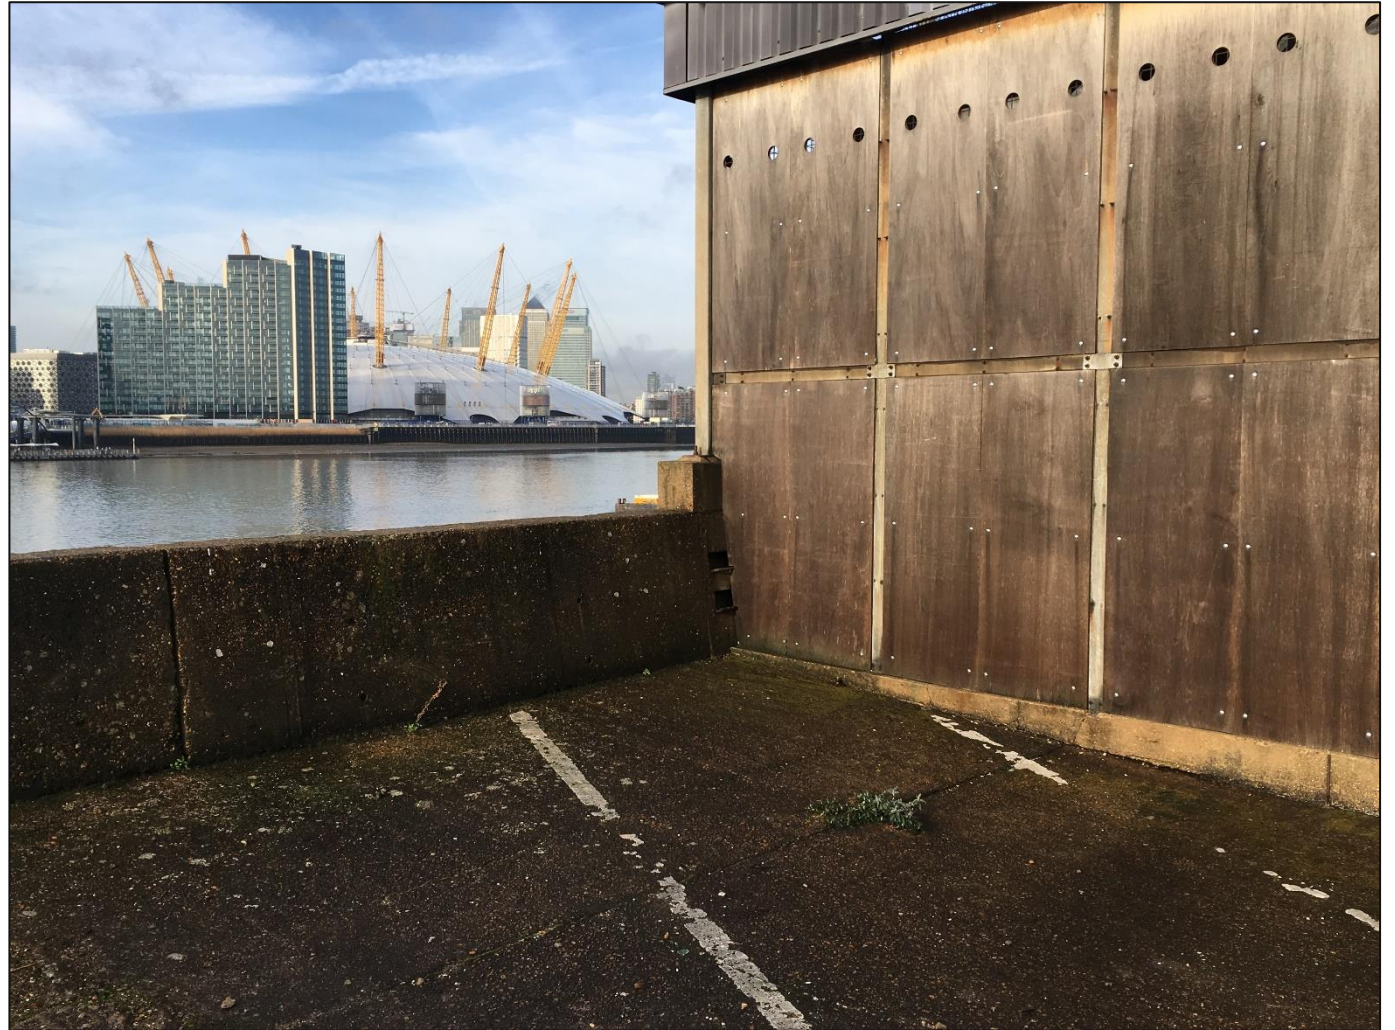
Location 4

Hard standing area – north corner

- No cracks observed in concrete parapet wall or concrete hard standing during first inspection on 19th December 2017.
- No new cracks observed in concrete parapet wall or concrete hard standing.
- No evidence of movement at interface between timber hoarding, concrete parapet wall and concrete hard standing.
- No obvious indications of movement or settlement of parapet wall or hard standing.

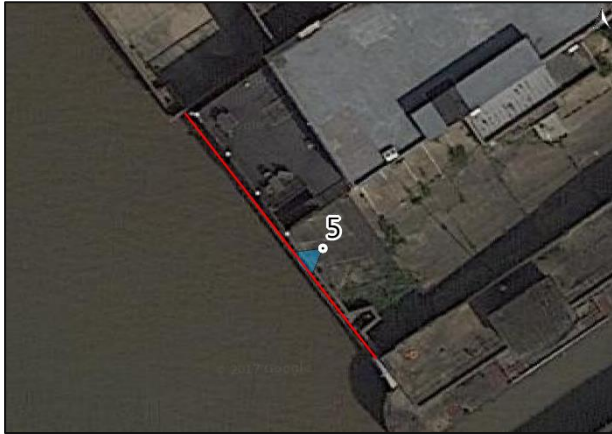
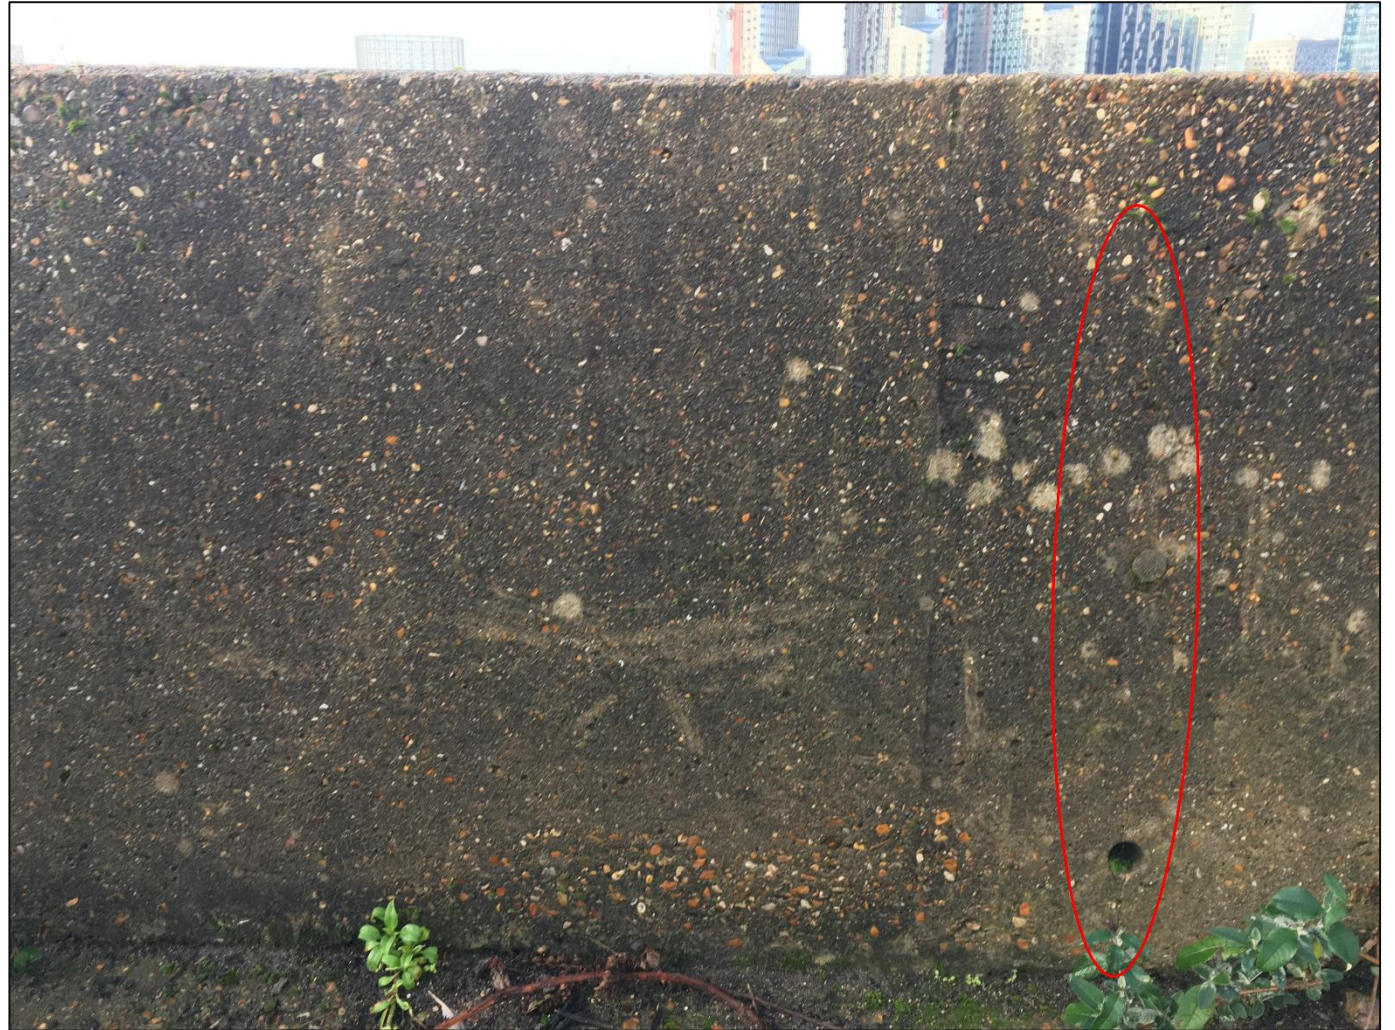
Location 5

Hard standing area – crack in parapet wall

- Existing hairline crack in concrete parapet wall first observed during first inspection on 19th December 2017.
- Crack originates through penetration in wall, assumed to be a construction defect rather than caused by movement of the river wall.
- No new cracks observed in concrete parapet wall or concrete hard standing.
- No evidence of movement since previous inspection on 26th September 2018.

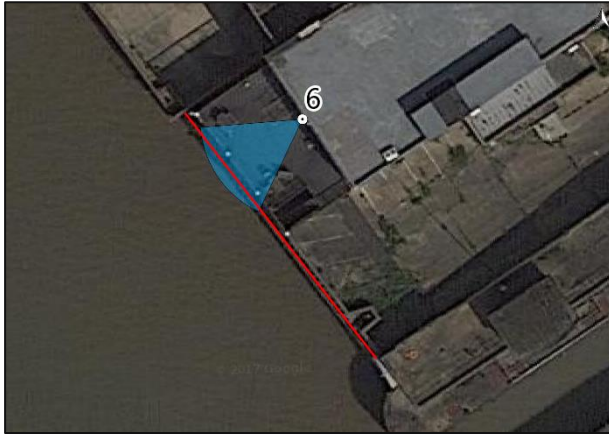
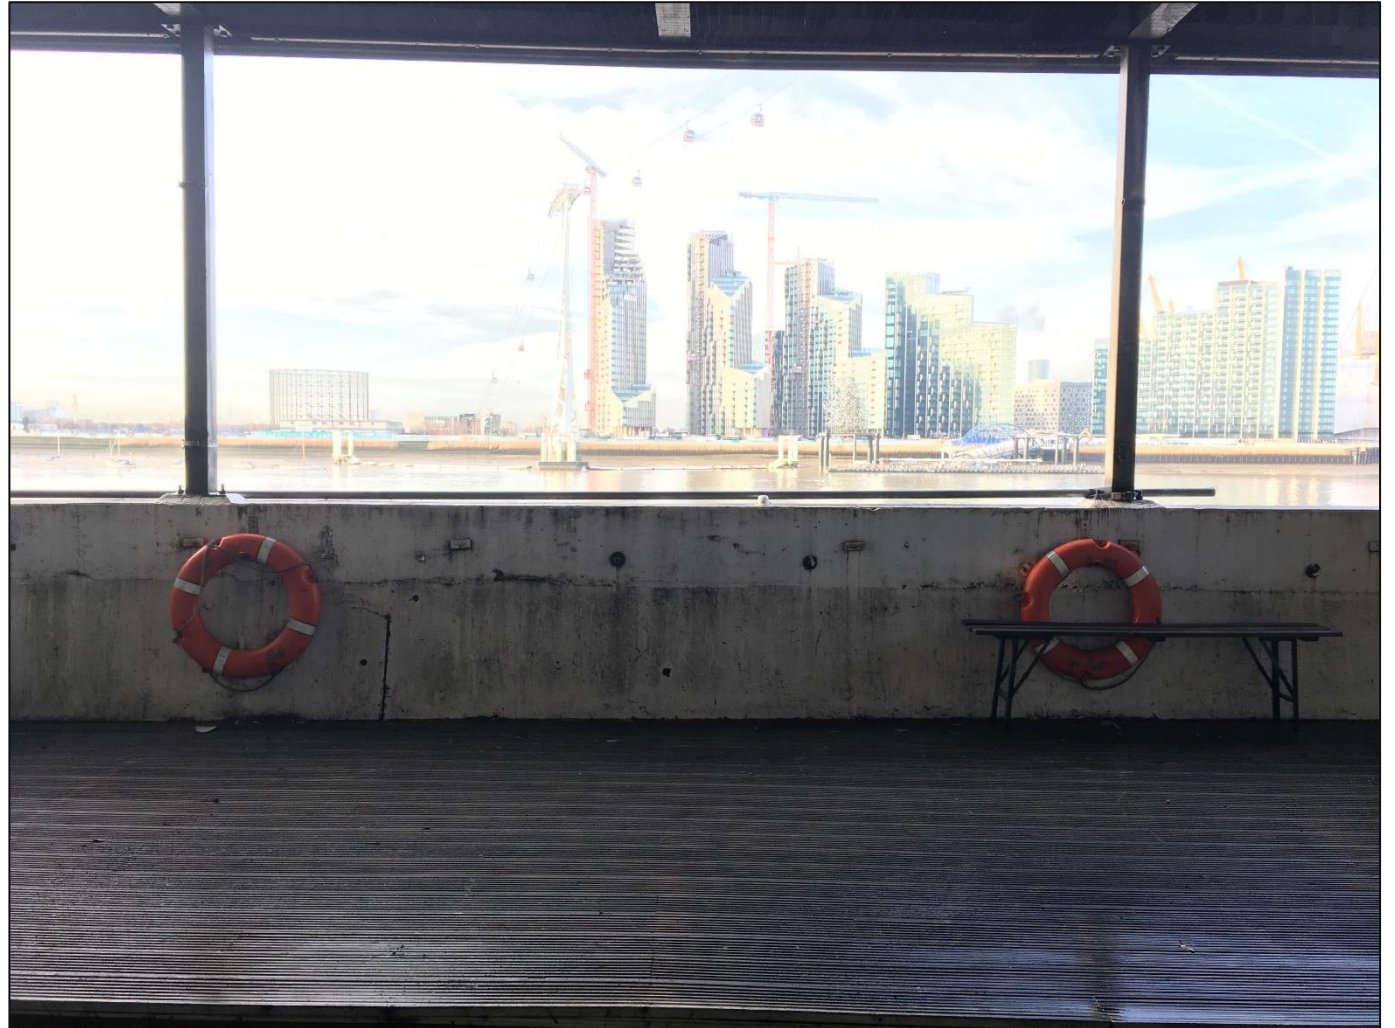
Location 6

TOBS terrace area – overview of parapet wall

- No new cracks observed in concrete parapet wall.
- Inspection of ground behind parapet wall prevented by presence of timber deck.
- No obvious indications of movement or settlement.

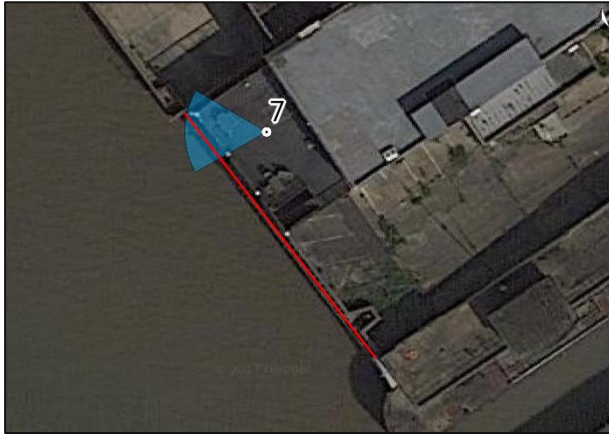
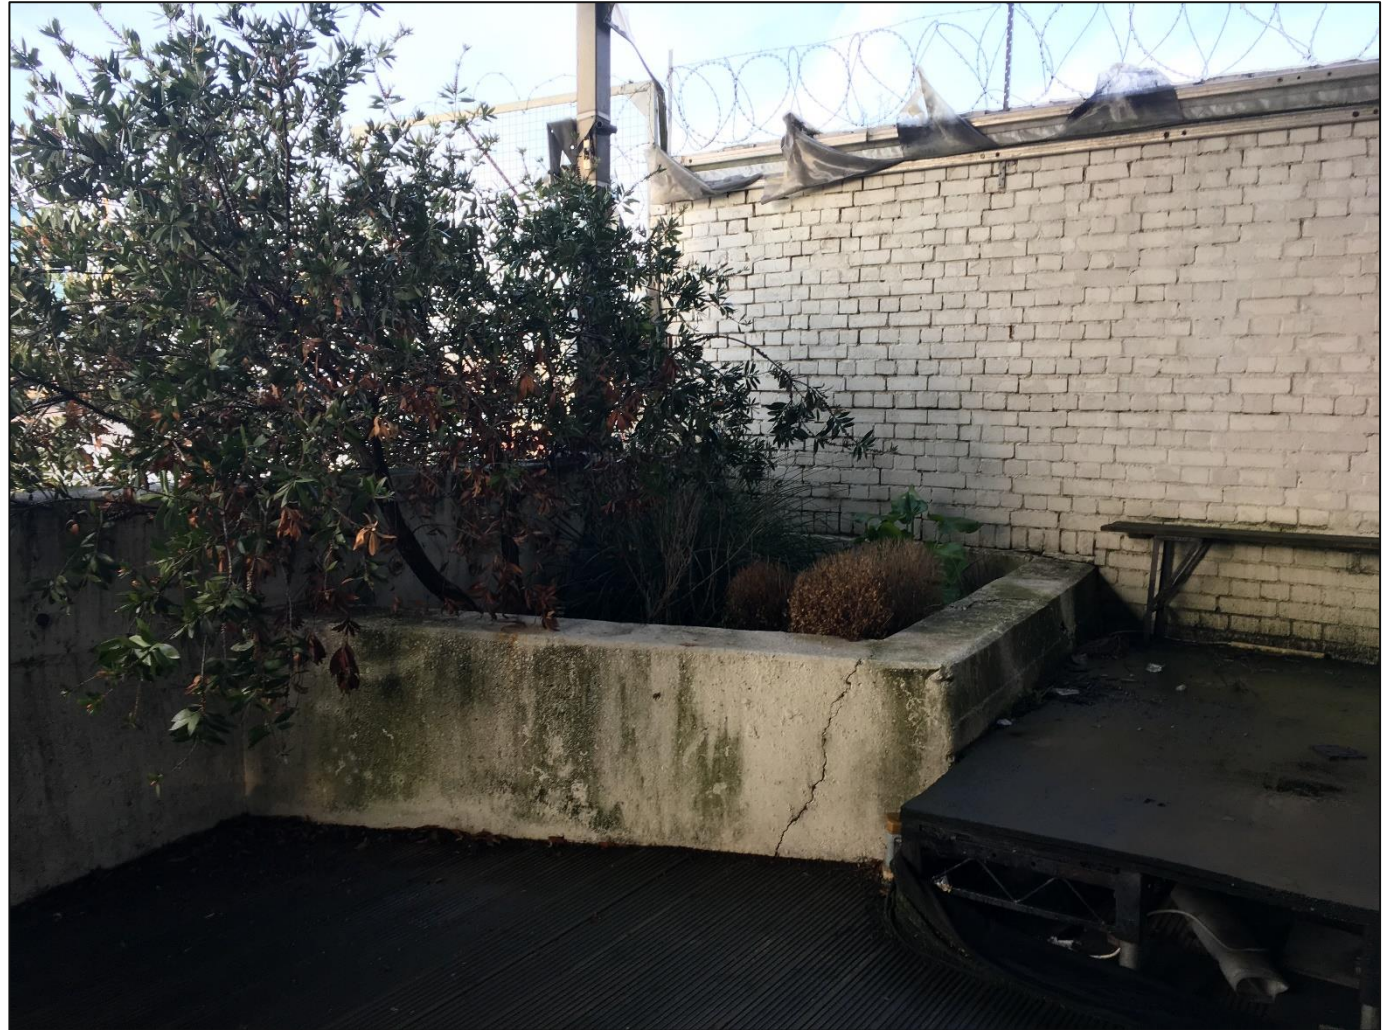
Location 7

TOBS terrace area – north corner

- Existing crack in wall of concrete planter first observed during first inspection on 19th December 2017. See location 8 for detail.
- No new cracks observed in concrete parapet wall or adjoining brick wall.
- No obvious indications of movement or settlement.

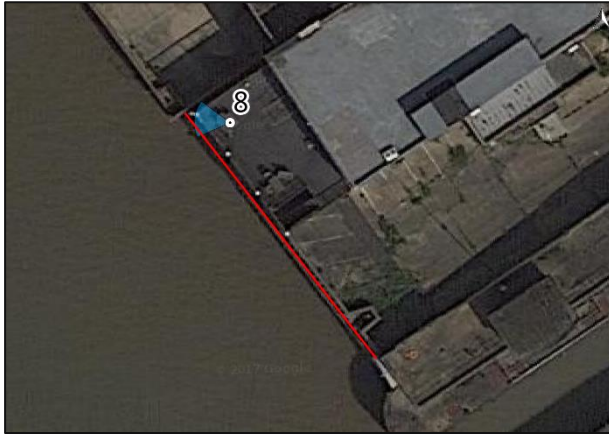
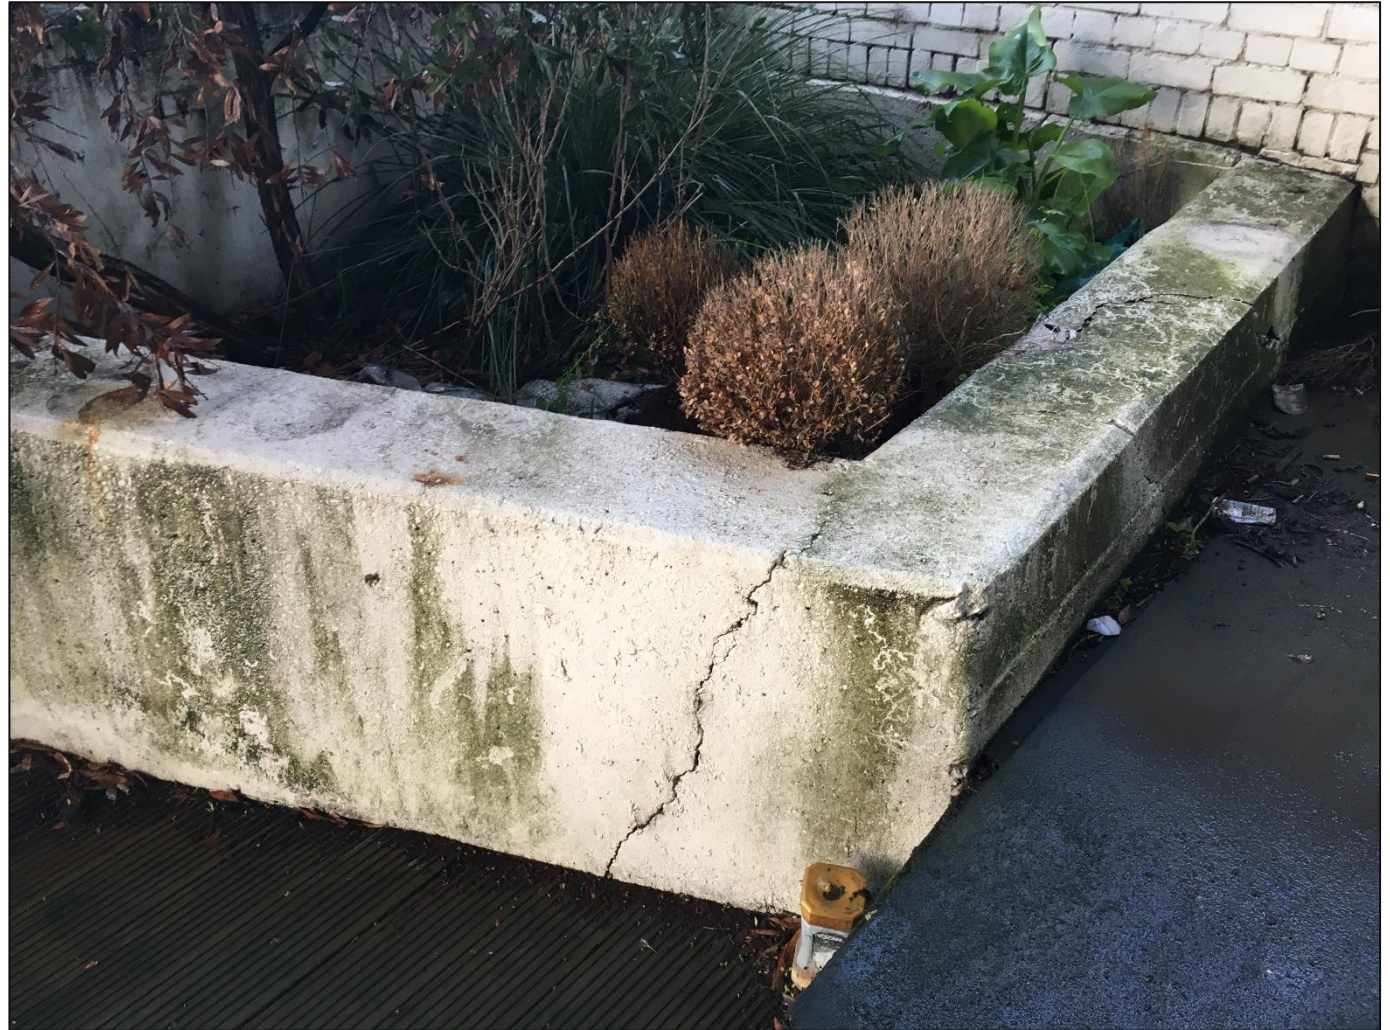
Location 8

TOBS terrace area – north corner planter crack detail

- Existing crack in wall of concrete planter first observed during first inspection on 19th December 2017.
- Extent of crack remains unchanged since last inspection.
- No evidence to indicate that crack has widened since last inspection.
- No new cracks observed in wall of concrete planter.

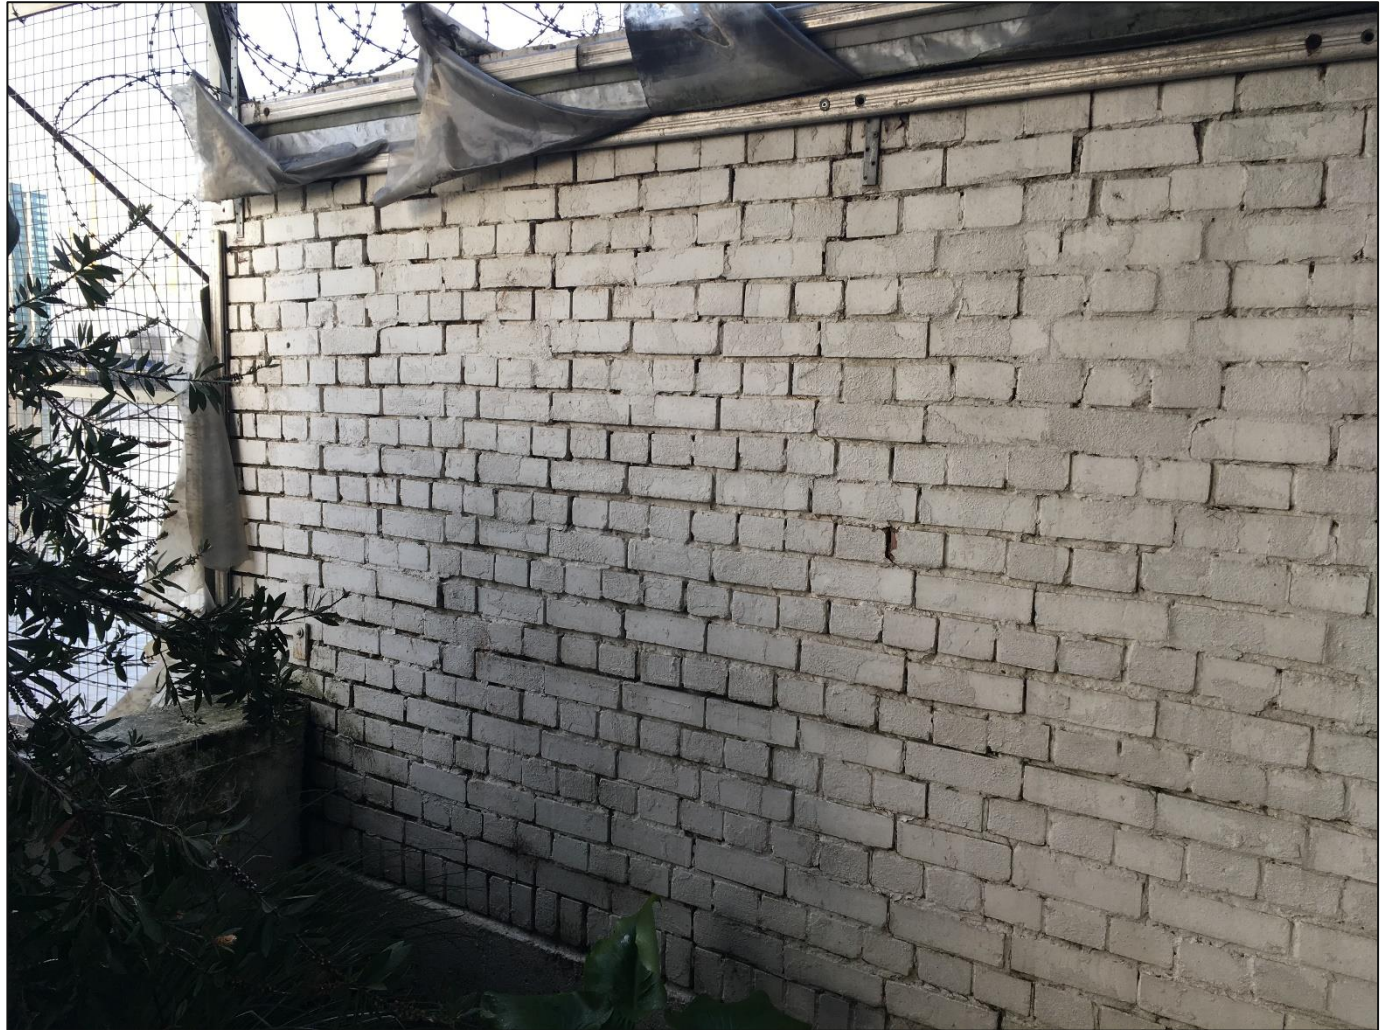
Location 9

TOBS terrace area – north cornered brick wall detail

- Adjoining brick wall at north boundary of Dohm Wharf river wall.
- Existing minor crack along horizontal mortar joints in brick wall first observed during first inspection on 19th December 2017.
- No evidence to indicate that crack has widened or extended since last inspection.
- No new cracks observed in brick wall.
- Note that condition of mortar is poor in places.

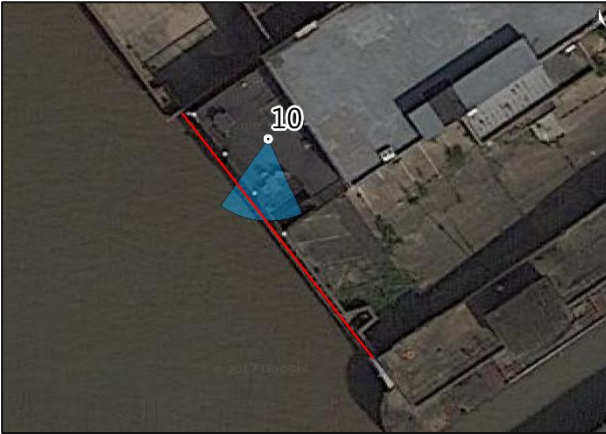
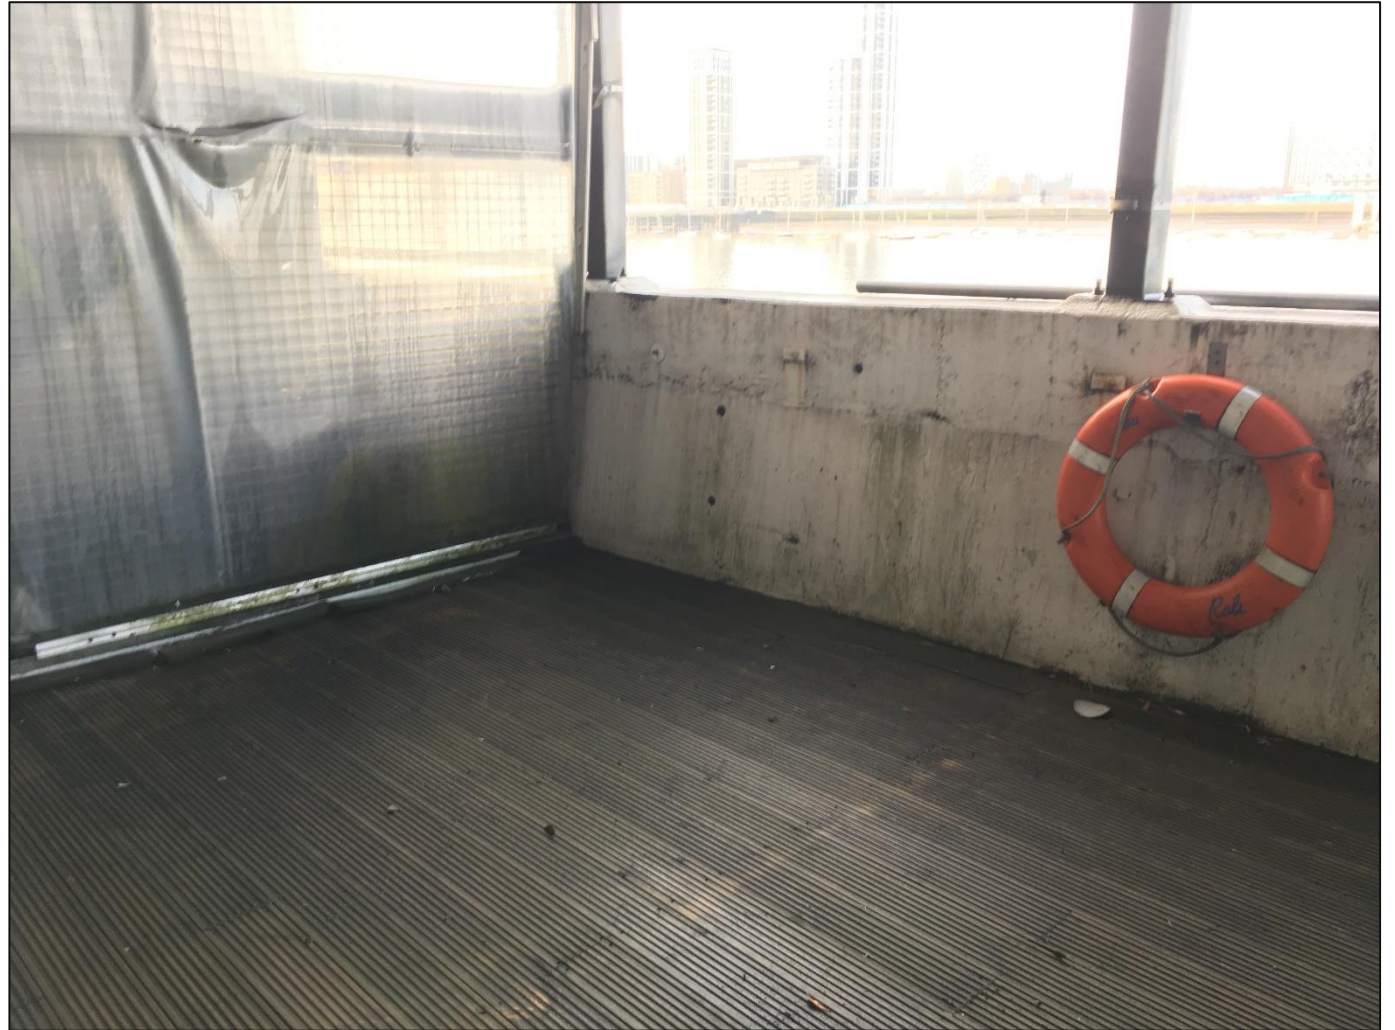
Location 10

TOBS terrace area – south corner

- No new cracks observed in concrete parapet wall.
- No obvious indications of movement or settlement.

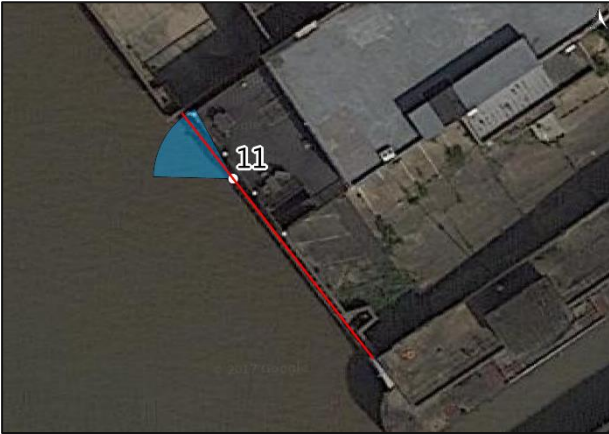
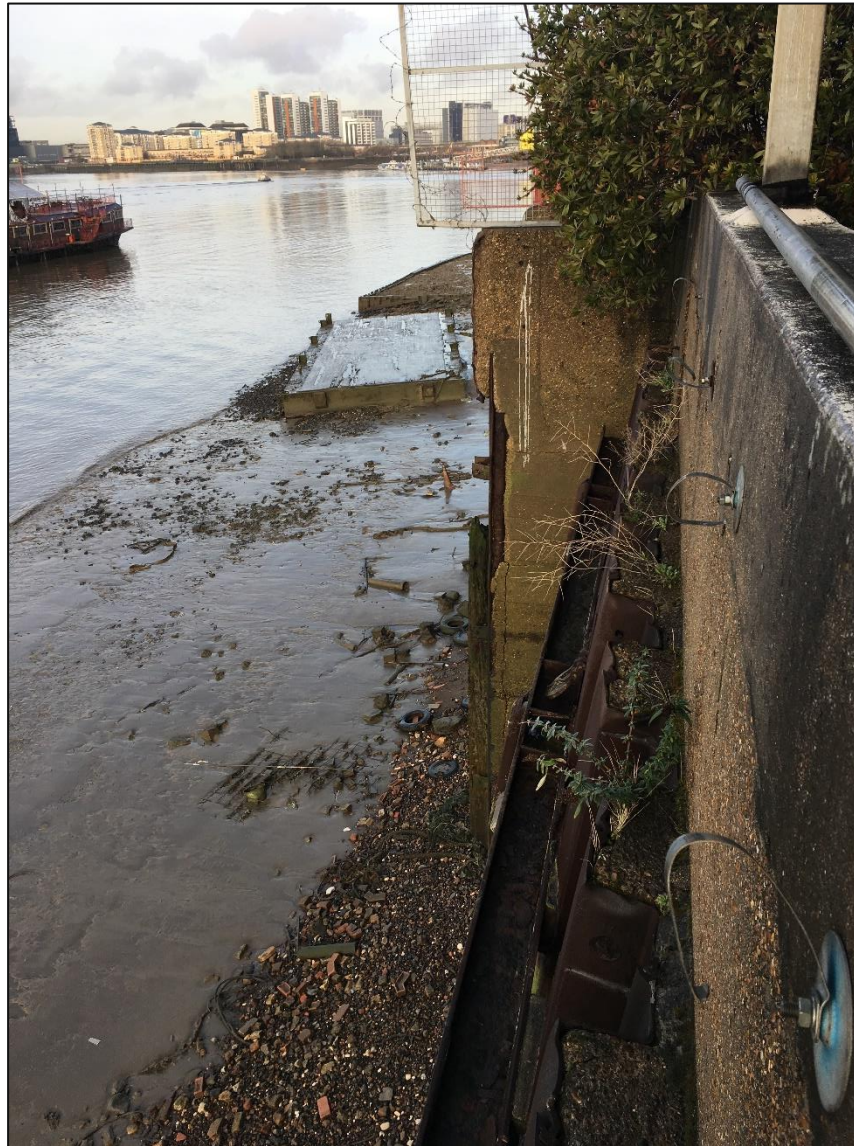
Location 11

TOBS terrace area – end face of adjacent wall to north

- Adjoining river wall to north steps out from alignment of Dohm Wharf river wall.
- Reinforcement within concrete face of adjoining river wall exposed, first observed during first inspection on 19th December 2017. No obvious deterioration since last visit on 26th September 2018.
- No evidence of movement at interface between two river walls.
