Project Thames Side West

Subject Dohm Wharf River Wall Quarterly Inspection – February 2019

Project no 035668

Date 14 February 2019

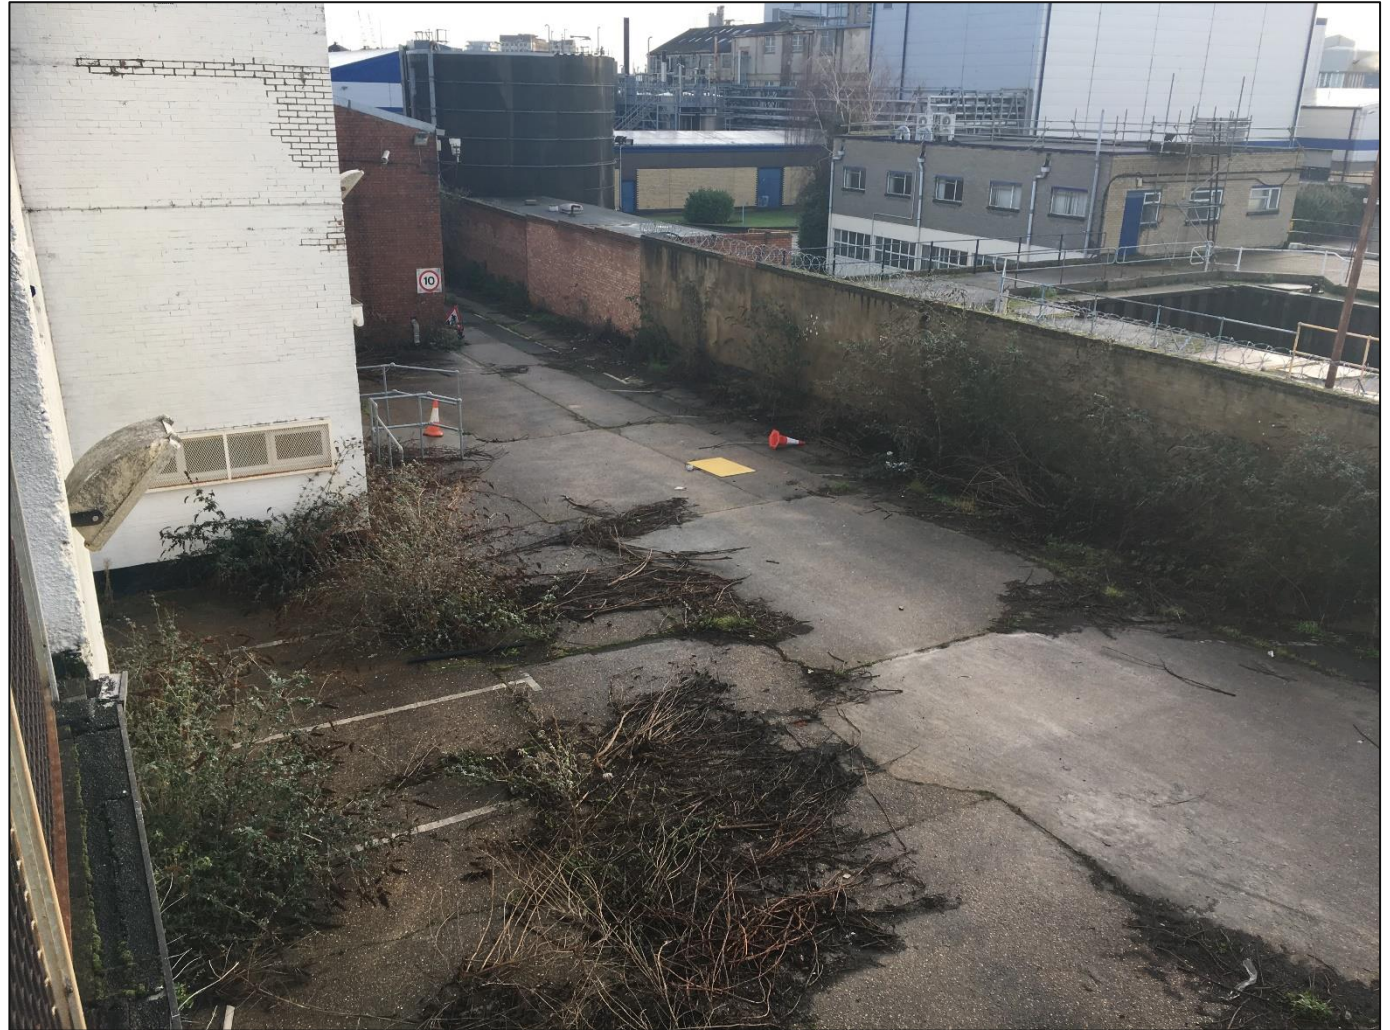
Location 12

Hard standing area – overview of hard standing

- Taken from the upper deck of the TOBS roof terrace.
- Existing cracks in concrete hard standing first observed during first inspection on 19th December 2017.
- No new cracks or other evidence of movement or settlement within concrete hard standing observed.
- Vegetation within concrete hard standing has been partially cut back since previous inspection on 26th September 2018.
- Borehole within concrete hardstanding, containing monitoring equipment. Presumed to be part of site investigation works by TfL for the Silvertown Tunnel.

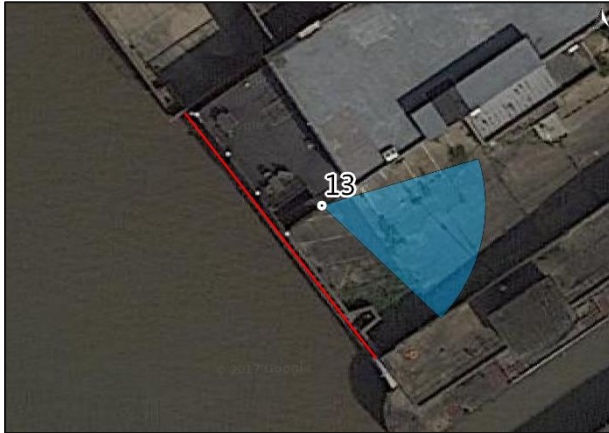
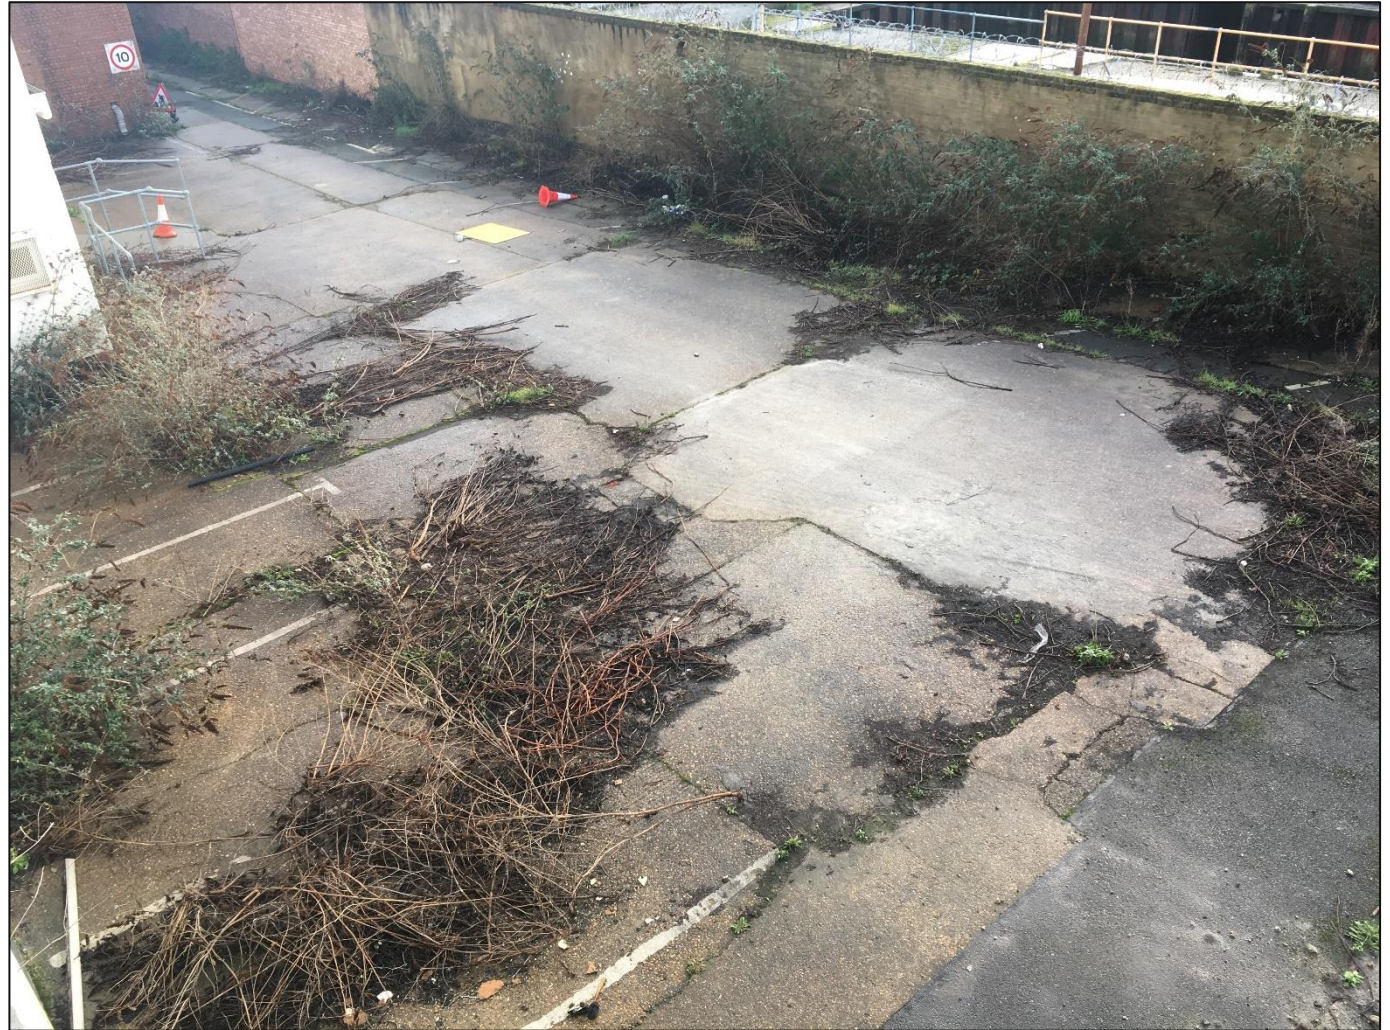
Location 13

Hard standing area – overview of hard standing

- Taken from the upper deck of the TOBS roof terrace.
- Existing cracks in concrete hard standing first observed during first inspection on 19th December 2017.
- No new cracks or other evidence of movement or settlement within concrete hard standing observed.
- Vegetation within concrete hard standing has been partially cut back since previous inspection on 26th September 2018. Borehole within concrete hardstanding, containing monitoring equipment. Presumed to be part of site investigation works by TfL for the Silvertown Tunnel.

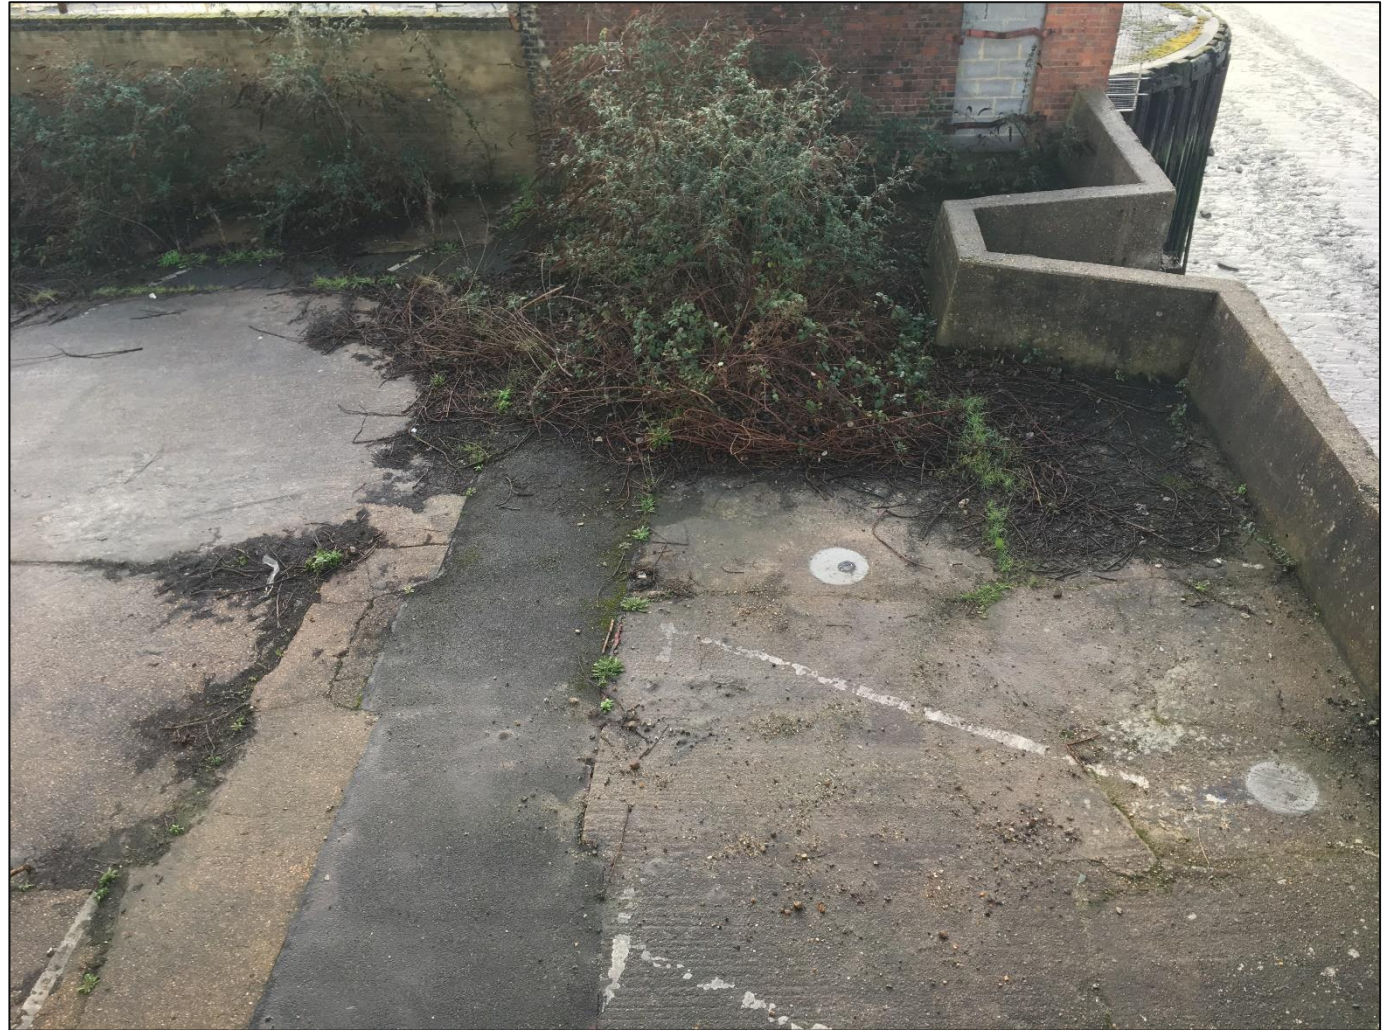
Location 14

Hard standing area – overview of hard standing

- Taken from the upper deck of the TOBS roof terrace.
- Existing cracks in concrete hard standing first observed during first inspection on 19th December 2017.
- No new cracks or other evidence of movement or settlement within concrete hard standing observed.
- Vegetation within concrete hard standing has been partially cut back since previous inspection on 26th September 2018.
- Borehole within concrete hardstanding approx. 2m from face of river wall has been capped. A second borehole approx. 0.5m from face of river wall has been backfilled with concrete. Presumed to be part of site investigation works by TfL for the Silvertown Tunnel.

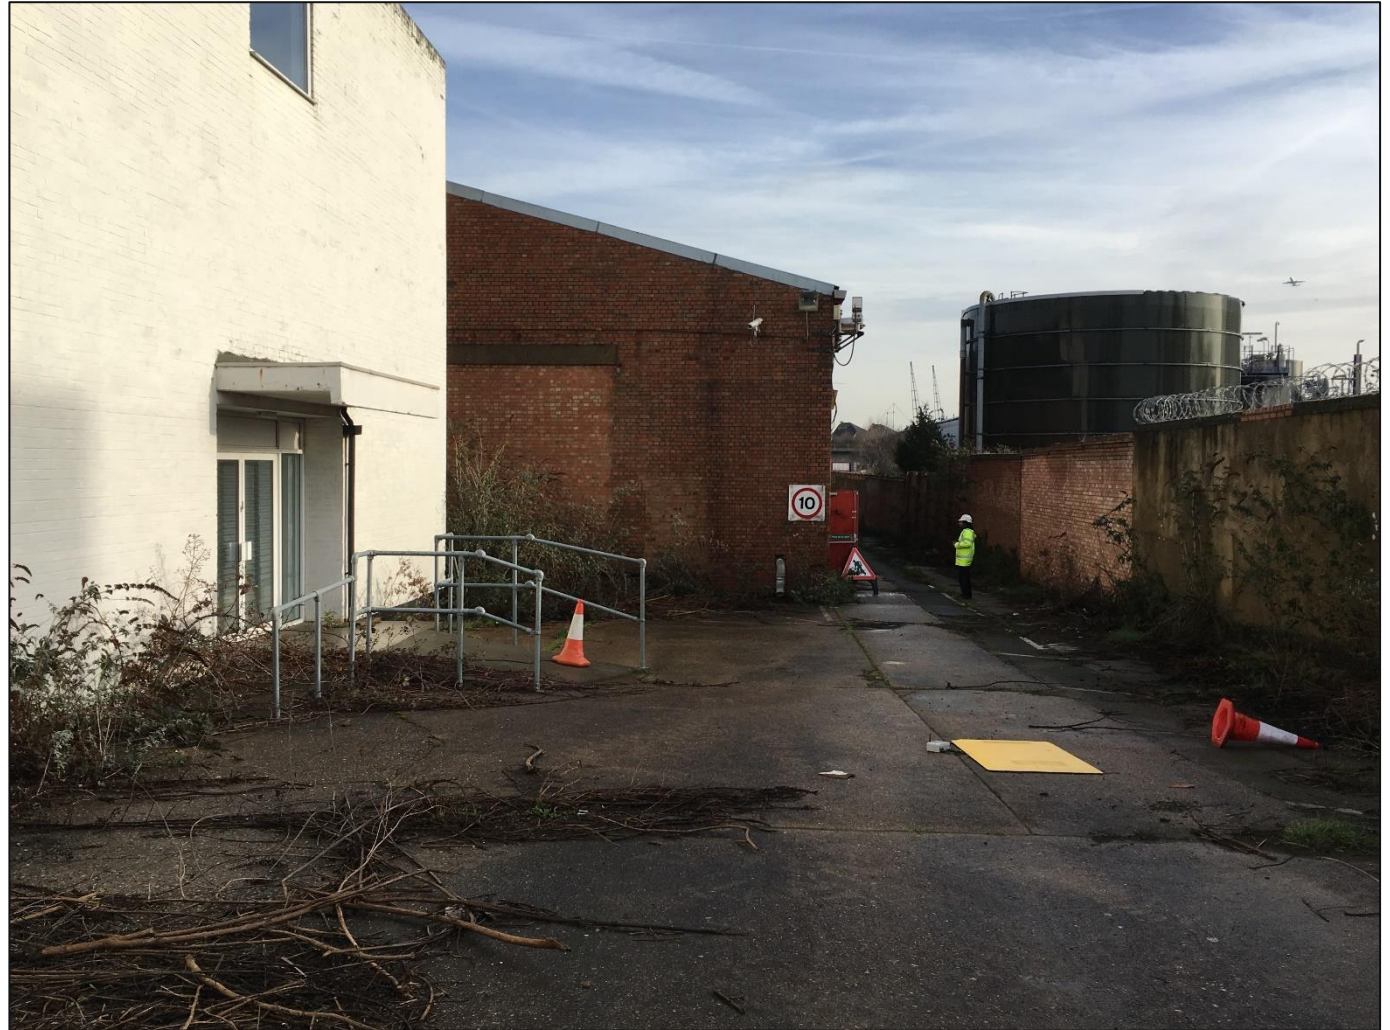
Location 15

Hard standing area – view away from river wall

- Existing cracks in concrete hard standing first observed during first inspection on 19th December 2017.
- No new cracks or other evidence of movement or settlement within concrete hard standing observed.
- Vegetation within concrete hard standing has been partially cut back since previous inspection on 26th September 2018
- Borehole within concrete hardstanding, containing monitoring equipment. Presumed to be part of site investigation works by TfL for the Silvertown Tunnel.

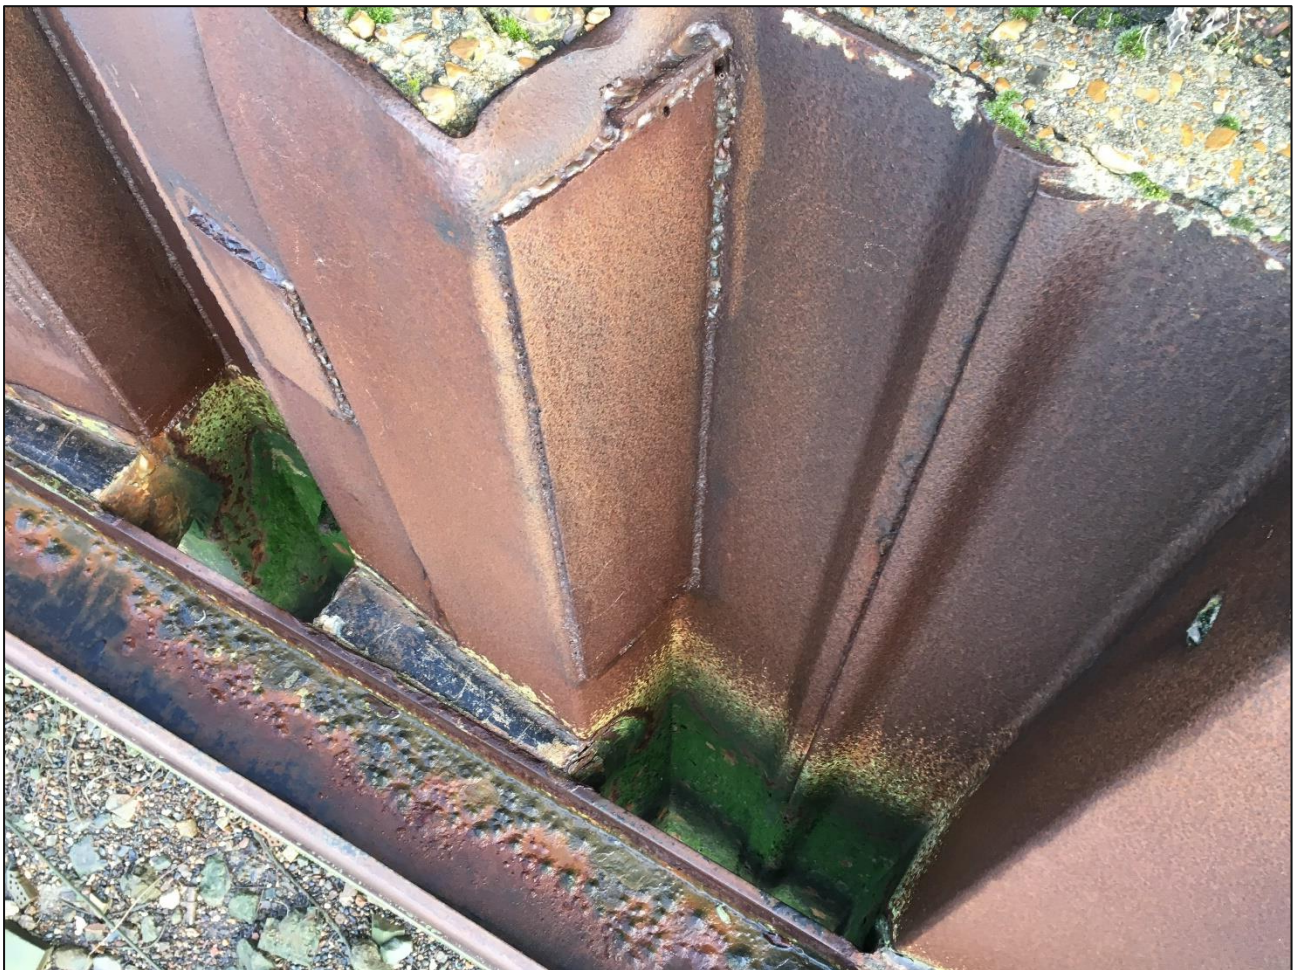
Figure 3.1: Typical photograph of upper level of river wall, showing steel plate repairs to sheet piling, taken from the land side of the river wall

All plate repairs appear to remain securely welded to the existing sheet pile sections and there is no evidence of further degradation of the condition of the remaining steel. Figure 3.1 shows a typical photograph of the upper level of the river wall, showing the steel plate repairs securely welded to the sheet piling.

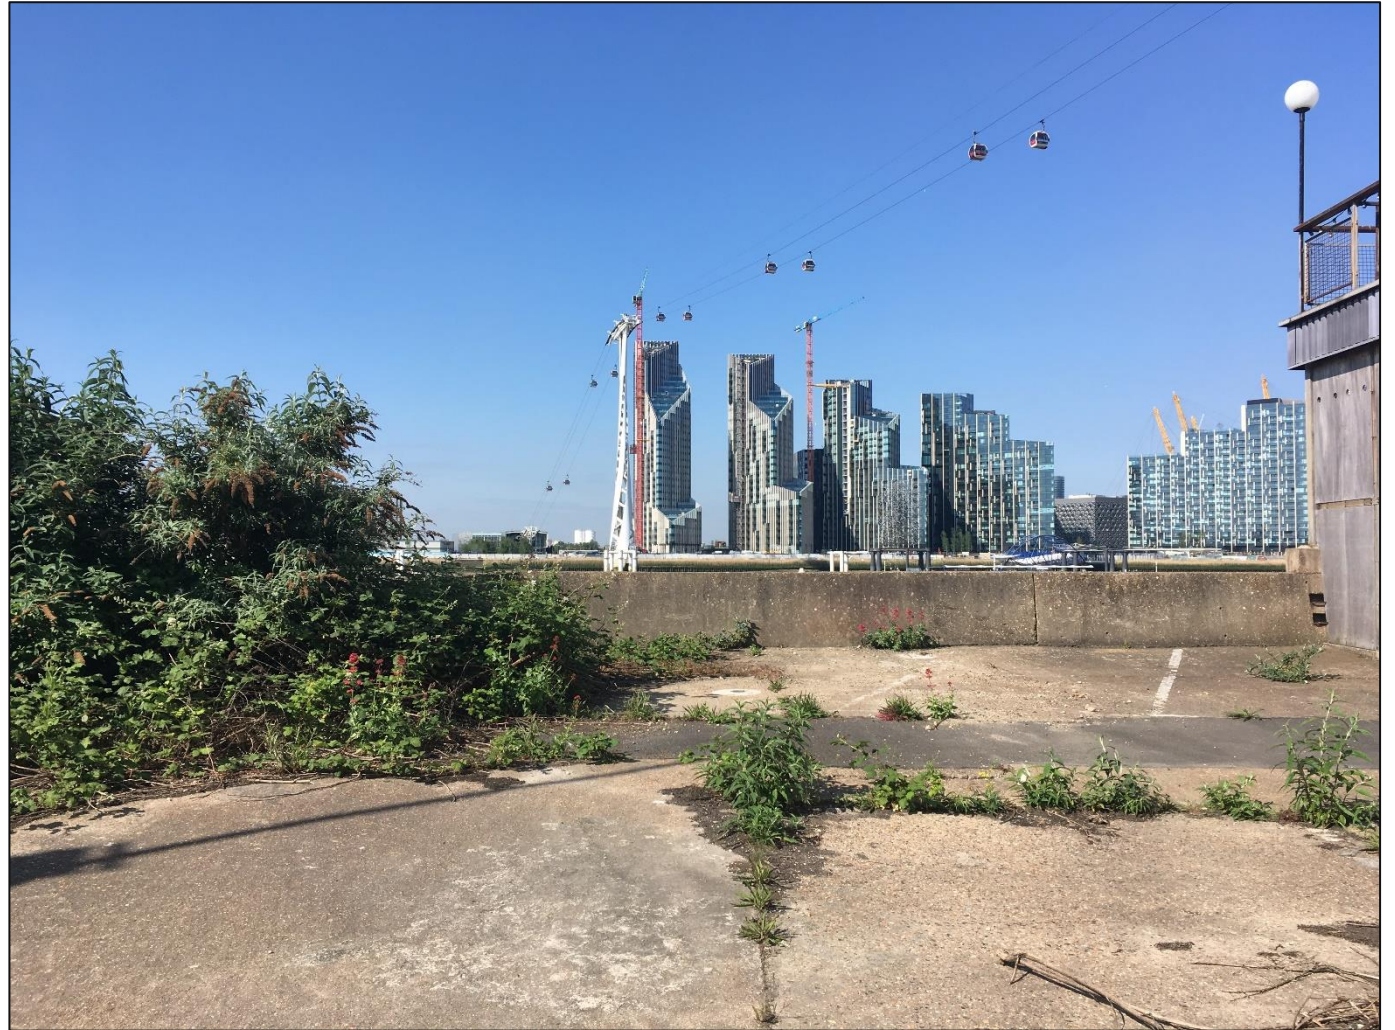
Location 1

Hard standing area – overview of parapet wall

- Hard standing generally in good condition.
- Existing cracks in hard standing previously observed during all previous inspections.
- No new cracks observed in concrete parapet wall or concrete hard standing.
- No obvious indications of movement or settlement of parapet wall or hard standing.
- Significant vegetation within concrete hard standing since previous inspection on 6th February 2019.

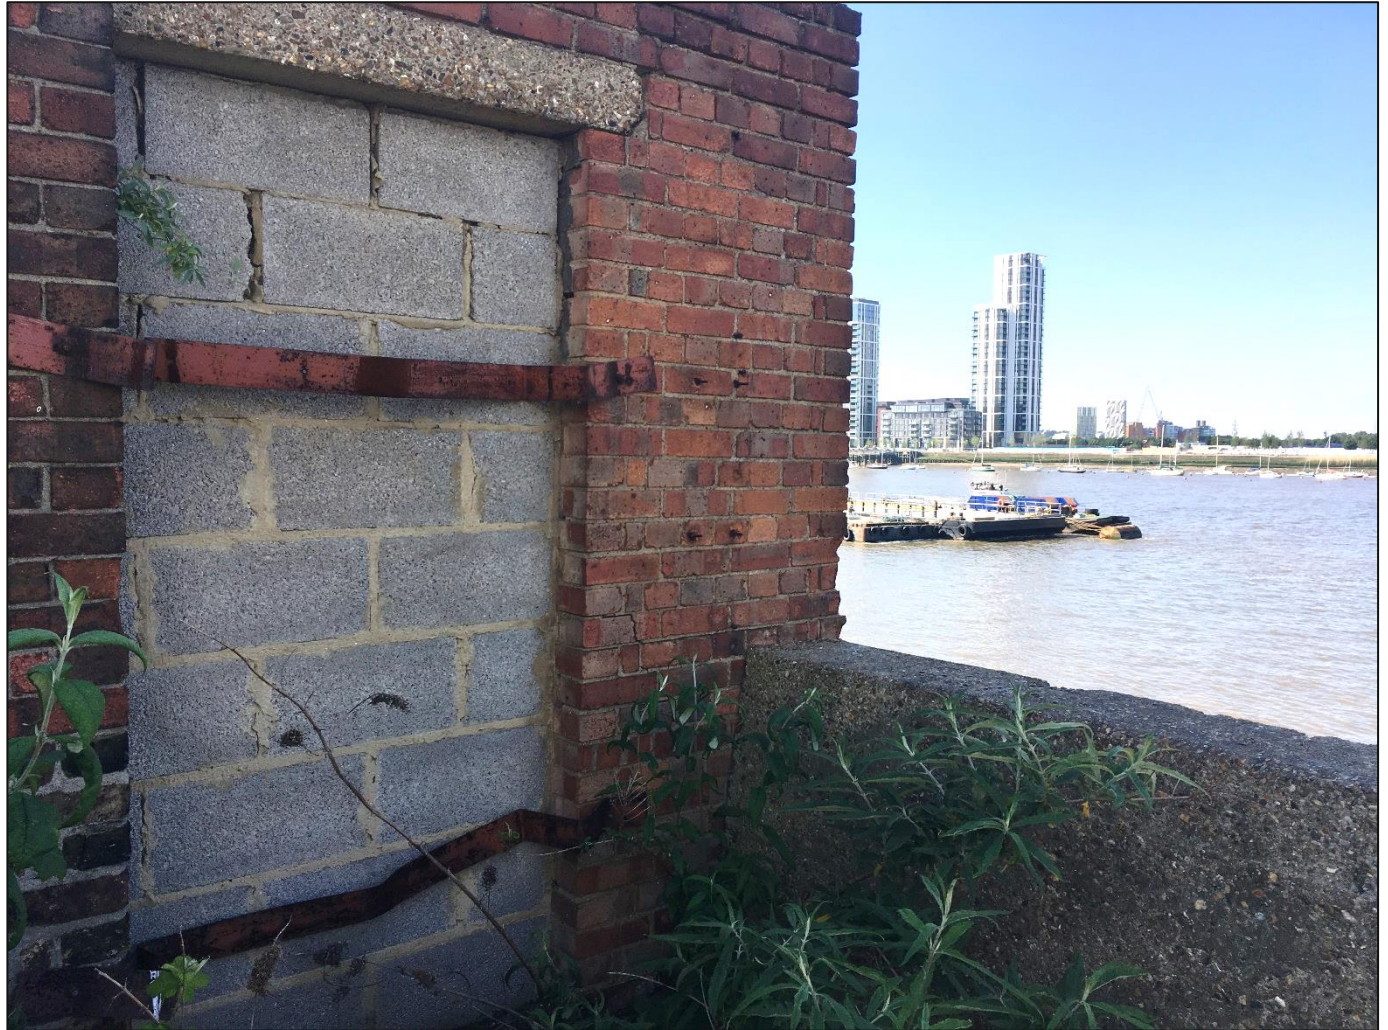
Location 2

Hard standing area – south corner

- Brick wall perpendicular to river wall, at south boundary of Dohm Wharf river wall.
- Existing crack in brick wall unchanged since last inspection. See location 3 for detail.
- No new cracks observed in concrete parapet wall, adjoining red brick wall or concrete hardstanding.
- Significant growth of vegetation within concrete hard standing since previous inspection on 6th February 2019.

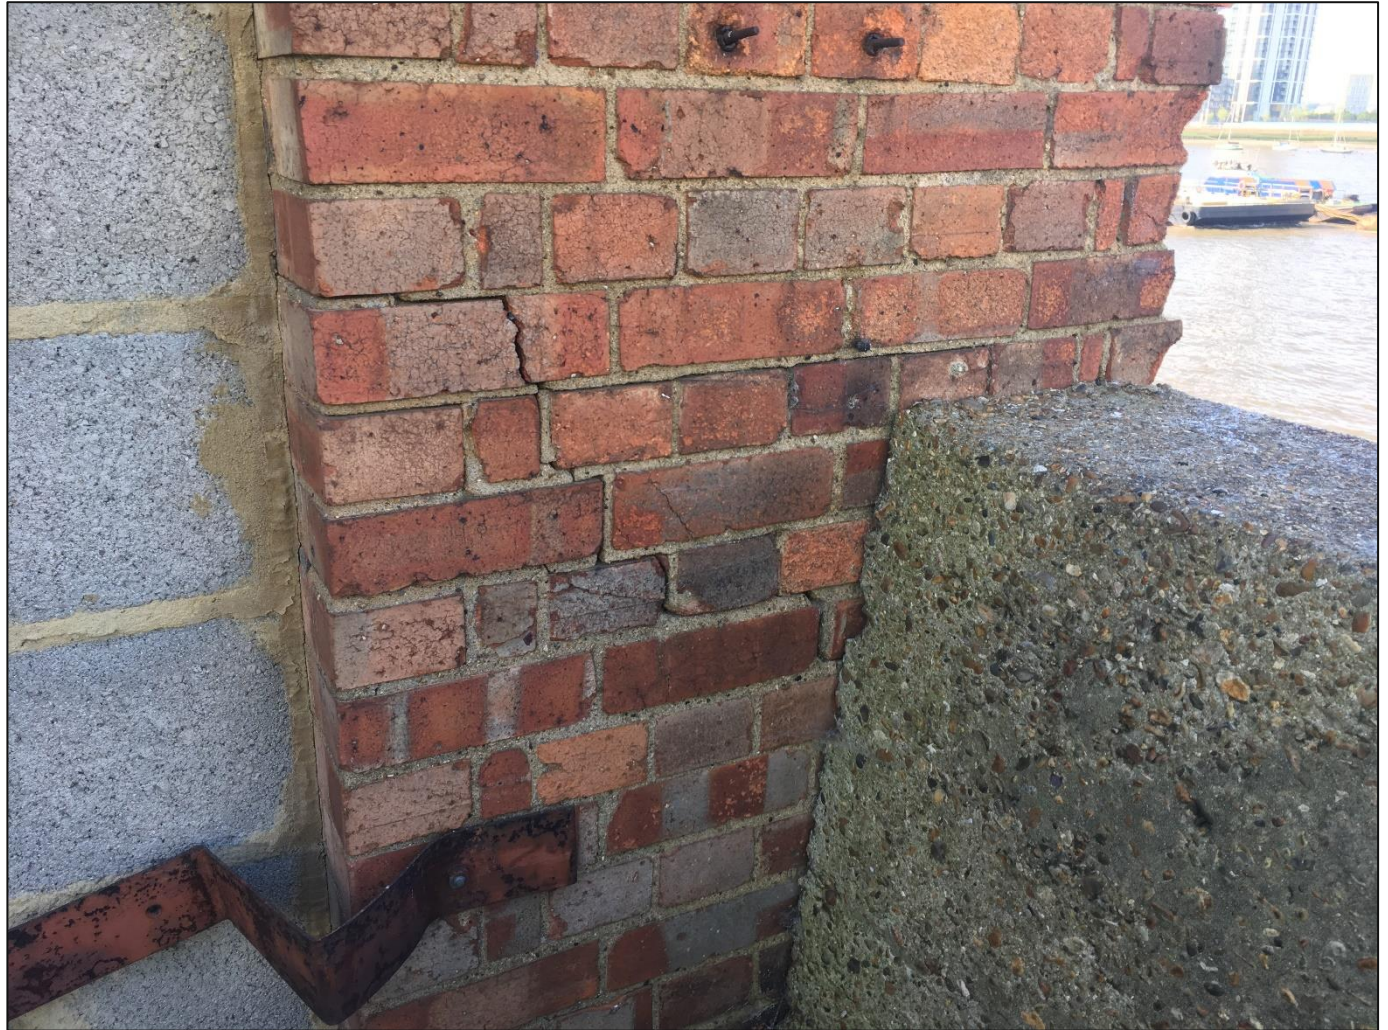
Location 3

Hard standing area – south corner brick wall crack detail

- Brick wall perpendicular to river wall, at south boundary of Dohm Wharf river wall.
- Existing crack in brick wall at approximate level of crest of concrete parapet wall first observed during first inspection on 19th December 2017.
- Extent of crack remains unchanged all previous inspections.
- Crack does not appear to have widened since previous inspections.
- No new cracks observed within brick wall or concrete parapet wall.
- No obvious indications of movement or settlement.
