Technical Note

Project Thames Side West
Subject Dohm Wharf River Wall Inspection – December 2019
Project no 035668
Date 31 December 2019

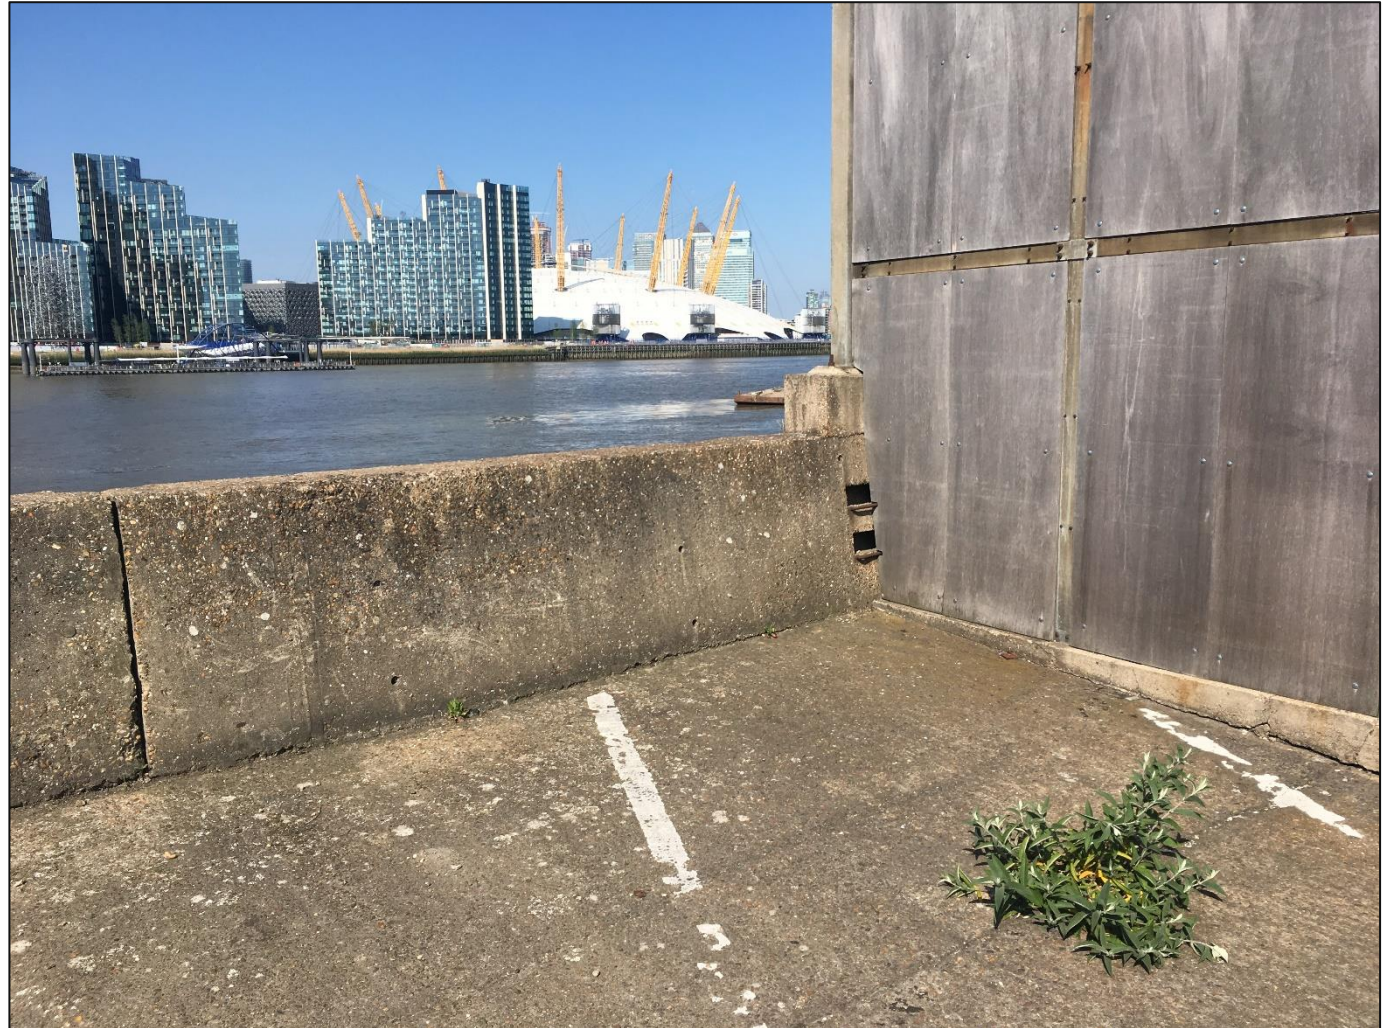
Location 4

Hard standing area – north corner

- No cracks observed in concrete parapet wall or concrete hard standing during first inspection on 19th December 2017.
- No new cracks observed in concrete parapet wall or concrete hard standing.
- No evidence of movement at interface between timber hoarding, concrete parapet wall and concrete hard standing.
- No obvious indications of movement or settlement of parapet wall or hard standing.

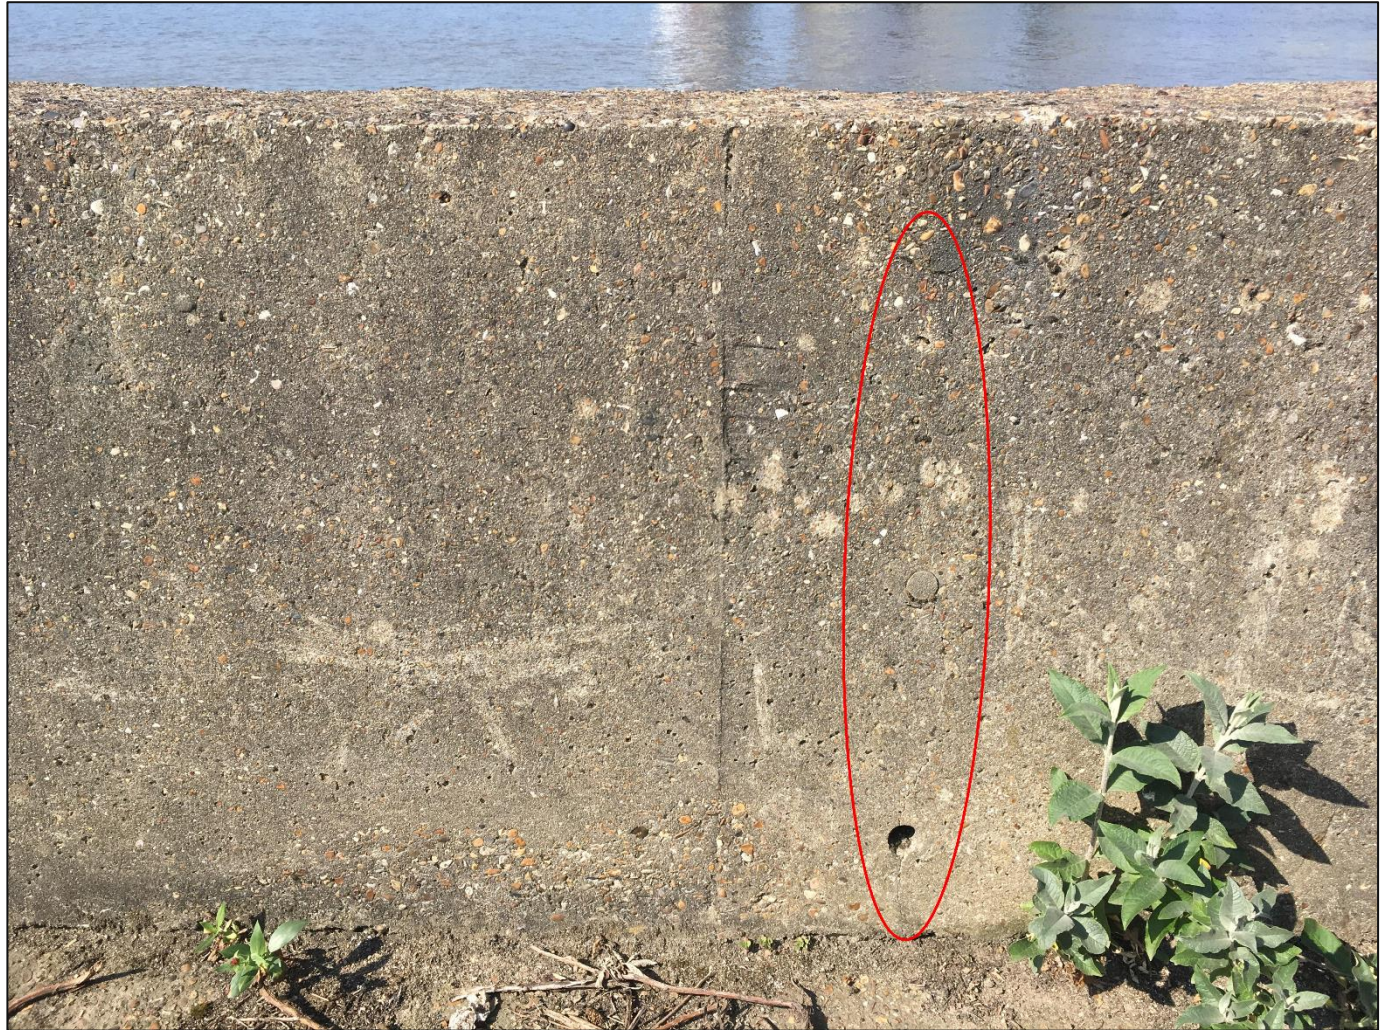
Location 5

Hard standing area – crack in parapet wall

- Existing hairline crack in concrete parapet wall first observed during first inspection on 19th December 2017.
- Crack originates through penetration in wall, assumed to be a construction defect rather than caused by movement of the river wall.
- No new cracks observed in concrete parapet wall or concrete hard standing.
- No evidence of movement since previous inspection on 6th February 2019.

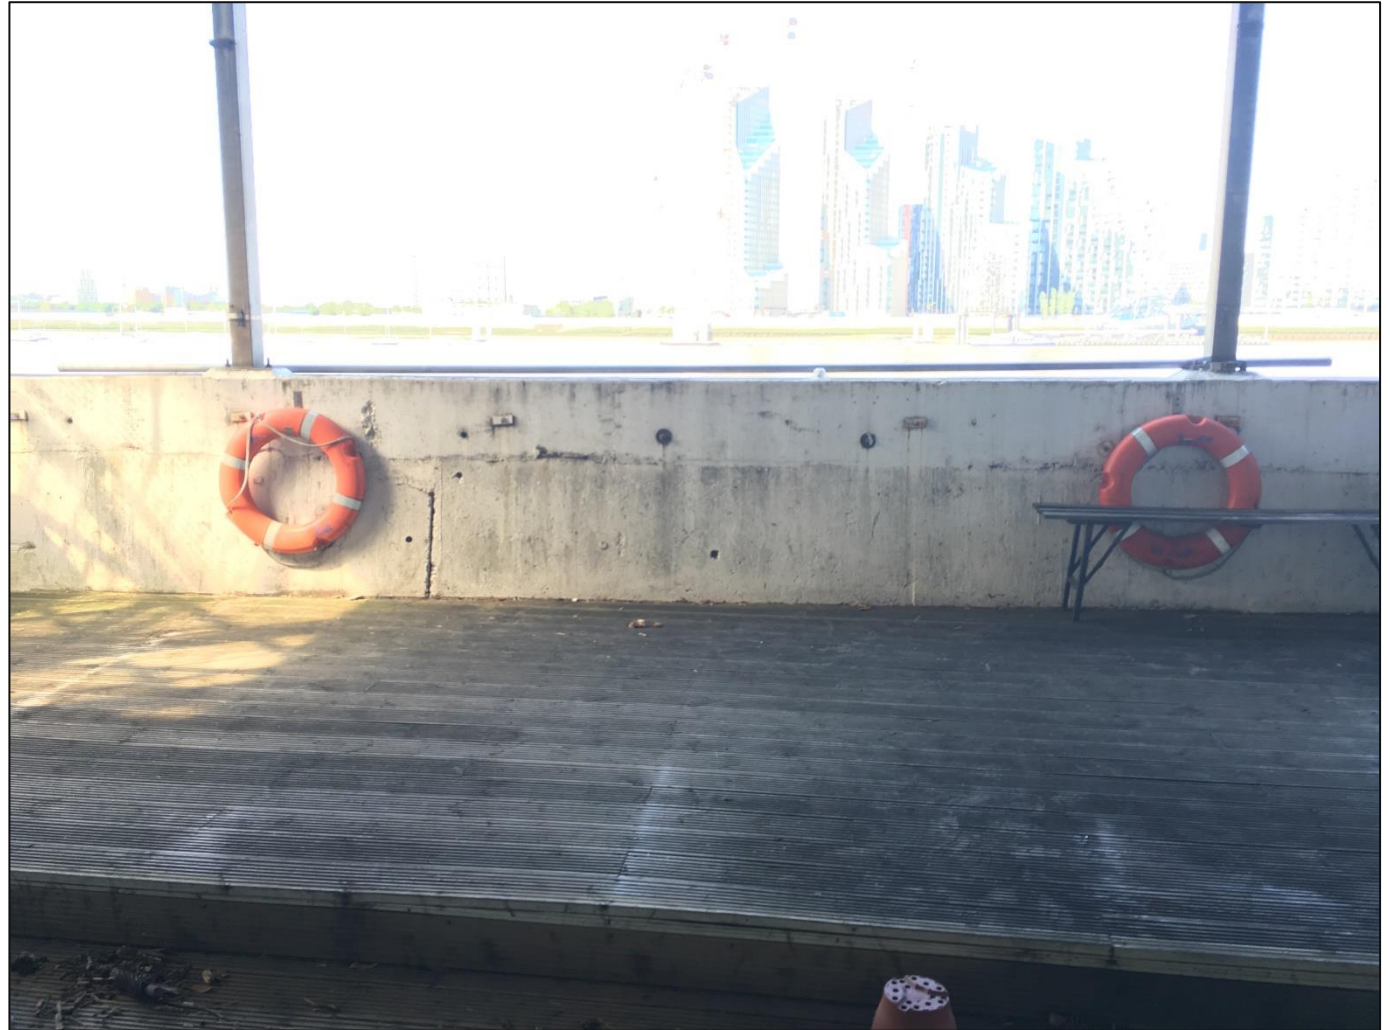
Location 6

TOBS terrace area – overview of parapet wall

- No new cracks observed in concrete parapet wall.
- Inspection of ground behind parapet wall prevented by presence of timber deck.
- No obvious indications of movement or settlement.

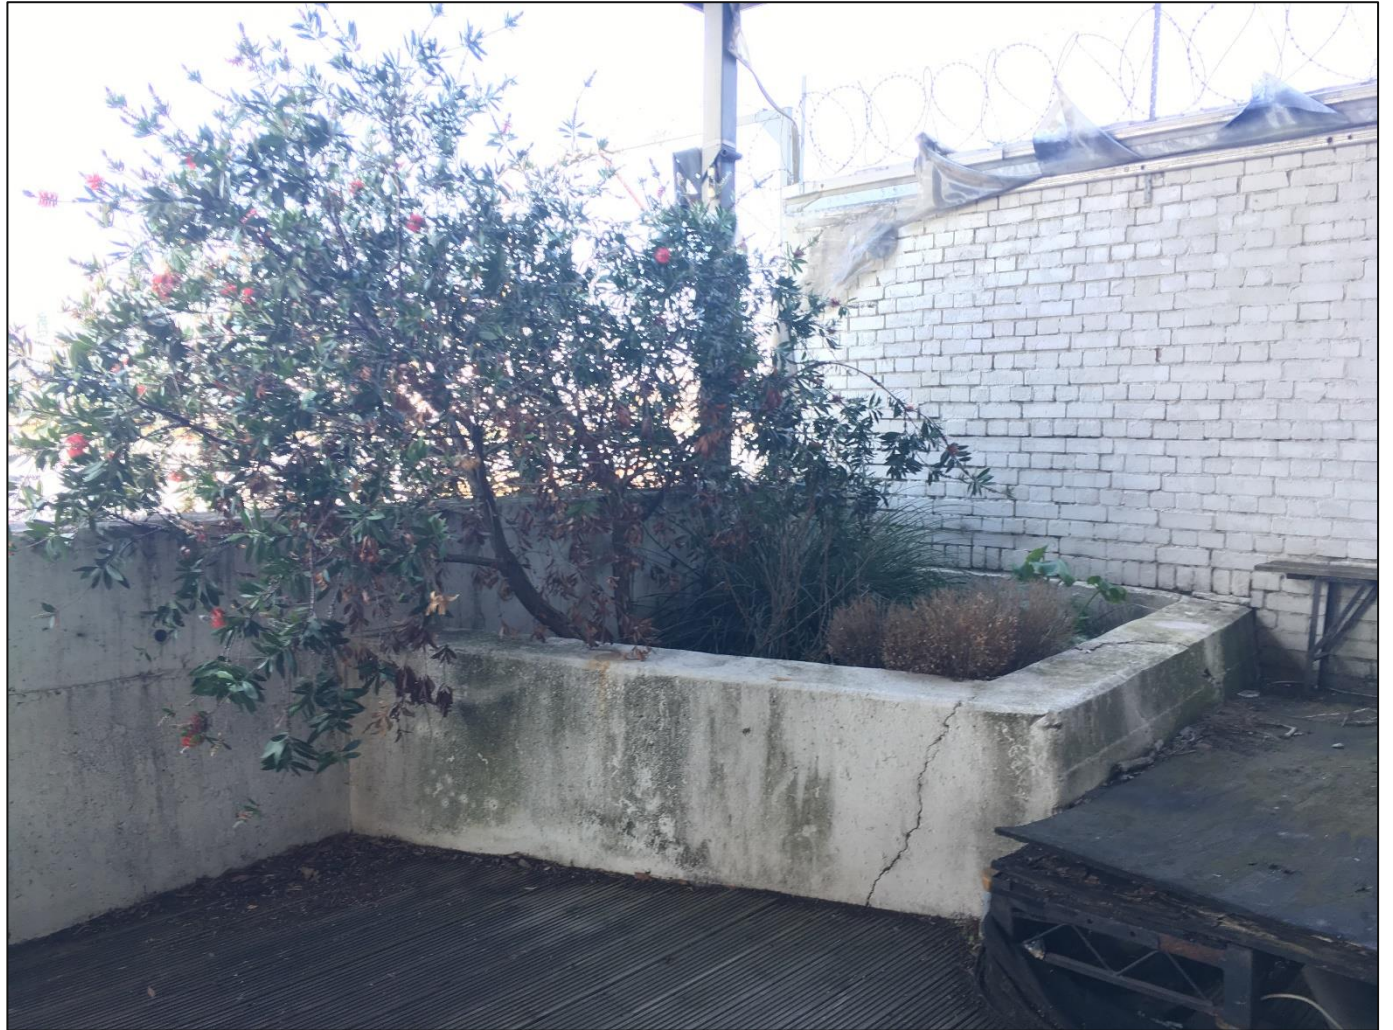
Location 7

TOBS terrace area – north corner

- Existing crack in wall of concrete planter first observed during first inspection on 19th December 2017. See location 8 for detail.
- No new cracks observed in concrete parapet wall or adjoining brick wall.
- No obvious indications of movement or settlement.

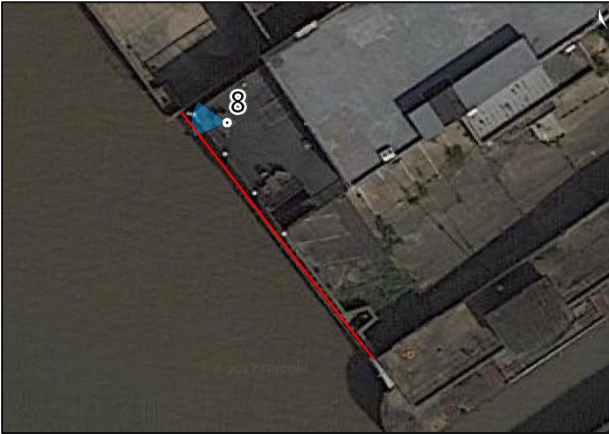
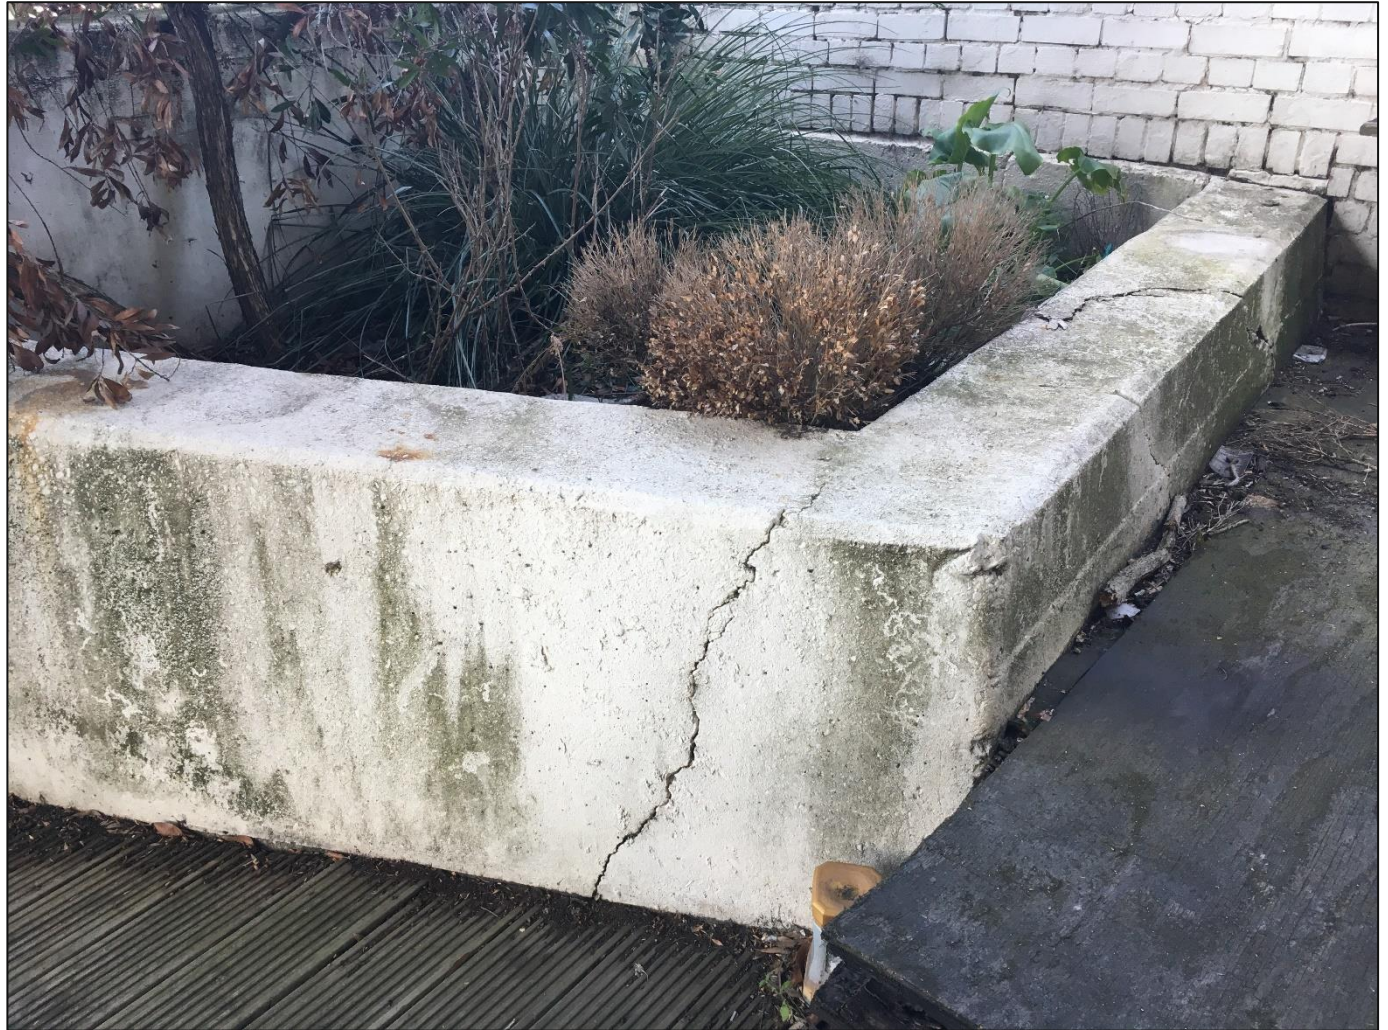
Location 8

TOBS terrace area – north corner planter crack detail

- Existing crack in wall of concrete planter first observed during first inspection on 19th December 2017.
- Extent of crack remains unchanged since last inspection.
- No evidence to indicate that crack has widened since last inspection.
- No new cracks observed in wall of concrete planter.

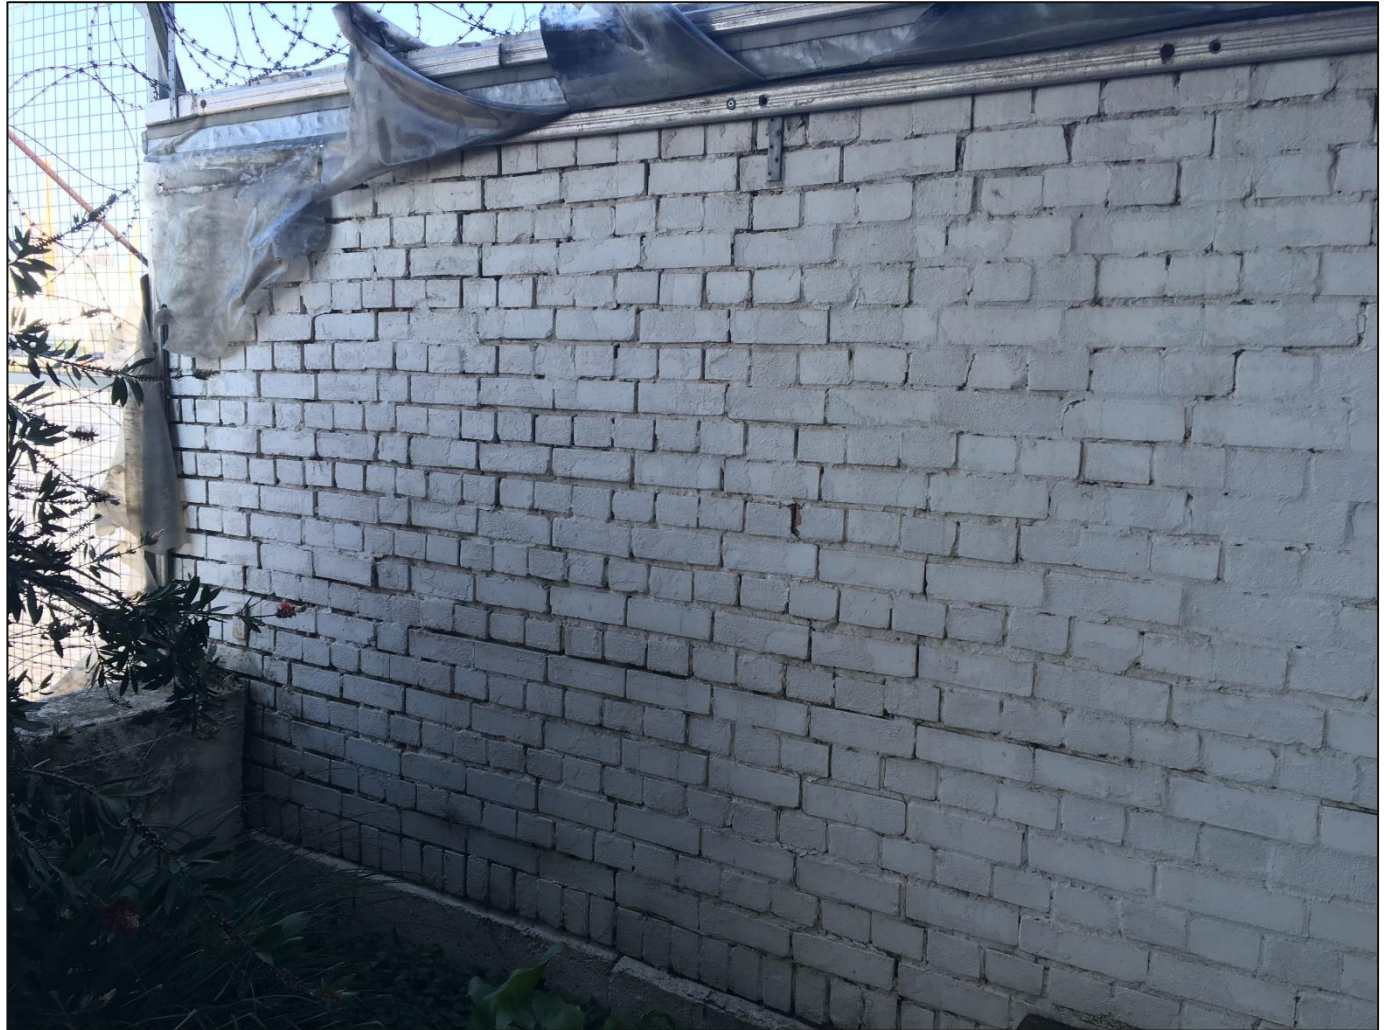
Location 9

TOBS terrace area – north cornered brick wall detail

- Adjoining brick wall at north boundary of Dohm Wharf river wall.
- Existing minor crack along horizontal mortar joints in brick wall first observed during first inspection on 19th December 2017.
- No evidence to indicate that crack has widened or extended since last inspection.
- No new cracks observed in brick wall.
- Note that condition of mortar is poor in places.

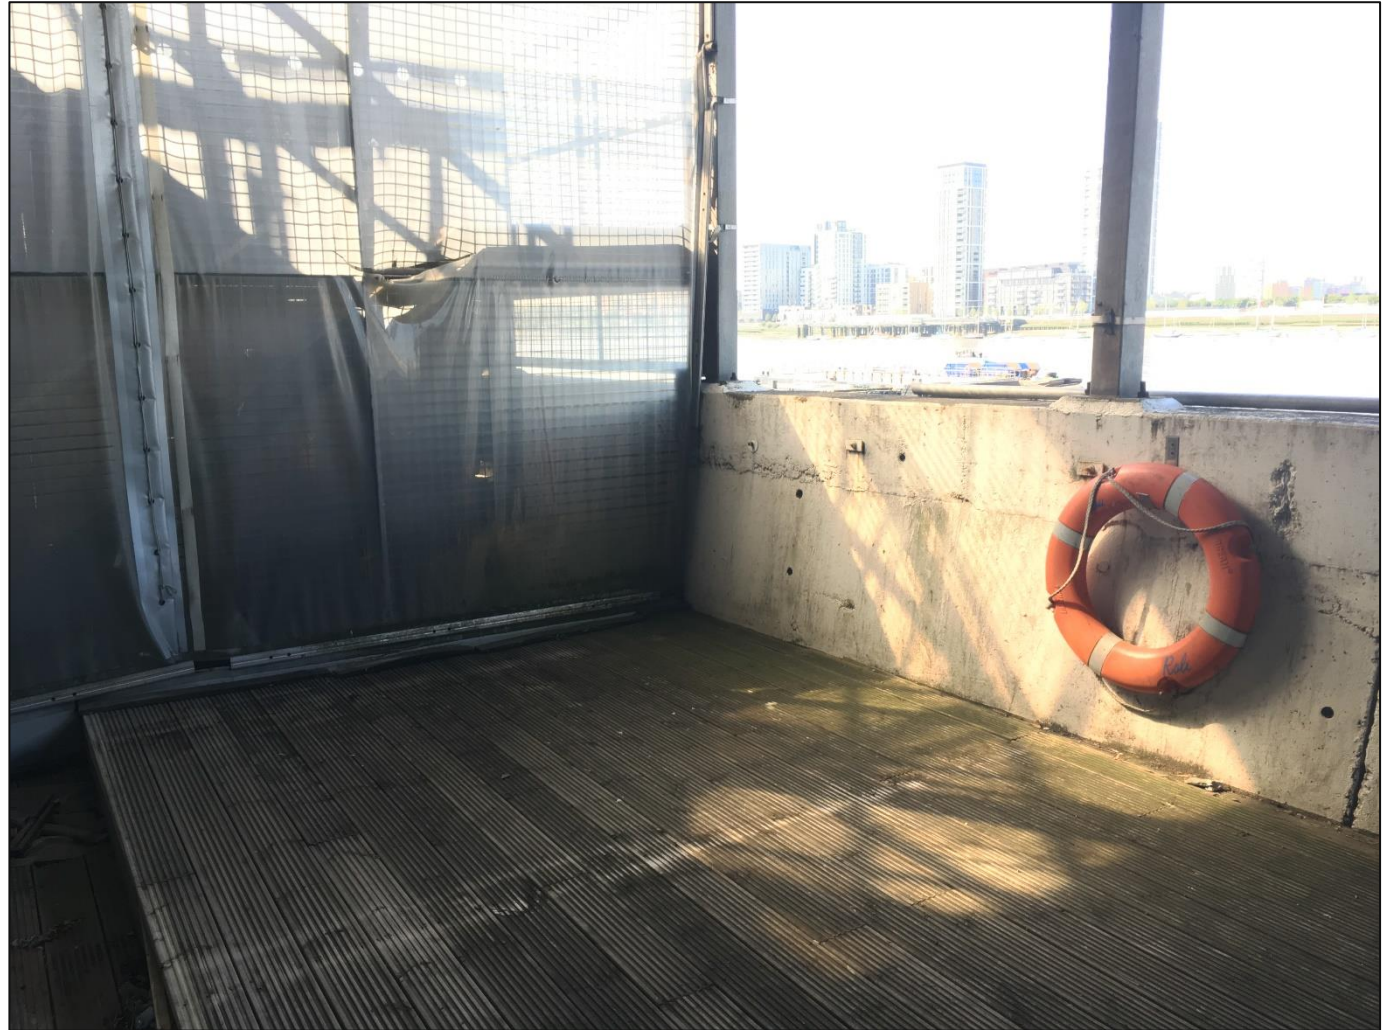
Location 10

TOBS terrace area – south corner

- No new cracks observed in concrete parapet wall.
- No obvious indications of movement or settlement.

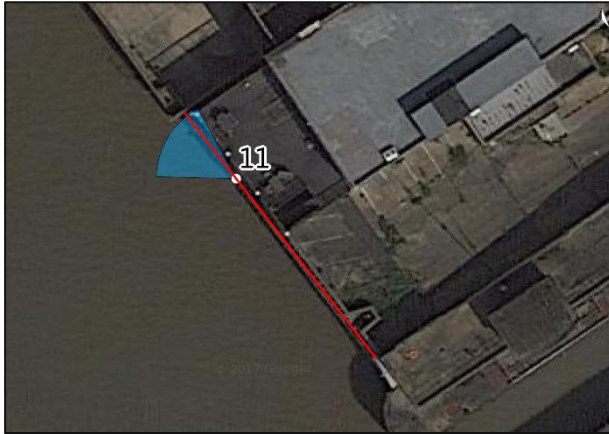
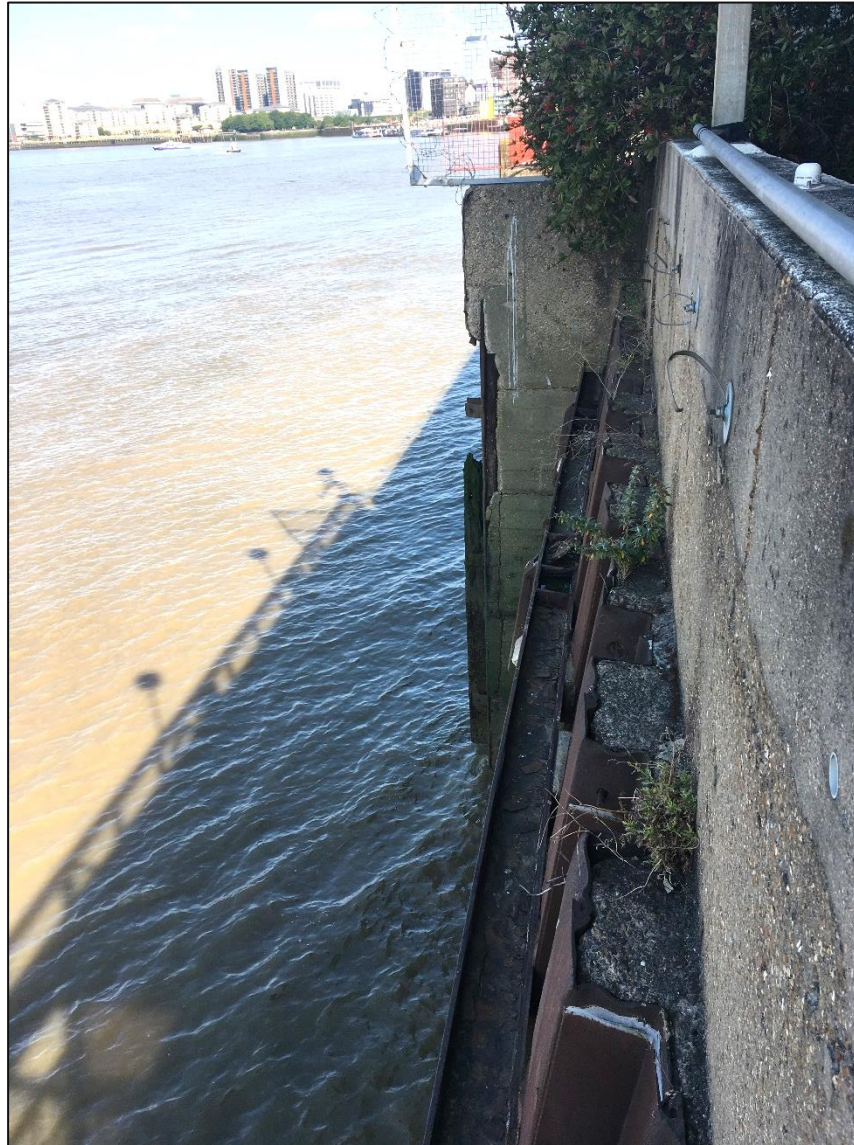
Location 11

TOBS terrace area – end face of adjacent wall to north

- Adjoining river wall to north steps out from alignment of Dohm Wharf river wall.
- Reinforcement within concrete face of adjoining river wall exposed, first observed during first inspection on 19th December 2017. No obvious deterioration since last visit on 6th February 2019.
- No evidence of movement at interface between two river walls.

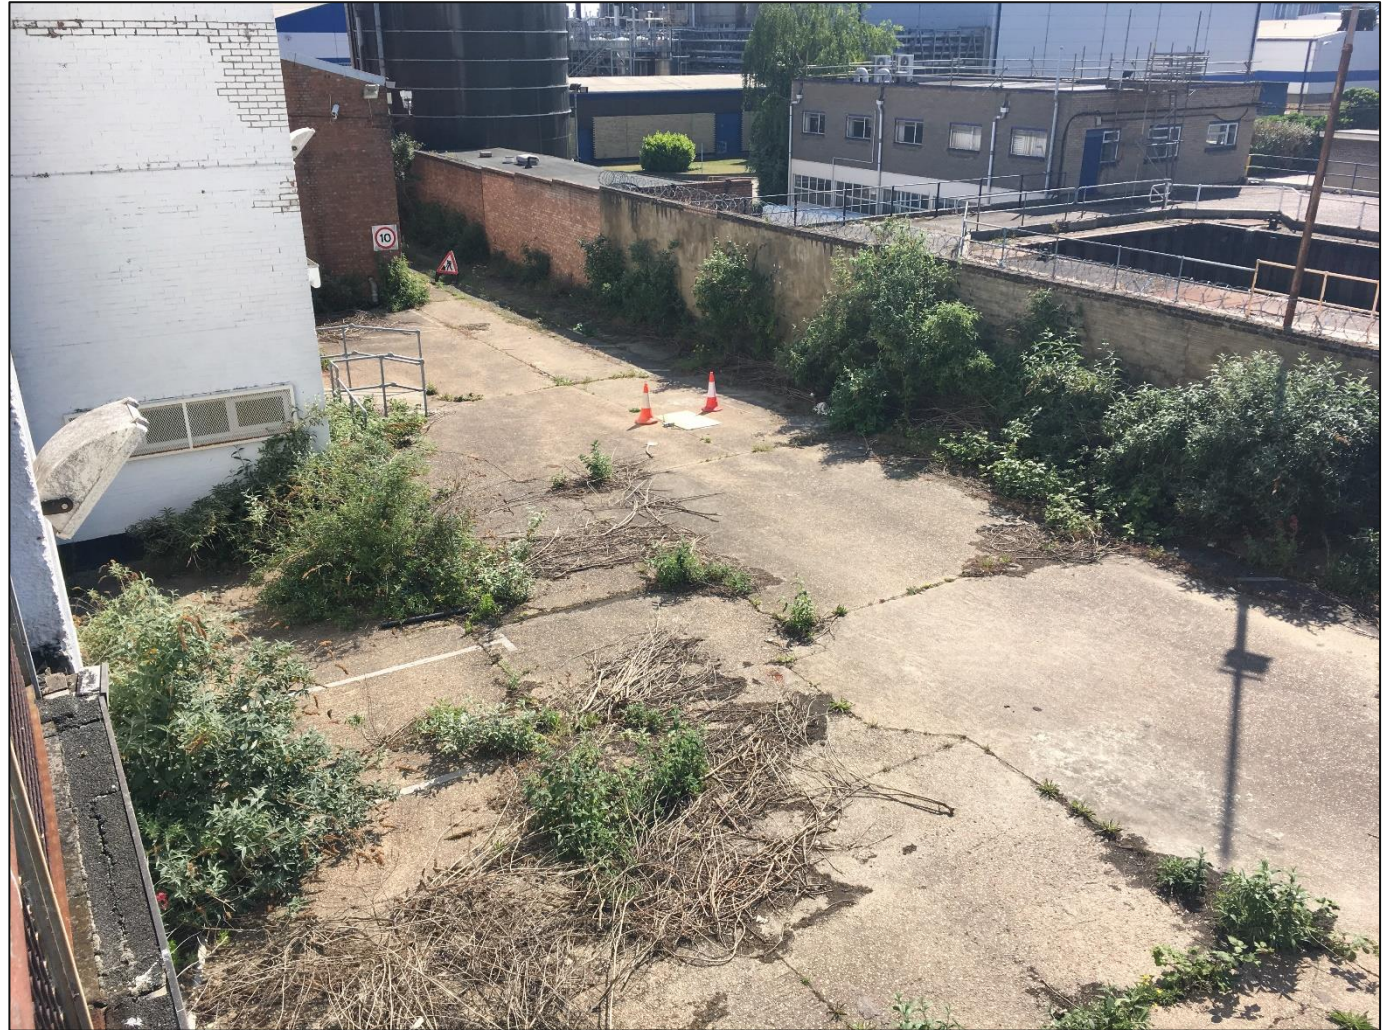
Location 12

Hard standing area – overview of hard standing

- Taken from the upper deck of the TOBS roof terrace.
- Existing cracks in concrete hard standing first observed during first inspection on 19th December 2017.
- No new cracks or other evidence of movement or settlement within concrete hard standing observed.
- Vegetation within concrete hard standing has regrown since the previous inspection on 6th February 2019, having been partially cut back prior to the 26th September 2018 inspection.
- Borehole within concrete hardstanding, containing monitoring equipment. Presumed to be part of site investigation works by TfL for the Silvertown Tunnel.

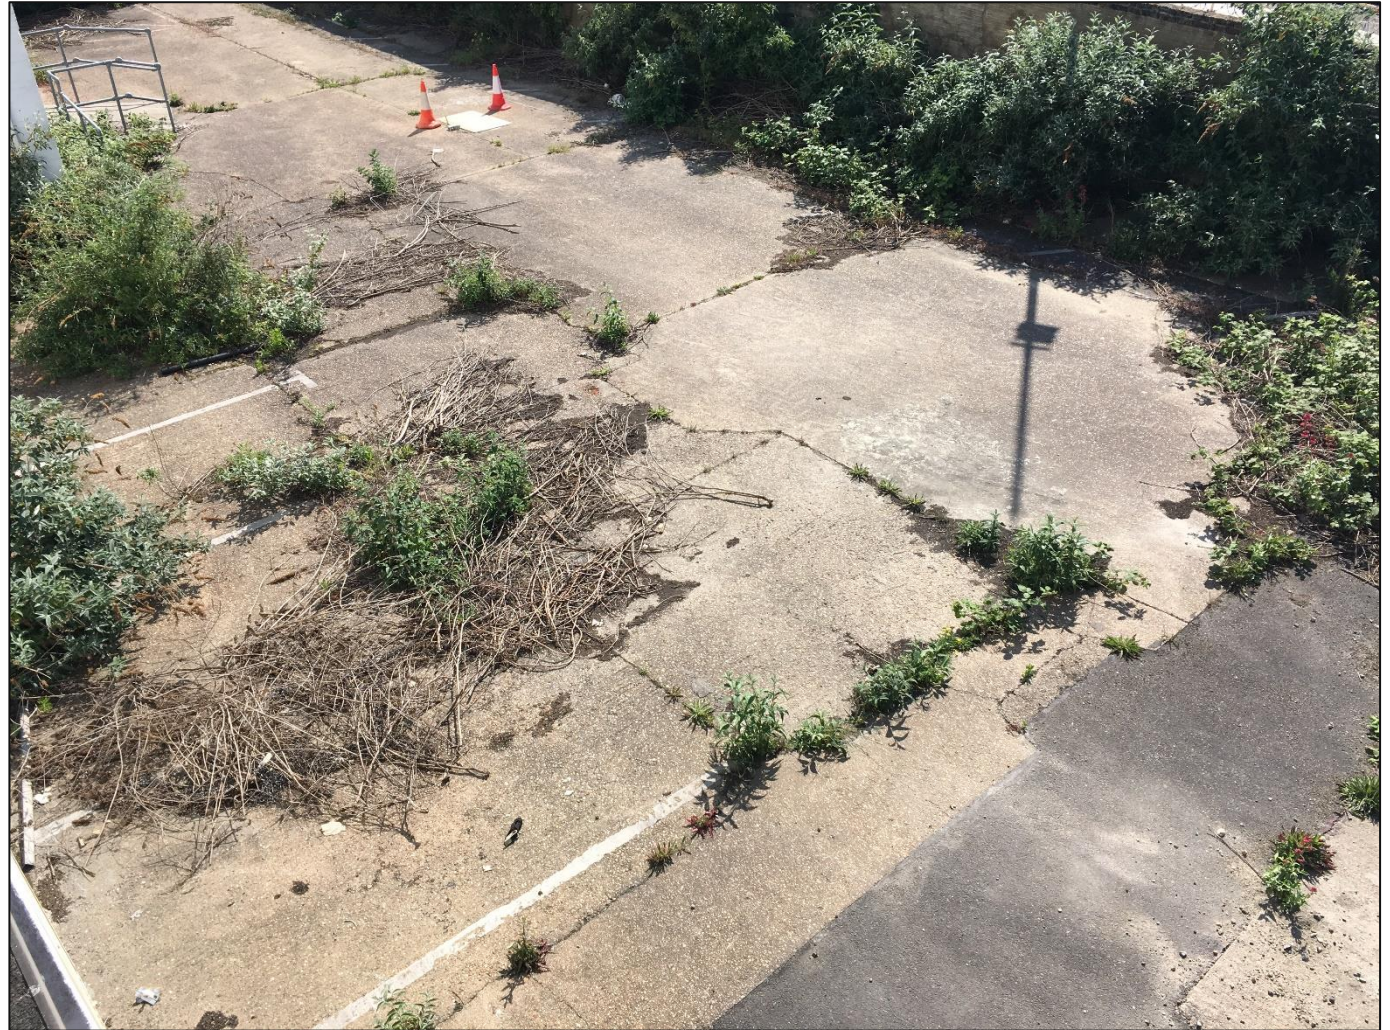
Location 13

Hard standing area – overview of hard standing

- Taken from the upper deck of the TOBS roof terrace.
- Existing cracks in concrete hard standing first observed during first inspection on 19th December 2017.
- No new cracks or other evidence of movement or settlement within concrete hard standing observed.
- Vegetation within concrete hard standing has regrown since the previous inspection on 6th February 2019, having been partially cut back prior to the 26th September 2018 inspection.
- Borehole within concrete hardstanding, containing monitoring equipment. Presumed to be part of site investigation works by TfL for the Silvertown Tunnel.

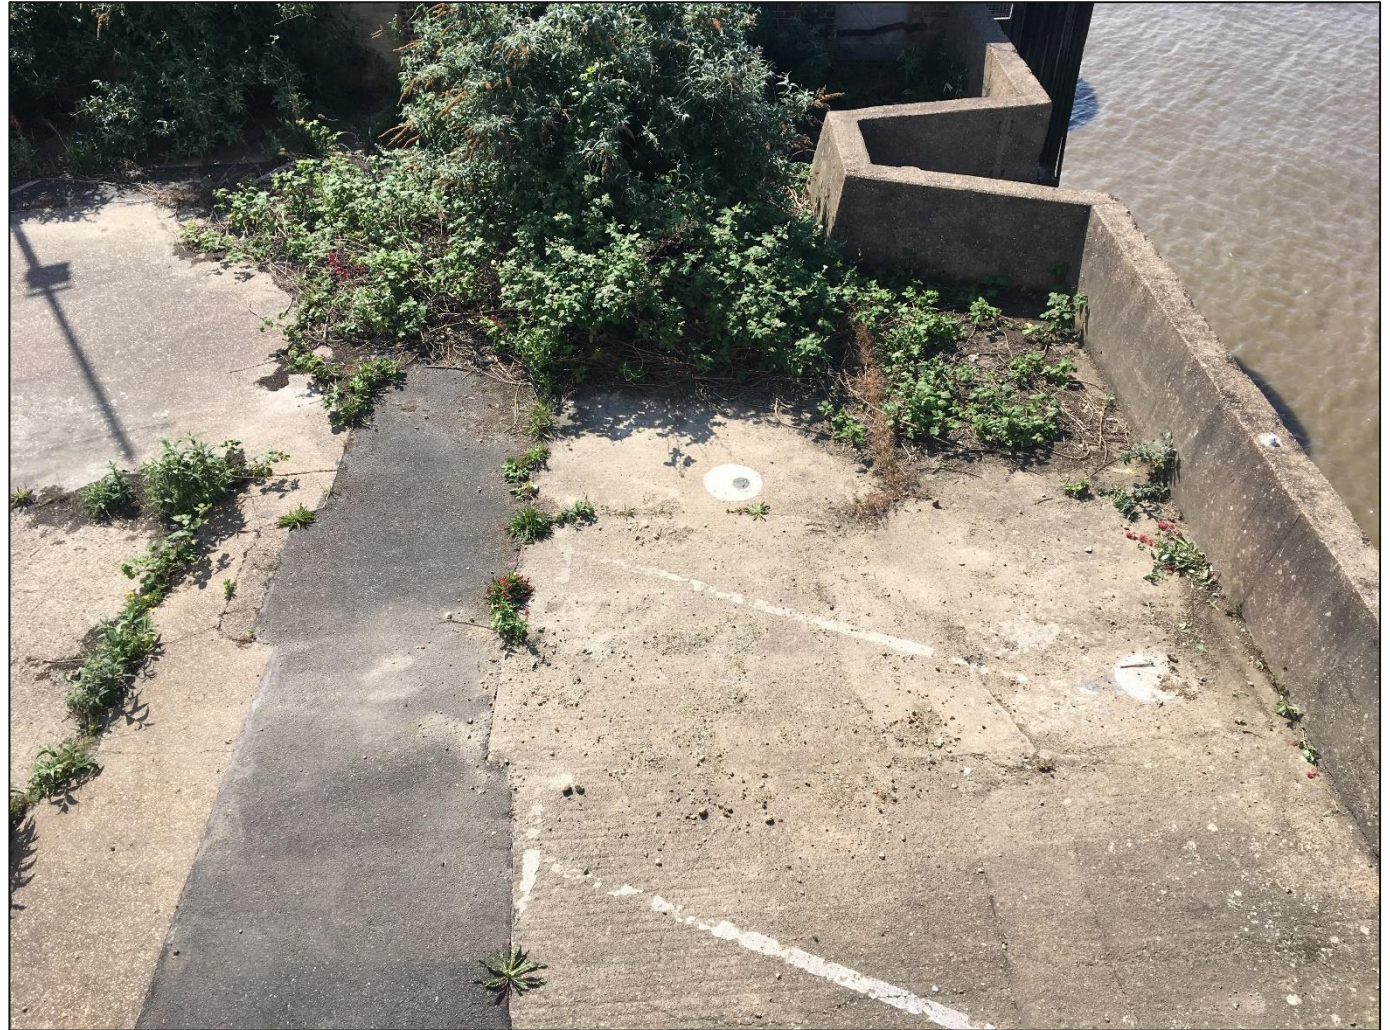
Location 14

Hard standing area – overview of hard standing

- Taken from the upper deck of the TOBS roof terrace.
- Existing cracks in concrete hard standing first observed during first inspection on 19th December 2017.
- No new cracks or other evidence of movement or settlement within concrete hard standing observed.
- Vegetation within concrete hard standing has regrown since the previous inspection on 6th February 2019, having been partially cut back prior to the 26th September 2018 inspection.

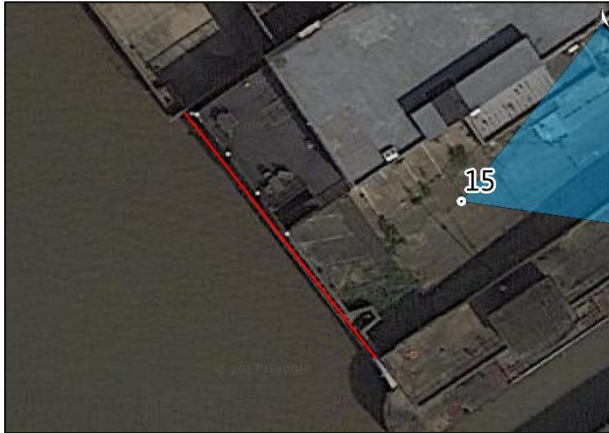
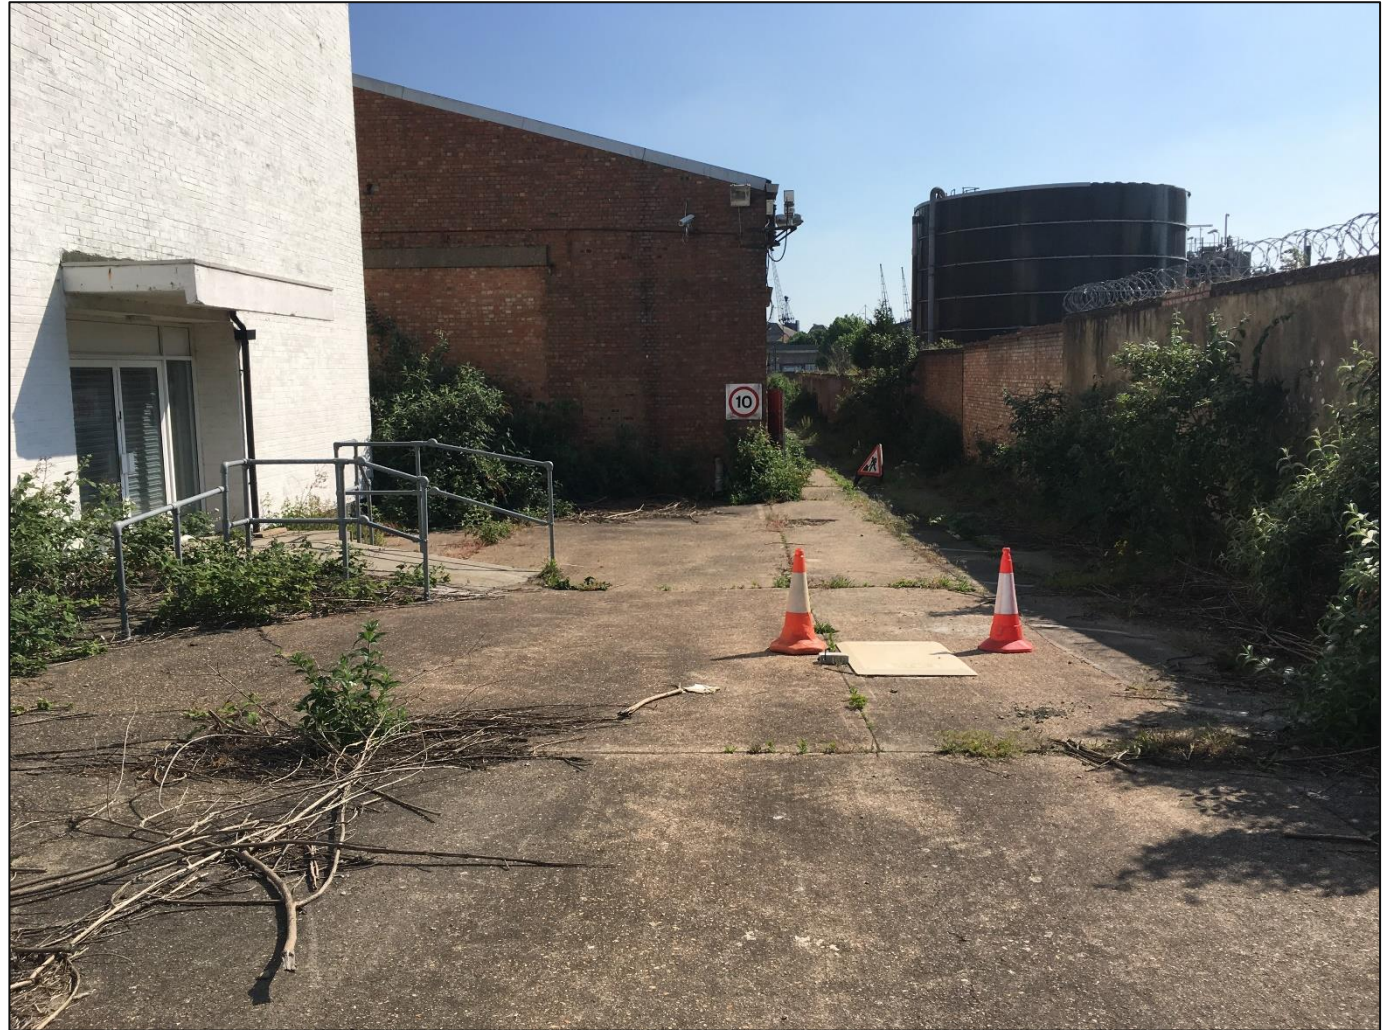
Location 15

Hard standing area – view away from river wall

- Existing cracks in concrete hard standing first observed during first inspection on 19th December 2017.
- No new cracks or other evidence of movement or settlement within concrete hard standing observed.
- Vegetation within concrete hard standing has regrown since the previous inspection on 6th February 2019, having been partially cut back prior to the 26th September 2018 inspection.
- Borehole within concrete hardstanding, containing monitoring equipment. Presumed to be part of site investigation works by TfL for the Silvertown Tunnel.

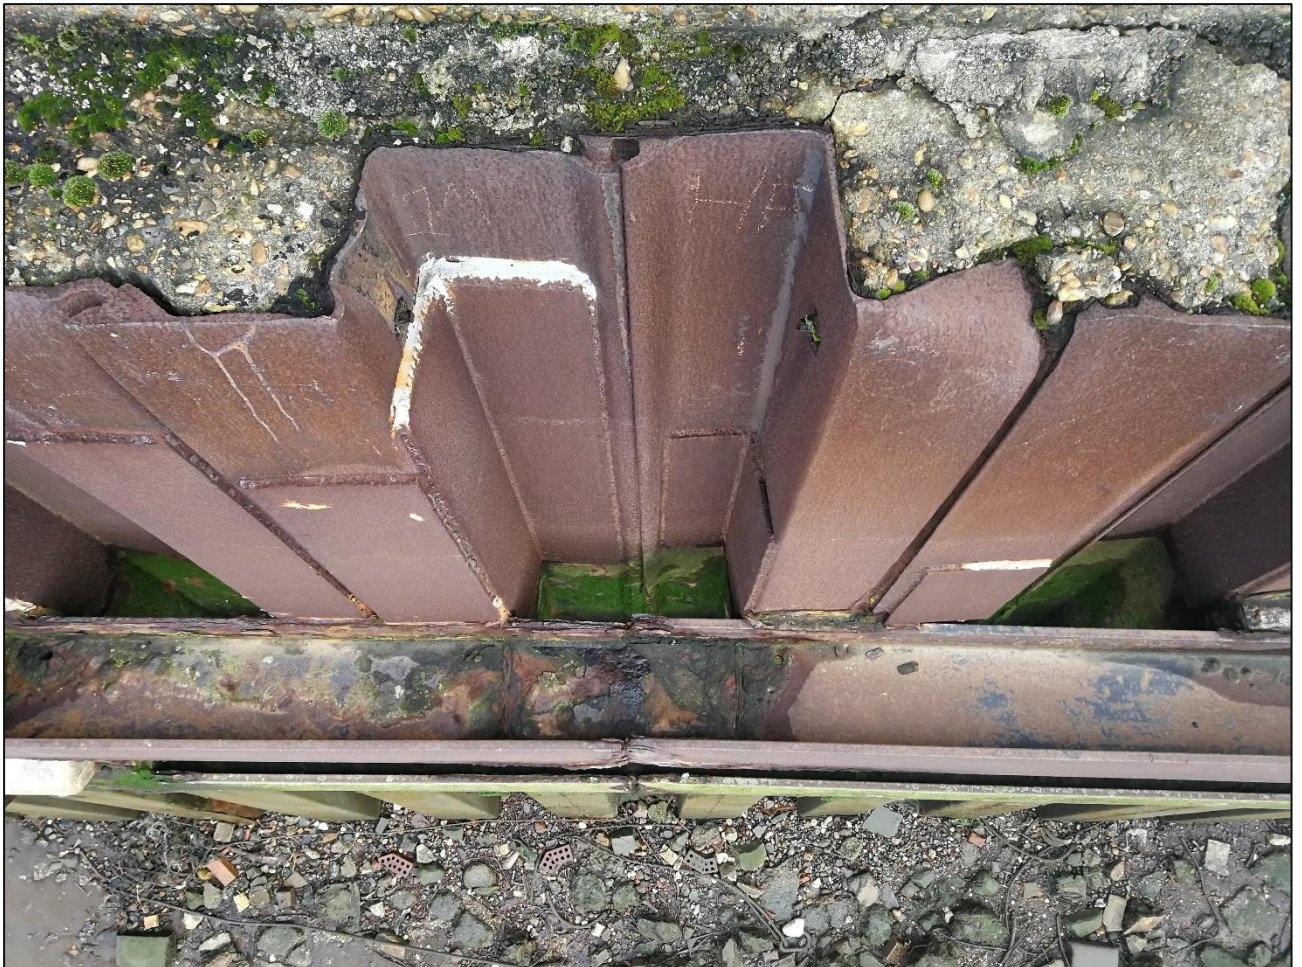
All plate repairs appear to remain securely welded to the existing sheet pile sections and there is no evidence of further degradation of the condition of the remaining steel. Figure 3.1 shows a typical photograph of the upper level of the river wall, showing the steel plate repairs securely welded to the sheet piling, with mastic sealant still in place.

Figure 3.1: Typical photograph of upper level of river wall, showing steel plate repairs to sheet piling, taken from the land side of the river wall

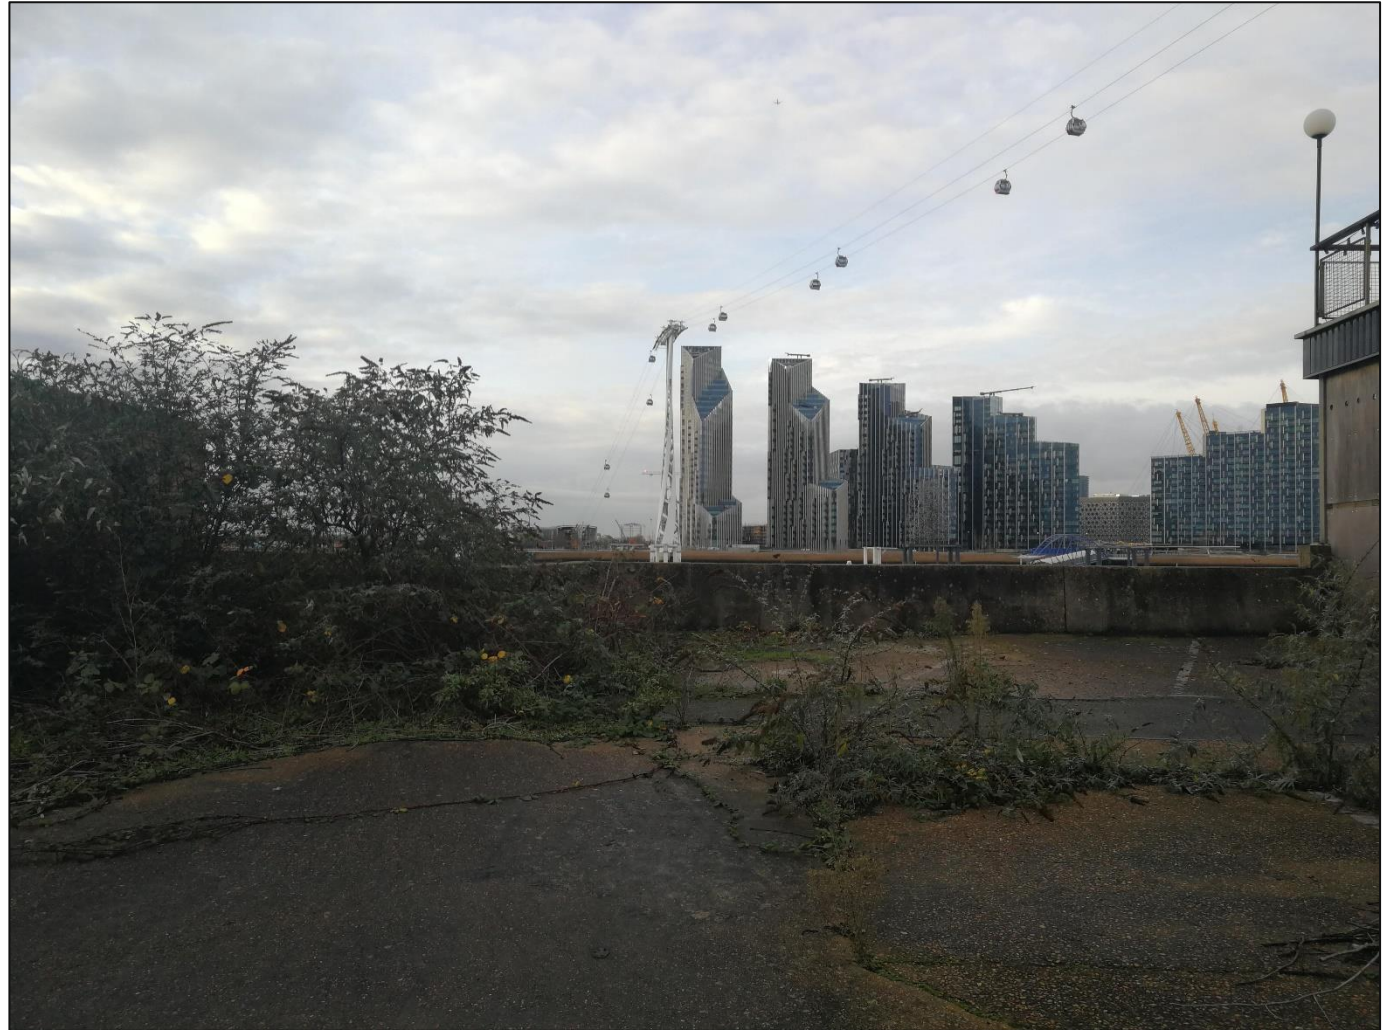
Location 1

Hard standing area – overview of parapet wall

- Hard standing generally in good condition.
- Existing cracks in hard standing previously observed during all previous inspections.
- No new cracks observed in concrete parapet wall or concrete hard standing.
- No obvious indications of movement or settlement of parapet wall or hard standing.
- Further vegetation growth within concrete hard standing since previous inspection on 24th May 2019.
