Technical Note

Project Thames Side West
Subject Dohm Wharf River Wall Inspection – December 2019
Project no 035668
Date 31 December 2019

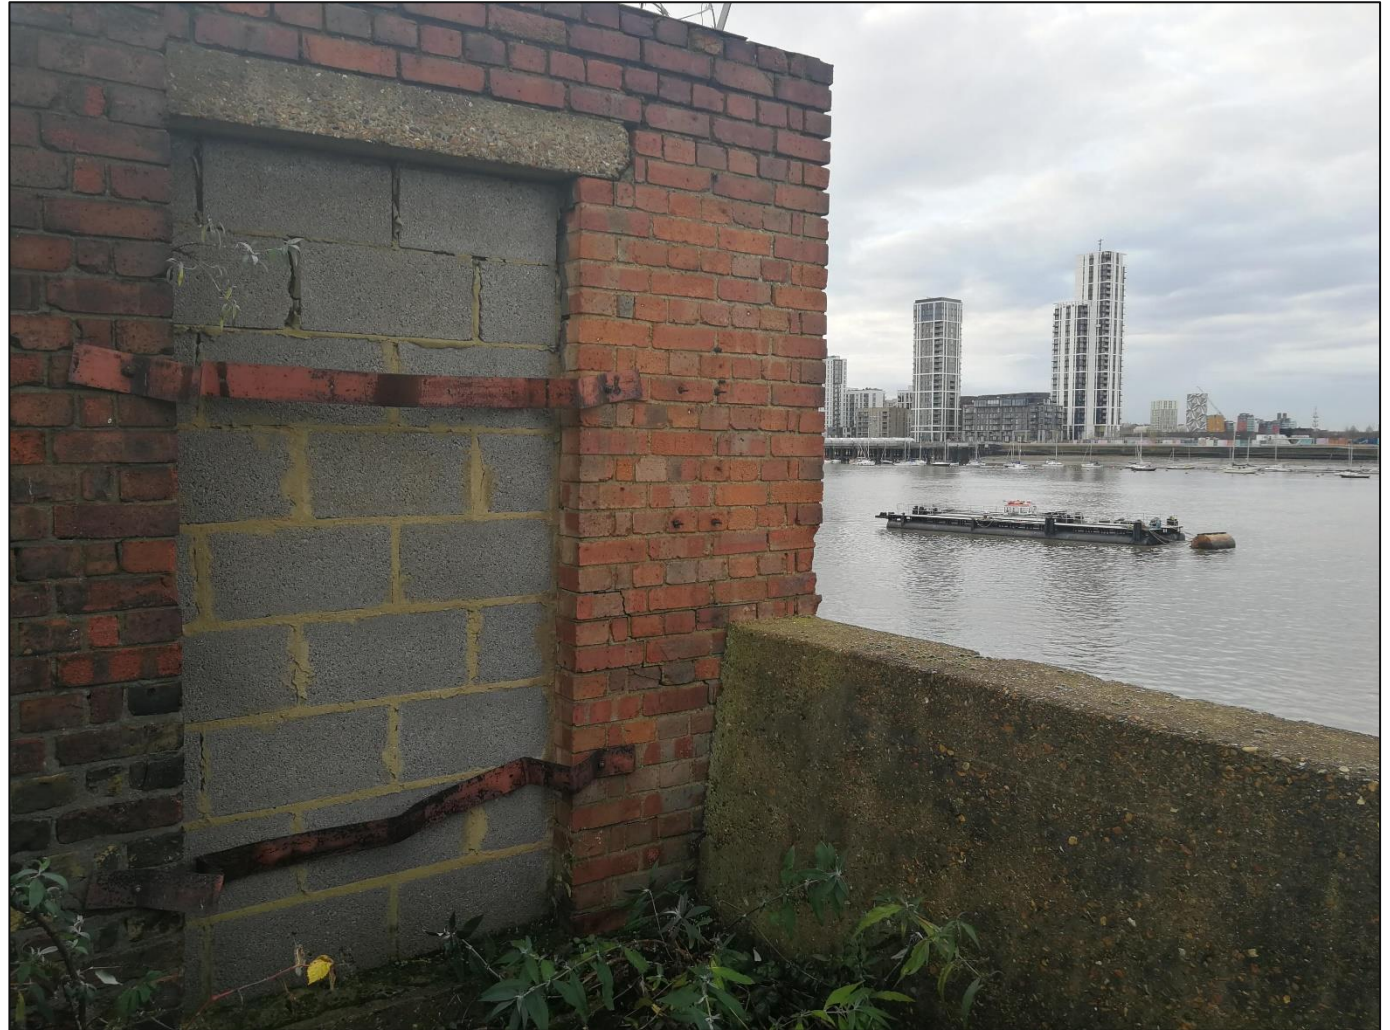
Location 2

Hard standing area – south corner

- Brick wall perpendicular to river wall, at south boundary of Dohm Wharf river wall.
- Existing crack in brick wall unchanged since last inspection. See location 3 for detail.
- No new cracks observed in concrete parapet wall, adjoining red brick wall or concrete hardstanding.
- Further growth of vegetation within concrete hard standing since previous inspection on 24th May 2019.

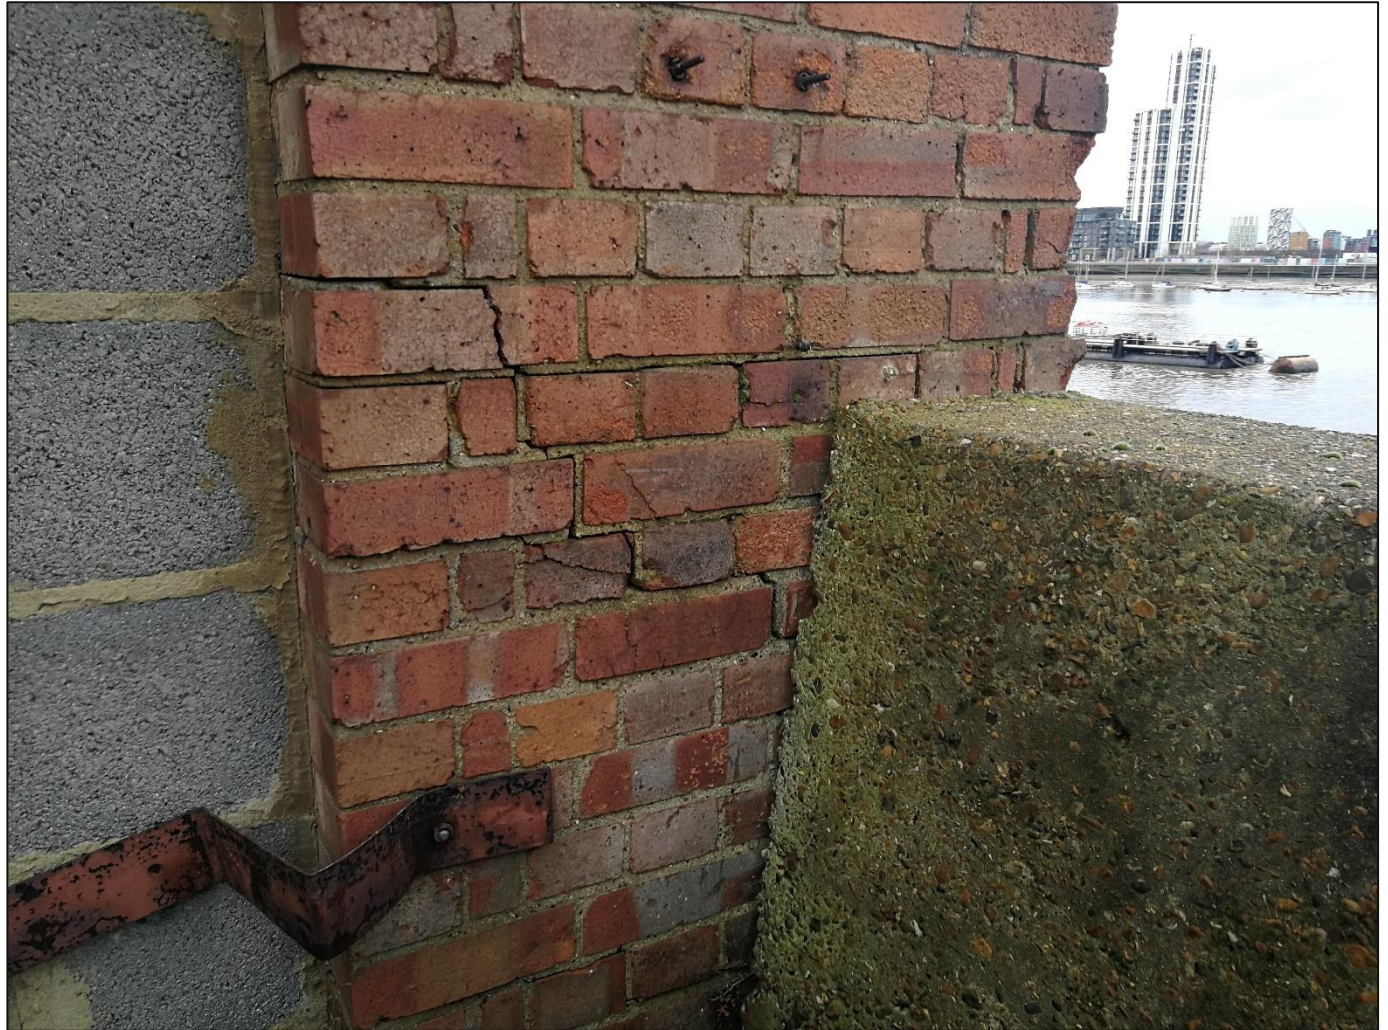
Location 3

Hard standing area – south corner brick wall crack detail

- Brick wall perpendicular to river wall, at south boundary of Dohm Wharf river wall.
- Existing crack in brick wall at approximate level of crest of concrete parapet wall first observed during first inspection on 19th December 2017.
- Extent of crack remains unchanged all previous inspections.
- Crack does not appear to have widened since previous inspections.
- No new cracks observed within brick wall or concrete parapet wall.
- No obvious indications of movement or settlement.

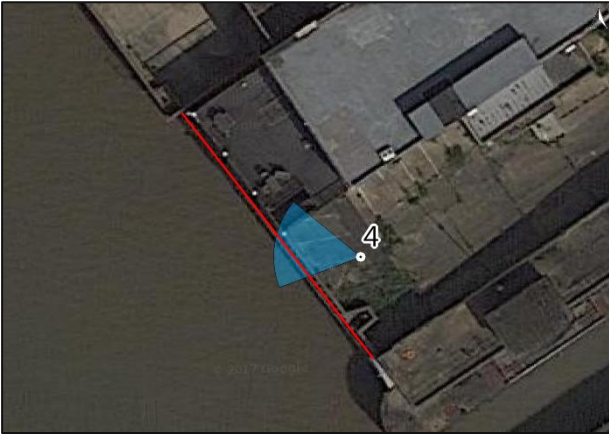
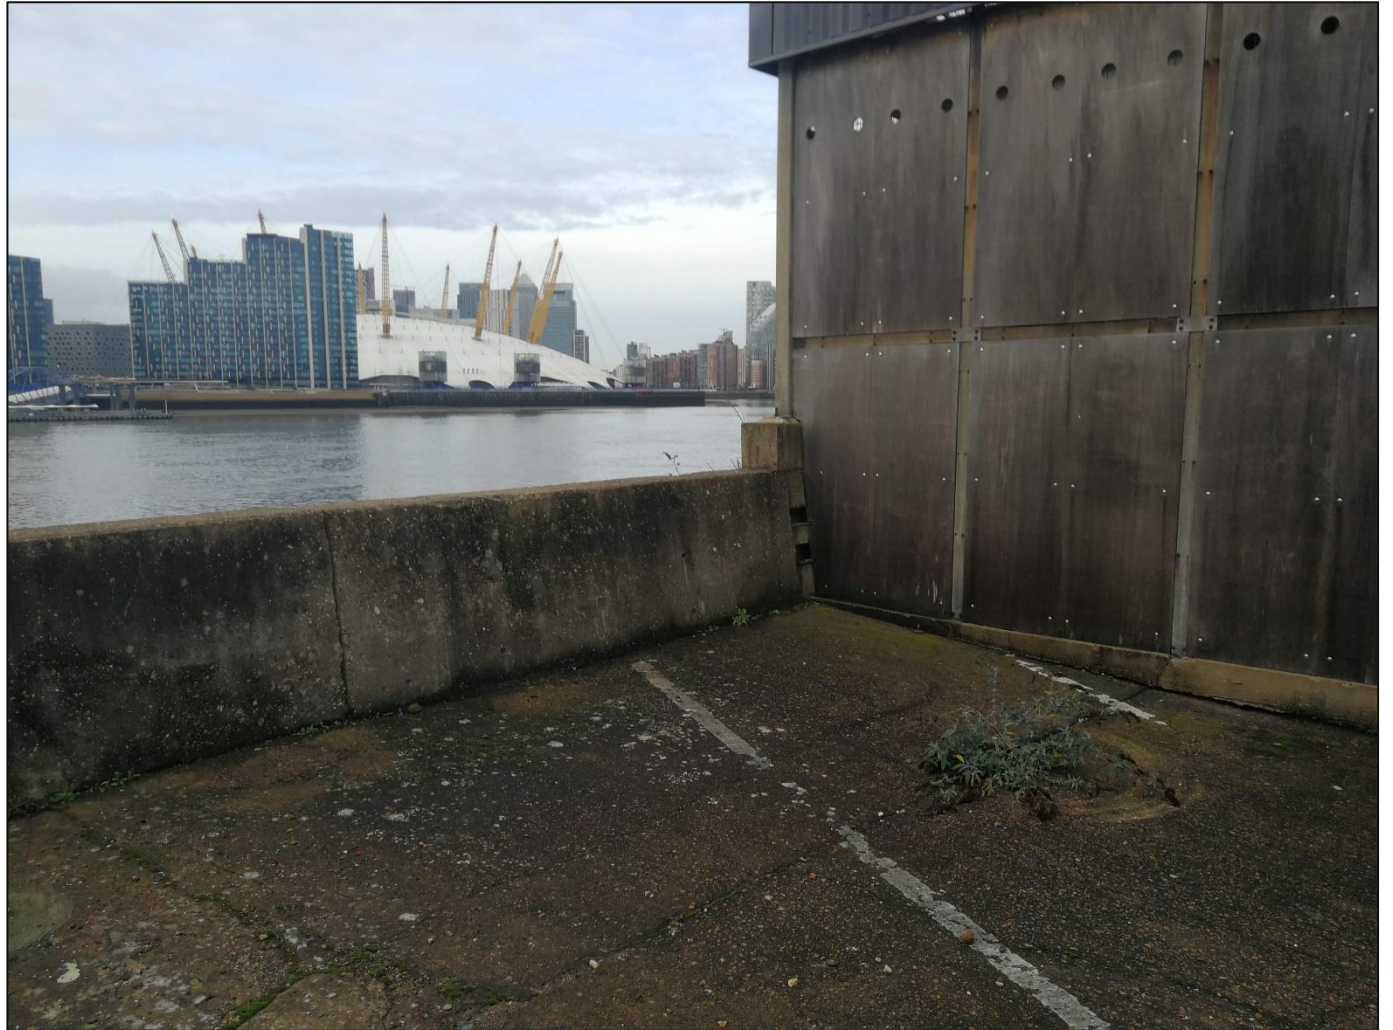
Location 4

Hard standing area – north corner

- No cracks observed in concrete parapet wall or concrete hard standing during first inspection on 19th December 2017.
- No new cracks observed in concrete parapet wall or concrete hard standing.
- No evidence of movement at interface between timber hoarding, concrete parapet wall and concrete hard standing.
- No obvious indications of movement or settlement of parapet wall or hard standing.

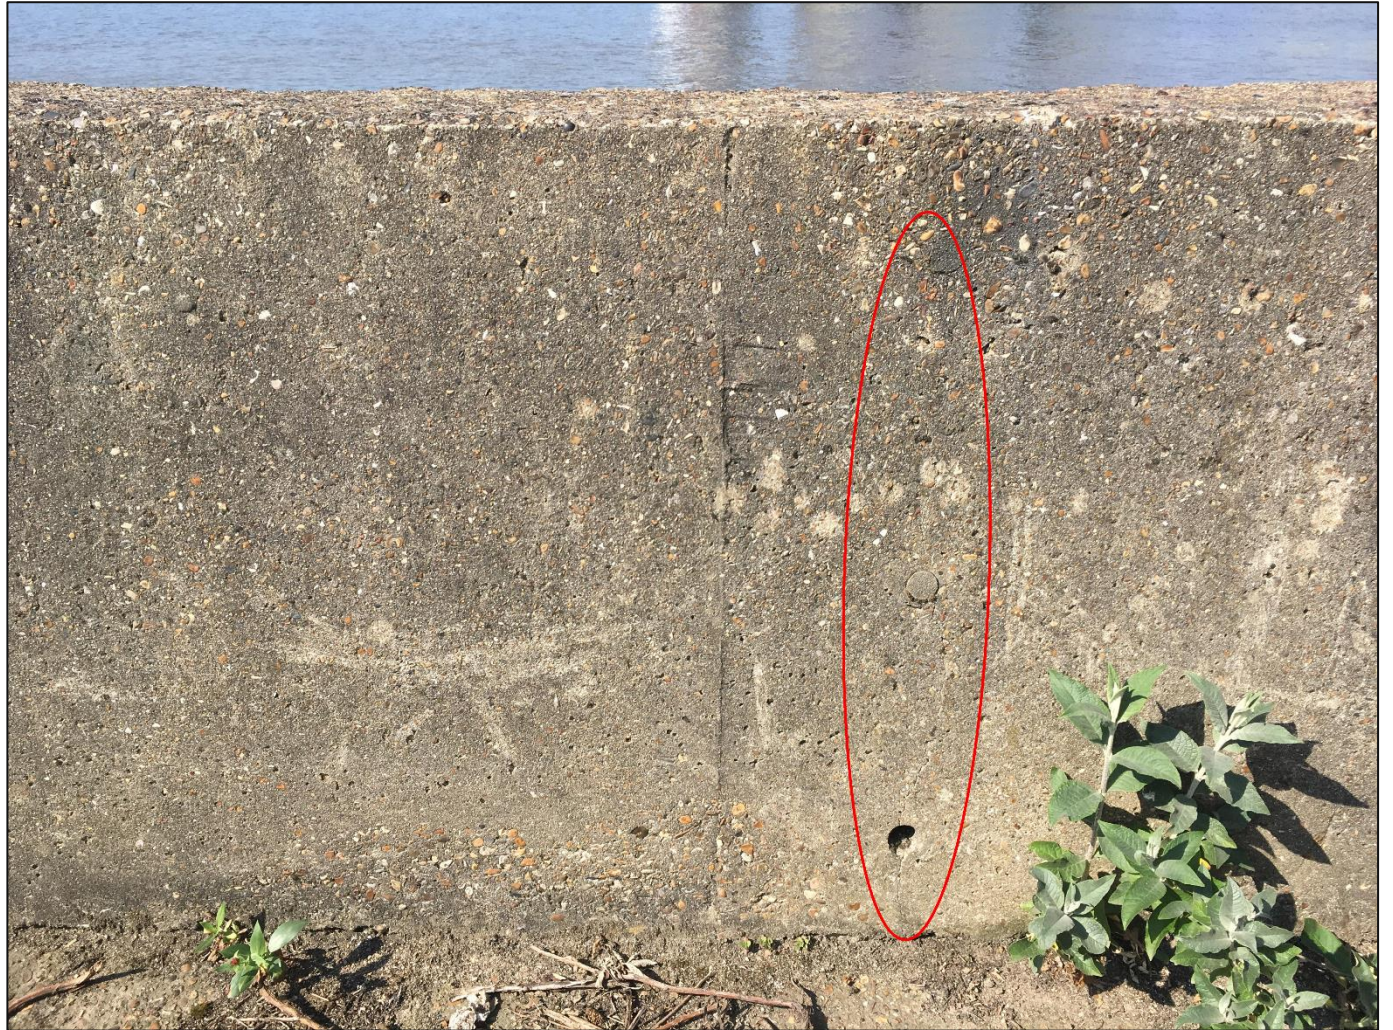
Location 5

Hard standing area – crack in parapet wall

- Existing hairline crack in concrete parapet wall first observed during first inspection on 19th December 2017.
- Crack originates through penetration in wall, assumed to be a construction defect rather than caused by movement of the river wall.
- No new cracks observed in concrete parapet wall or concrete hard standing.
- No evidence of movement since previous inspection on 24th May 2019.
- Note photo is from 24th May 2019 inspection.

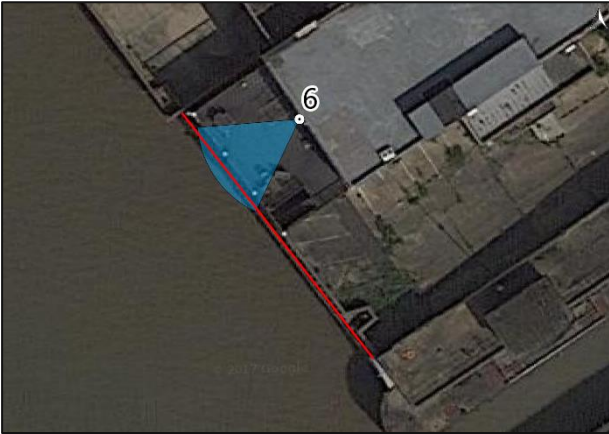
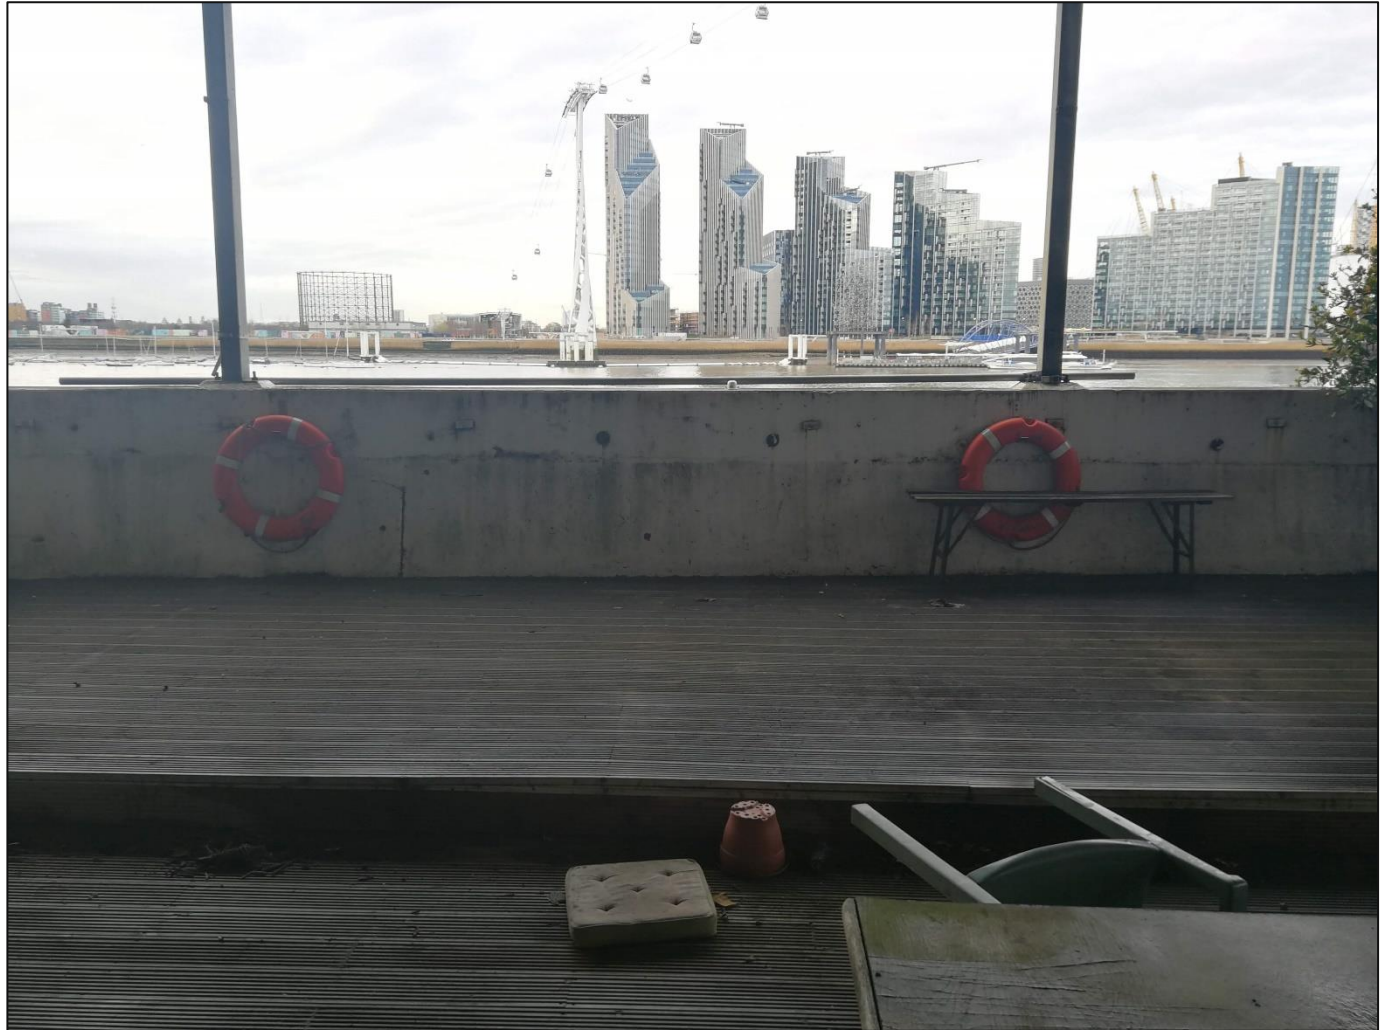
Location 6

TOBS terrace area – overview of parapet wall

- No new cracks observed in concrete parapet wall.
- Inspection of ground behind parapet wall prevented by presence of timber deck.
- No obvious indications of movement or settlement.

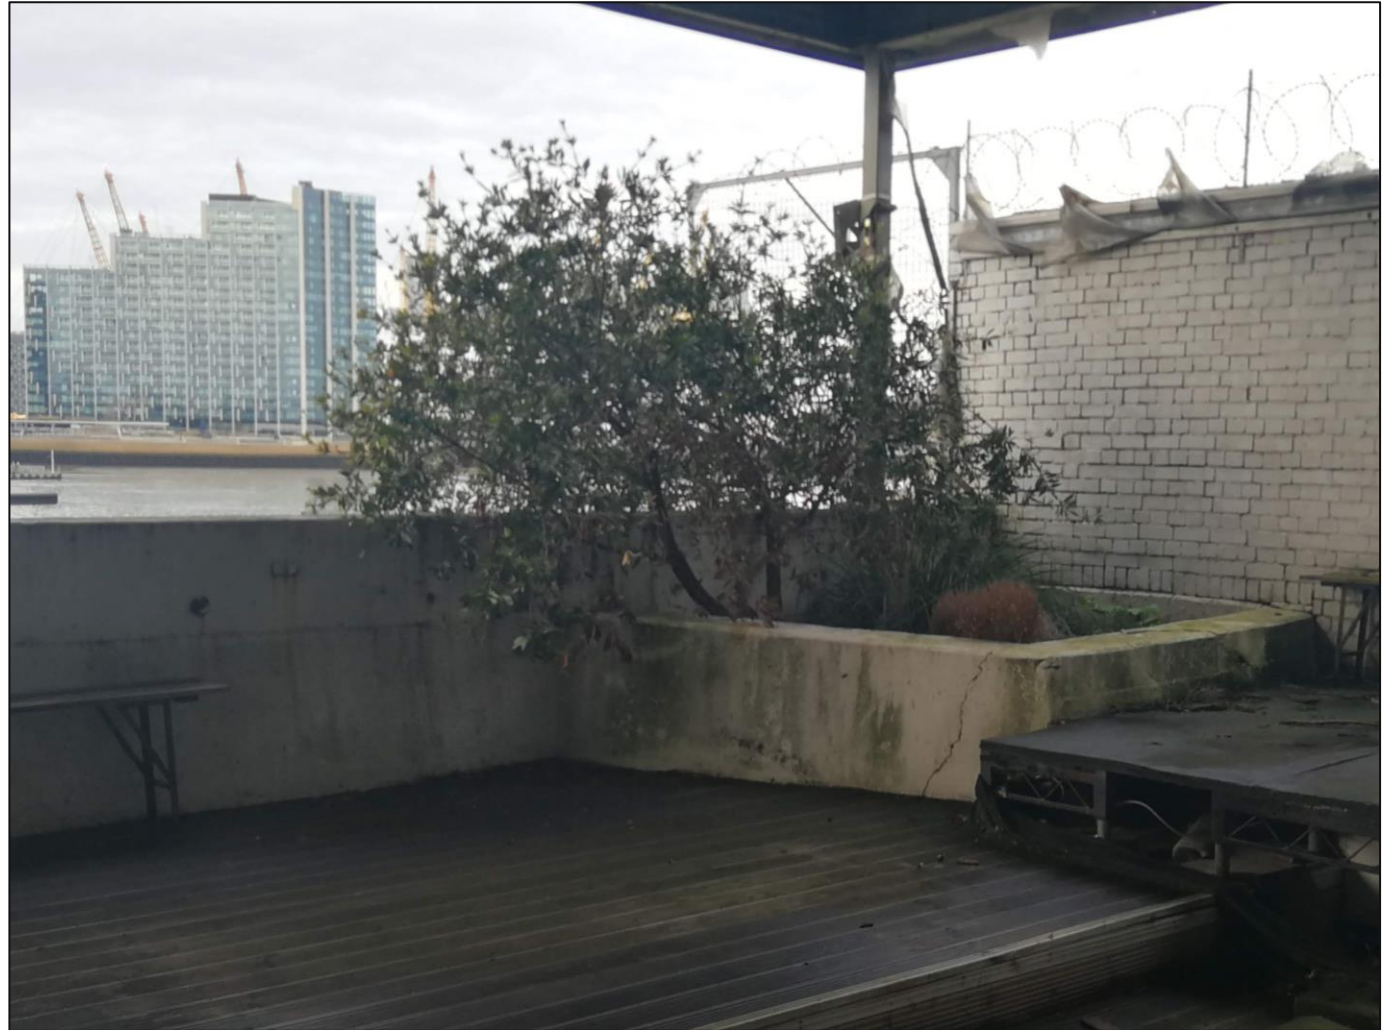
Location 7

TOBS terrace area – north corner

- Existing crack in wall of concrete planter first observed during first inspection on 19th December 2017. See location 8 for detail.
- No new cracks observed in concrete parapet wall or adjoining brick wall.
- No obvious indications of movement or settlement.
