Technical Note

Project Thames Side West
Subject Dohm Wharf River Wall Quarterly Inspection – June 2018
Project no 035668
Date 29 June 2018

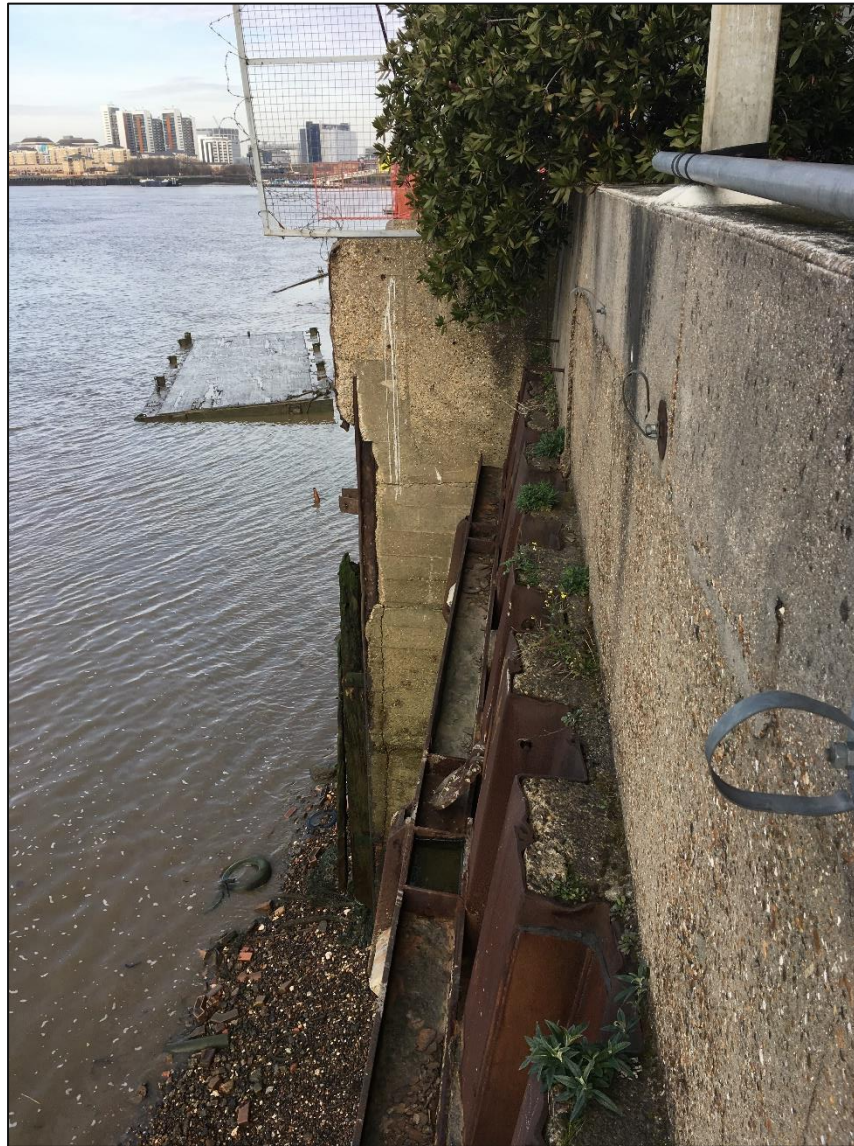
Location 11

TOBS terrace area – end face of adjacent wall to north

- Adjoining river wall to north steps out from alignment of Dohm Wharf river wall.
- Reinforcement within concrete face of adjoining river wall exposed. No obvious deterioration since last visit on 19th December 2017.
- No evidence of movement at interface between two river walls.

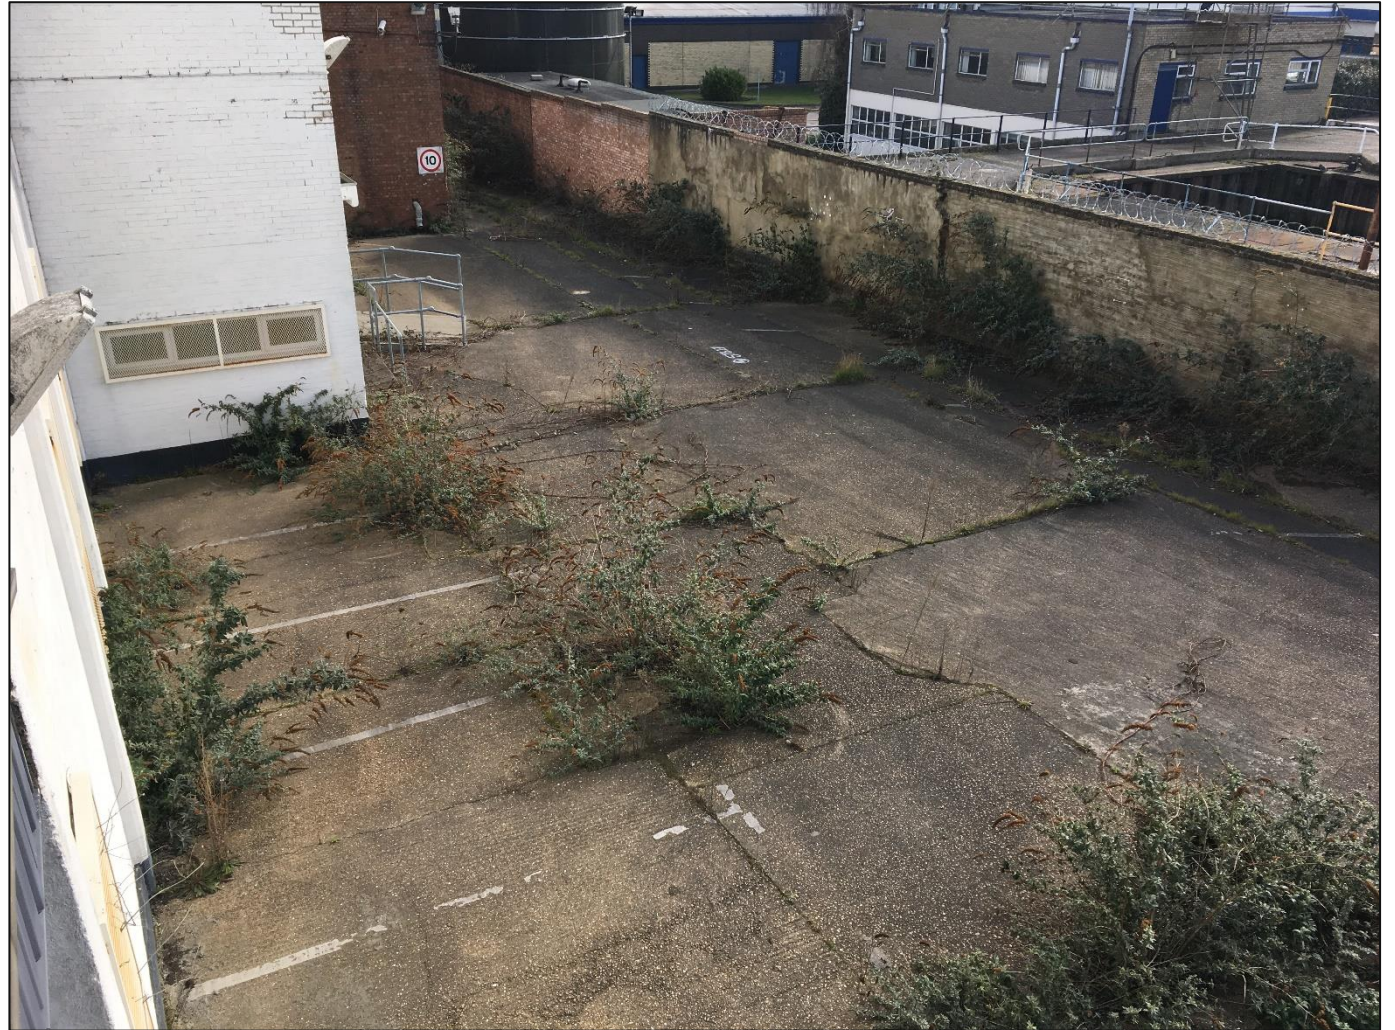
Location 12

Hard standing area – overview of hard standing

- Taken from the upper deck of the TOBS roof terrace.
- No new cracks or other evidence of movement or settlement within concrete hard standing observed.

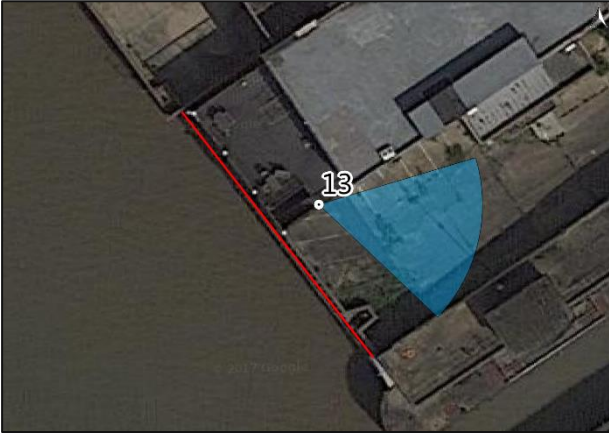
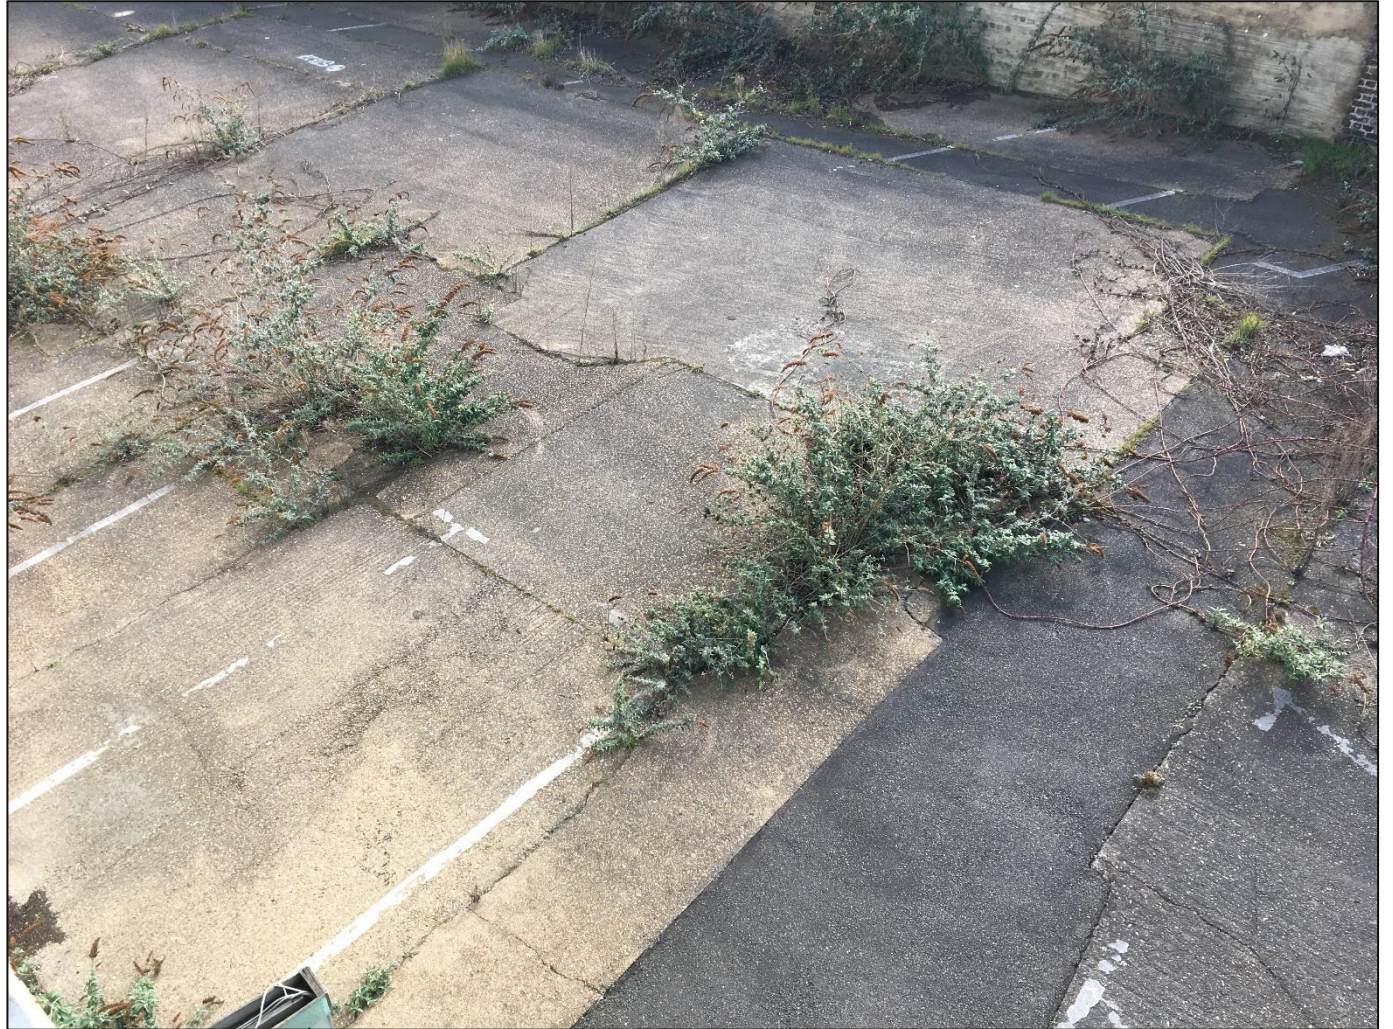
Location 13

Hard standing area – overview of hard standing

- Taken from the upper deck of the TOBS roof terrace.
- No new cracks or other evidence of movement or settlement within concrete hard standing observed.

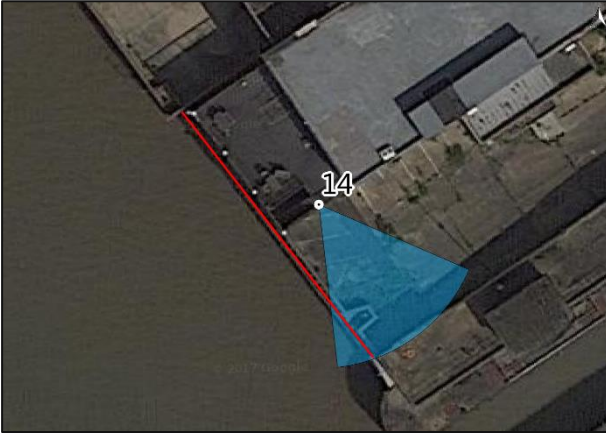
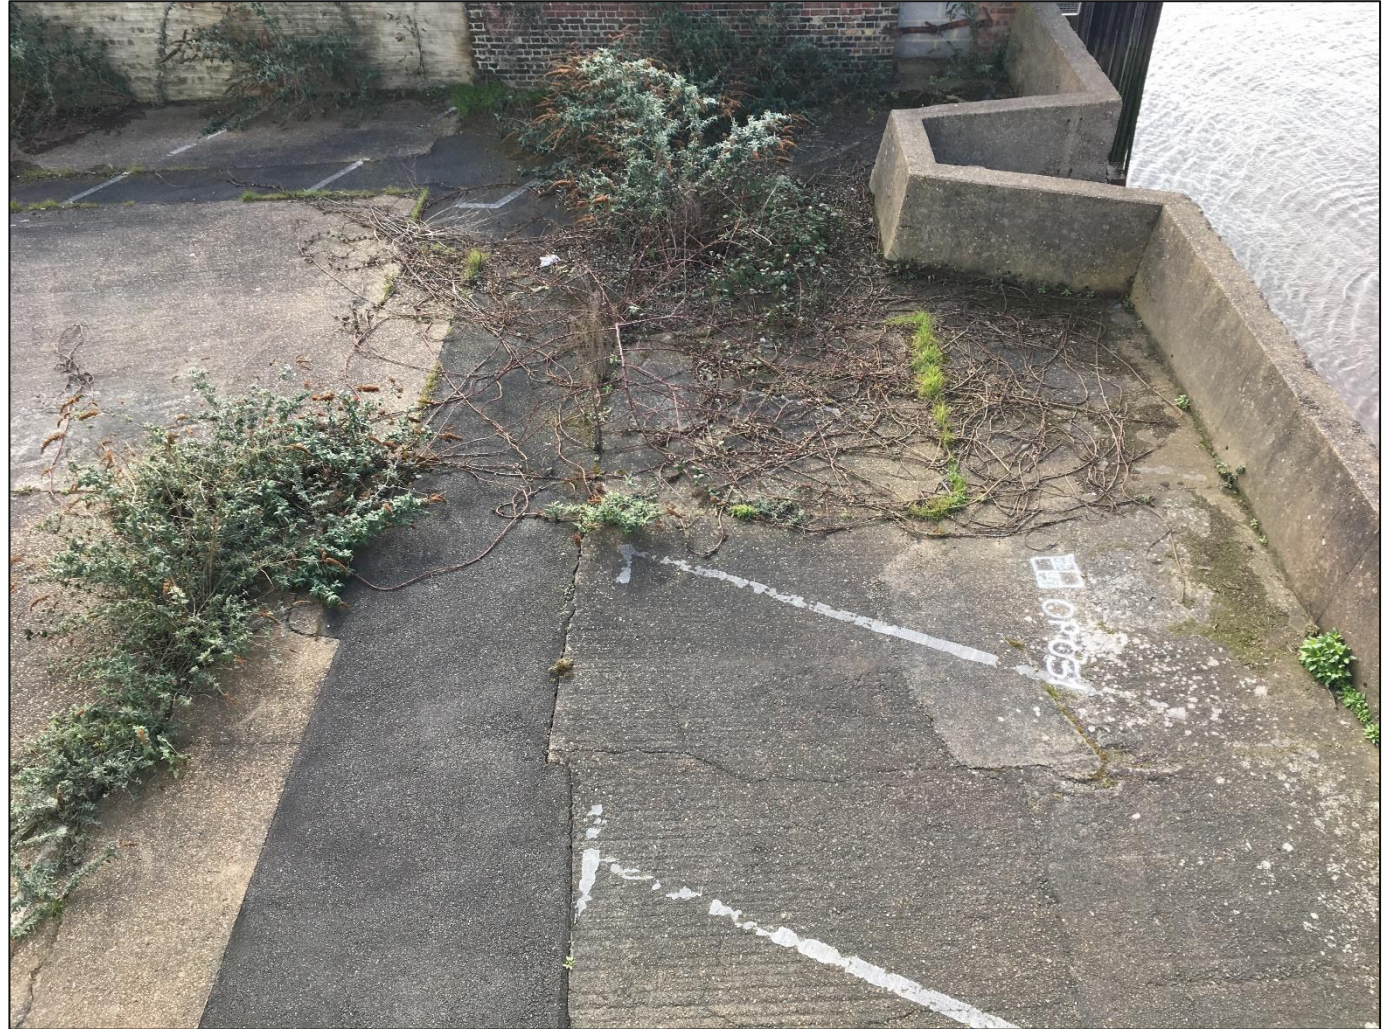
Location 14

Hard standing area – overview of hard standing

- Taken from the upper deck of the TOBS roof terrace.
- No new cracks or other evidence of movement or settlement within concrete hard standing observed.

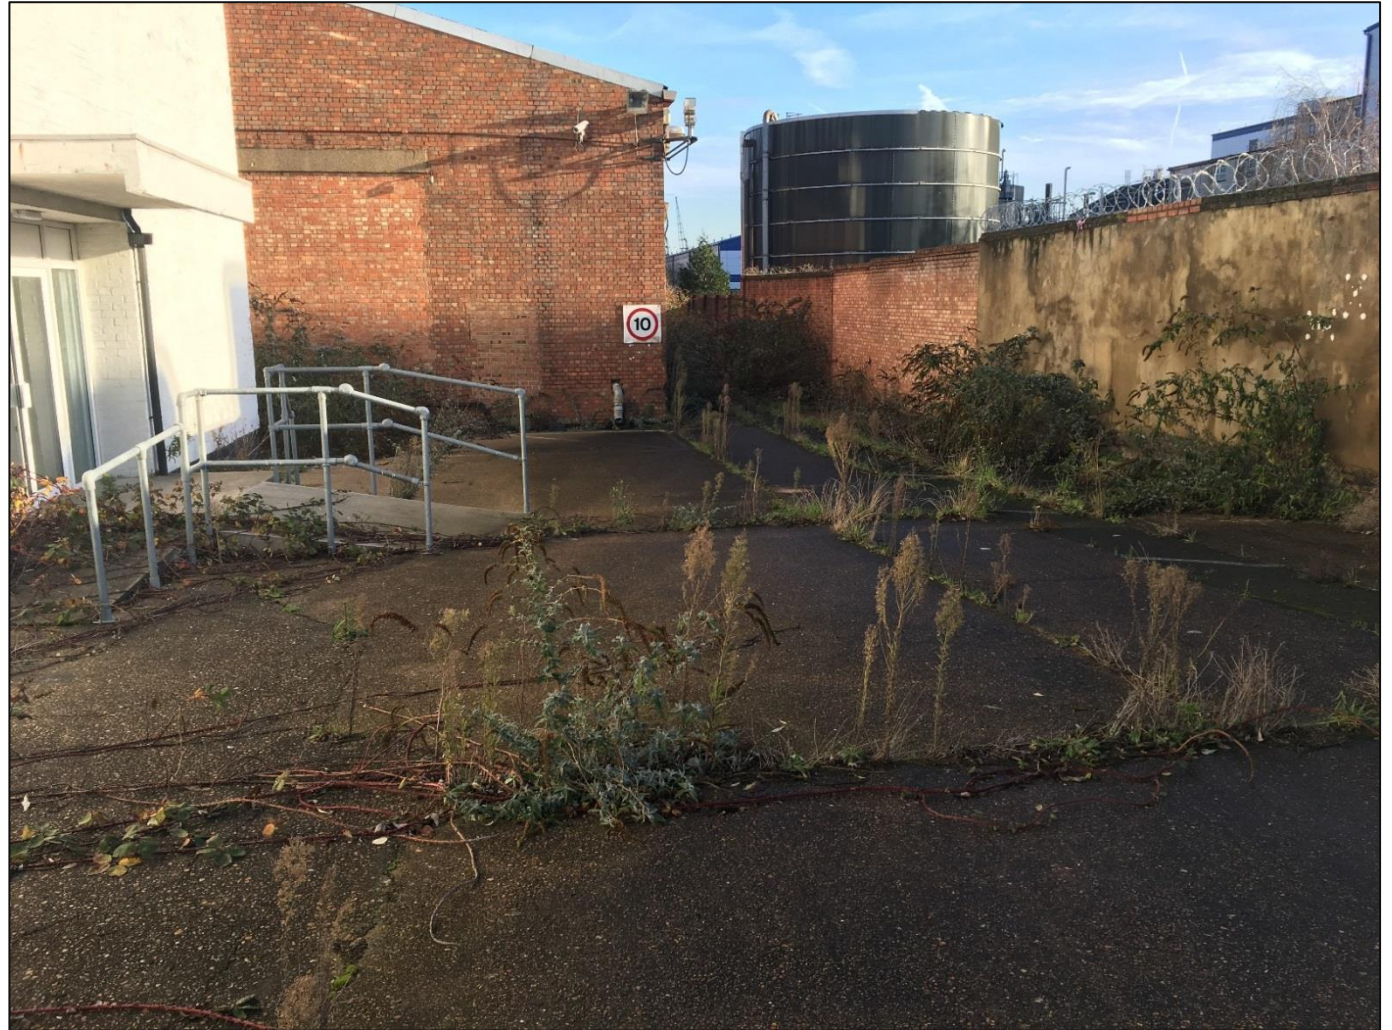
Location 15

Hard standing area – view away from river wall

- No new cracks or other evidence of movement or settlement within concrete hard standing observed.

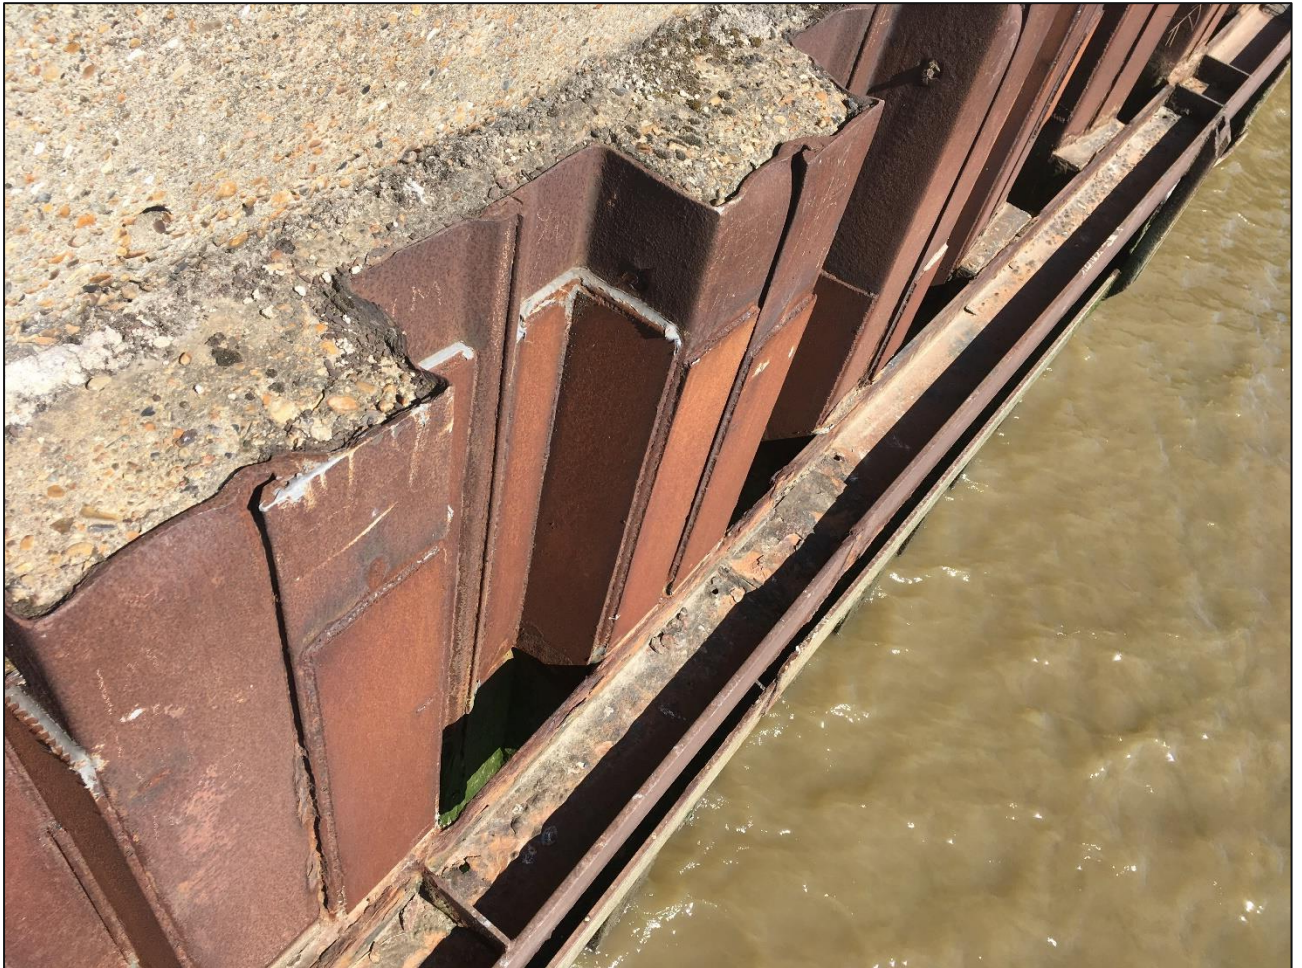
Figure 3.1: Typical photograph of upper level of river wall, showing steel plate repairs to sheet piling, taken from the land side of the river wall

All plate repairs appear to remain securely welded to the existing sheet pile sections and there is no evidence of further degradation of the condition of the remaining steel. Figure 3.1 shows a typical photograph of the upper level of the river wall, showing the steel plate repairs securely welded to the sheet piling.

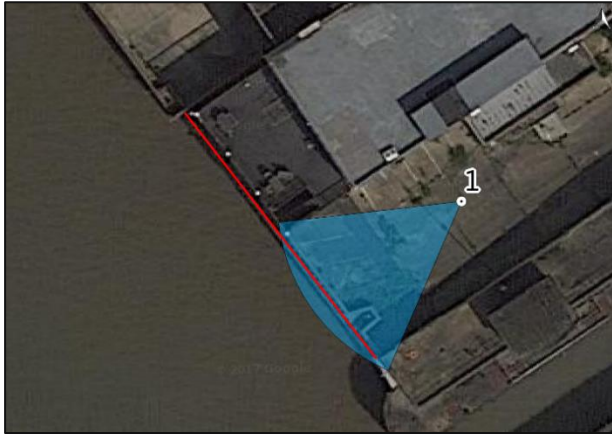
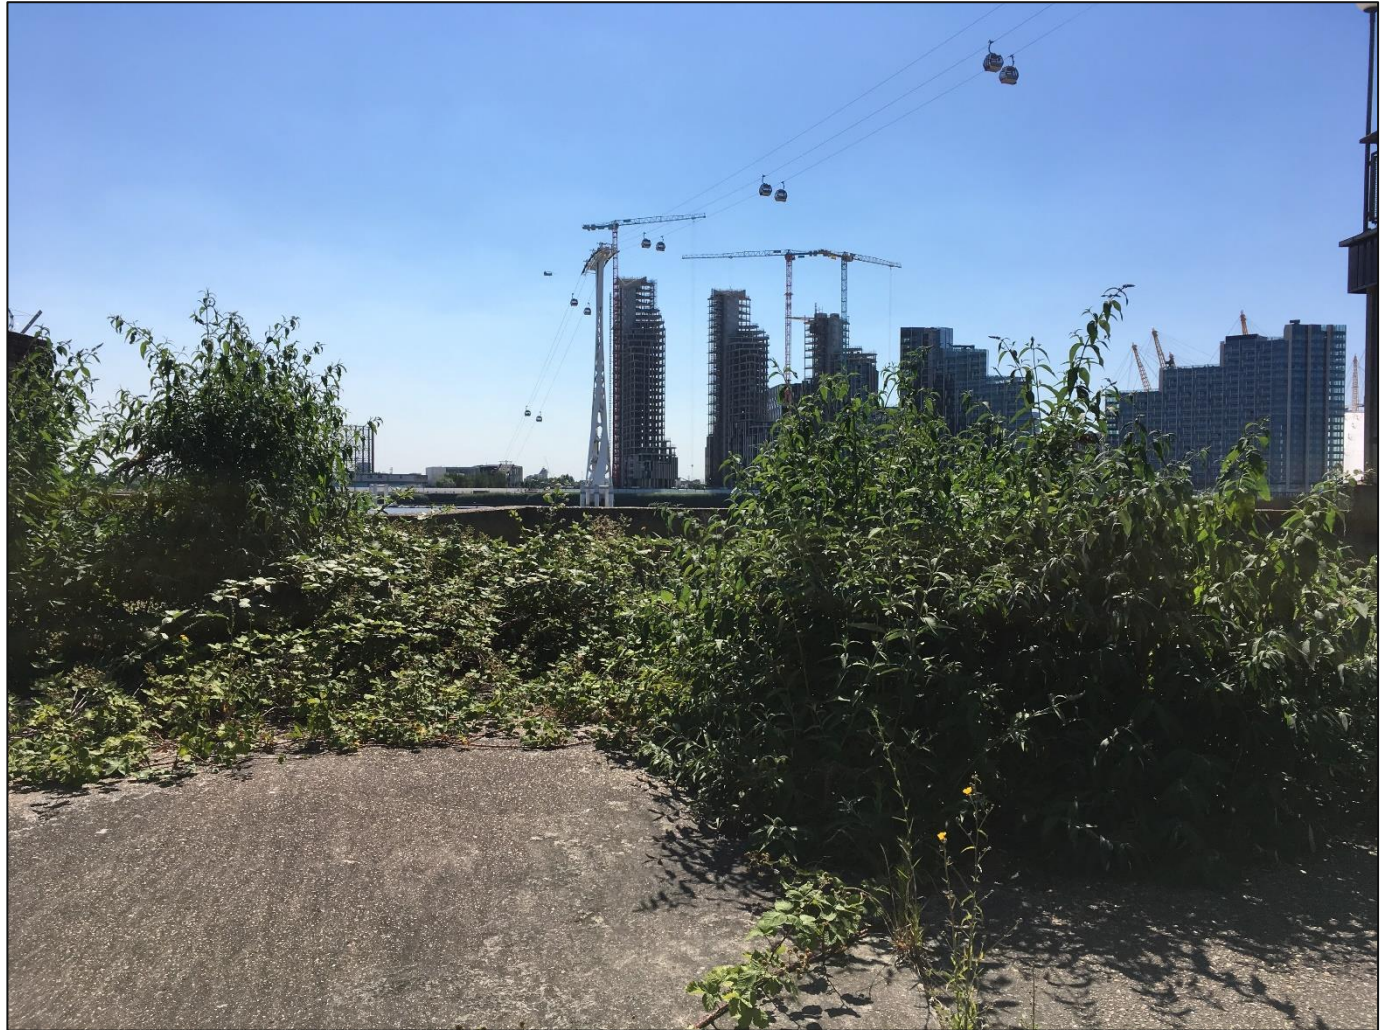
Location 1

Hard standing area – overview of parapet wall

- Hard standing generally in good condition.
- Existing cracks in hard standing previously observed during 23rd February 2017, 19th December 2017 and 22nd March 2018 inspections.
- No new cracks observed in concrete parapet wall or concrete hard standing.
- No obvious indications of movement or settlement of parapet wall or hard standing.
- Significant growth of vegetation since previous inspection on 22nd March 2018.

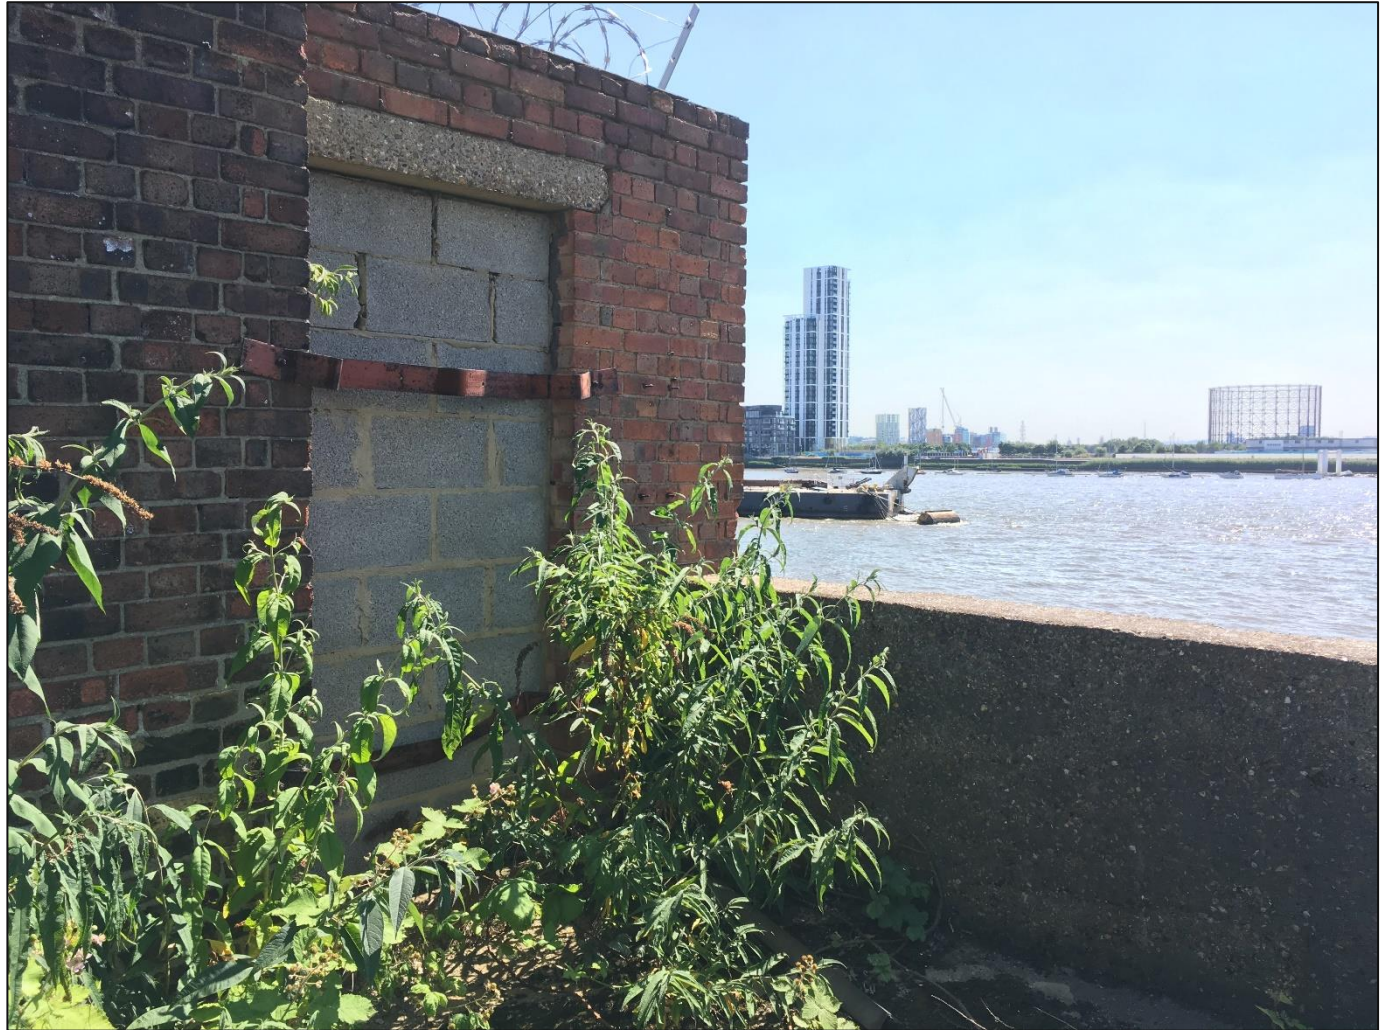
Location 2

Hard standing area – south corner

- Brick wall perpendicular to river wall, at south boundary of Dohm Wharf river wall.
- Existing crack in brick wall unchanged since last inspection. See location 3 for detail.
- No new cracks observed in concrete parapet wall, adjoining red brick wall or concrete hardstanding.

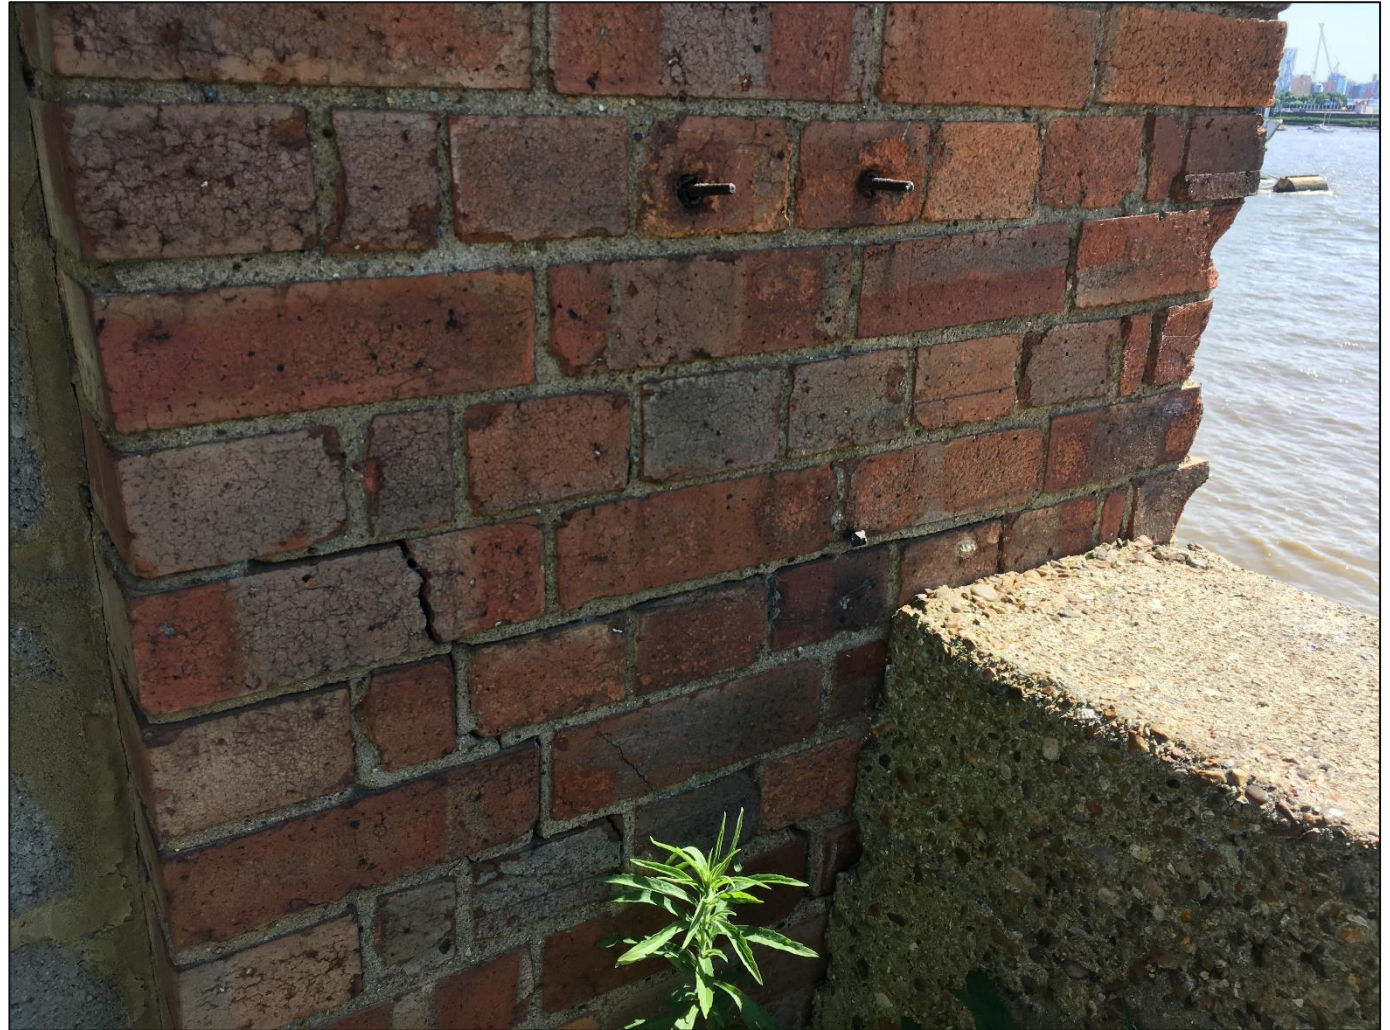
Location 3

Hard standing area – south corner brick wall crack detail

- Brick wall perpendicular to river wall, at south boundary of Dohm Wharf river wall.
- Existing crack in brick wall at approximate level of crest of concrete parapet wall.
- Extent of crack remains unchanged since 19th December 2017 and 22nd March 2018 inspection.
- Crack does not appear to have widened since 19th December 2017 and 22nd March 2018 inspection.
- No obvious indications of movement or settlement.

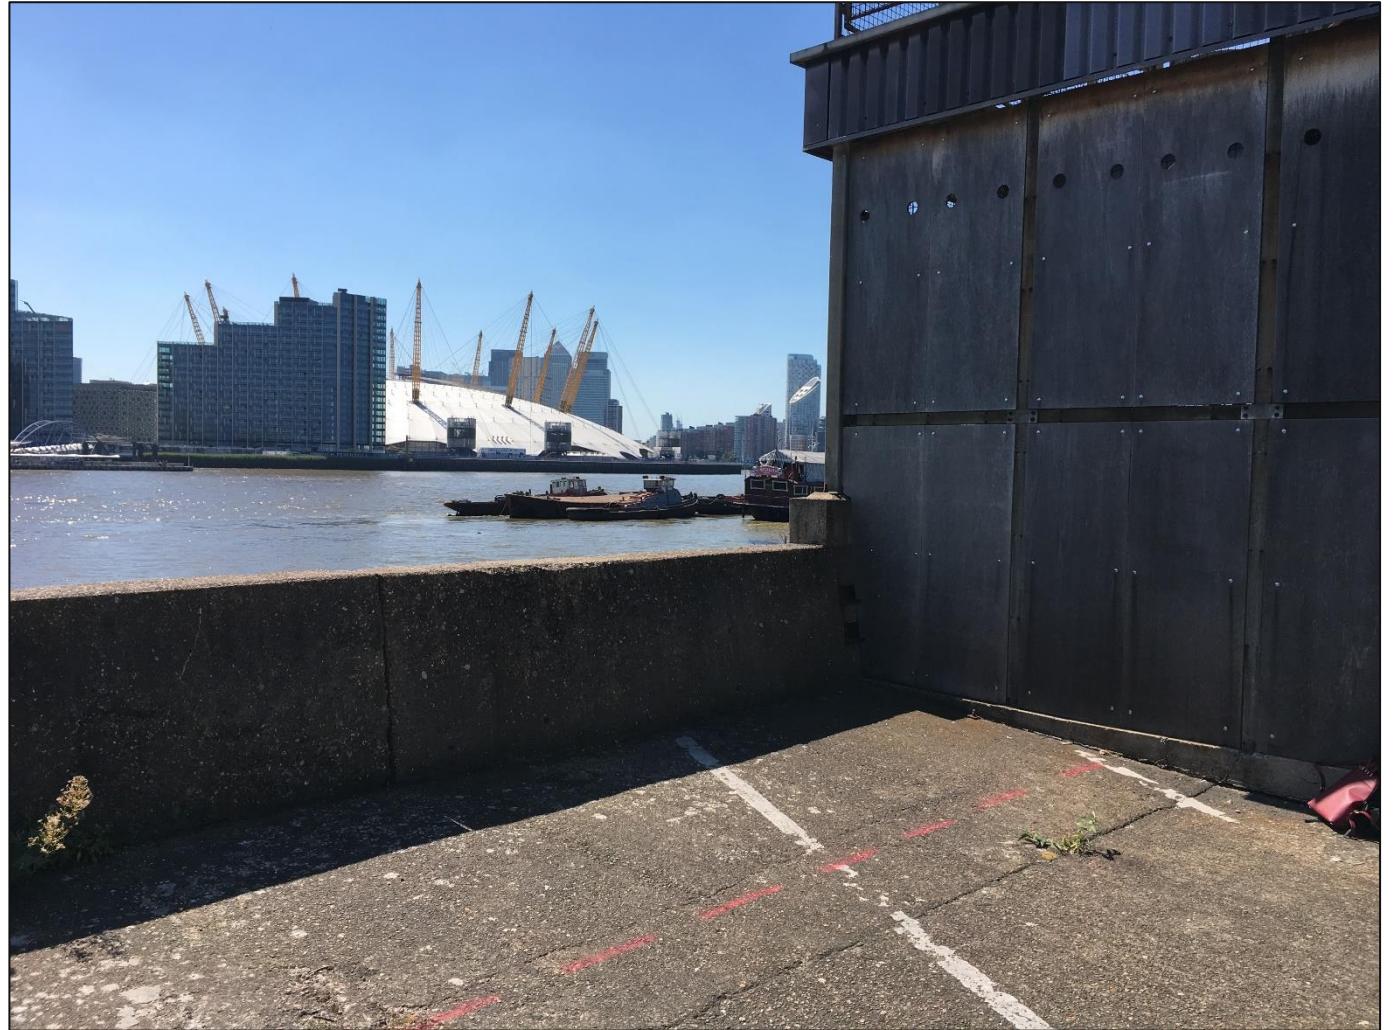
Location 4

Hard standing area – north corner

- No new cracks observed in concrete parapet wall or concrete hard standing.
- No evidence of movement at interface between timber hoarding, concrete parapet wall and concrete hard standing.
- No obvious indications of movement or settlement of parapet wall or hard standing.

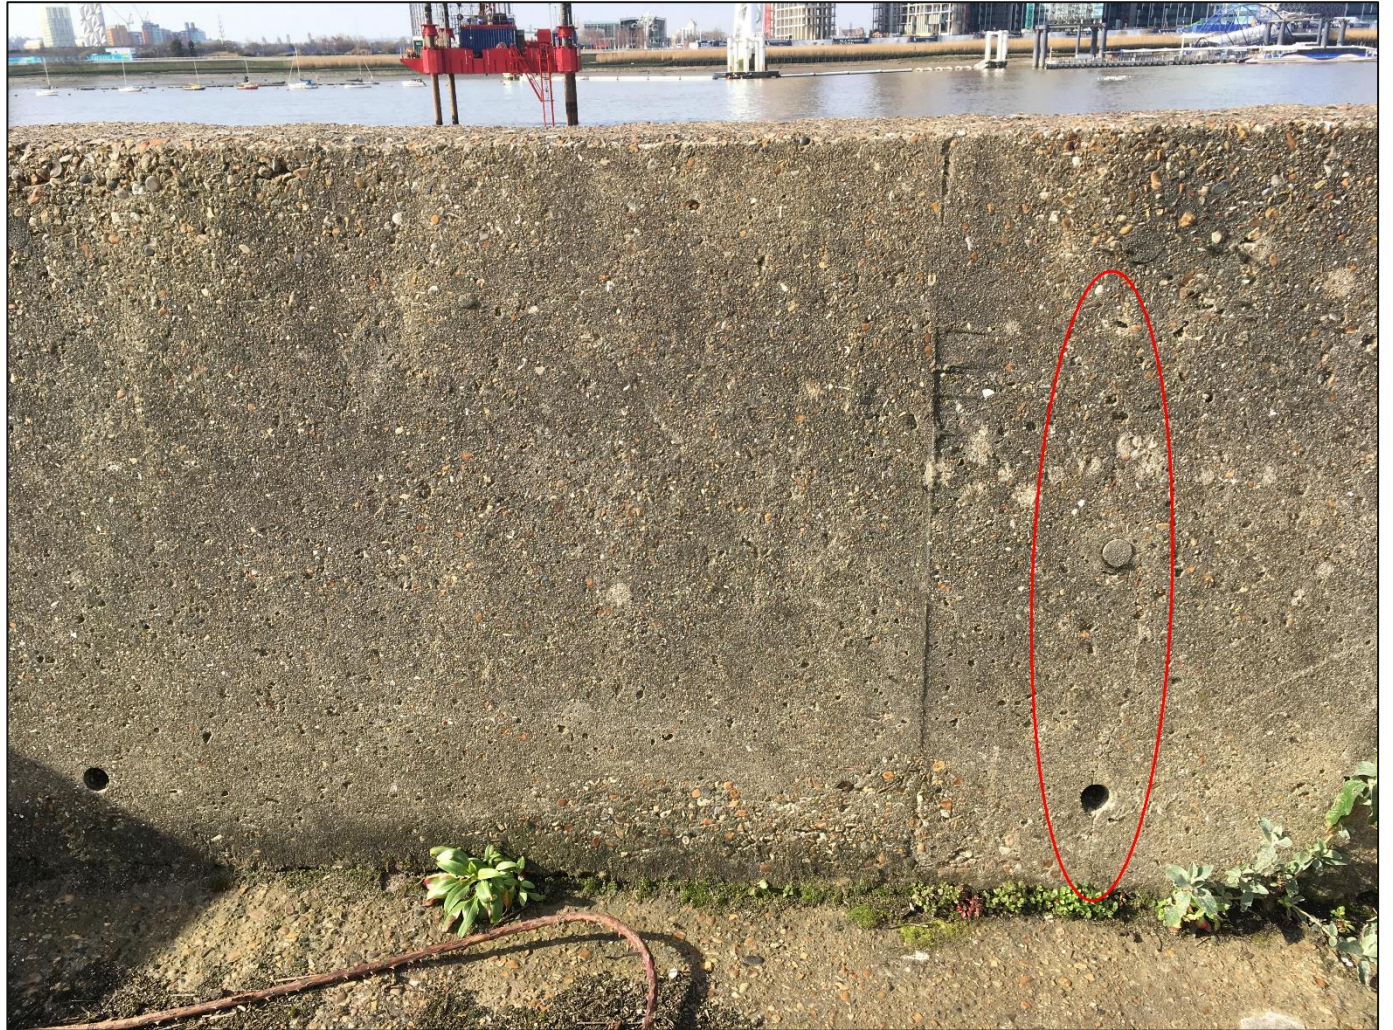
Location 5

Hard standing area – crack in parapet wall

- Hairline crack in concrete parapet wall.
- Crack originates through penetration in wall, assumed to be a construction defect rather than caused by movement of the river wall.
- No evidence of movement since previous inspection on 22nd March 2018.
- Note photo is from 22nd March 2018 inspection.

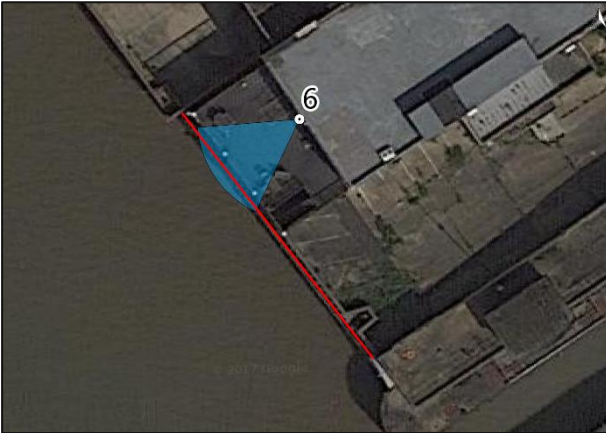
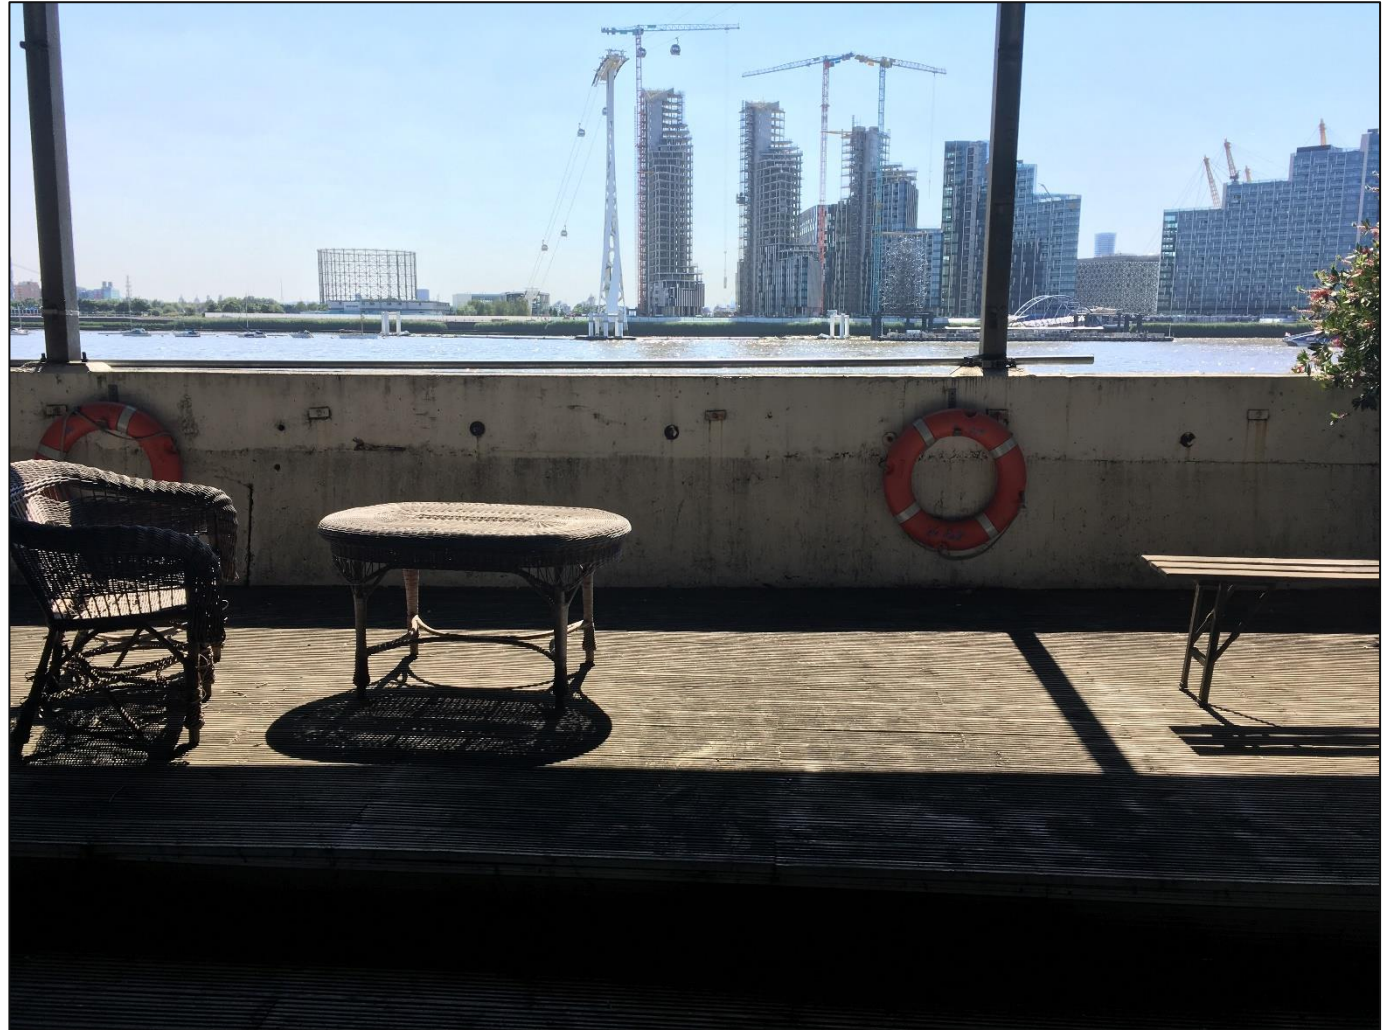
Location 6

TOBS terrace area – overview of parapet wall

- No new cracks observed in concrete parapet wall.
- Inspection of ground behind parapet wall prevented by presence of timber deck.
- No obvious indications of movement or settlement.

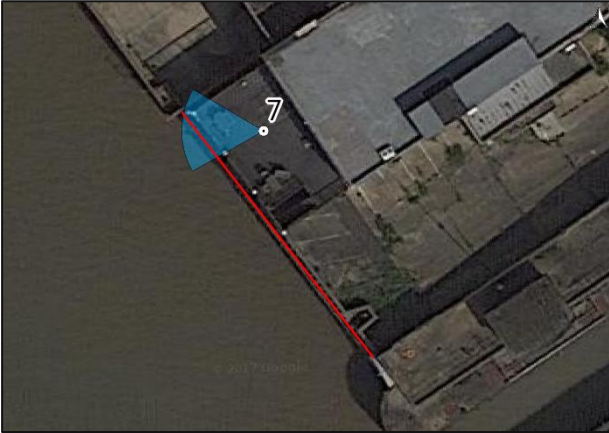
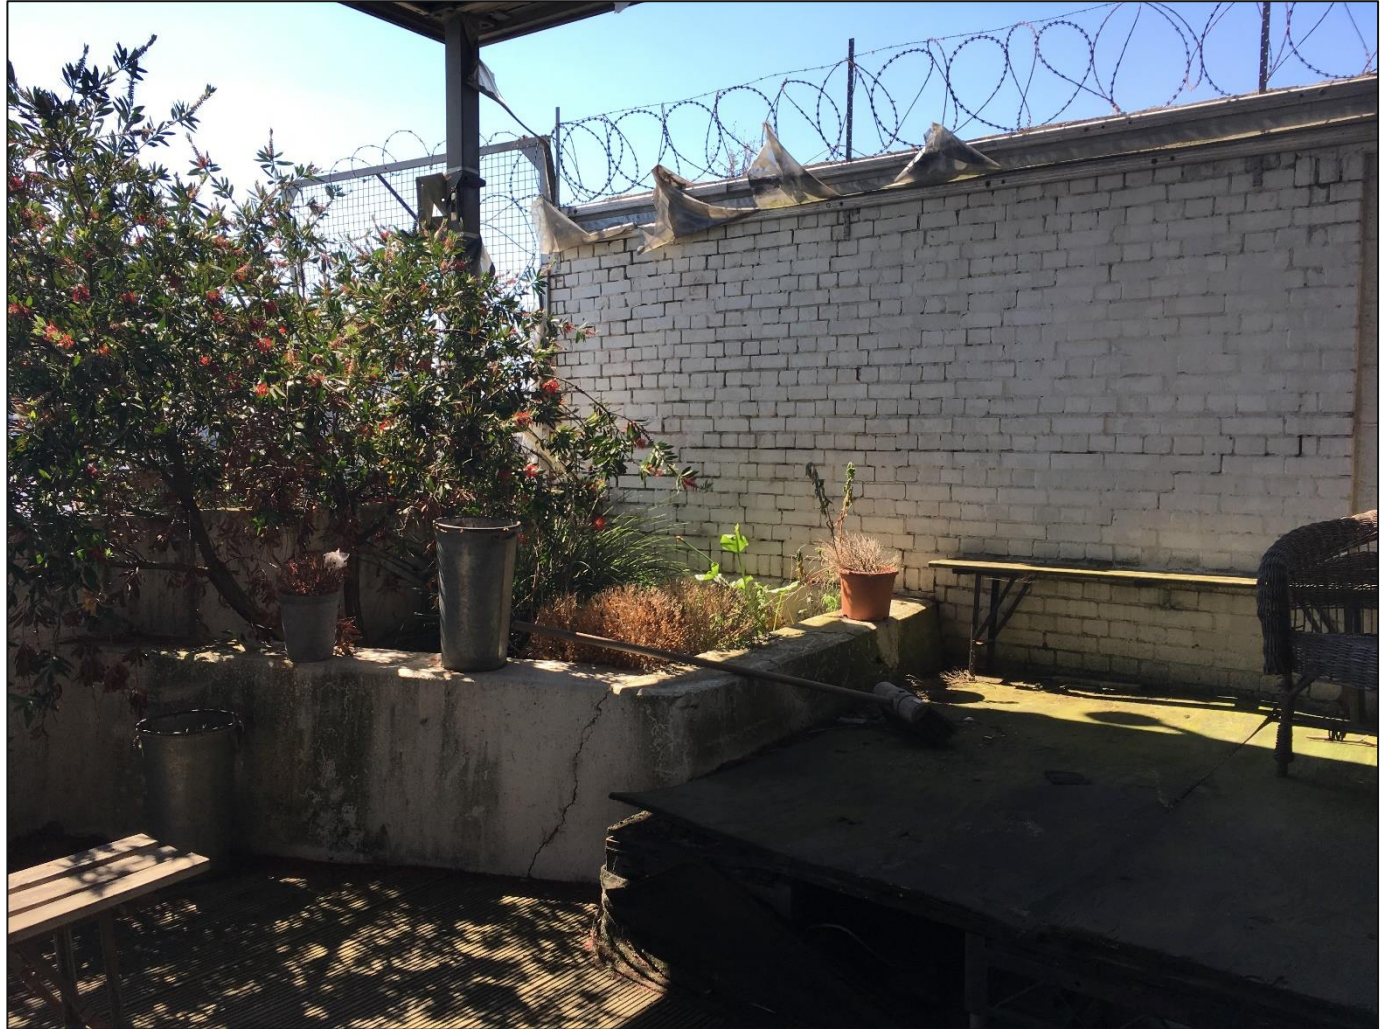
Location 7

TOBS terrace area – north corner

- Existing crack in wall of concrete planter. See location 8 for detail.
- No new cracks observed in concrete parapet wall.
- No obvious indications of movement or settlement.

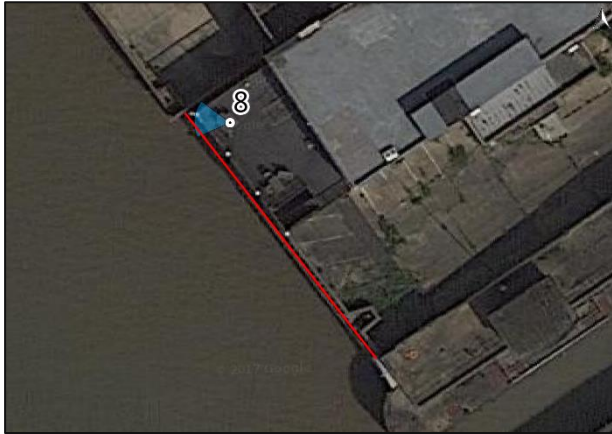
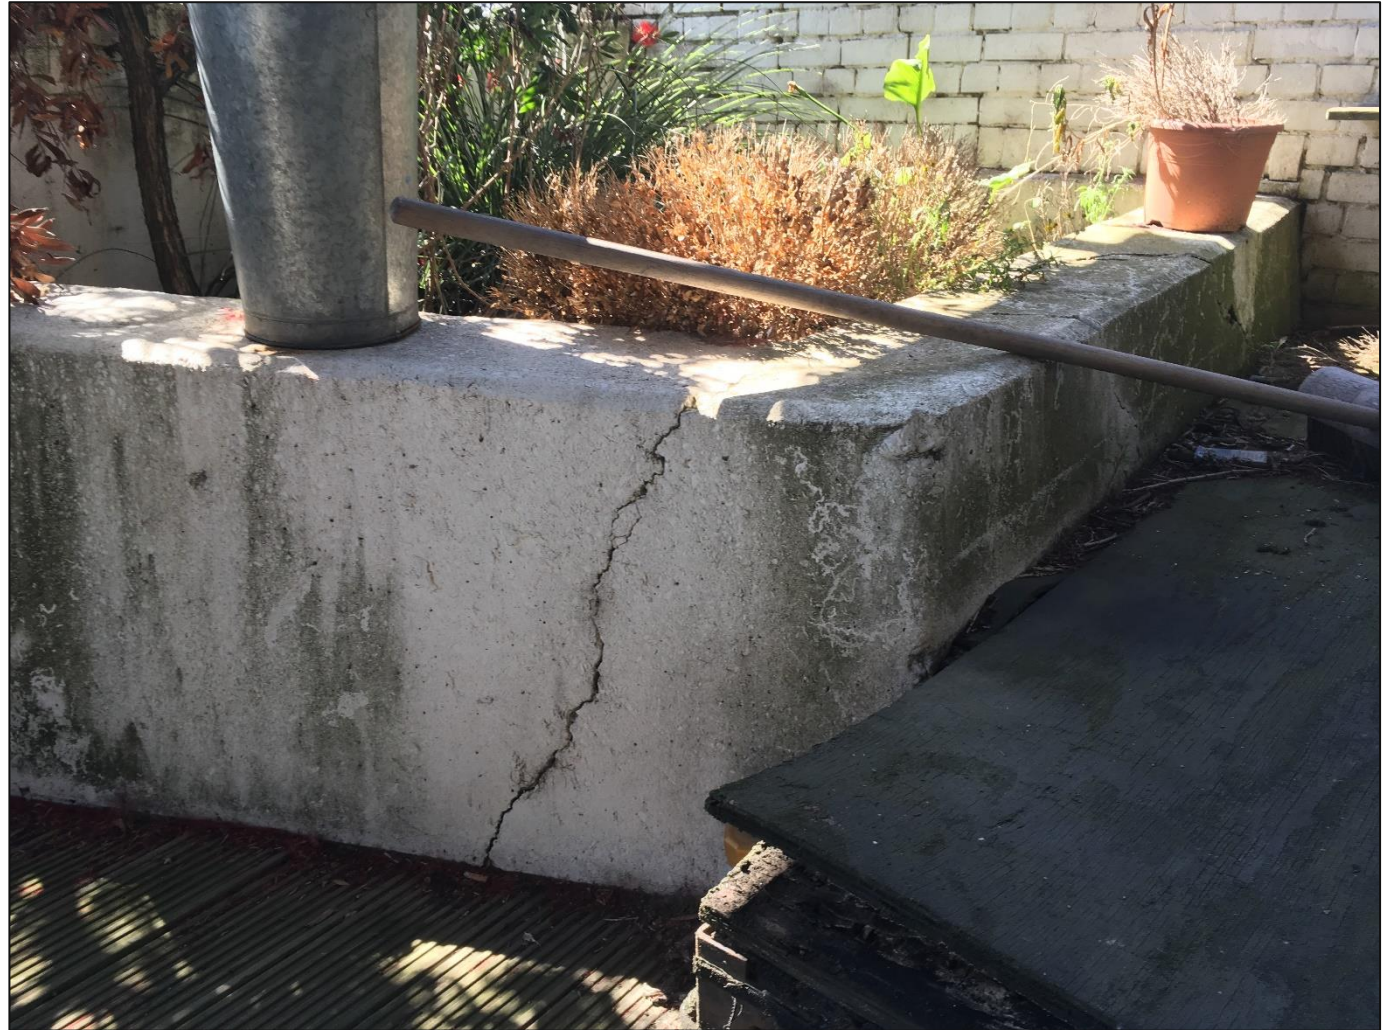
Location 8

TOBS terrace area – north corner planter crack detail

- Existing crack in wall of concrete planter.
- Extent of crack remains unchanged since last inspection.
- No evidence to indicate that crack has widened since last inspection.
