Technical Note

Project Thames Side West
Subject Dohm Wharf River Wall Quarterly Inspection – June 2018
Project no 035668
Date 29 June 2018

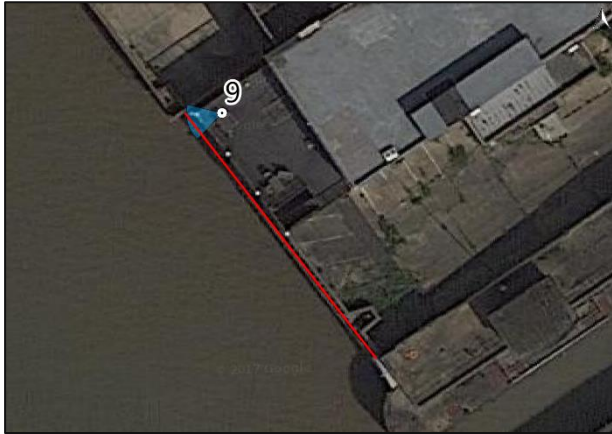
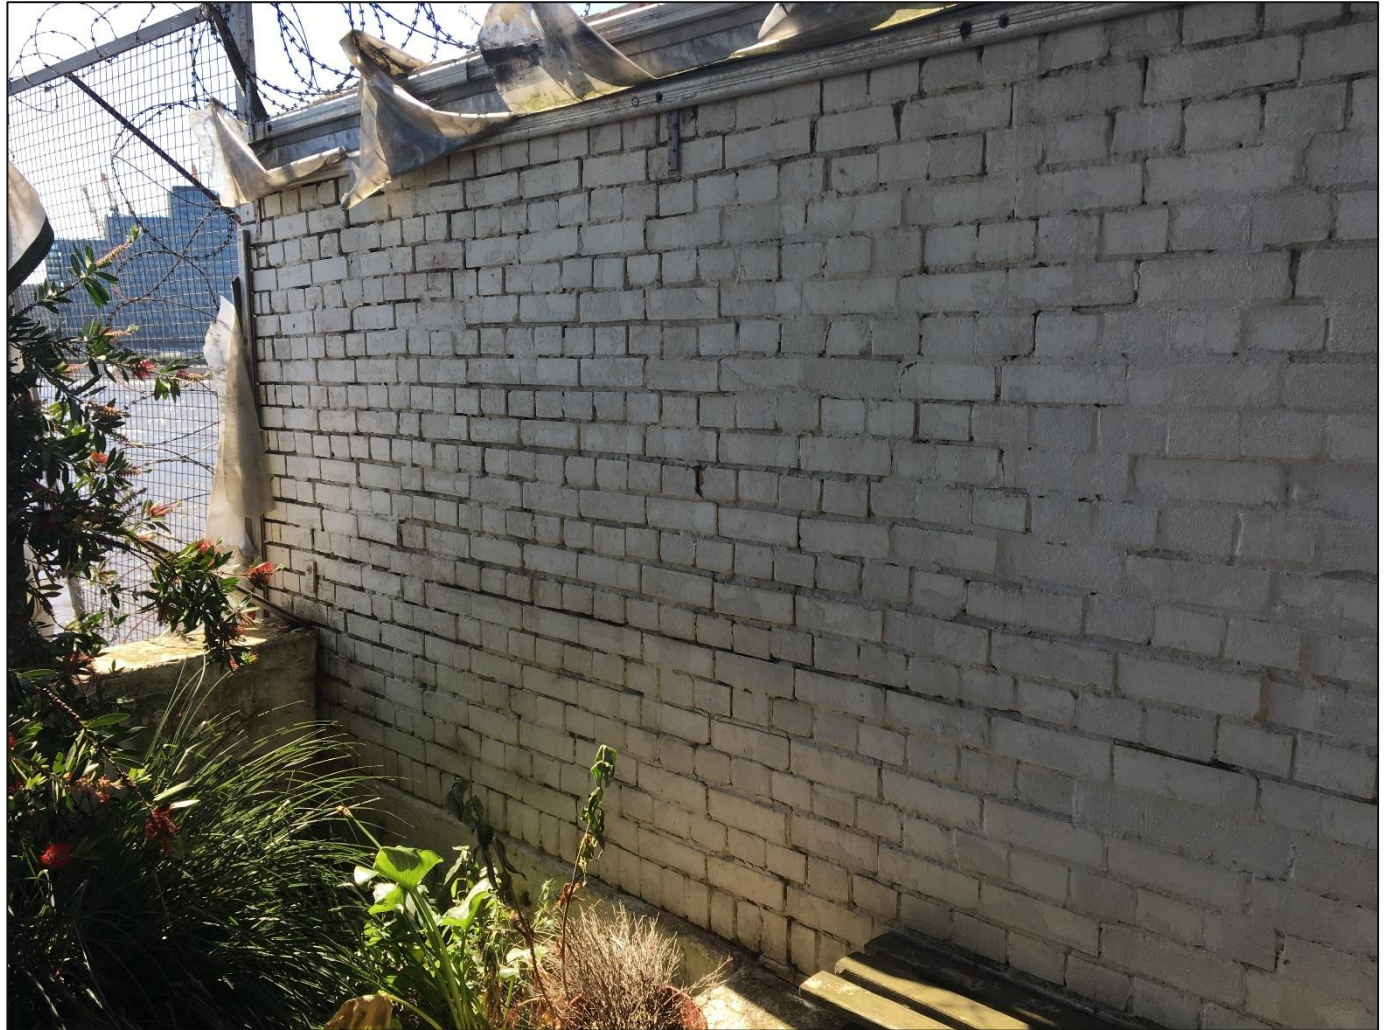
Location 9

TOBS terrace area – north cornered brick wall detail

- Adjoining brick wall at north boundary of Dohm Wharf river wall.
- No evidence to indicate that crack has widened or extended since last inspection.
- Note that condition of mortar is poor in places.

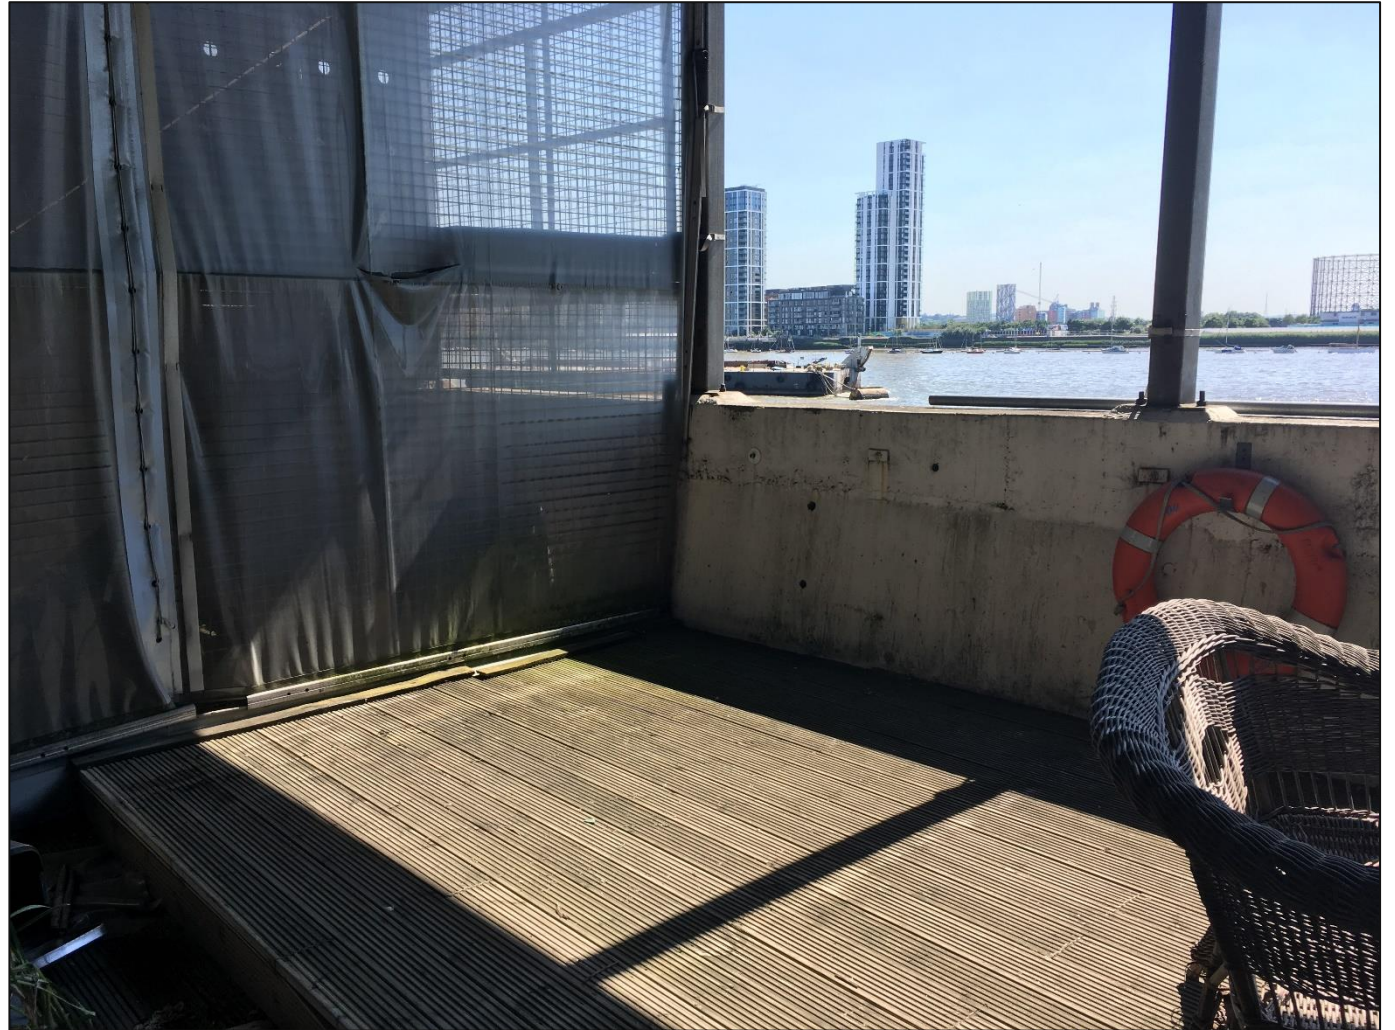
Location 10

TOBS terrace area – south corner

- No new cracks observed in concrete parapet wall.
- No obvious indications of movement or settlement.

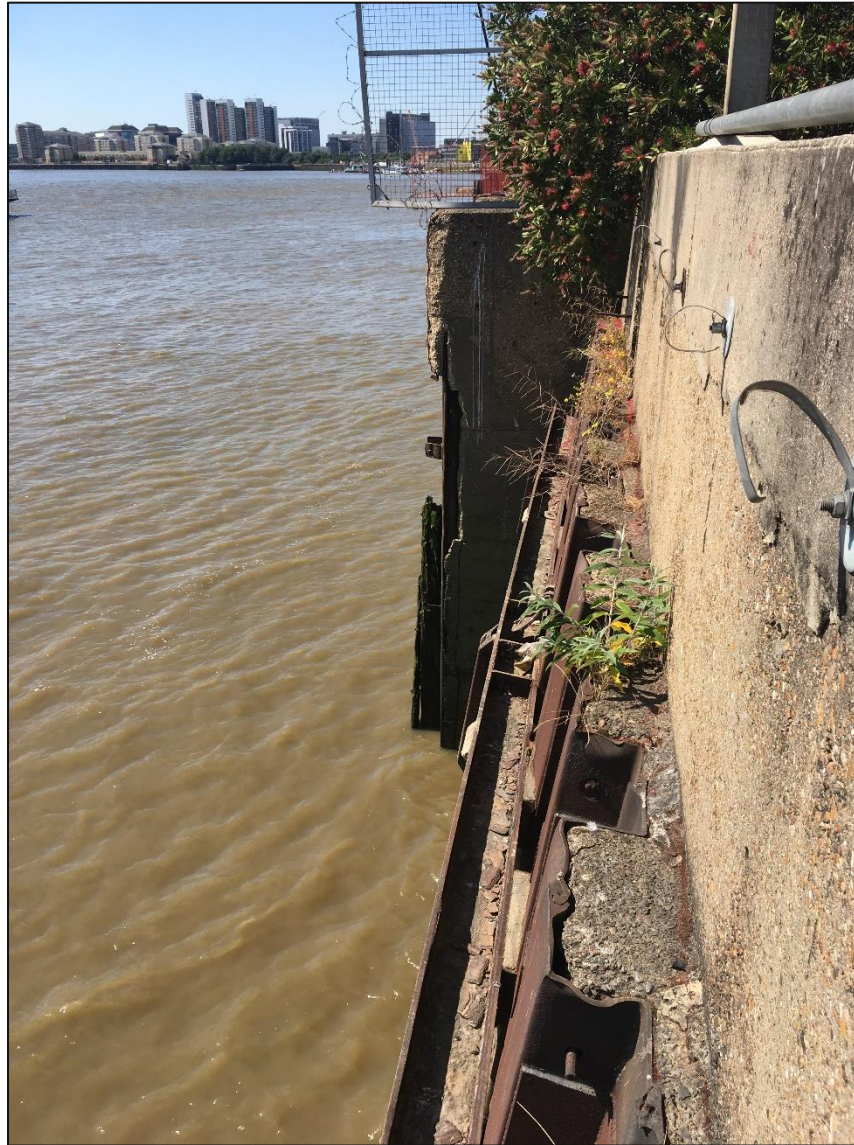
Location 11

TOBS terrace area – end face of adjacent wall to north

- Adjoining river wall to north steps out from alignment of Dohm Wharf river wall.
- Reinforcement within concrete face of adjoining river wall exposed. No obvious deterioration since last visit on 22nd March 2018.
- No evidence of movement at interface between two river walls.

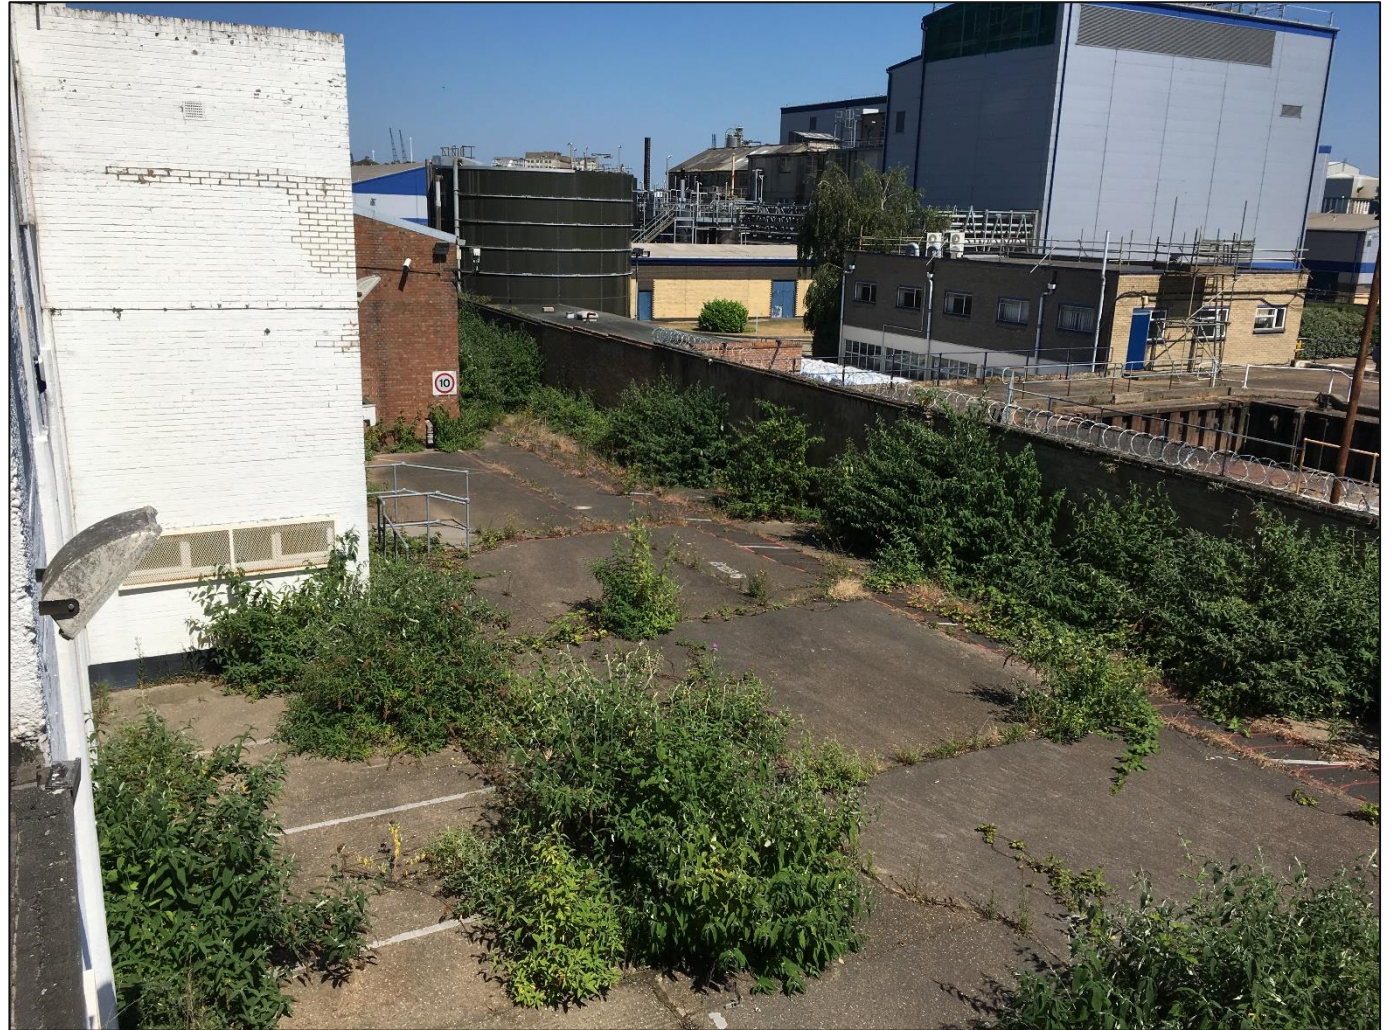
Location 12

Hard standing area – overview of hard standing

- Taken from the upper deck of the TOBS roof terrace.
- No new cracks or other evidence of movement or settlement within concrete hard standing observed.
