Waste Infrastructure Survey

Stage 1 Report

10/08/2022

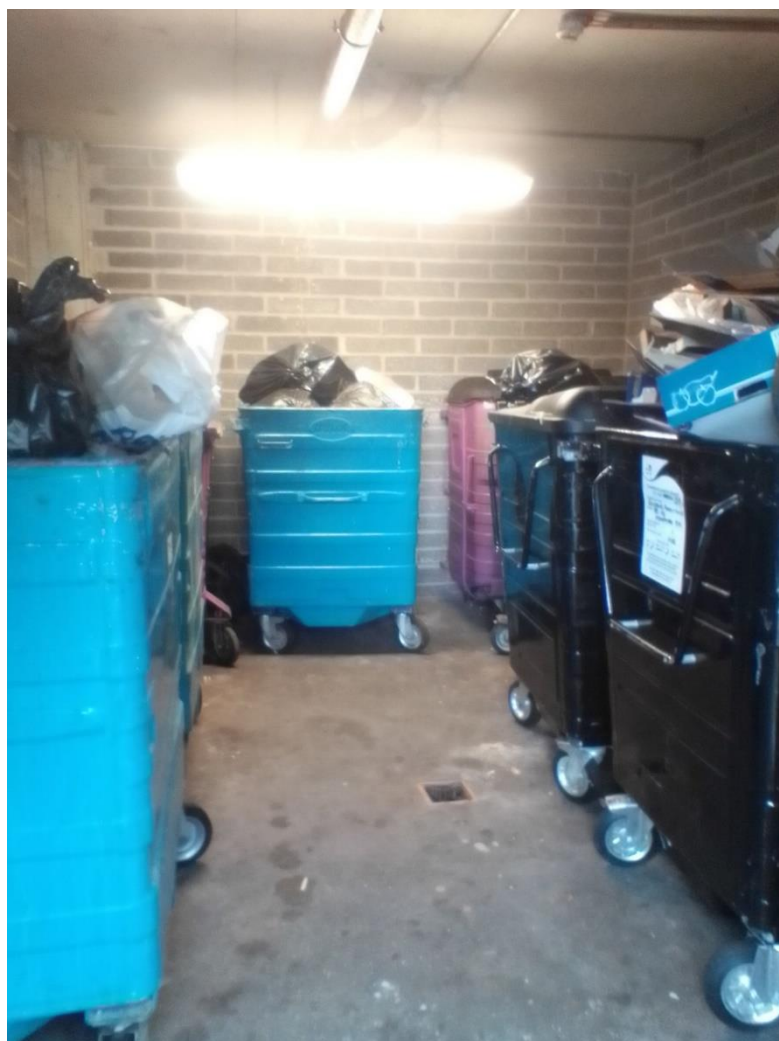
Within the evaluation model, it was apparent that many sites did not have adequate provision of residual waste and recycling signage. In part, this was due to a number of bin stores not having a sufficient number of signs, or in some cases no signs, above the bins. There were also a number of high scores within the evaluation model indicating bin stores which had poor or no stickers on the bins themselves, with 99.7% of residual waste bins received the highest score for bin signage, meaning the residual waste bins had no signage on them. Of these residual waste bins, 27% were recorded as “unable to determine”, and as such were given the lowest score possible.

Figure 6 Image to show a bin store with lack of appropriate signage

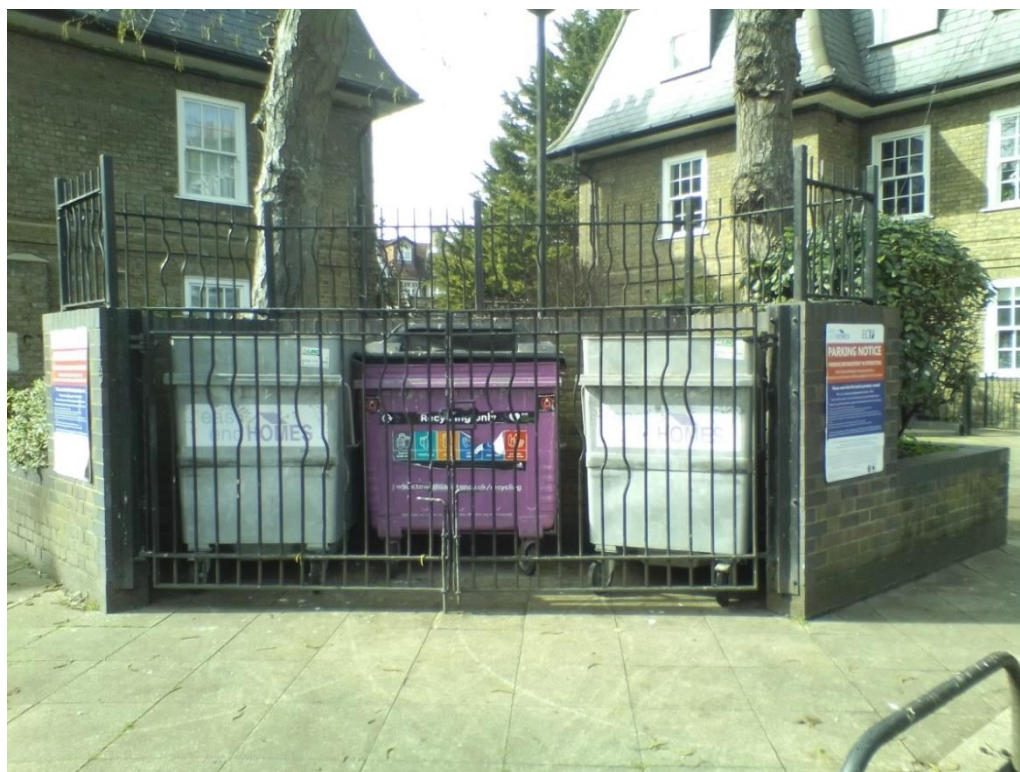
In the FRP, it is recommended that the residual waste and recycling bins are clearly separated to allow residents to more easily identify the correct bins to use. Out of the 362 bin stores which had both recycling and residual waste facilities, 8% of the bin stores had the residual waste and recycling bins mixed together, 59% had both bins in designated spaces where it was clear which was the area for recycling and which was the area for residual waste. Finally, 29% of bin stores had recycling and residual waste bins which were separate but were very close to each other. As such, this shows there is scope to improve the segregation of recycling and residual waste bins. 4% of bin stores had "unable to determine" as the survey answer, and as such, were given the lowest possible score.

Figure 7 Image to show outdoor bin store with no separation of bins and poor signage

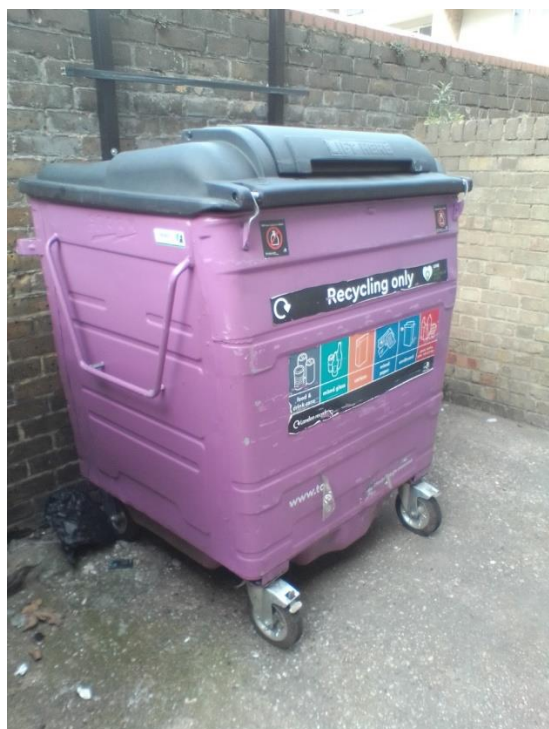
The lid type on the recycling bins also varied a lot, with 26% of the recycling bins having no lid and being completely open, 43% had a normal lid, 28% had a lid with an aperture and only 4% had a reverse lid. The reverse lidded bins are recommended by ReLondon for recycling as they prevent the whole lid from being opened, and residents can only fit recycling through the aperture, which greatly reduces the incidents of contamination, particularly of bulky waste and large bags of rubbish. In addition, reverse lids can be retrofitted onto existing bins, eliminating the need to replace the whole bin in these situations which can prove to be a cost-

Figure 8 Image showing a recycling lid with a reverse lid.
