Ground Investigation Report (April 2016)

## **Ground Investigation**

**Pentavia Retail Park  
Watford Way  
MILL HILL  
London  
NW7 2ET**

**Report No: 15.02.014a  
September 2016**

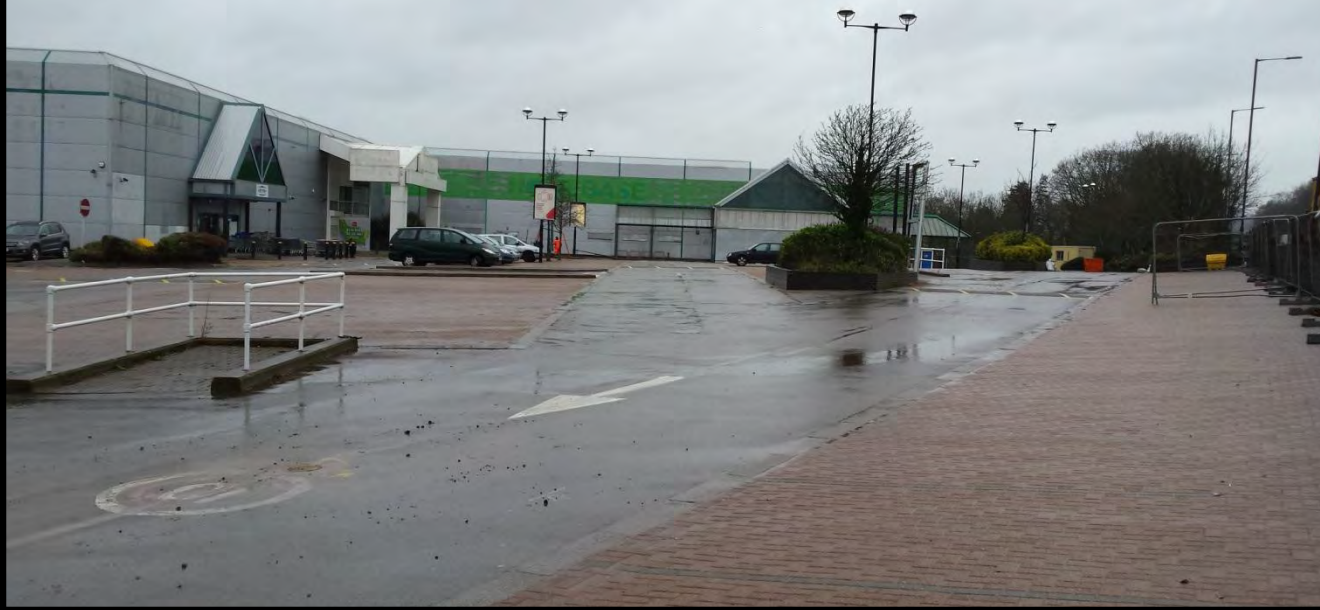
Eastern area of the site, viewed from the south

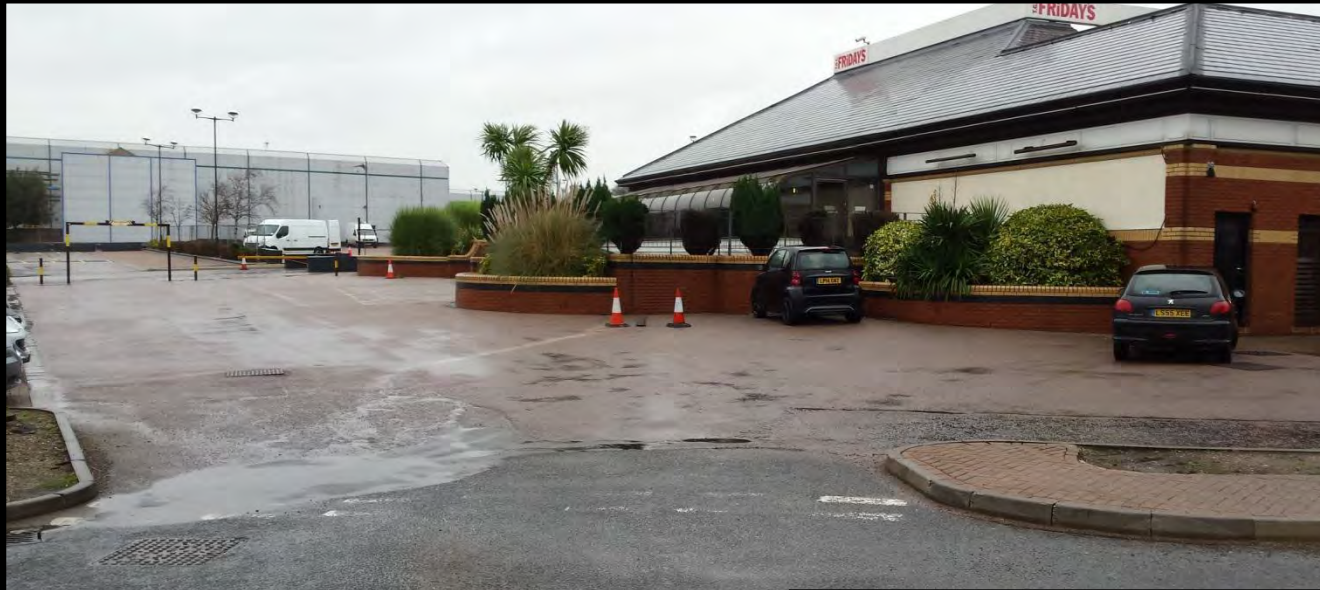
Restaurant in the southern area of the site, viewed from the south

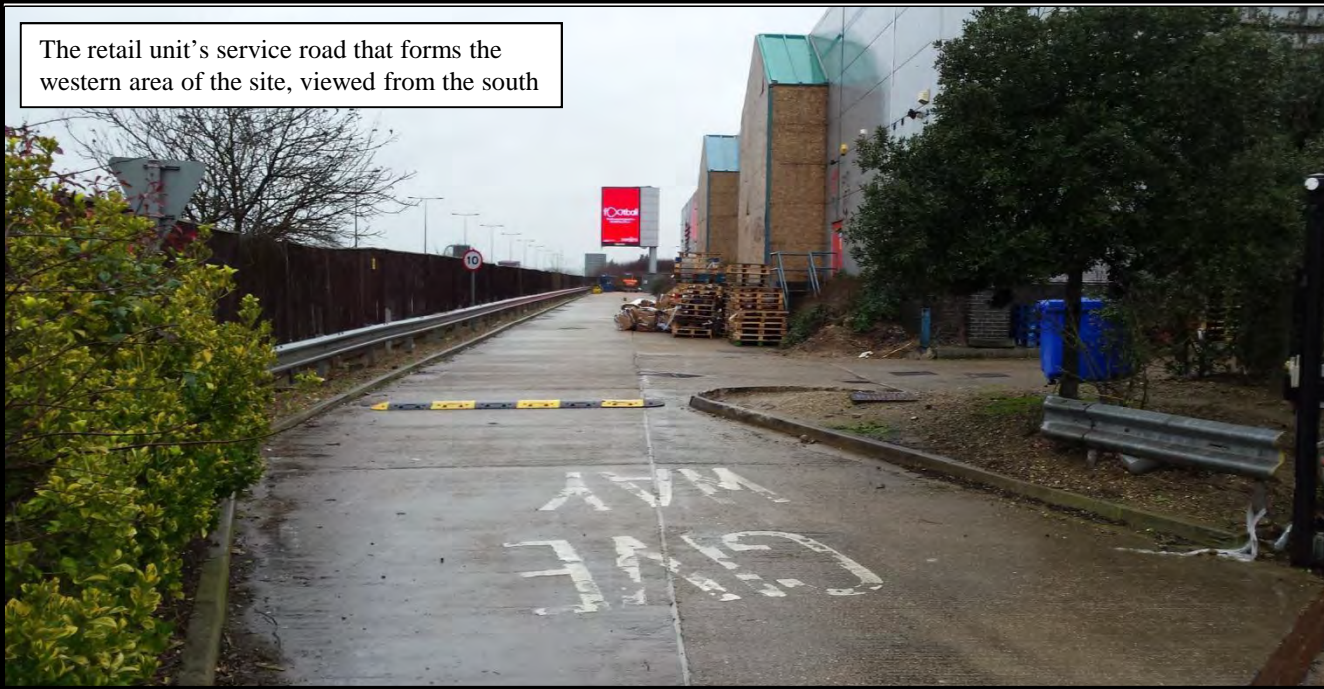
The retail unit's service road that forms the western area of the site, viewed from the south
