Bishopsgate Goodsyard: Land Quality Desk Study

P23553_R1_REV1
October 2023

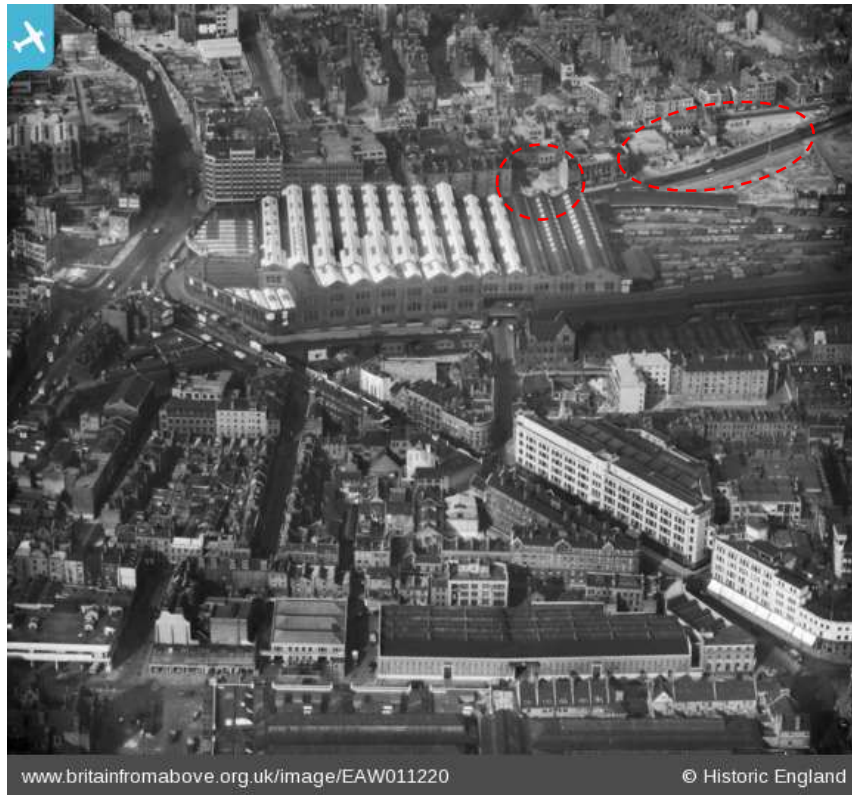
Figure 2-2 Aerial imagery flown in 1947 showing an oblique view of the Site facing north.

Aerial imagery flown in 1947 sourced from Britain from Above¹ shows an oblique view of the Site facing north, with two ruins in view to the north of the Site (Figure 2-2).
