Order Number: 210572128\_1\_1  
 Customer Ref: 17-0420.03  
 National Grid Reference: 507800, 184900  
 Slice: A  
 Site Area (Ha): 3.65  
 Search Buffer (m): 1000

Gleeson Mcl Ltd, Long Lane, Hillingdon, UXBRIDGE, UB10 9NR

**PRIVATE AND CONFIDENTIAL**  
**PHASE I INITIAL ENVIRONMENTAL REPORT**  
**MASTER BREWER, HILLINGDON**  
**Delta-Simons Project Number: 14-0724.01**  
**Dated: 4<sup>th</sup> November 2014**

**Phase I Environmental Assessment**

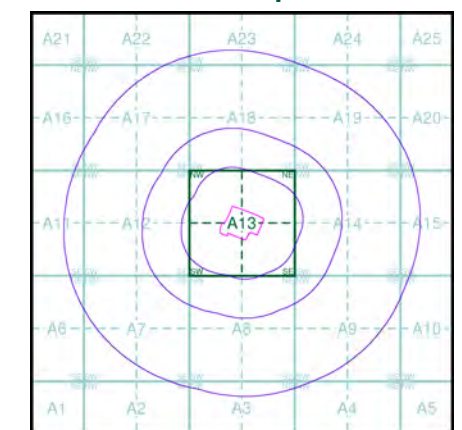
### OS Water Network Map - Slice A

### OS Water Network Data

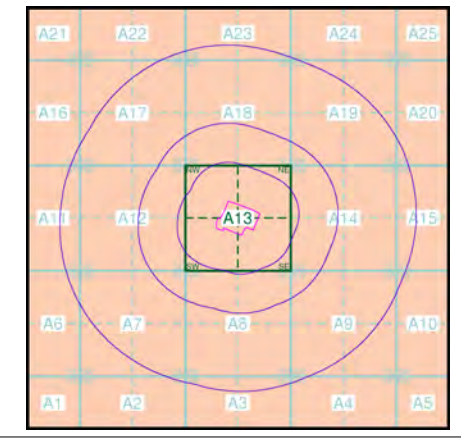
**E/NRW Suitability Map - Slice A**

**Risk of Flooding from Surface Water**

- High - 30 Year Return
- Medium - 100 Year Return
- Low - 1000 Year Return

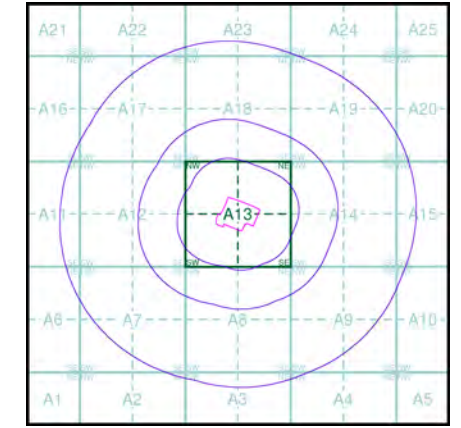
Urban Soil Chemistry Arsenic - Slice A

Urban Soil Chemistry Arsenic

BGS Urban Soil Chemistry Measured Concentration Values (mg/kg)

Arsenic Concentrations mg/kg

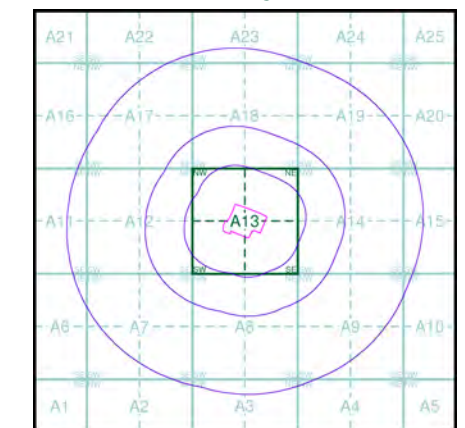
## Urban Soil Chemistry Nickel - Slice A

## Urban Soil Chemistry Nickel

BGS Urban Soil Chemistry Measured Concentration Values (mg/kg)

Nickel Concentrations mg/kg

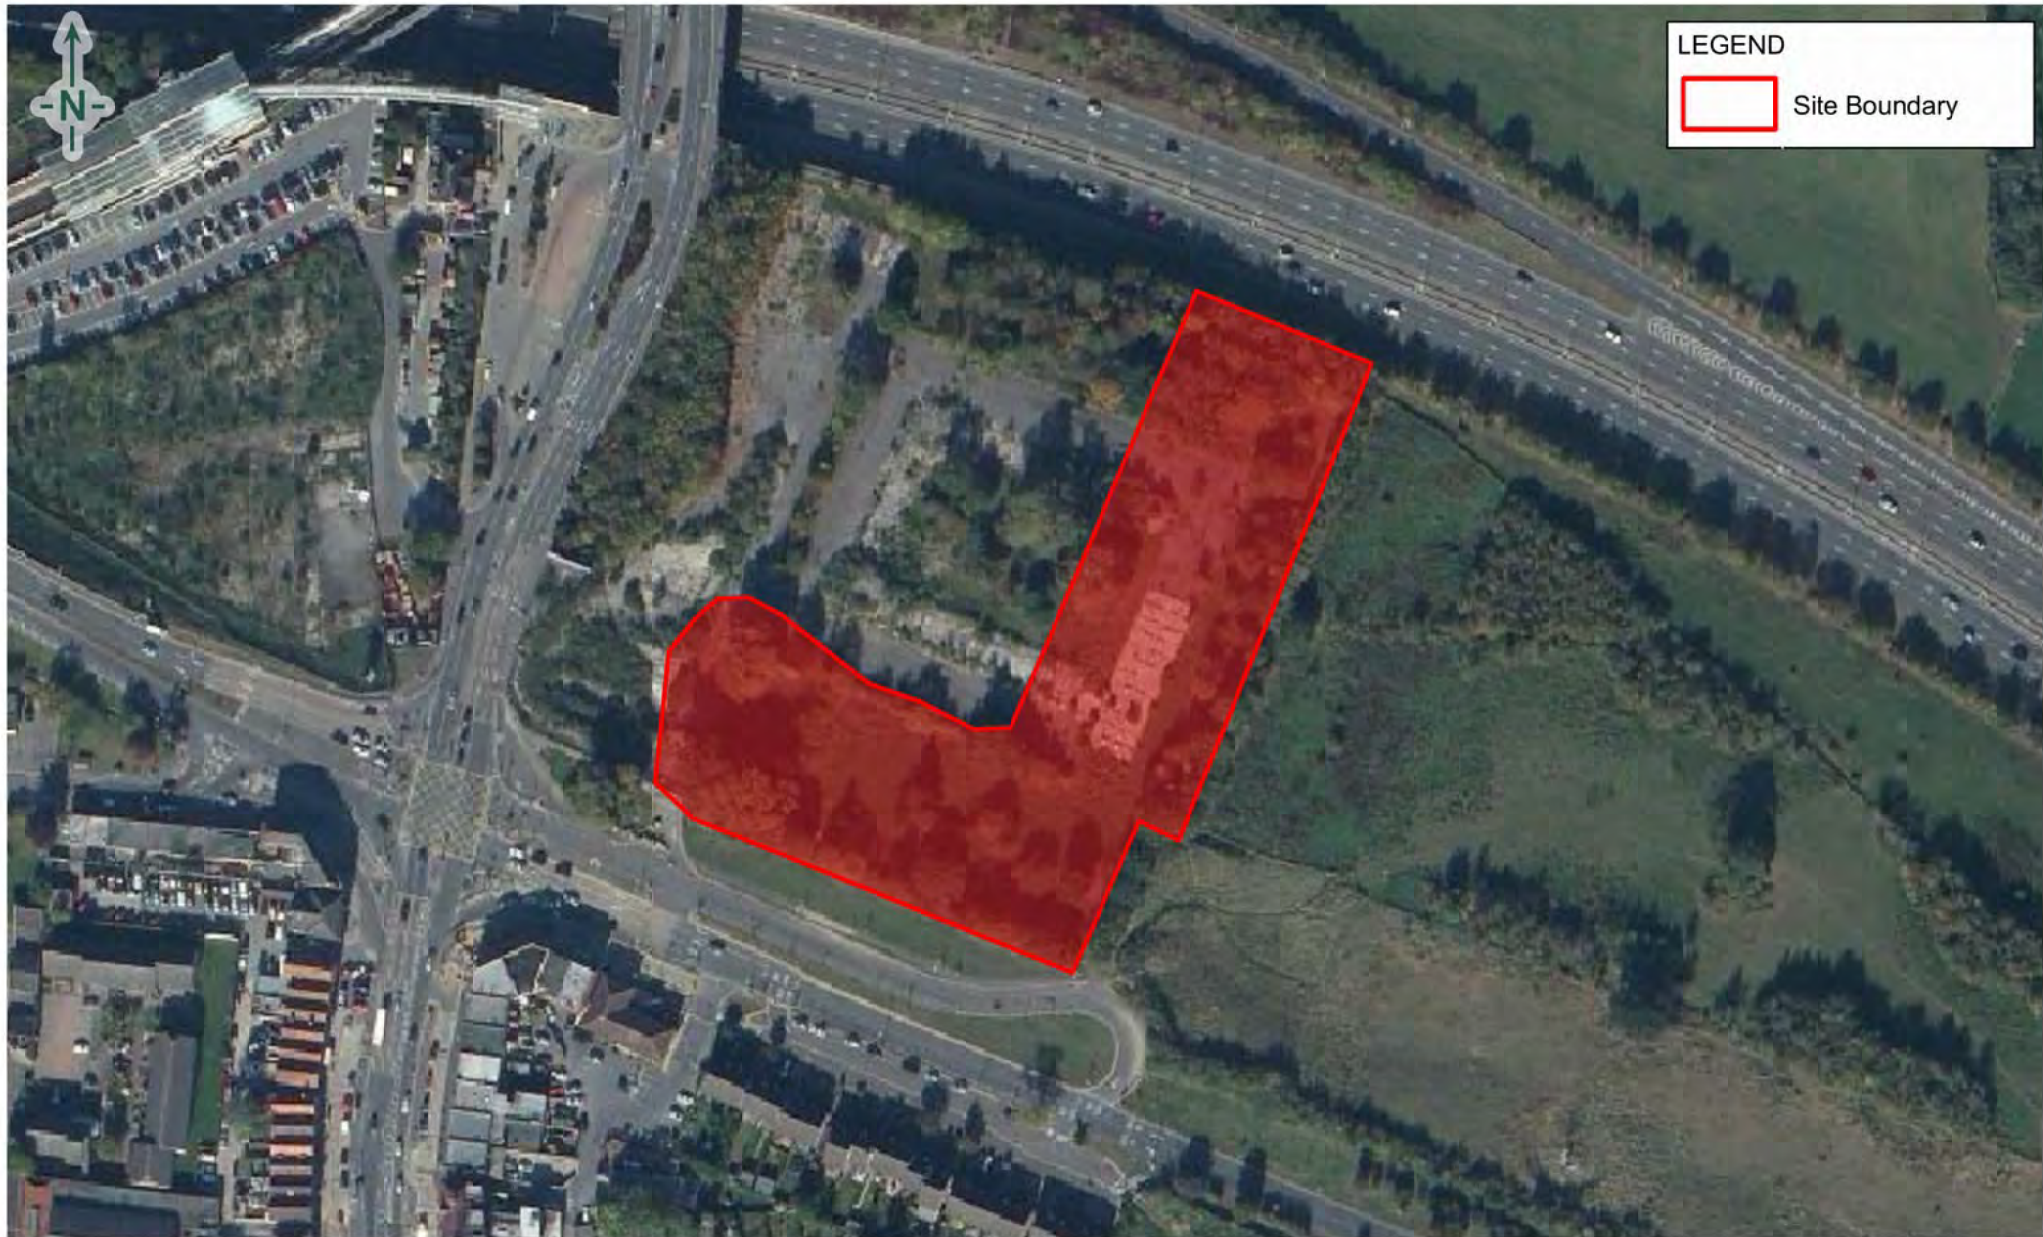
DRAWN BY: DP	SCALE: Not to Scale	PROJECT NO: 14-0724.02
CHECKED BY: KM	REVISION: 1	FIGURE NO: 2
DATE: 05 January 2015

TITLE:  
Site Layout Plan  
Freezeland Way  
Hillingdon
