FORMER MASTER BREWER  
SITEFREEZELAND  
WAYUXBRIDGE, UB10 9QE

**Former Master Brewer Site, Hillingdon  
Delta-Simons Project No. 14-0724.02**

**Combined Phase I/II Environmental Assessment,  
Former Master Brewer, Hillingdon.  
For Spen Hill Developments Ltd.  
Delta-Simons Project No. 14-0724.01\_E  
Issued: June 2015**

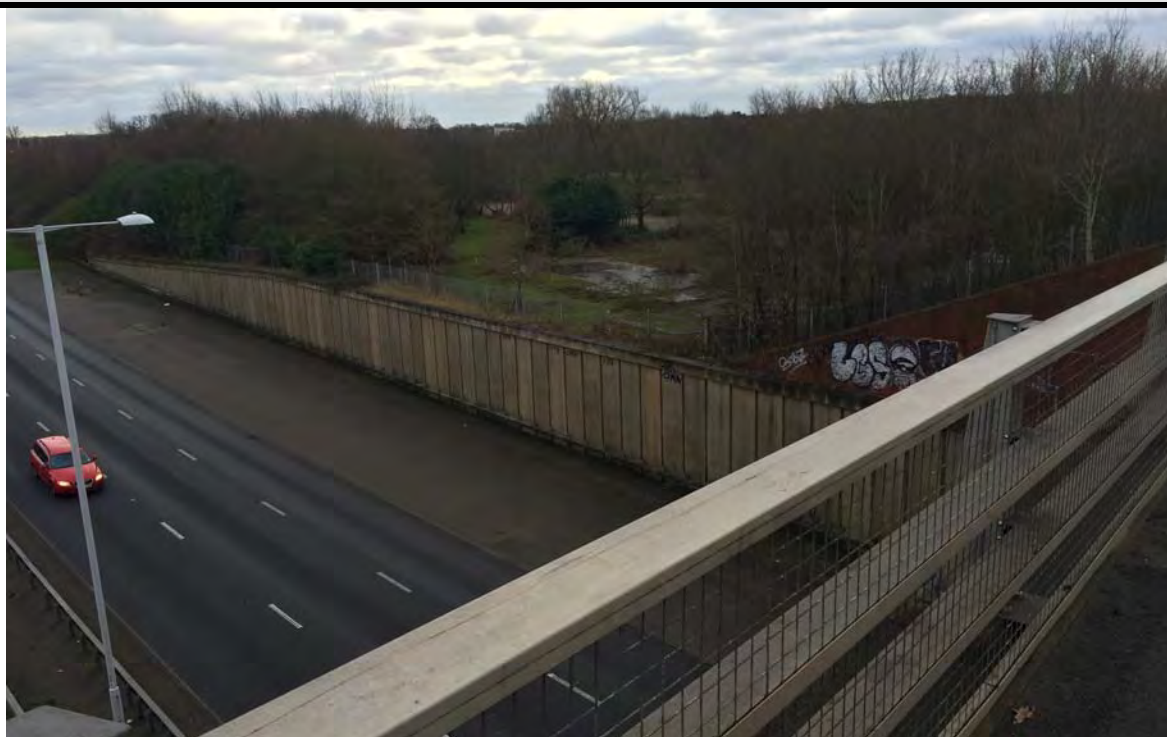
Photograph 1 – View of the north of the Site from the Long Lane bridge over the A40.

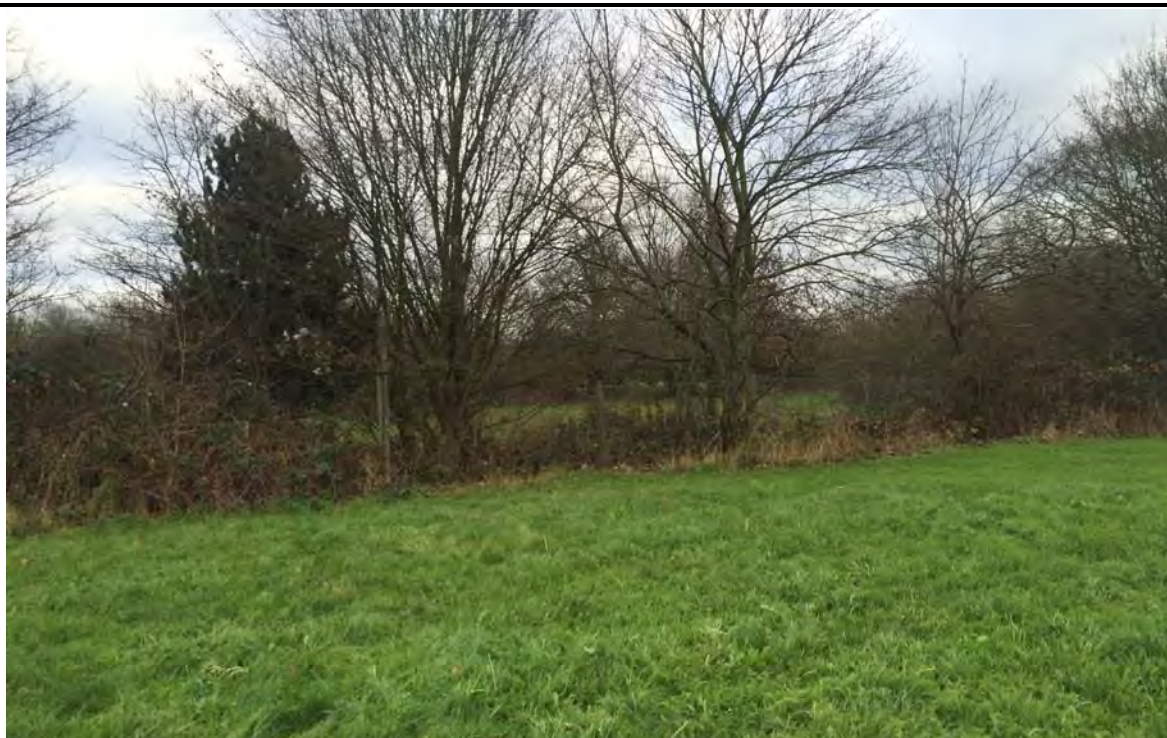
Photograph 2 – View of the south of the Site from Freezeland Way.

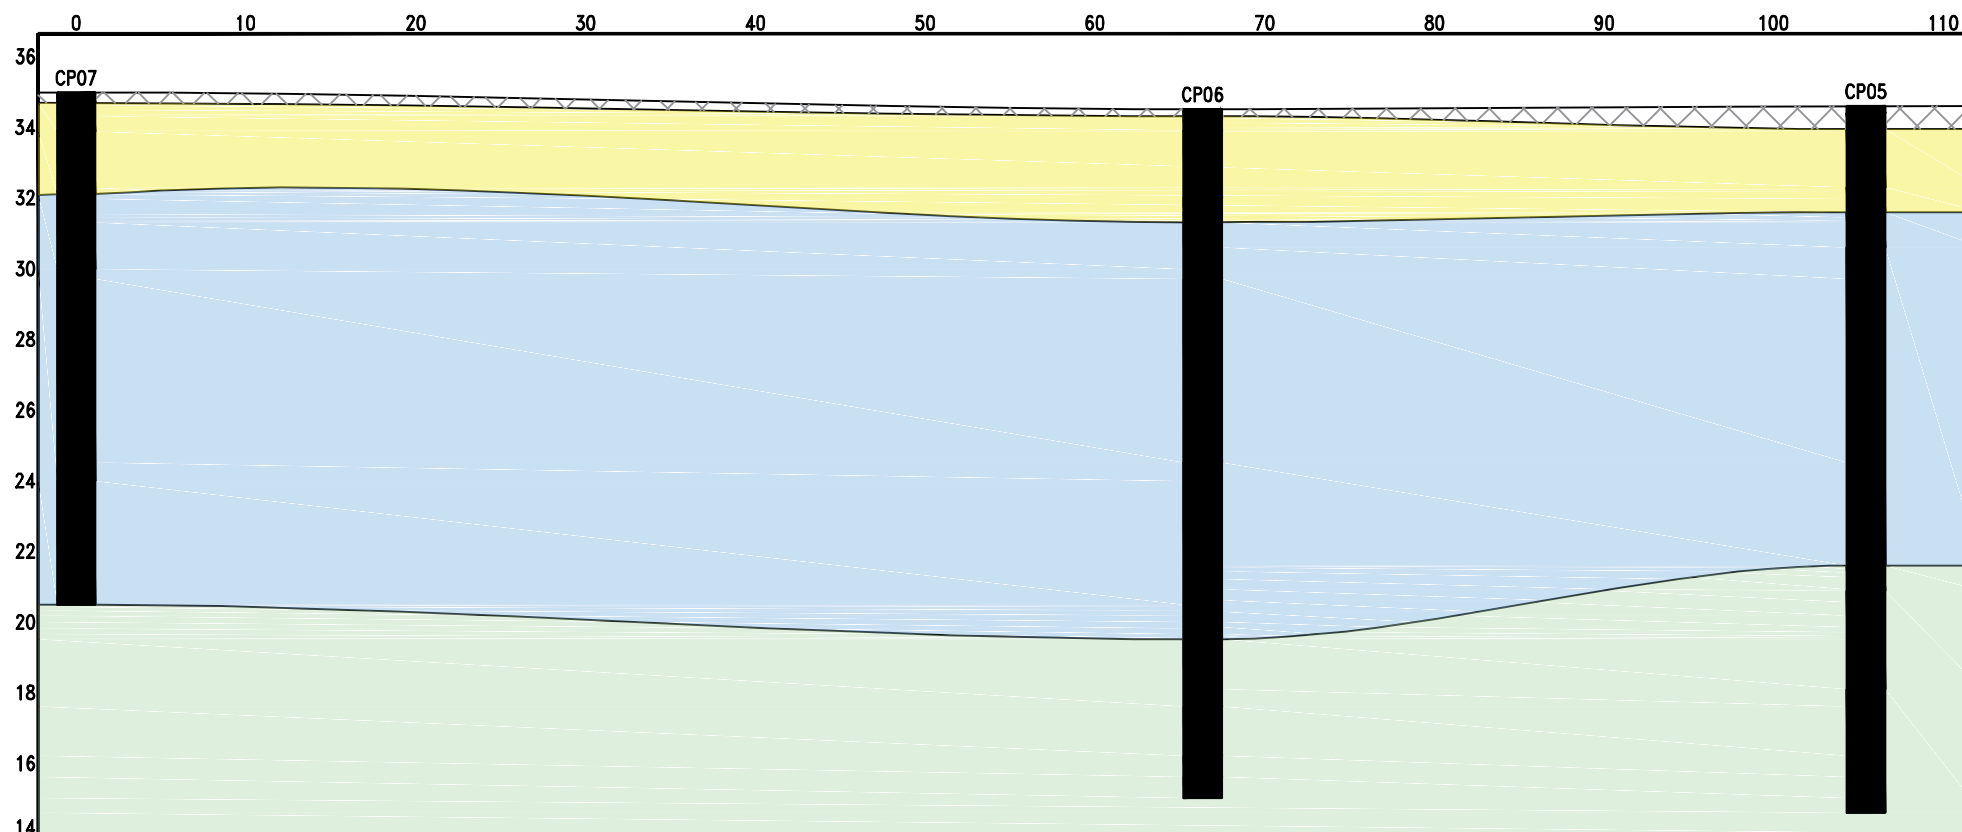
TITLE:  
Cross Section A  
Master Brewer  
Hillingdon

**A West**

**East A1**

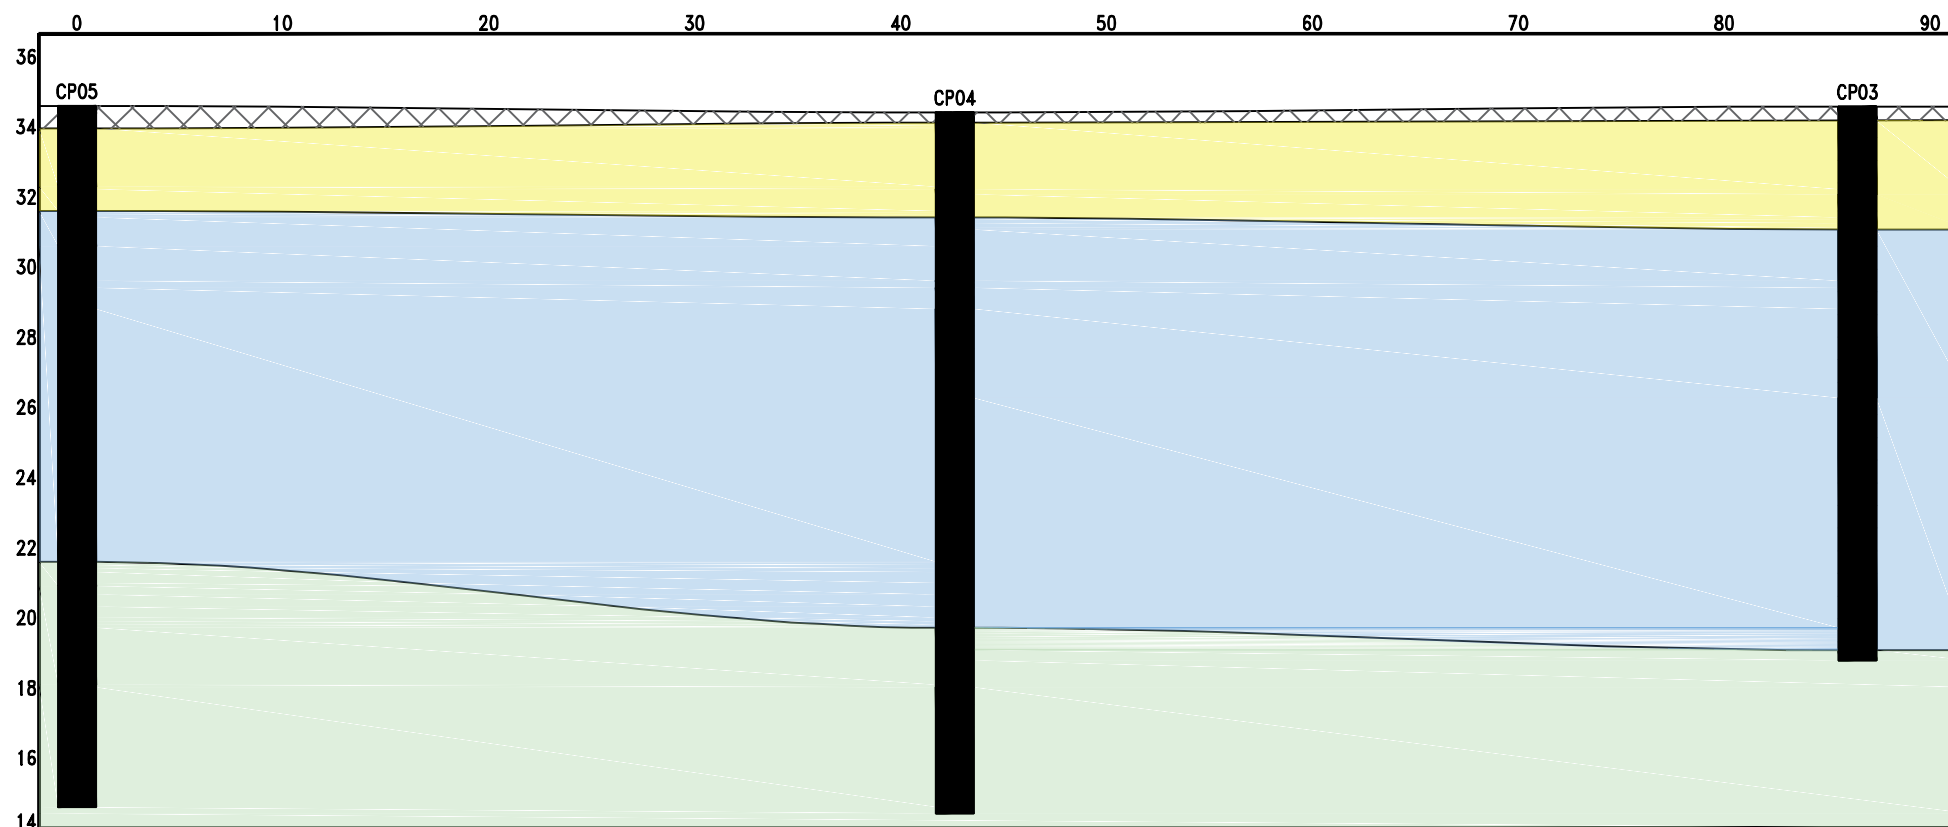
TITLE:  
Cross Section D  
Master Brewer  
Hillingdon

**D North**

**South D1**
