Pedestrian Wind Comfort Conditions - Mitigation 4: Proposed Development with existing surrounding buildings and Proposed Landscaping

Charlton Riverside, London (U.K.)

Project #1601701

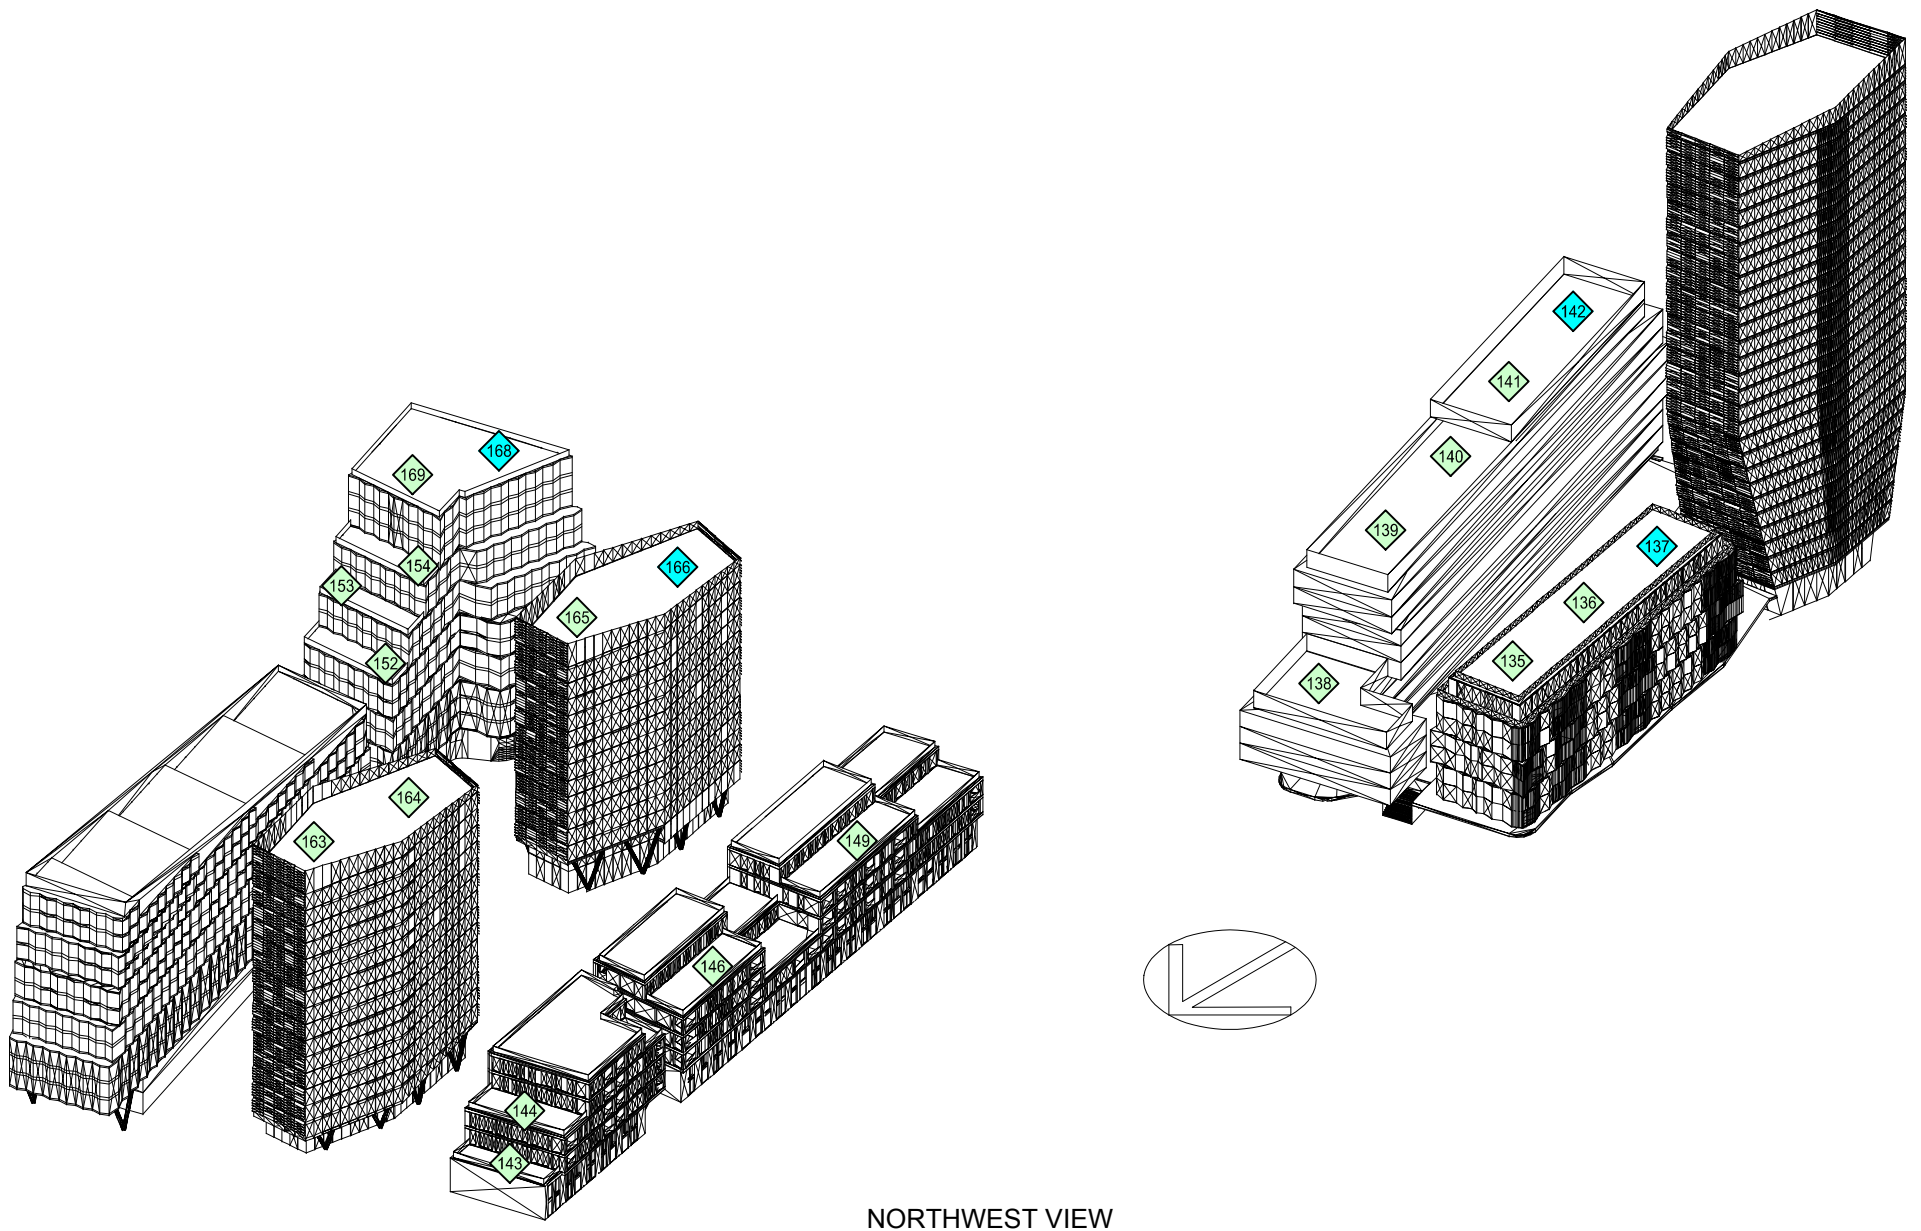
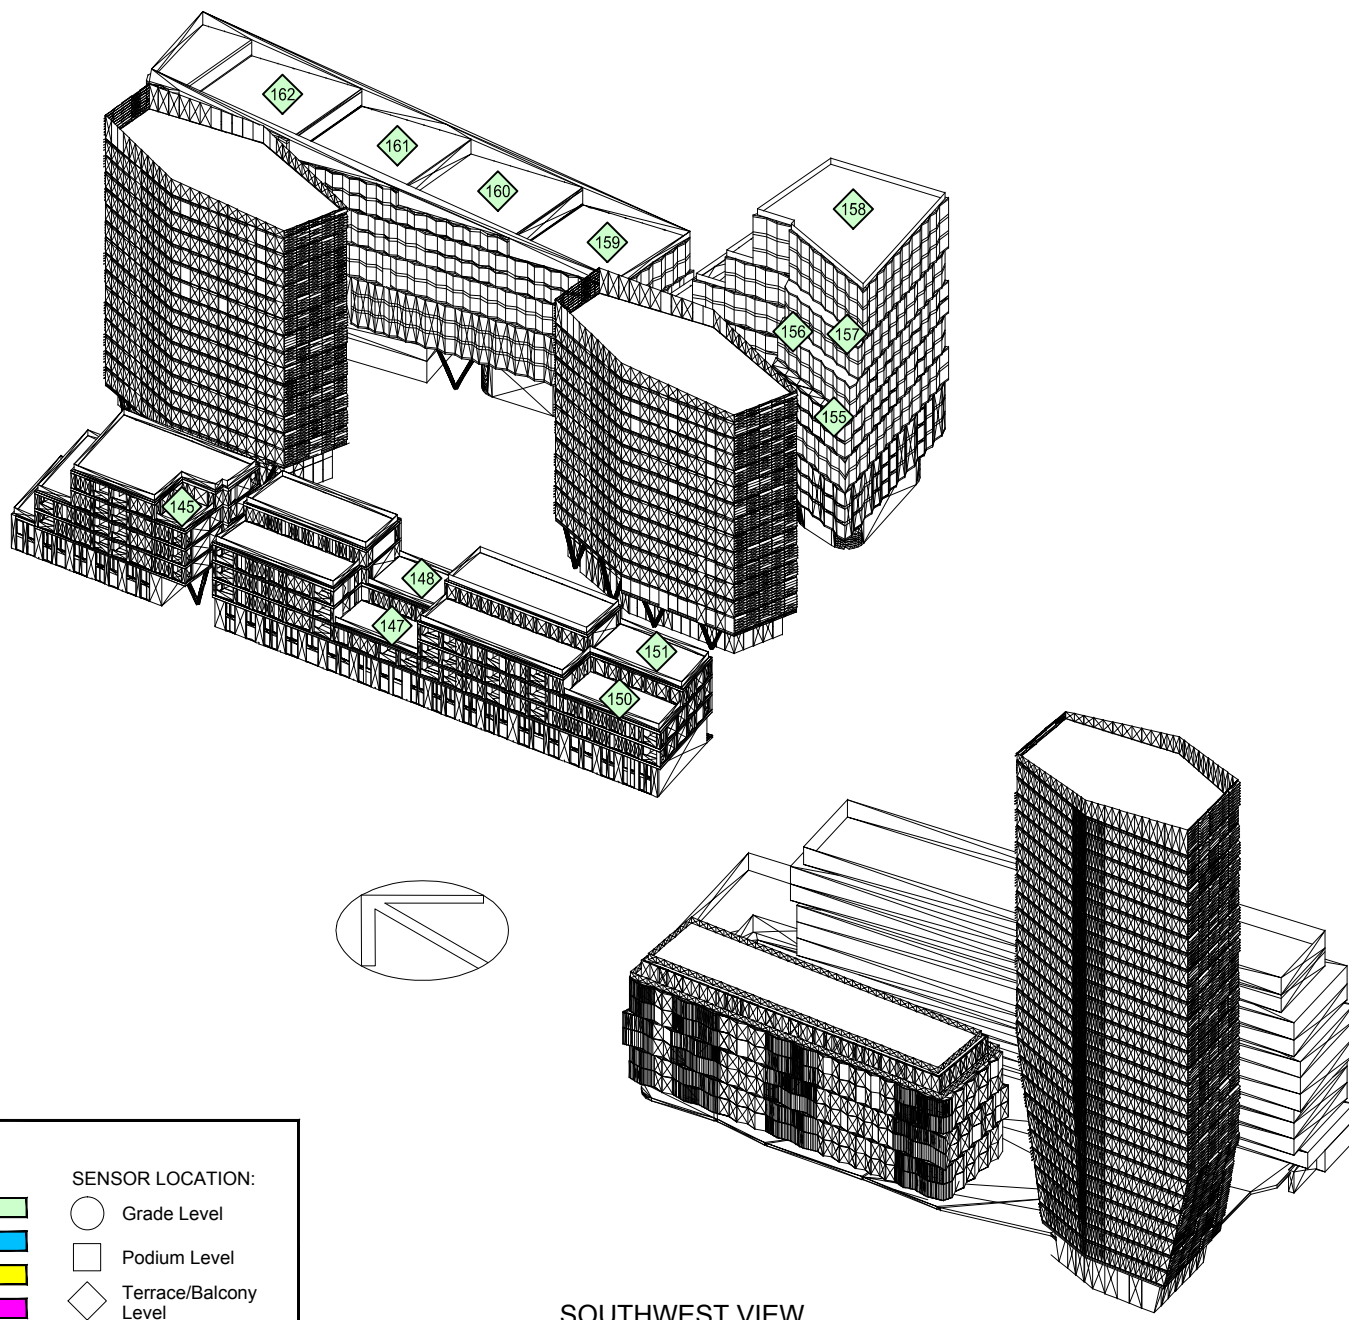
Drawn by: CAX Figure: 12

NORTHWEST VIEW

SOUTHWEST VIEW

Summer Season

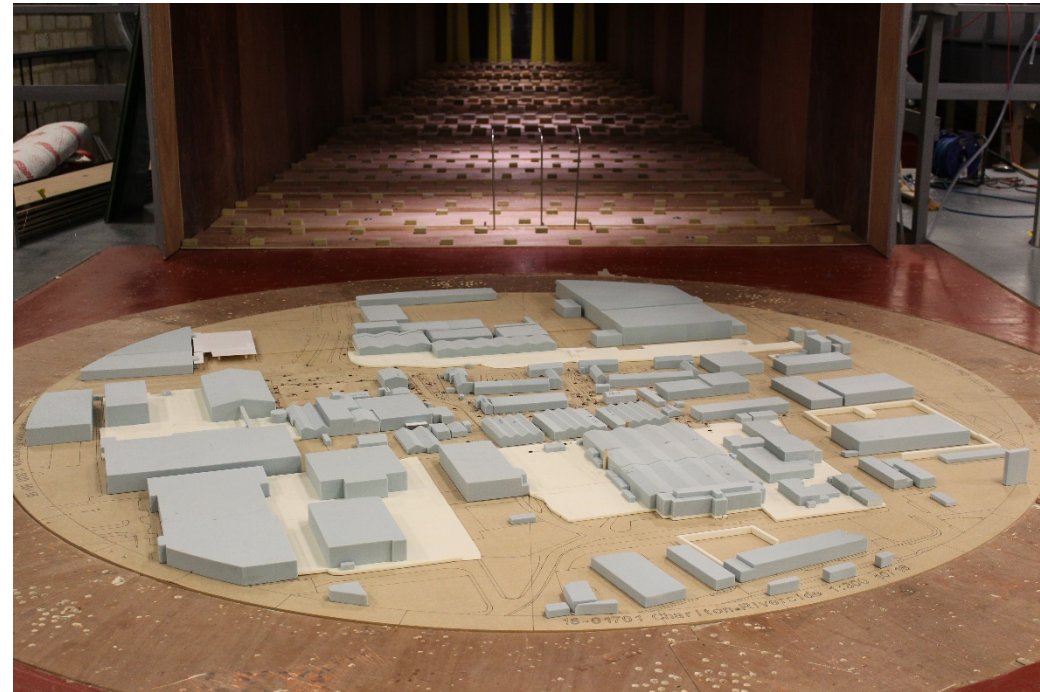
Figure 13: Existing building with existing surrounding buildings– View in the Wind Tunnel (from the East)

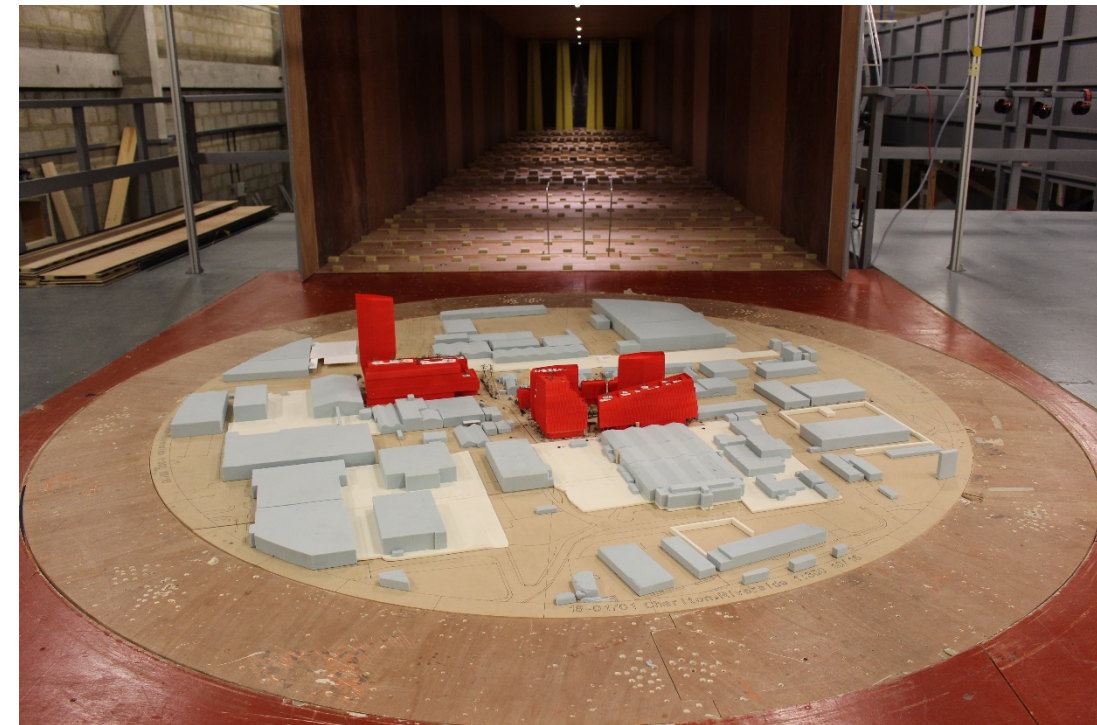
Figure 15: Proposed Development with cumulative surrounding buildings and landscaping– View in the Wind Tunnel (from the East)

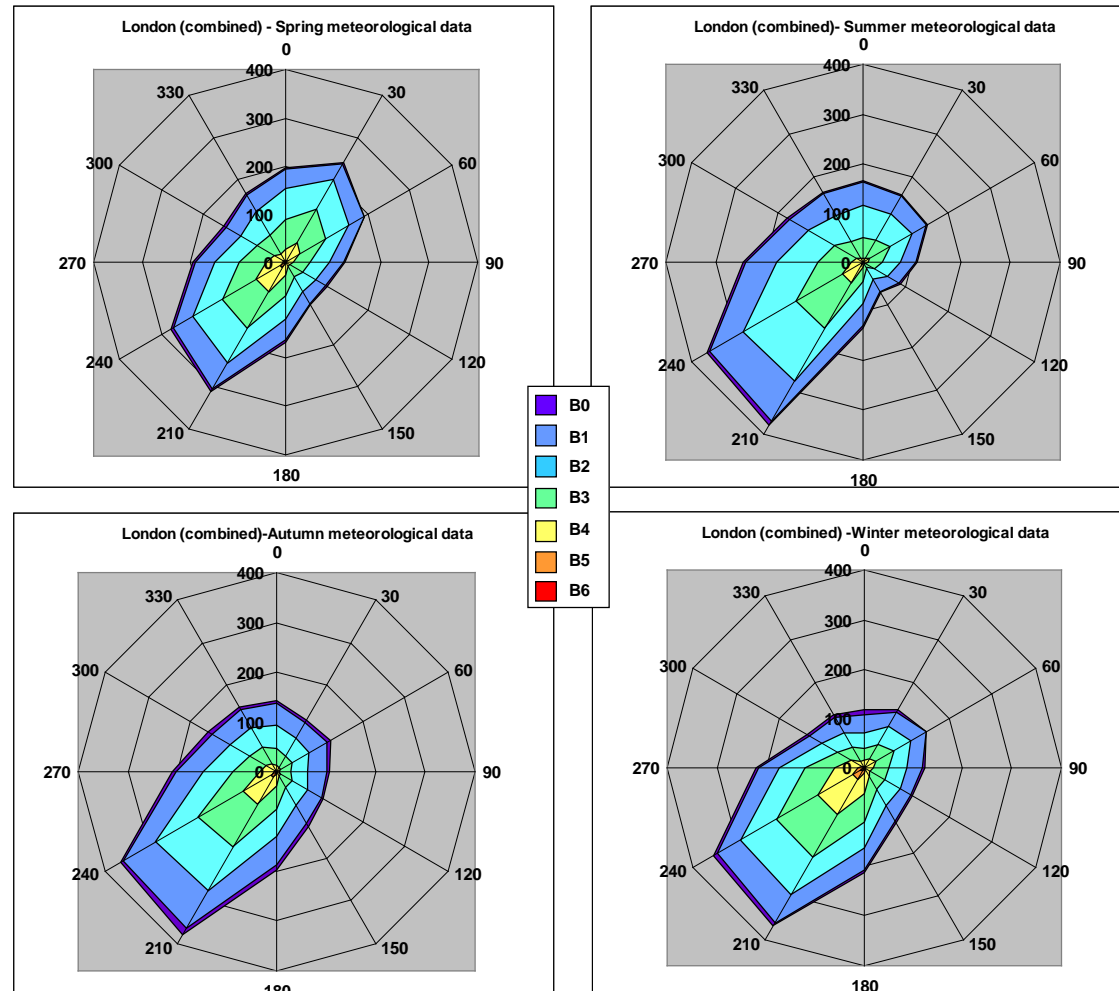
**Figure 16: Seasonal wind roses for London (in Beaufort Force)**  
(Radial axis indicates the hours for which the stated Beaufort Range is exceeded)

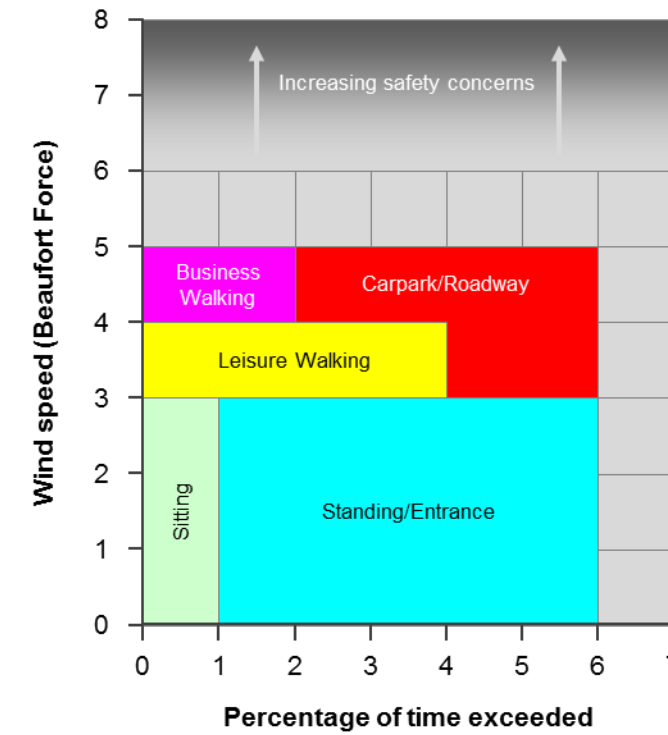
**Figure 17: Graphical representation of the Lawson Comfort Criteria**

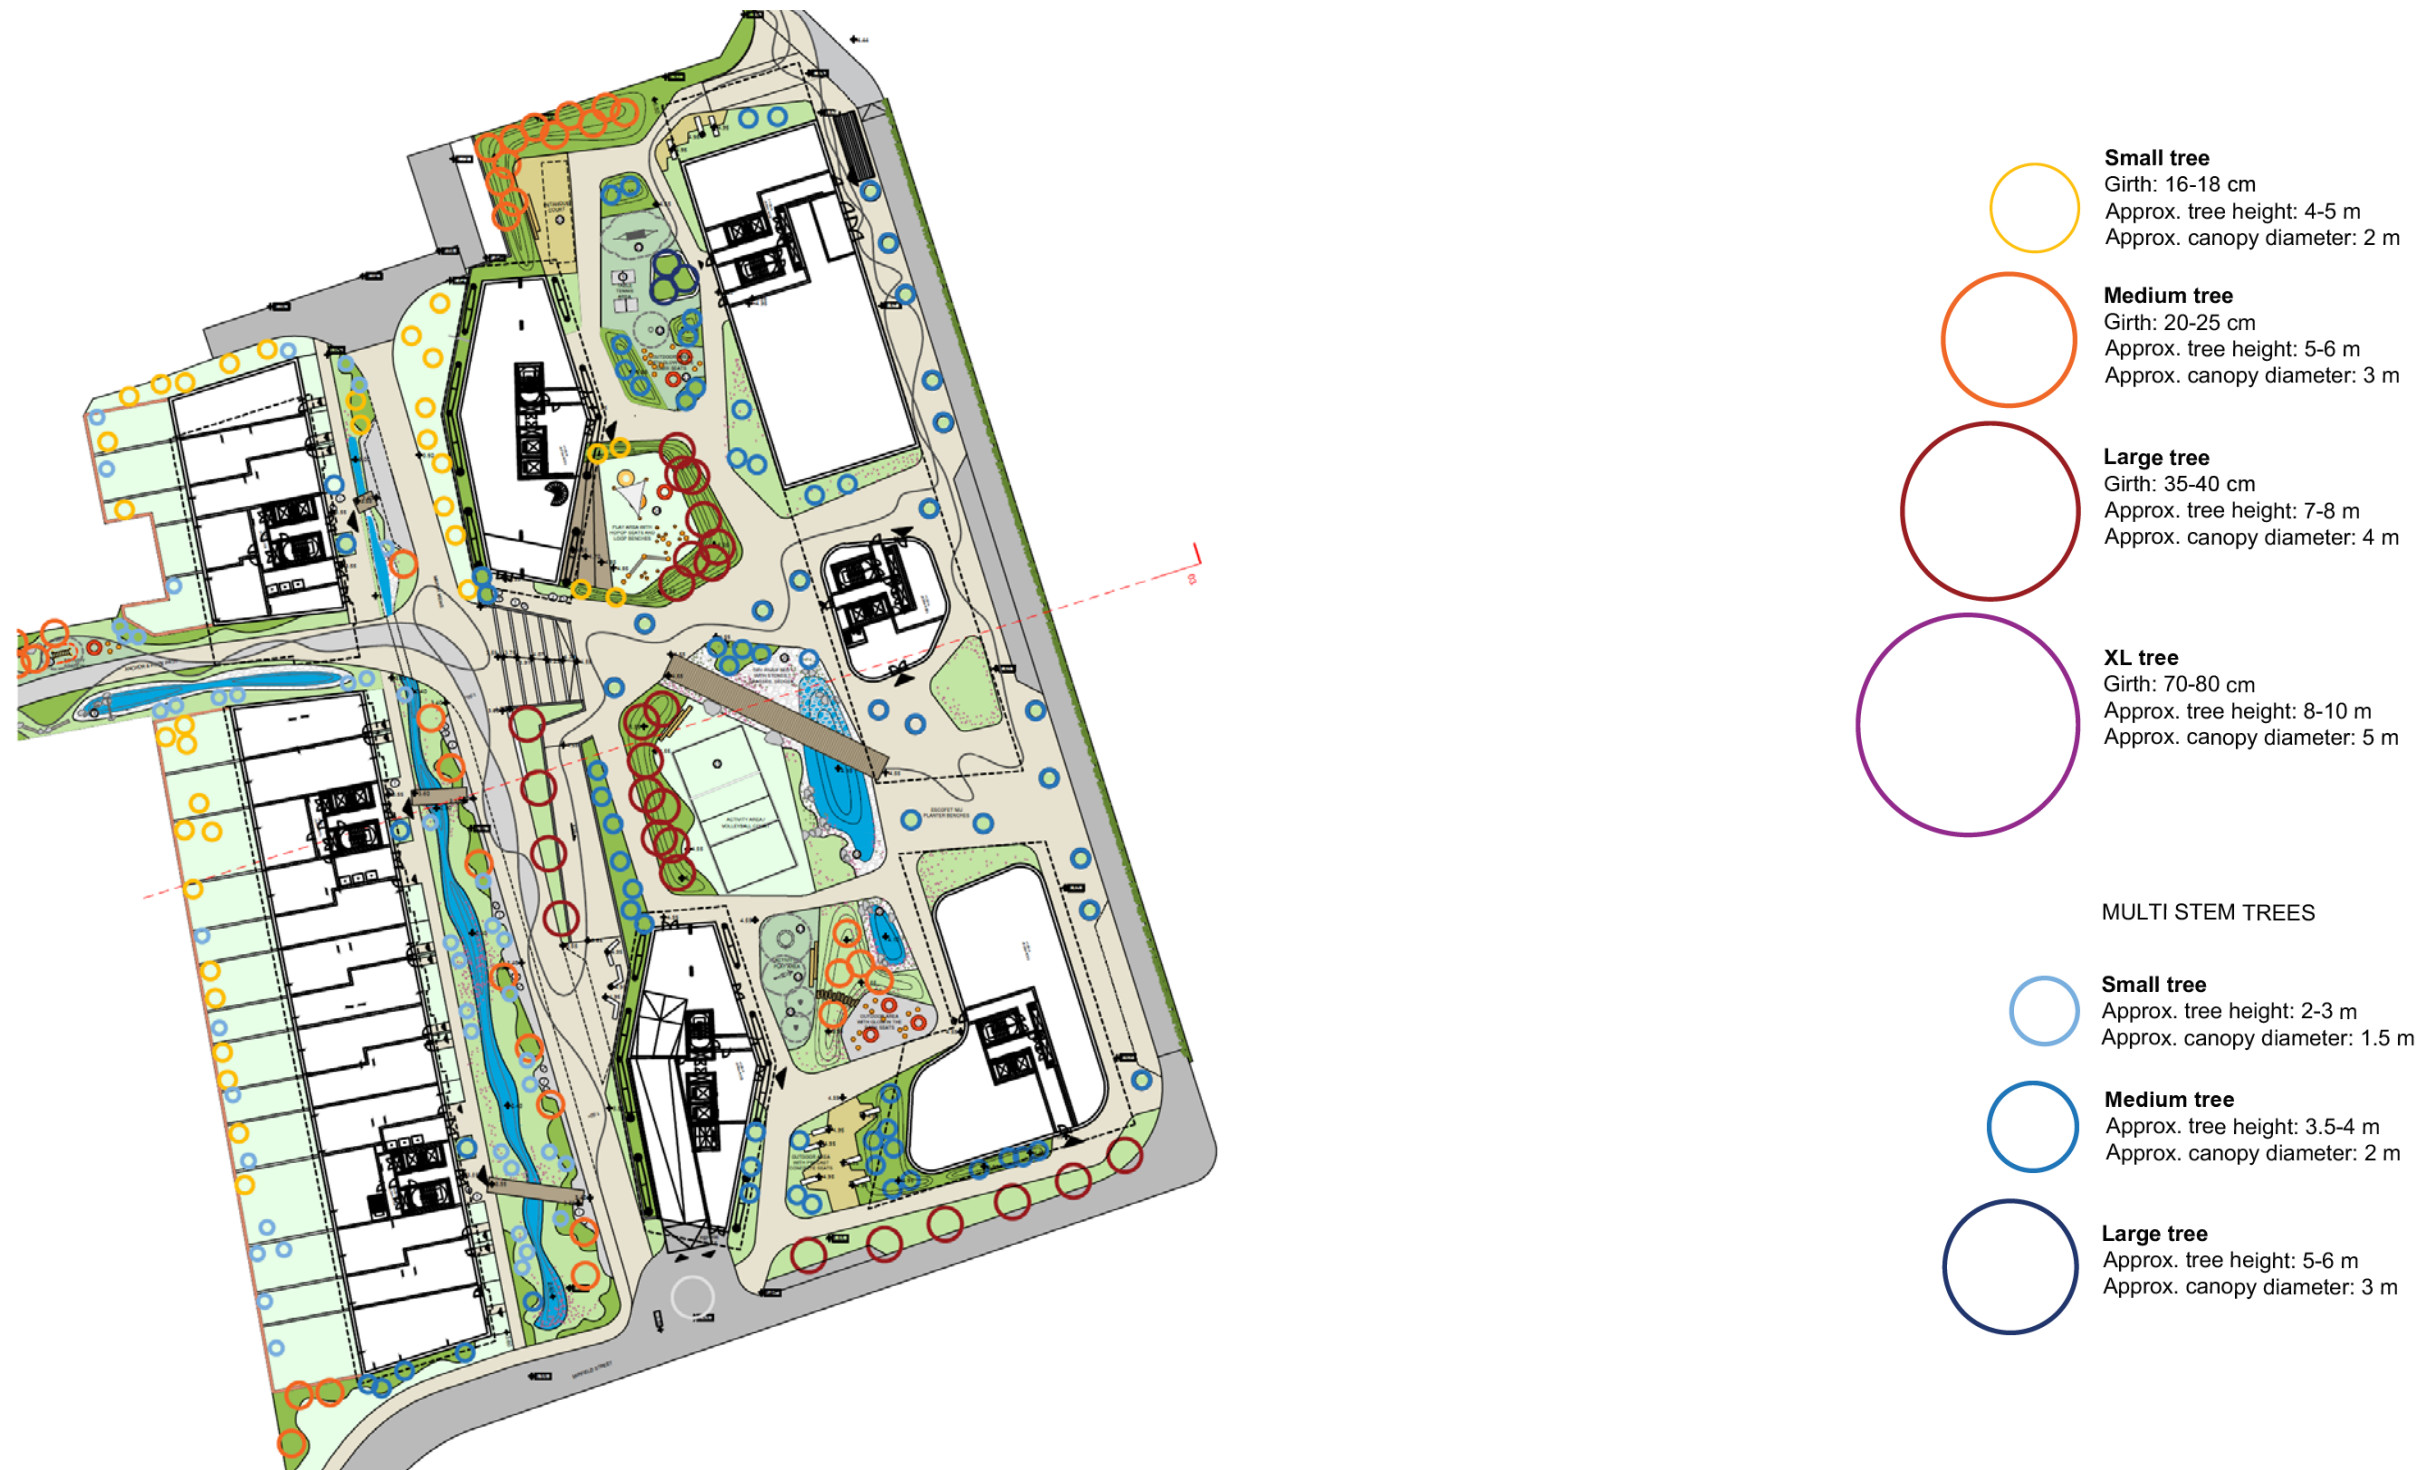
Figure 18: Ground floor Plot A Landscape Scheme received October 26<sup>th</sup>, 2016

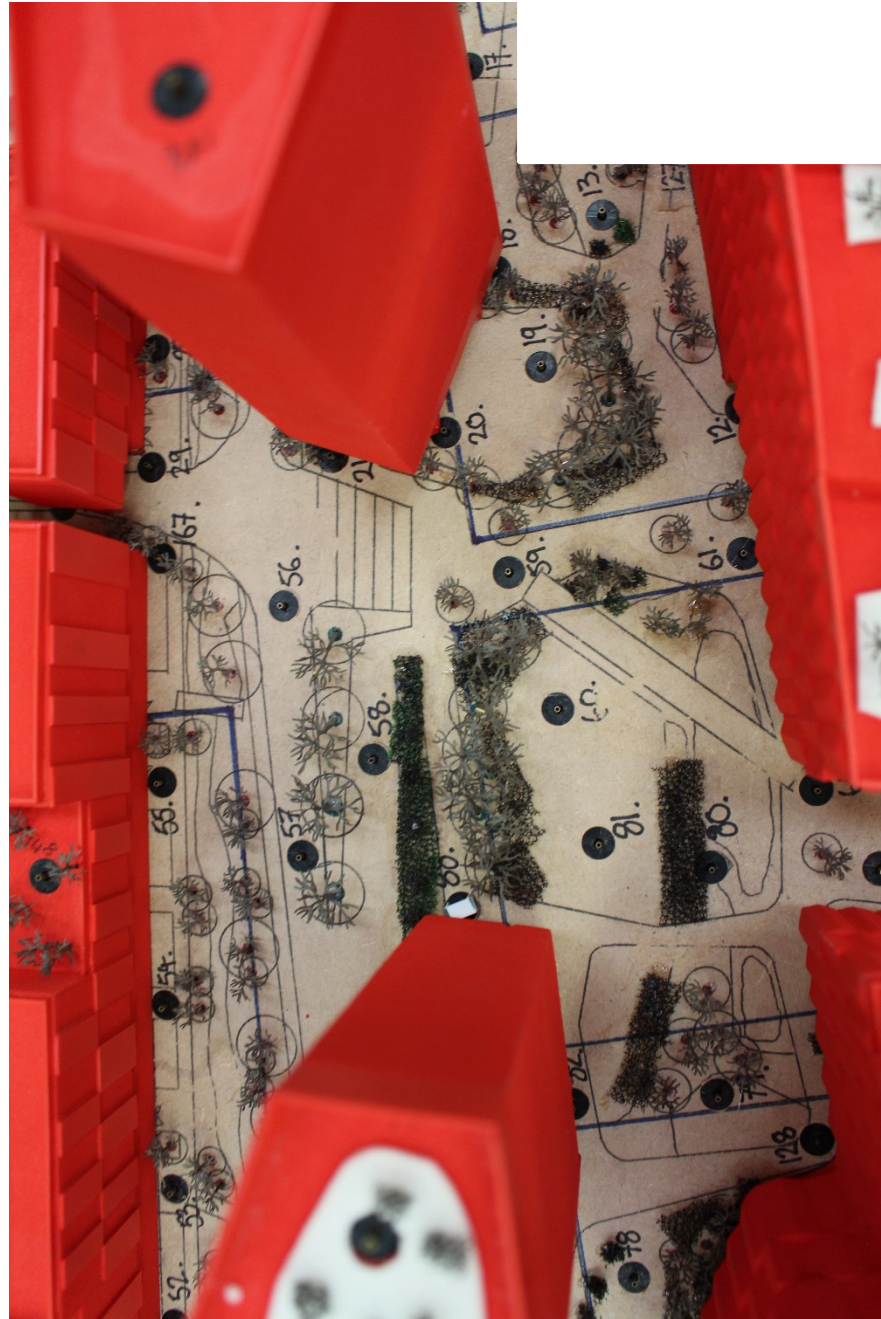
Figure 19: Plot A ground floor landscape plan with mark-up of additional mitigation measures
