Bat Survey Report

ABERFELDY VILLAGE MASTERPLAN

Aberfeldy Village Masterplan – Bat Survey Report

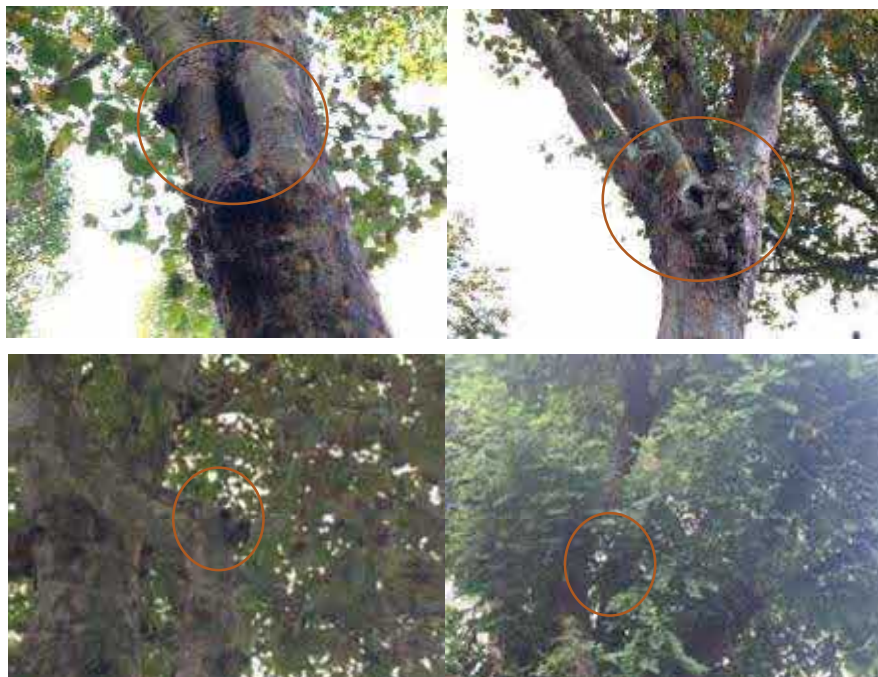
Figure 2.1 Potential roosting features within trees

- Common pipistrelle (*Pipistrellus pipistrellus*);
 - Soprano pipistrelle (*P. pygmaeus*); and
 - Nathusius' pipistrelle (*P. nathusii*).
- 2.12** An assessment of the trees on site identified numerous features which have the potential to support roosting bats:

Tree reference and species (See Figure 2 for location)	Potential roost feature(s)	Potential to support roosting bats
T1 London plane	Large rot hole on north side of main stem at 3m	Low
T2 London plane	Rot hole on southwest side of main stem at 3.5m and small rot hole at 4.5m on secondary branch	Low
T3 London plane	Rot hole at 6.5m on north side in canopy	Low
T4 London plan	Rot hole at 5m on southeast side of main stem	Low
T5 False acacia	Cavity at 6m in central canopy on south side, visible from public road	Low

2.15 As all the trees identified as having potential roosting features are said to have 'low' potential to support roosting bats, emergence/re-entry surveys were not recommended. It is recommended that if any of these trees require removal, they should be section felled, with limbs lowered gently to the ground and left on the ground for 24hrs before being disposed of, in line with best practice guidelines².

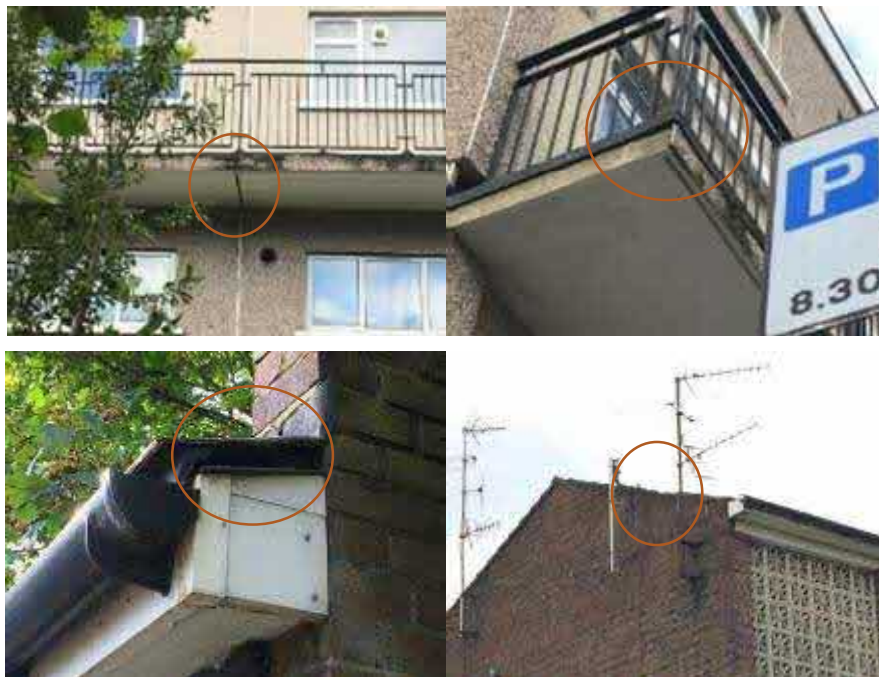
Figure 2.2 Potential roosting features within the built form

2.13 In addition, a number of features associated with the built form were identified as having potential to support roosting bats. These include:

- Gaps above garage doors leading to internal voids which were not accessible;
- Gap above soffit box and below roofing material on buildings;
- Crack between underside of slabs on balconies;

- Lifted flashing on bin stores;
- Missing/dislodged roof wiles; and
- Missing mortar/crack in brick wall.

2.14 The location of all potential roosting features identified is shown in Figure 1. The potential roosting features associated with the built form are all considered to have low potential to support summer feeding roosts of common crevice dwelling species such as common pipistrelle (*Pipistrellus pipistrellus*). None of the features identified have potential to support hibernation or maternity roosts.

2.16 Buildings with low potential to support roosting bats were recommended to be subject to a single emergence or return survey between May and August.

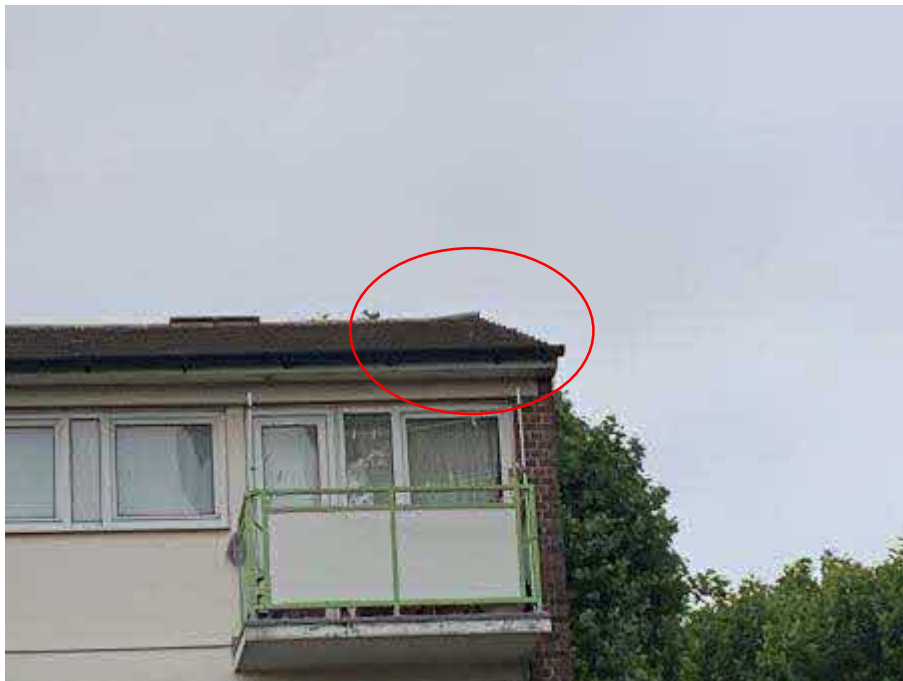
Figure 4.1 Figure 4.1 Pipistrelle roost location

- 4.3** The second survey undertaken on 16/07/2021 observed a single common pipistrelle re-entry beneath a ridge tile on the roof at the southern end of Jura House (see Figure 2). The common pipistrelle exhibited typical re-entry behaviour, circling around the roost numerous times, landing and taking off before re-entering at 04:24. During this survey visit, other surveyors either recorded no bat activity, or only low levels of common pipistrelle activity (average of two bat passes recorded per surveyor). One of these passes recorded by another surveyor was the same pipistrelle which was recorded entering the roost.

- 4.5** Location of observed roosts can be found on the plan at Figure 2 with images of features below.

5.27 The removal of roof tiles should be undertaken by hand, under the supervision of a licenced ecologist.

- 5.43** The existing roost will be destroyed; however, a replacement roost could be provided in the form of bat bricks and bat tiles in the vicinity of the existing roost in new buildings.

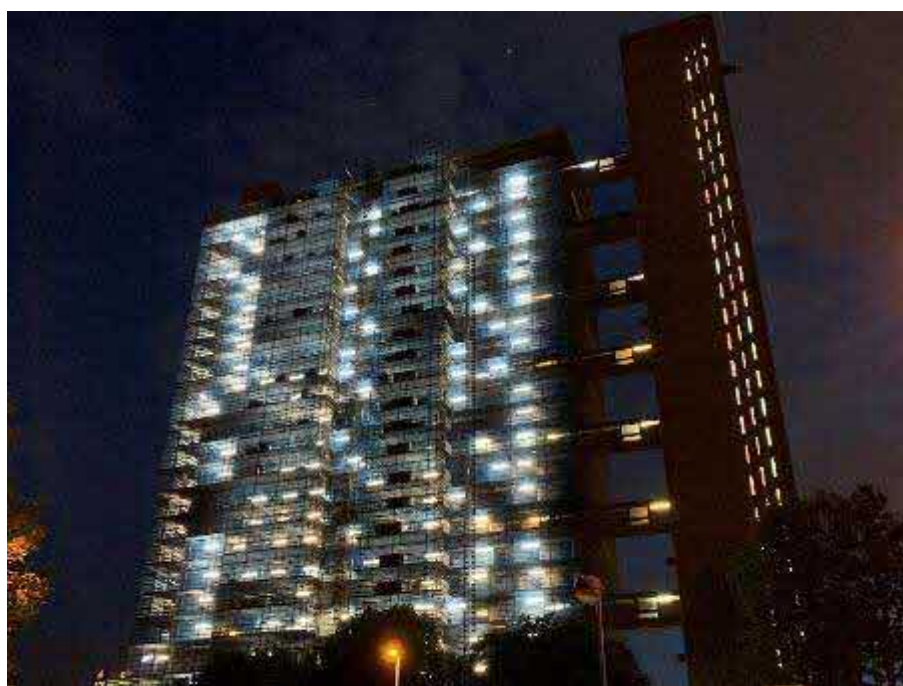
Figure 4.2 External lighting in the area which is likely prohibitive to bats

- 4.6 The overall very low levels of bat activity on site was attributed to the poor-quality habitat on site, high levels of disturbance associated with major roads which pass through the site and very high levels of external lighting in the area.

- 5.38** Any lighting associated with the proposals should be designed following appropriate guidance described in the Bat Conservation Trust and Institute of Lighting Engineers joint guidance document⁷. This should include directional lighting, appropriate luminescence and protection from light spill and should ensure that all lighting is designed, operated and maintained under best practice conditions. No uncontrolled lighting should occur and light spill should be minimised; this would enable the continued use of the site as a roosting and foraging resource.

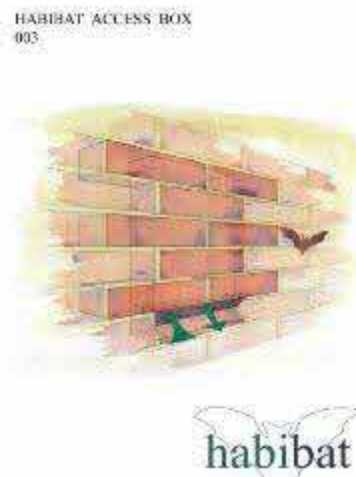
Figure 5.1 Figure 7. Habibat bat boxes and bat access tiles

- 5.28 Bat boxes should be installed in appropriate places in the surrounding trees being retained within the proposals so that they can be used for shelter in the event that a bat is found while features are being removed.
- 5.29 Bat boxes should be incorporated into the fabric of all new buildings at site as compensatory roosting space. These should mirror the specifications of the existing roost as far as possible, being of a similar height, on the same elevation, although given the abundance of opportunities in the new buildings, a variety of conditions should be allowed for providing options for bats.
- 5.30 The figure below gives examples of bat boxes and bat tiles that can be seamlessly incorporated into the design of the new building.

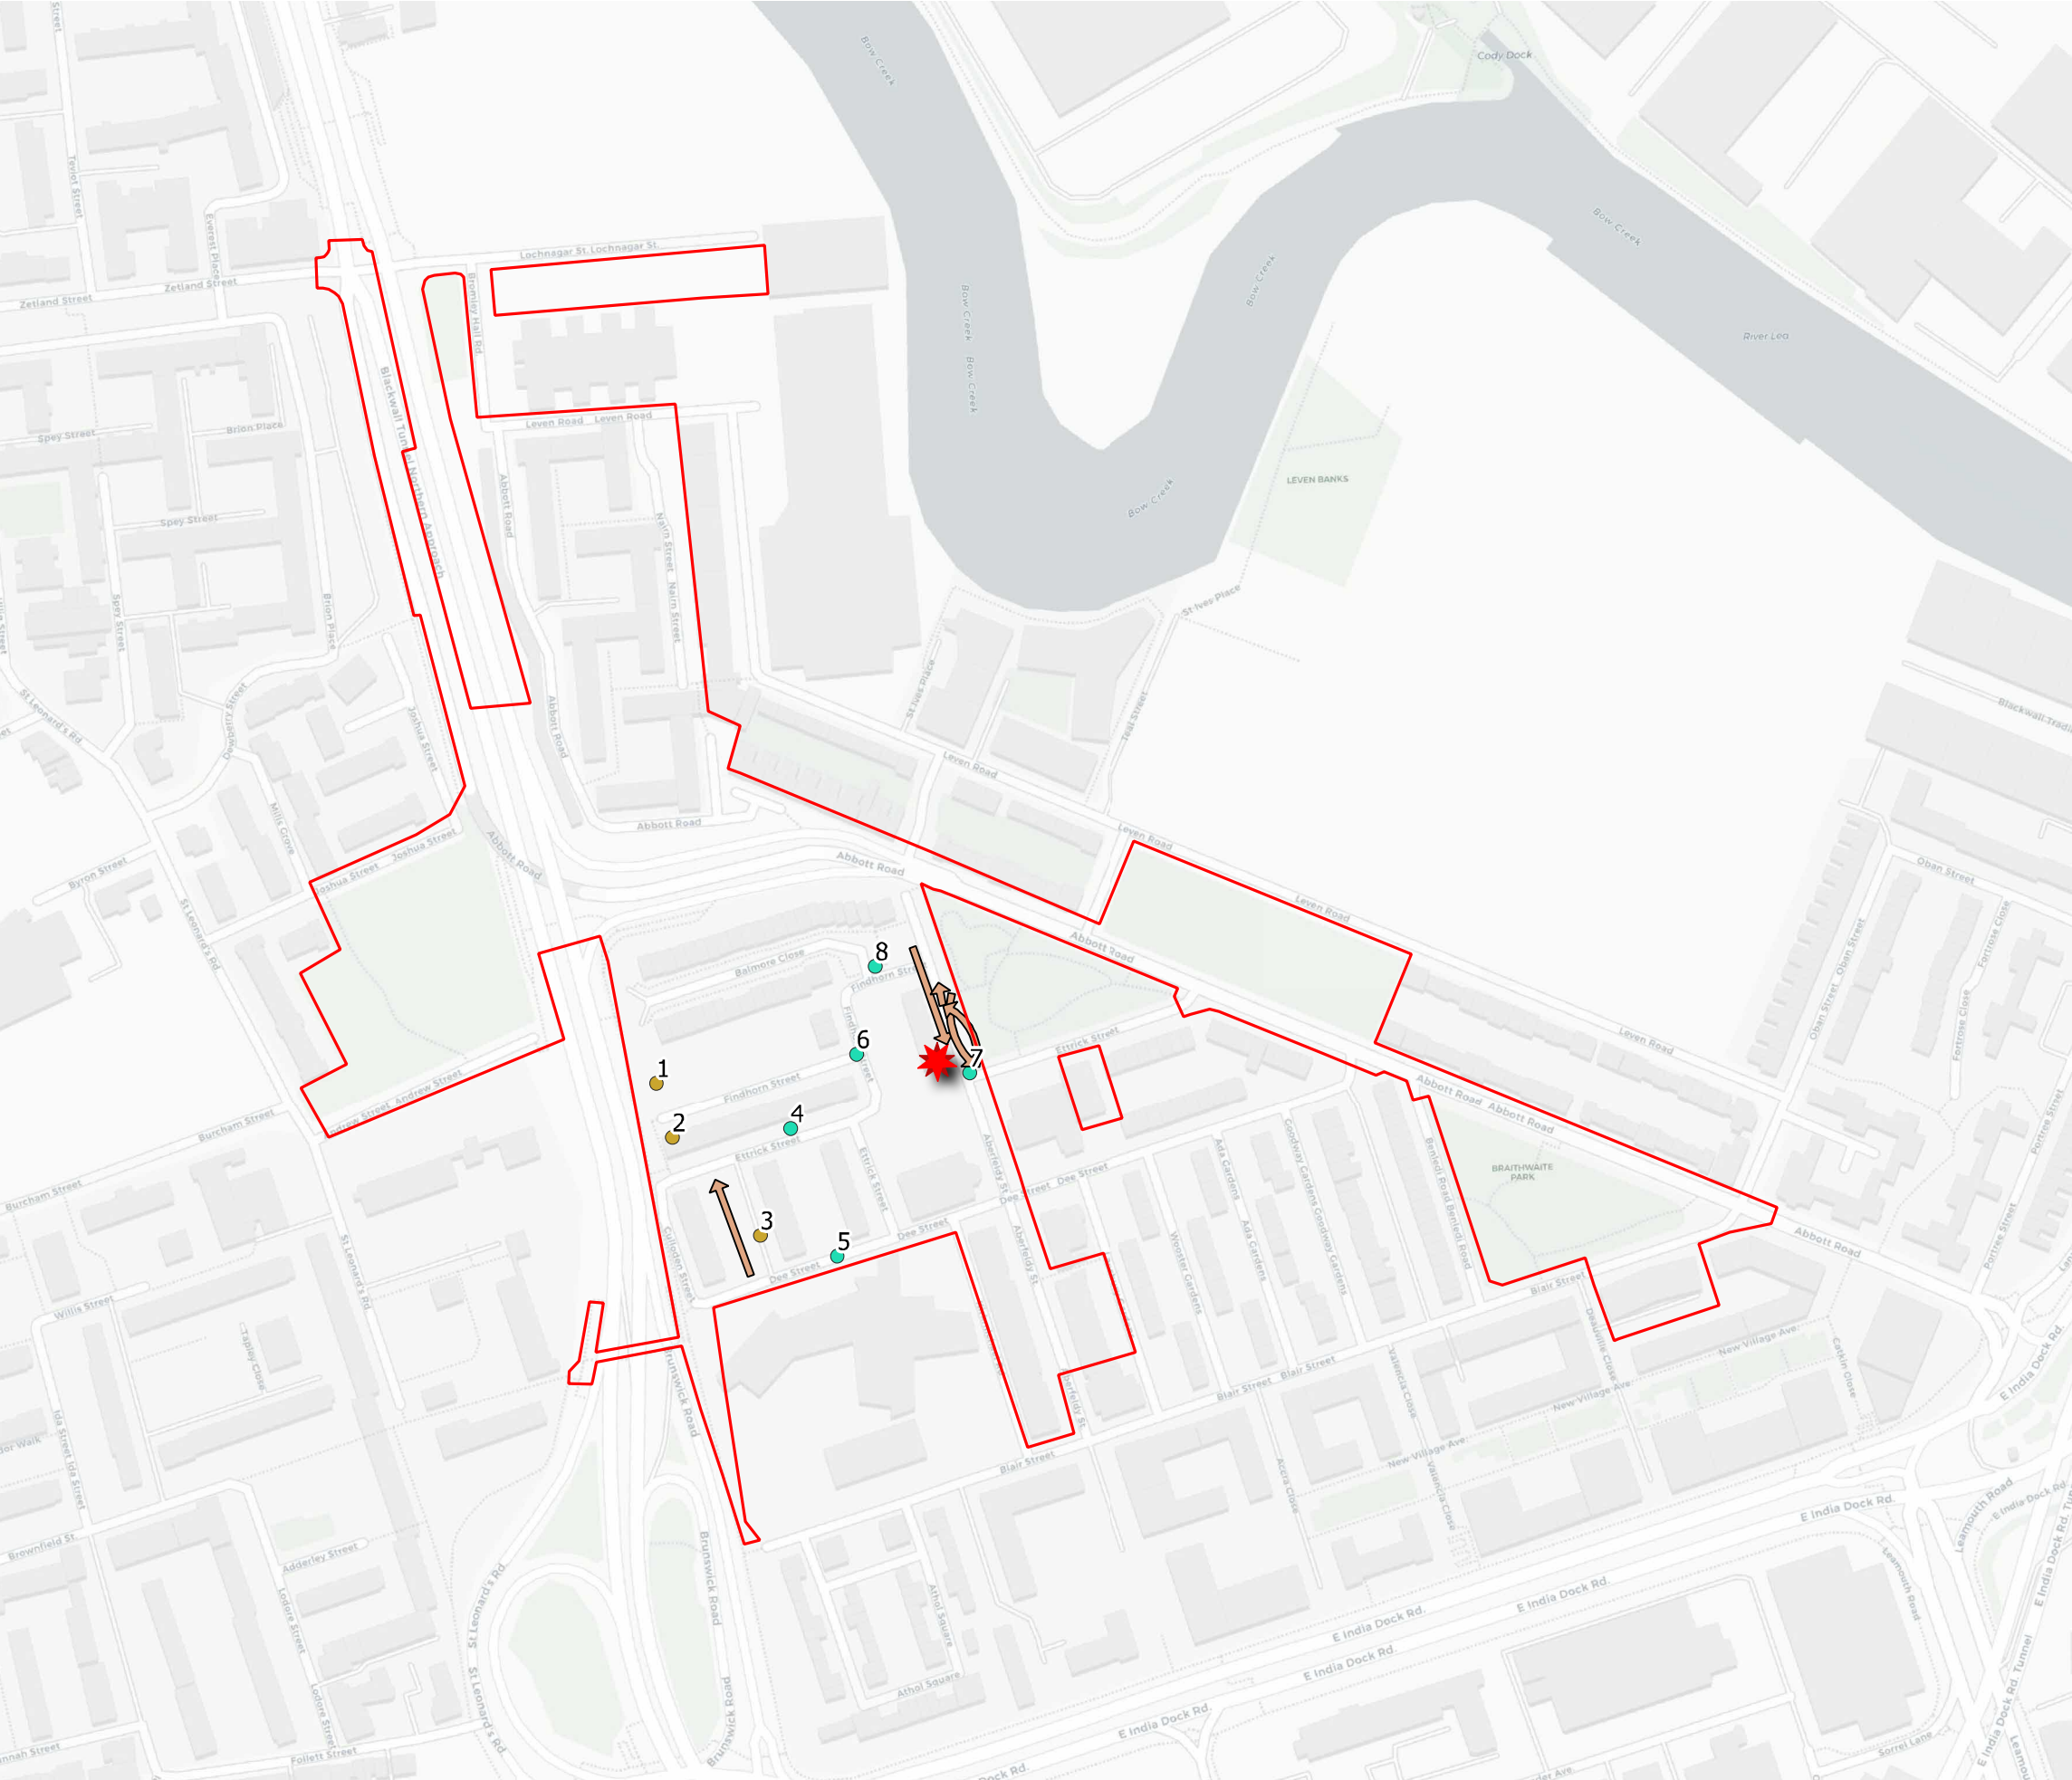
FIGURE 2 BAT SURVEY RESULTS

- 4.1** During the surveys, eight positions were surveyed around the buildings to observe any evidence of bats emerging from features identified as being of potential value. The locations were selected as from these vantage points it was possible to observe the elevations of the buildings where all potential roosting features were identified. Location of surveyors and bat activity can be found in Figure 2.

- 4.2** The first survey, undertaken on 09/06/2021 recorded no roosting bats. A single pass by a common pipistrelle was recorded at location 3, although this was 45 minutes after sunset.
