# ABERFELDY VILLAGE

## PHASE 1 PRELIMINARY GEO-ENVIRONMENTAL AND GEOTECHNICAL RISK ASSESSMENT

Aberfeldy Village Masterplan, Aberfeldy Street, London E14 0NU

JER8921  
Aberfeldy Village Masterplan  
V2  
R0  
2<sup>nd</sup> July 2021

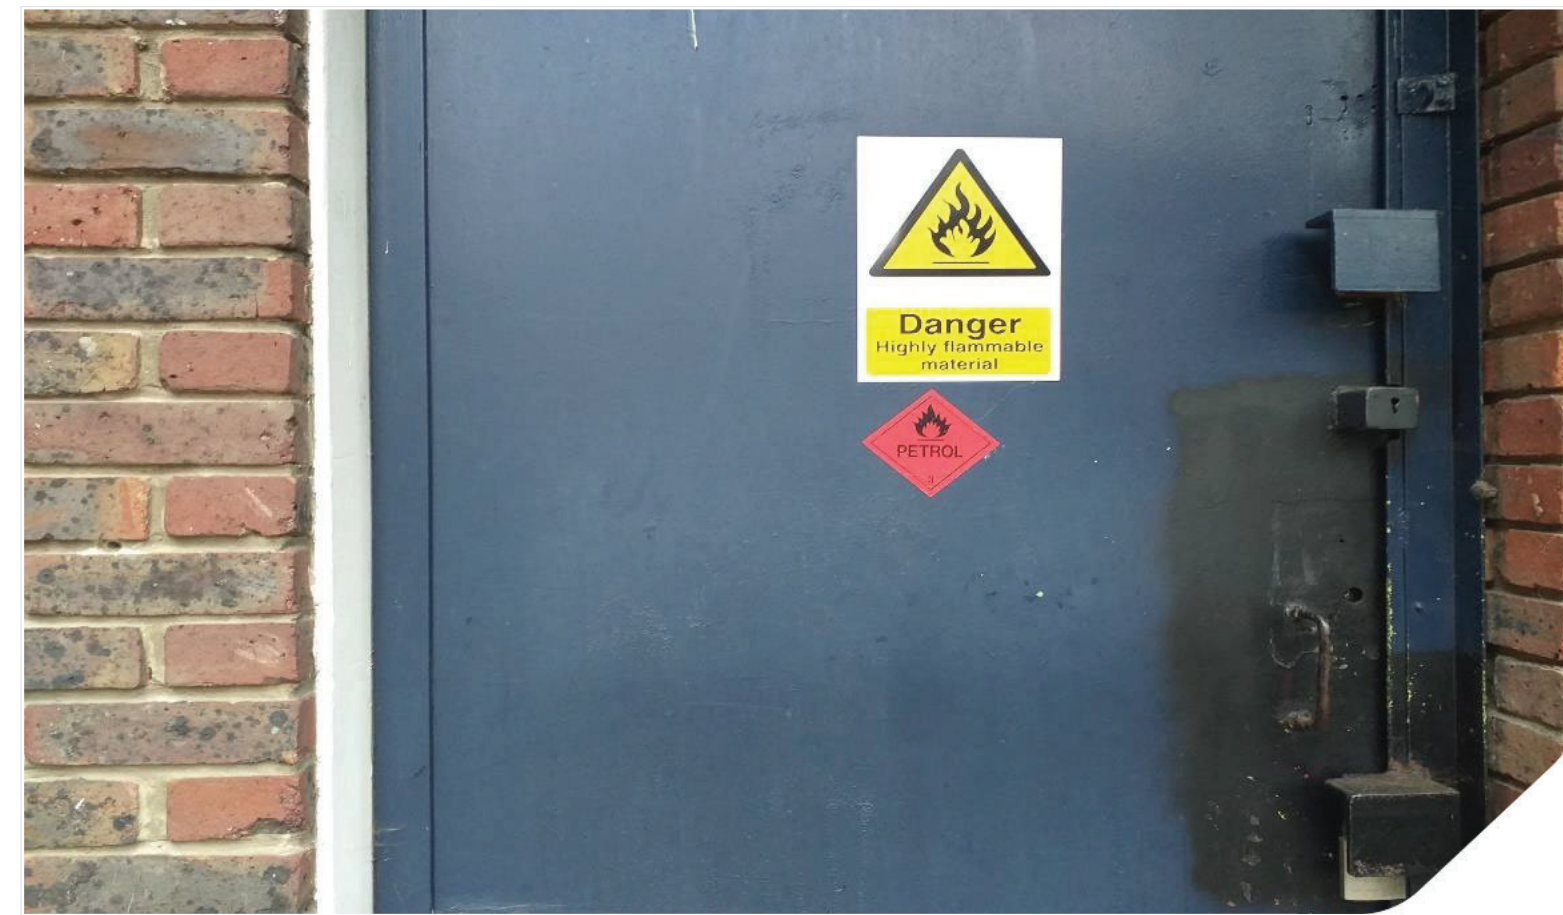
Photo 01: Petrol warning signs on areas present between Abbot Road and Nairn Street (north of site)

| Section | Description |
|--|--|
| Bulk Storage / Tanks: | No evidence of bulk storage tanks was observed during the walkover. However, several warning signs for storage of petrol were noted on doors within the development between Abbot Road and Nain Street in the north of the site (example on Photo 01). Access into these areas was not possible at the time of the walkover to verify if/how the petrol was stored. It is suspected that these may make misrepresentative reference to the storage of diesel to fuel back-up generators in these areas. |

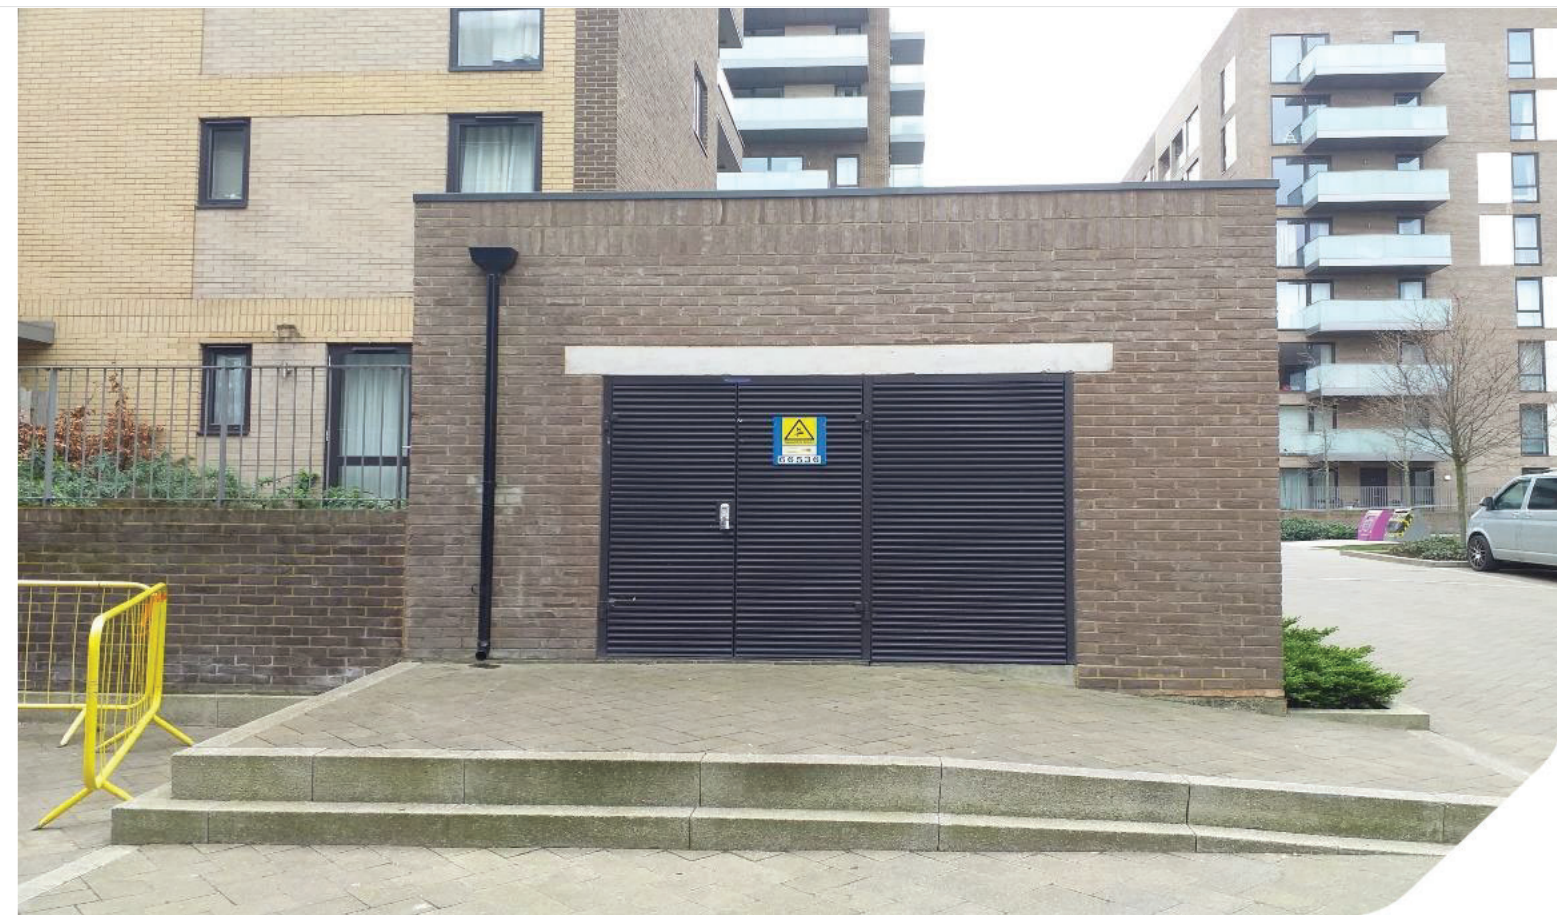
Photo 02: Electricity substation in development next to Braithwaite Park

| Section | Description |
|--|--|
| Electricity Substations /Transformers: | One electricity substation was readily observed during the walkover. This was located in the far east of the site, in the south of the Blairgowrie Court area (Photo 02). |

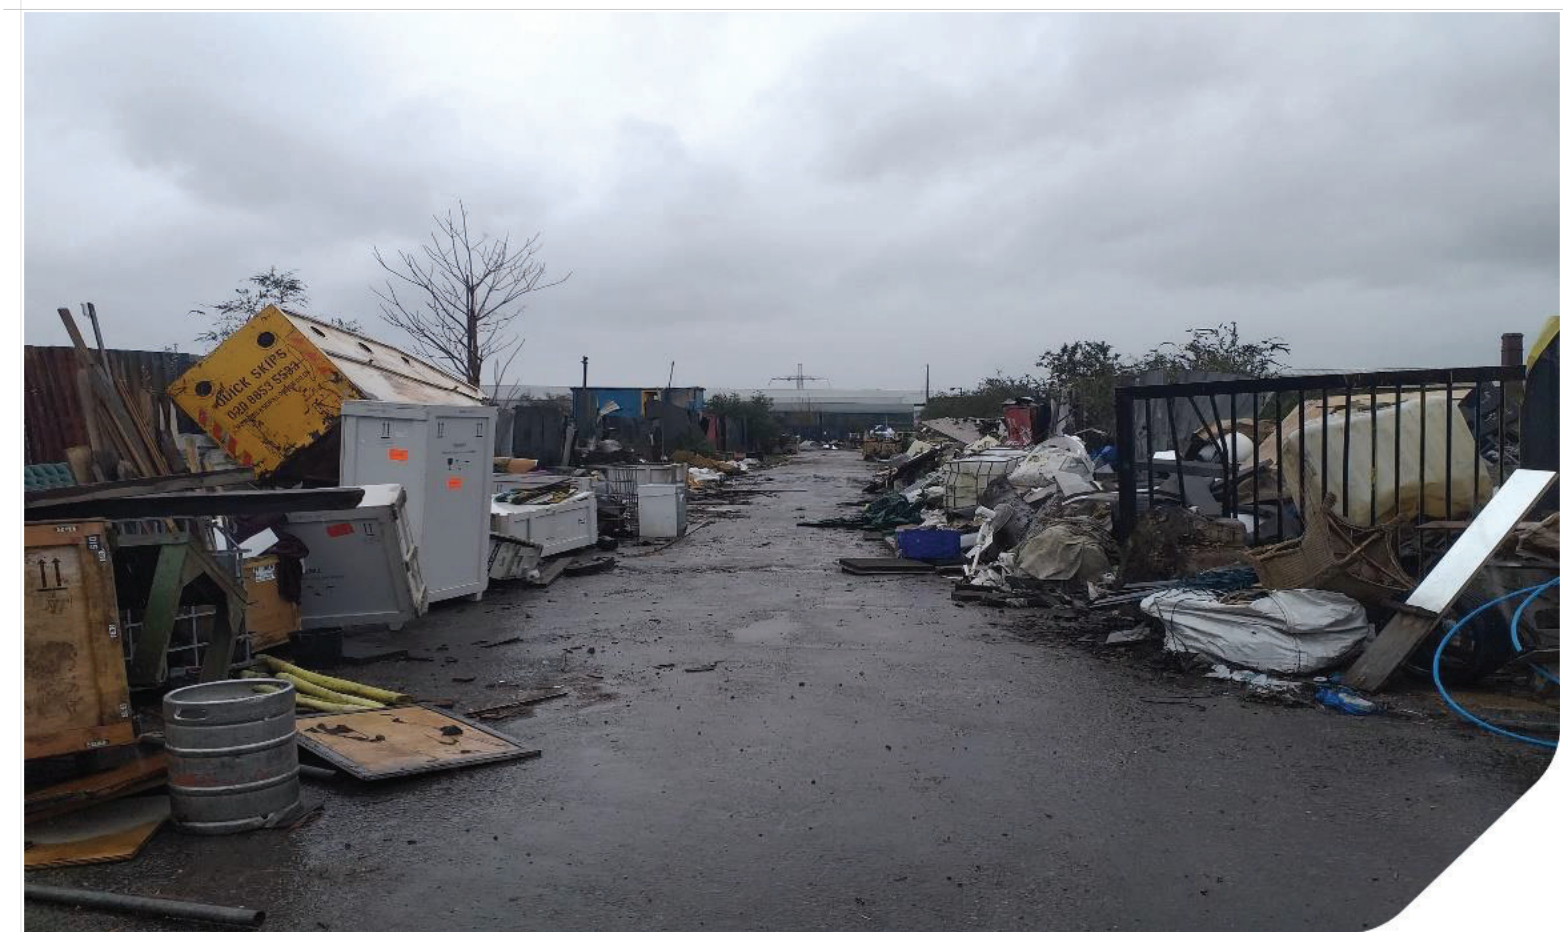
Photo 03: Fly tipping off Lochnager Road

| Section | Description |
|---|--|
| Other Geo-Environmental Issues: | Whilst no asbestos containing material was noted during the walkover, given the age of the buildings across the development it is highly likely that asbestos containing material may be present. In addition, the large amount of fly tipping around Lochnager Street may be a potential source of asbestos. (Photo 03) |

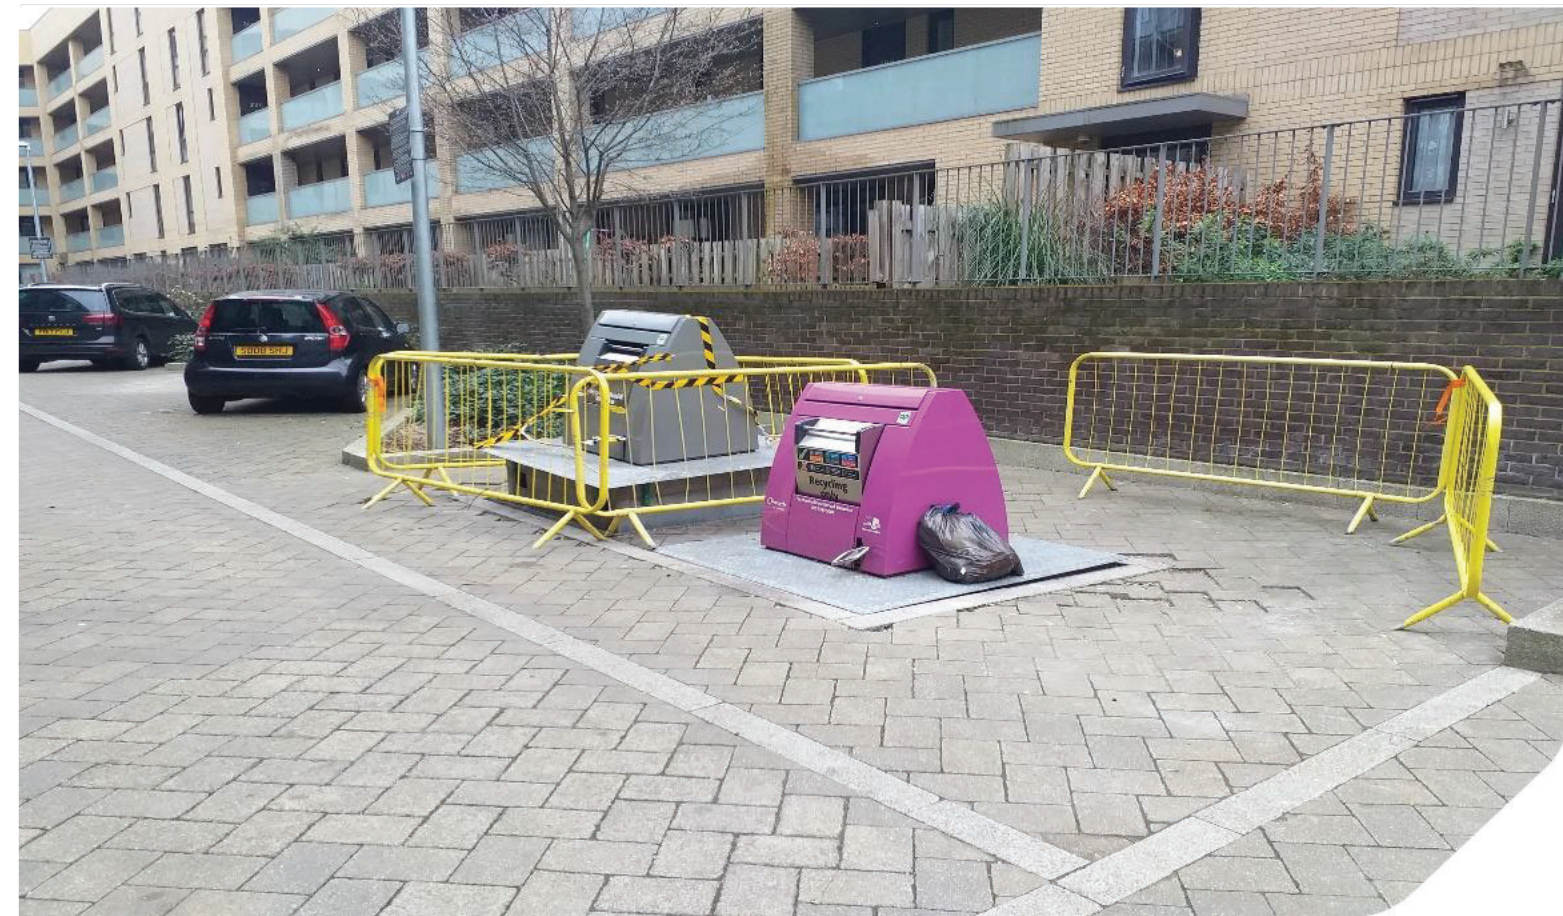
Photo 05: Blairgowrie Park underground waste storage system

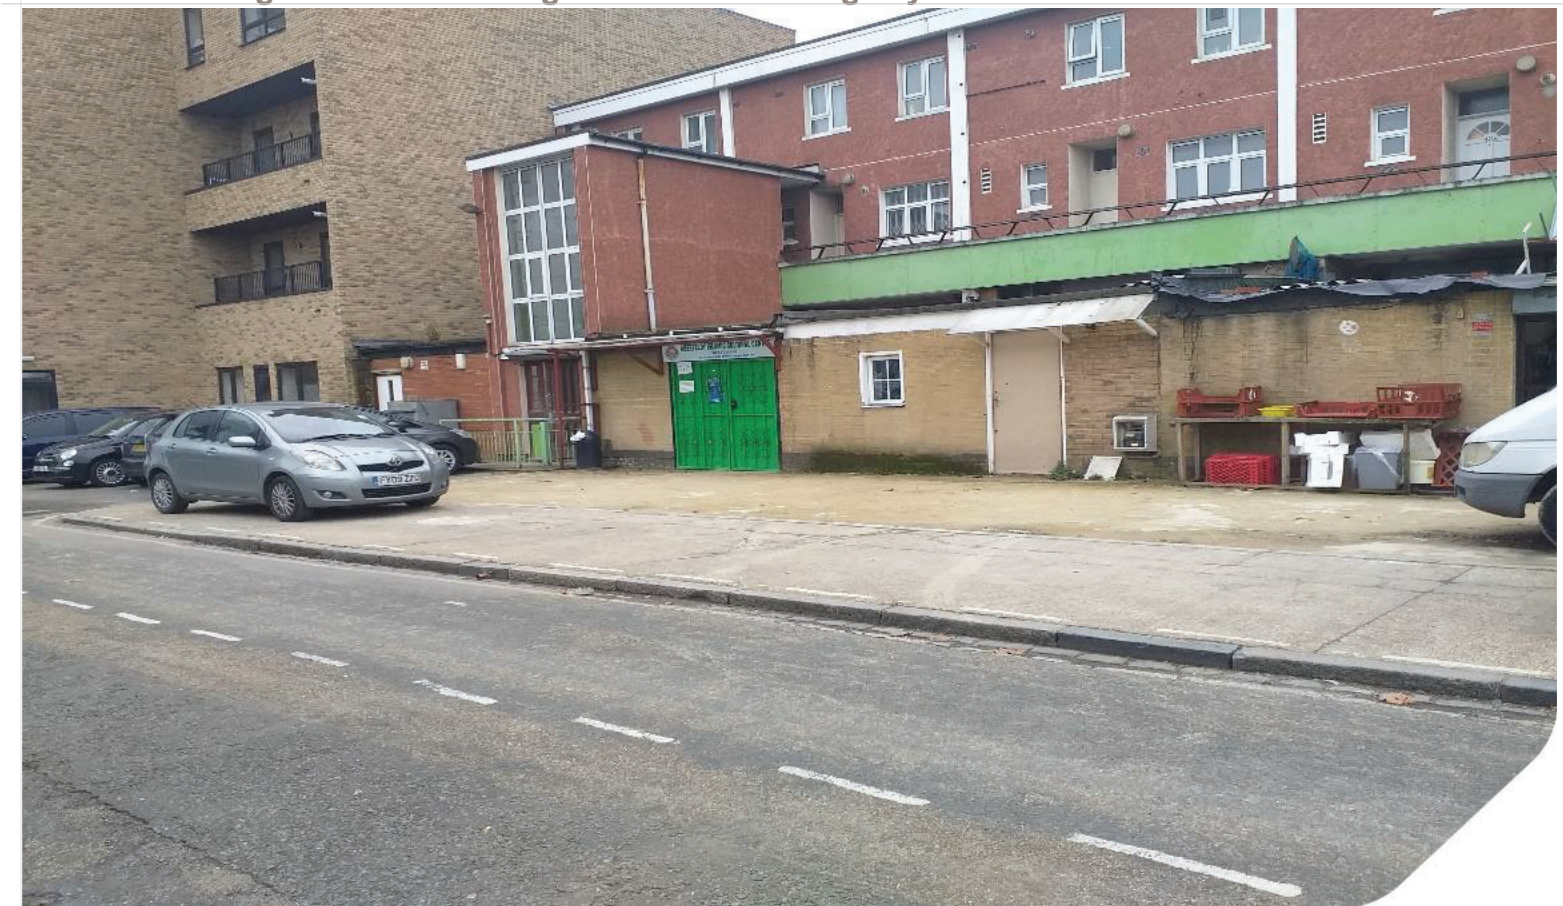
Photo 07: Area of hardstanding on Lansbury Gardens
