Built Character

Heritage + Listed Buildings

Aberfeldy Context

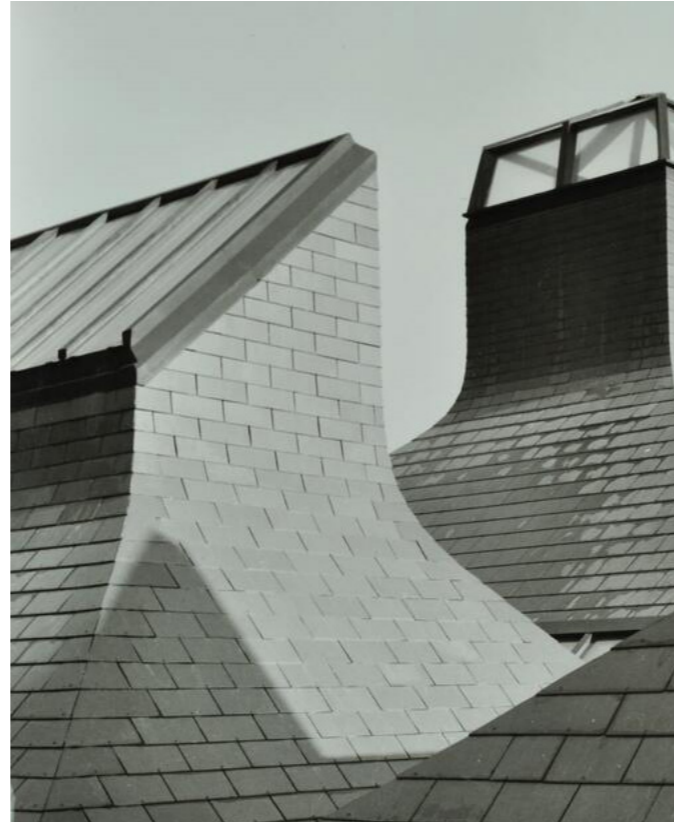
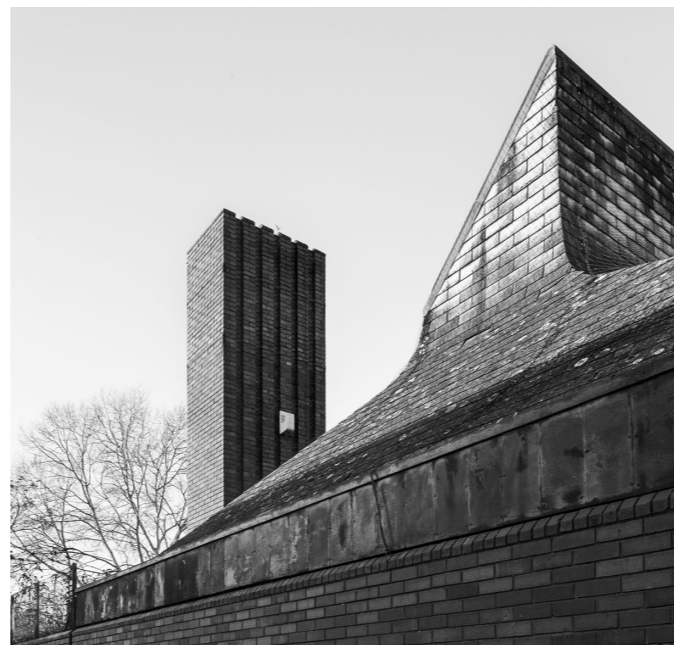
Historic imagery of Bromley Hall School

Built as a school for physically disabled children by the LCC/GLC Architects' Department under Bob Giles; Bromley Hall School opened in 1968 and was extended 1978-9. This closed in 2002 and the site has remained vacant. The building was listed Grade II in 2012 however it is on Historic England's Heritage at Risk Register where its condition is judged to be 'Poor'.

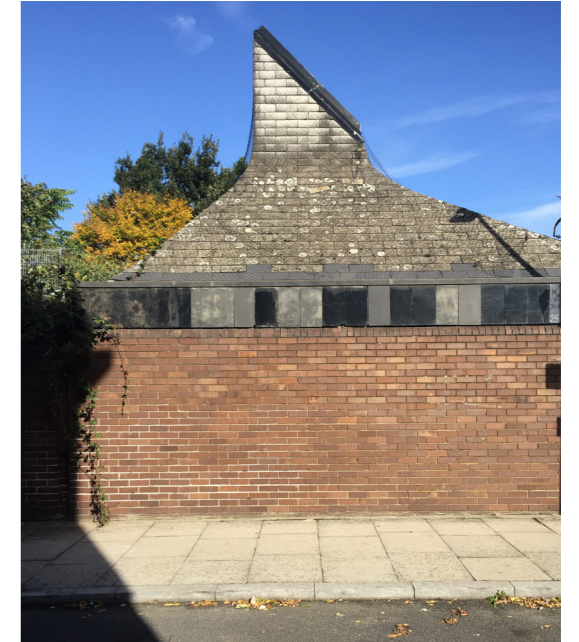
Modern day imagery of Bromley Hall School

Designed to sit within an intensely urban setting, the inward-looking building is very much isolated from its context by its 2m high perimeter wall. Its heritage significance does not rely on its setting, however the condition of its present setting, amongst brownfield sites and scrub, is a negative factor which somewhat affects the ability to appreciate its architectural and aesthetic merits.

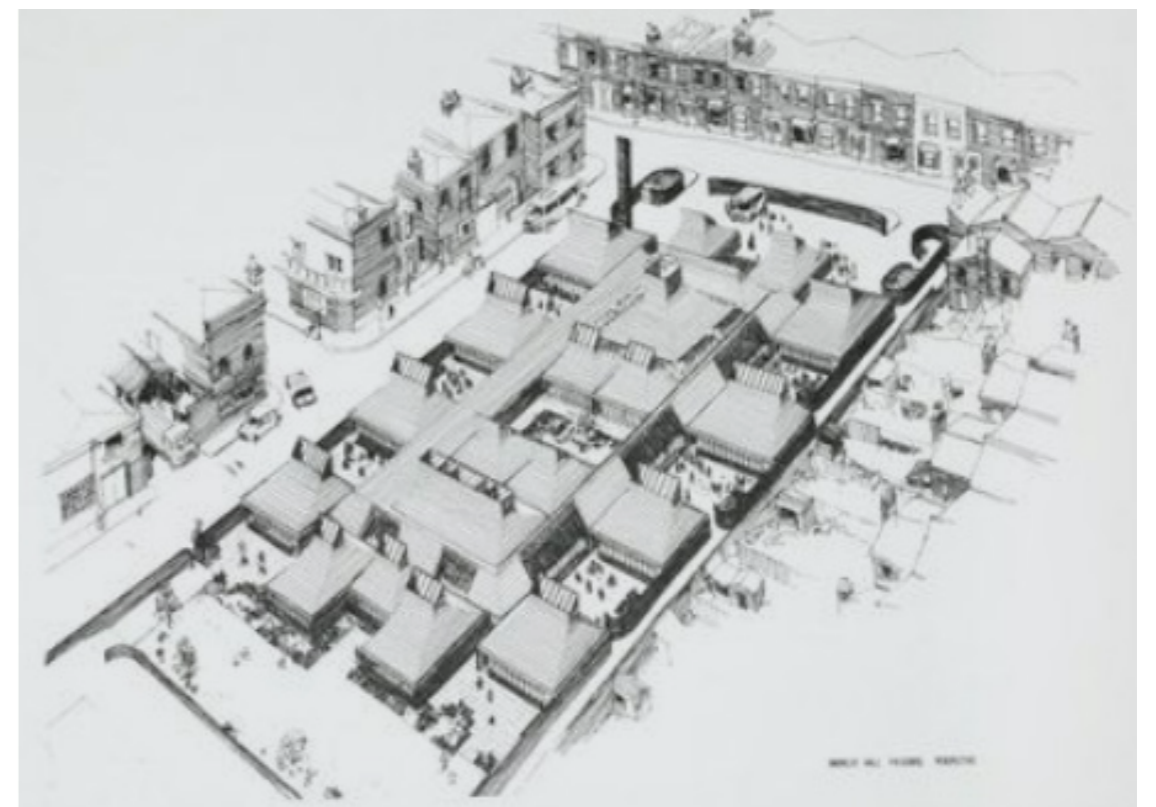
Historic Isoetric drawing of Bromley Hall School

The building's significance lies in its architectural quality and meticulously planned spaces. It is described in the listing as 'one of the architecturally outstanding schools of the 1960s, combining intimate, child-scaled interiors with bold, expressive external forms reflecting the local industrial vernacular. This 'vernacular' is referenced in the tall, hipped roof forms rising to a canted roofline which top a series of linked classroom pavilions.'

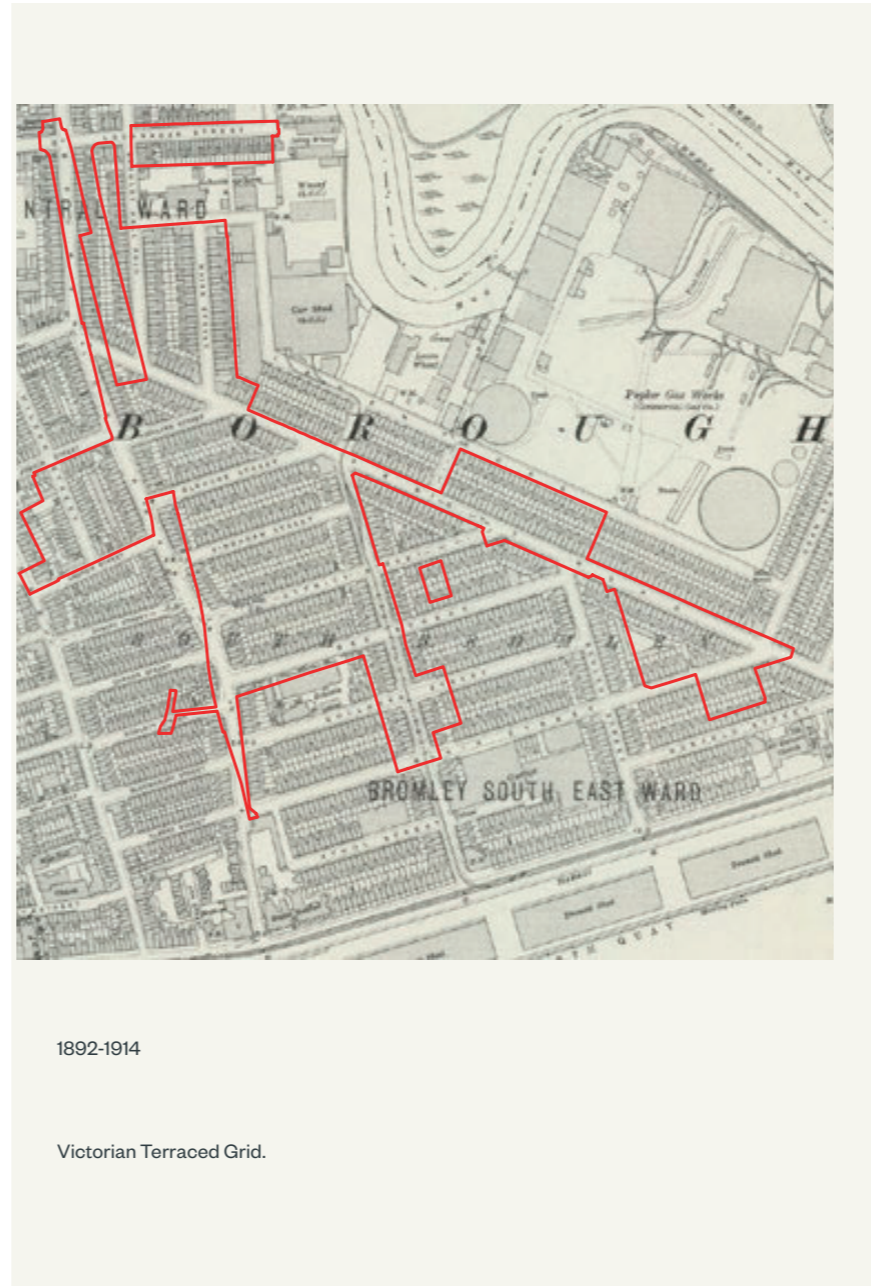
War Damage.

- Total Destruction
- Damage Beyond Repair
- Seriously Damaged; Doubtful if Repairable
- Seriously Damaged; But Repairable at Cost
- General Blast Damage, Minor in Nature
- Blast Damage, Minor in Nature
- Clearance Areas
- V2 Bomb
- V1 Bomb

The history and built character of the Aberfeldy neighbourhood has been greatly affected by significant bomb damage and subsequent parcels of land development.

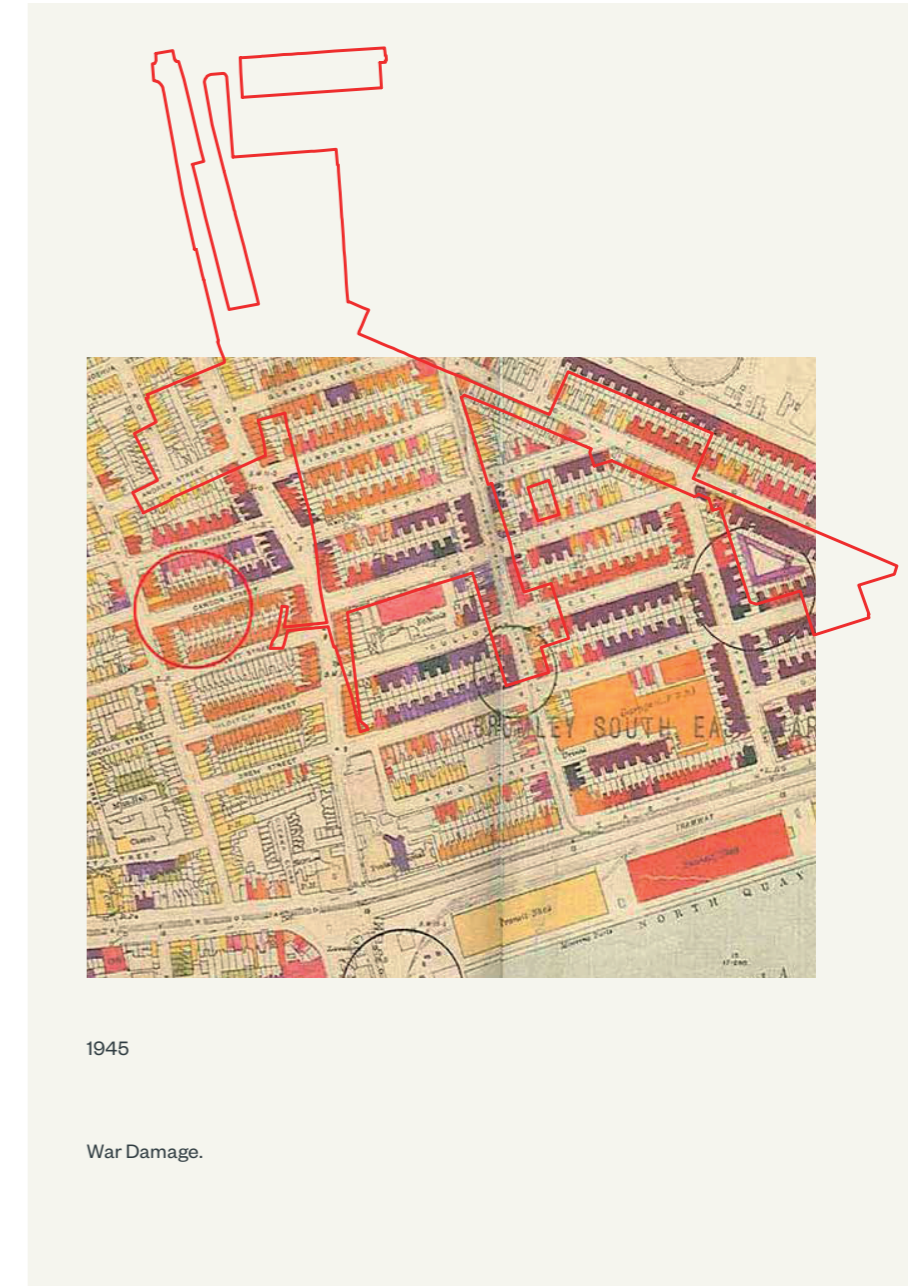
Patchwork

Distinct break in Victorian grain, site has been broken down in different sections, creating a patchwork of interconnected areas.

Post WWII the 19th century Victorian grain of terrace housing was broken up into different sections with subsequent development within each, creating a 'patchwork' of interconnected but disparate areas. This is identified on the diagrams adjacent. The intersection of the two major roads (A12 and A13) further separated this Aberfeldy patchwork from its neighbours to the West and South.

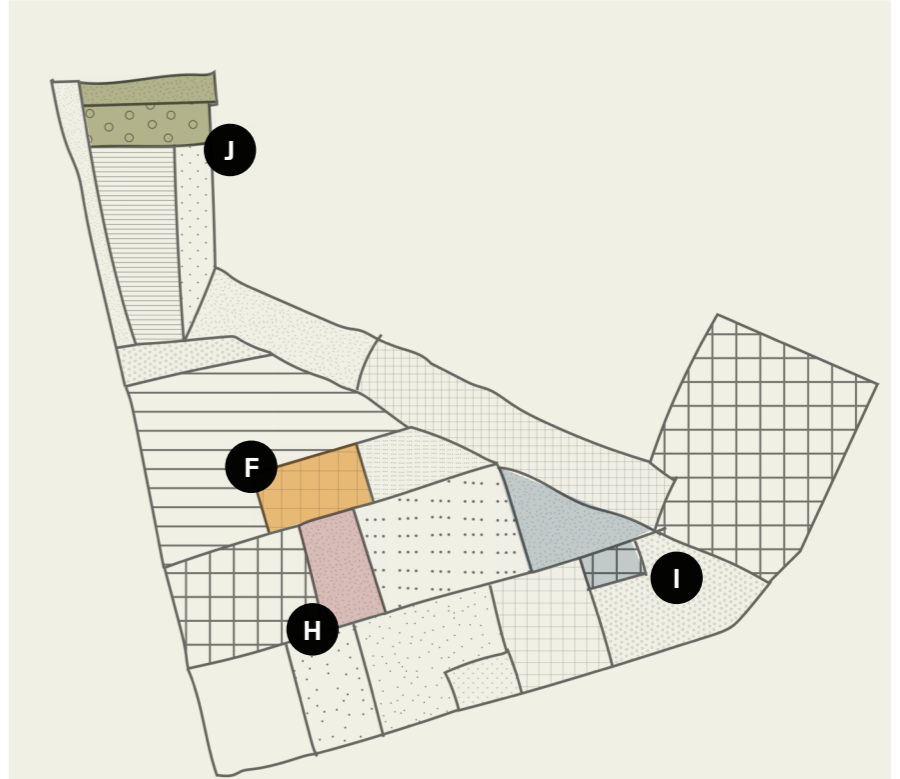
Post WWII 1950

Distinct break in Victorian grain, site has been broken down in different sections, creating a patchwork of interconnected areas.

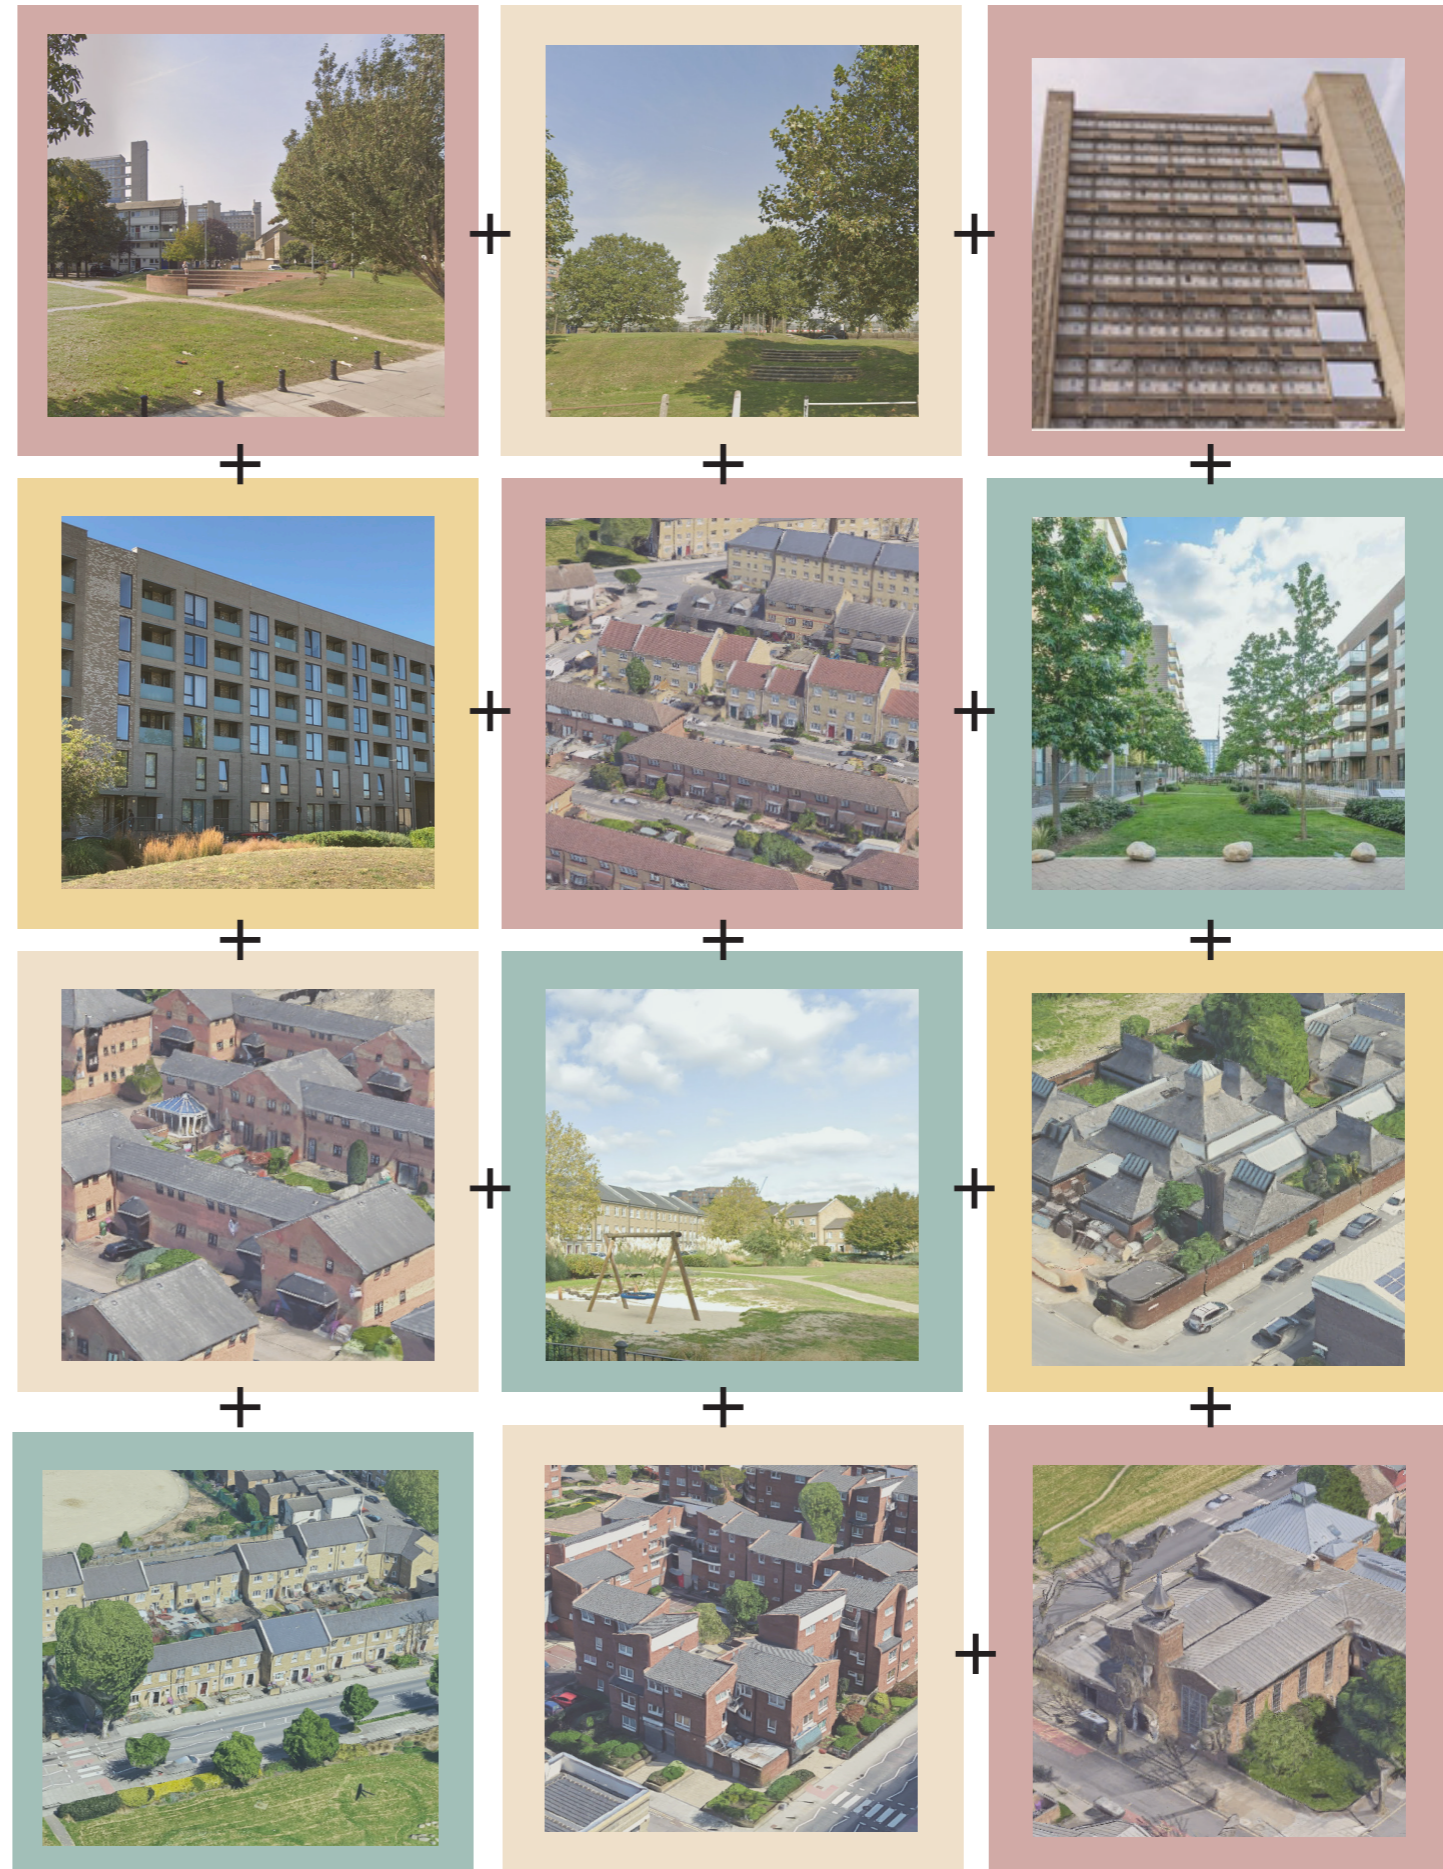
Existing Patches

The built character of the existing Aberfeldy `patches` vary in style and scale.

These patches of development are often separated by areas of existing open space (some of which is underused currently), and dividing roads, both reducing the potential for connectivity across Aberfeldy.

The Phase A proposals are acutely aware of this variation in style and scale across the neighbourhood, from the Grade II* listed Balfron Tower to the West and Bromley Hall School to the North, with a host of - predominantly 20th century - development in between, right up to the first Phase of Aberfeldy built around the new East India Green, to the South of Plot I.
