APPENDIX G - OFF-SITE UTILITY BUDGET QUOTE

Site Address: Aberfeldy, Abbott Road, London, E14 0NE

Detailed Unexploded Ordnance (UXO) Threat & Risk Assessment

ABERFELDY NEW VILLAGE

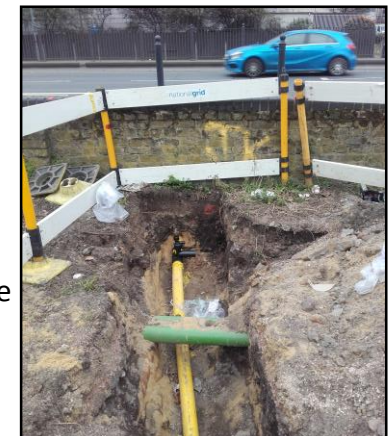
Gas pipe work in central area

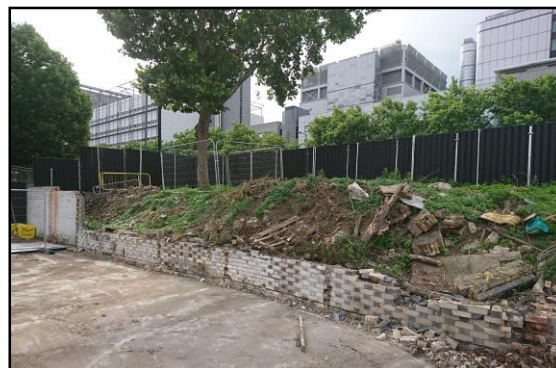
Area before excavation

- The majority of this JK within the P3 boundary had been transported in from P2. As such it was relatively easy to grade off back to the original profile of the bank which was readily identifiable from the old vegetation. No actively growing JK was discovered and all of the rhizome in the pile was decayed

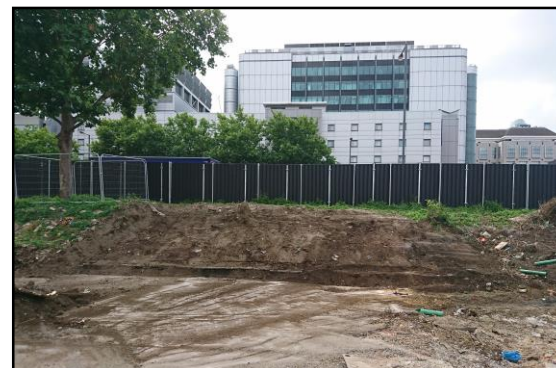
On completion of 14t work

- The work was done in 2 stages with the 14t working from the bottom of the bank and moving spoil straight to the stock pile. At a later date the 5t worked from the top of the bank moving spoil via the dumper to a temporary stockpile in the substation area. This material was subsequently removed from site with a grab wagon

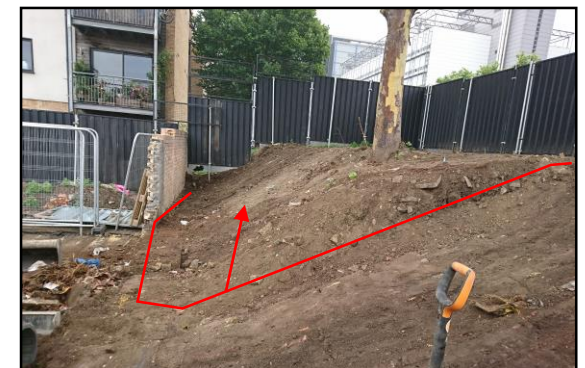
On completion of JK works

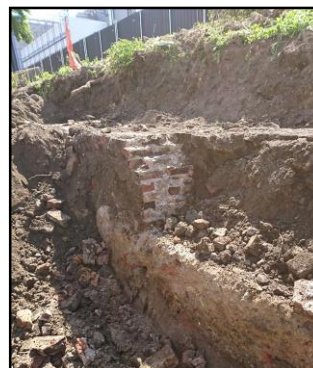
Footings encountered during excavation

- The main stand was dug out using the 14t with spoil being tracked over to the stockpile area beside Julius House
 - Significant concrete footings from old houses were present under the stand; some rhizome penetration meant these had to be removed. Contaminated sections were broken off and the majority of the concrete was disposed of as clean material

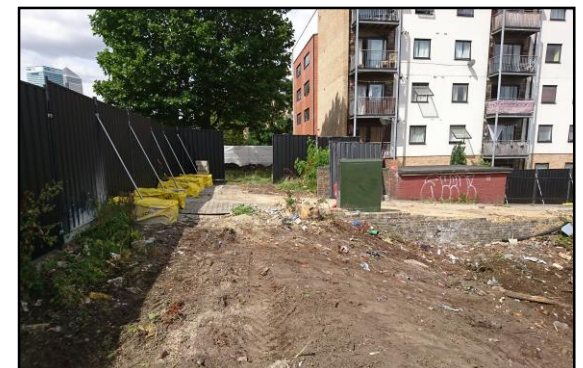
Surface scraped off towards substation area

- The small JK plants were also dug out using the 14t sitting on a pile of crush to enable sufficient reach. This material was moved directly to the temporary stockpile beside the substation

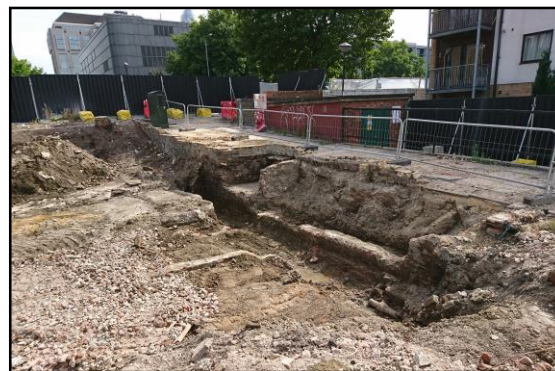
General area showing buried walls and footings

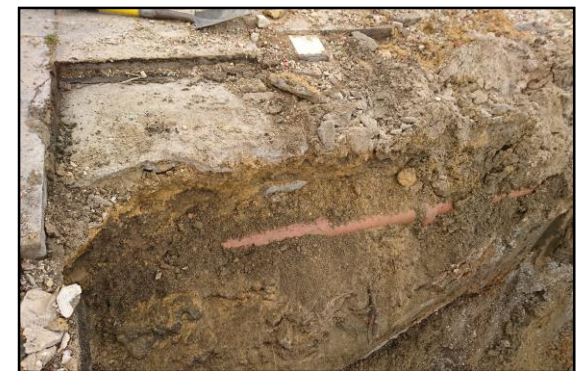
Chasing out around services by hand

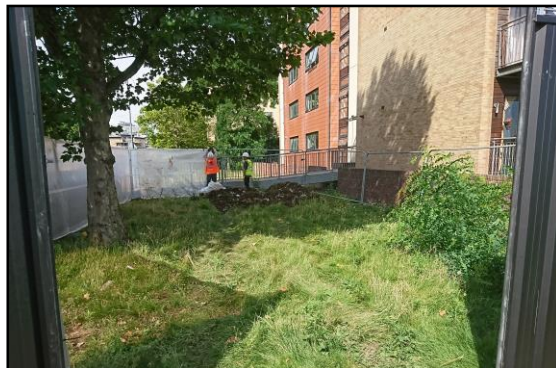
Temporary fence being installed

- No excavation was undertaken in this area, only stockpiling
- Stockpile height was dictated by the trees, the boundary wall to the A13 pavement and the retaining wall to Franklin House
- Prior JK infestation, the same ownership as the other areas and the incorporation of the area into the site boundary meant that the JK was not being taken off site or spread
- Once the stockpile had reached its maximum height it was battered down with a ditching bucket to allow grass to be sown
- This method was used in front of Julius House for the phase 2 spoil, no increase in JK occurred. All the JK had been treated prior to movement and the rhizome network was broken leaving only fragments in the spoil
- The JK rhizome under the A13 pavement remains the biggest threat of re-infestation to the area

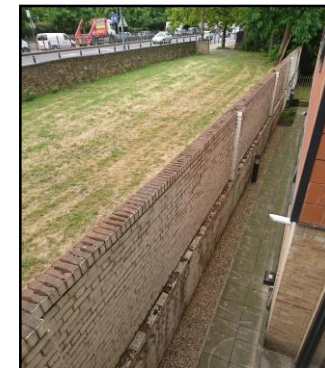
Change in level and retaining wall removes pathway from JK to Franklin House
