THE GOODSYARD

Heritage Statement: Appendix A -
Audit of Historic Structures and Heritage Assets

Bishopsgate Goodsyard

Shoreditch High Street, London E1

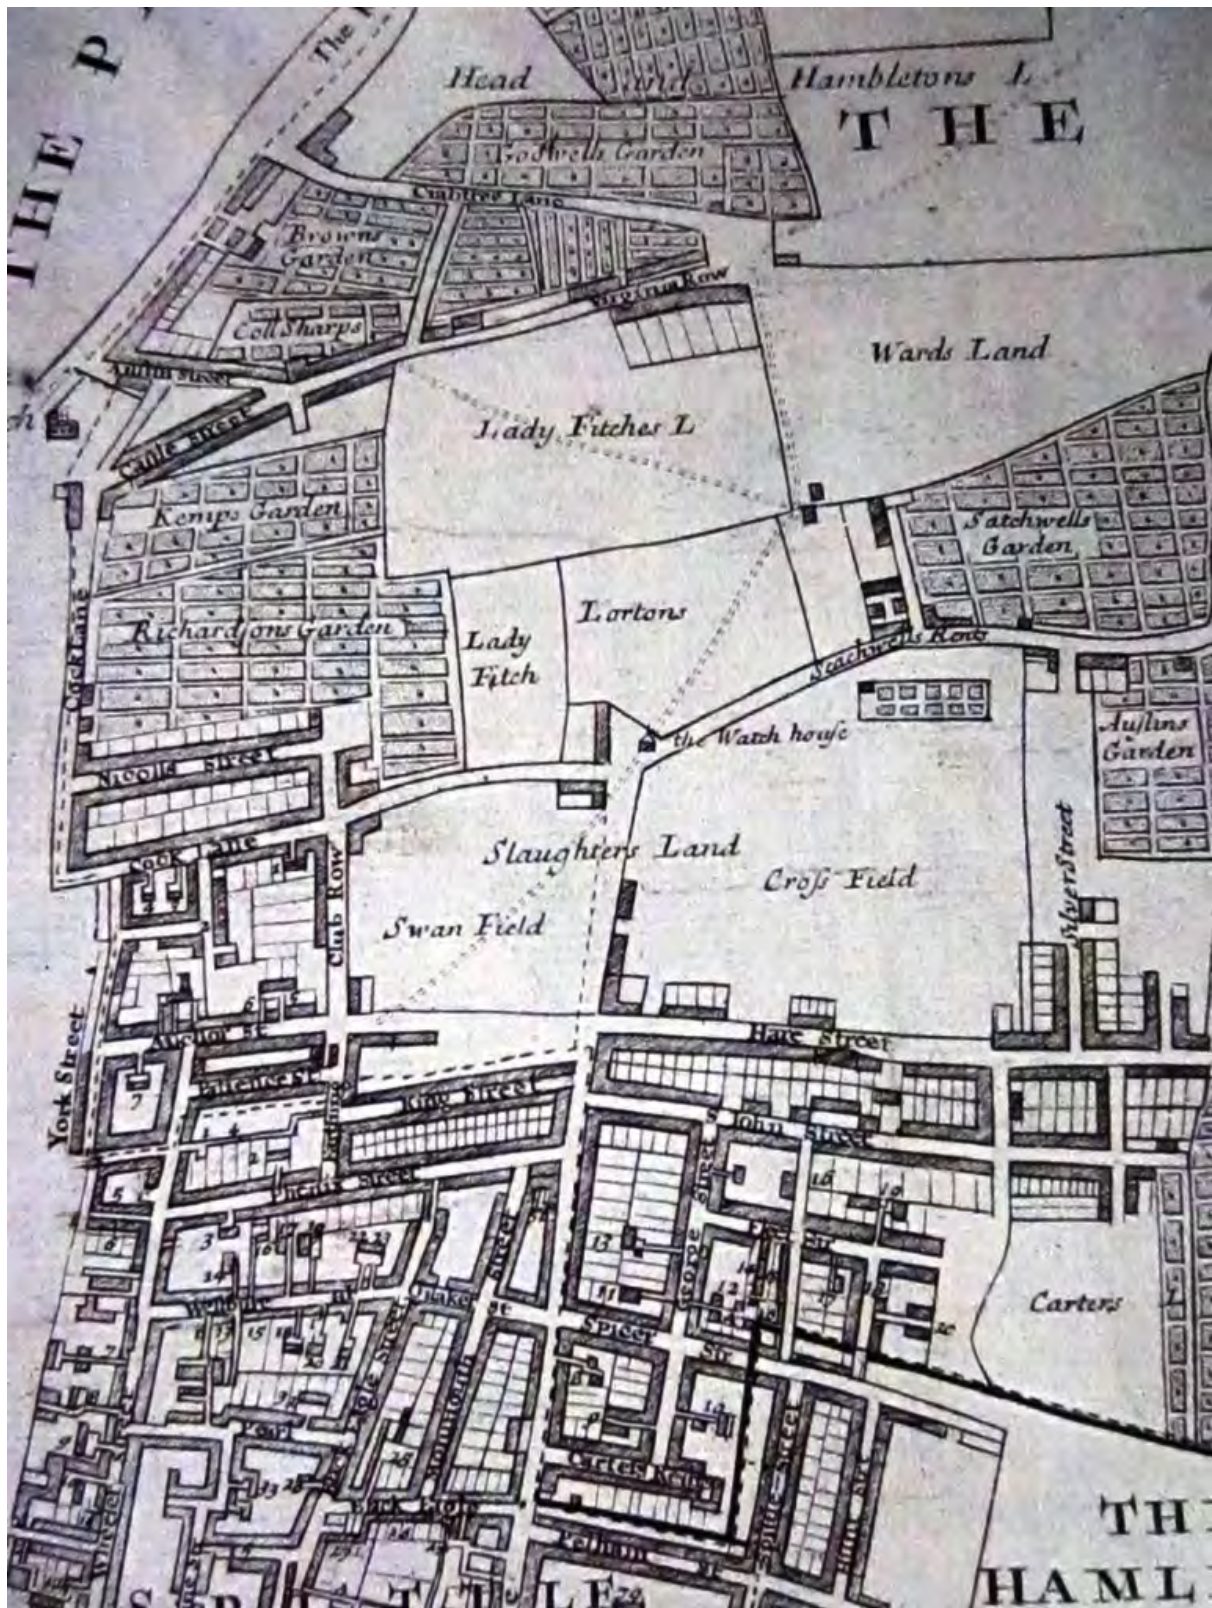
Figure 1: Joel Gascogne, *Survey of the Parish of St Dunstan, Stepney*, 1703 showing the area around Bishopsgate Goodsyards prior to its redevelopment in the 1840s. The

Goodsyard site is located to the north of Phoenix Street (now demolished) and south of Anchor Street (redeveloped in the 19th century to create Bethnal Green Road).

- 2.38 In 1727 the writer Daniel Defoe noted that the area had become 'all town' during his lifetime and where there had once been fields and gardens, houses and markets now stood.²⁷ A survey made in 1703 shows the area around Hare (now Chesham) Street and Brick Lane (running north-south) just before the building of Sclater Street, showing Slaughter's land (as a Norse word, Sclater is pronounced '*Slaughter*') still as fields (figure 1).

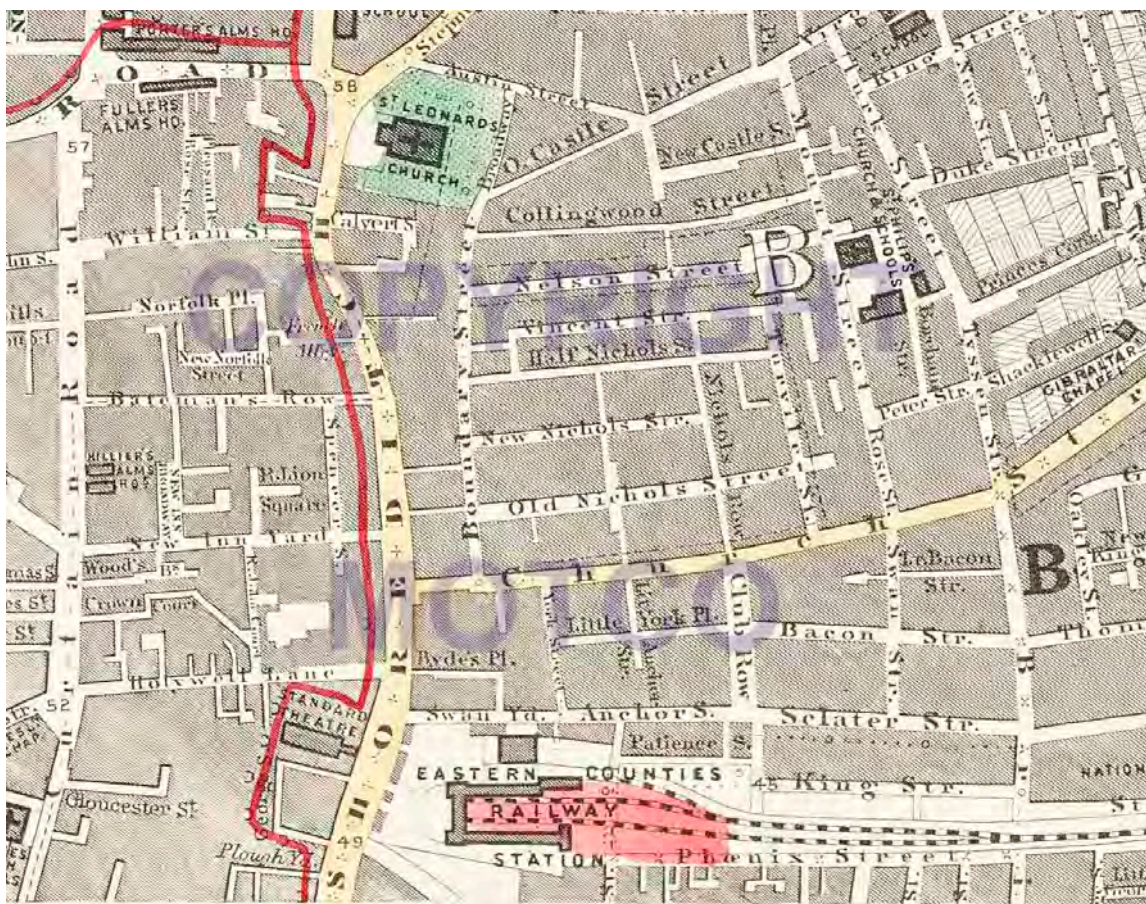
Figure 5: An extract from Stanford's map of London (1862) showing the form of the station and the forecourt walls to Shoreditch High Street.

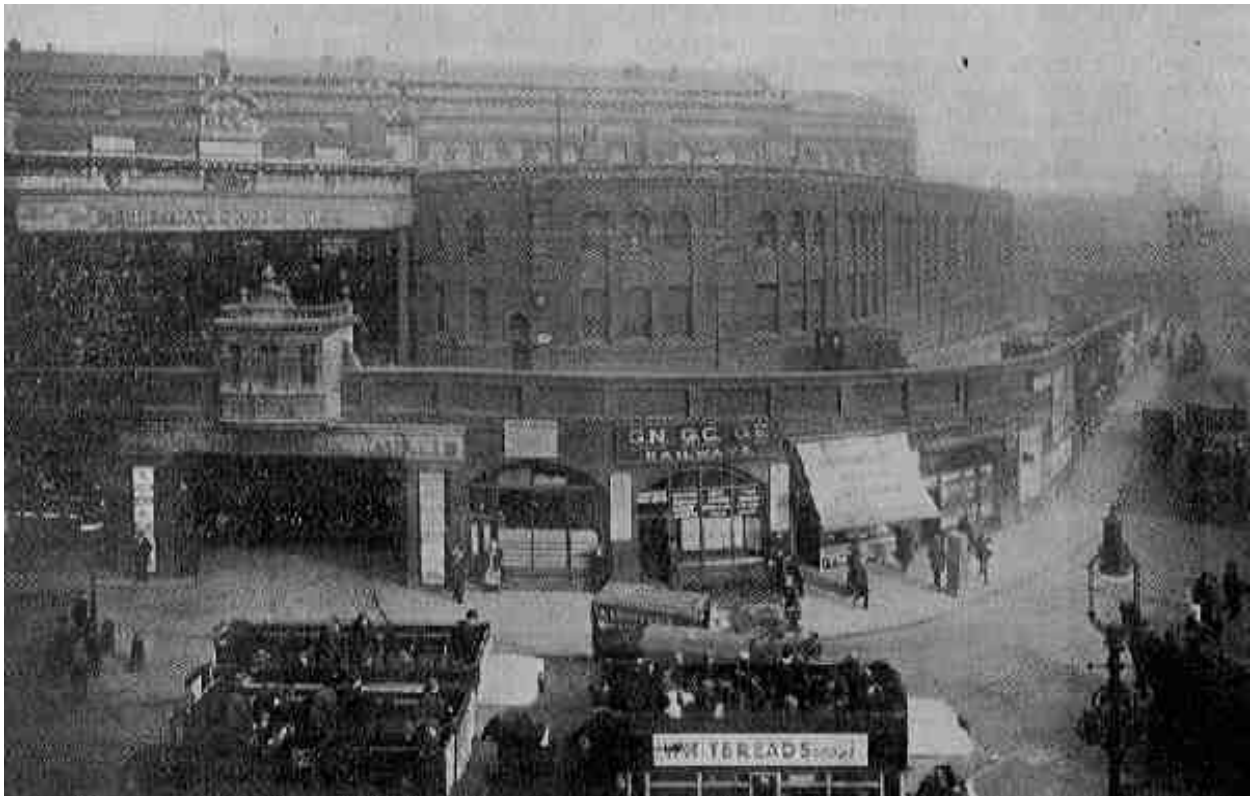
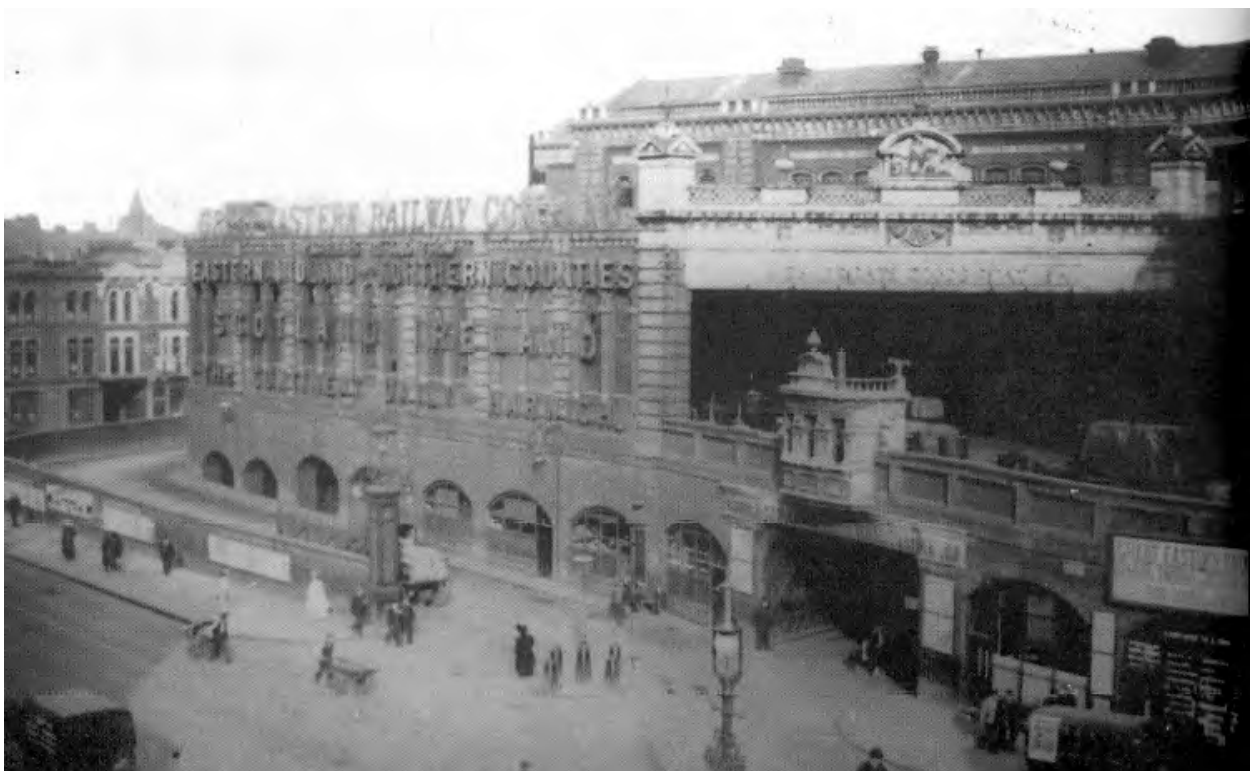
Figures 9 & 10: Views of the main entrance of Bishopsgate Goodsyard in 1924.

- 2.21** The Goodsyard was clearly designed to be visually impressive (figures 9-11) the upper level warehouse being covered with an iron and glass roof resting on massive iron columns. It occupied a site much larger than the station it replaced and was an extensive and complex operation. A comparison between figures 6 and 12 highlights the growth of the site by the end of the 19th century. In the space of just forty years, the site of the Goodsyard was transformed from a small-scale residential network of streets to firstly a passenger terminus and then later an extensive goods station for the GER. Consequently, the character of the area changed considerably.

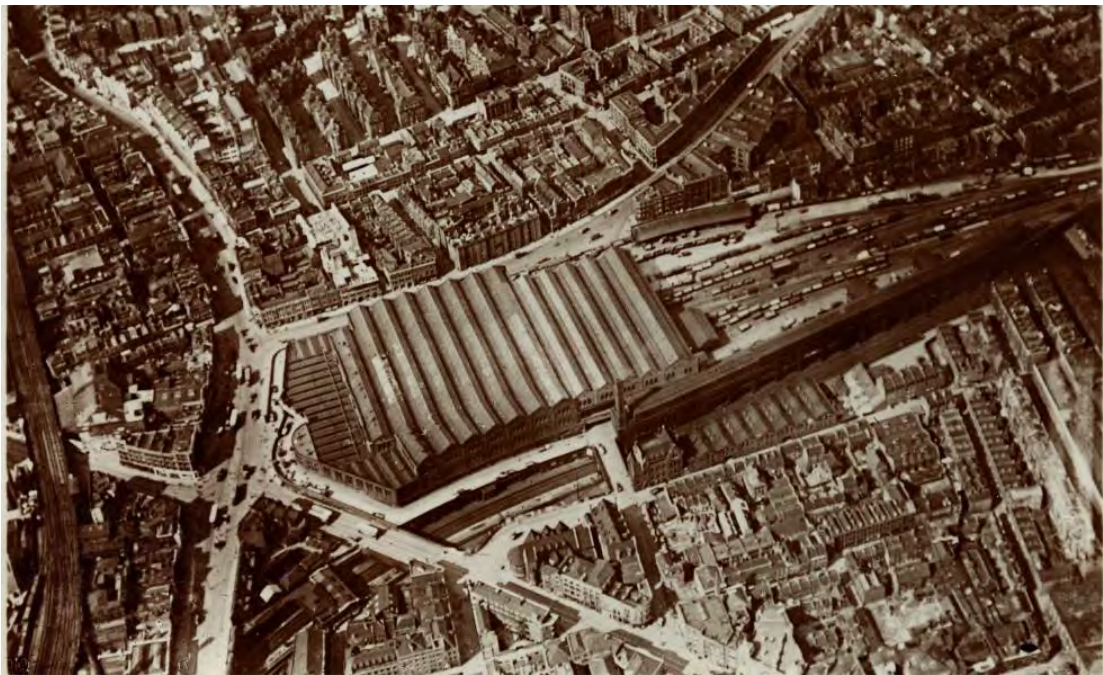
Figure 11: WWII aerial view of the Goodsyards site showing the impressive scale of the operation and the strong contrast between the building and the surrounding built environment.

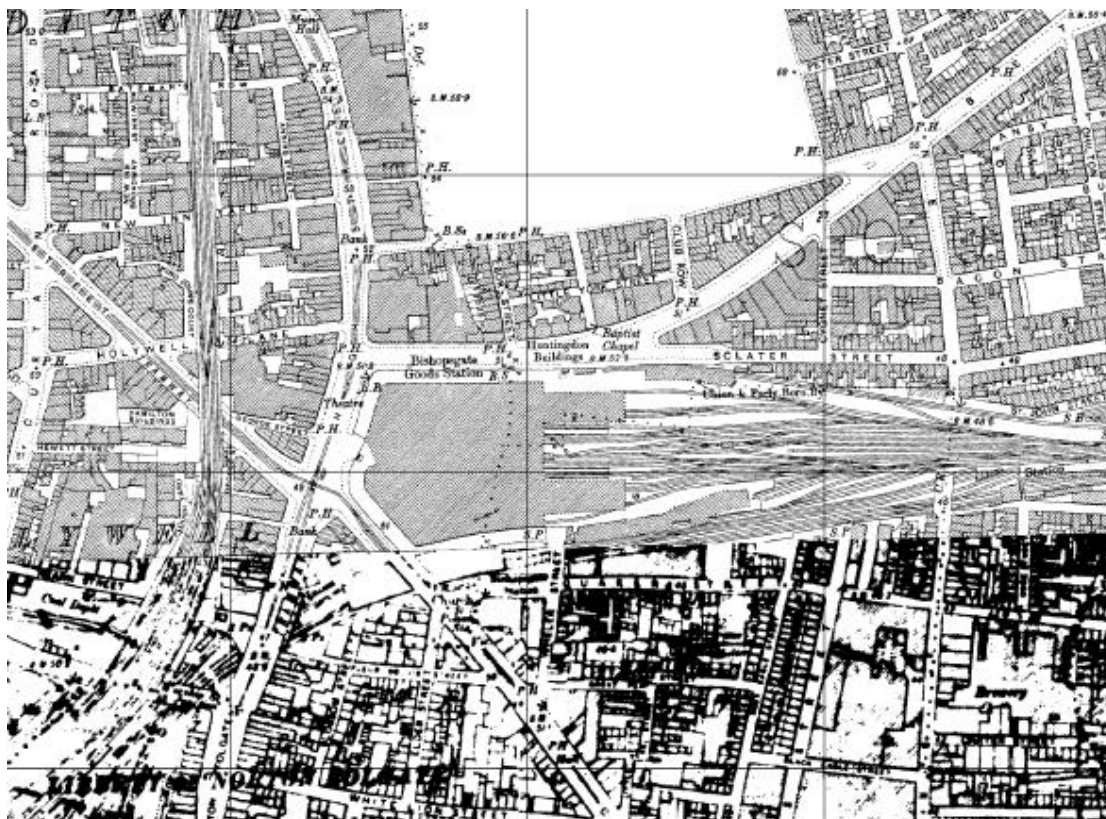
Figure 12: Extract from OS Map of 1896 showing the scale of the Goodsyards in its immediate context. The cleared area to the north shows the planned area of the

Boundary Estate following the demolition of the Old Nichol slum. Bethnal Green Road has also been laid out at this time using the western half of Sclater Street before turning to the north-east.

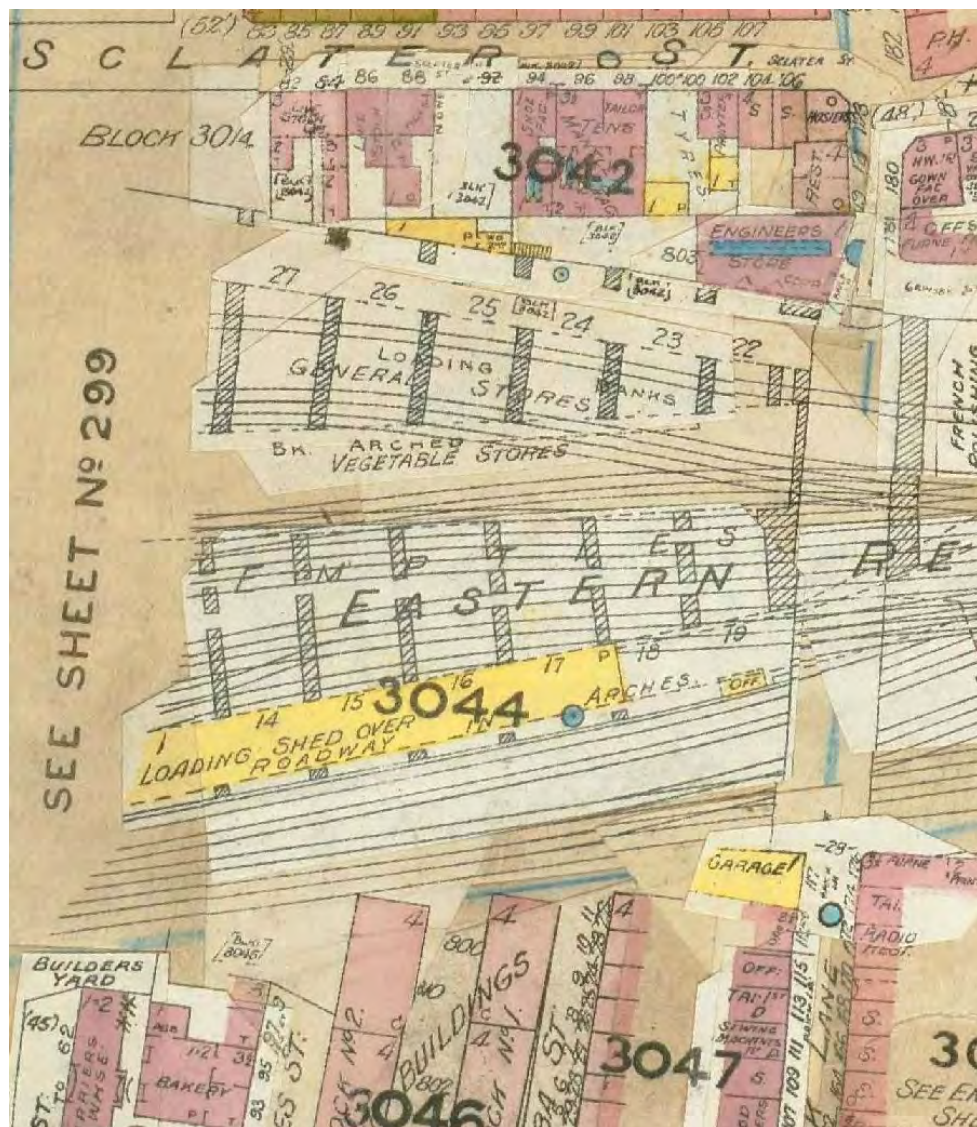
Figure 15c: The Goad Plan showing the far eastern end of the Goodsyard site in 1959.

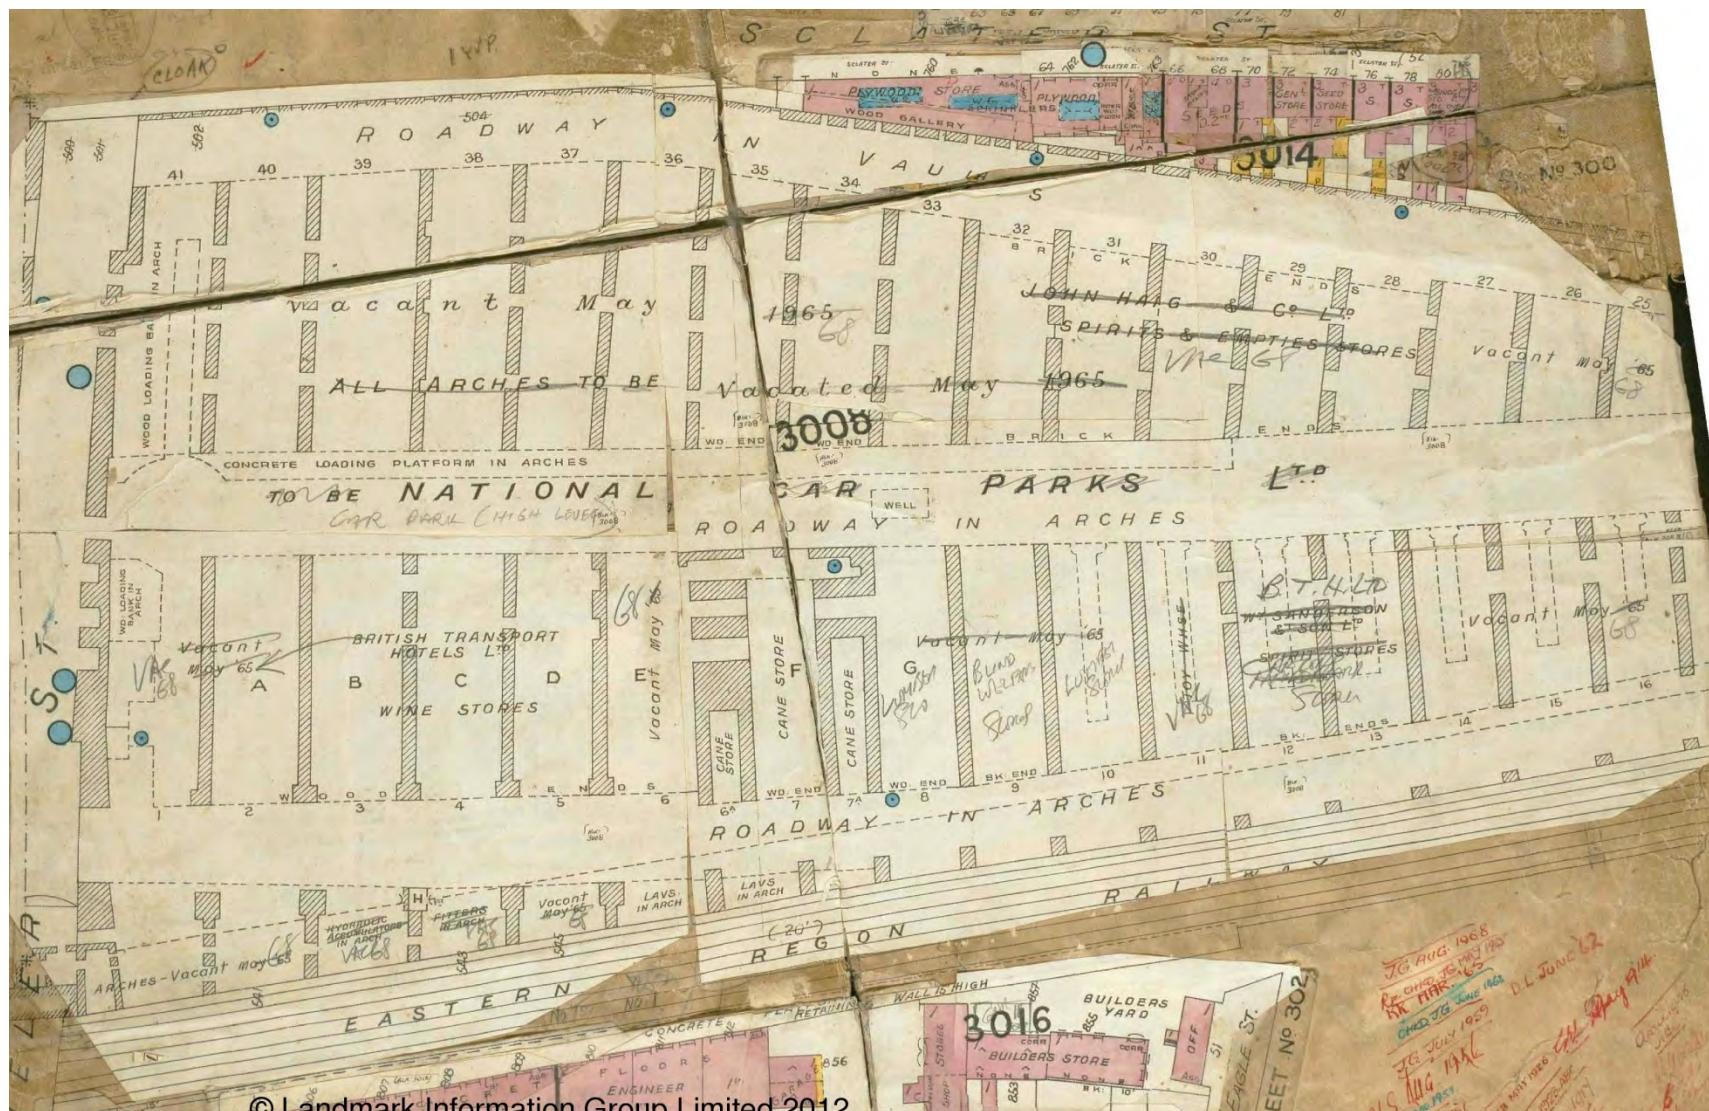
Figure 16b: Goad Plan showing the eastern end of the site in 1968.

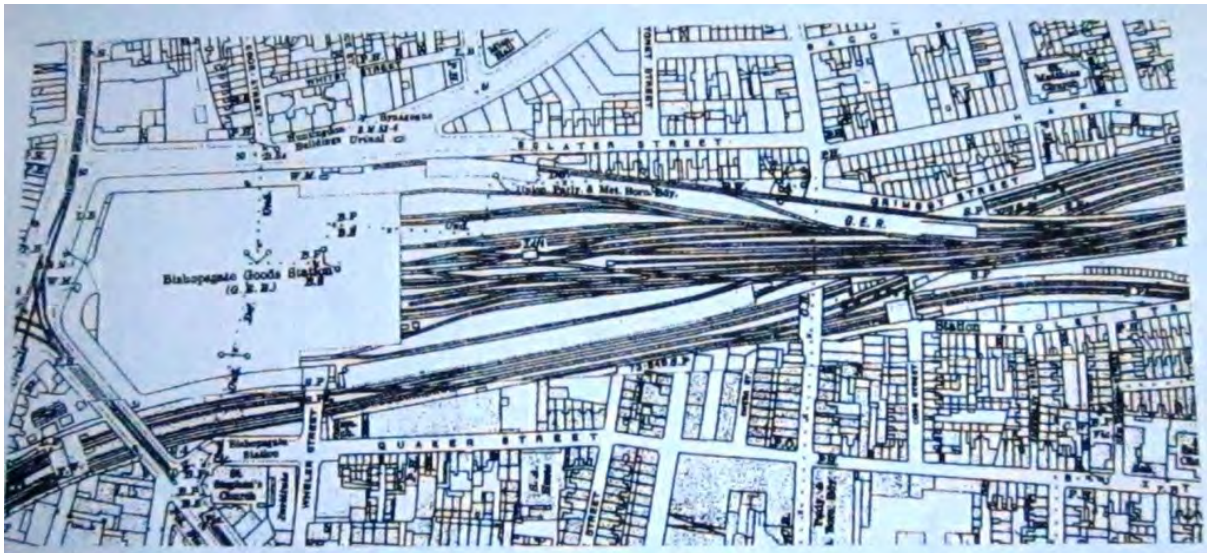
Figure 17: Extract from OS Map of 1914: The main changes since 1894 are the extension of the warehouse to the east and removal of the previously roofed-over areas; the lengthening of the Fruit Bank and the removal of the south side loading dock and ramp.

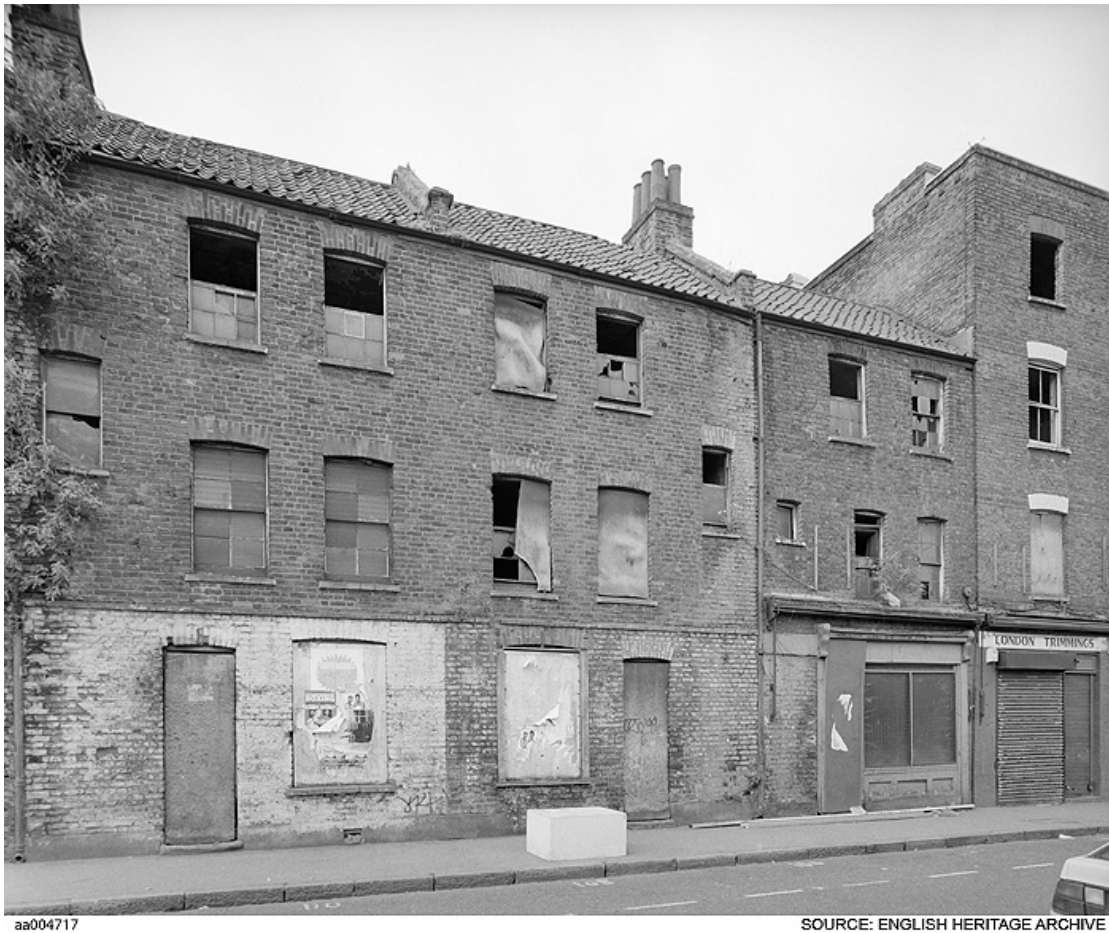
Figure 19: Nos. 74-70 Sclater Street (English Heritage Archives).

- 2.42 Nos. 70-74 Sclater Street have their origins as weavers' tenement houses and were built c.1719 (figure 13). From 1718 to 1721 William Farmer and other builders were taking 61-year leases (usually in lots for two houses) from Thomas Sclater alias Bacon and building small square plan houses on 17 ft or 17ft 6ins wide sites with a depth of 60ft.³² Insurance policies were taken out in September 1719 by Richard Hatt a weaver, for brick houses that have been identified as nos. 72 and 74 Sclater Street. These specify two 17ft 6in by 18ft houses with 15ft by 9ft back buildings, made of timber.³³ Their ground plans have been recreated by English Heritage in figure 14 and a section through no. 72 recreated in figure 15.

window above the original site of the front door (figures 13 and 16). The one room plan main blocks all have their staircases to the front beside the chimneystacks. There are six flues to each stack, suggesting three fireplaces to each house and unheated cellars (figure 15). The long back buildings reflect the original arrangements but these have also been rebuilt. The back buildings were often used as dye houses or as carpenters' yards. The properties have been rearranged internally over the years. It seems quite probable that when first built in 1719, they had single broad first-floor windows and long north-facing top floor mullion casements, like the houses that used to stand elsewhere in Sclater Street (figure 16). Thus, although nos. 72-74 are much rebuilt, they retain the essential form of earlier buildings associated with silk weaving.

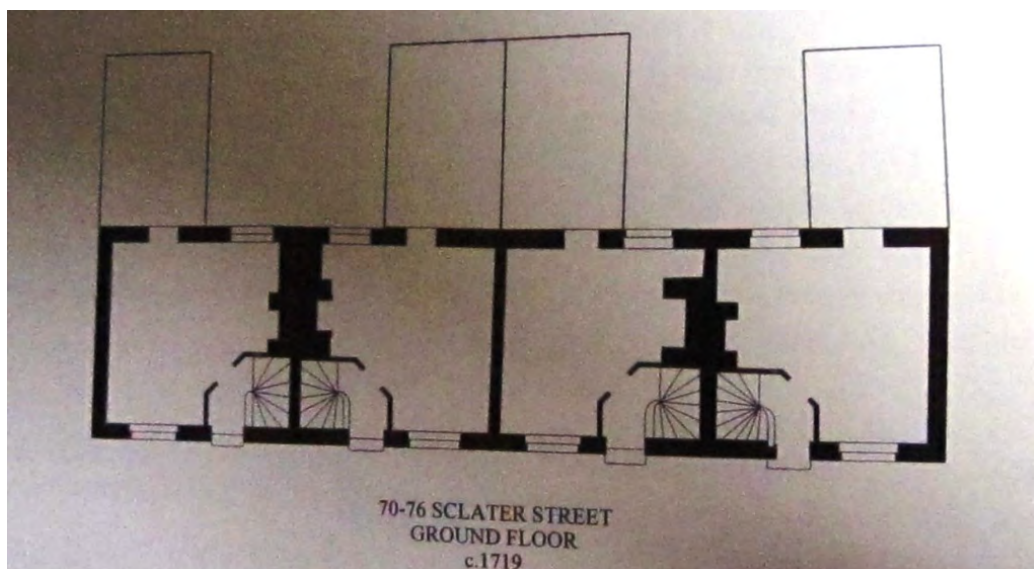
Figure 20: Nos. 70-76 Sclater Street: recreations of ground floor plans [Peter Guillery, *The Small House in Eighteenth Century London*, (2009), p. 98].

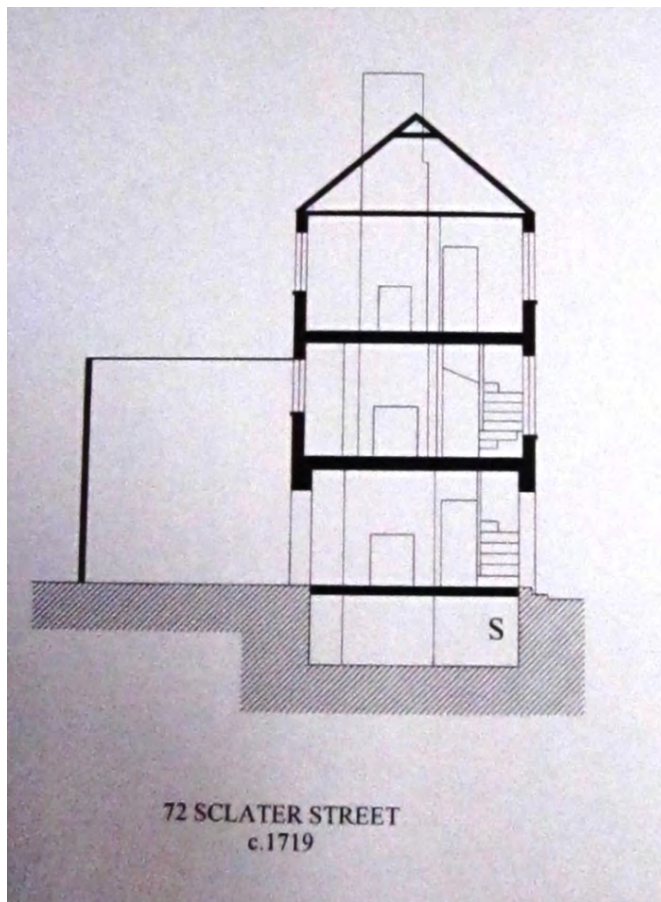
Figure 21: A section through no. 72 Sclater Street from surviving building fabric and documentary evidence [Peter Guillery, *The Small House in Eighteenth Century London*, (2009), p. 98].

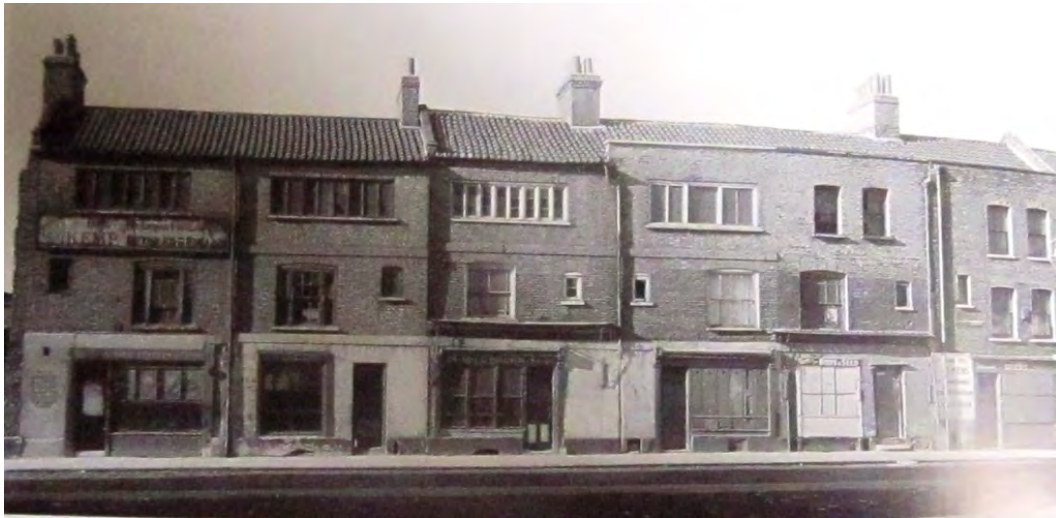
Figure 22: Nos. 78-88 Sclater Street c.1955 before their demolition showing full width weavers' windows on the top floor. Similar ones may have originally been at nos. 70-74 Sclater Street.

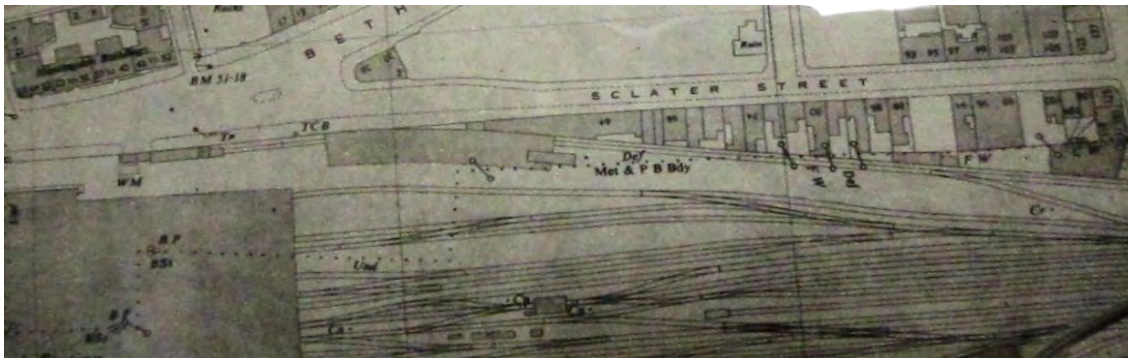
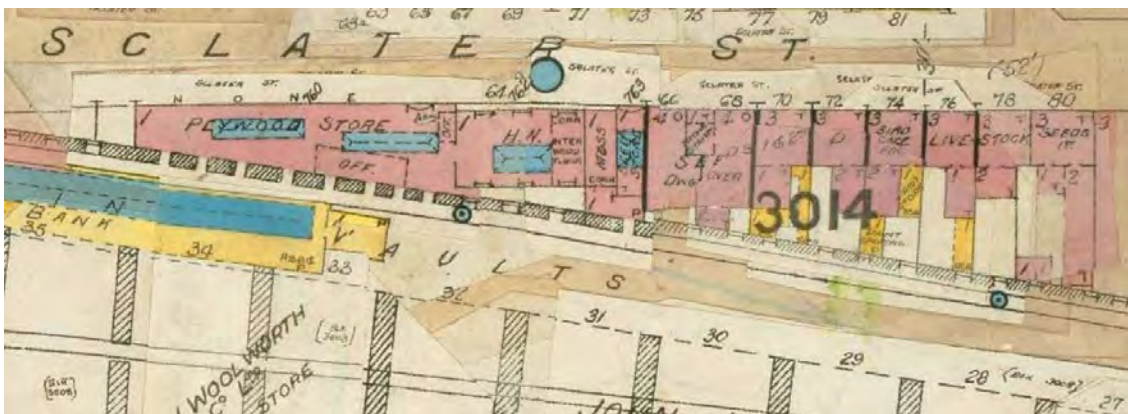
Figure 24: The 1938 OS map showing the conversion of the chapel building and a Goad plan extract of 1958 when the former mission church was converted to a plywood store.

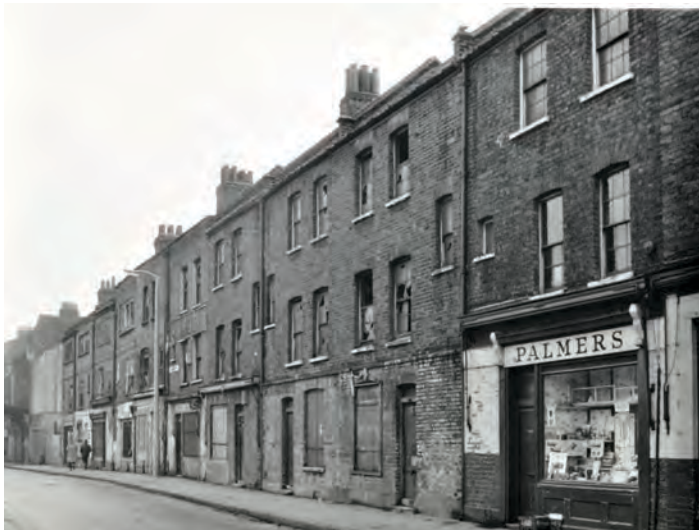
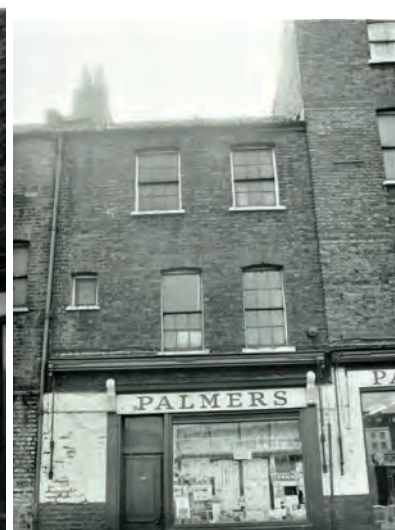
Figures 29-30: Nos. 70-84 Sclater Street (before some houses were demolished) and No. 70 Sclater Street [© Guildhall Library]
