Drawing status:			PLANNING					Job No:		3465		Drawing No:		BGY-FBA-07-XX-DR-A-00_10-7C04		Rev:		P1	
			FOR LISTED BUILDING CONSENT																
Job Title:			The Goodyard										© Drawing & Design Copyright of:

Drawing Title:			PLOT 7C - EXISTING SECTIONS SHEET 4										<div>FAULKNERBROWNS ARCHITECTS</div> <div></div> <div>FaulknerBrowns LLP Oldson House Northumbrian Way Killingworth Newcastle upon Tyne NE12 5DW T +44 (0) 191 2683007 F +44 (0) 191 2478132</div>						
Date:		April 19		Scale:		1:50@A1		Drawn By:		JK		Checked By:							TL

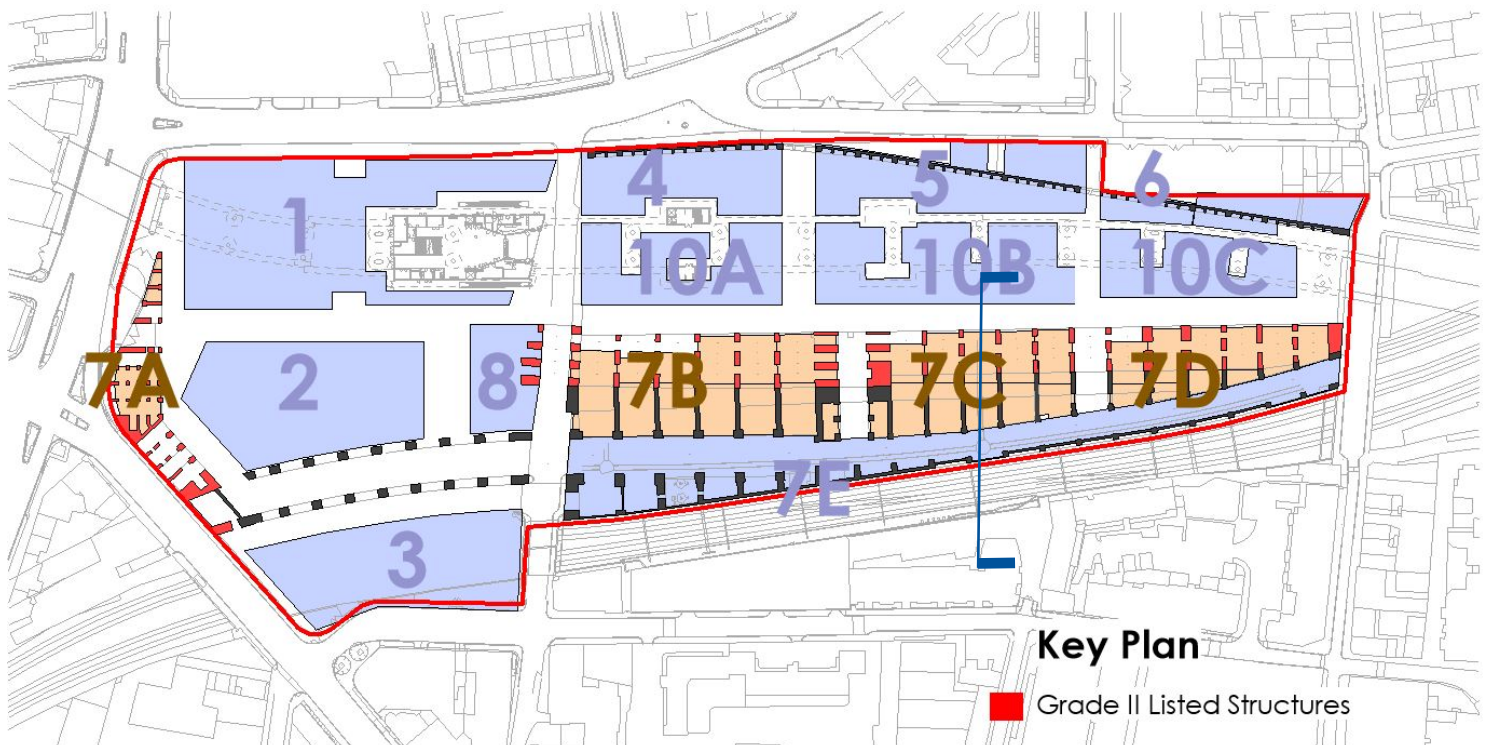
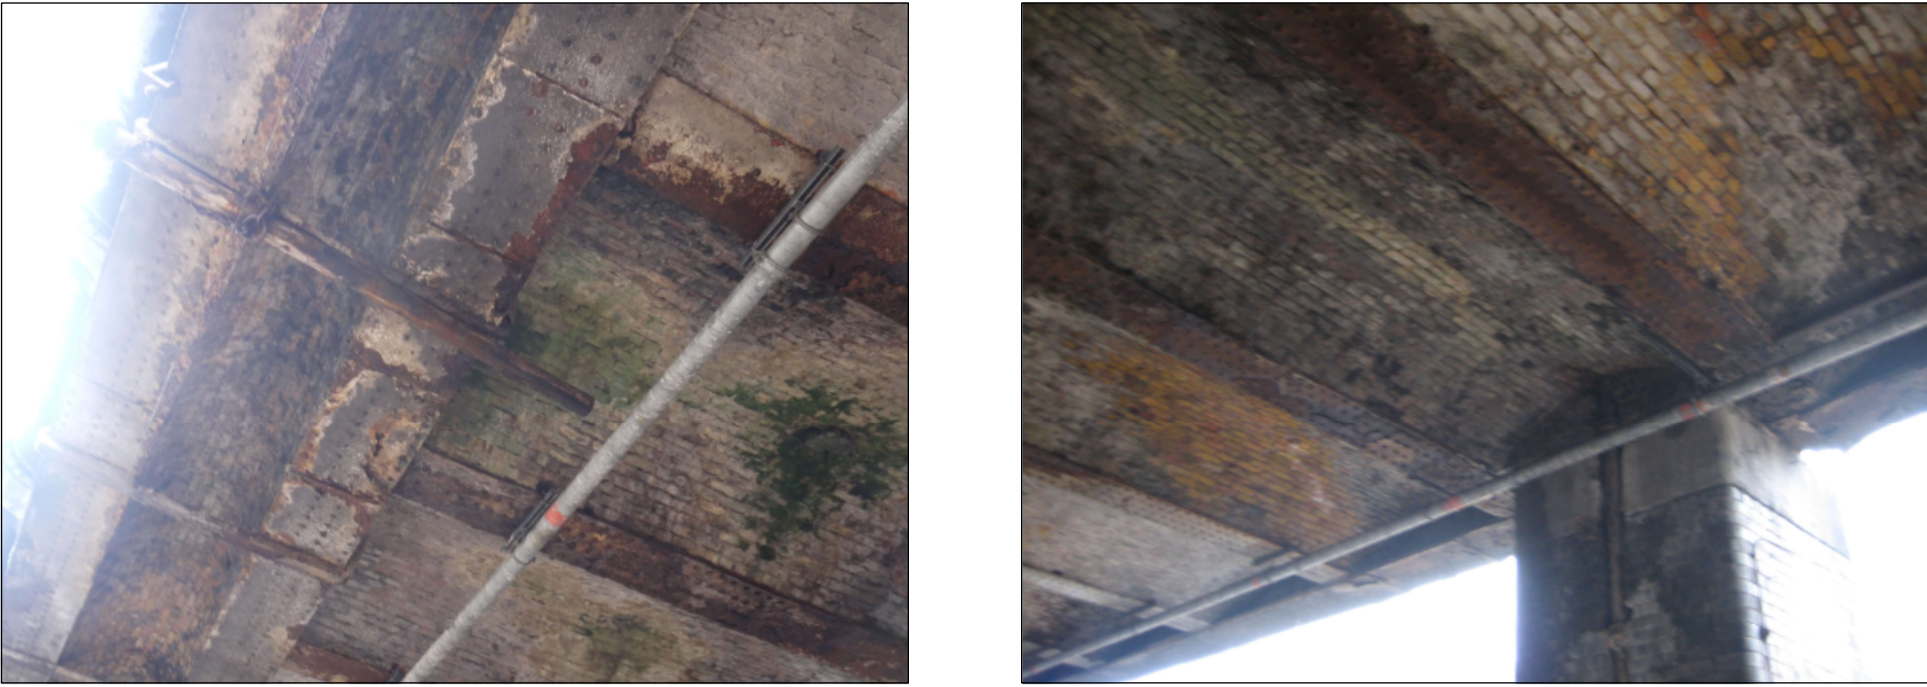
EXAMPLES OF DEGRADATION OF JACK ARCH BEAMS DUE TO WATER INGRESS FROM PARK LEVEL ABOVE - Please see Structural engineers report for description of required remedial works.
