**GREAT NORTH LEISURE PARK,
LEISURE WAY, NORTH FINCHLEY**
Stage 1 Road Safety Audit

J190736

Stage 1 Road Safety Audit

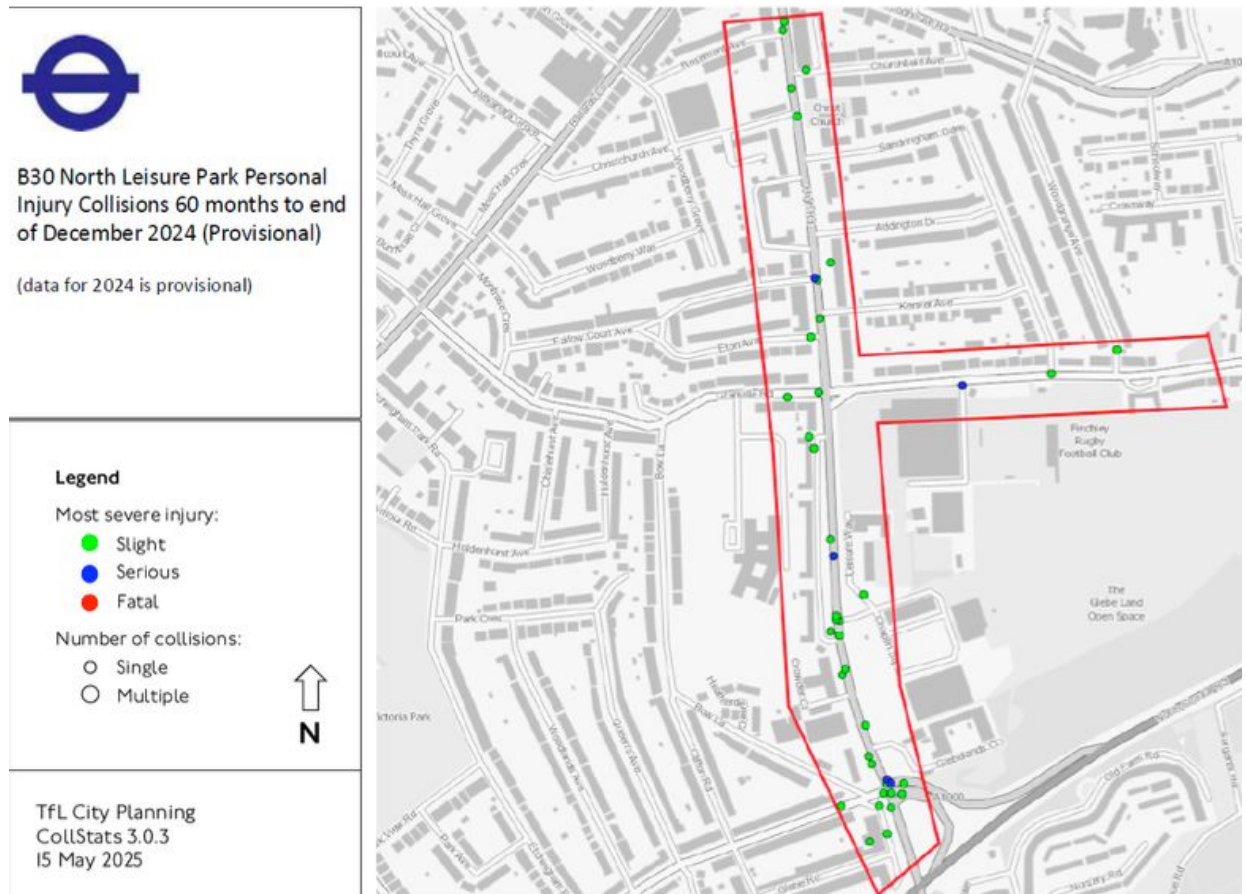
1.4.1 Leisure Way is a single carriageway road and has an initial width of c.8.9 metres. It serves the retail park and operates a 15mph speed limit. Footways are provided on both sides of the carriageway. The horizontal alignment of Leisure Way is generally straight, whilst the vertical alignment gently inclines in the eastbound direction.

1.4.2 The A1000 High Road is a single carriageway road (two lanes in each direction) and subject to a 30mph speed limit. It has a width of 13.5 metres, including cycles lanes on both sides. Footways and street lighting are present on both sides of High Road. Parking restrictions in the form of double yellow line markings are present on both sides. The A1000 High Road forms part of a two-way bus route. The horizontal alignment of High Road has a gentle right-hand bend in the northbound direction. The vertical alignment gently inclines in the northbound direction.

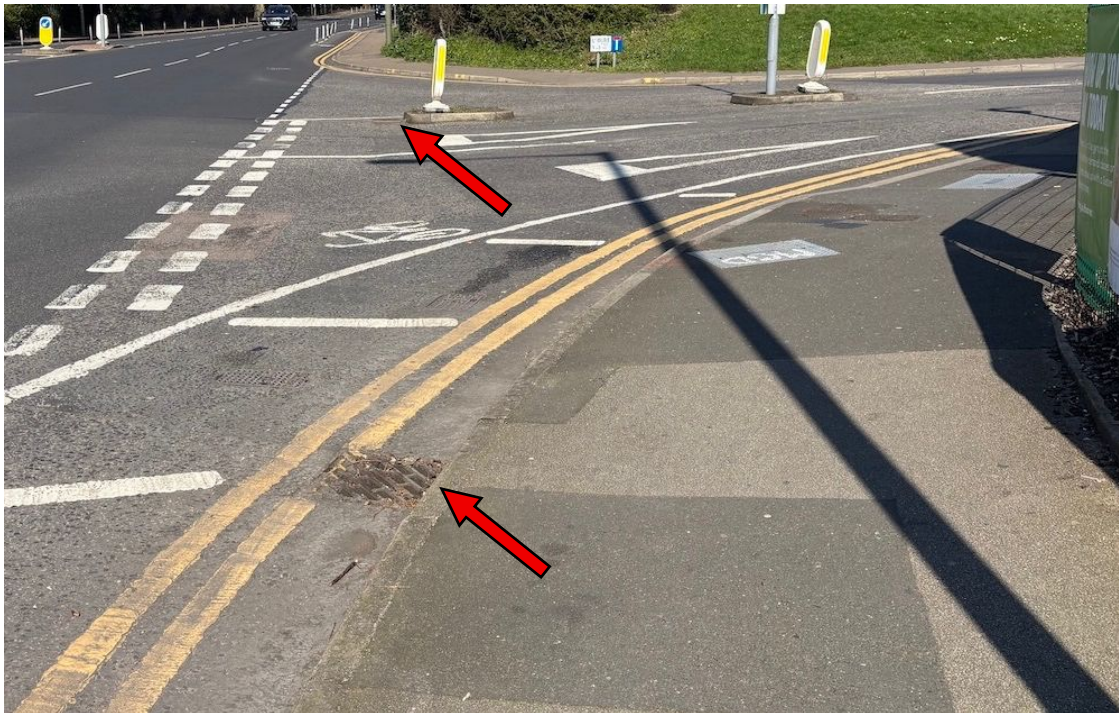
Problem 1	
Location	Pedestrian refuge
Summary	Risk of pedestrian falls/trips

<p>It is proposed to relocate and widen the pedestrian refuge at the site access. There are existing gullies at the junction which appear to be positioned on the desire line for the new refuge. This may result in pedestrians tripping at the gullies and falling in the carriageway.</p>	
Recommendation	Relocate gullies or provide pedestrian-friendly grates.

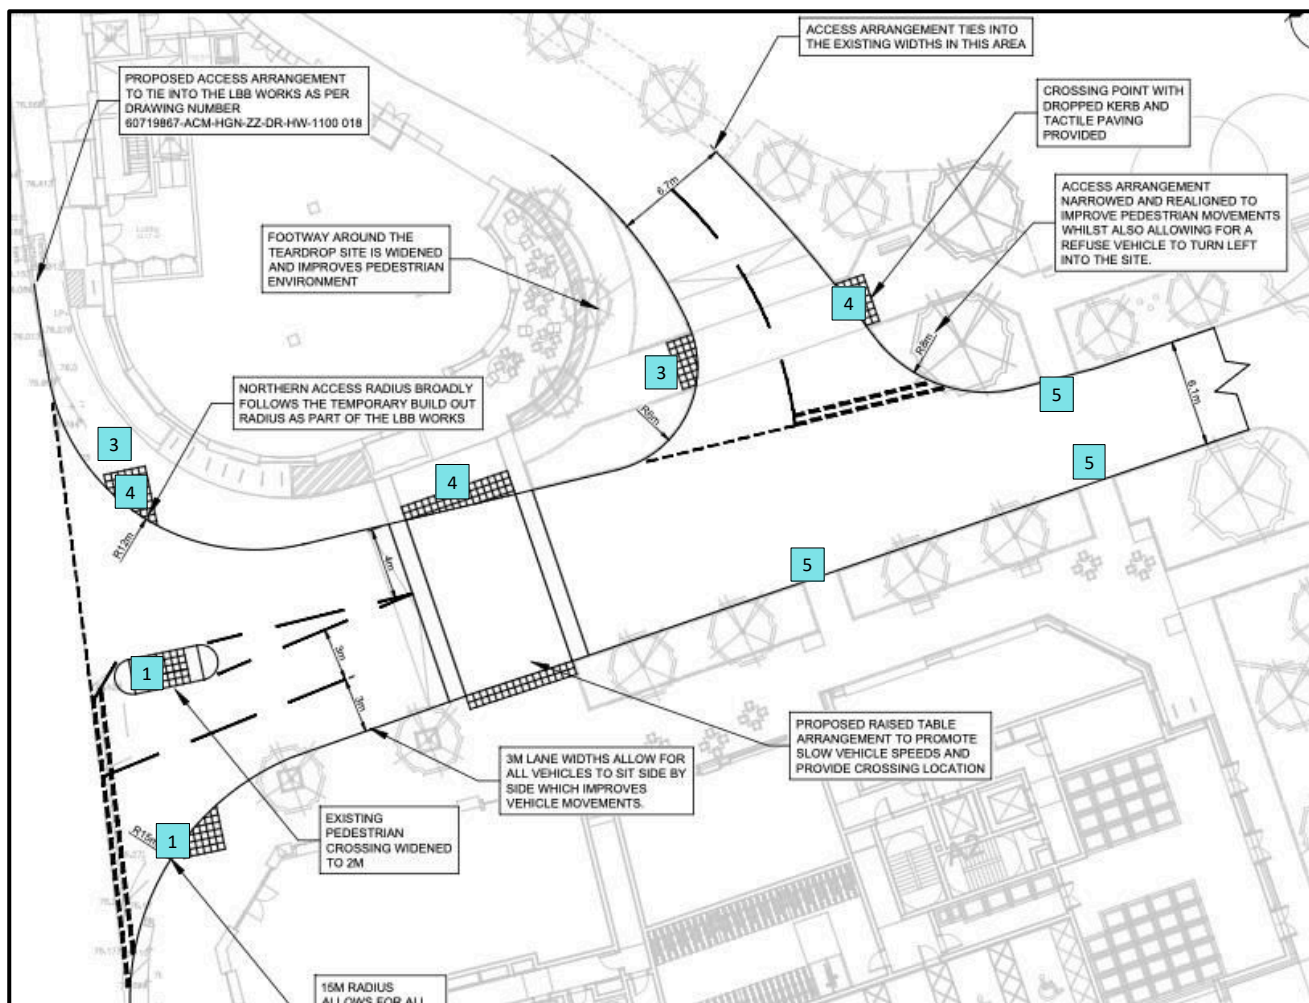
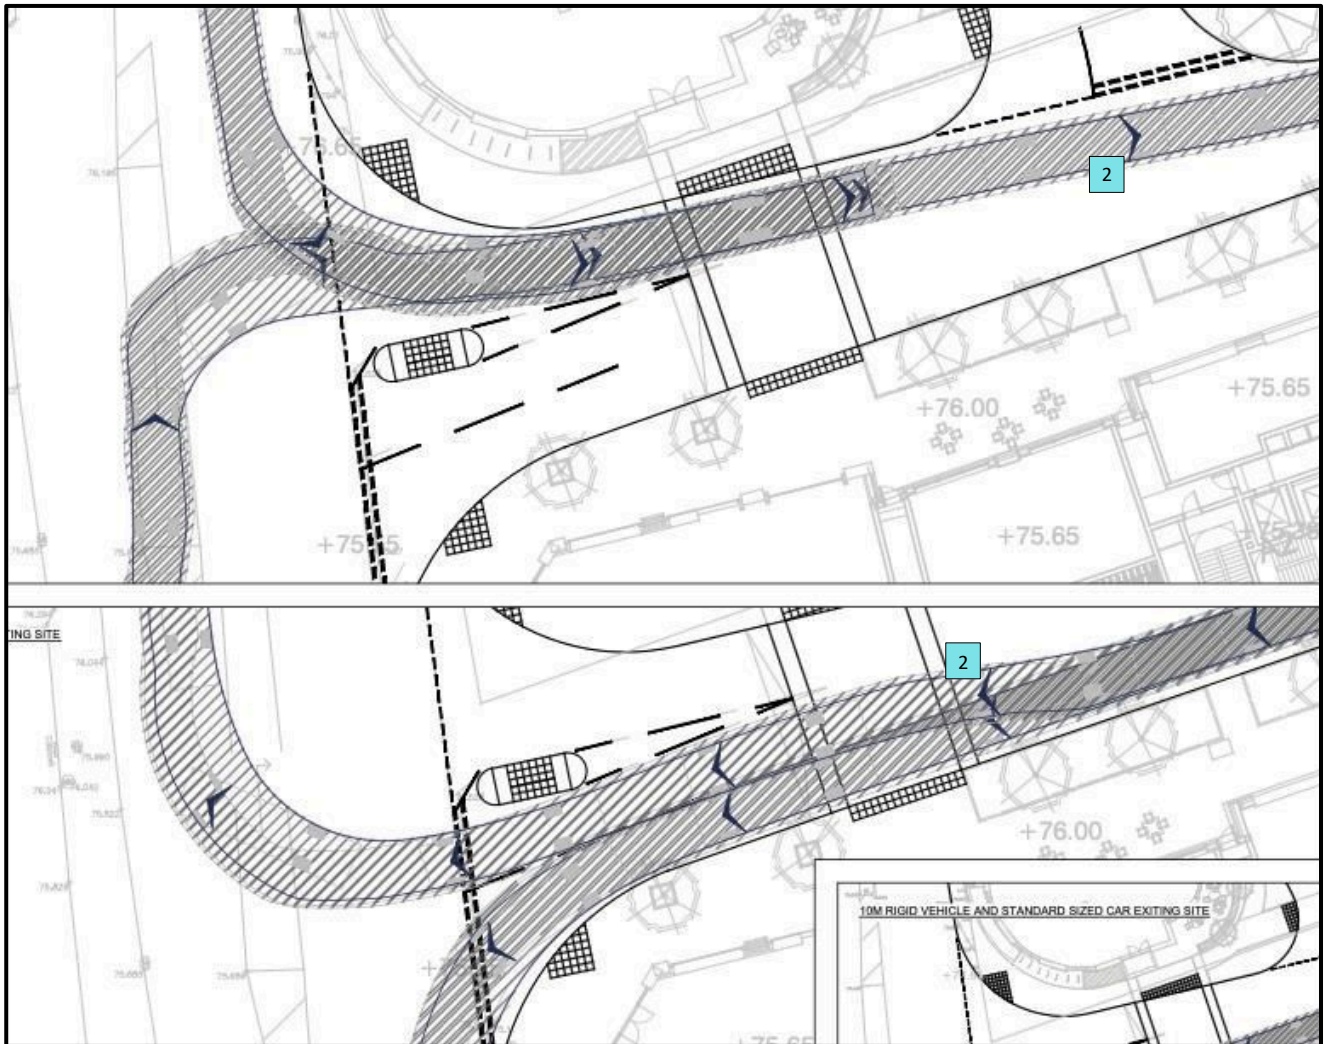
Appendix C Problem Location Plan

- 1.8.4 The submitted design drawings have been annotated to show the location of problems identified during this Stage 1 Road Safety Audit, which are shown at **Appendix C**.
