**GREAT NORTH LEISURE PARK,
SUMMERS LANE, NORTH
FINCHLEY**
Stage 1 Road Safety Audit

J190736A

Stage 1 Road Safety Audit
J190736A

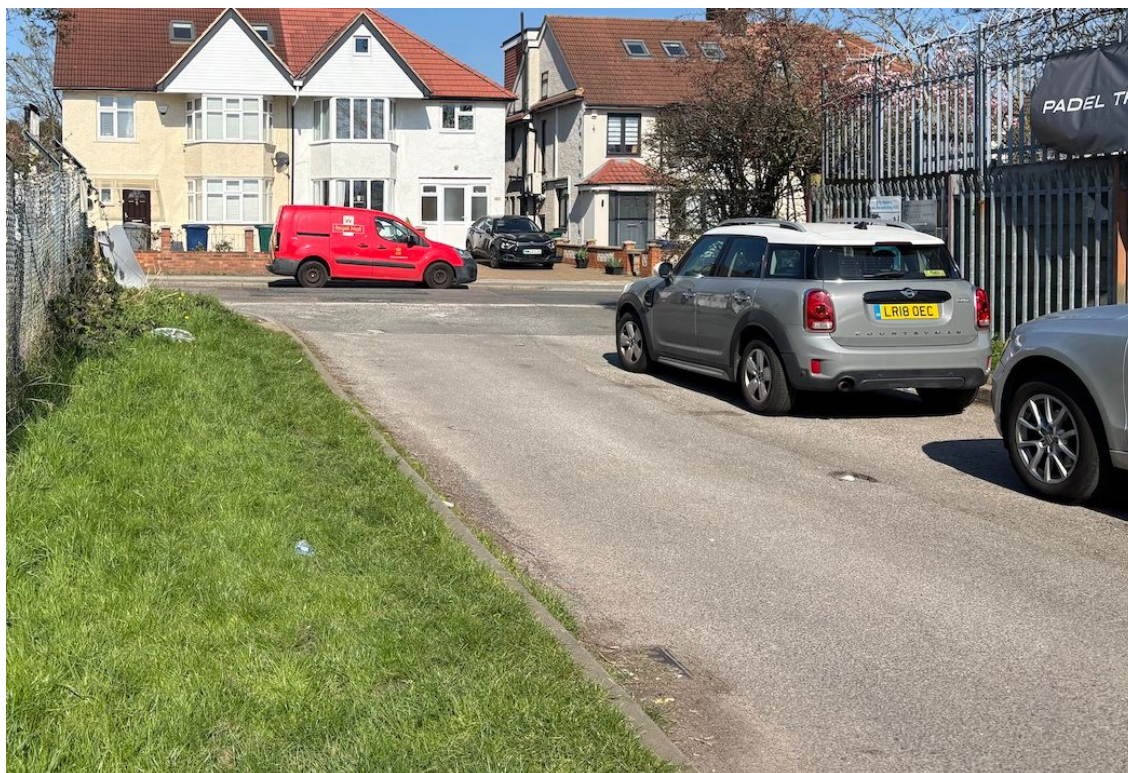
Problem 2

Location	Eastern side of access road
Summary	Risk of collisions with parked vehicles

Parked vehicles will obstruct visibility for pedestrians using the new crossing from the eastern side. This may cause pedestrians to cross the access road when an approaching vehicle has not been detected. This may result in vehicles colliding with pedestrians entering the crossing.

Recommendation	Ensure pedestrian intervisibility is achieved at the crossing facility.
-----------------------	---

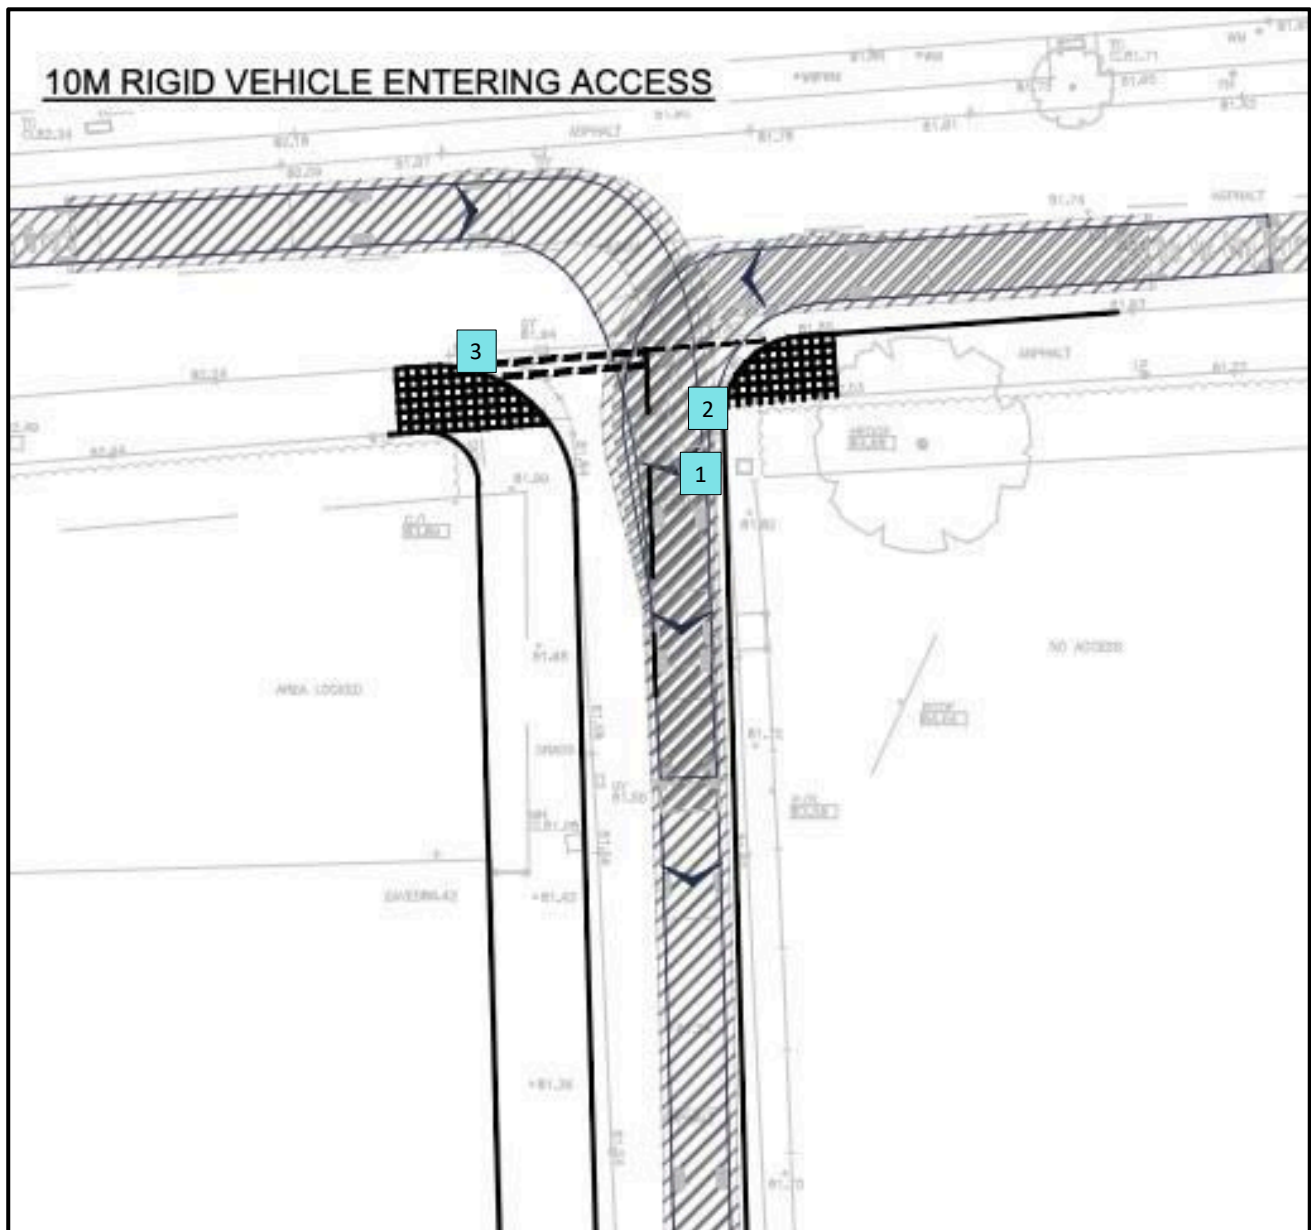
Appendix C Problem Location Plan

Problem 1	
Location	Eastern side of access road
Summary	Risk of collisions with parked vehicles
  <p>The swept path analysis indicates that a delivery vehicle will require a significant width of the amended access road in order to turn into the site from Summers Lane. It was observed that vehicles park along the length of the eastern side of the access road. There are no proposals for parking restrictions on the site access. This may cause an obstruction to the passage of vehicles entering and exiting the site. This may result in side-swipe collisions with parked vehicles.</p>	
Recommendation	Ensure that all vehicles can safely enter and exit the site.

Tactile paving is proposed for the new pedestrian crossing over the site access. Tactile paving is shown to be provided for the full width of the footway on the southern side of Summers Lane. This may cause confusion for visually impaired pedestrians (VIPs) who are exiting the site (northbound) and detect the tactile paving. This may cause VIPs to believe that there is a crossing facility over Summers Lane. This may result in VIPs continuing northbound and falling in the carriageway when encountering full-height kerbs.

Recommendation	Provide a separation between the tactile paving and the carriageway.
-----------------------	--
