**APPENDIX C**  
**GROUND CONDITIONS**

**Manor Road, Richmond**

**Ground Investigation Report**

**July 2021**

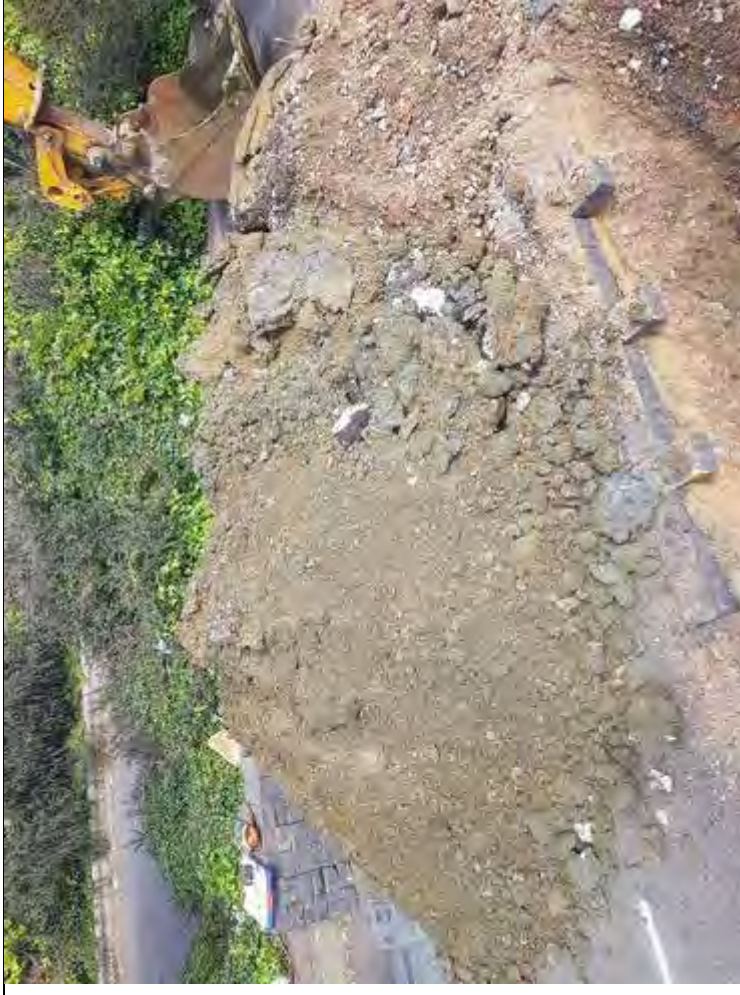
Plate 1: TP01 Arisings

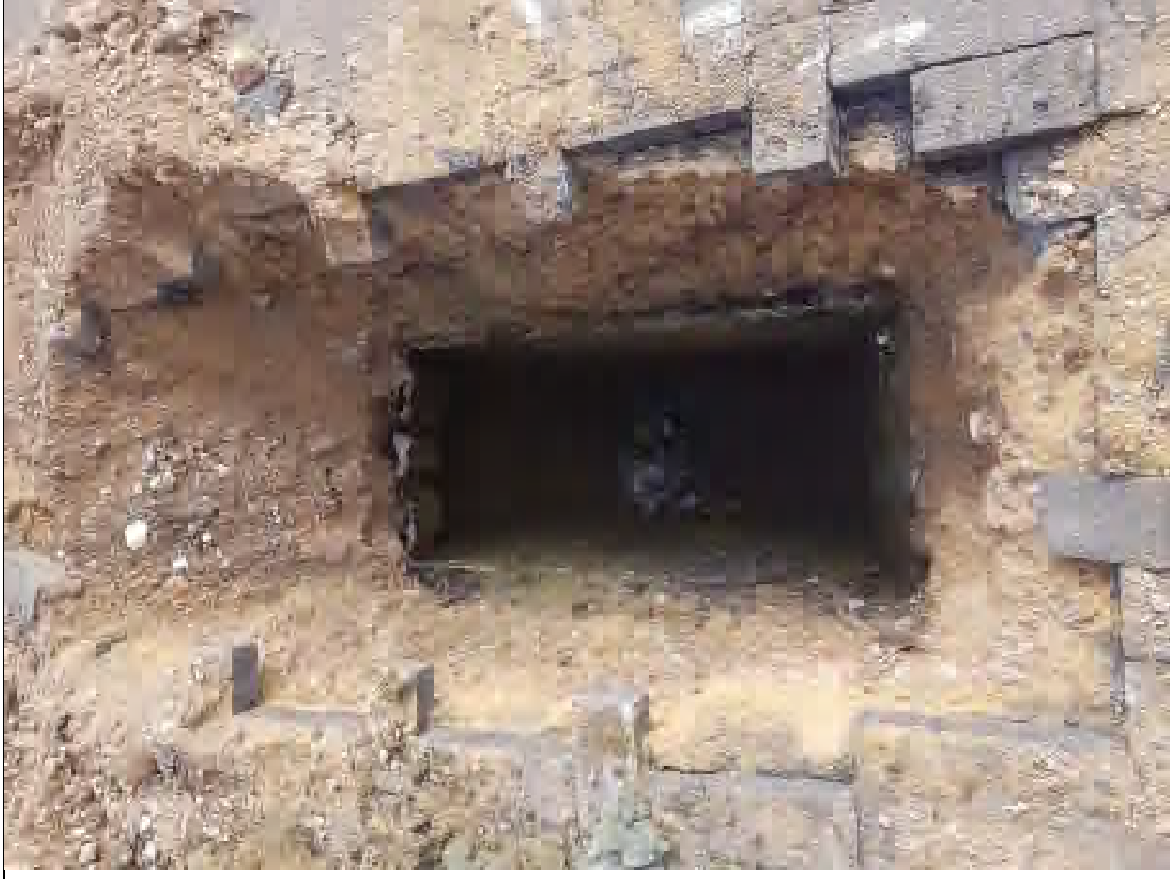
Plate 2: TP01 excavation.

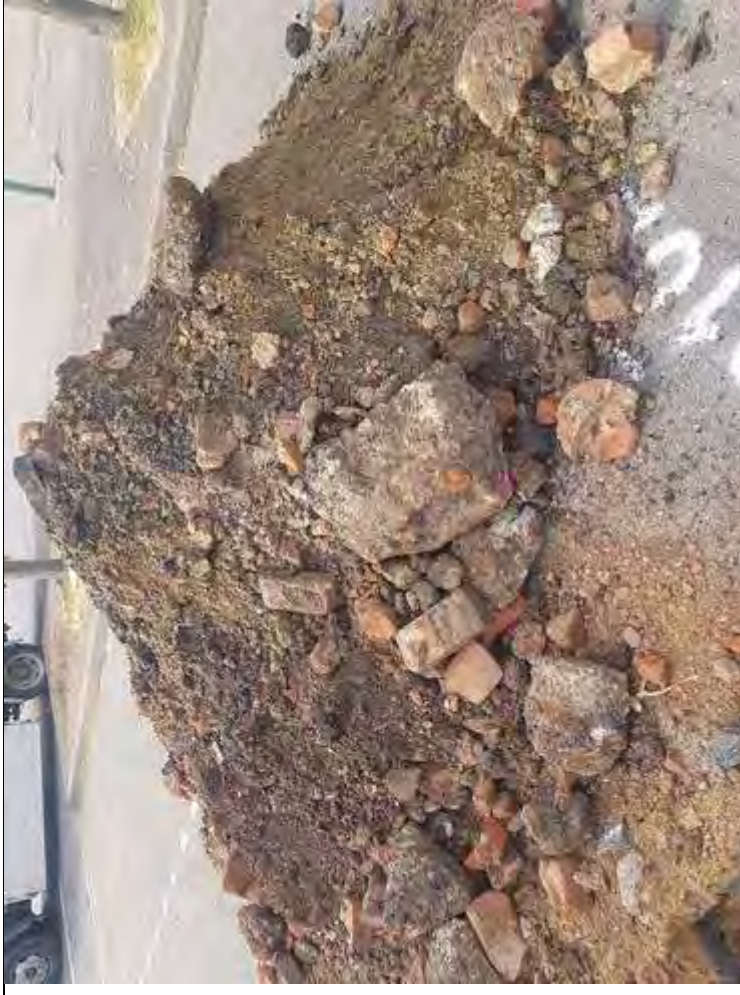
Plate 3: TP02 excavation

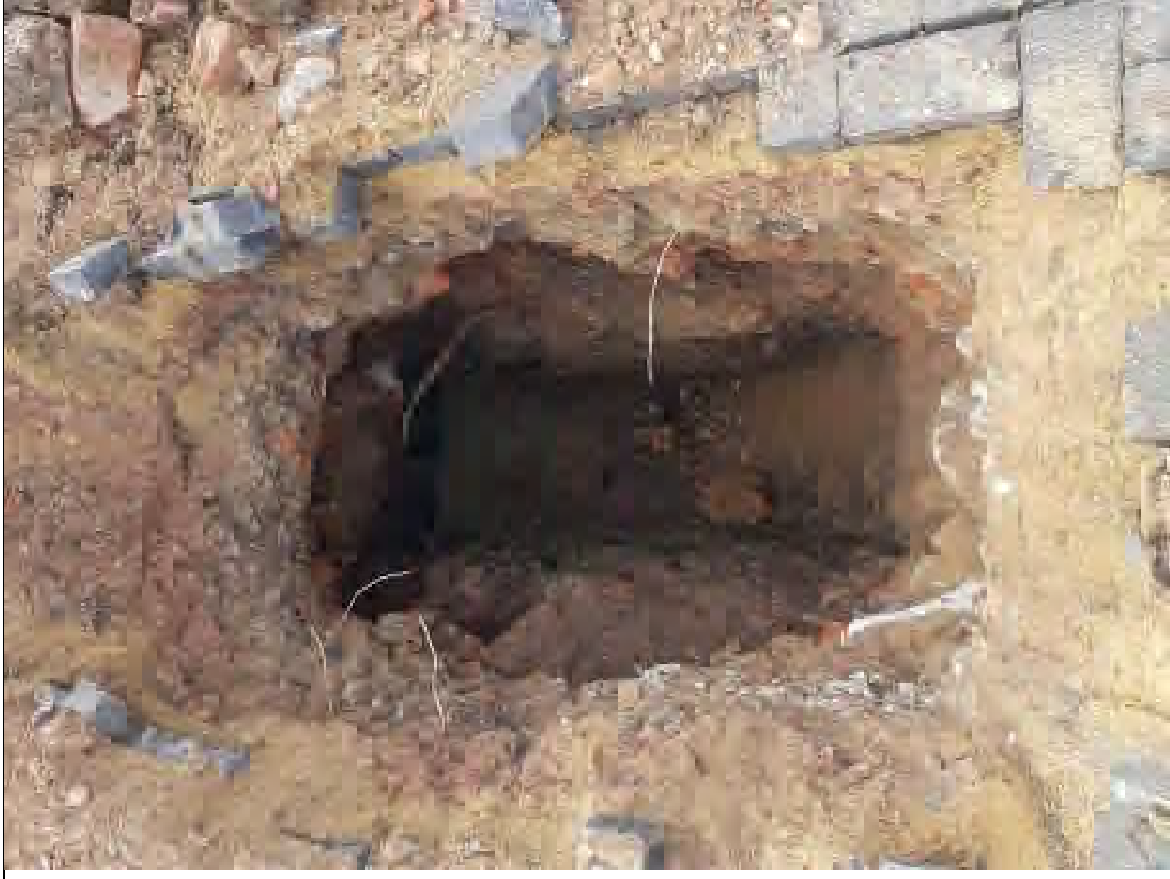
Plate 4: TP02 arisings

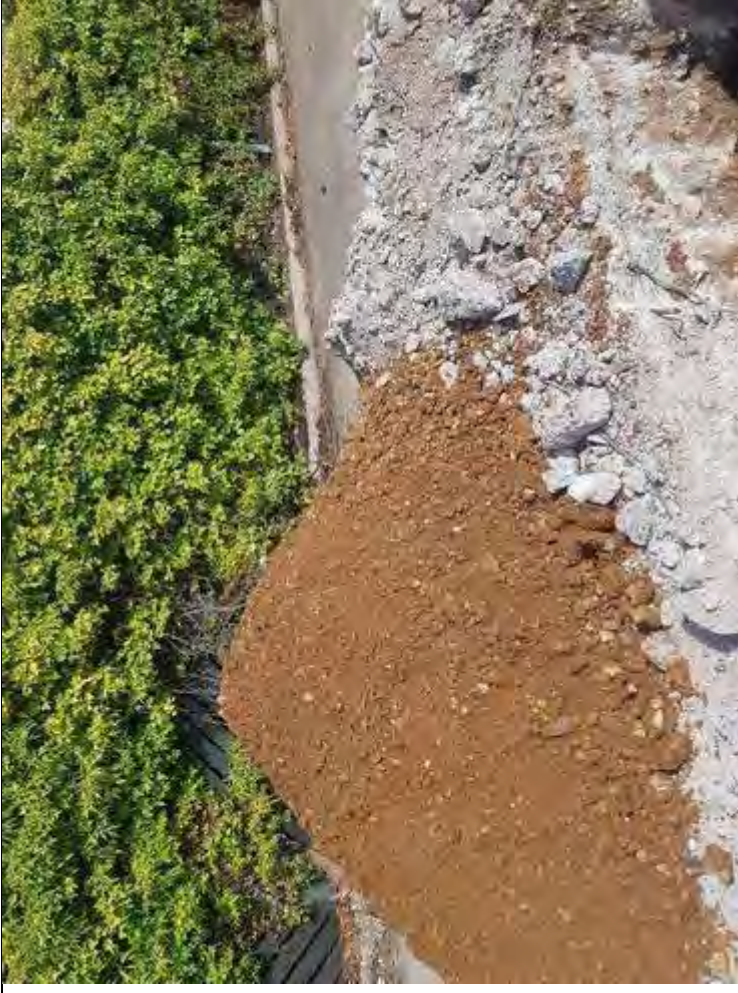
Plate 5: TP03 excavation

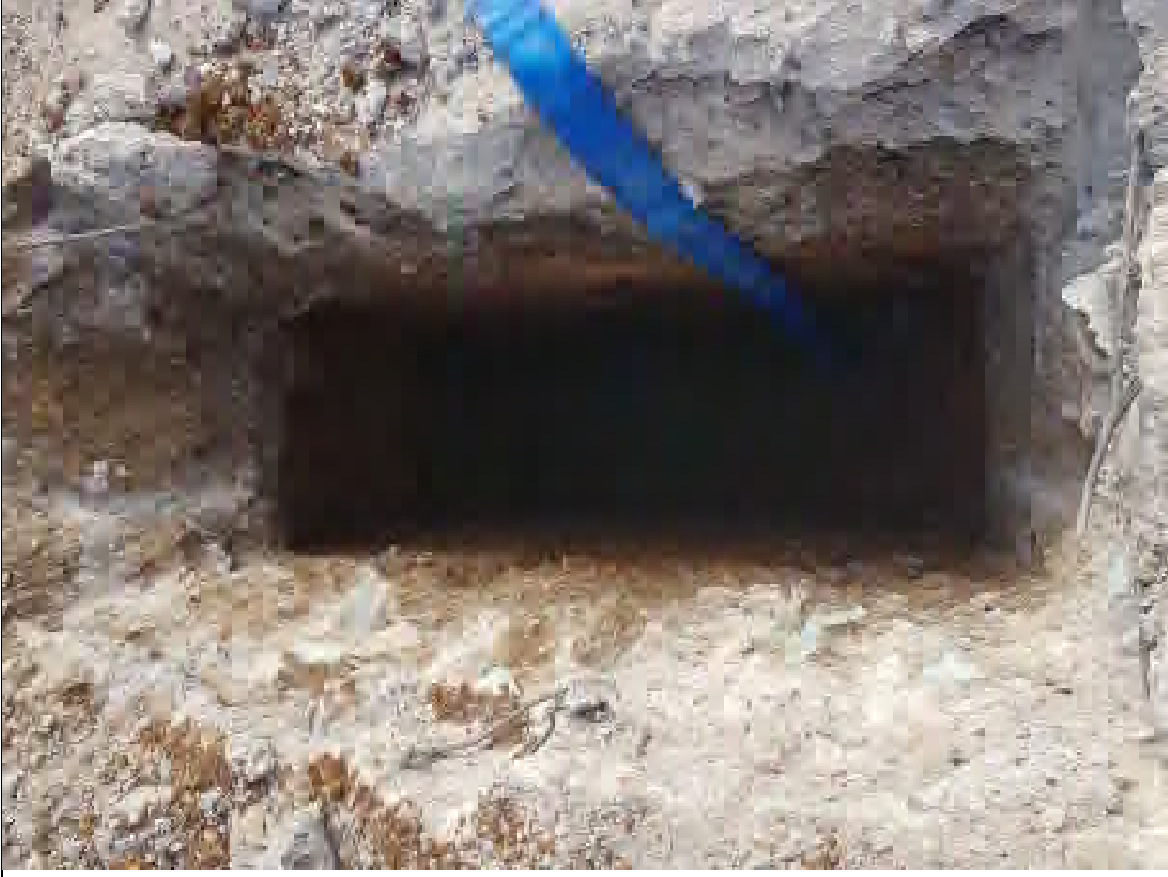
Plate 6: TP03 arisings
