VICTORIAN BUILDING Demolitions

VICTORIAN BUILDING Proposed plans

THE MISSION HALL Existing Condition

STATION WALL Existing Condition

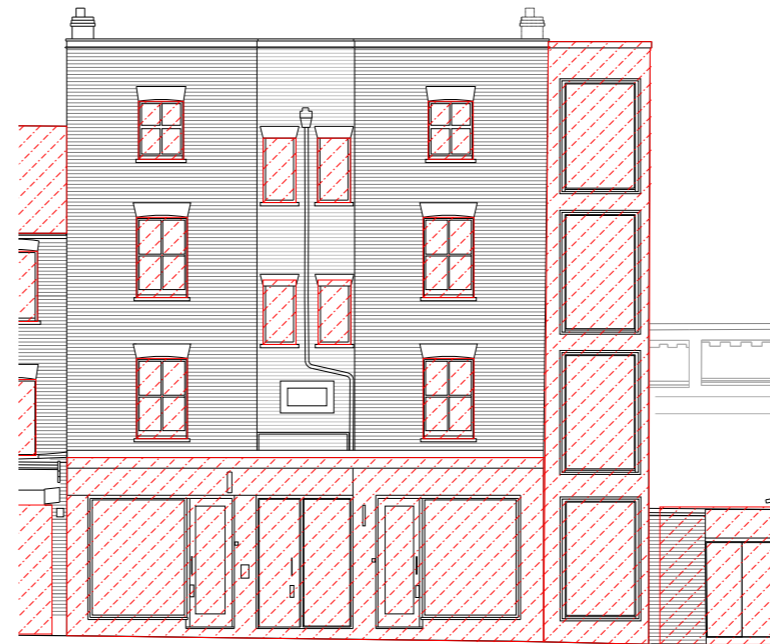
Victorian Building. Front

We proposed to retain this building, its roof and its Victorian facade above ground floor.

Modern extensions to the West and rear, and the modern rear facade to be demolished. The modern shopfronts at ground floor level will be replaced.

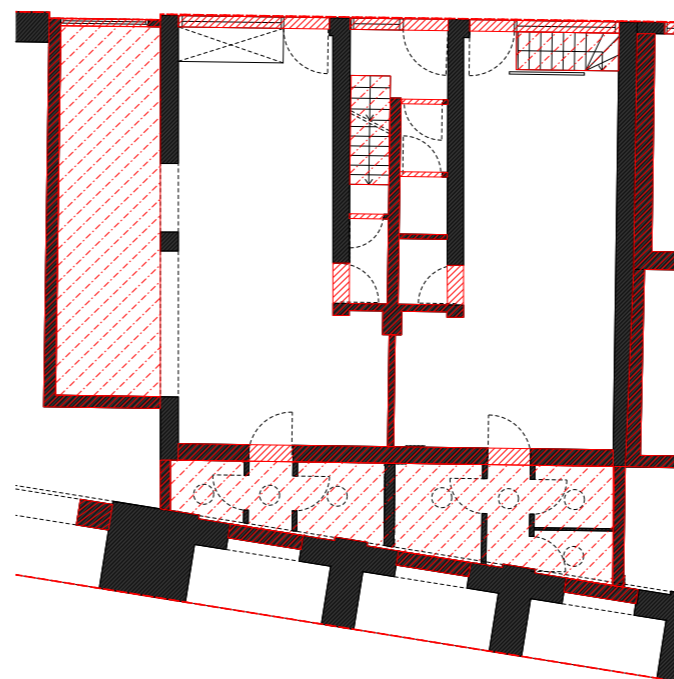
Victorian Building - Ground floor plan

This will reveal the key surviving parts of this building, so that it can be sensitively restored.

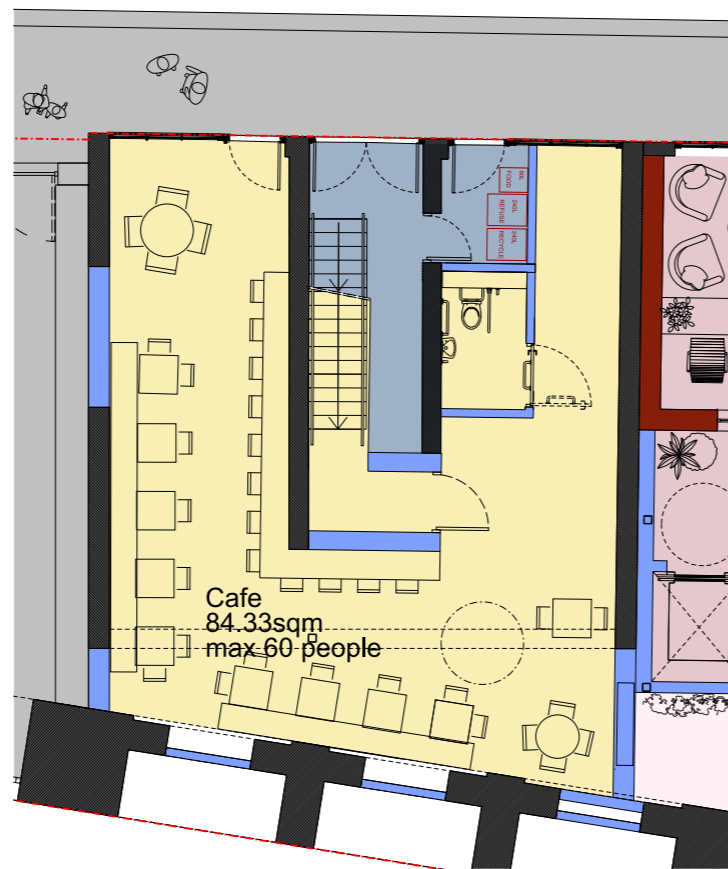
Victorian Building - Ground floor plan

The ground floor and basement will become a commercial unit. The existing single storey rear extension will be replaced to provide a rooflight to get daylight into the back of the unit. The enclosed area of station wall will be cleaned and repointed as necessary.

The existing stair location will be retained as it is original to the building, with a modern stair inserted.

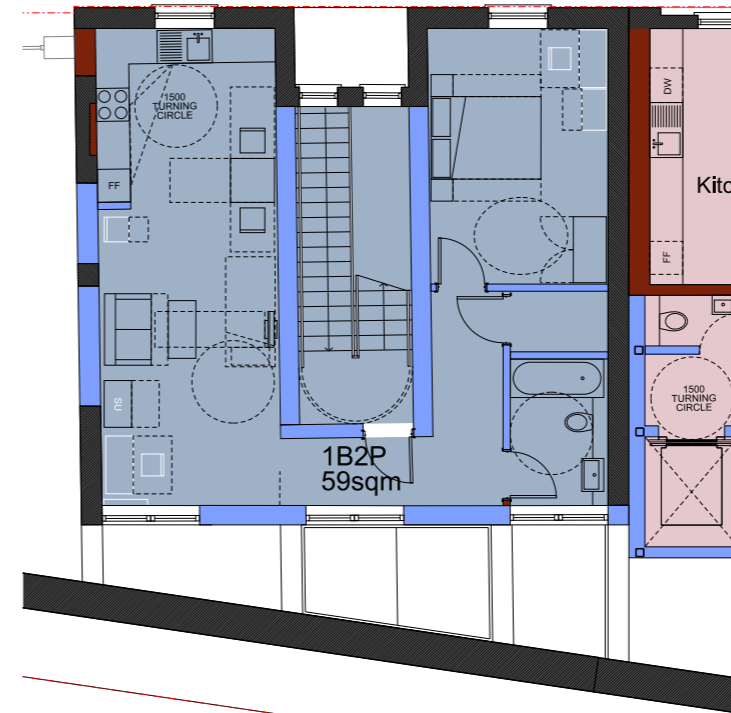
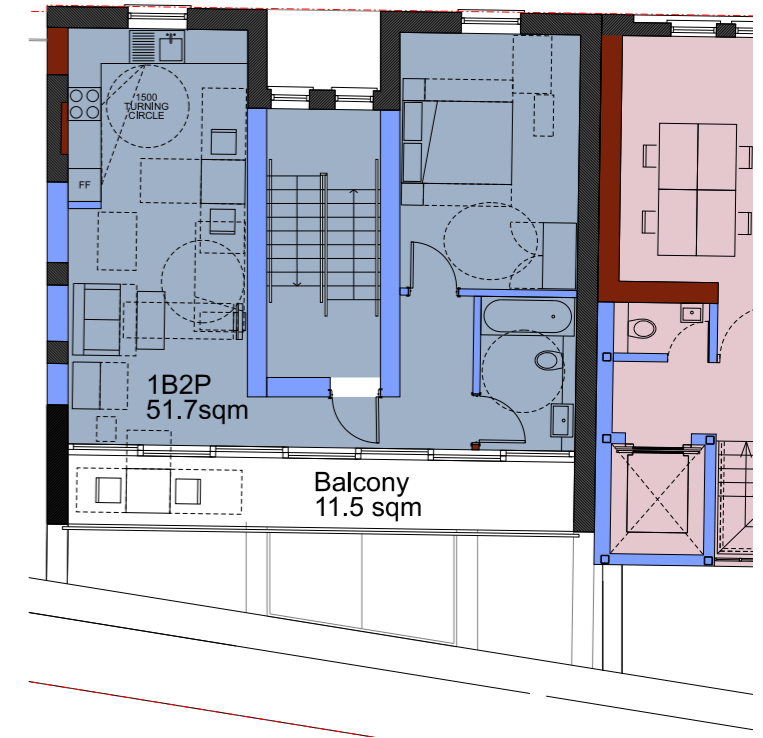
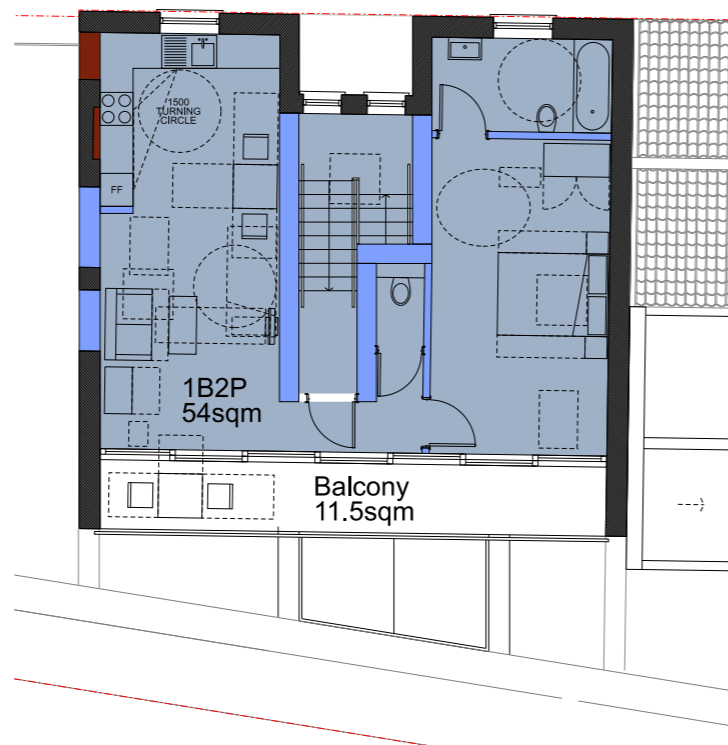
The building will be reconfigured internally to provide three one bed residential units, one per floor. Each unit will be dual aspect, with the second and third floor apartments having south facing rear terraces.

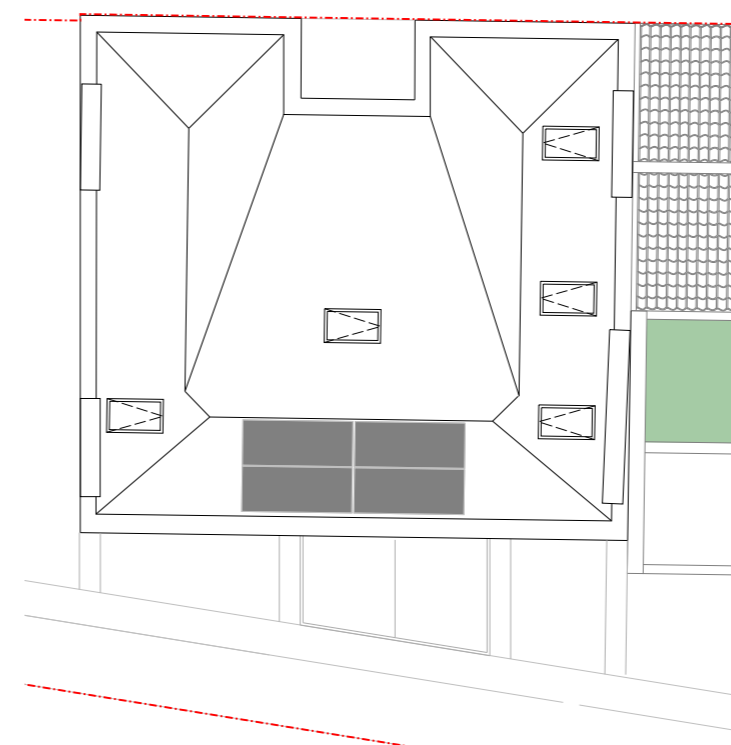
Victorian Building - Roof plan

There will be new photovoltaic panels on the roof.

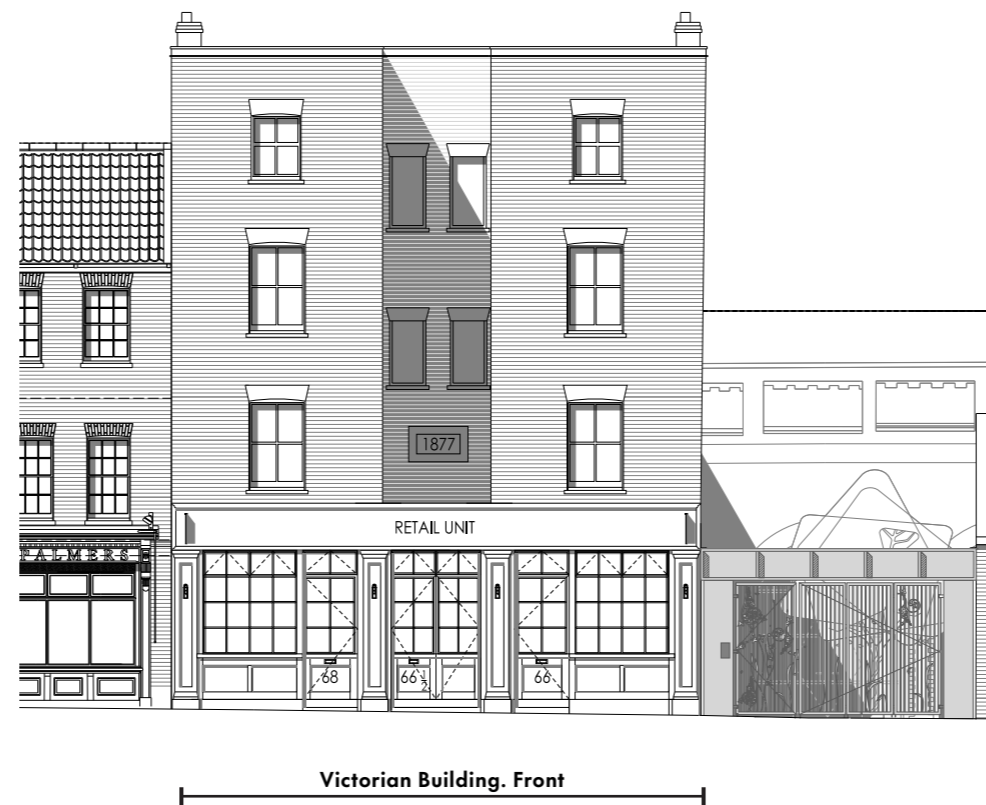
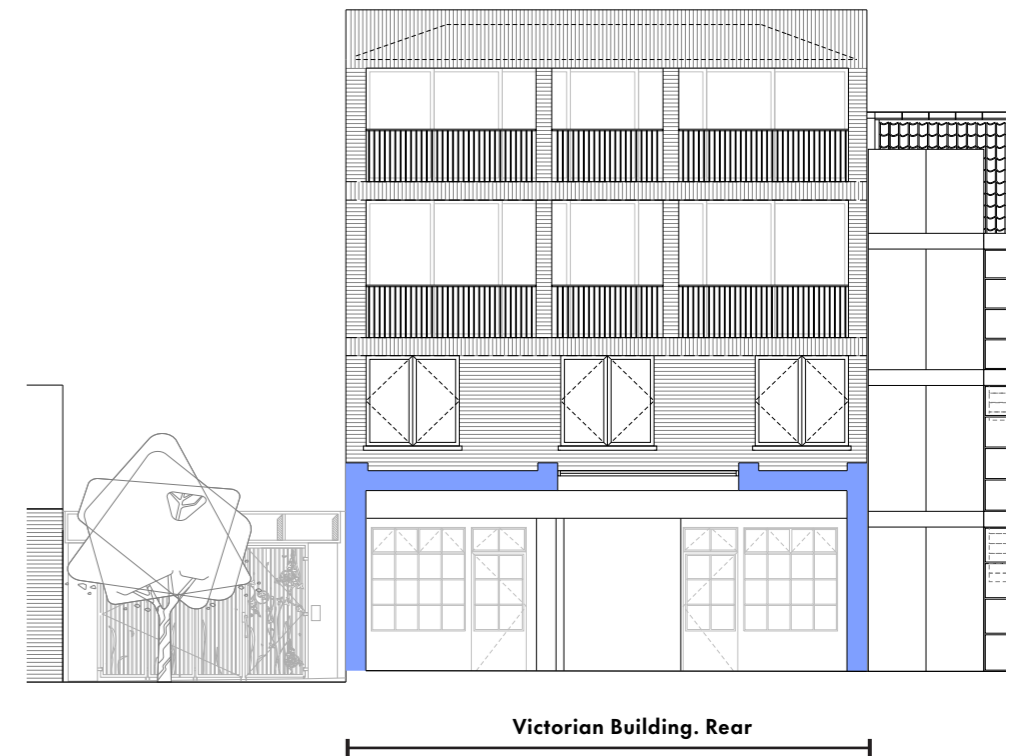
On the front facade, the building's brickwork will be cleaned, locally repaired as necessary and repainted.

Timber shopfronts, which are appropriate for a building of this era, will be installed. These shopfronts will respect the historic division of the ground floor, creating a central entrance to the upper levels, with symmetrical shopfronts on either side. These shopfronts will be made from timber with small pane glazing, decorative moldings and entablature and glazed timber panel doors.

The rear elevation will be rebuilt in London Stock bricks to match the existing. Recessed balconies at second and third floor levels will have painted metal rod balustrades.

The gable wall will be rebuilt using London Stock bricks to match existing.

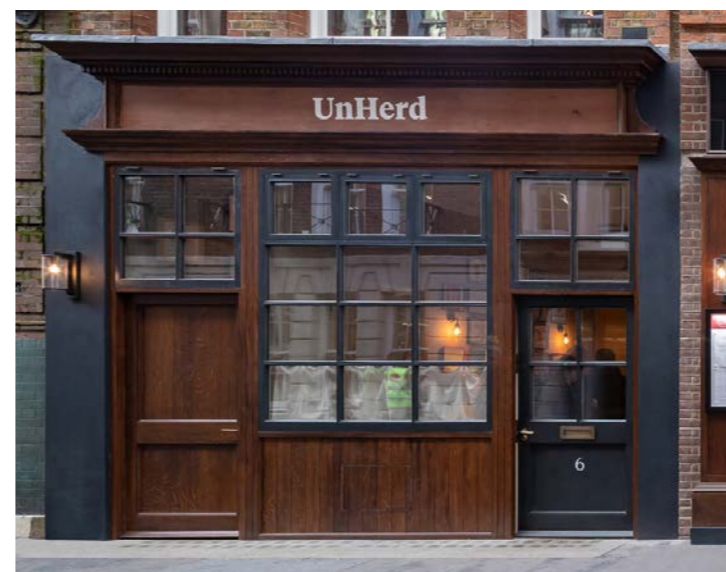
An example of a reinstated timber shopfront, by CDA in Westminster

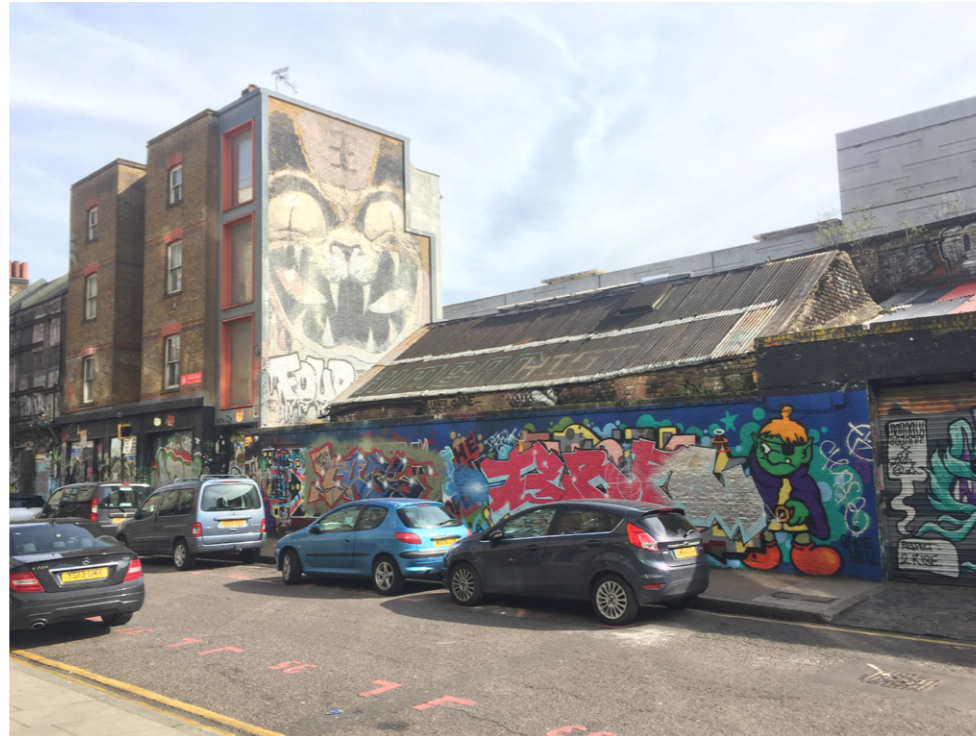
Photograph of the existing 20th century wall screening the Mission Hall off from Sclater street

By the early of the twentieth century the hall had ceased to be used for religious purposes and was used for various trades including, amongst other things, a monumental masons workshop and as a timber store. The hall is screened off from the street by 20th century brick wall, which bears testament to these later uses.

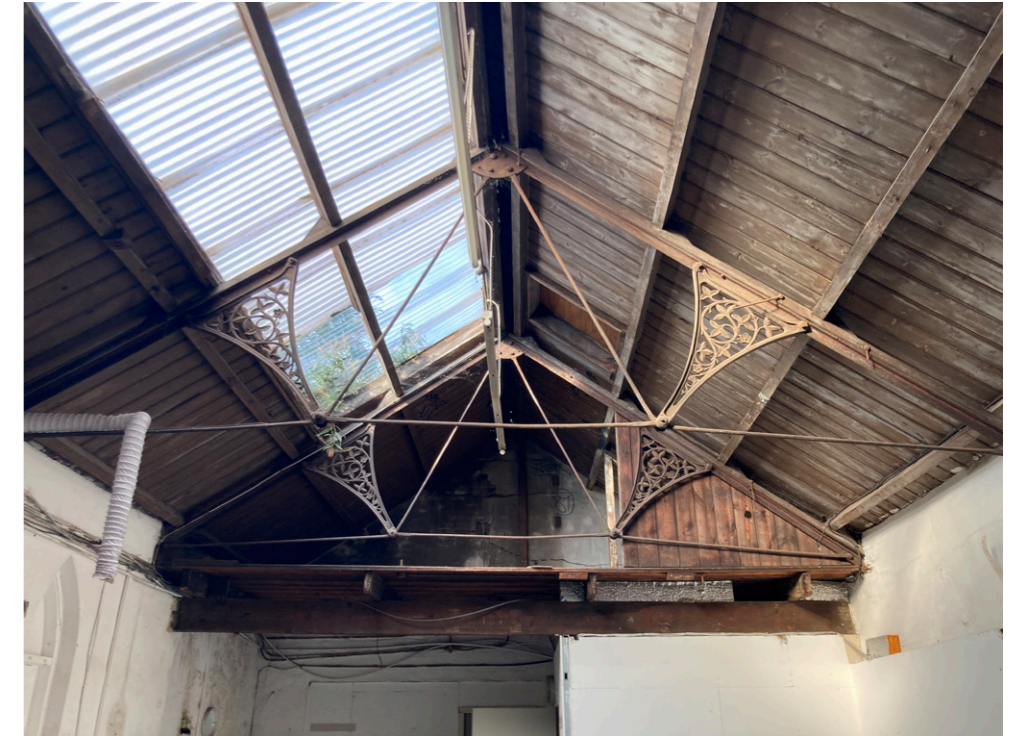
Mission Hall - Photograph of existing iron roof structure

The original Mission Hall's brick walls and cast iron roof structure remain largely intact but are largely hidden from view. The building has been extended to the east, west and rear to create a reasonably large commercial unit.

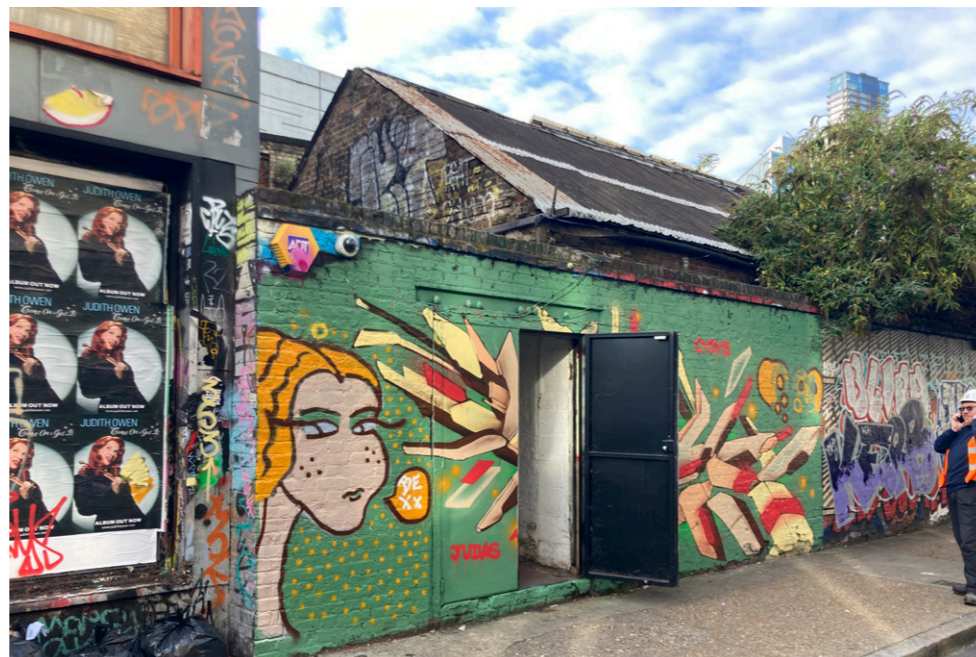
Photograph of the existing 20th century wall screening the Mission Hall off from Sclater street

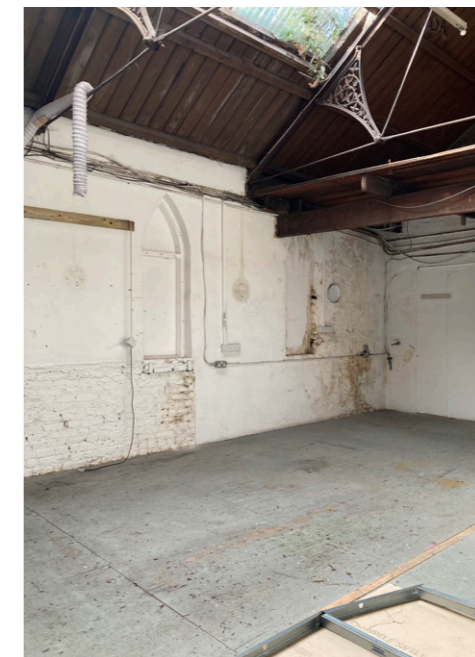
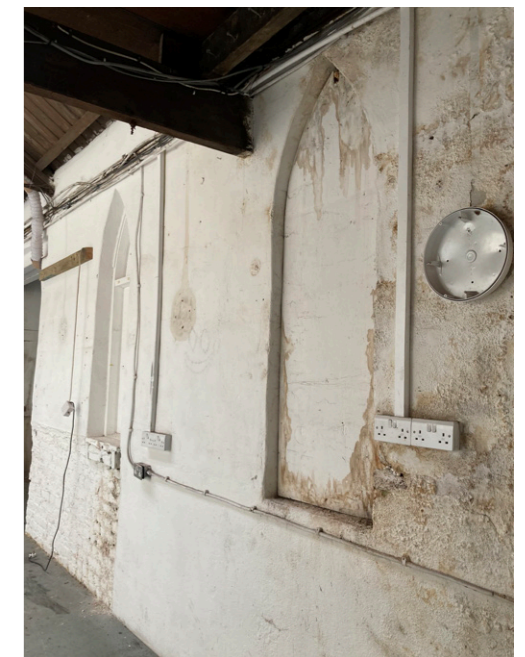
Mission Hall - Photograph of existing internal features

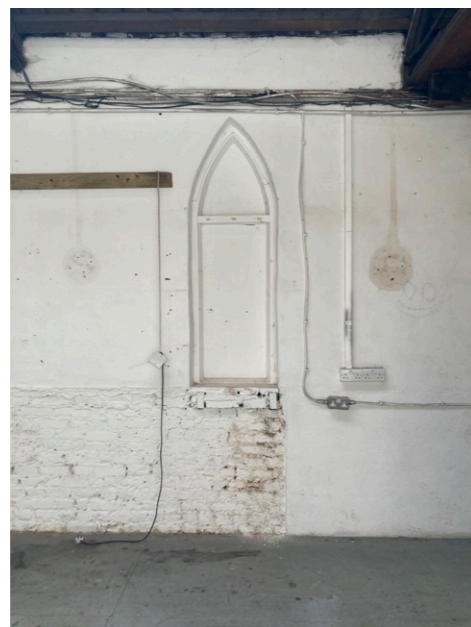
Surviving Gothic Window in Mission Hall Wall

The existing Gothic window openings will be retained, and where one is missing, reinstated. These openings will be glazed with timber framed, single glazed windows.

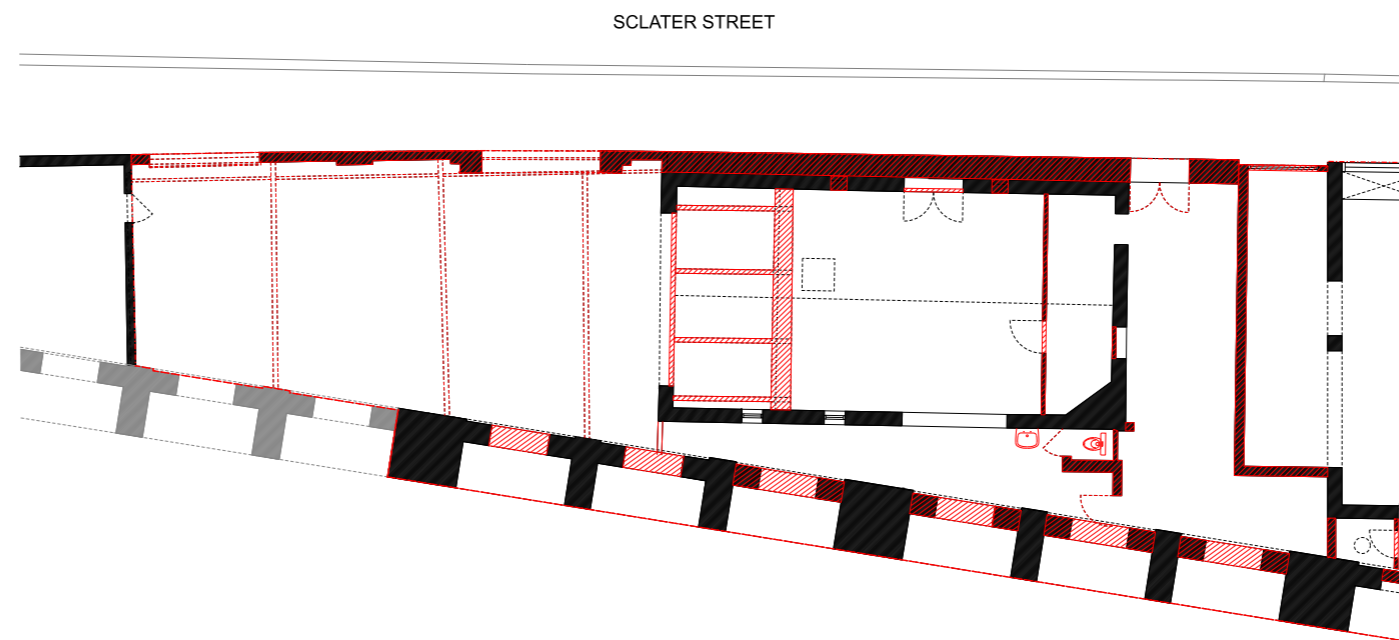
Mission Hall - Ground floor plan

The Mission Chapel has been substantially extended at various points in the late twentieth century, including a single storey brick wall to the street. Extensions mean that the building is connected to the Victorian Building to the East and the Station wall to the South.

Our proposal removes the modern extensions and the modern street wall to reveal the original form of the chapel.

Modern roof coverings and windows will be removed. Historic roof structure will be retained.

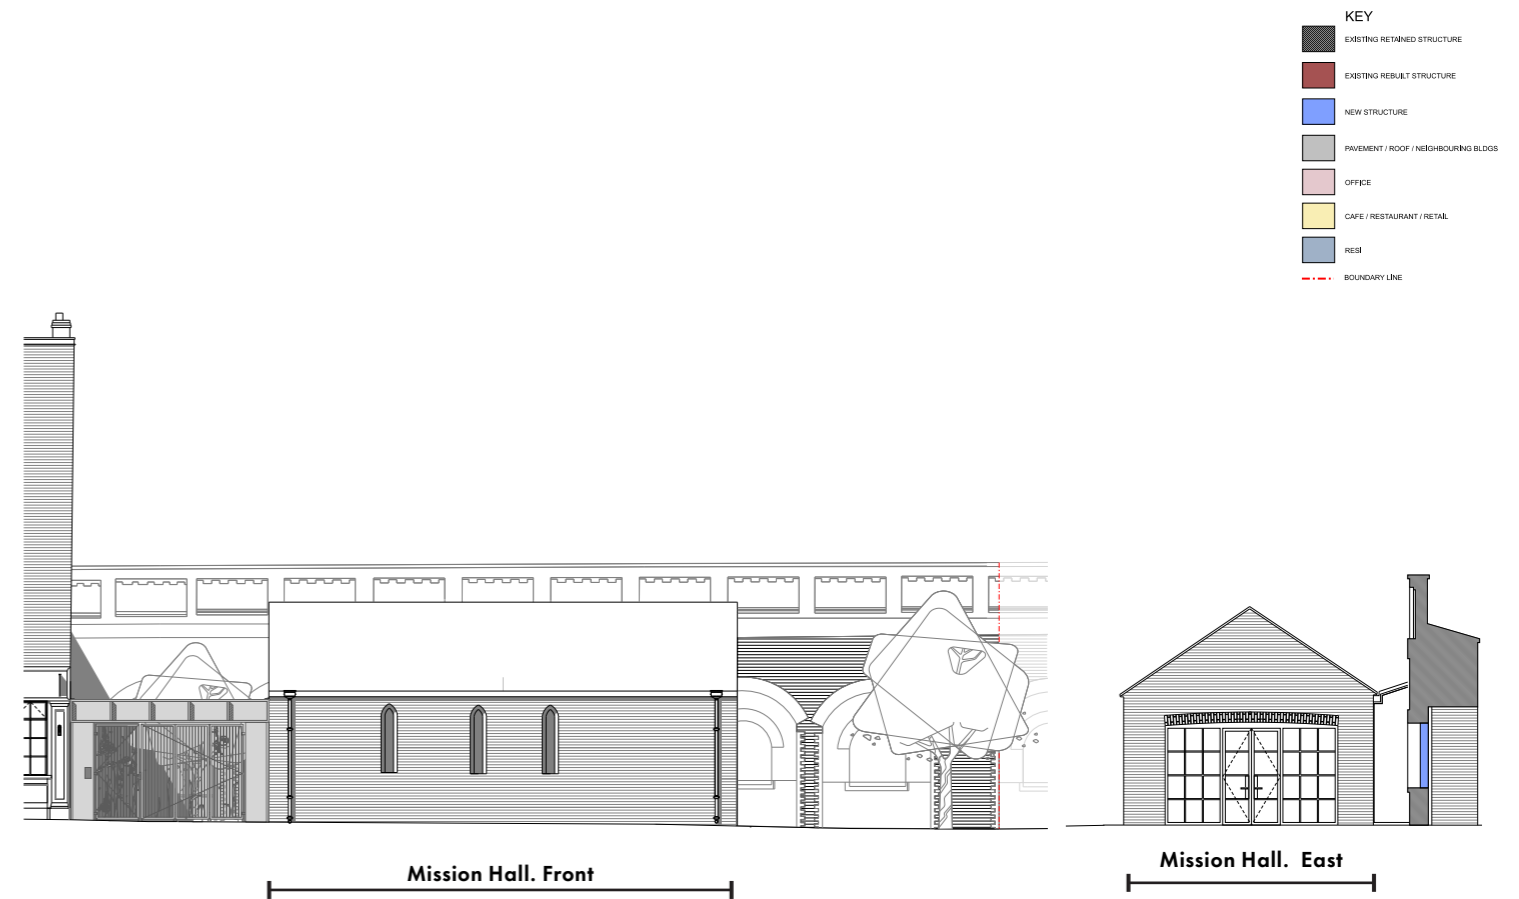
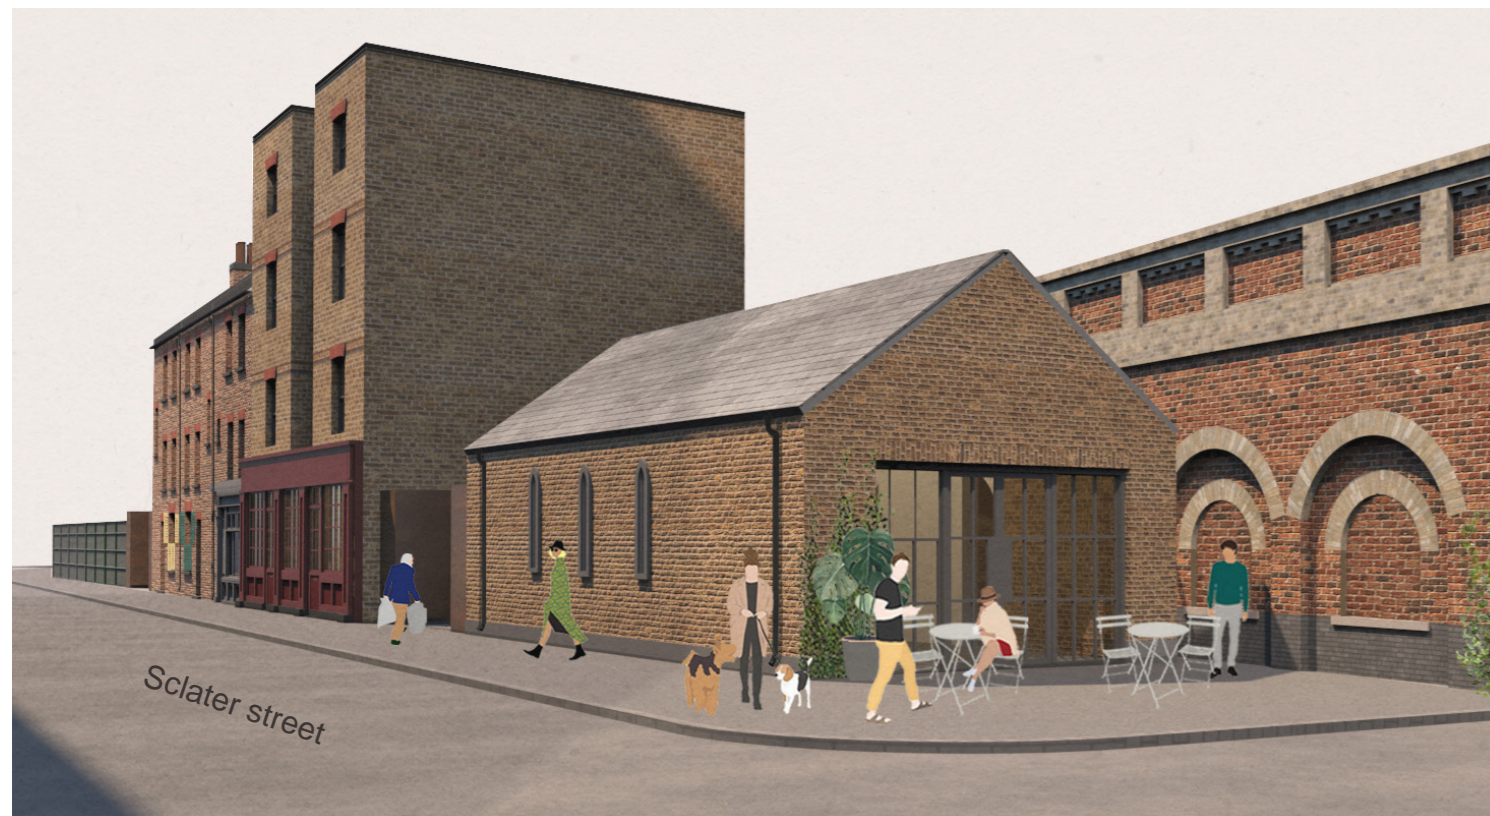
The existing brickwork walls will be cleaned and re-pointed as necessary. An existing opening on the west facade will be used as an entrance, the opening filled with Crittal type glazing and glazed doors.

The repaired roof will be clad in slate. All rain water goods will be made from cast iron, painted black.

To increase the internal area of the cafe, the building will be connected to the station wall with a fully glazed link. This will be detailed using frameless glazing, to create a glass slot between the two historic structures. The area will be used as seating for the cafe.

The enclosed area of station wall will be cleaned and repointed as necessary. The two enclosed arches will have their infill brickwork removed, so that the depth of the wall can be used to create seating nooks. The new infill, to the rear of the arch will be made from the bricks taken from the wall and reclaimed bricks to match.

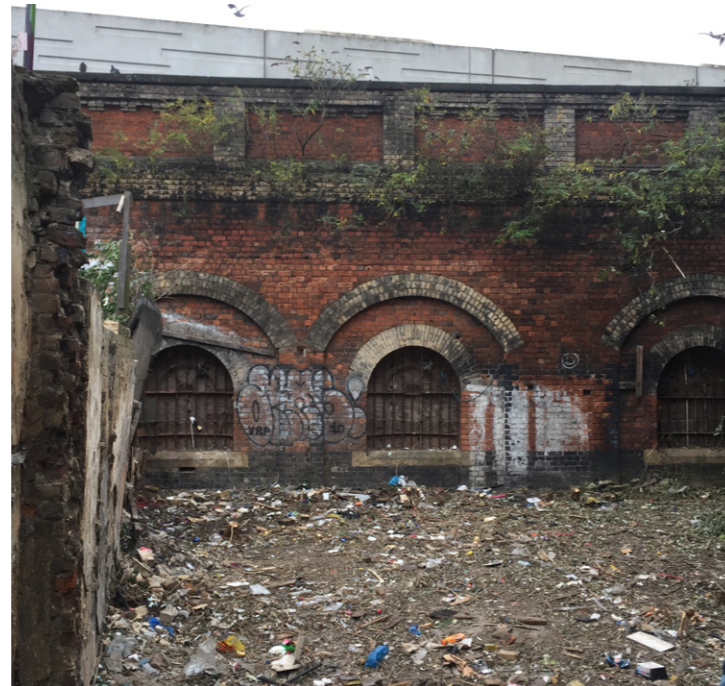
Station Wall behind the Weavers Cottages. The arches retain some cast iron window frames, which will be set aside for reuse.

Where it is exposed to the elements, behind the Weavers Cottages and above the extensions to the Victorian Building and Mission Hall, the wall has been heavily graffitied and is showing some signs of brick decay. In some of the open arches, the original cast iron window frames survive, but in most cases they have been lost.

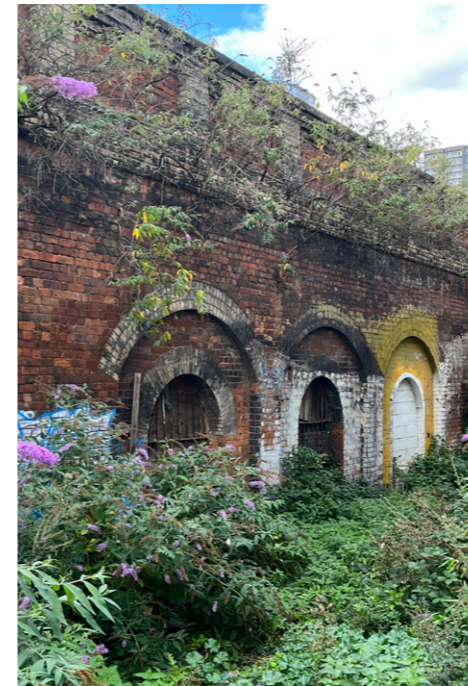
Station Wall behind the Weavers Cottages

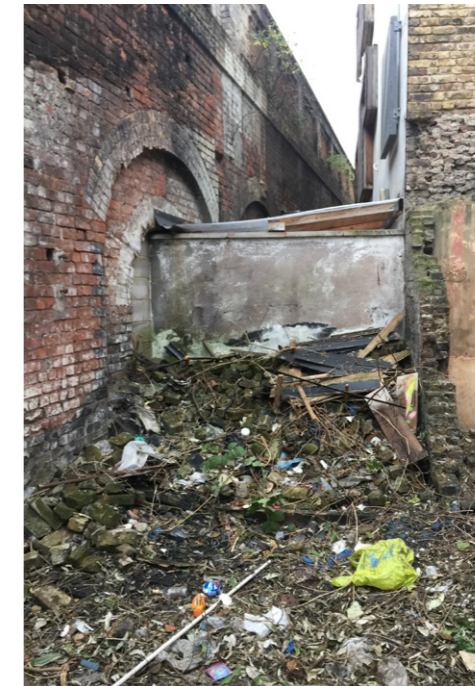
Station Wall behind the Weavers Cottages showing the Victorian Building extension

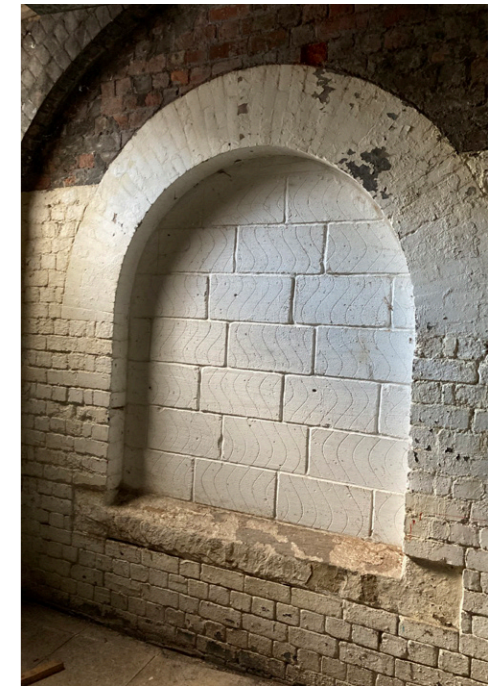
Station Wall inside the Victorian Building

Where the wall has been enclosed, behind the Victorian Building and Mission Hall, the arches have been infilled in a piecemeal fashion, using block work, brickwork or timber panels. The brickwork has been painted, and where it was necessary to do so, it has been hacked away to allow for the installation of structure or services.

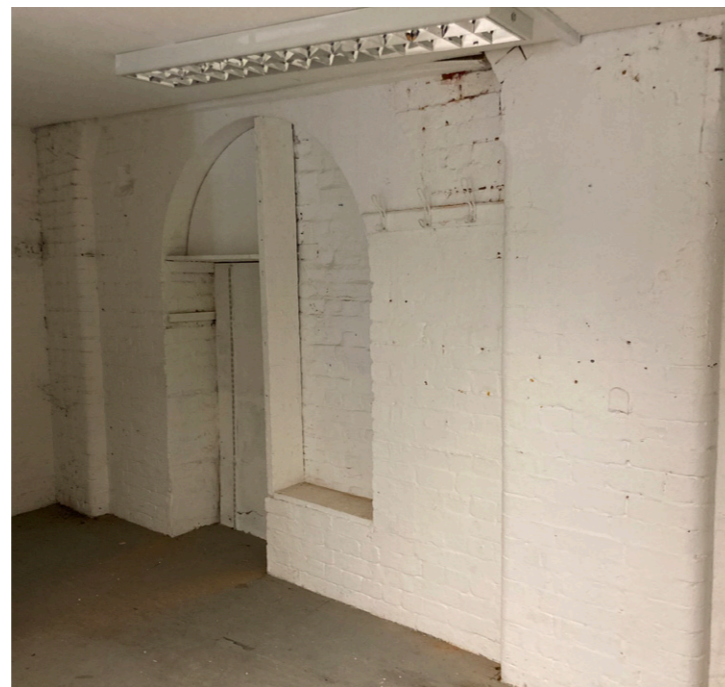
Station Wall inside the Mission Hall

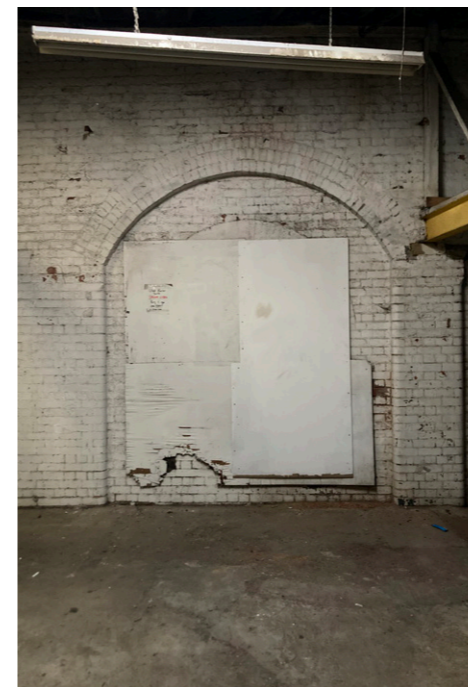
Station Wall inside the Mission Hall western extension

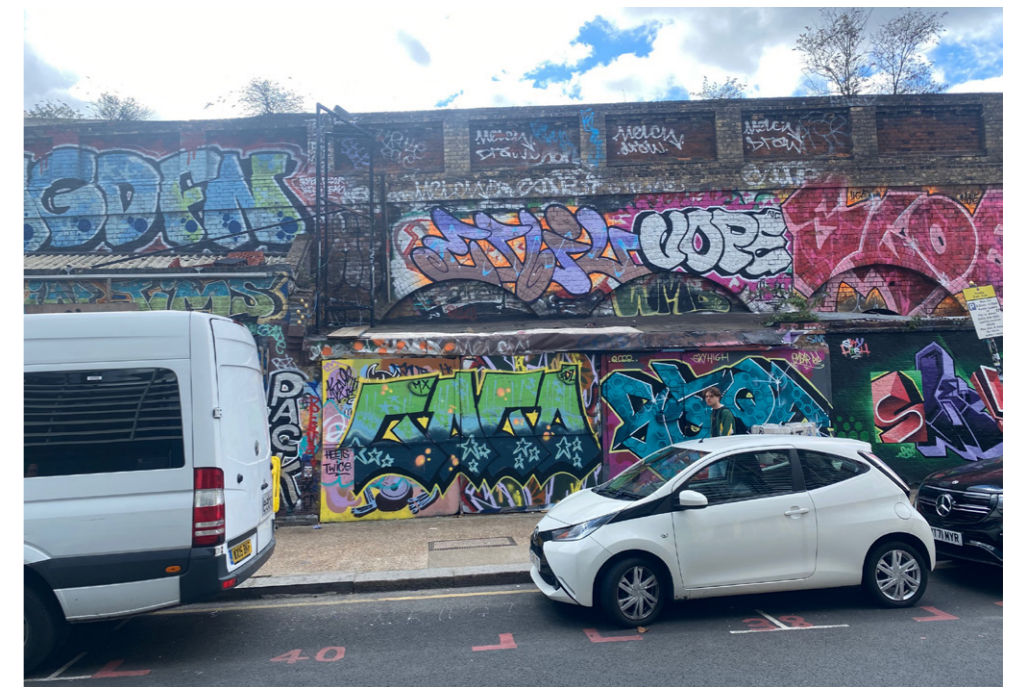
The Station Wall can be seen behind the western extensions of the Mission Hall
