Bishopsgate Goodsyard Plot 5

HERITAGE RECORDING

SCLATER STREET BUILDINGS

March 2024

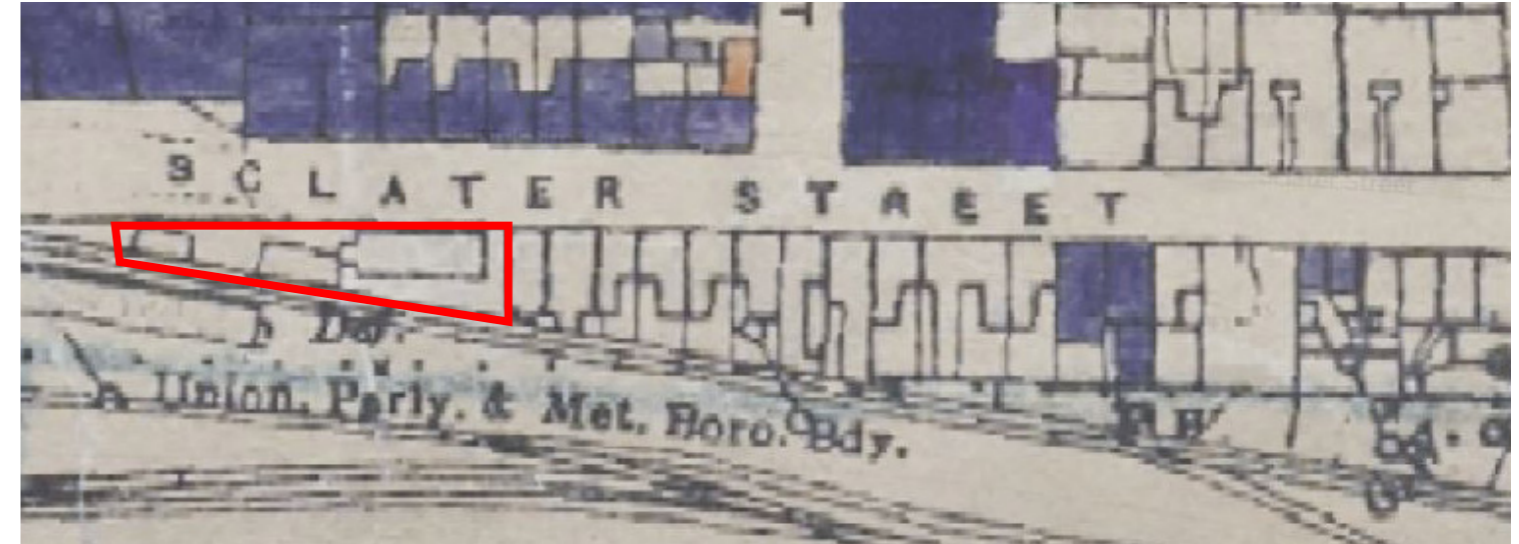
03

- 1—OS map from 1876
- 2—OS map from 1915
- 3—extract from the bomb damage map 1945 showing the Mission Mission Hall unaffected
- 4—OS map from 1940-1960 showing the conversion of the Mission Hall building into storage facilities.
- 5—Goad plan extract of 1958 when the former mission Mission Hall was converted to a plywood store.

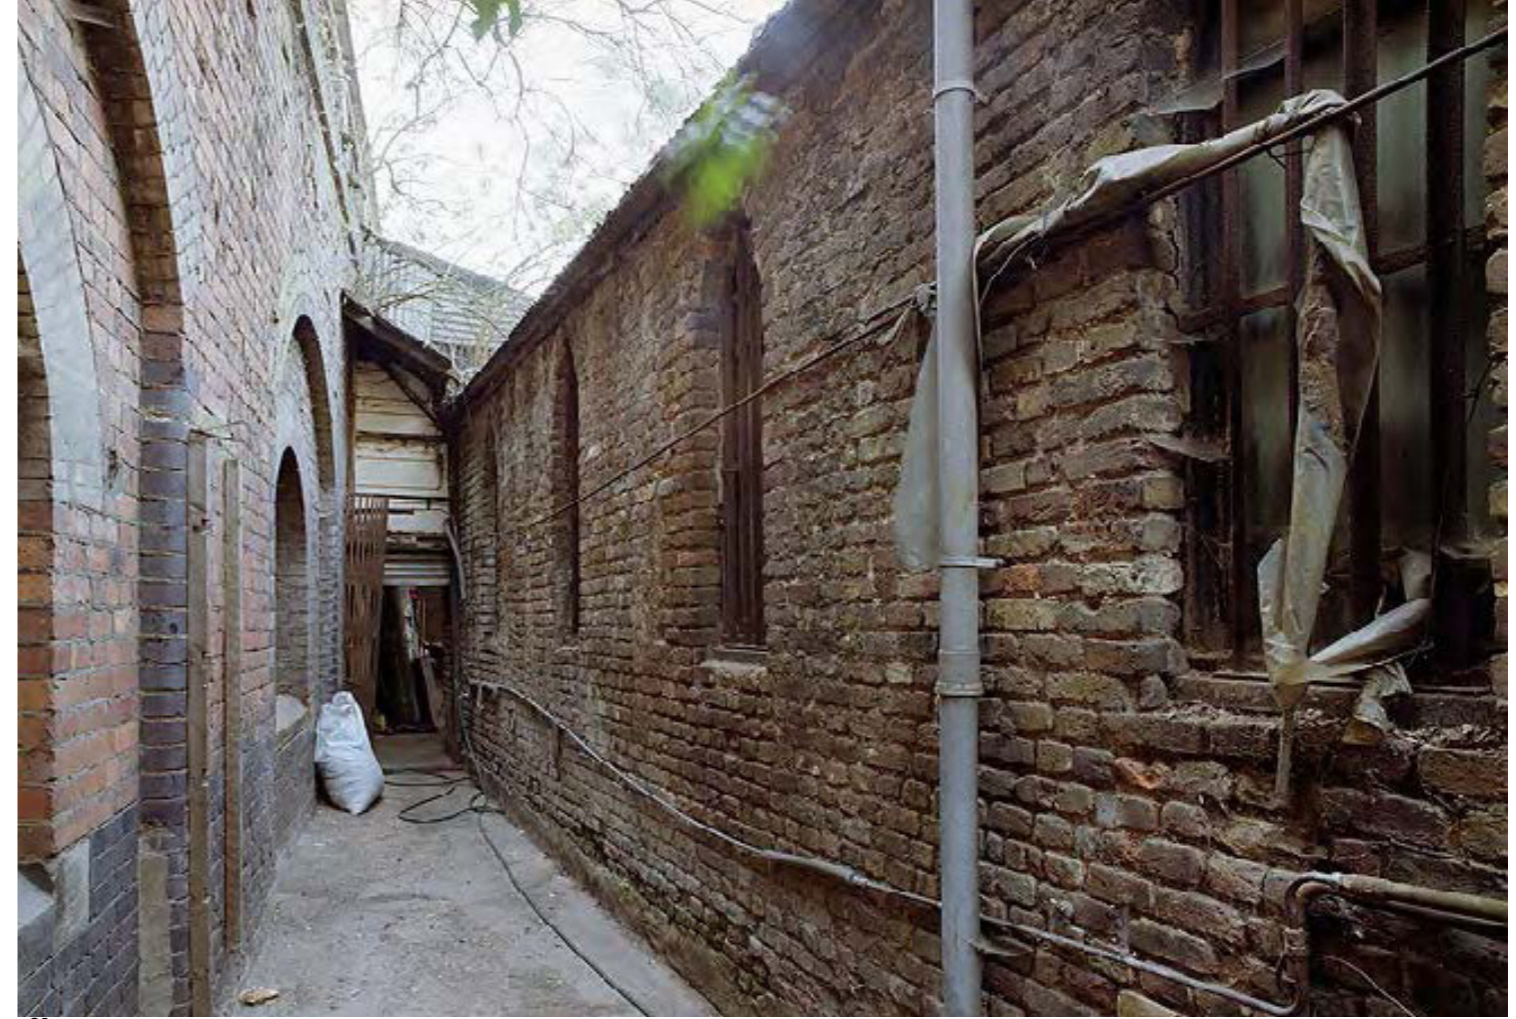
01

- 1—The Rear wall of the Mission Hall with the Goodsyard boundary wall to the left.
- 2—Street level view of the Mission Hall from 2008

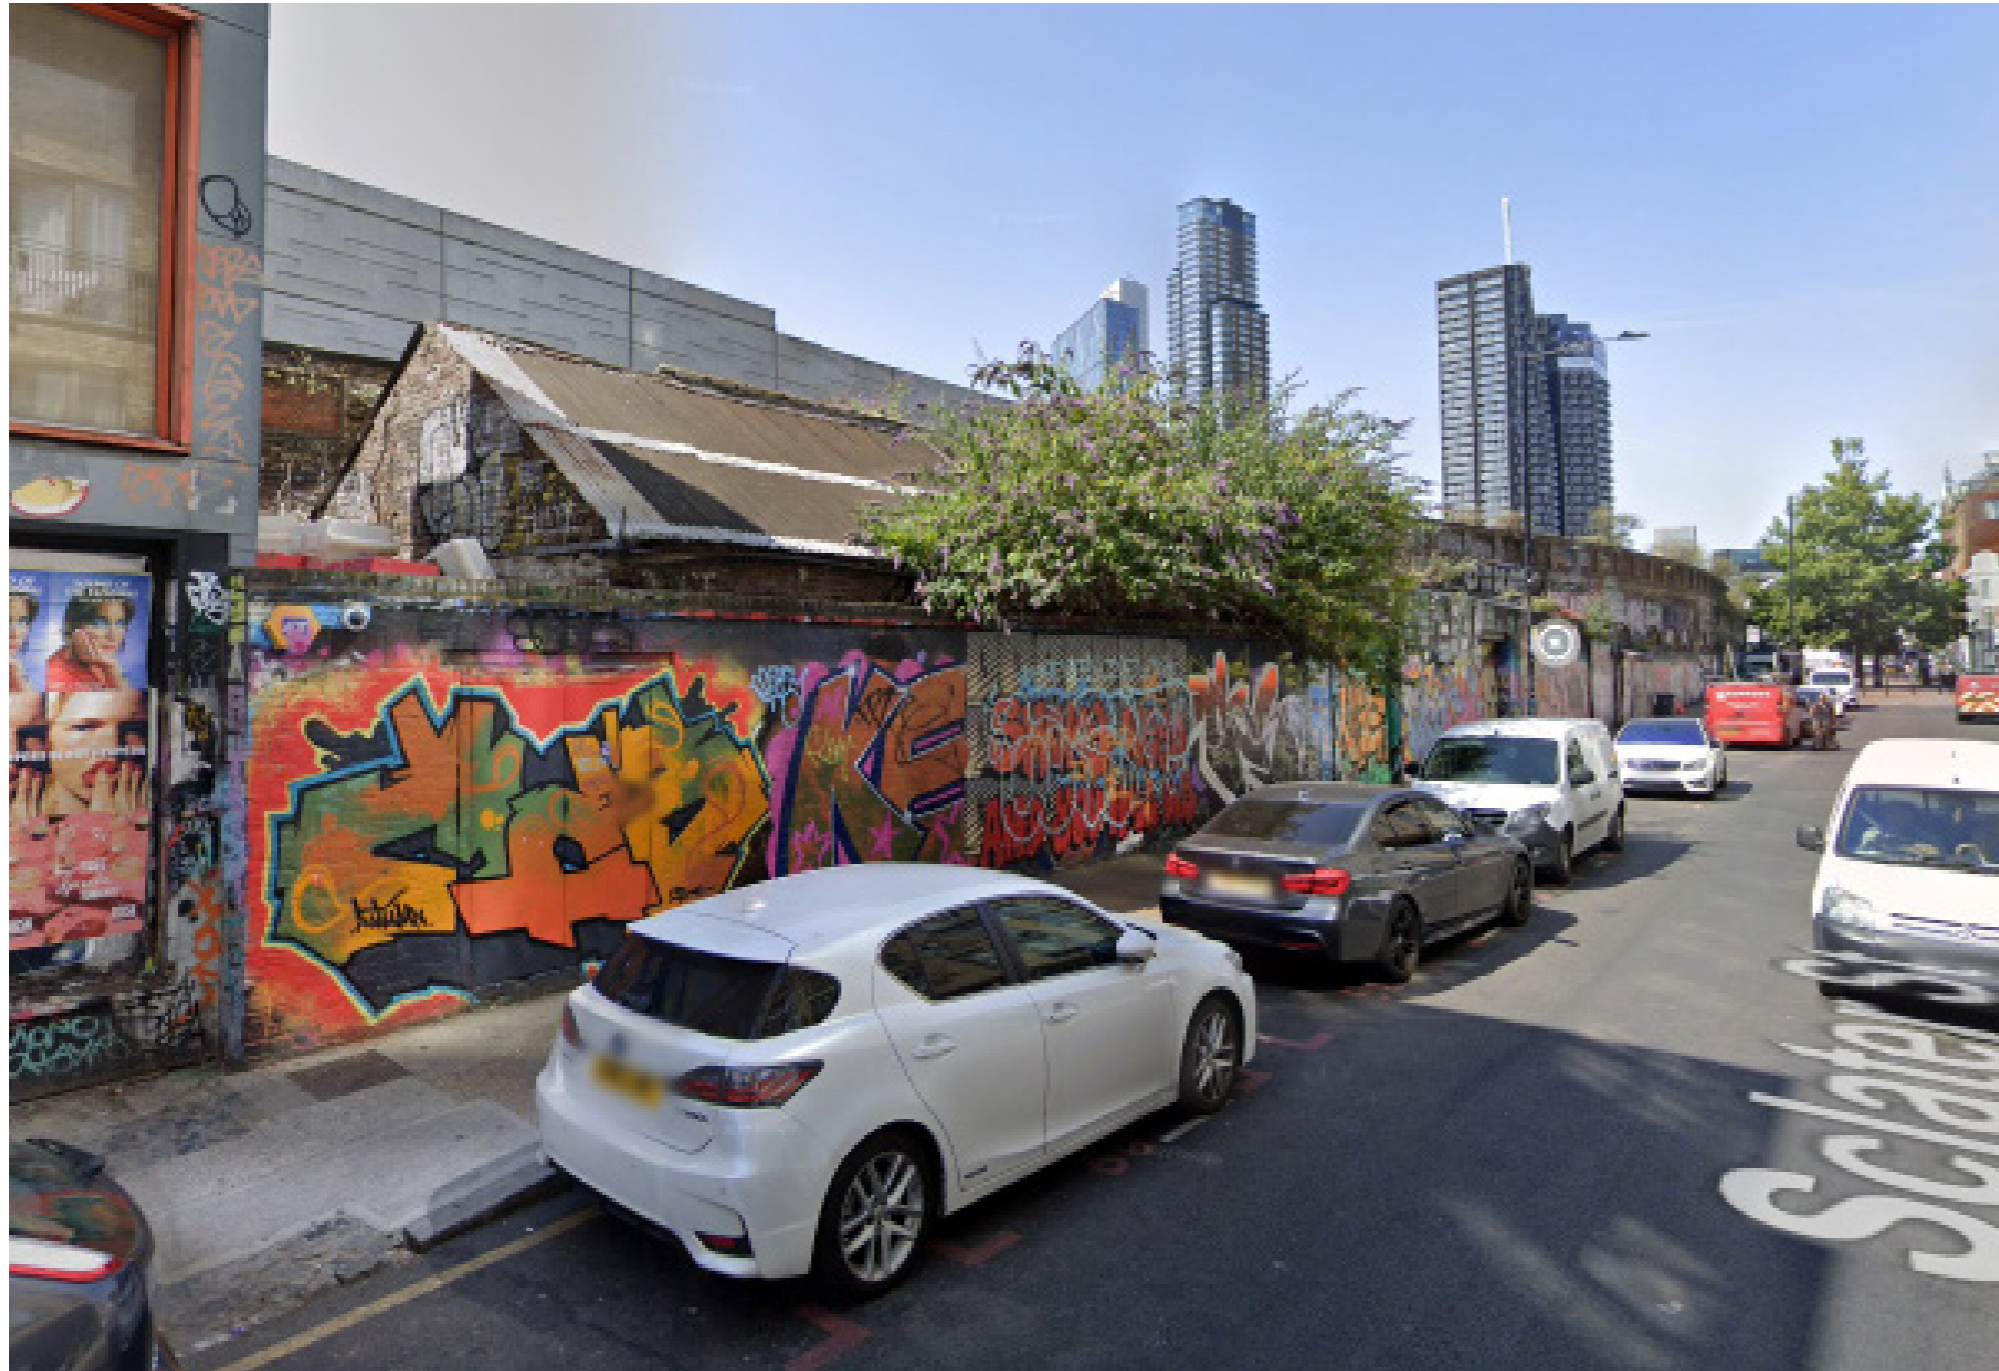
01

- 1—General view of the Mission Hall as seen from street level.
- 2—cobbled dropped kerb to the Western end of the Mission Hall.

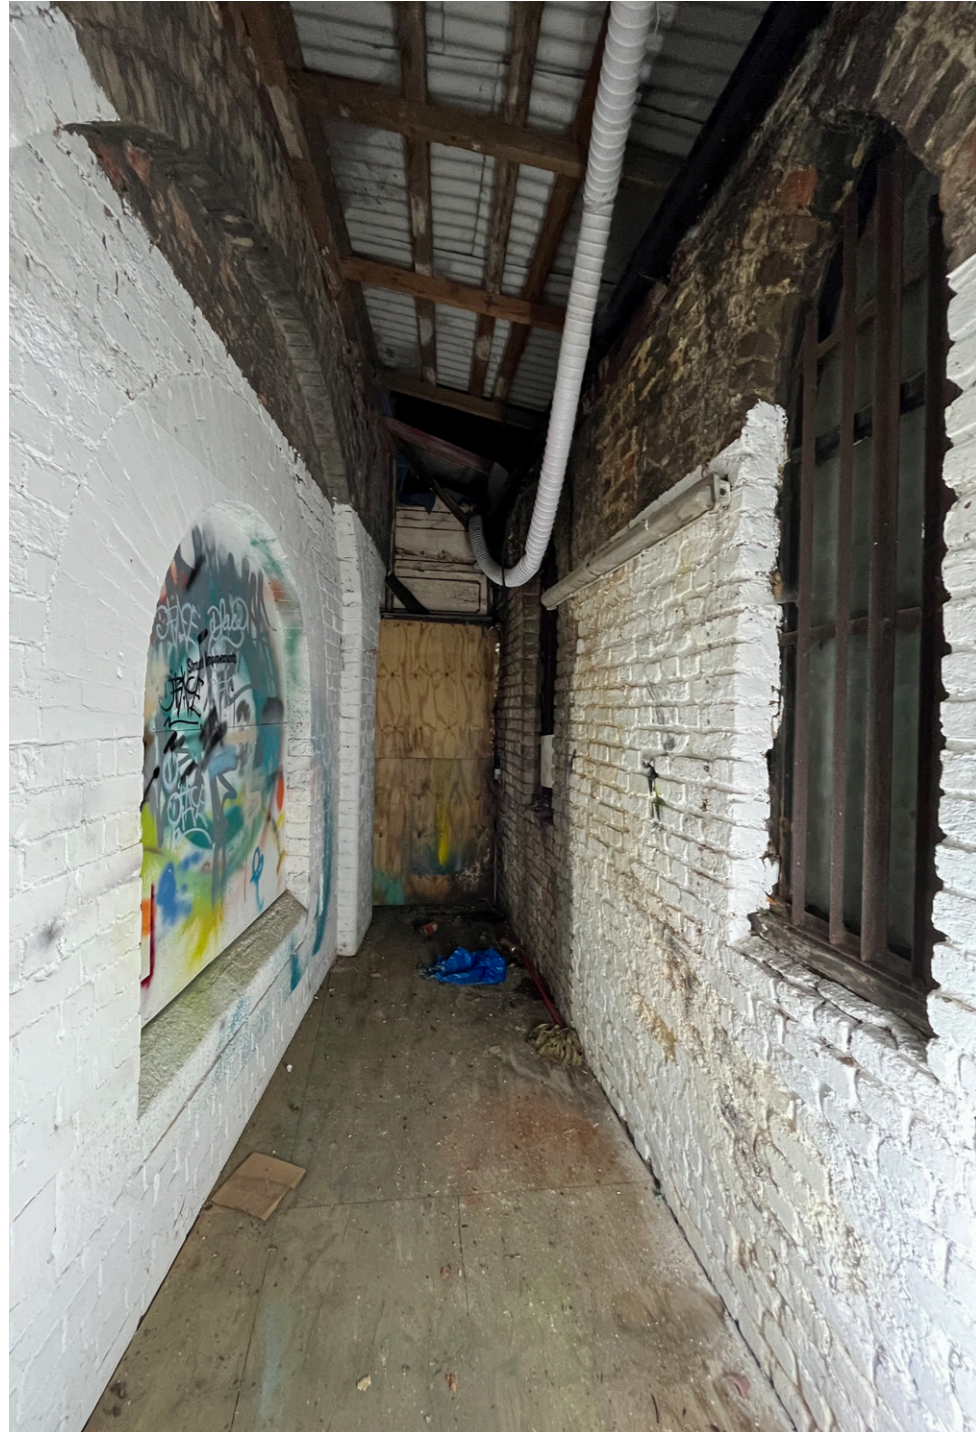
03

3—South elevation of the Mission Hall seen on the right, with the old brick wall from the Goodsyard Station on the left. Various modern elements fitted on the Mission Hall facade, with part of the brickwork painted in white.

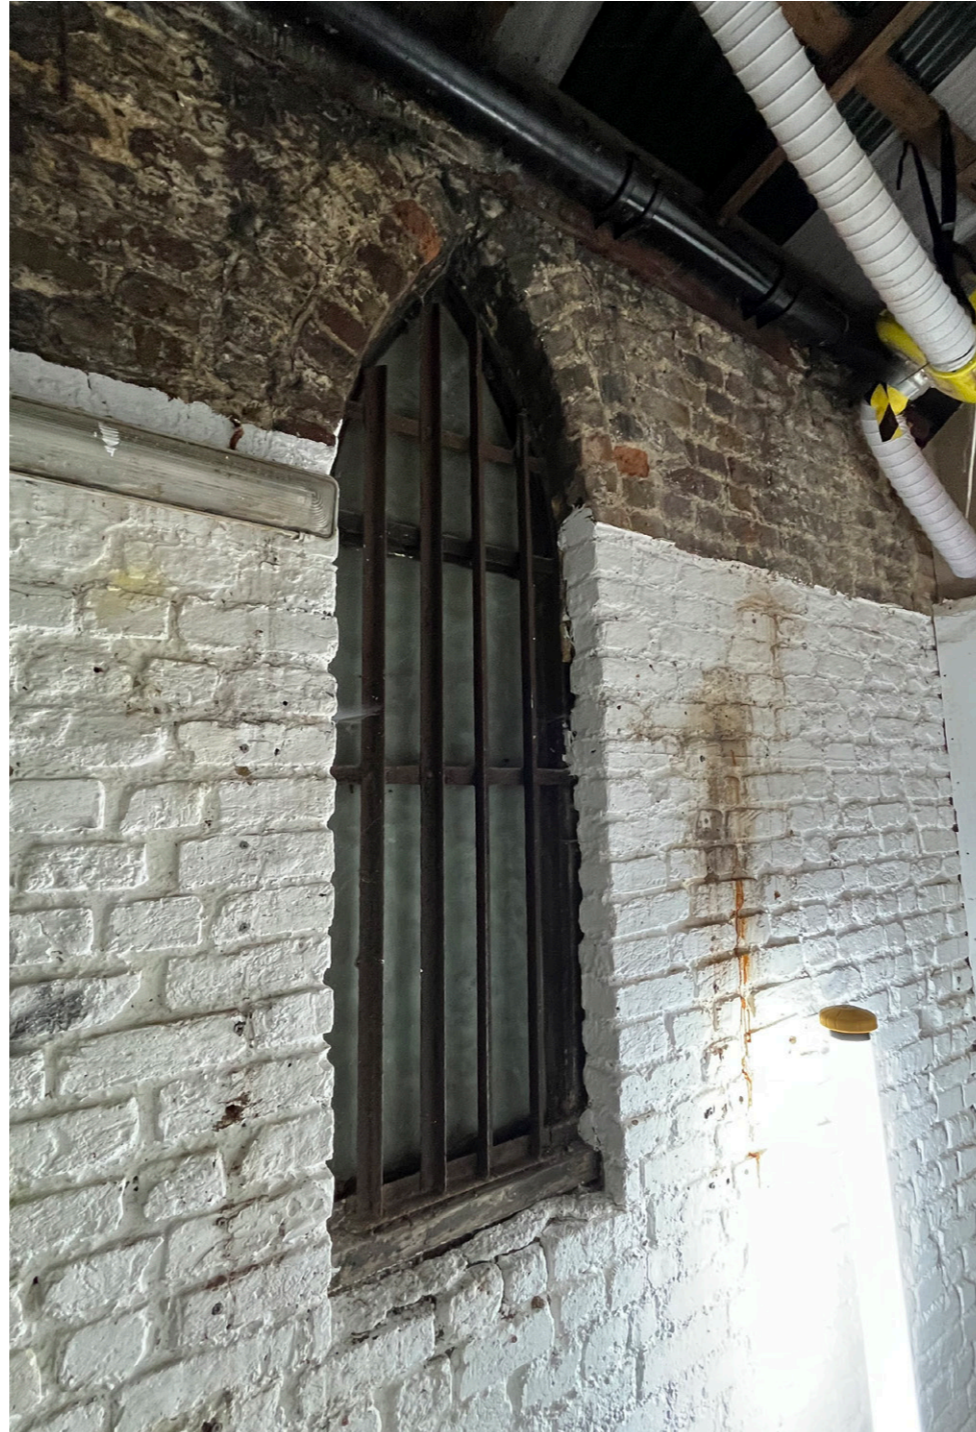
04

4—detail shot of the lancet window on the right hand side of the facade, with metal grilles fitted on the outside. Timber window frame visible, but boarded up on the inside. External cill is missing.

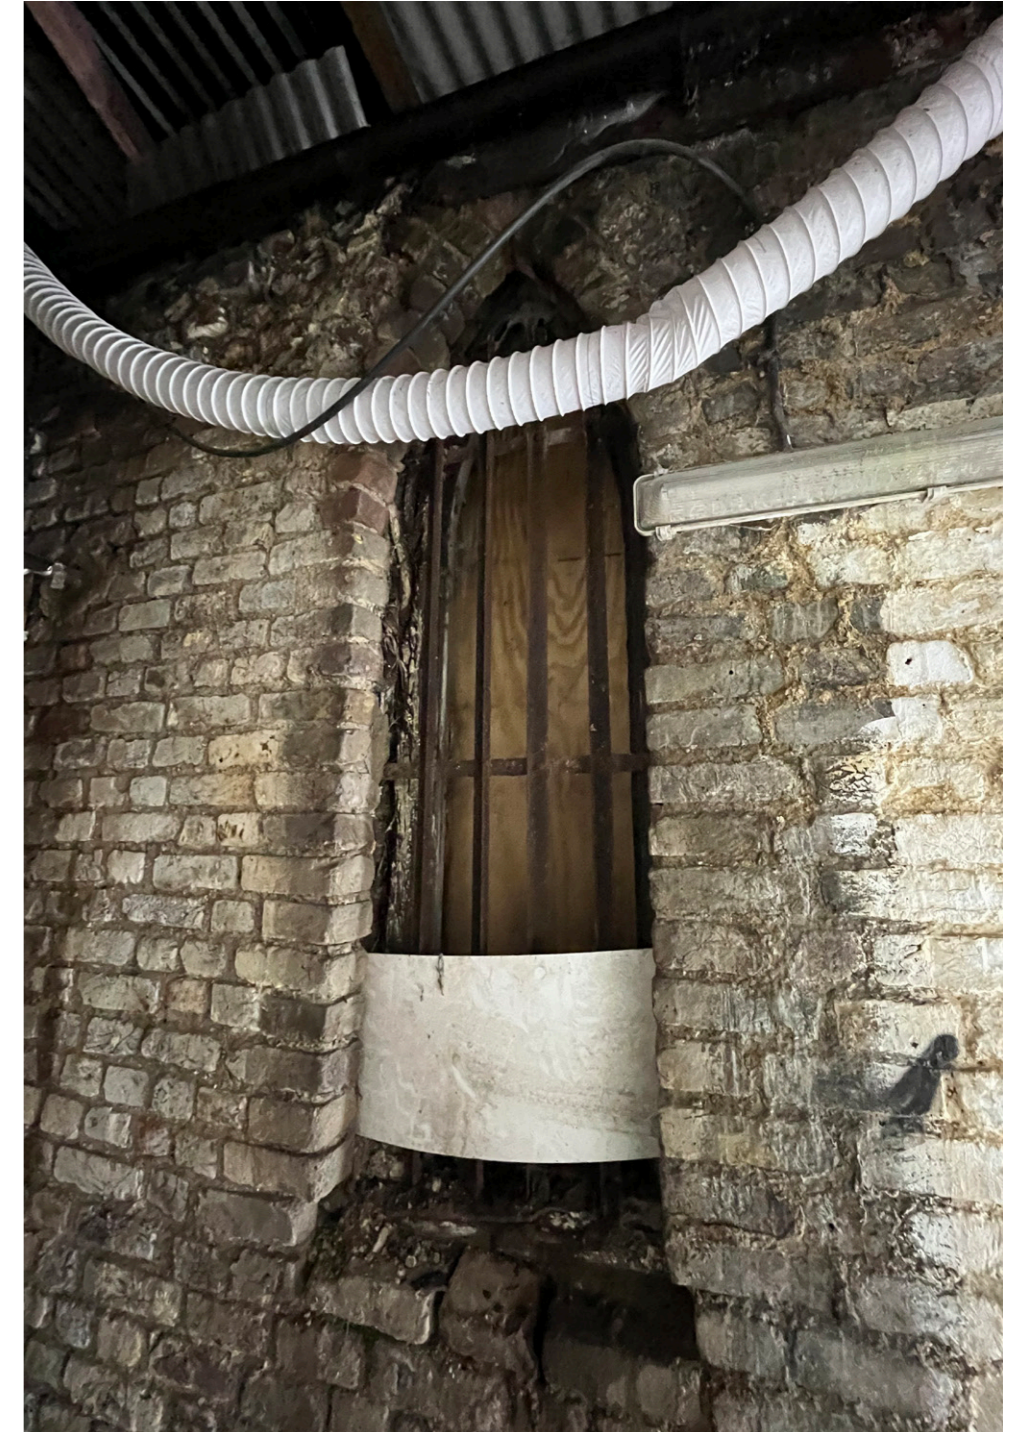
05

5—detail shot of the lancet window on the left hand side of the facade, with metal grilles fitted on the outside. External cill, window glass and frame are missing.

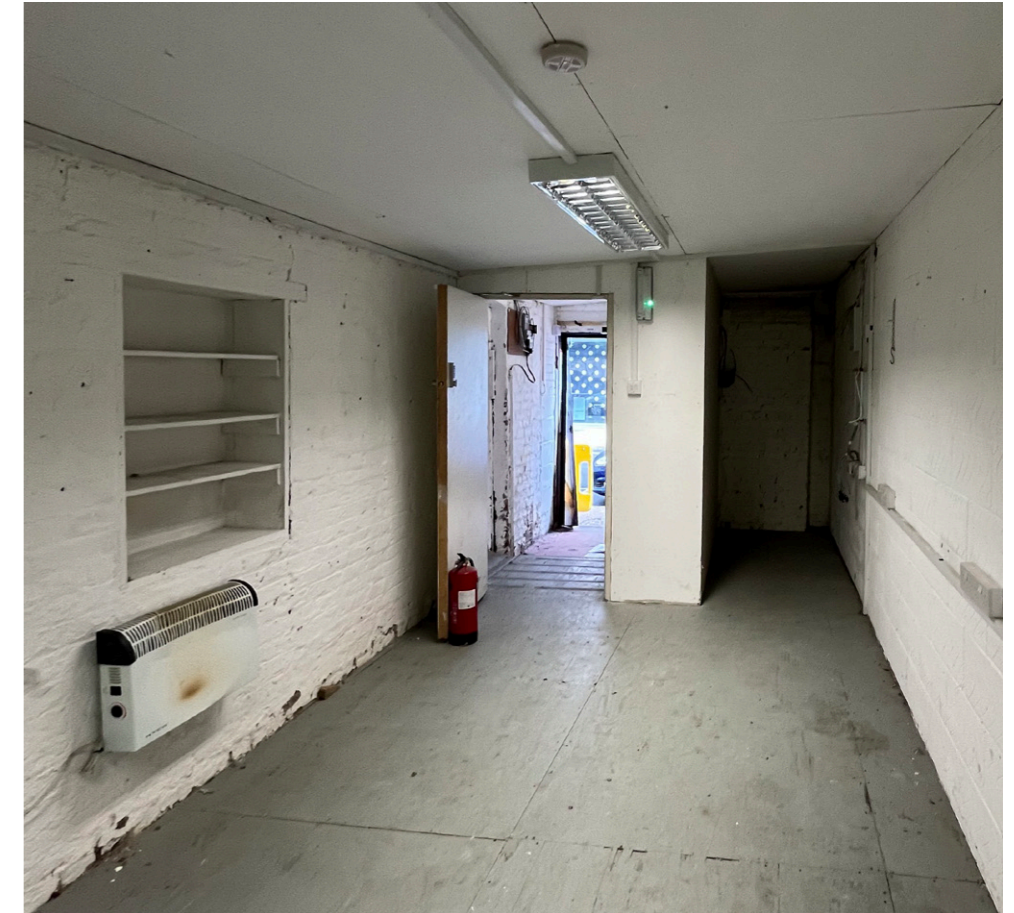
06

- 6—East elevation of the Mission Hall seen on the left hand side of the image. Brickwork has been painted white, with various modern items fitted onto the wall.
- 7—detail image of the modern door which leads to a reconfigured toilet area.
- 8—detail image of the brick pier that marks the South East corner of the Mission Hall. Water ingress visible at high level, which damaged the paintwork.
- 9—original wall recess into facade wall, with modern shelves fitted inside.
- 10—modern fittings installed onto brickwall.
- 11—metal plates fixed through wall - potentially original.

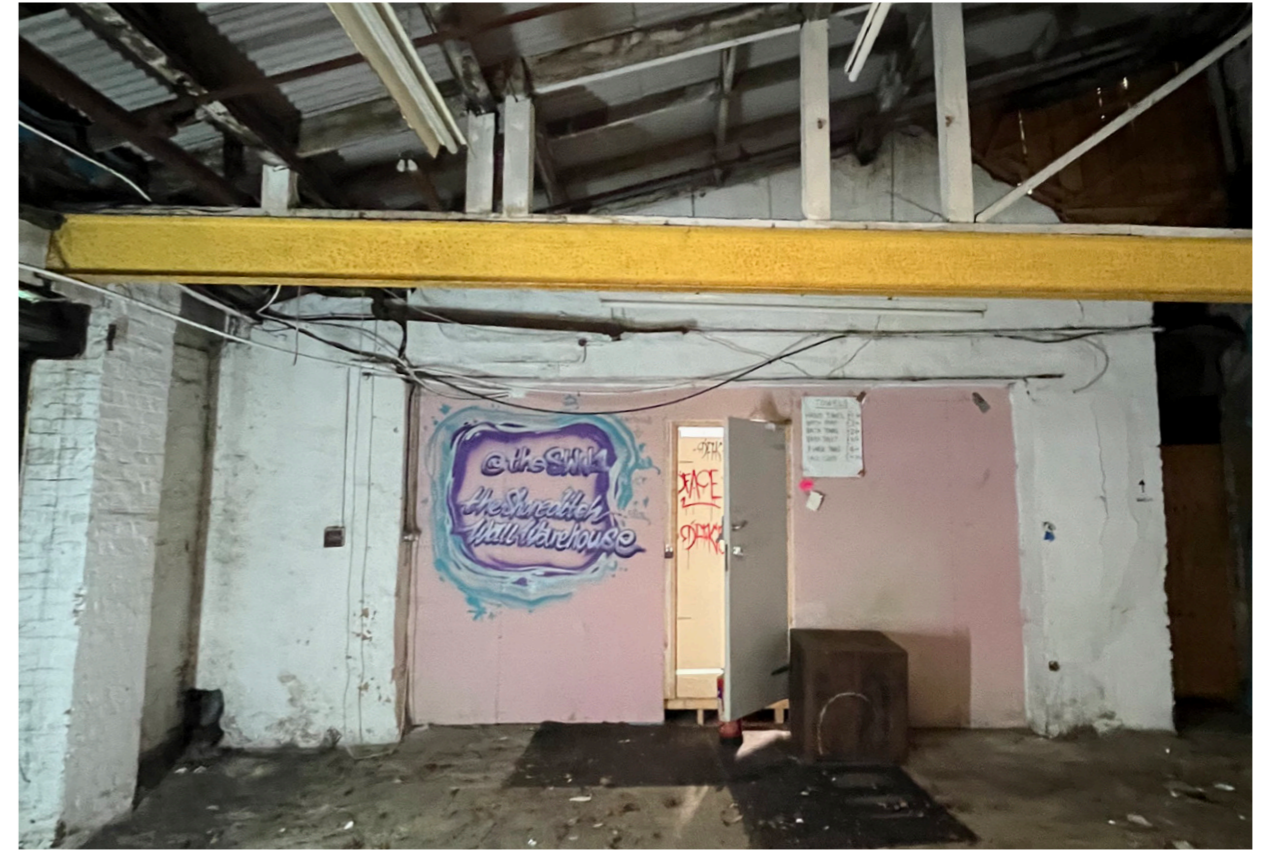
12

- 12—West elevation of the Mission Hall seen in background. Original brickwork has been rendered over and painted white. Original opening within this facade has been widened, through a steel beam spanning the opening.
- 13—detail image of an unoriginal opening in the North West corner of the facade.
- 14—modern conduits fitted on to the facade. pipework penetrating facade.
- 15—detail image of old switches.

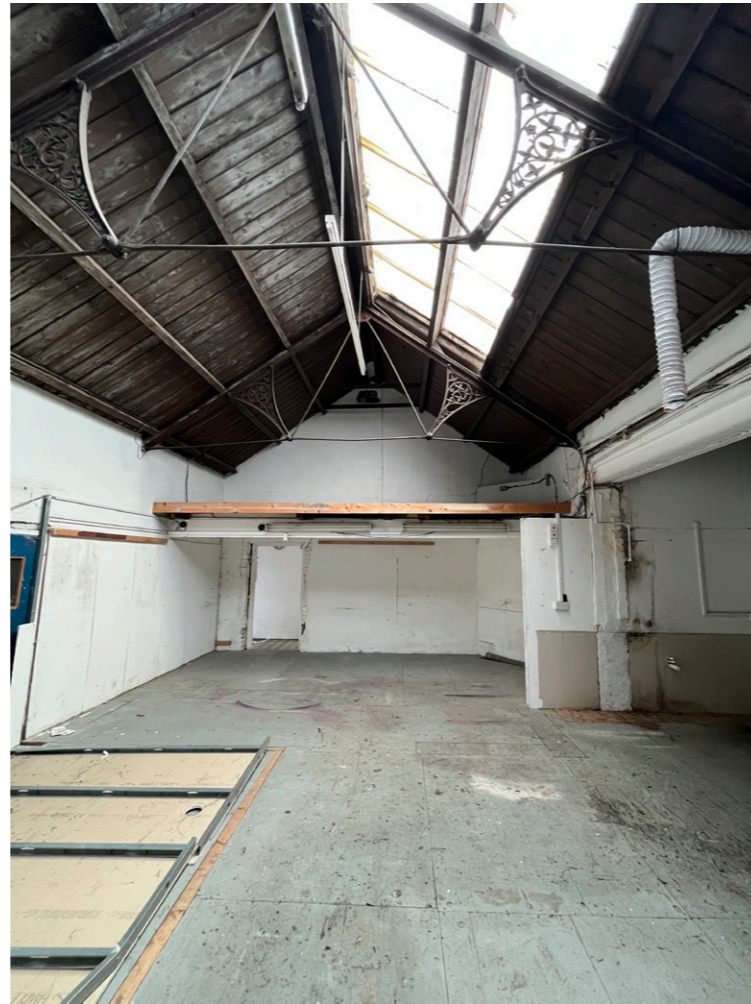
16

16—Internal space looking East.
17—image of the roof with original iron trusses and timber roof panels.
18—detail image of the original Victorian foliate cast iron trusses.
19—image of the space and roof looking West.

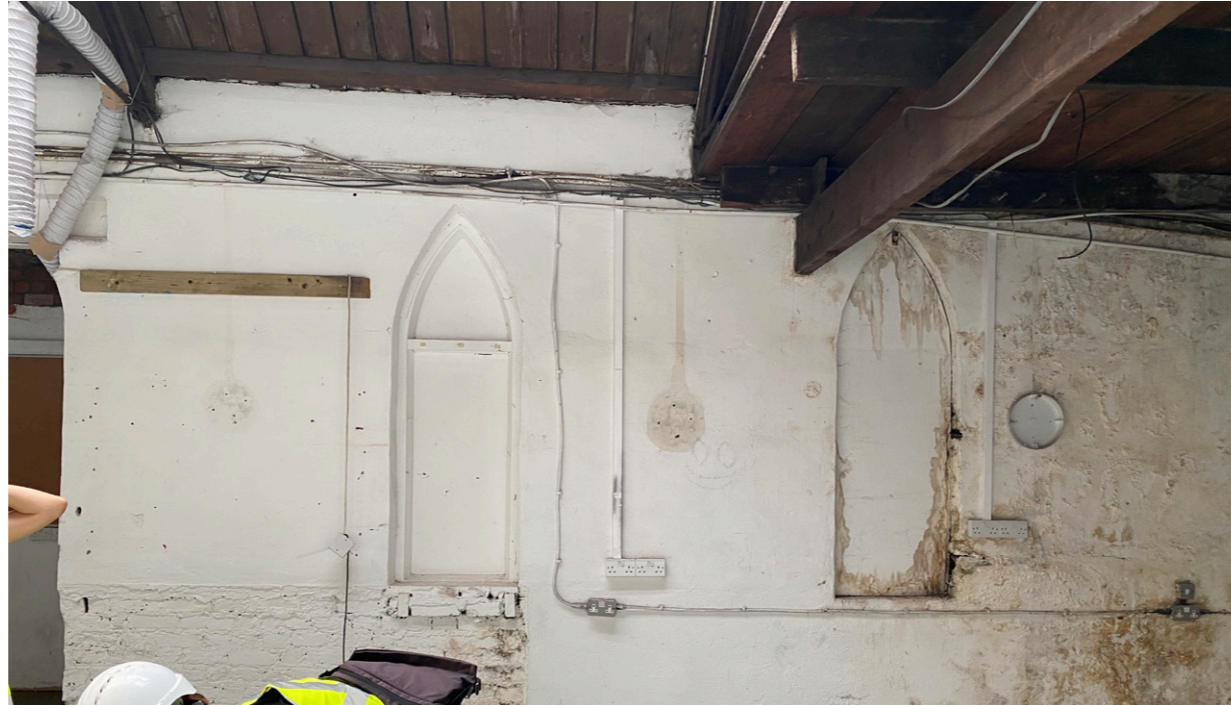
20

20—South wall seen from the inside, featuring the lancet windows boarded up. The original brickwork mostly rendered over and painted white. Modern fittings fixed to the wall. Sign of damp areas in the South Western corner of the Mission Hall (right hand side of the image).
21—image of the modern enclosed wall, featuring the exposed original brickwork which has been painted white.
22—detail image of one of the lancet windows, with original window cill and glass missing.
23—detail image of one of the lancet windows, with signs of damp area on the right hand side. Original internal sill missing, and window frame and glass missing.
24—detail image of the window reveal showing timber within brickwork damaged at the exposed end.

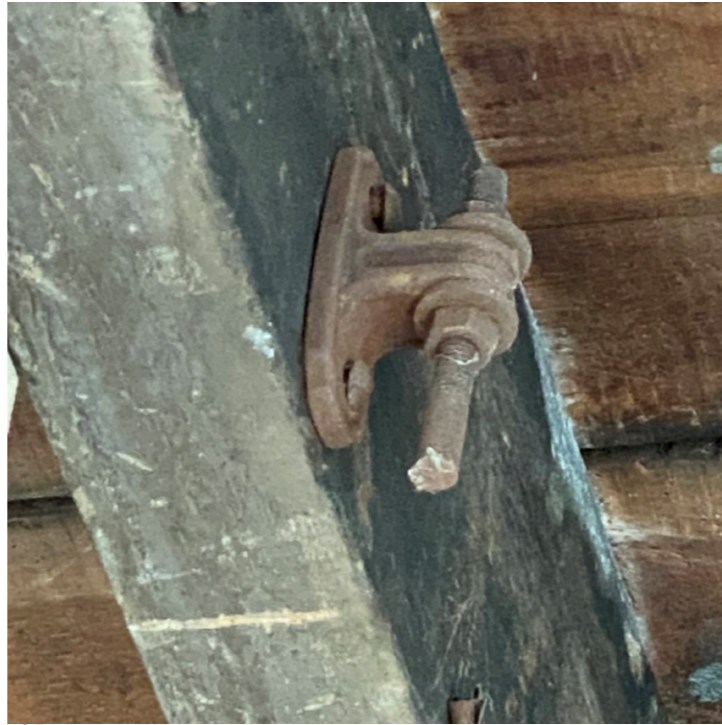
25

25—original metalwork item
 26—modern opening towards Sclater Street- Original brickwork mostly rendered over and painted white. Colour of brickwork visible where render has fallen off - brickwork seems to be yellow London stock bricks, with horizontal timber beams strengthening the walls.
 27—detail image of old pendant rose.
 28— original metalwork item with timber bead and butt anelling behind.
 29— original metalwork item.
 30—main entrance into the Mission Hall through the East facade, with modern timber door frame and concrete lintel over.
 31—brick wall in corner rendered over with drainage pipe at low level, penetrating through the floor.

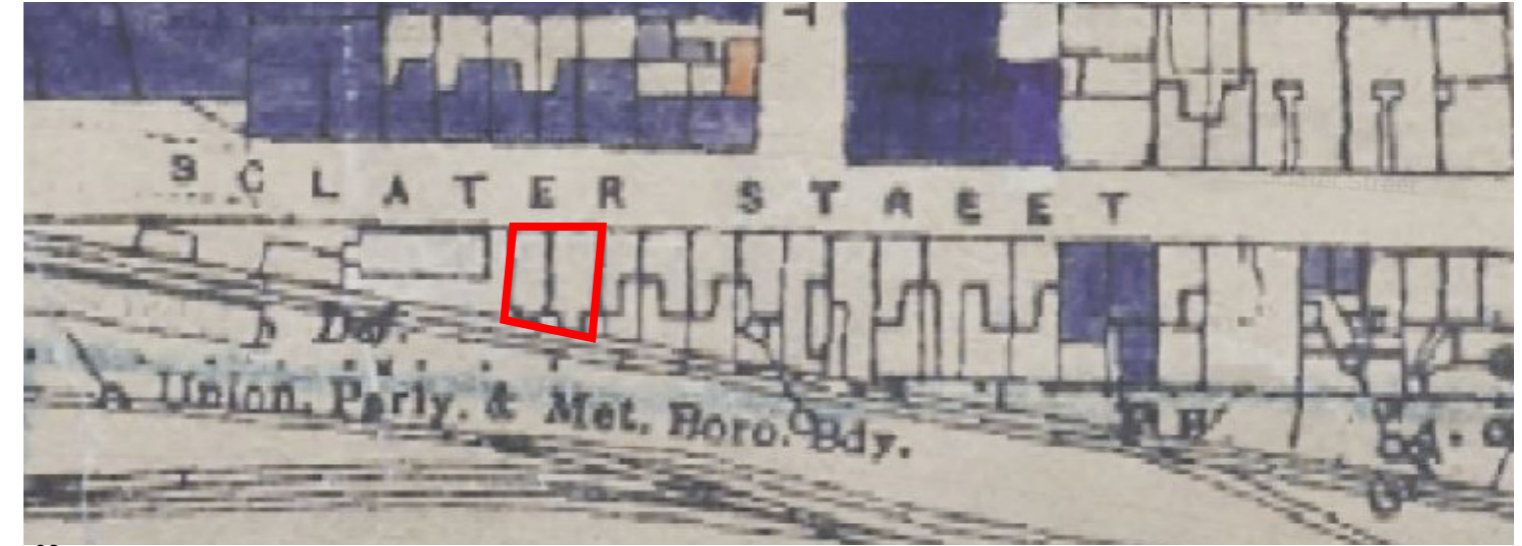
03

- 1—OS map from 1876 without the Victorian building on it.
- 2—OS map from 1915
- 3—extract from the bomb damage map 1945
- 4—OS map from 1940-1960.
- 5—Goad plan extract of 1958

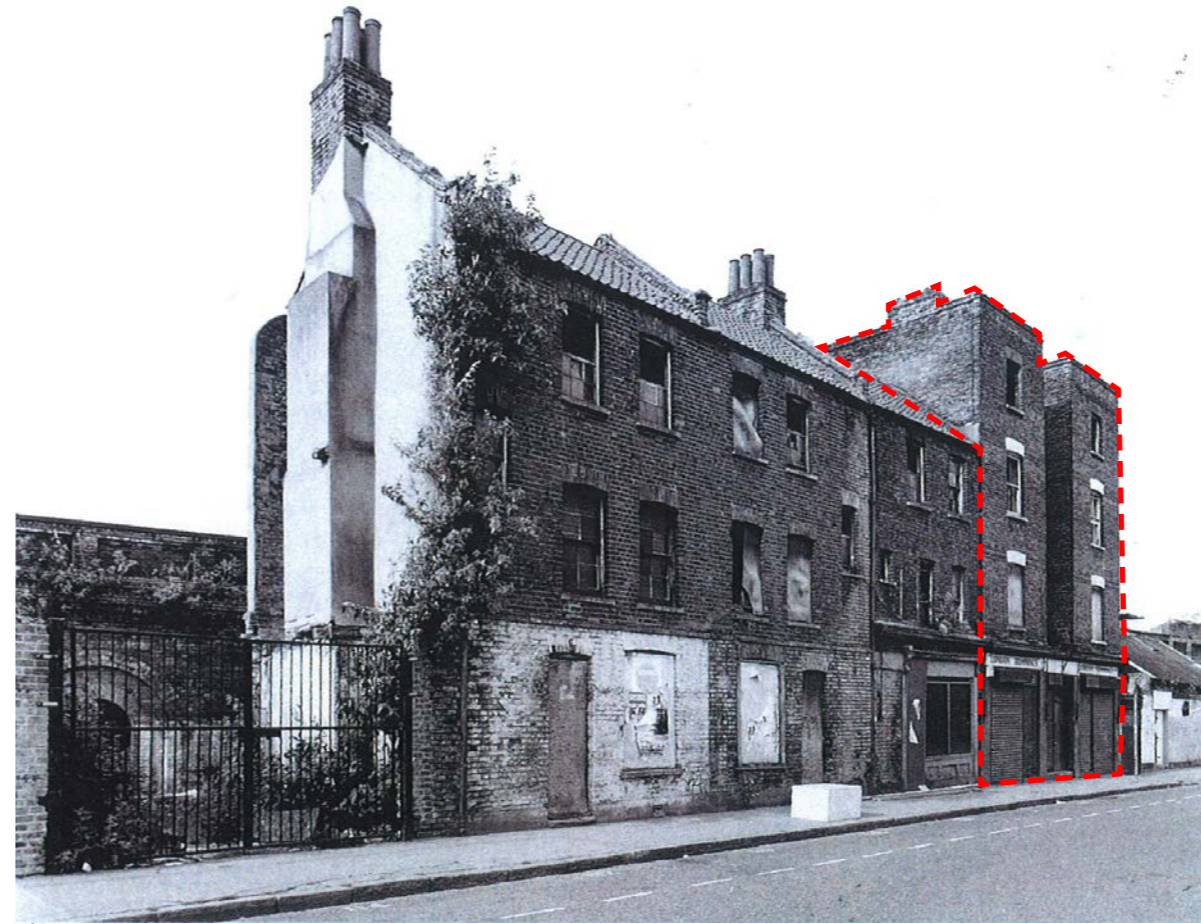
01

- 1—Nos 66-74 Sclater Street view from 2000.
- 2— No 66 Sclater Street view from 2008 with a new extension on the right.
- 3— Nos 70-74 Sclater Steet view From 1970s.

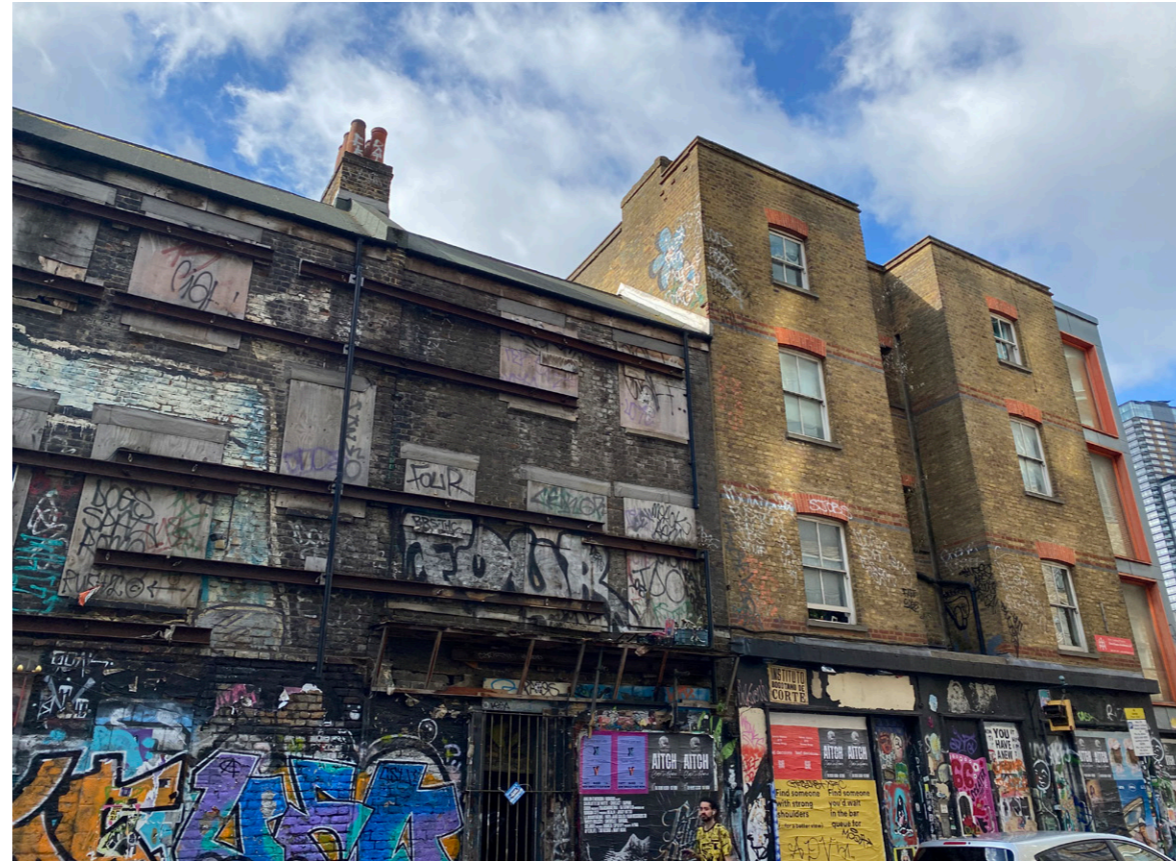
01

- 1—General view of the Victorian building and the Cottages on the left from street level.
- 2—Elevation view of the building.
- 3—Year of construction sign.

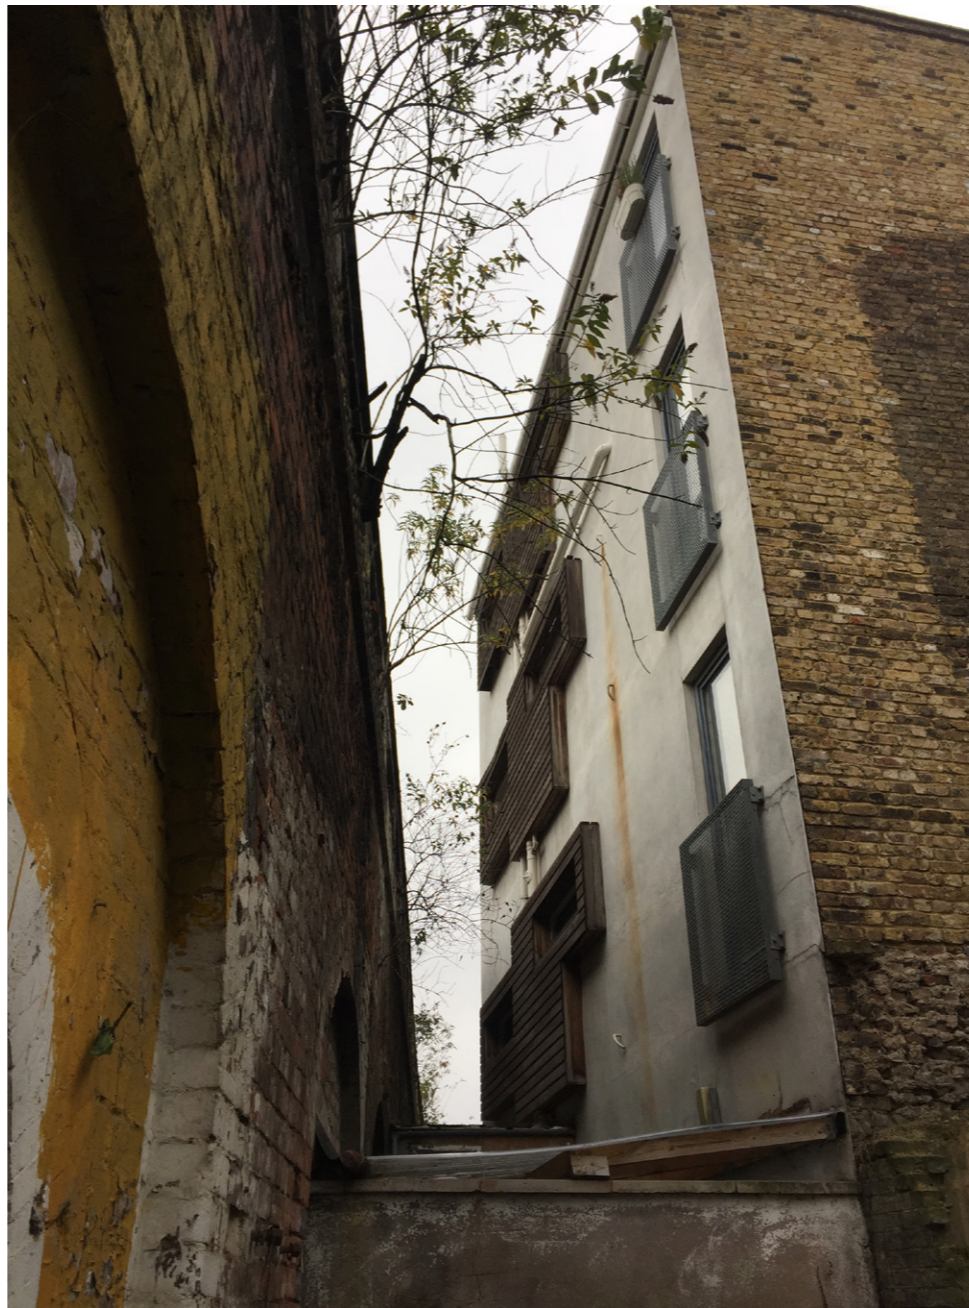
04

- 4—South elevation of the Victorian building, with the old brick wall from the Goodsyrd Station on the left.
- 5—Rear elevation inside the extension with modern electrical supplies.

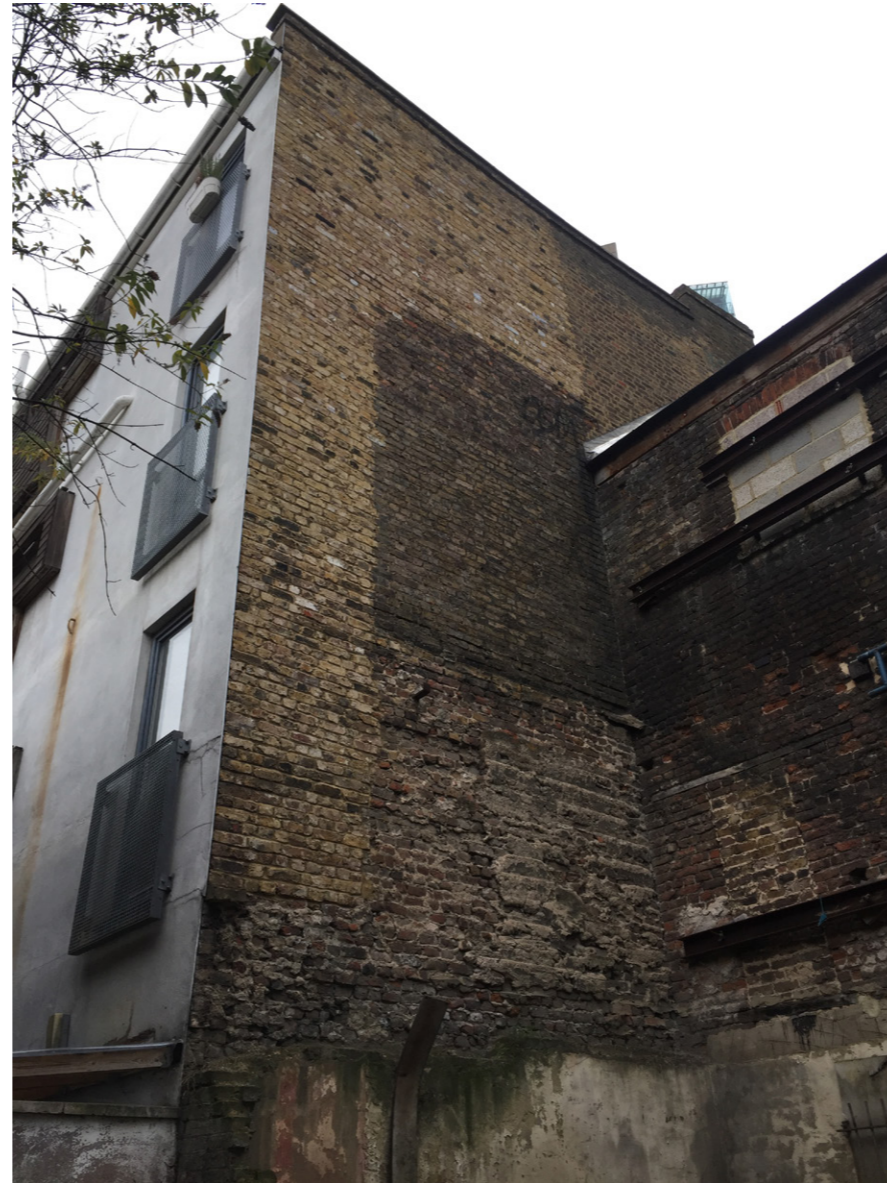
06

6-7—East elevation of the Victorian building with the part of the Cottages on the right.
8— East elevation shows timber cladding and balconies.

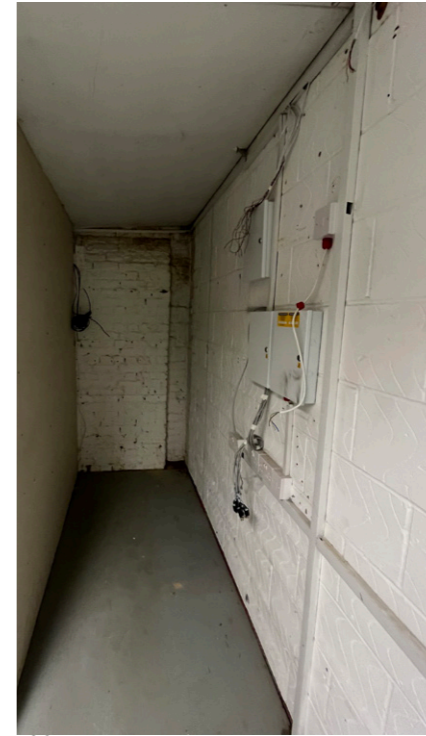
08

8-9—the Victorian building inside the extension seen on the right hand side of the image. Brickwork has been painted white, with modern electrical supplies and panels.
10—West elevation of the Victorian building from the street view.

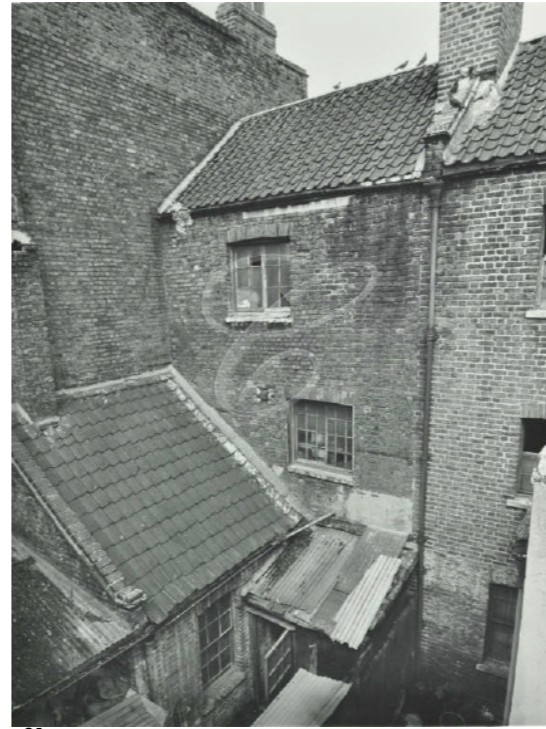
01

- 1-3—View of rear elevations of 70-84 Sclater Street from 1973.
- 4—View of front elevation of house and Palmers shop 70 Sclater Street from 1973
- 5—Nos 70-74 Sclater Steet view From 1970s.

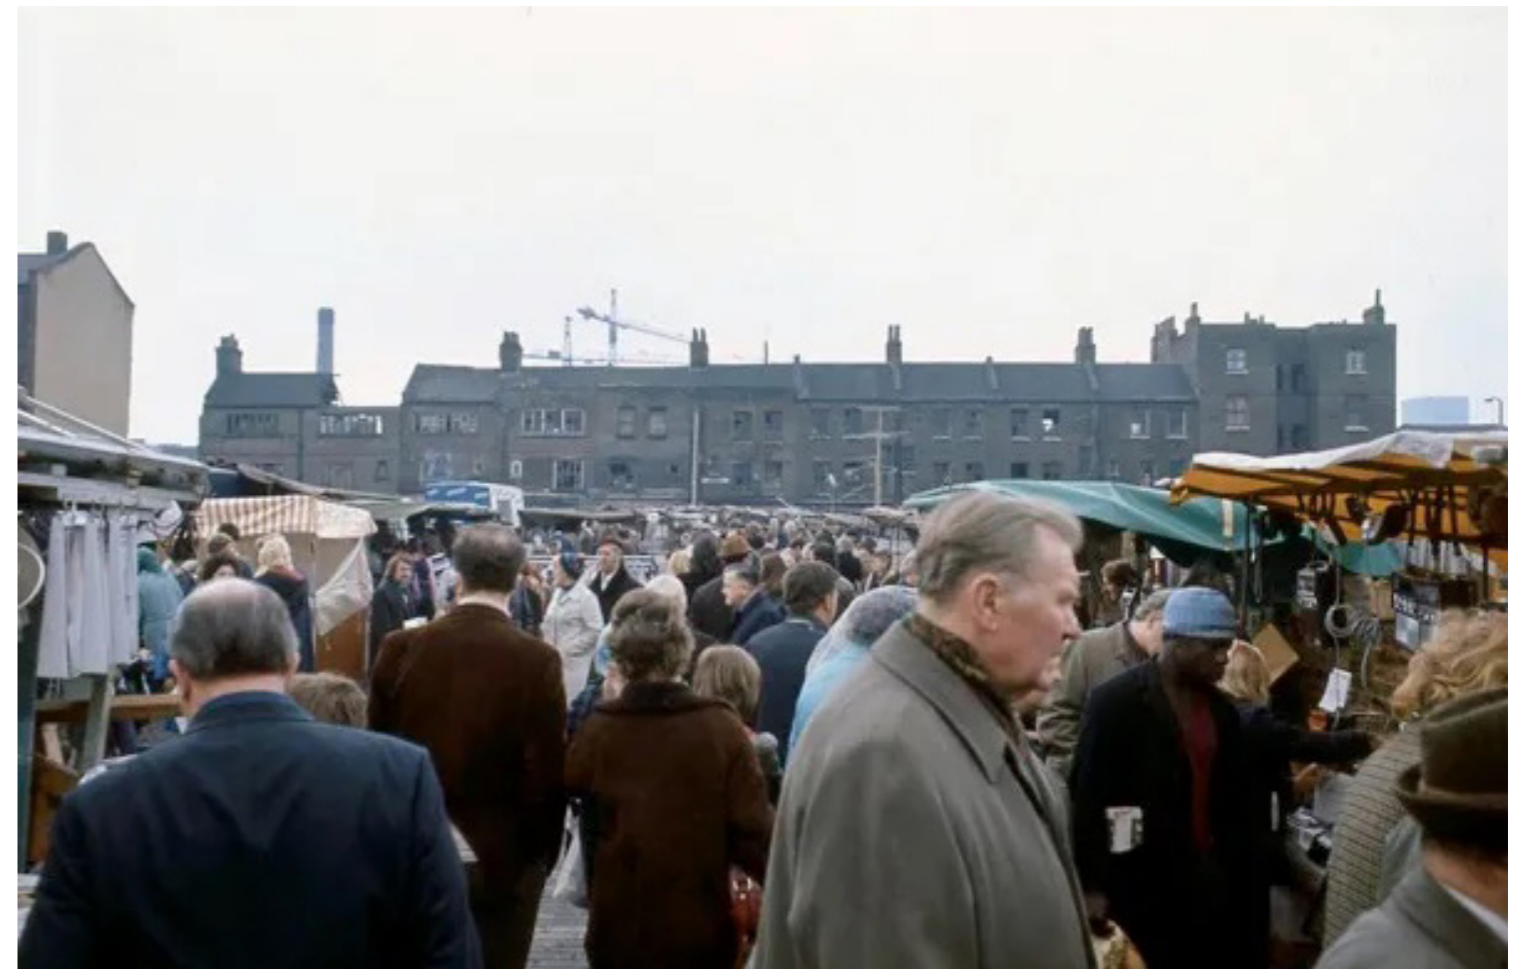
05

6-7—No. 70-74 Sclater Street view from 2000
