Bishopsgate Goodsyard Plot 5

HERITAGE RECORDING

SCLATER STREET BUILDINGS

March 2024

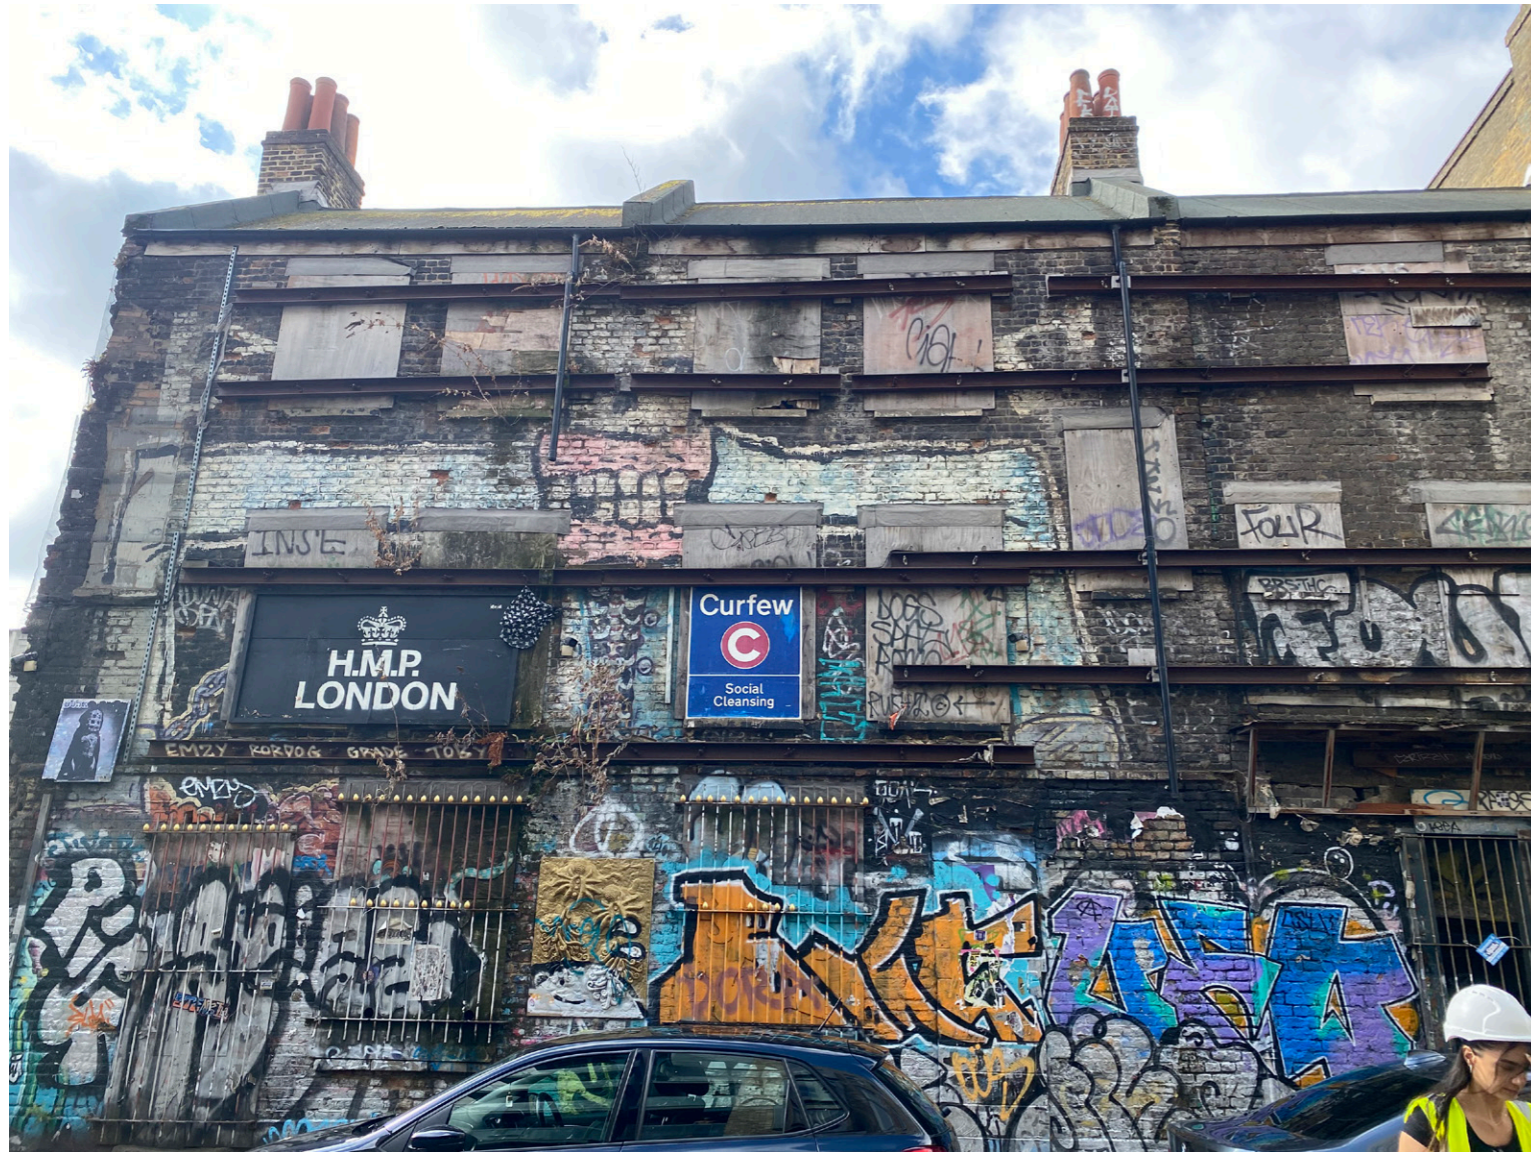
01

- 1—Front view of the Cottages, with several metal beams, plywood panels on the upper windows and grilles on the ground floor windows.
- 2—General view of the Cottages from street level.

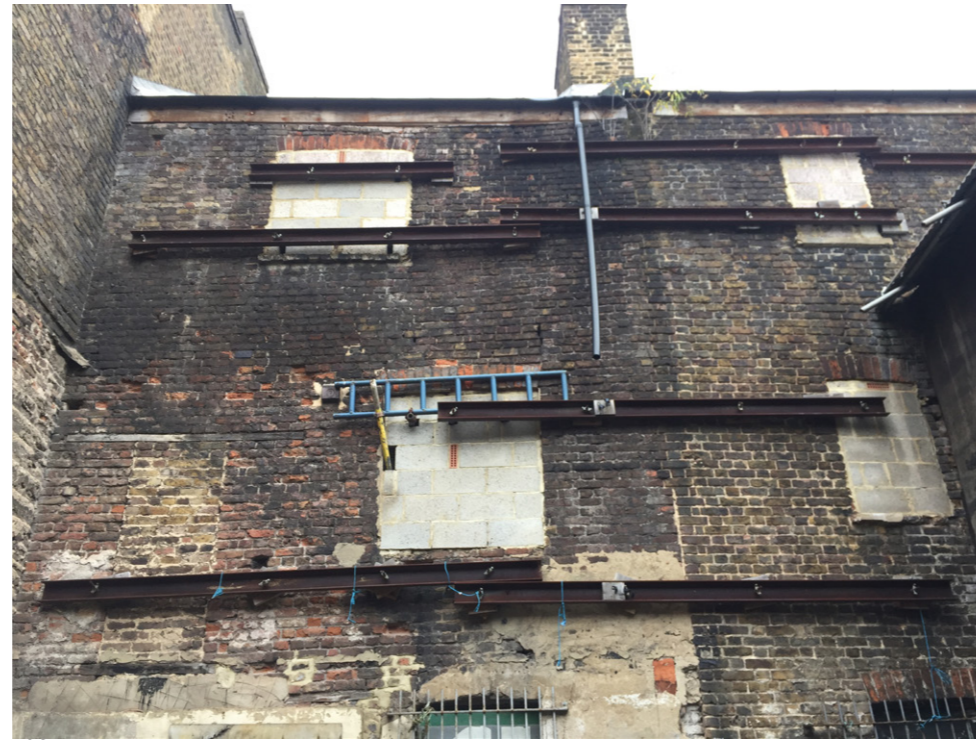
03

- 3—No. 74 Sclatler Street rear elevation view, with infilled windows and metal beams on them.
- 4—No. 74 Sclatler Street rear elevation view, with grilles and plywood panels on the groundfloor windows.
- 5—No. 72 Sclatler Street rear elevation view, with metal beams and grilles on the windows. Modern electrical supplies, conduits and CCTV.

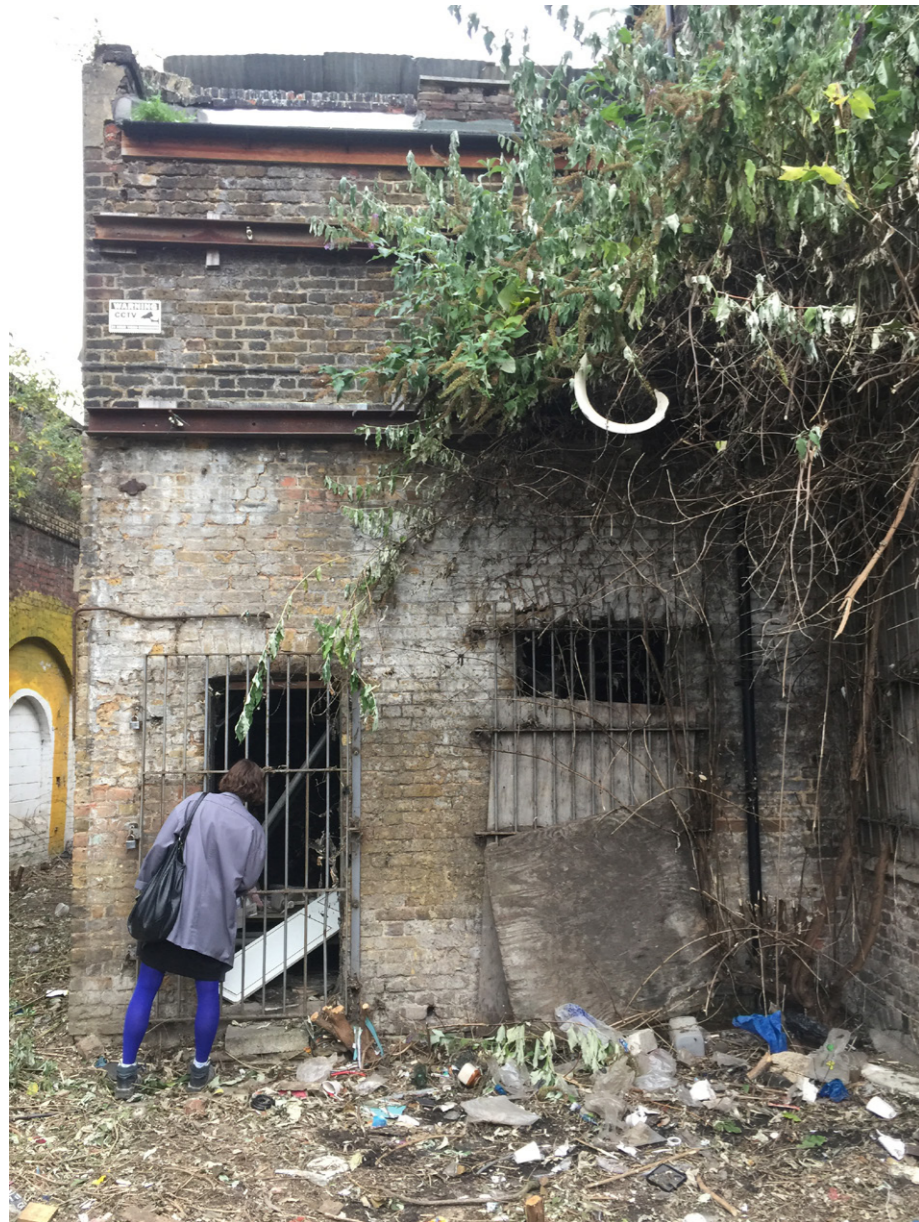
06

- 1—No. 72 Scletter Street east elevation view, with metal beams and grilles on the windows.
- 7—No. 72 Scletter Street east elevation view, with chimney.
- 8—old fireplace

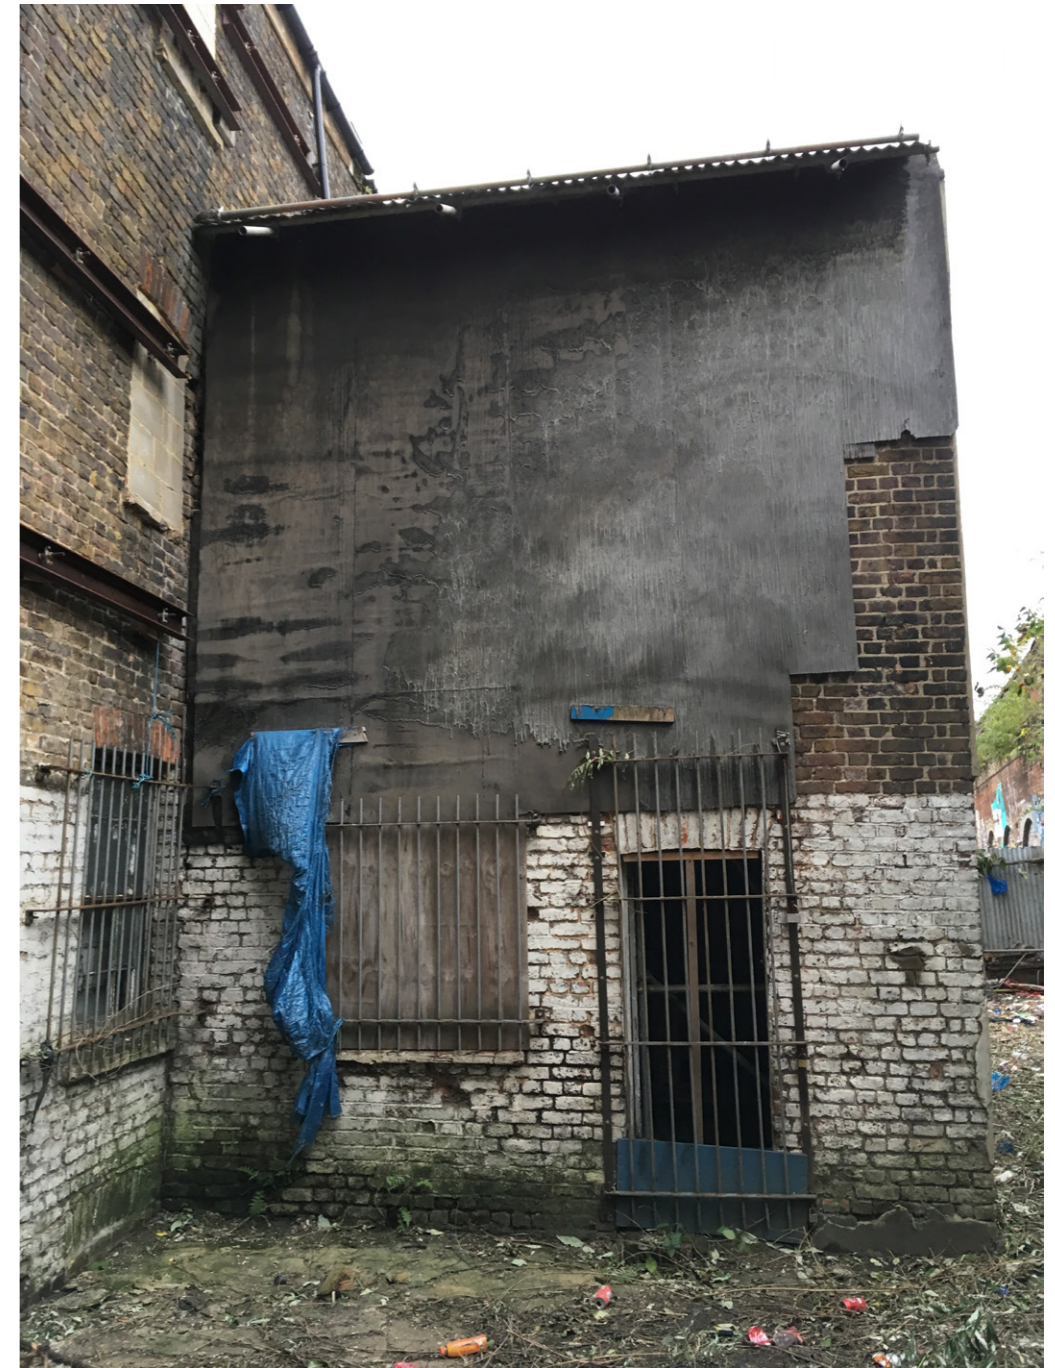
9—Side view of the extension, with plywood covering and grilles on the windows.

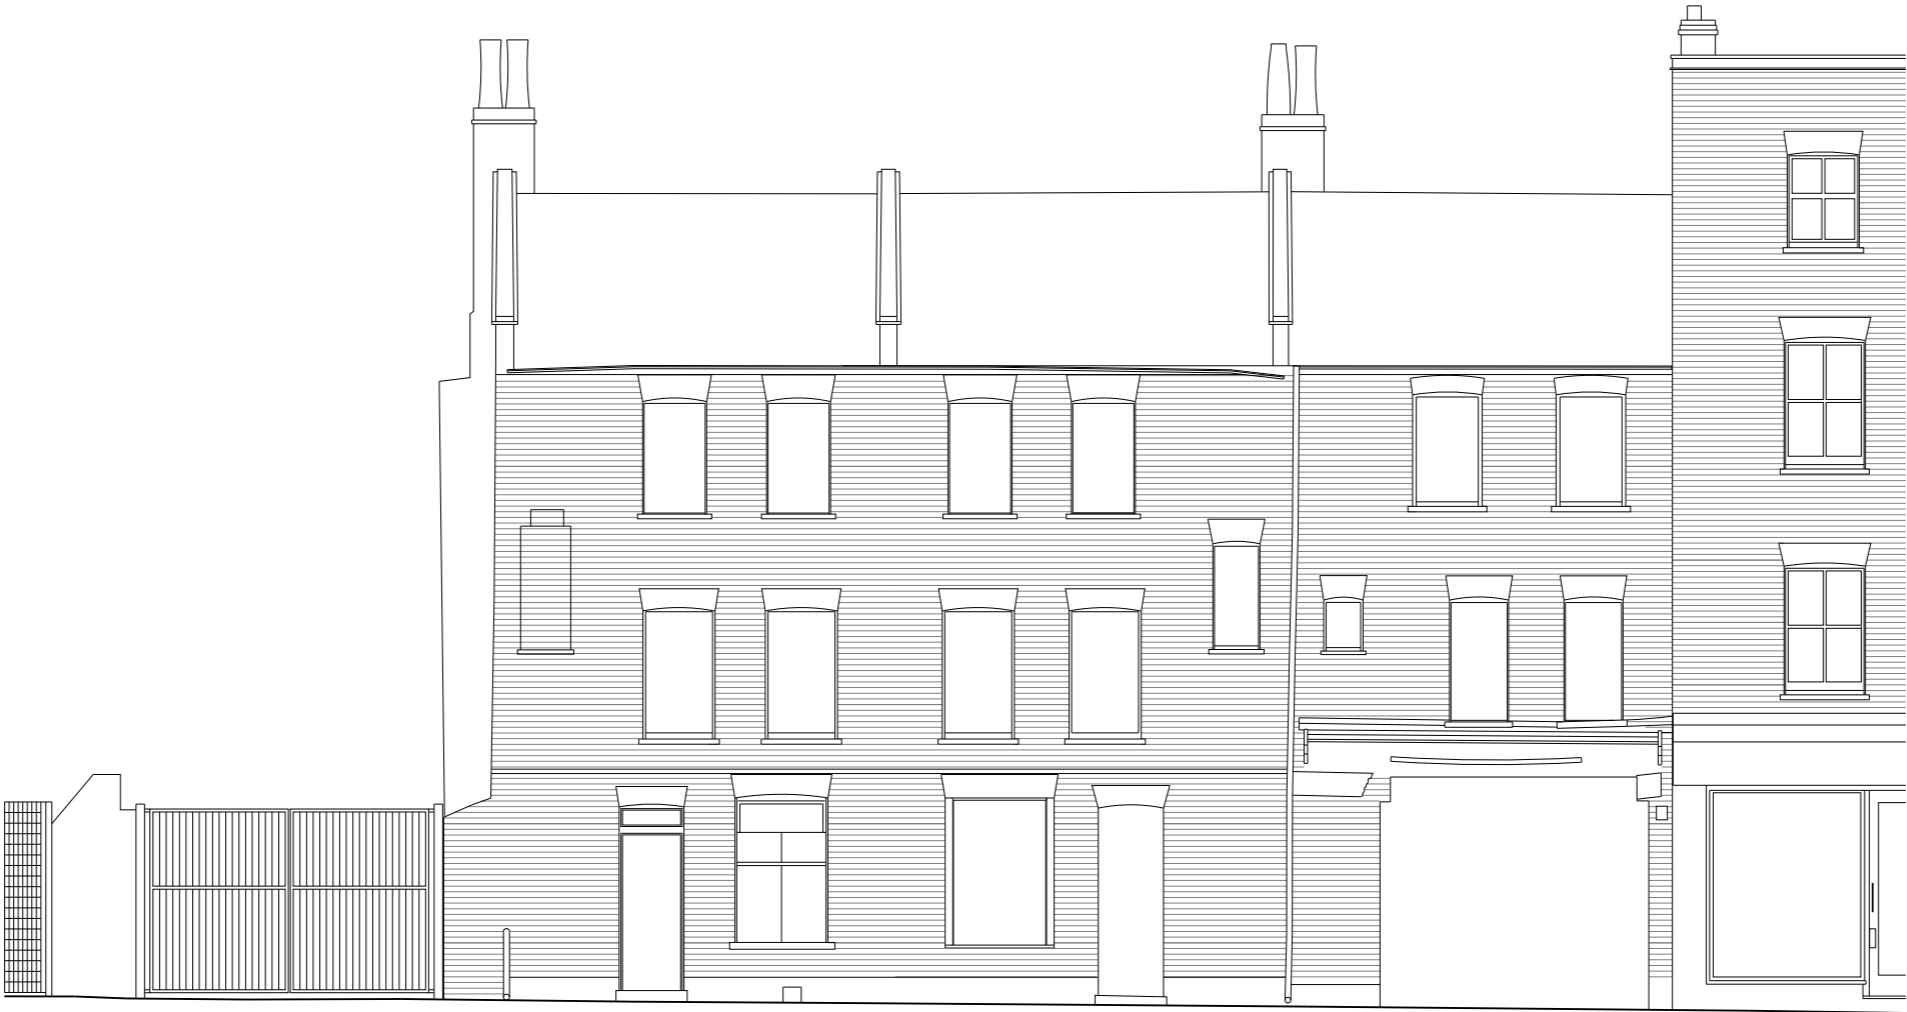
1 1:50 @ A1 / 1:100 @ A3
EXISTING FRONT ELEVATION - 1

Existing Sclater Street Elevation

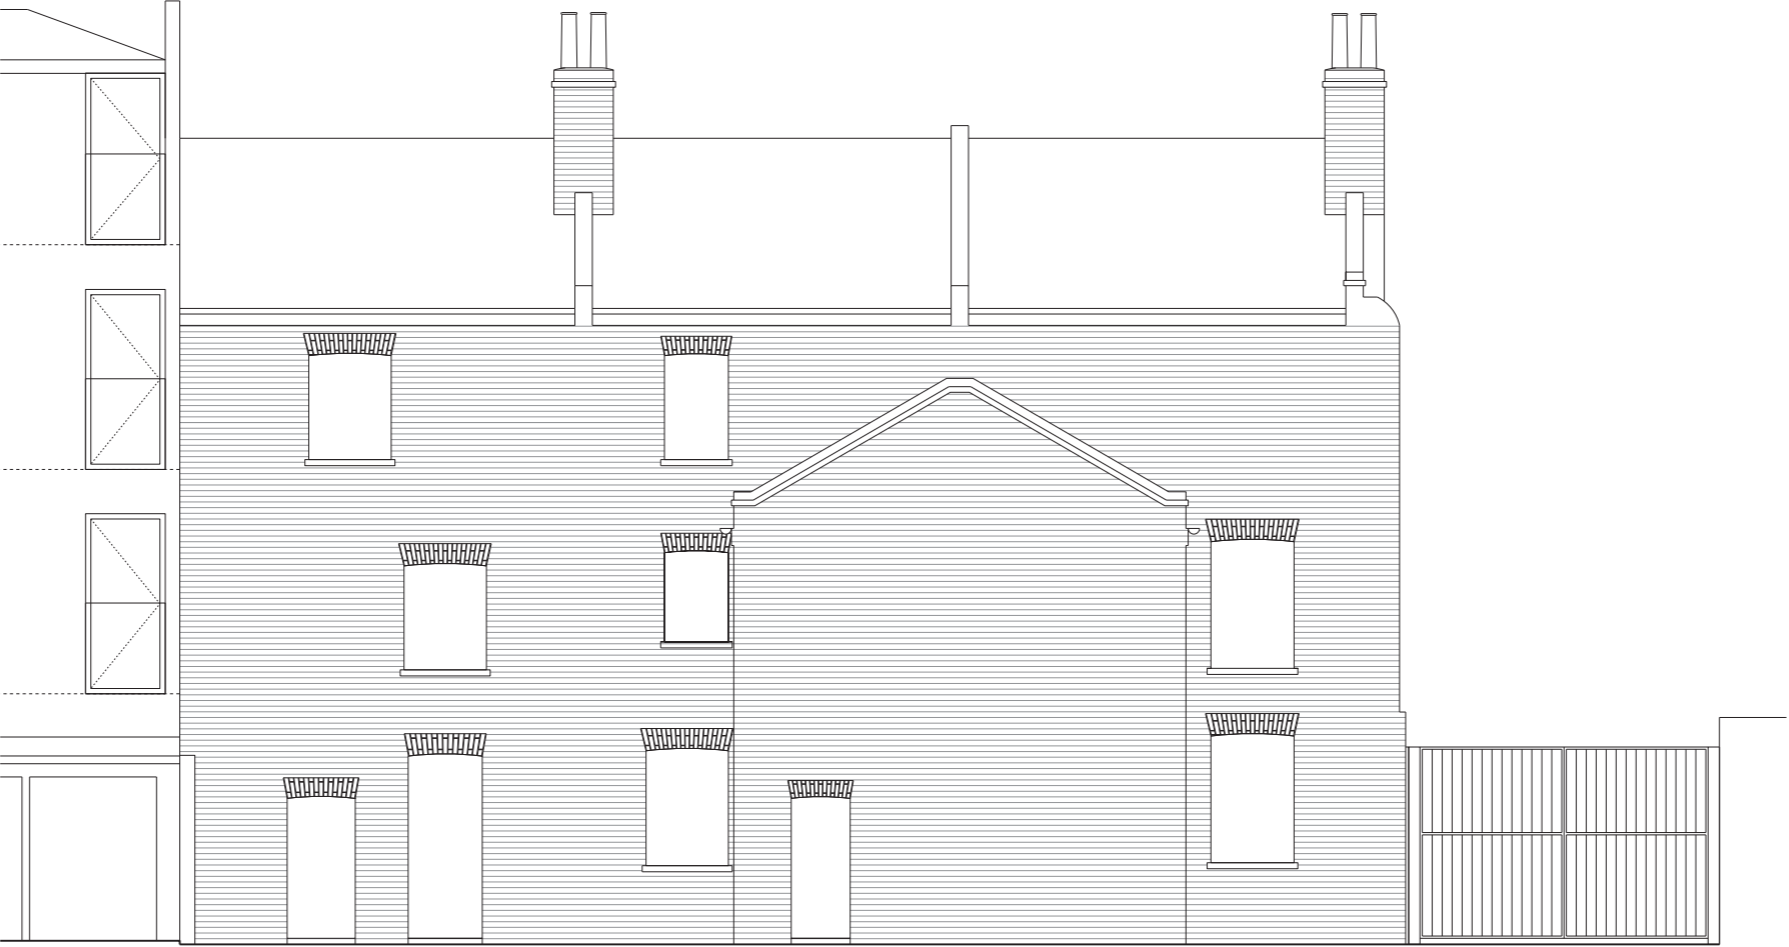
1 1:50 @ A1
EXISTING ELEVATION

Existing Rear Elevation

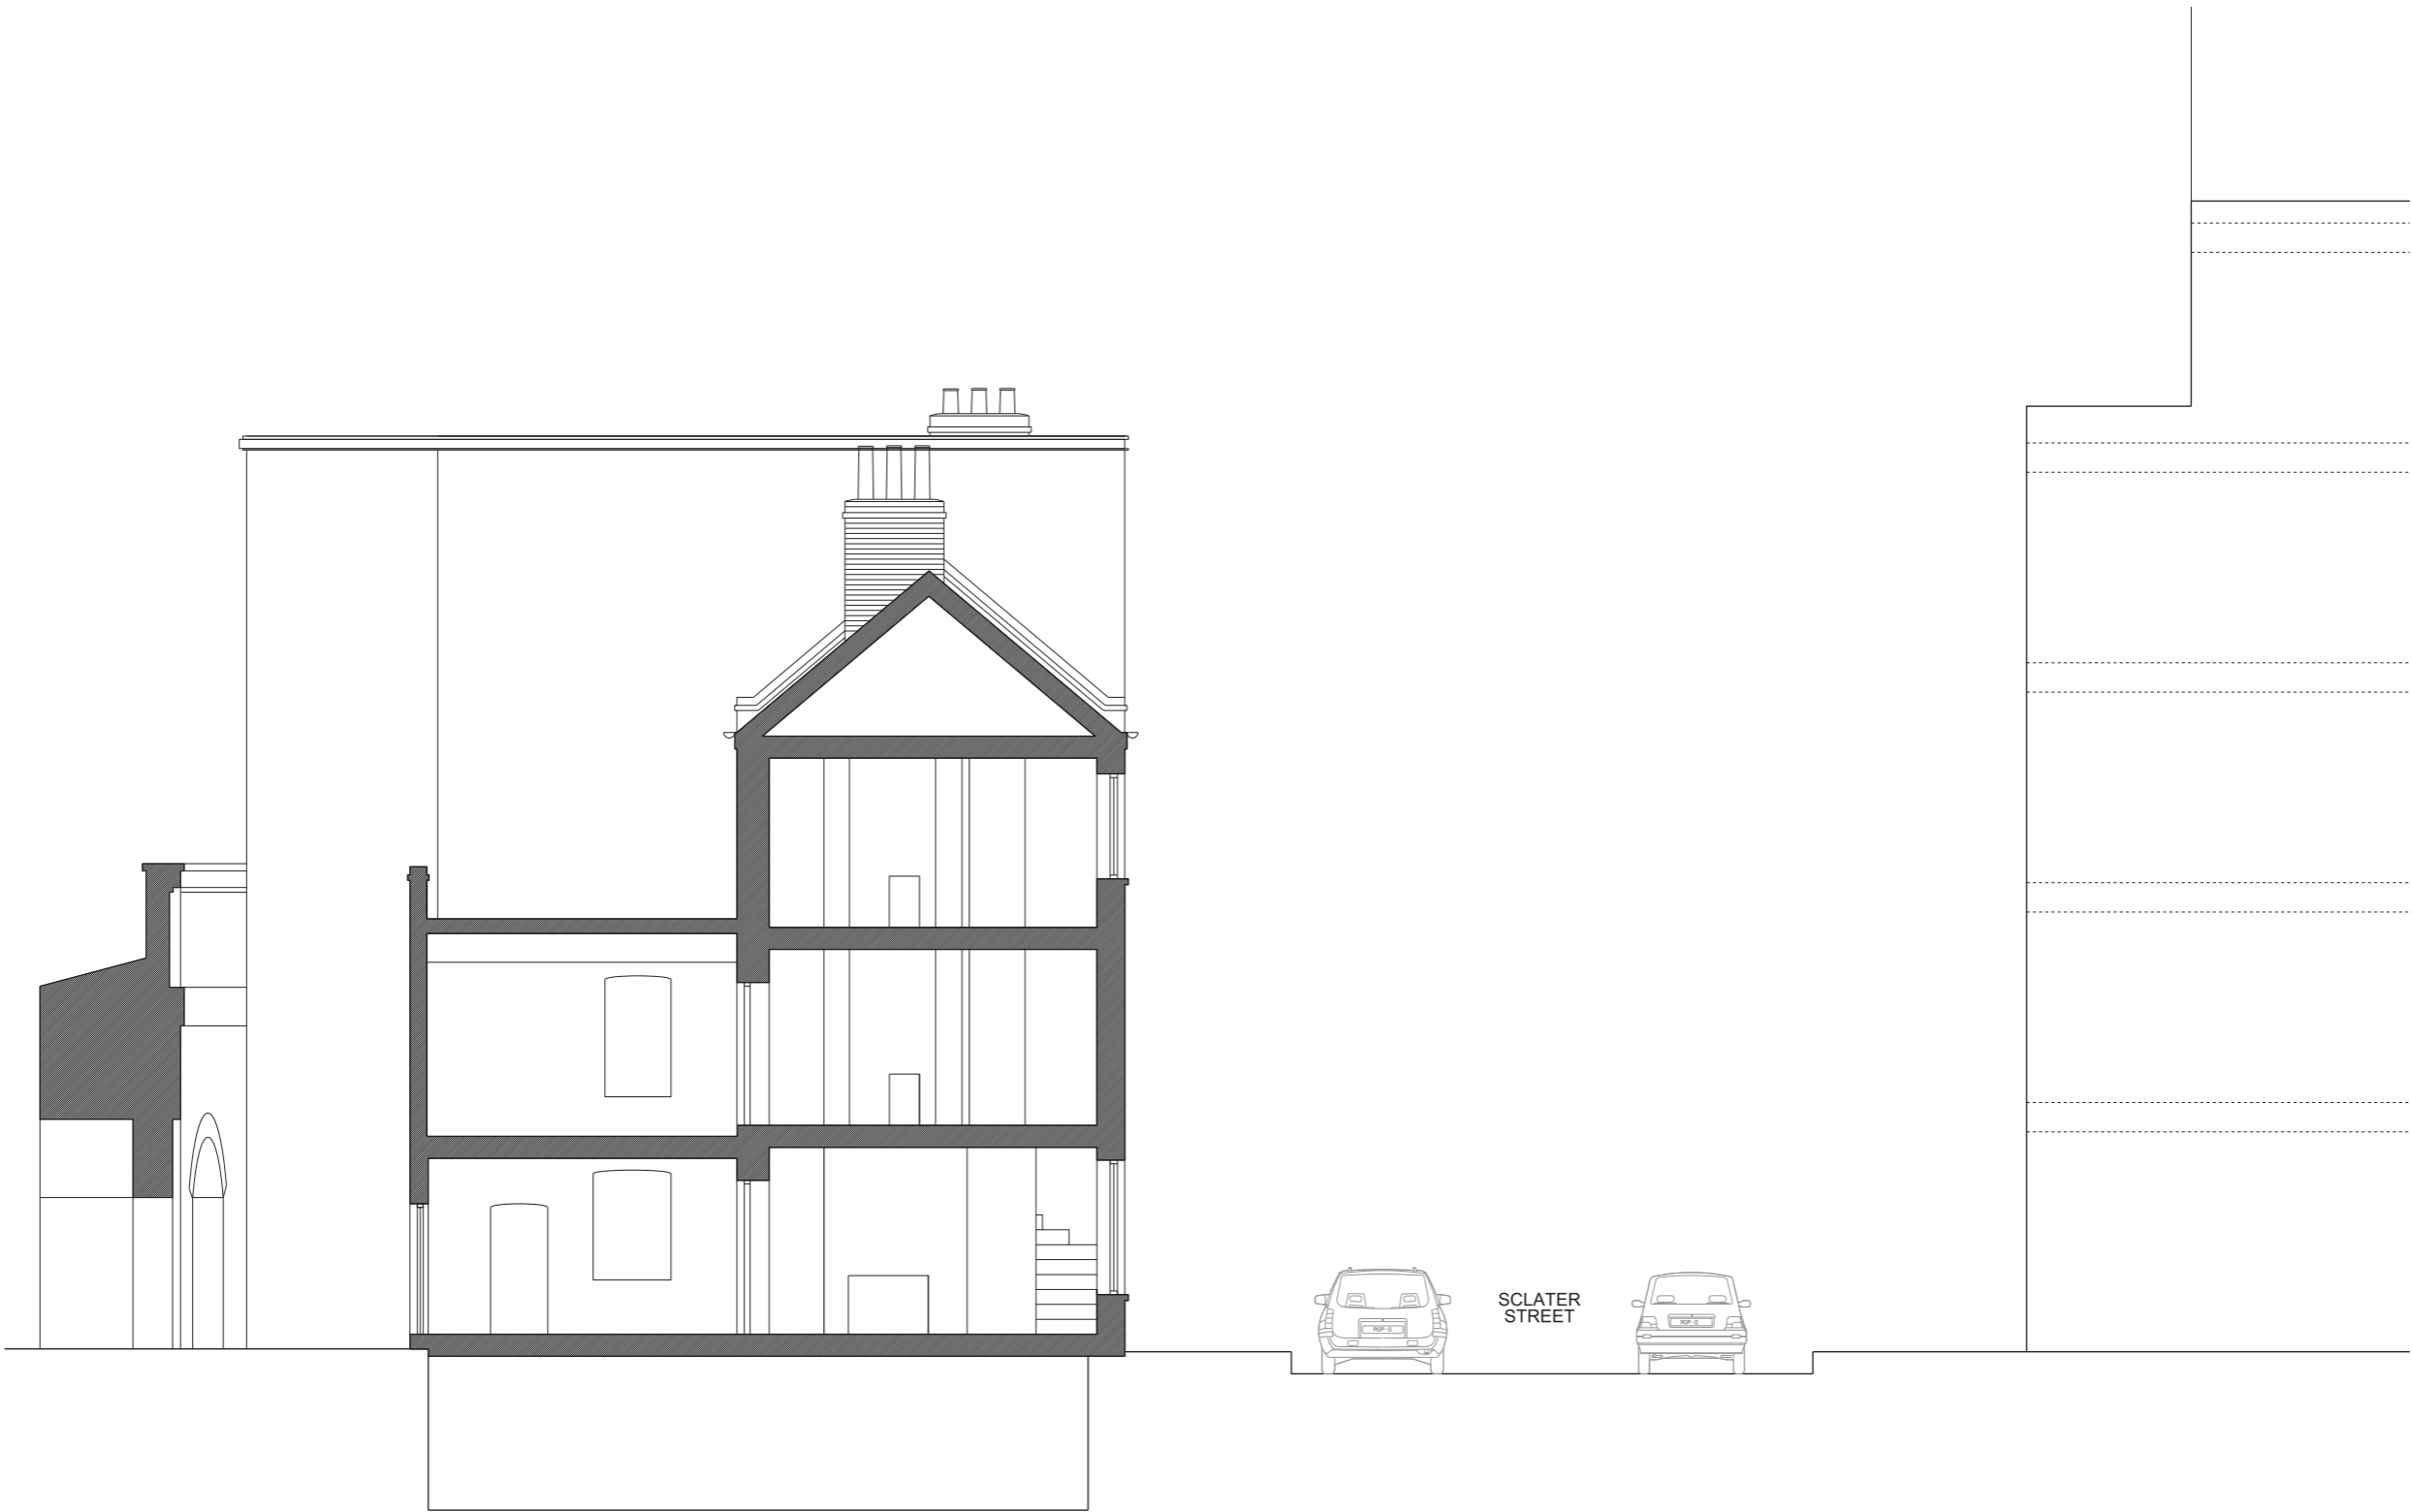
1 1:50 @ A1 EXISTING SECTION CC

Existing Section Through
