Drawing status: PLANNING
FOR LISTED BUILDING CONSENT

Drawing No: BGY-FBA-07-XX-DR-A-00_10-7B03

Job Title: The Goodsyard

Drawing Title: PLOT 7B - EXISTING SECTIONS
SHEET 3

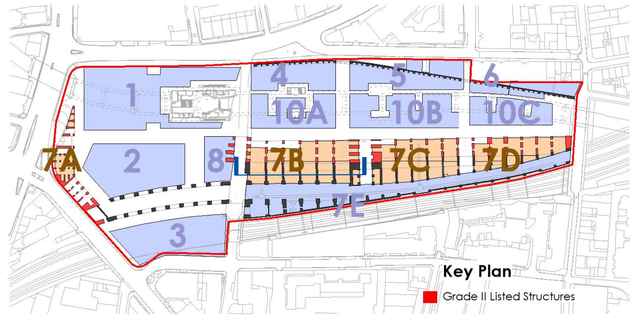
EXAMPLES OF DEGRADATION OF JACK ARCH BEAMS DUE TO WATER INGRESS FROM PARK LEVEL ABOVE - Please see Structural engineers report for description of required remedial works.
