THE GOODSYARD

Structural Engineering Condition Survey Report

September 2019

This is a structural visual condition survey report of the existing structures on the Bishopsgate Goodsyrd site undertaken on 15th & 18th February 2019 prepared by WSP.

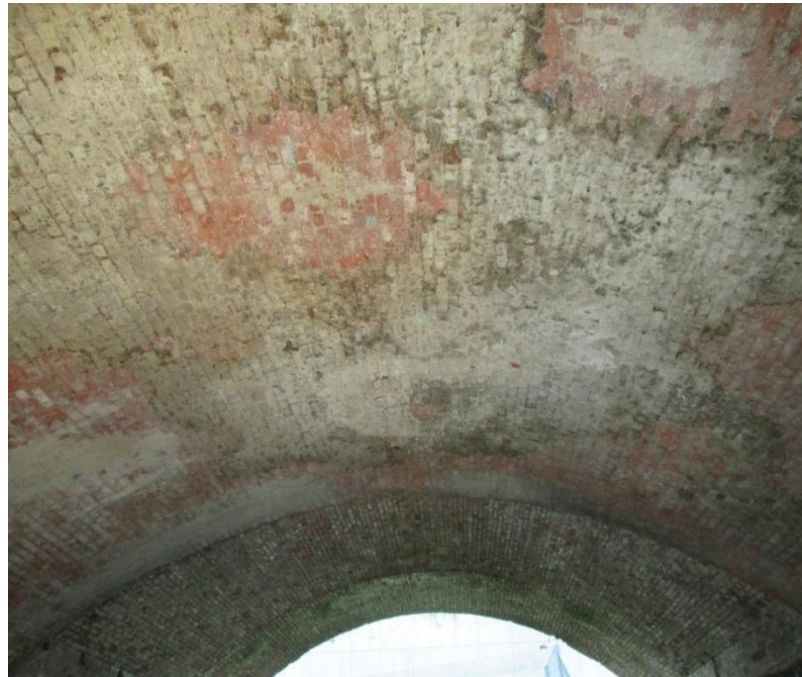
WA2: Braithwaite Arch

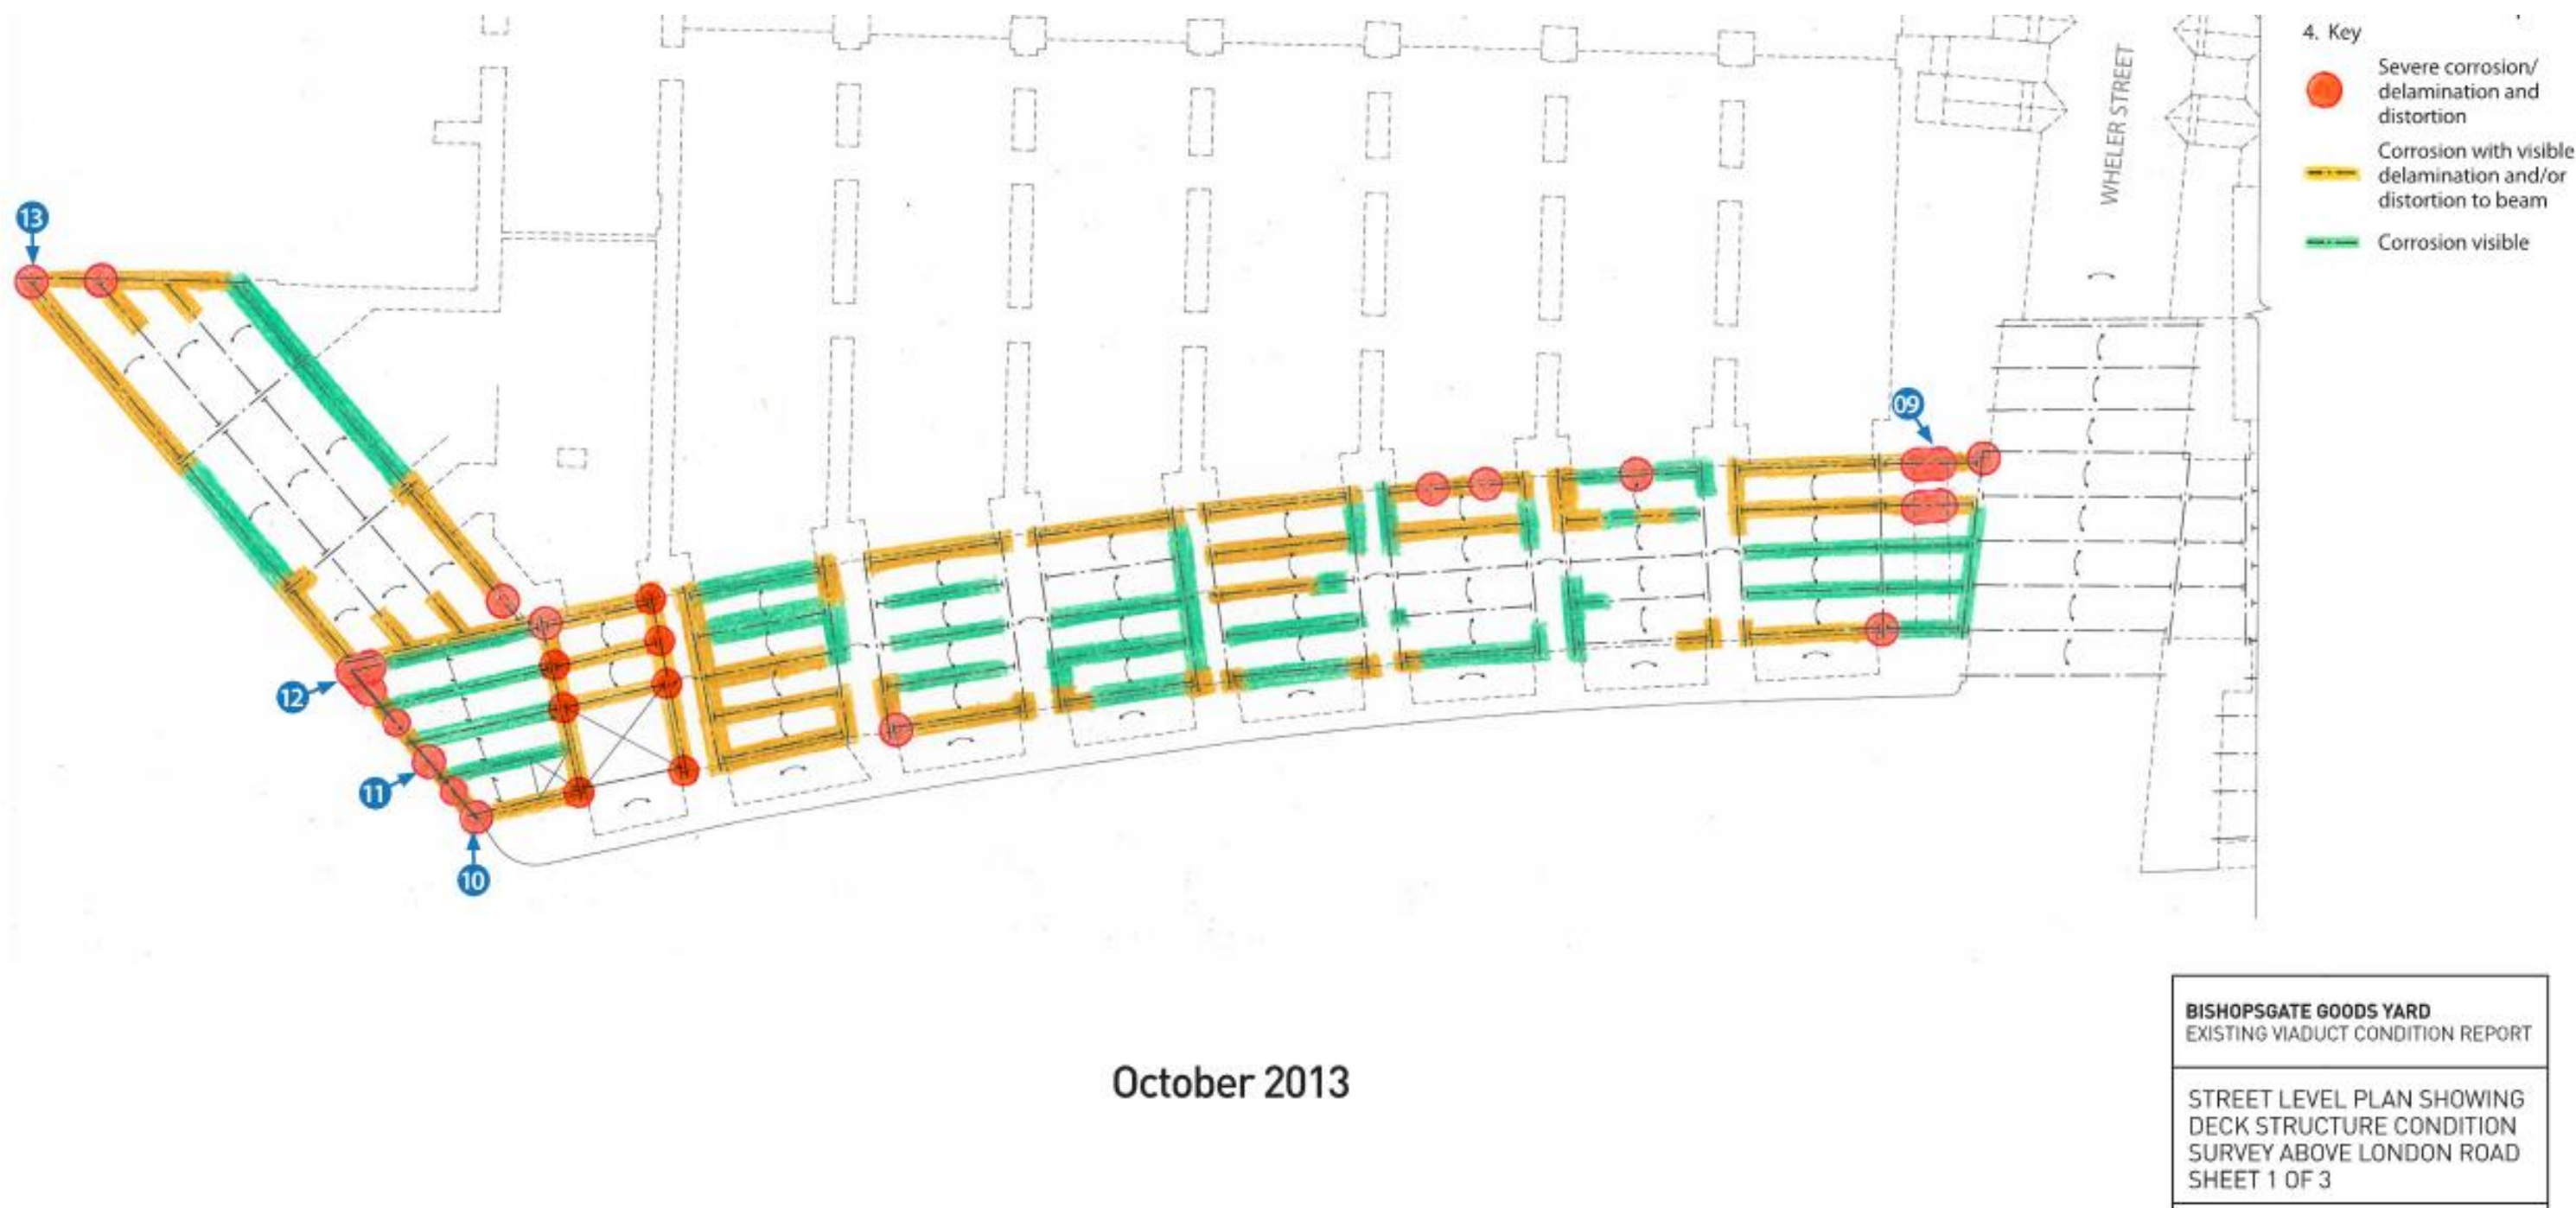
Fig 1.4.1: Extract Alan Baxter 2013 report Condition Plan London Road Deck Structure sheet 1 of 3

The Alan Baxter 2013 report states the Jack Arch structure is in extremely poor condition with further deterioration of the jack arch beams and supporting beams having taken place. Where water continues to penetrate the structure very significant loss to sections of the beams is apparent. The worst of the corrosion was noted as being along the southern most exposed side of the structure, to the edge of the viaduct. Concern was expressed at the extent and ongoing deterioration and it was recommended temporary support be provided to the worst affected beams.

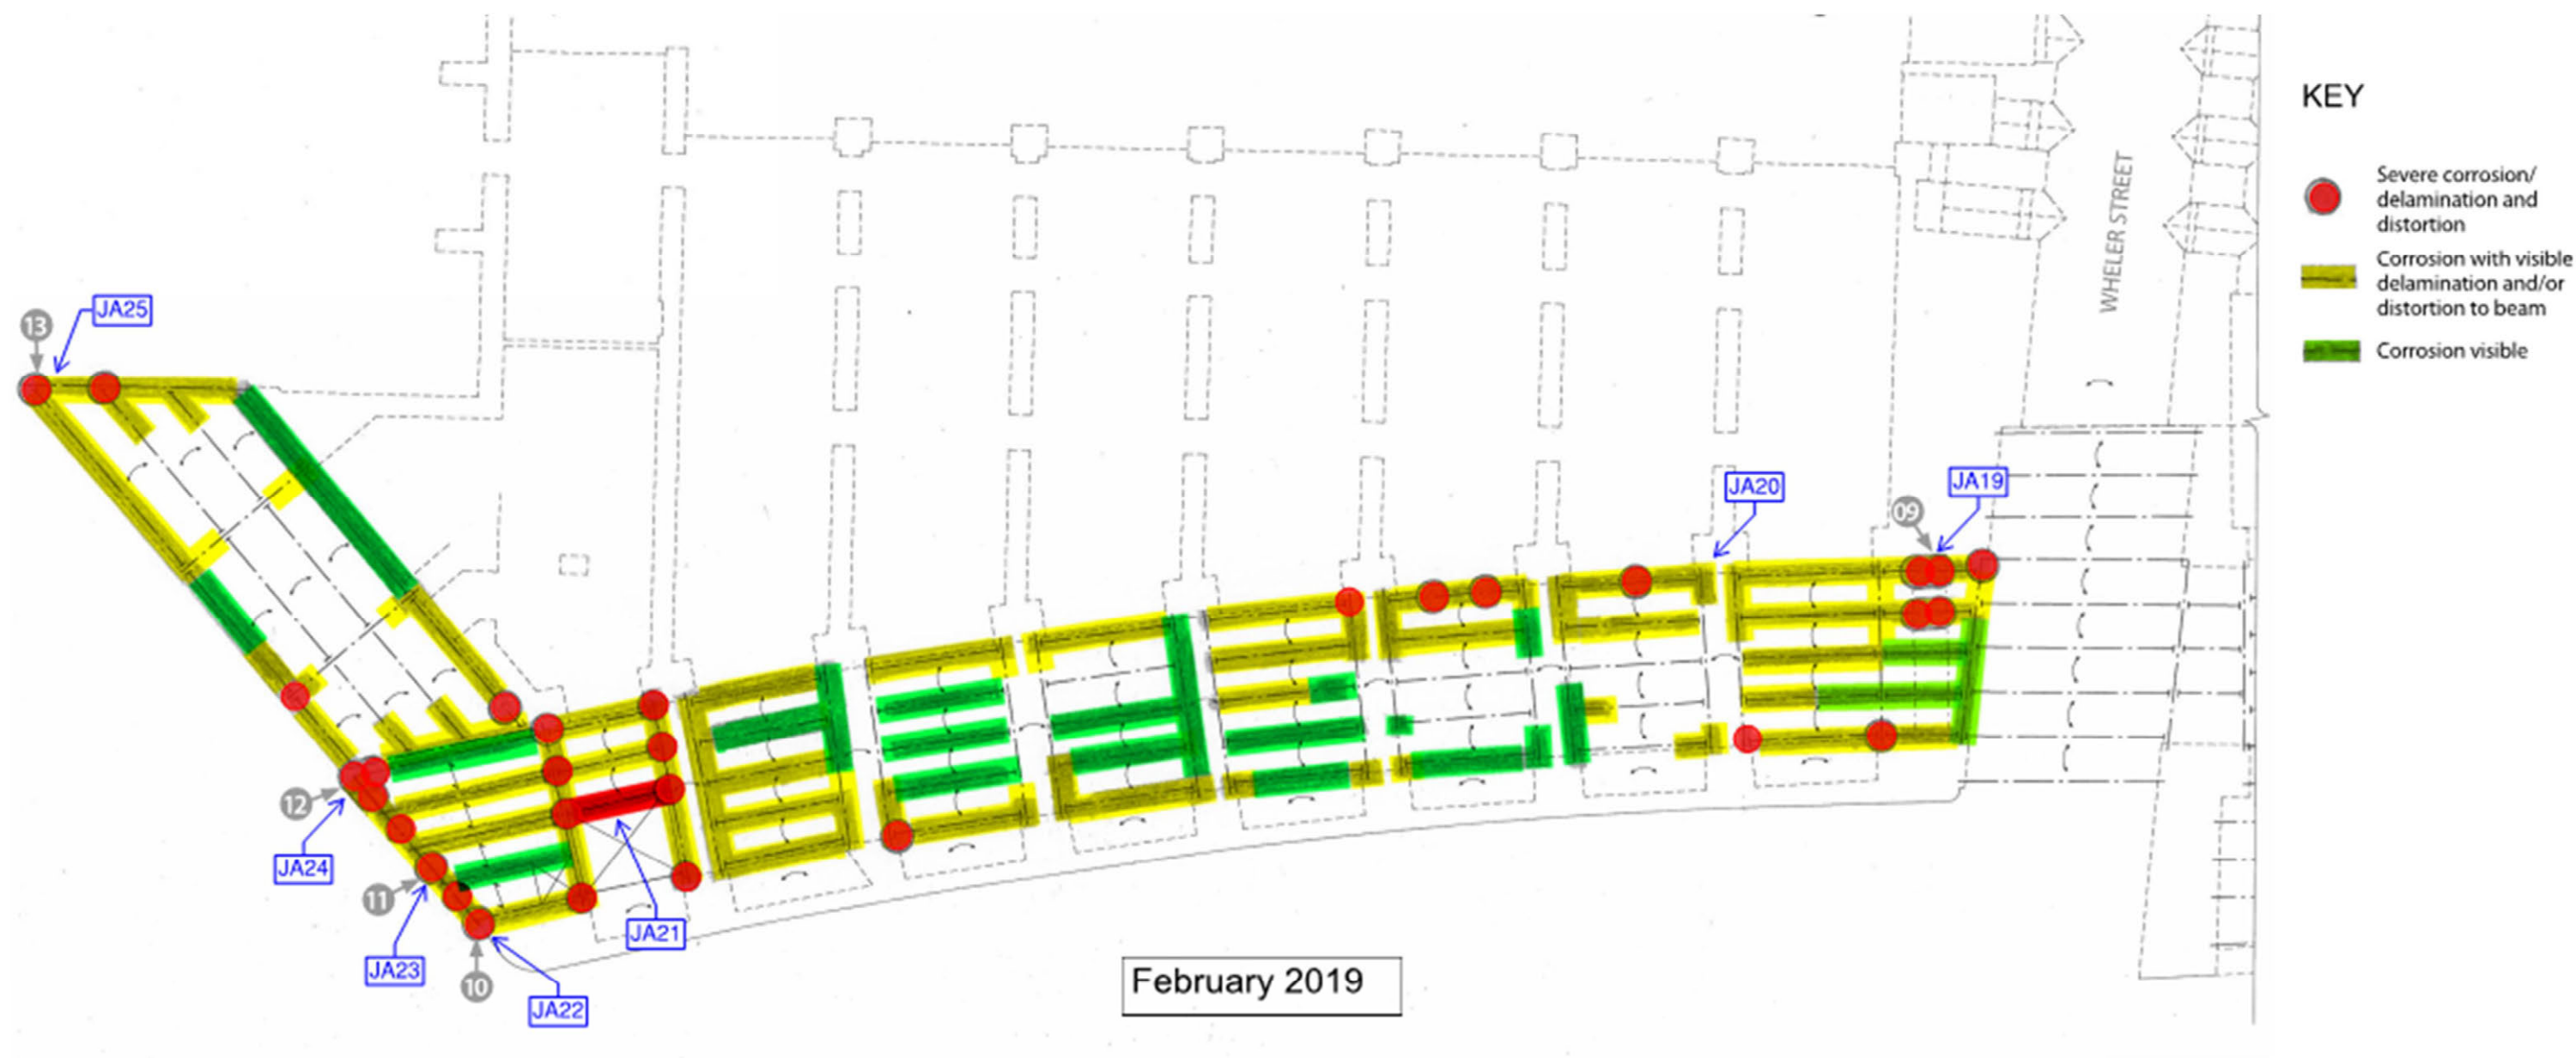
Fig 1.4.2: WSP observations 2019 Condition Plan London Road Deck Structure sheet 1 of 3

Based on Alan Baxter 2009 and 2013 photographic evidence and a marked-up condition plan summarising the condition of the viaduct structure, it's evident further continued deterioration of the steel members has taken place over the past 6 years due to continued weathering / water penetration.

Due to the substantial loss of steel to some of the members combined with the ongoing continued deterioration due to water ingress, we are of the opinion in order to avoid the potential risk of structural failure to the worst corroded areas temporary propping to these beams should be undertaken as soon possible combined with the removal of the fill material above currently surcharging the jack Arch structure.
