THE GOODSYARD

Heritage Statement: Appendix C – Heritage Fabric Assessment

September 2019

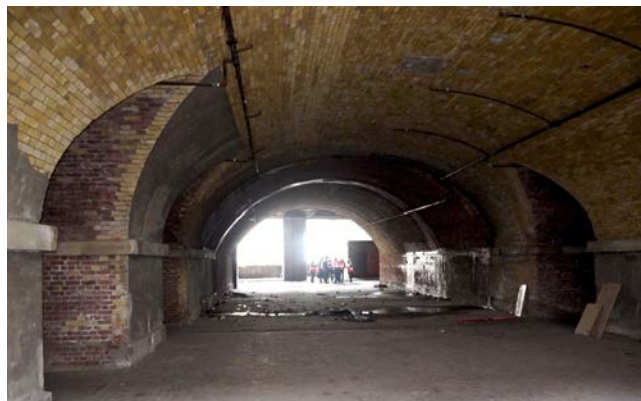
2.1.1.2.1 The Braithwaite Arches constructed in the 1840's was recorded as being in good condition for its age and type. There was no apparent sign of settlement and no sign of cracking or frost damage to the brickwork. It was noted that the northern face of the Braithwaite Viaduct appeared to be cut back to accommodate an extension which has since been demolished leaving the rendered cut face exposed.

Fig 2.1.2: Braithwaite Arches Vault looking south

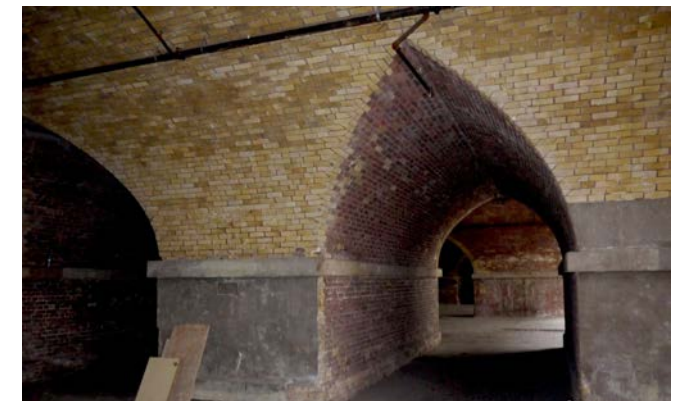
Fig 2.1.3: Gothic style cross vaults

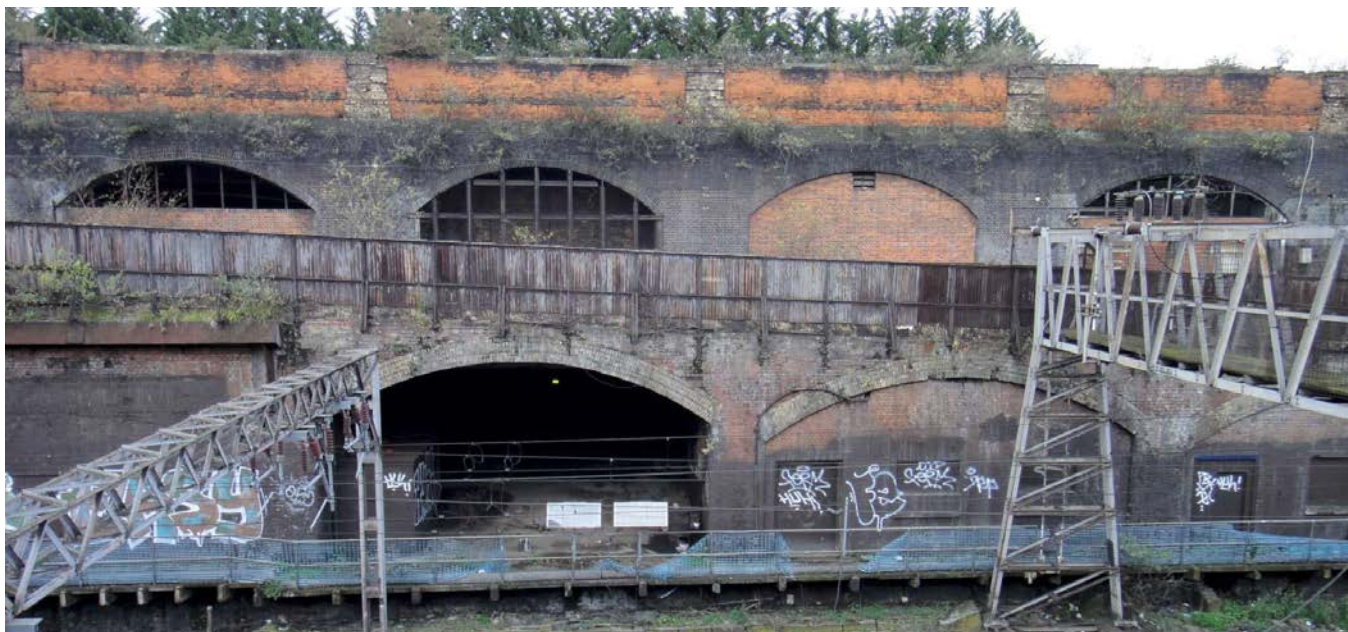
- 2.1.2.5.7 Water markings were noted to the underside of the brickwork arch soffits, which most probably has been caused from water seeping in from above, but there was no evidence of spalling to the brick arches due to weathering. Missing bricks to the fascia fronting the main line railway to a few arches were noted.

Fig 2.1.19: General view of the Sliver arches overlooking the main line

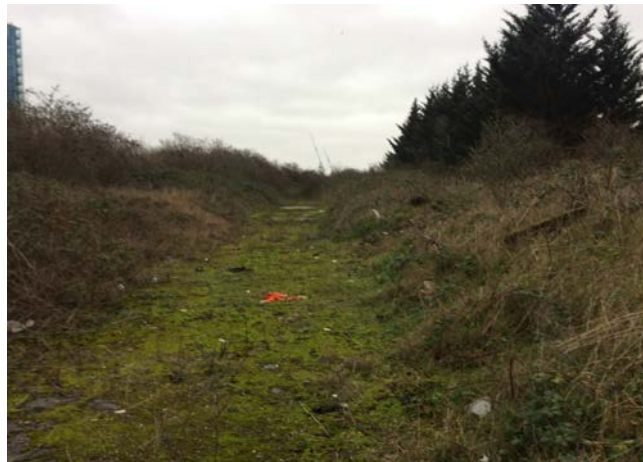
Fig 3.1.4: Extensive vegetation looking east over London Road

3.1.8.5 There is currently extensive loss of materials and vegetation over the viaduct / arch structures which in areas extends over 1.5 to 2.0 metres in height.

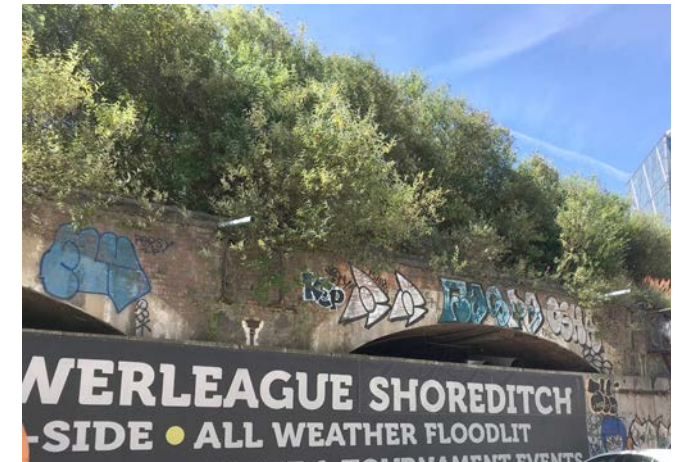
Fig 3.1.5: Extensive vegetation to the edge of the Braithwaite Viaduct

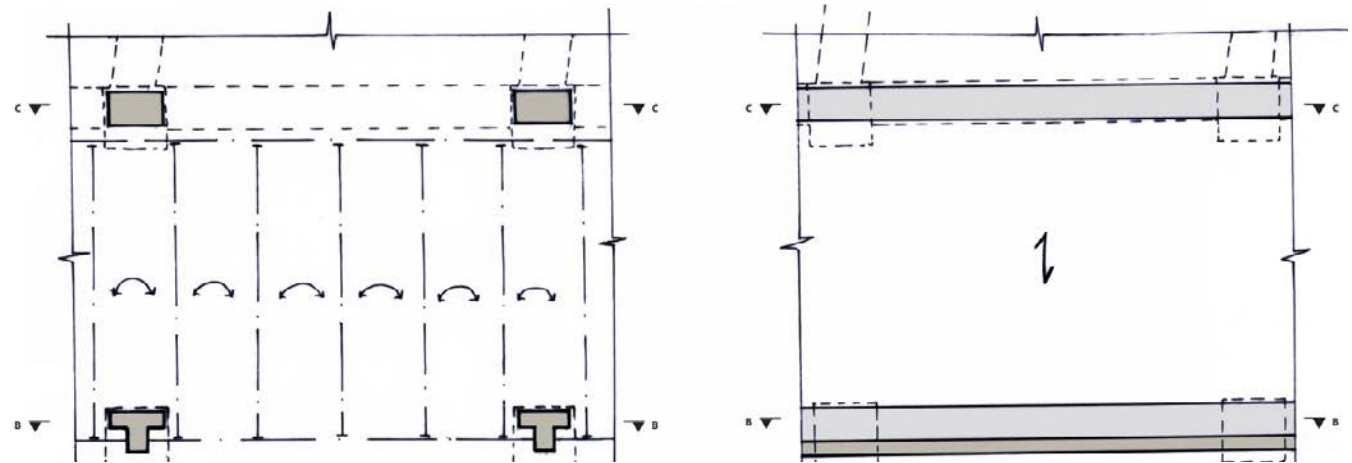
3.6.12.1 Above London road and the SLT a series of steel and brick jack arches span across the line at London Road level and at Park level. The condition of the Jack Arch structure is poor as previously reported by Alan Baxter's in their reports of 2009 & 2013.

3.6.12.2 The steelwork to the jack arches at the upper and lower levels are heavily corroded and a number are likely to have to be replaced. Alan Baxter in their report of 2009 proposed a possible solution where the existing steel beams remain in place and are hung from a new reinforced concrete structure installed above the beams.

Fig 3.6.16: Existing jack arch deck with proposed support locations for new concrete deck

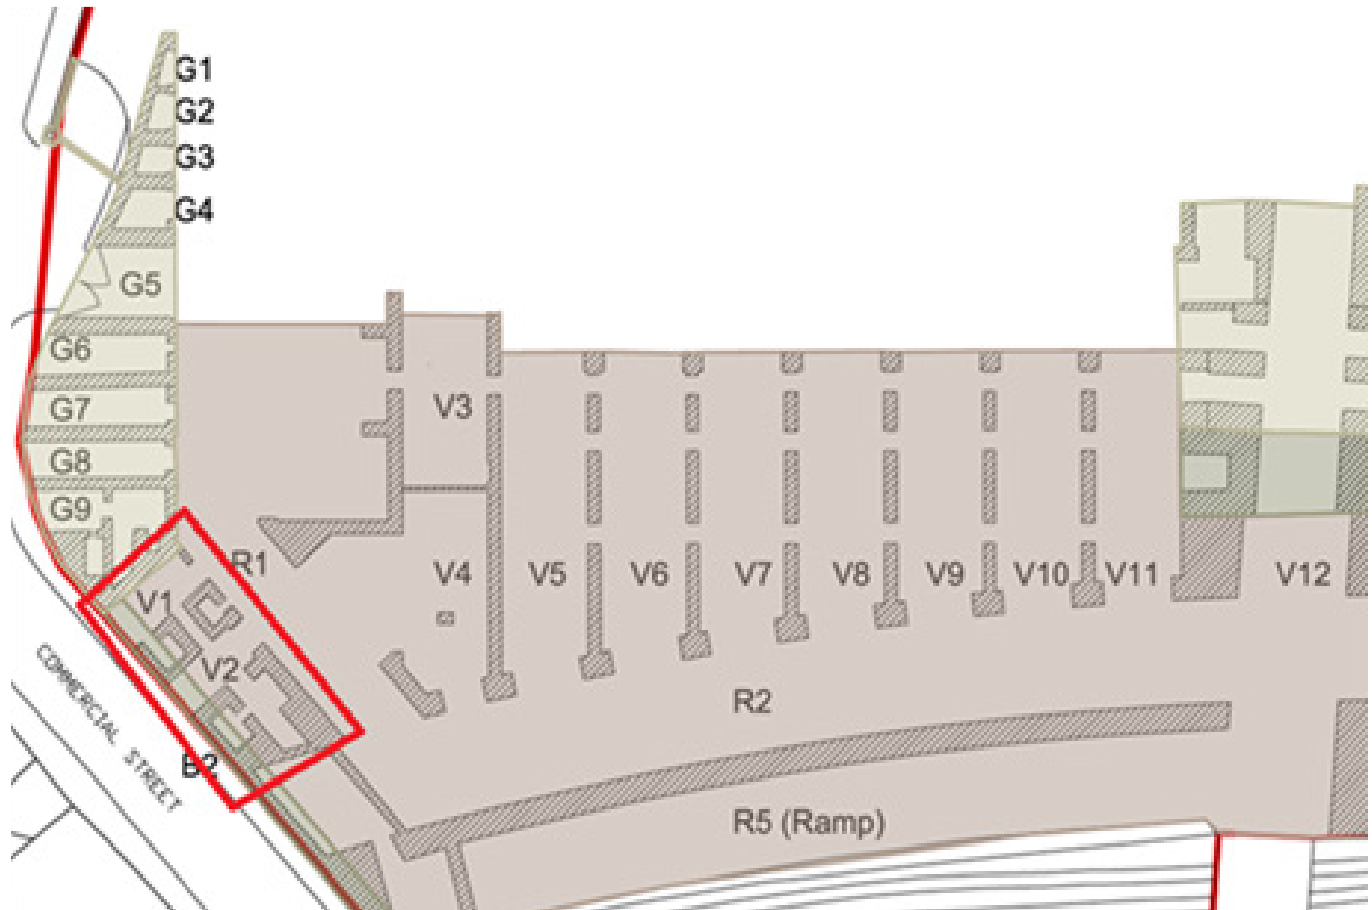
Fig 3.6.20: Extent of survey in western arches

3.6.15 WSP undertook a visual inspection of those areas accessible to verify if any of the brick / jack arch structures had significantly deteriorated over the past 6 years compared to the Alan Baxter 2013 condition survey.
