REPORT N° STR 001

70-74 SCLATER STREET

STRUCTURAL EXTERNAL INSPECTION

OCTOBER 2017

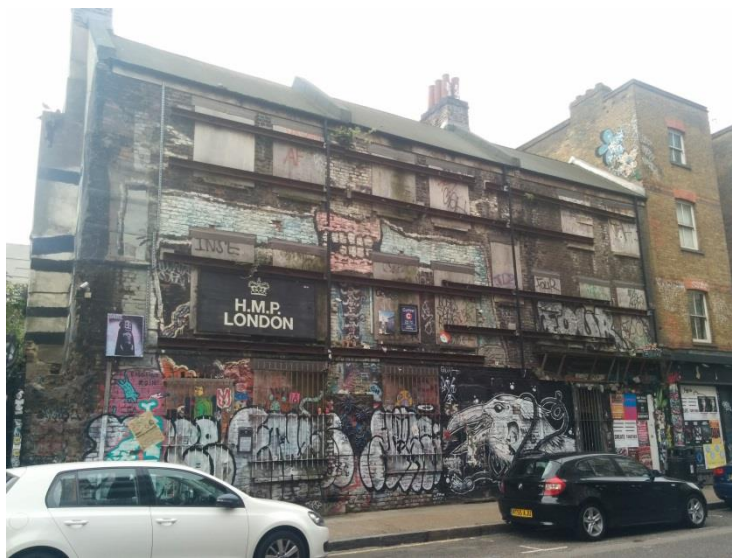
Numbers 70-74 Sclater Street – “Weavers” Cottages

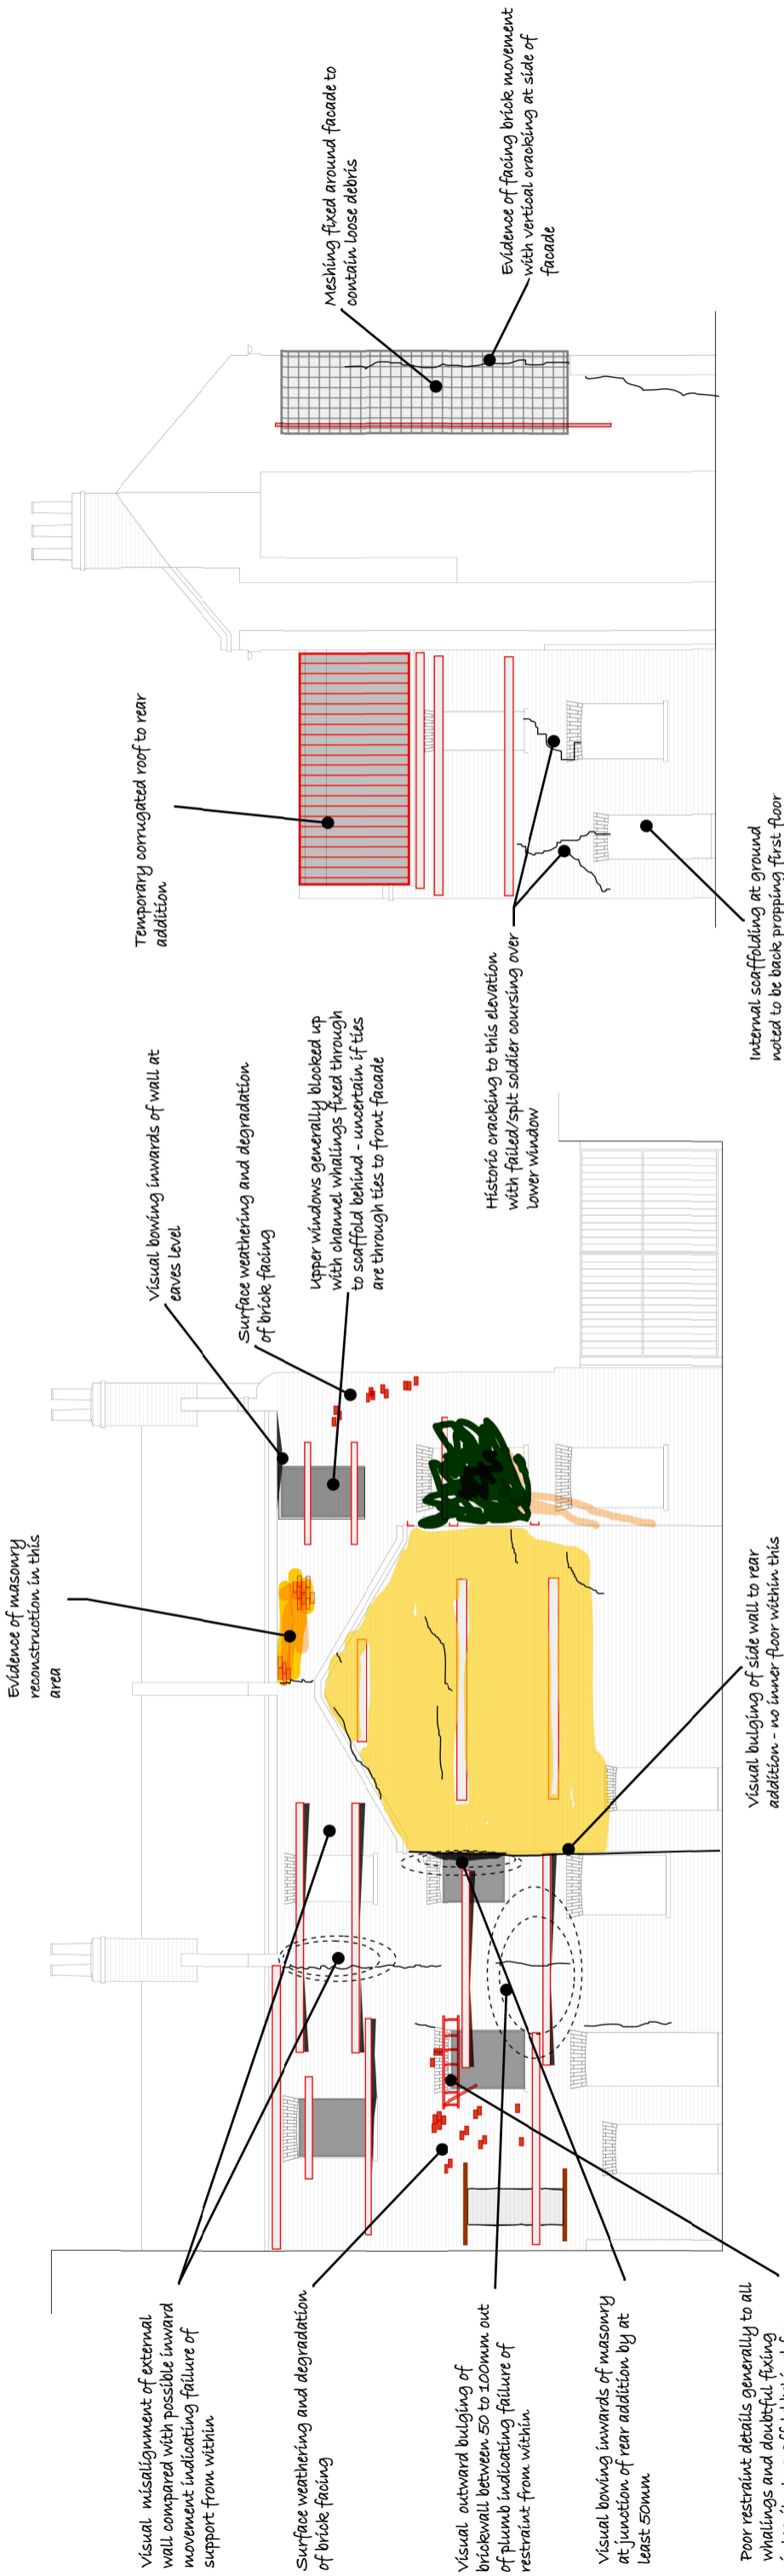
REAR ELEVATION

The external structure inspected was in poor condition, with clear evidence of out of plane wall bowing particularly to sections of the main rear elevation and western elevation to the rear addition. Evidence of established organic growth in walls and gutters has further accelerated the poor condition of the masonry. Bed joints are in some cases heavily eroded, examples of this were found on the rear elevation near the east end. Brick facings had also deteriorated due to weathering. Whilst the roof to the main building appeared to have been relined relatively recently, the existing roof to the rear addition was non-existent with a corrugated steel roof being pitched over and back propped by scaffolding beneath.

Due to the condition of the building, some areas of the existing building will likely have to be taken down in the first instance and rebuilt, which lends some gravitas to a more developed solution for extending the rear. See Appendices for anticipated areas of demolition and rebuild.
