Technical Note

Project Thames Side West

Subject Dohm Wharf River Wall Quarterly Inspection – September 2018

Date 28 September 2018

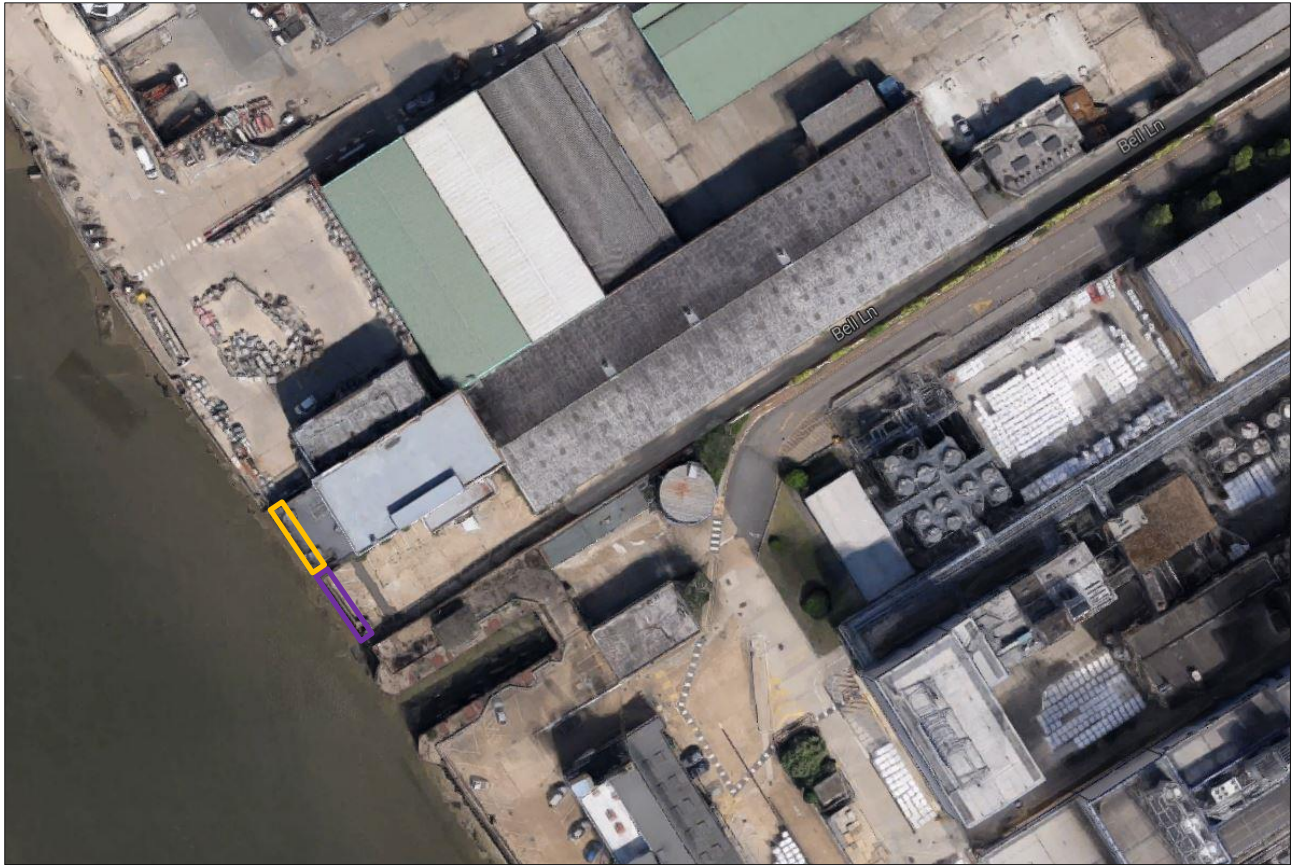
Figure 2.1: Aerial view of Dohm Wharf showing inspection areas

A visual inspection of the river wall was carried out from the land side, with access gained via the following two areas shown in Figure 2.1 which are separated by timber hoarding and a fire escape from the adjacent building.

- Concrete hardstanding (purple)
- The Old Basket Supply (TOBS) terrace area, both at ground and first floor level (orange)
