Project Thames Side West

Subject Dohm Wharf River Wall Quarterly Inspection – February 2019

Project no 035668

Date 14 February 2019

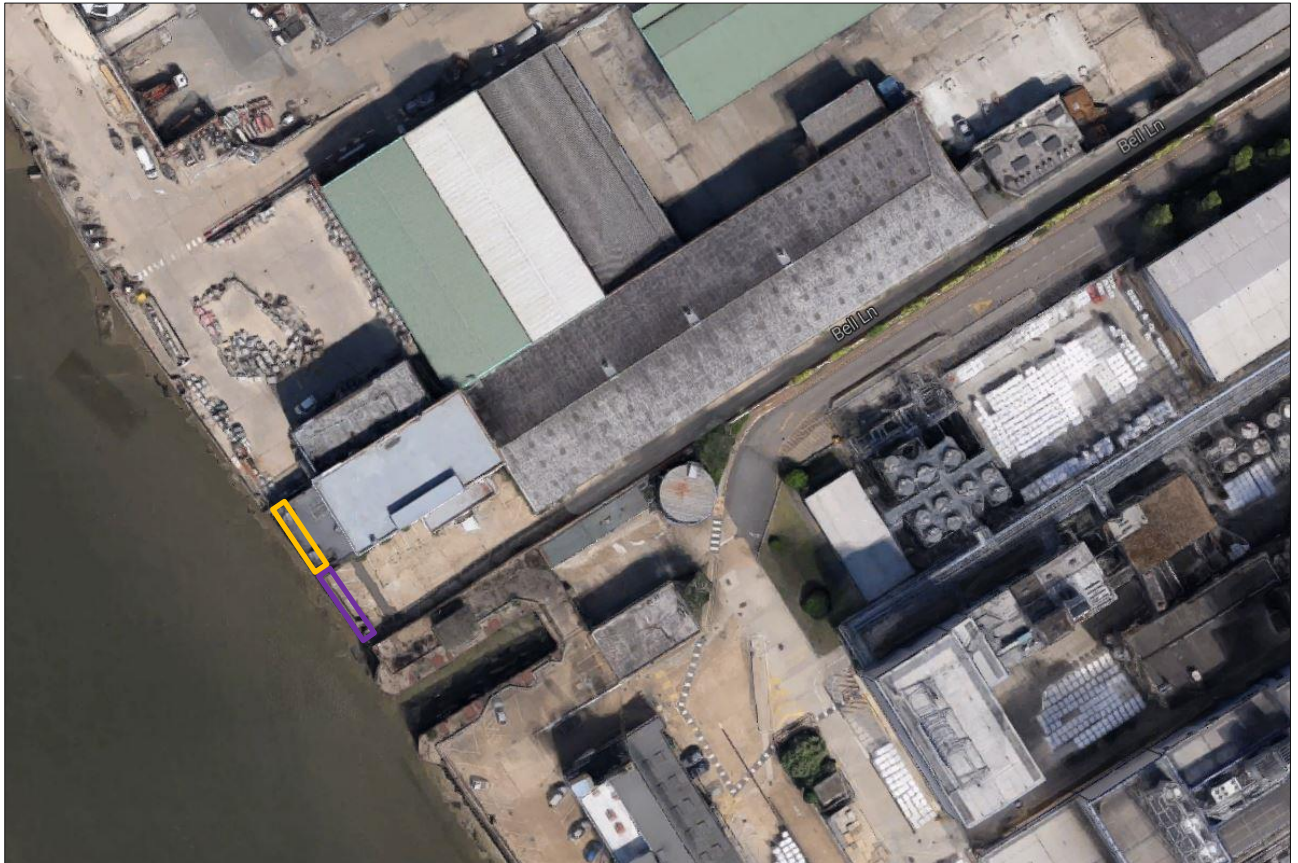
Figure 2.1: Aerial view of Dohm Wharf showing inspection areas

A visual inspection of the river wall was carried out from the land side, with access gained via the following two areas shown in Figure 2.1 which are separated by timber hoarding and a fire escape from the adjacent building.

- Concrete hardstanding (purple)
- The terrace area of the former The Old Basket Supply Co (TOBS), both at ground and first floor level (orange)

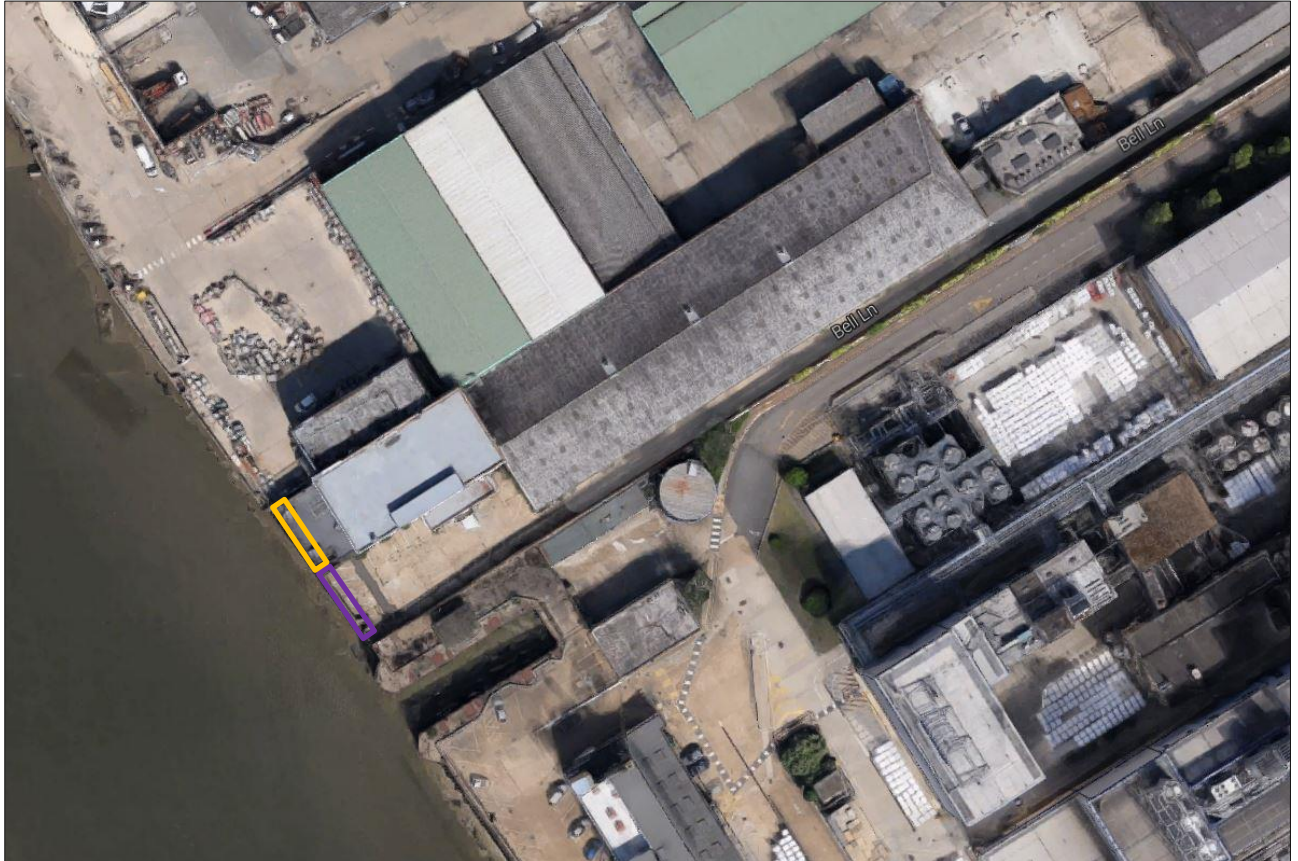
Figure 2.1: Aerial view of Dohm Wharf showing inspection areas

A visual inspection of the river wall was carried out from the land side, with access gained via the following two areas shown in Figure 2.1 which are separated by timber hoarding and a fire escape from the adjacent building.

- Concrete hardstanding (purple)
- The terrace area of the former The Old Basket Supply Co (TOBS), both at ground and first floor level (orange)
