Surface Water Management Plan

Infiltration SUDS Suitability Map

Desk Study Site Investigation Extract

5 Ground Conditions

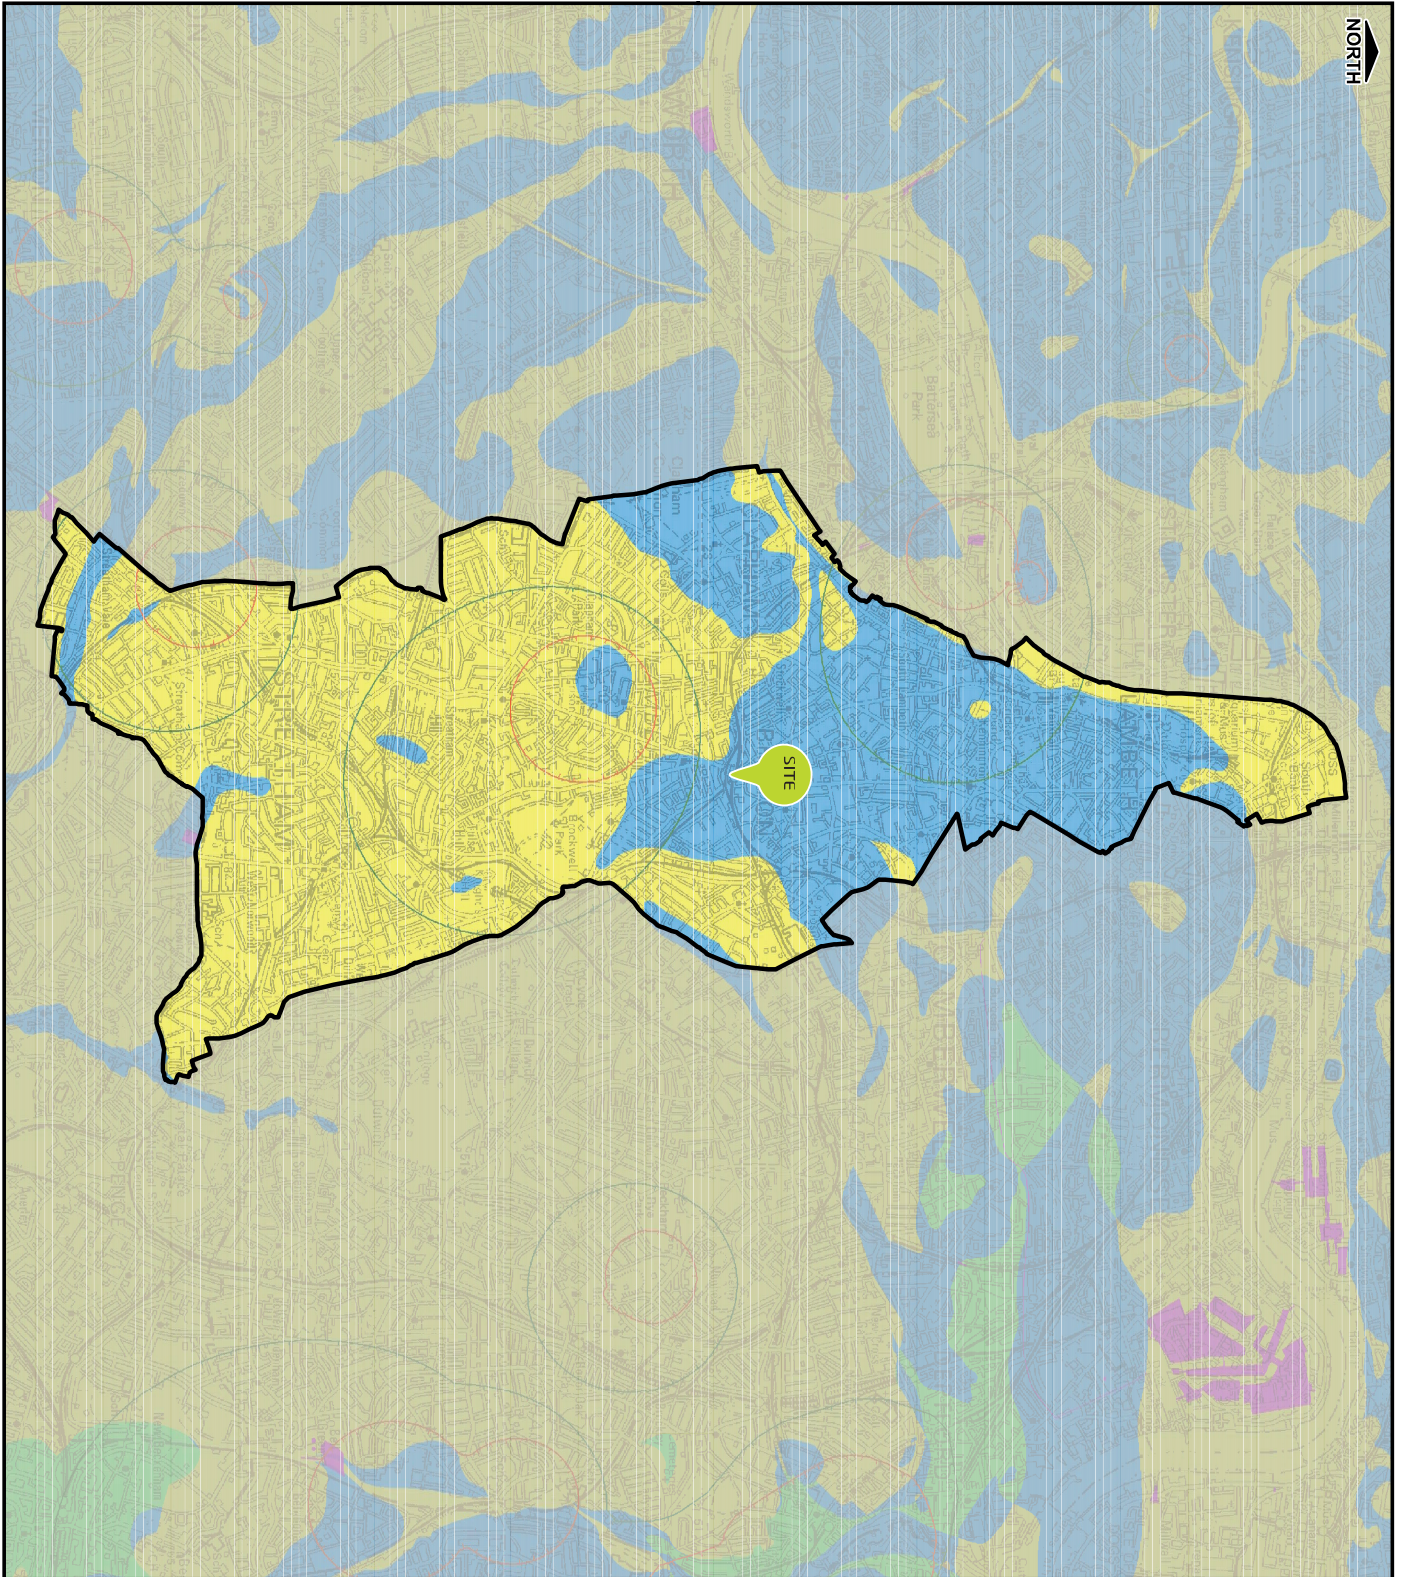
FIGURE 4

This map forms an approximate guide to Infiltration SUDS Suitability. However, for all new developments, site investigation is required to confirm local geology, depth to groundwater and infiltration rates.

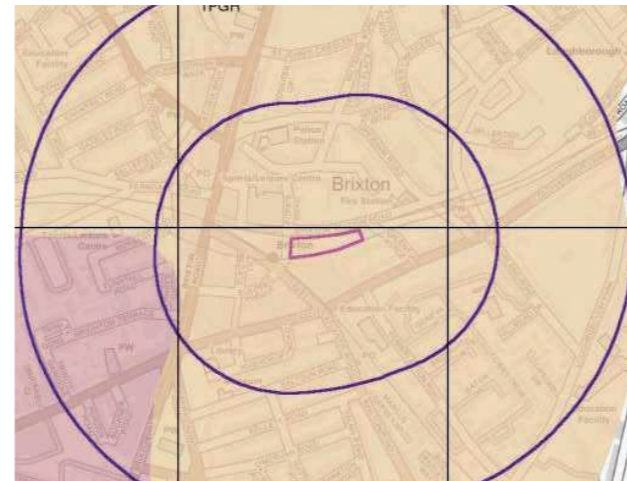
Figure 5.1 BGS map showing superficial geology

Geological maps from the BGS indicate the superficial strata to be made up of Taplow Gravel Formation (TPGR) which is likely made up of a combination of sand and gravel, the exact composition and extent will need to be confirmed as part of the future site investigation. The superficial strata is underlain by a layer of London Clay which forms the bedrock geology.

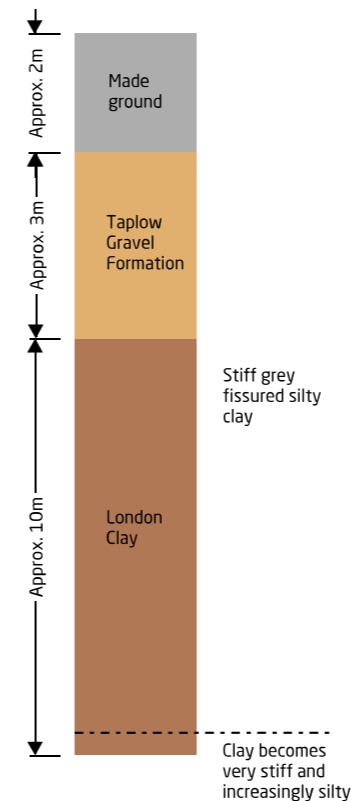
Figure 5.6 Indicative borehole

The indicative borehole below has been created from the information from these boreholes combined with internal experience from previous AKT II projects. However due to the age and the fact they were taken in proximity to the site and not within, it is recommended that further investigation is carried out to confirm the anticipated ground strata.

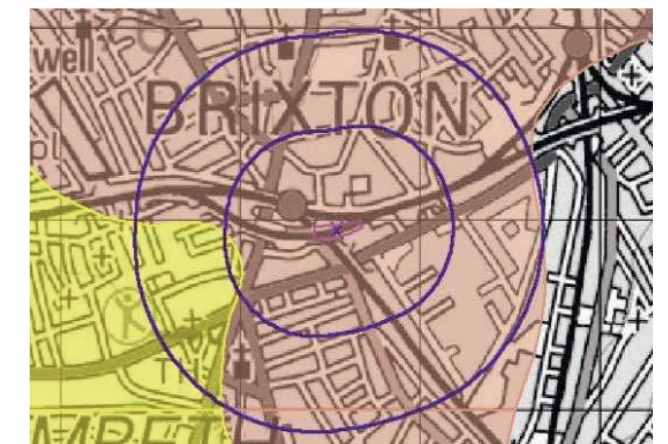
Figure 5.7 Superficial aquifer designation

- The groundwater vulnerability is classed a minor aquifer of high permeability;
- The superficial aquifer is designated as a Secondary A aquifer (permeable layers capable of supporting water supplies at a local rather than strategic scale, and in some cases forming an important source of base flow to rivers. These are generally aquifers formerly classified as minor aquifers);
- The bedrock aquifer is designated as an unproductive strata (these are rock layers or drift deposits with low permeability that have negligible significance for water supply or river base flow.)

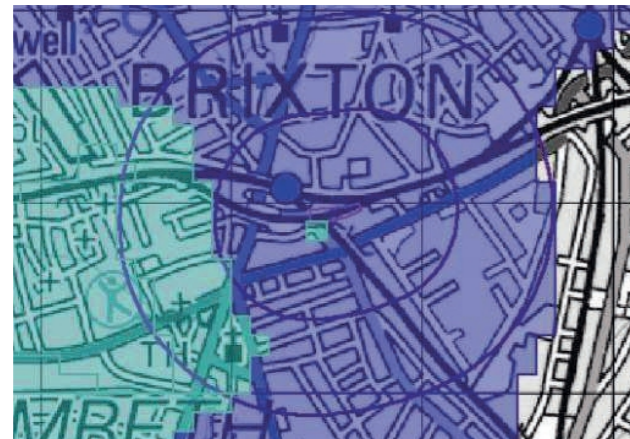
Figure 5.10 BGS groundwater flooding susceptibility

The following two maps provided by the British Geological Survey (BGS) and the EA indicate that the site could be subject to groundwater flooding under heavy pluvial conditions.

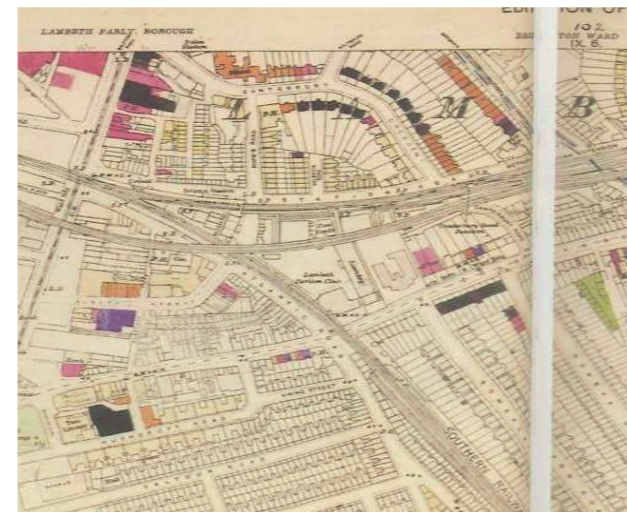
Figure 5.13 Bomb damage map

Although the presence of UXO is not indicated for this site, it can be seen in a few of the surrounding properties. The risk of UXO should be evaluated in the project risk assessment and a specialist consultant should be engaged, if deemed appropriate, in the next stages of design.

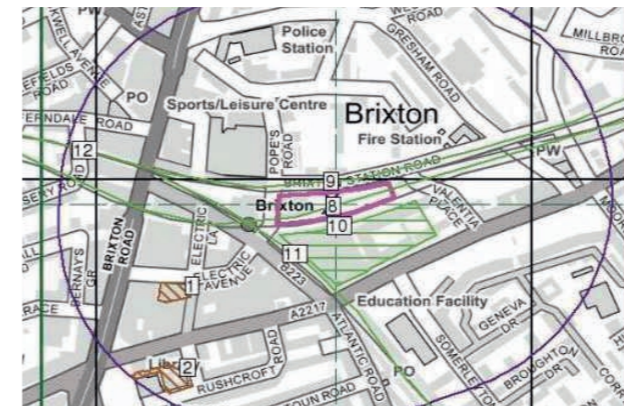
Figure 5.15 Historic land use map

Ground contamination maps show that the site is bordered to the south by a site highlighted as potentially contaminated due to past industrial land uses.

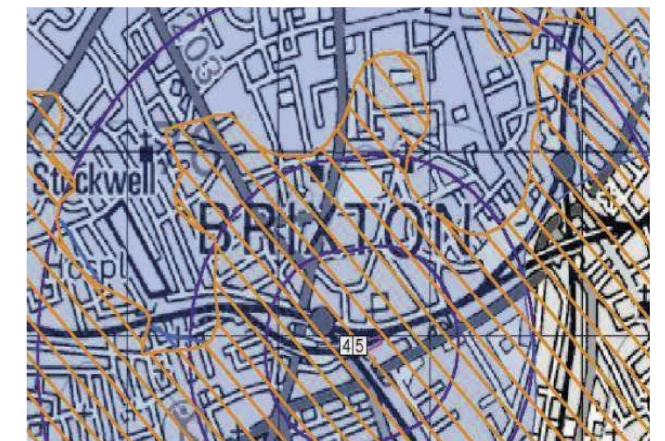
Figure 5.17 Ground stability data

The site is ranked as very low risk for:

- Compressible Ground Stability Hazards;
- Collapsible Ground Stability Hazards;
- Landslide Ground Stability Hazards;
- Ground Dissolution Stability Hazards;
- Potential for Running Sand Ground Stability Hazards.

The site does however fall under moderate risk for

- Potential for Shrinking or Swelling Clay Ground Stability Hazards.
