Tree Survey and Arboricultural Assessment

Aberfeldy Village

Arboricultural Impact Assessment

Report for Aberfeldy Village LLP

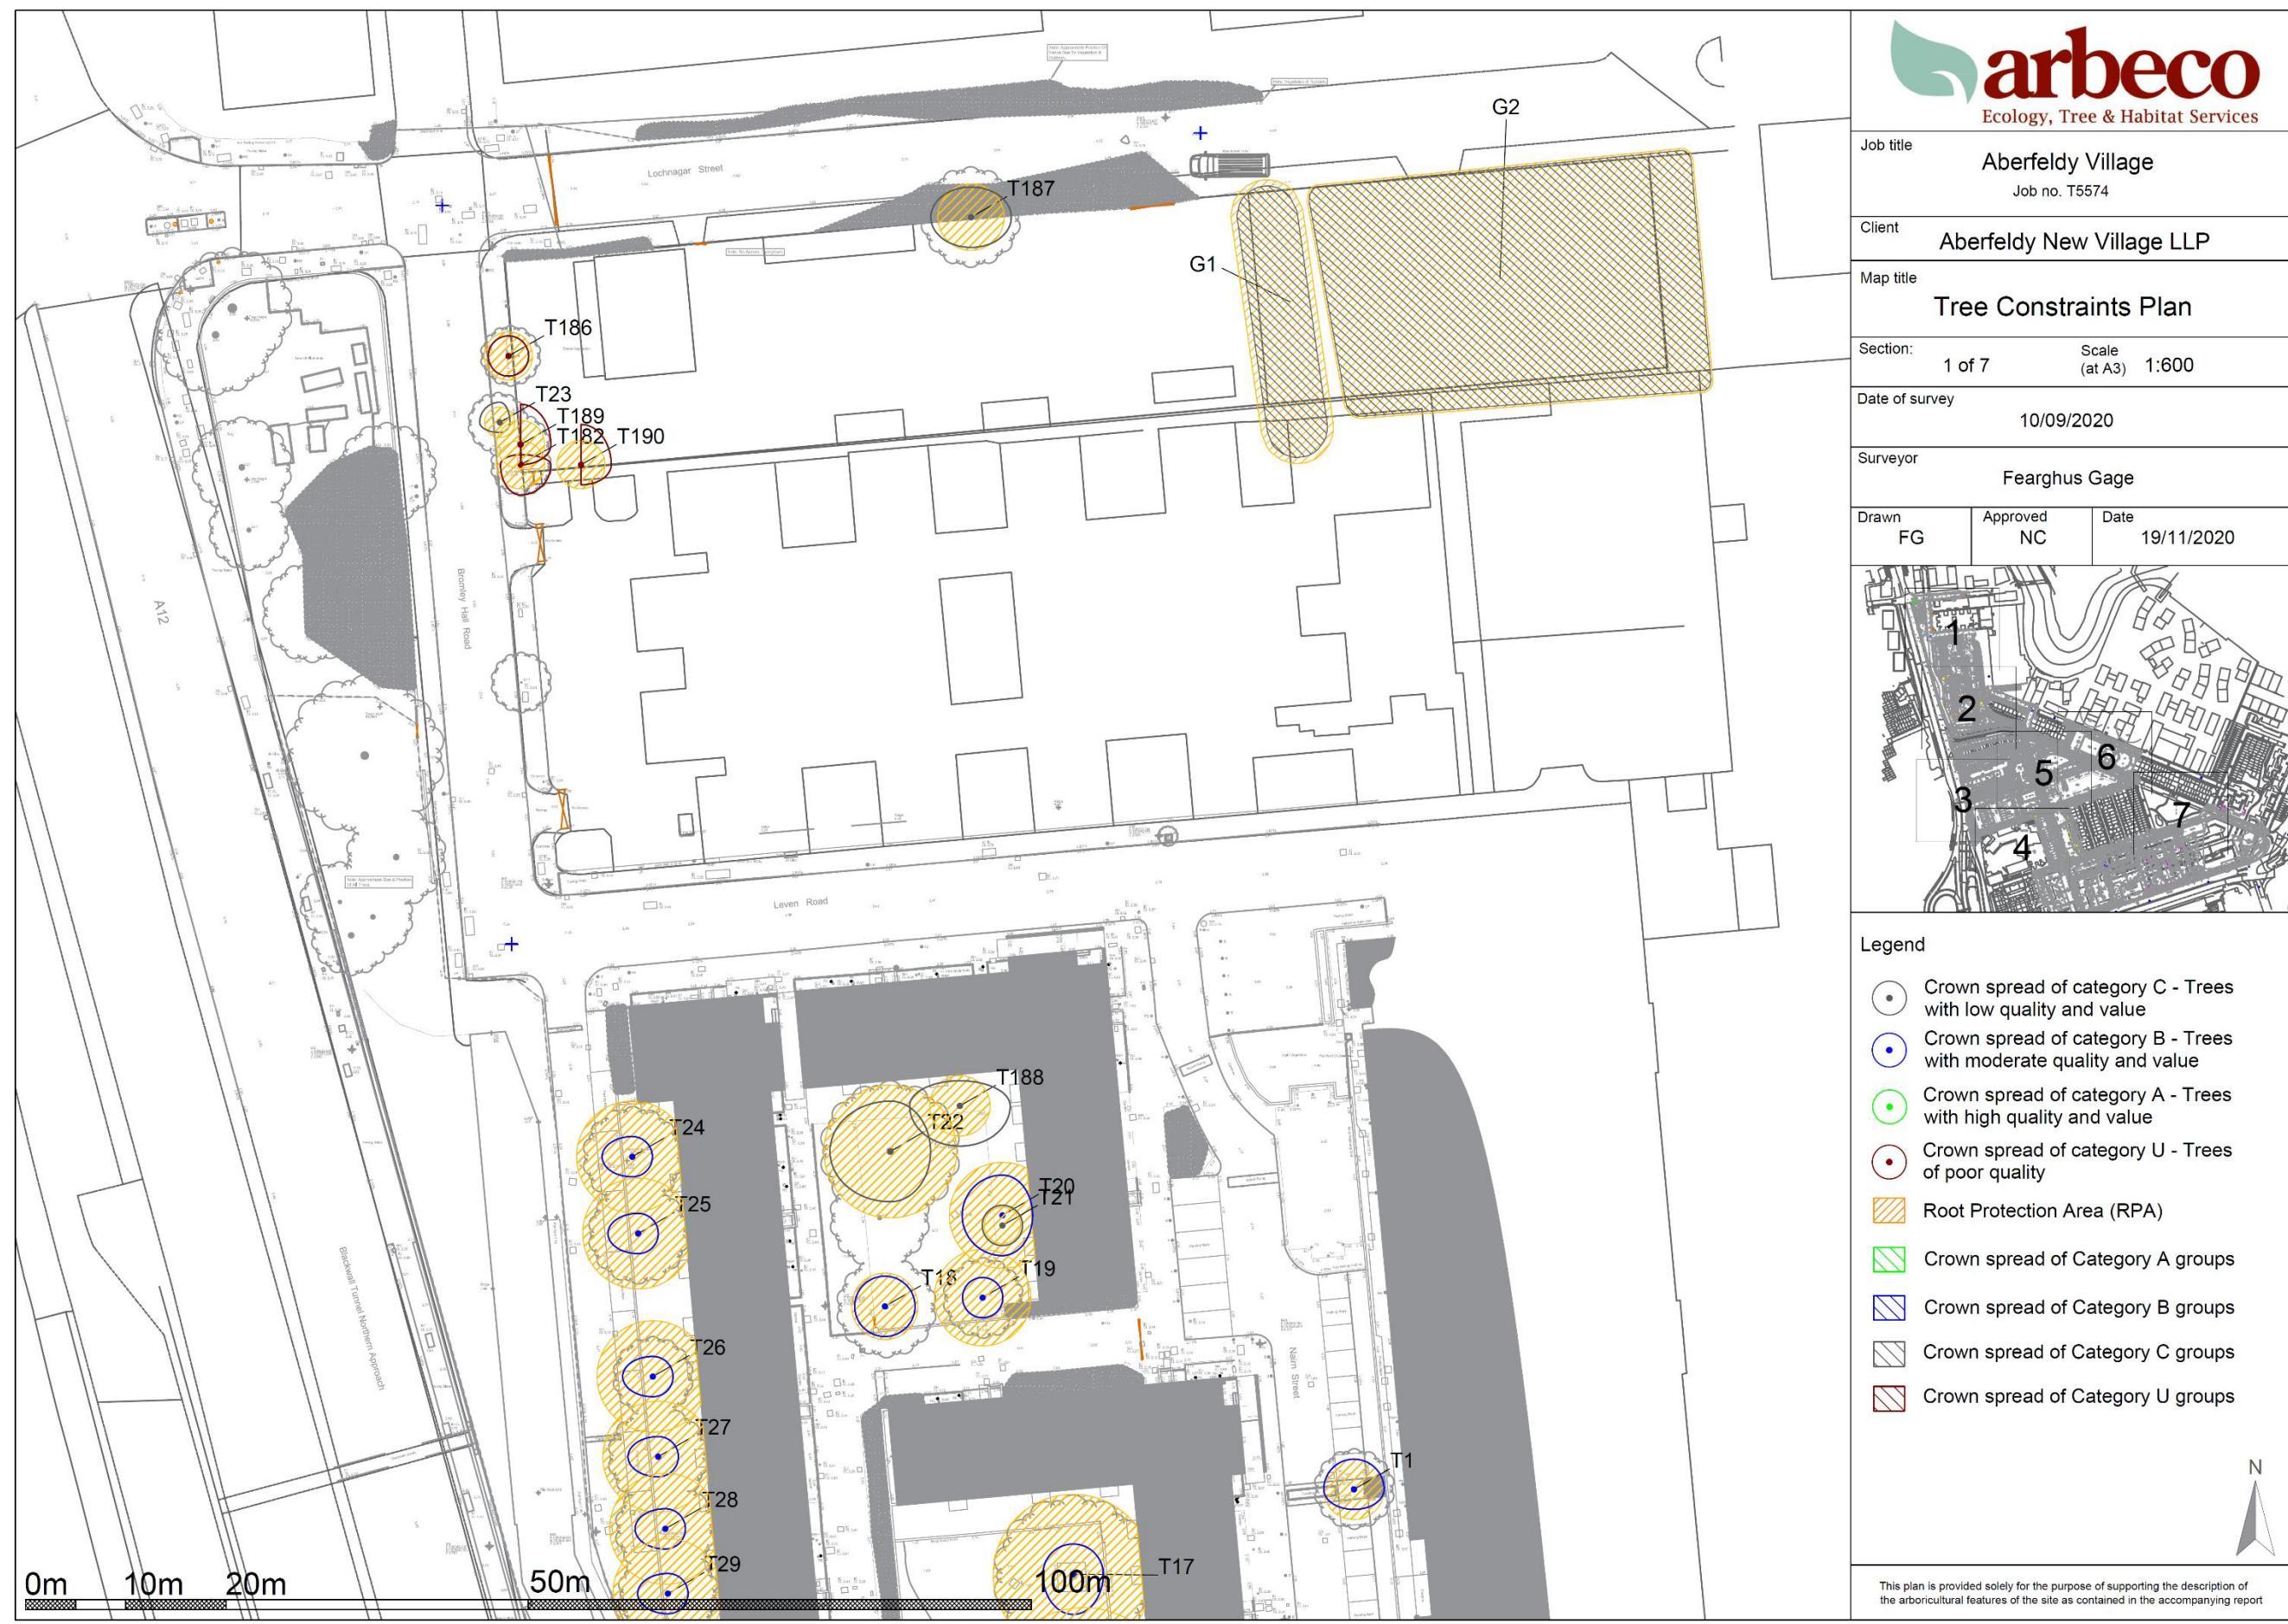
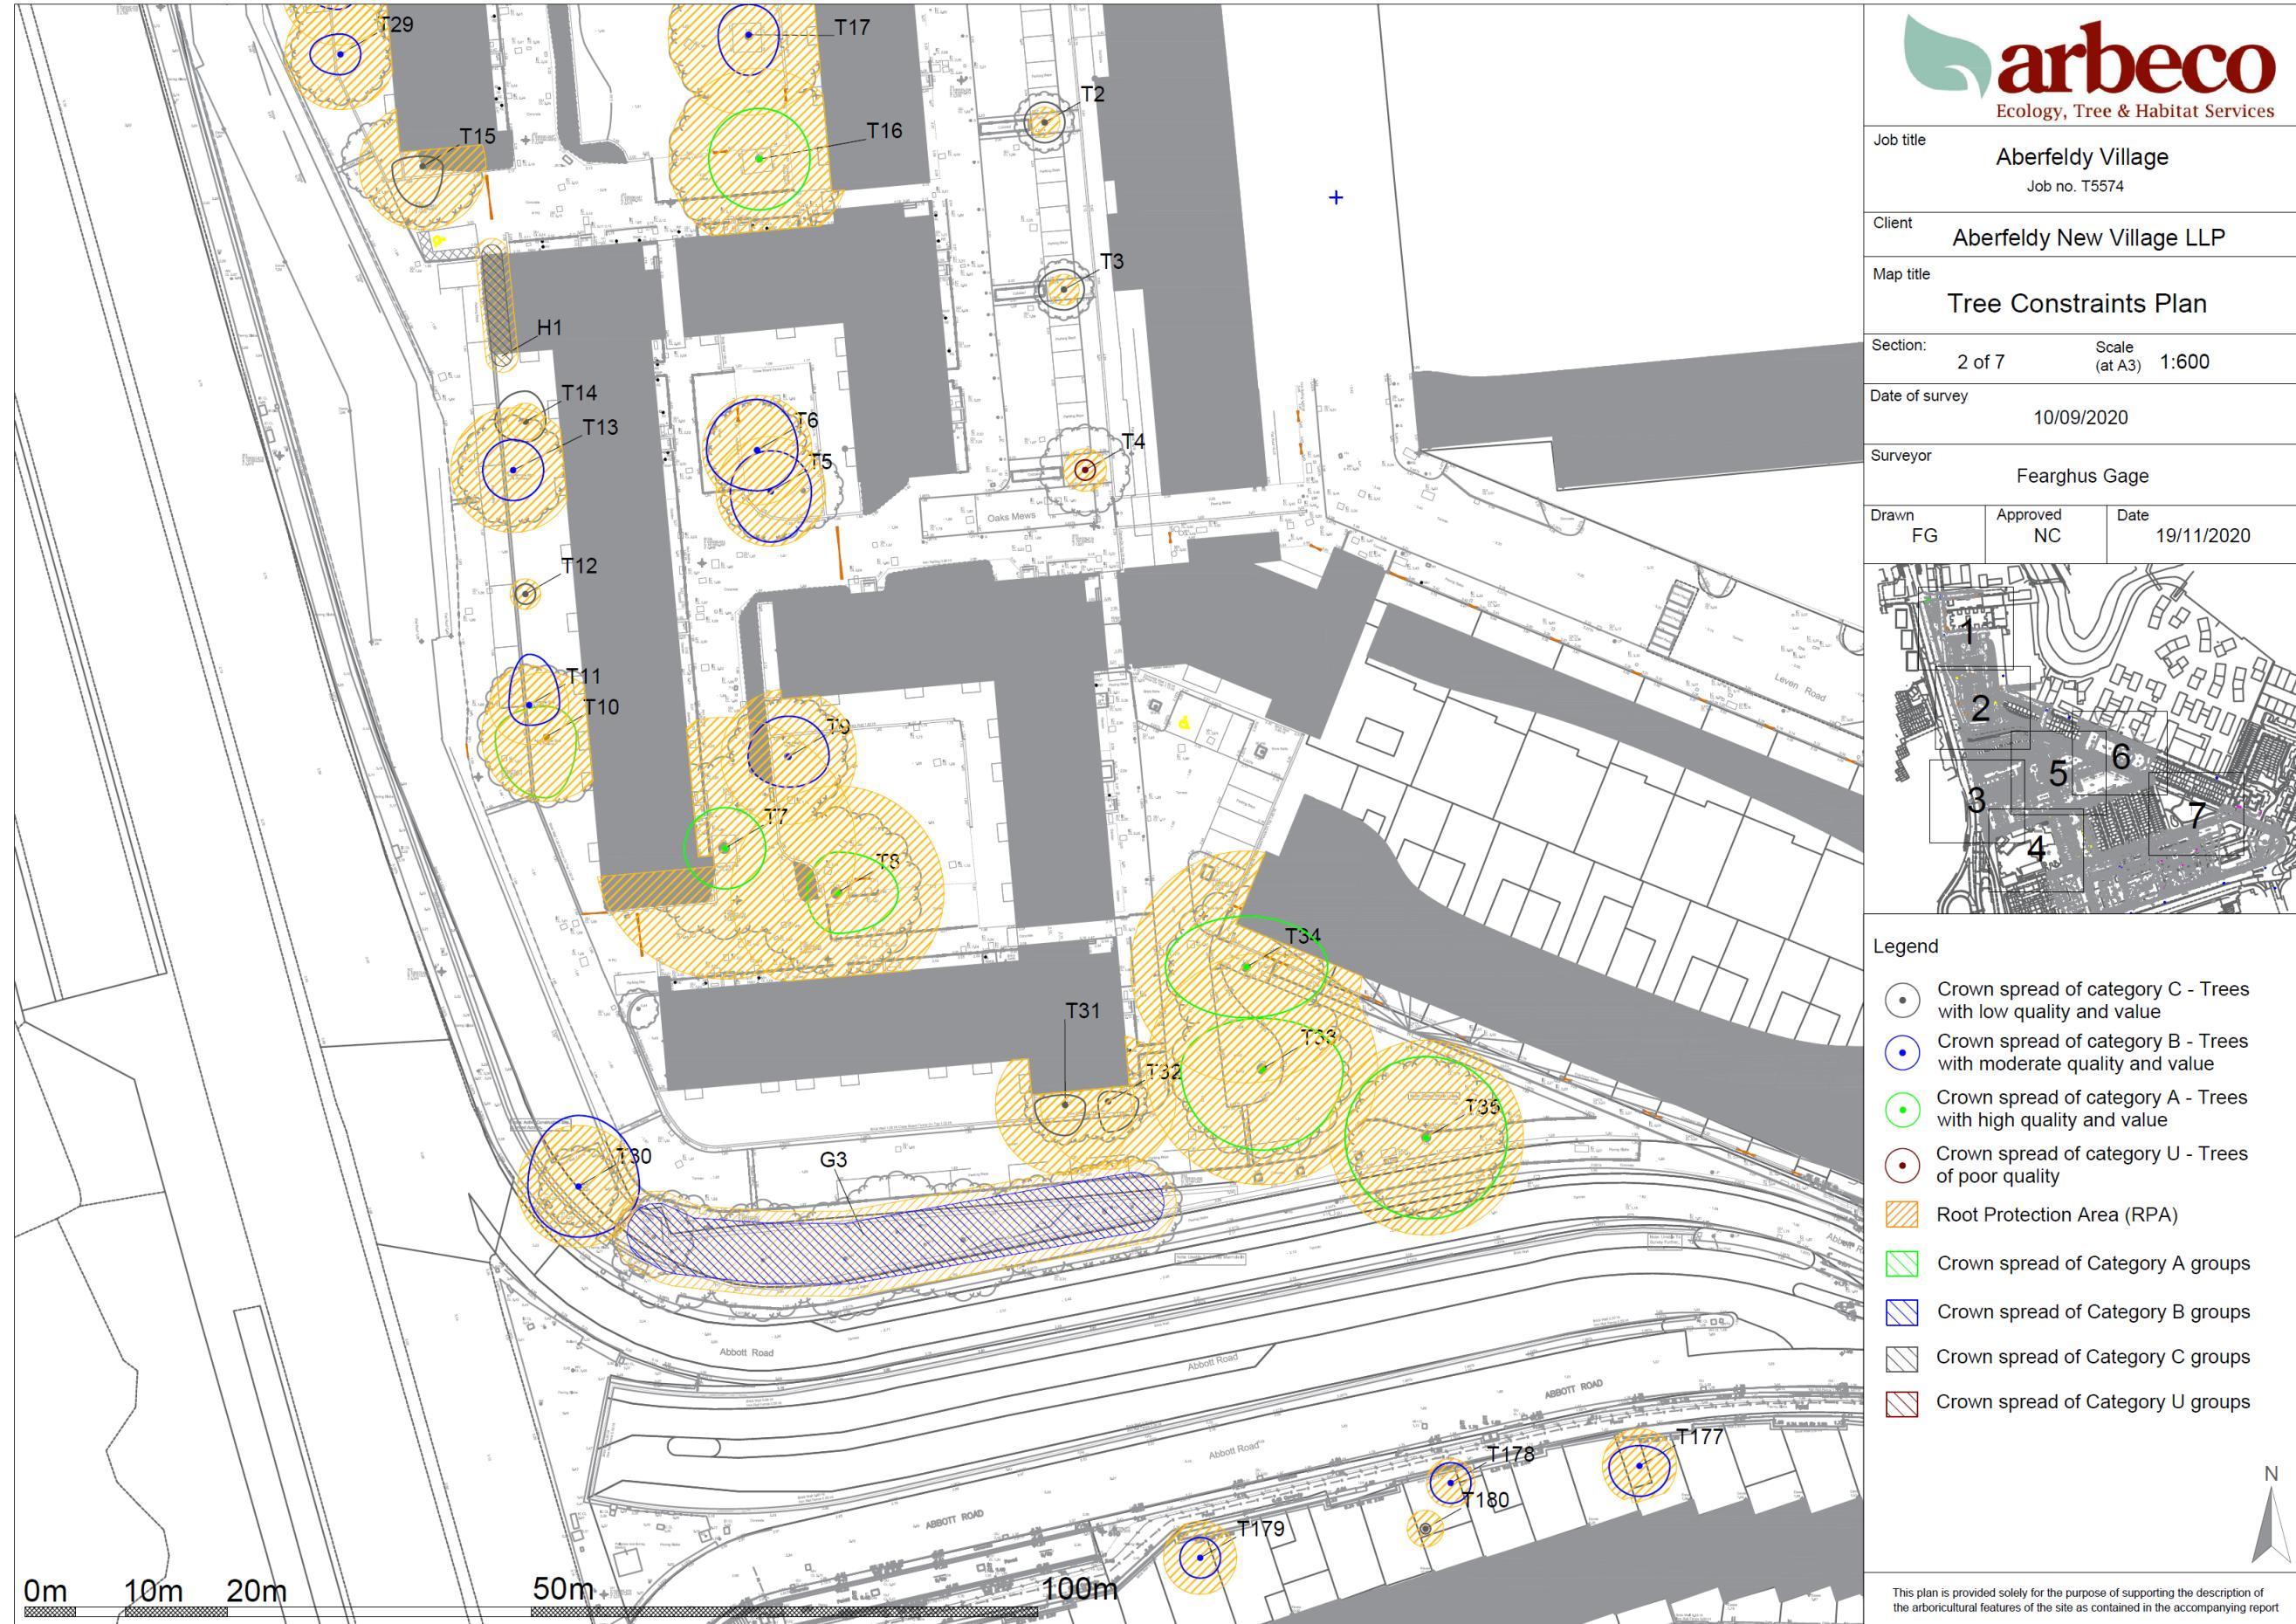
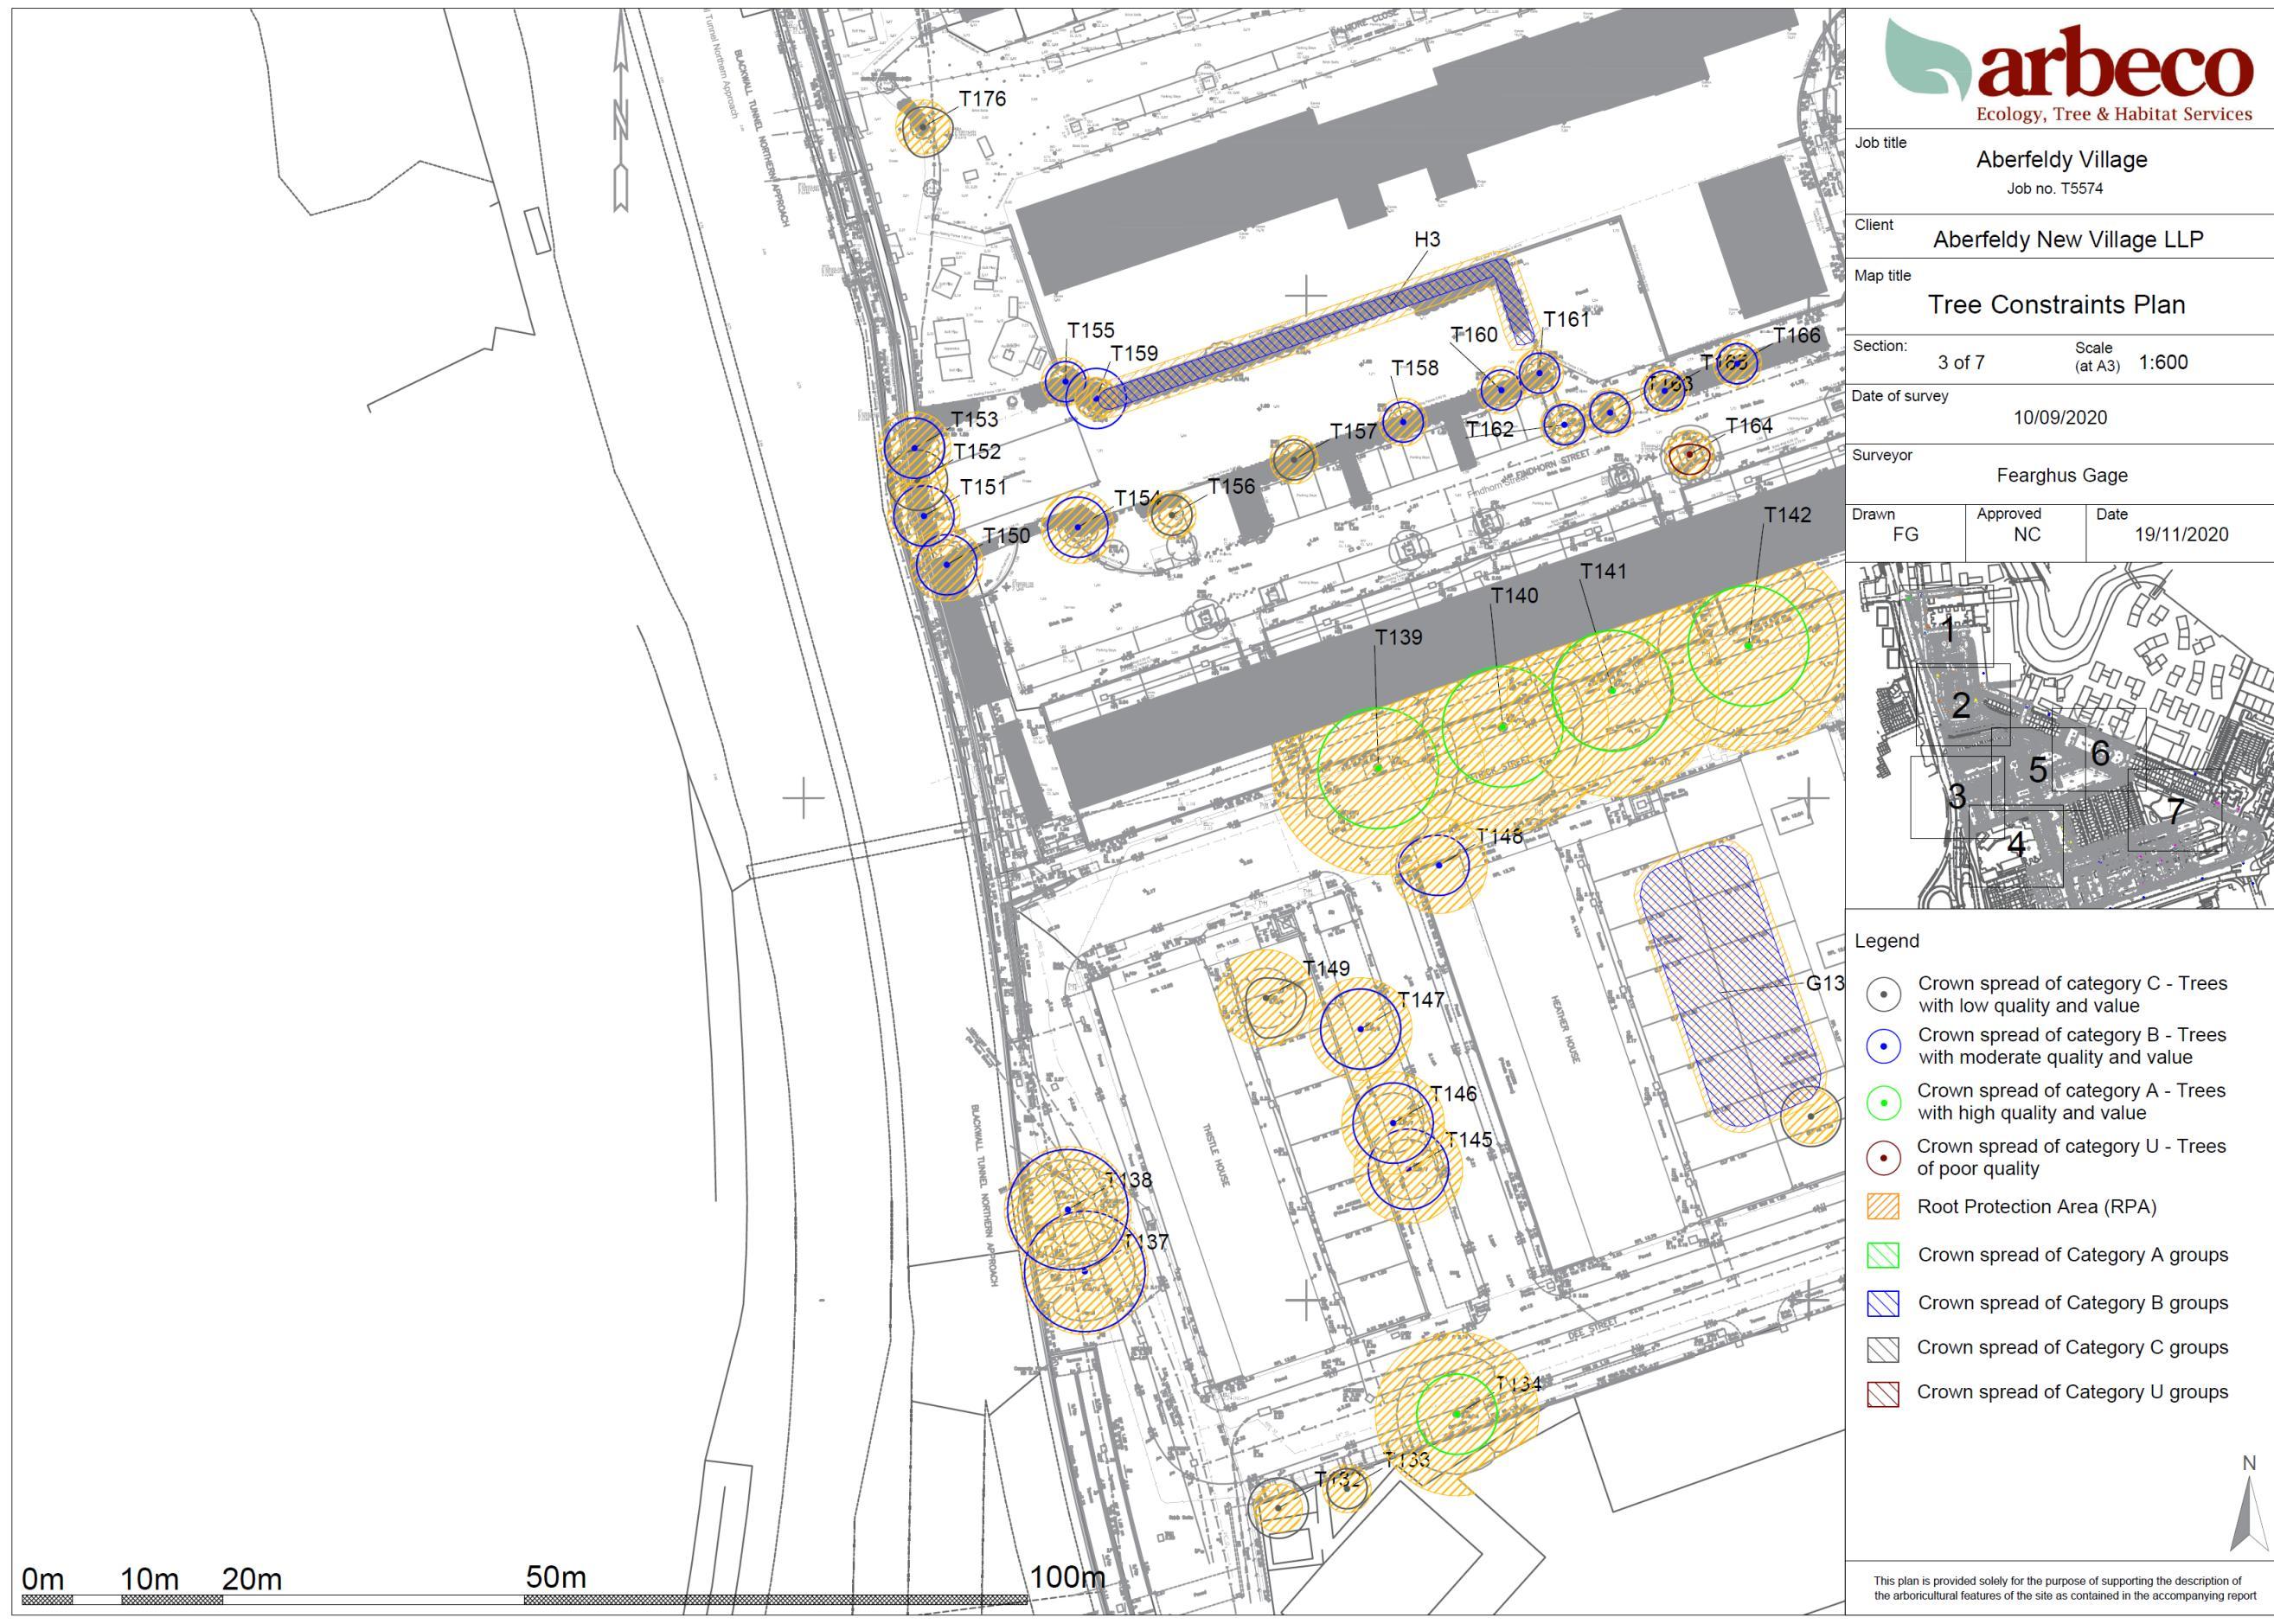
Appendix 2: Tree Constraints Plan

- 1.10 A tree constraints plan is presented in Appendix 2 showing the recommended root protection areas (RPA) for all surveyed trees. Each grading category has been highlighted using the colour key system as described in BS 5837:2012.

- 1.24 The results of the tree survey are provided in the Schedule of Trees in Appendix 1. A Tree Constraints Plan illustrating the BS 5837:2012 categories of each tree, their crown spread and RPA is presented in Appendix 2 and photographs of the site are provided in Appendix 5.
