PHASE 1 PRELIMINARY GEO-ENVIRONMENTAL AND GEOTECHNICAL RISK ASSESSMENT

Aberfeldy Village Masterplan, Aberfeldy Street, London E14 0NU

JER8921
Aberfeldy Village Masterplan
V2
R0
2nd July 2021

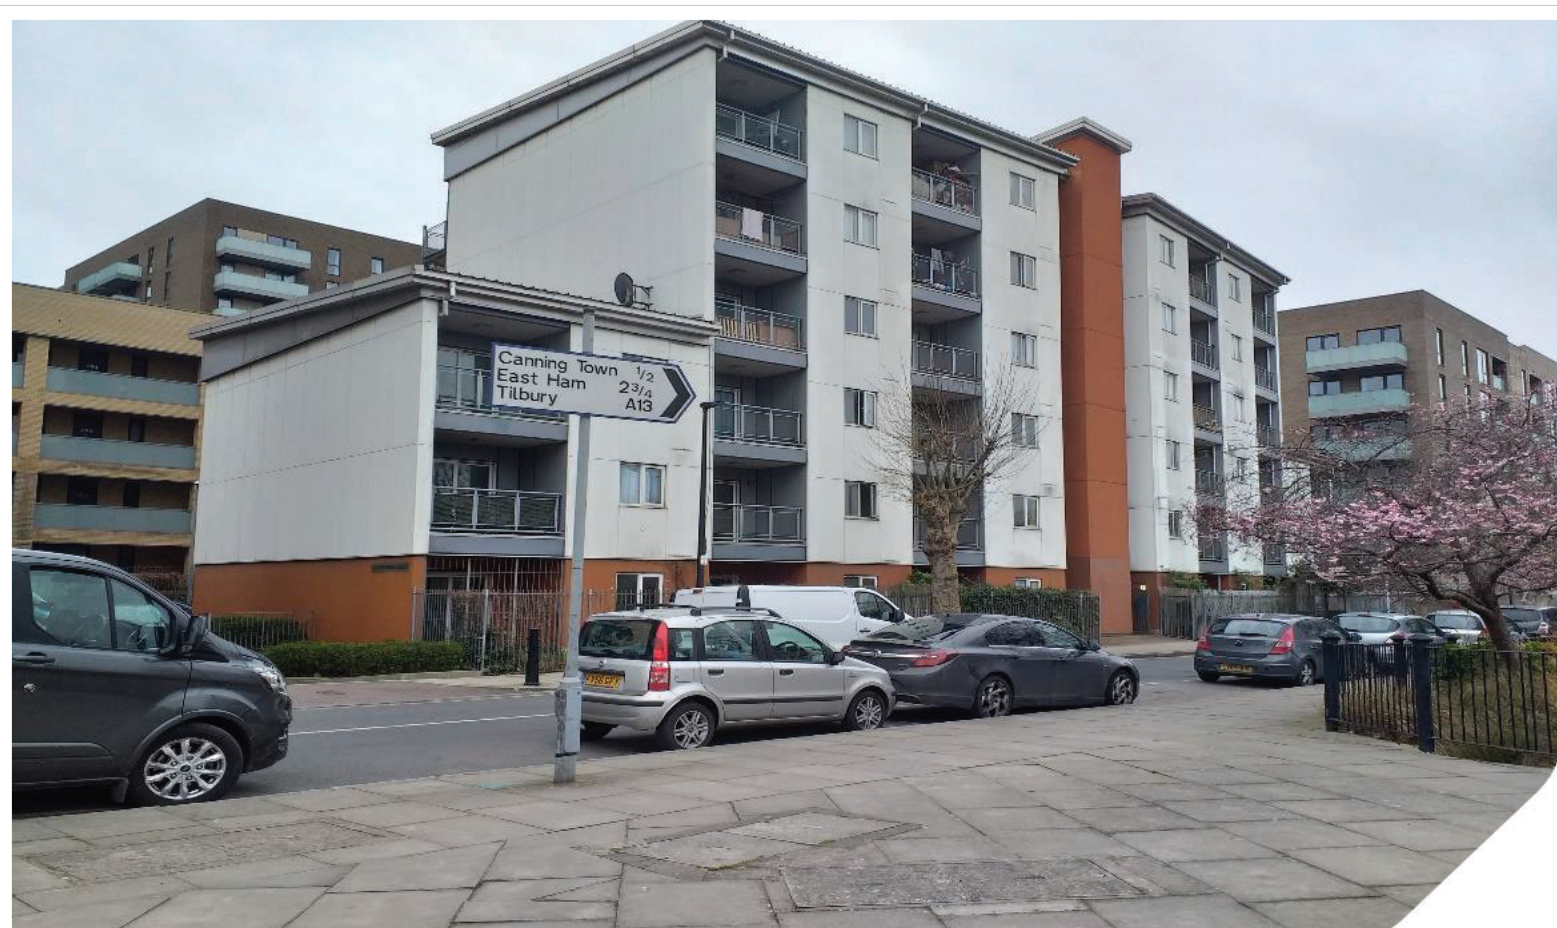
Photo 04: Blairgowrie Court

2.1.3 Located in the far east of the site, Blairgowrie Court comprises a five storey apartment complex to the south of Blair Street (Photo 04). The complex included an underground general and recycling refuse storage systems (Photo 05).

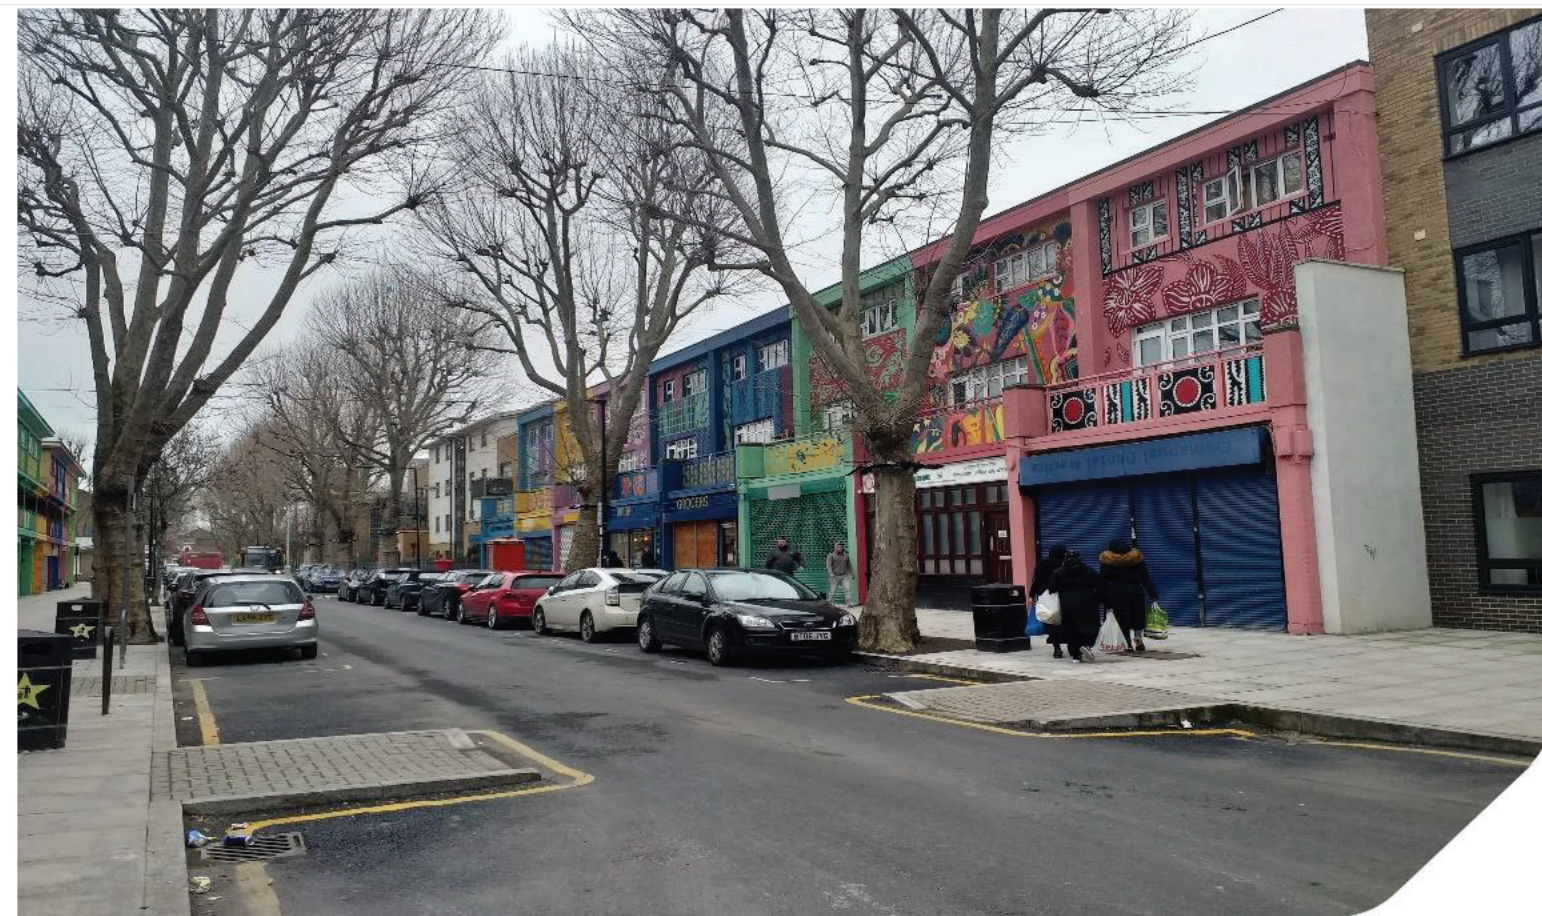
Photo 06: Aberfeldy Street

2.1.4 Located in the south of the site, this is formed of three storey brick built buildings on either side of Aberfeldy Street with retail premises at ground level and residential above (Photo 06). The retail premises were various and contained a number of takeaways, a pharmacy, general stores and an Islamic Cultural Centre. To the rear of these premises to the east, on Lansbury Gardens, is an area of hardstanding, which was being used for parking (Photo 07). To the rear of the shops to the west, on Kirkmichael Road, was a number of aircon units associated with the shops along with some cardboard recycling waste cages (Photo 08). A number of 1,000 litre wheeled recycling waste bins were located at the junction with Dee Street (Photo 09).
