Appendix C BuroHappold January 2020 Thameside West Visual Inspection Report

Technical Note

Project Thames Side West

Subject River Wall Inspection – January 2020

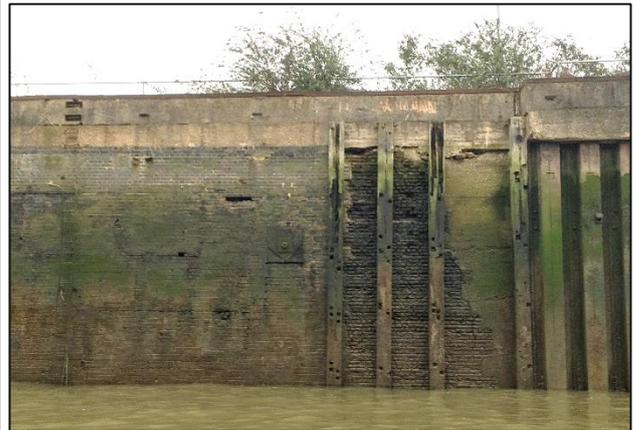
Figure 4-8: Downstream extent, showing older section of masonry with vertical timber fenders and loss of pointing

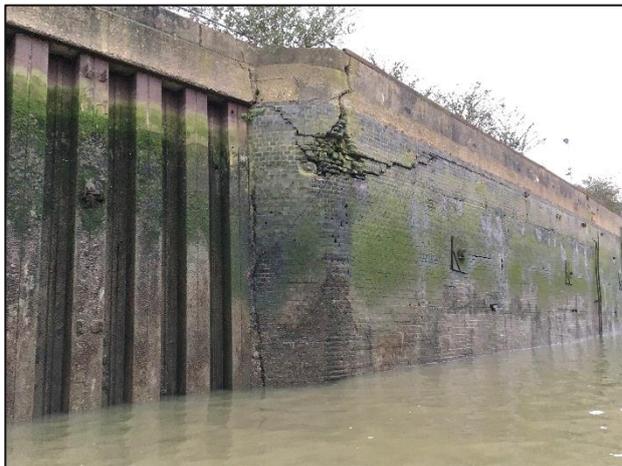
Figure 4-9: Upstream extent, showing unstable masonry

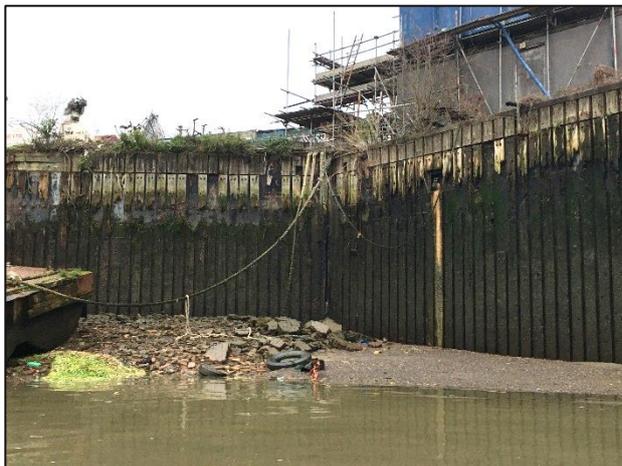
Figure 4-42: Former entrance to Royal Victoria Dock

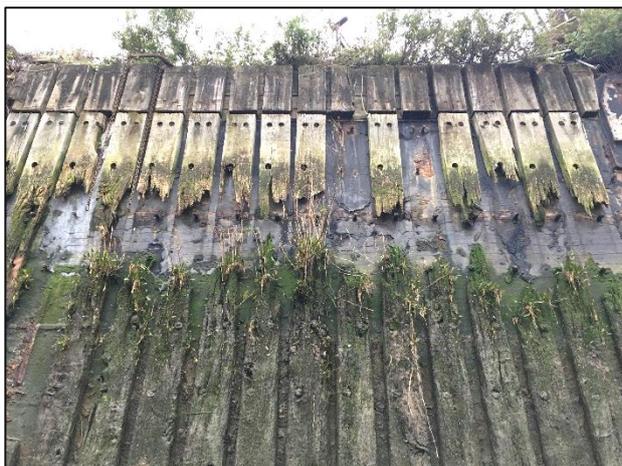
Figure 4-44: Steel lock gate with timber cladding
